Wilkinson, Kym and Thambiratnam, David and Ferreira, Luis (2005) Non Destructive Testing of Timber Bridge Girders. In Proceedings International Conference on Structural Condition Assessment, Monitoring and Improvement, Perth, Western Australia.

NON DESTRUCTIVE TESTING OF TIMBER BRIDGE GIRDERS

K Wilkinson, Prof D Thambiratnam and Prof L Ferreira
Faculty of Built Environment, Queensland University of Technology, Brisbane,
Australia

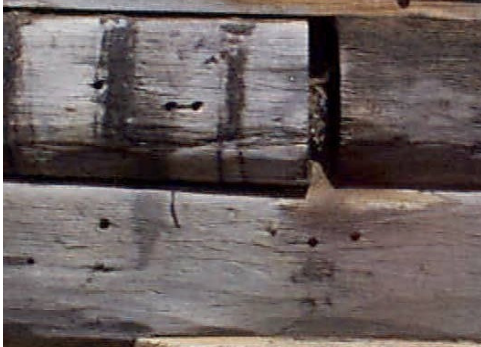
Figure 1: Damage from testing

Figure 1 shows the external damage that occurs to timbers from numerous tests and even though the amount of damage that is caused by a 12mm hole may be considered negligible, the damage caused by continuous testing must be considered. Preventative treatments are required after drilling to reduce rot, but from examining structures it has been evident that this procedure is not always carried out. Other forms of non-destructive testing must be considered when this failure in quality assurance and the repetitive and numerous locations that drilling is undertaken, is considered.

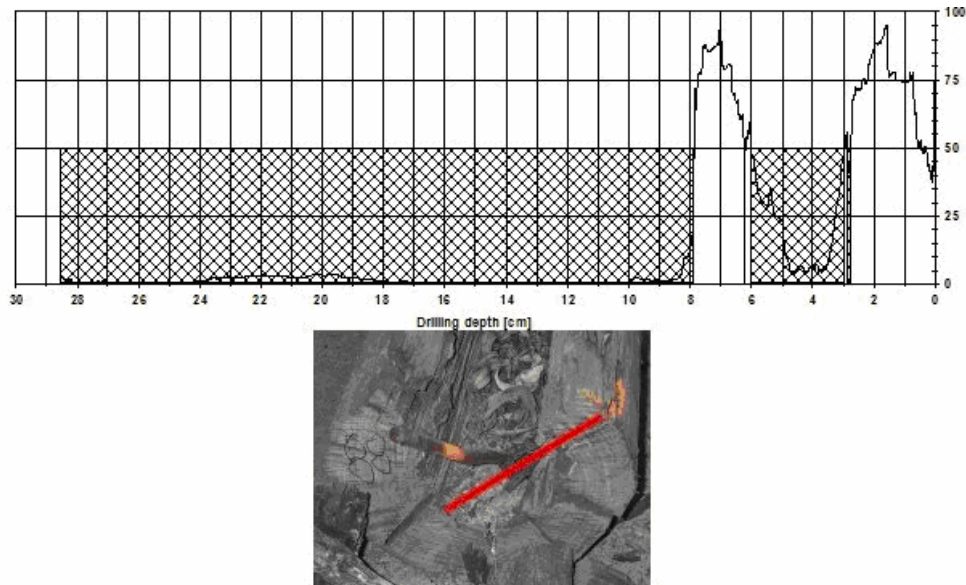
Figure 2: Resistograph Analysis

An example of a processed drilling is shown in Figure 2. The y-axis indicates the relative magnitude of the torque required by the drill to keep the bit moving at a constant speed. The x-axis indicates the depth that the drill has penetrated into the timber. After processing, information such as the location of cavities or advanced decay is indicated by cross-hatching. Further information such as the timber being soft or suspect can be included in the assessment if required.

The line shown on the photo of the girder in Figure 2 shows the approximate drill path. From examining the processed data it can be seen that the resistance of the timber dramatically drops at approximately 7.5cm and continues with negligible resistance for the rest of the drilling. However there is a discrepancy at around the 2cm mark. It is believed that the drill bit travelled along a crack in this softer area of the exterior fibres. This result correlates almost perfectly with the location of the void. It should be noted that the drill did not re-enter the solid timber. If this occurred the graph would have rapidly increased thereby showing a “U” shaped curve.

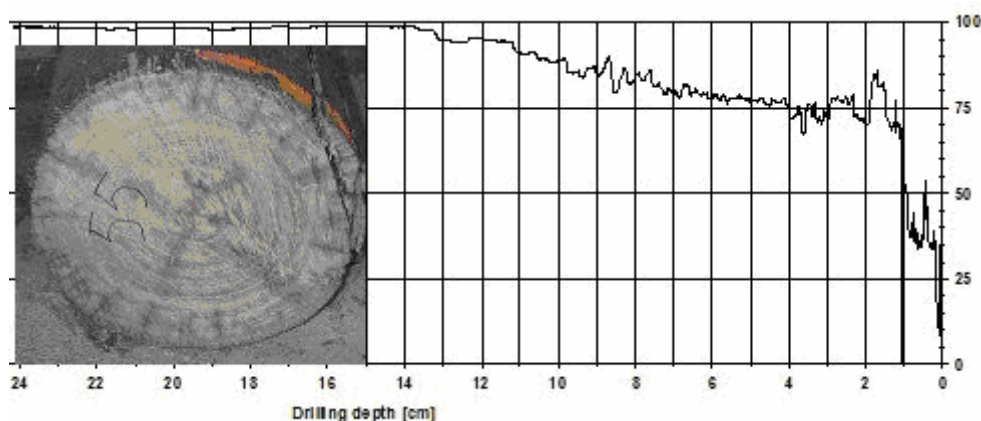
Figure 3: Correct Analysis

Initial analysis of the results of the drilling data undertaken by the abourist indicated that only 29% of the tests correlated with the actual samples of the cut girders. An example of a girder with correct predicted results is shown in Figure 3.

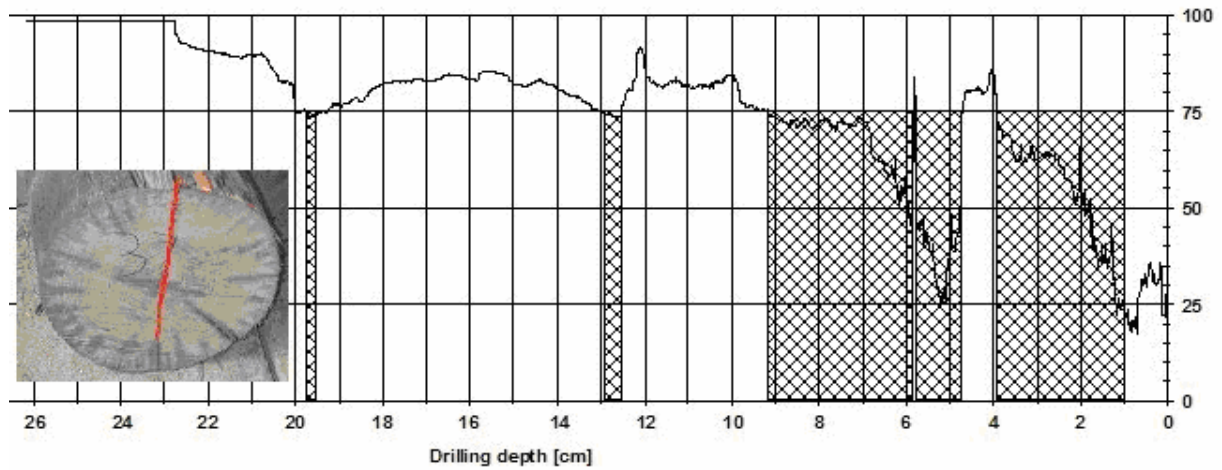
Figure 4: Cracking Identified as Cavities

Further investigation of the results showed that a large percentage of the "failed" tests indicated that there were cavities located in the first 5 to 8cm of the surface of the girders. An example of cavities being detected in the first 5 to 8cm of the girder is shown in Figure 4. The line on the picture of the girder indicates the approximate drilling path. From examination of the photo, it can be seen that there are no voids in the first 1-9cm of the girder as was indicated by the hatching on the printout. However, from further examination of the cross-section cracking can be seen extending towards the heart of the girder. It is concluded that due to the timber being softer in the location around the cracks that the resistance is lower in the outer region of the girder and that the drill bit had a tendency to follow these cracks. It is for this reason that while considering the predicted results that this outer section of the girder has been discarded during consideration of the results of the overall effectiveness of the resistograph.

Previously it was discussed that a number of the results showed that there were cavities located in the first 5 – 8 cm of the girder. Due to the number of false readings that were found in this region a methodology to limit the percentage of false interpretation is required.

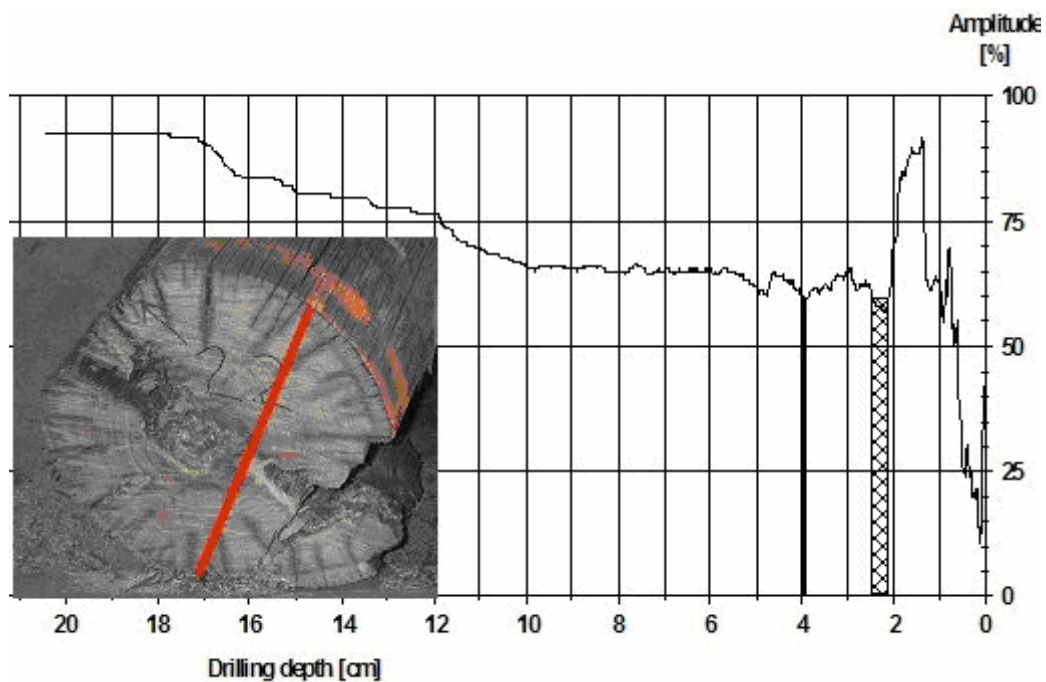
Figure 5: Missed void and rot

Of great concern is the Resistograph not detecting piping and rot in the centre of the girder. Two examples of this situation can be seen in Figures 5 and 6. The red line in Figure 5 indicates the path that the drill must have taken. From examining the drill path, it can be seen that it passes between two sections of rot. This problem is also experienced with conventional drilling. As the exact location of a defect is not known it is possible to not detect a defect.

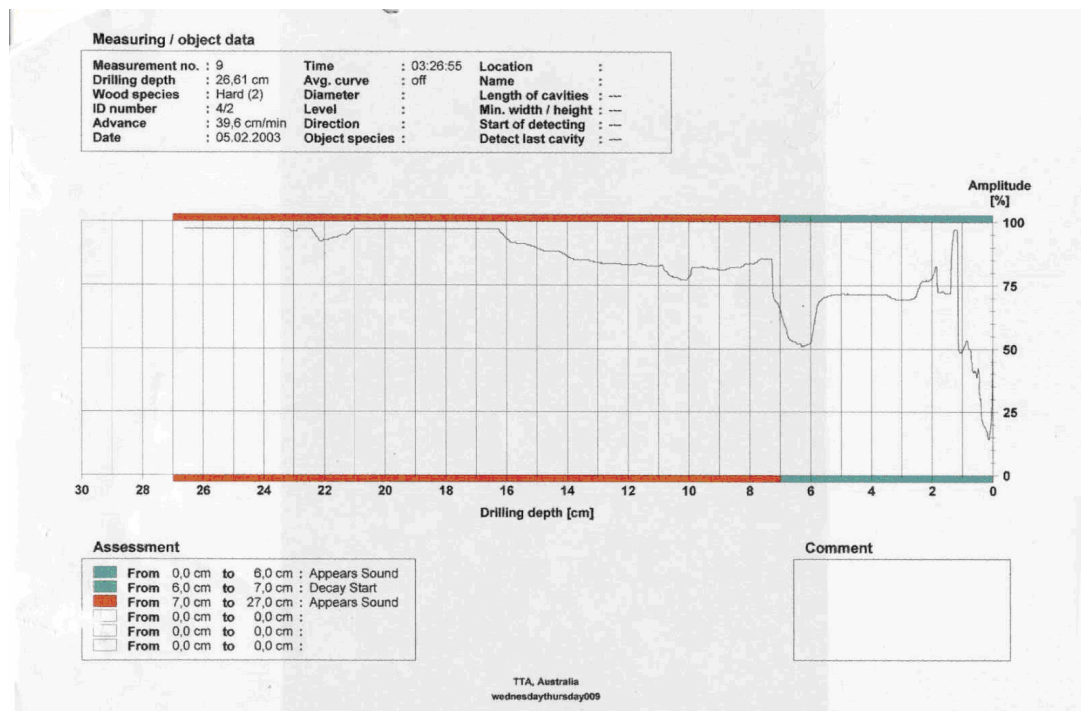
Figure 8: Results after Processing

A typical processed drill report is shown in Figure 8. In general, the results are presented clearly with both a visual and numerical interpretation of the degree of piping in the member. As part of the analysis the "Assessment" box was not always utilised. The use of this colour coding system would be a benefit to the end user to allow for a more detailed understanding of the state of the member. However, care must be taken to ensure that different colours are used to signify the different degrees of decay in the member.

Post processing of the data requires further attention to detail. As was discussed the first 5 - 8 cm of the girder has been ignored during the analysis of the results. It is proposed that this section of the graph be marked to indicate the variability of the girder. In addition, care must be taken to ensure that the colours used in the legend differ for each condition state of the timber.
