Science for Conservation

**STUDY OF THE BUILDING AND DECORATIVE
MATERIALS AND TECHNIQUES USED IN
HUNGARIAN ROMAN SITES**

Presentata da: **Anna Ruggeri**

Esame finale anno 2009

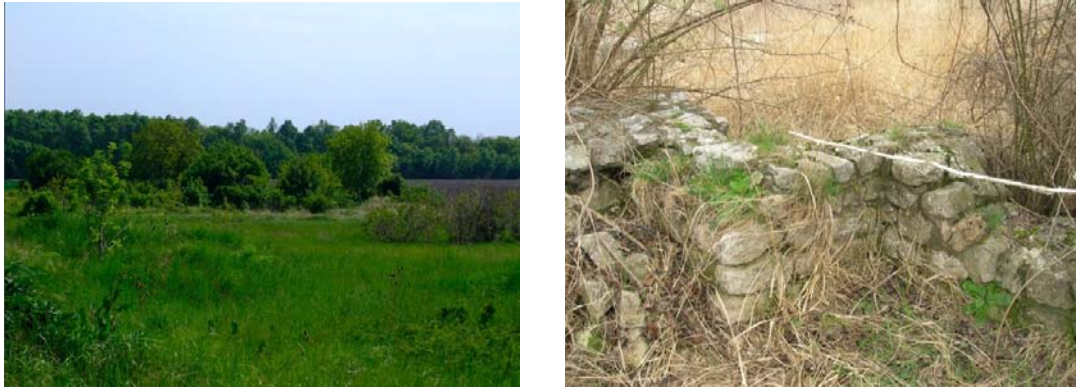
Fig.2 -3 Nagyharsány archaeological site from distance and a detail of a wall section.

There is no documentation on the criteria of selection and the typology of the material used during the partial restoring intervention on walls, carried out during last excavation’s campaigns. According to the common belief, the building stone used for replacing some parts of the ancient walls is compact limestone from local quarries.

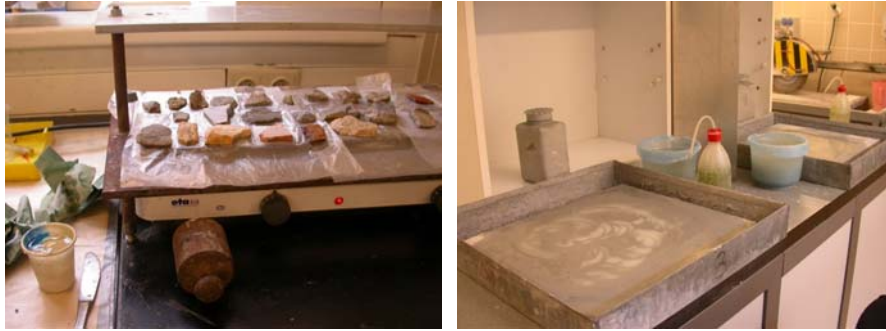
Fig.13-14 Heating table for the hardening of the resin and the equipment for the thinning procedure through abrasive powder of different granulometry (ELTE University laboratory in Budapest).

Afterwards, all specimens were cut and prepared for the thin section making process, The samples were cut by two different circular saw water-supplied systems, then fixed to the slides by the common bi-component epoxy adhesive Araldite (epoxyn resin with polyamine hardener Renshape Solutions REN HY 956). After the hardening, the excess of material was cut again and subjected to the thinning procedure, through abrasive powder of different granulometry on granitic slabs (fig.13-14).

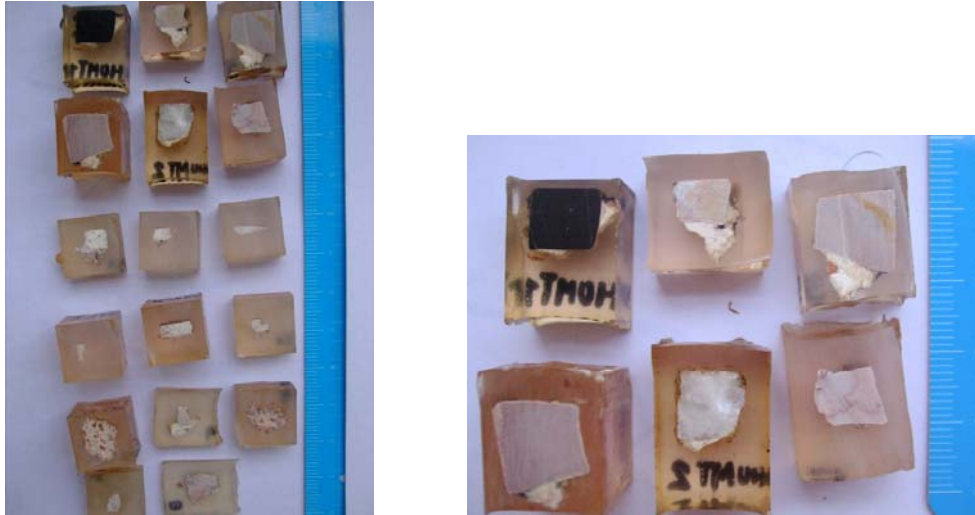
Fig.15-16 Cubes embedding mosaic tessera and mural painting samples.

Particular attention was paid to samples of mural paintings and mosaic tessera. Because of the value and the importance of those specimens, representative but very small specimens were collected. Dealing especially with mural paintings, the orientation for the cutting of the sample was set in order to obtain a thin section crossing the whole stratigraphy of the different layers, from the mortar substratum to the superficial painting layer. All samples were completely embedded in UV-hardenable reaction resin compounds (Custom Acrylic Resins, CAR-F150-F5). Afterwards they were irradiated in an UV-light applicator for the hardening. An initial, not activated reaction resin compound is irradiated after entering an input opening in a reactor having an irradiation space, a UV-radiation source.. Immediately after, the activated compound is supplied to the specimen to be surrounded, in an open casting mold. The final results (Fig.15-16) were many little glue cubes, which were cut and prepared for the thinning process.

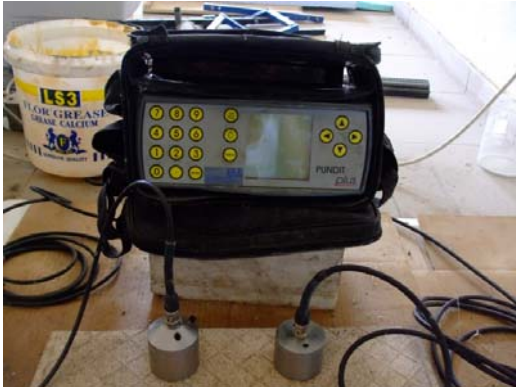
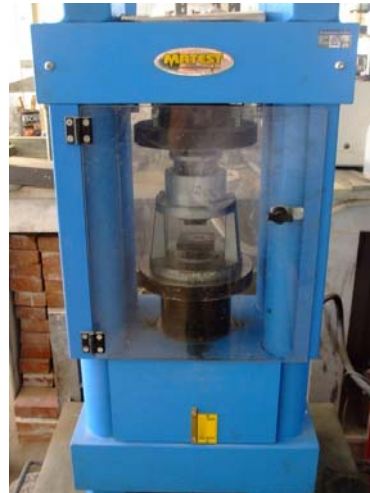
Fig.17-18 The equipments for ultrasound resistance and compressive strength tests

a) ultrasound resistance and compressive strength tests on building stone samples (Fig.17-18)

Samples have been cut in cubes (4x 4x 4 cm) and dried in the oven at 70 ± 5 °C for 24 hours before starting with the ultrasound velocity tests.

Afterwards, they have been immersed into water for 24 hours, for performing open porosity tests by vacuum assisted water absorption, according to the EN 1936: 2006 standard procedure for natural stones.

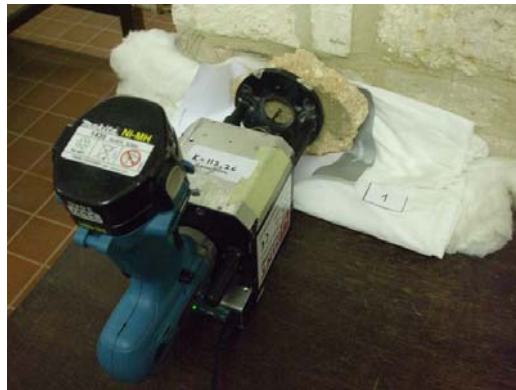
Fig.20 Molab drilling tests on mortar. The driller.

The Drilling Resistance Measurements System (DRMS, Fig.20) is a portable apparatus able to evaluate in situ the superficial “hardness” of a material. The resulting graphs shows on the X axes the depth of the drilling (mm) and on the Y axes the necessary Force (N). Picks and differences in the values of Force represent lack of homogeneity due to the possible presence of grains, gravel or voids. The system is usually used for the characterization of the cohesion profile of materials, and, as a consequence, gives information concerning the superficial state of decay and, in case of consolidating intervention, the efficiency and the depth of penetration of the treatments.

Tests were carried out successfully on mortars from mosaic fragments in the basement of the Museum.

Other in situ drilling tests were performed on the limestones of Nagyarsány villa’s walls. Although several attempts, it was not possible to carry out the tests properly: the drill bits were abraded from this kind of materials, that resulted too hard for both diamond and fischer drill bits.

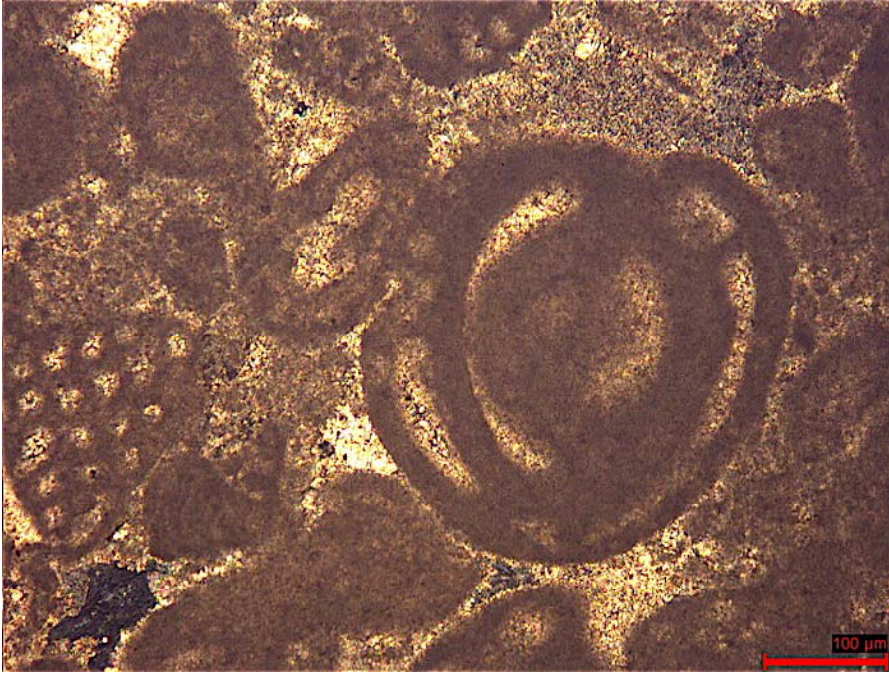
Fig.22 Detail of sample HUNVMEC4-3: Nagyharsány villa's walls. Biosparite with a big Miliolidae.

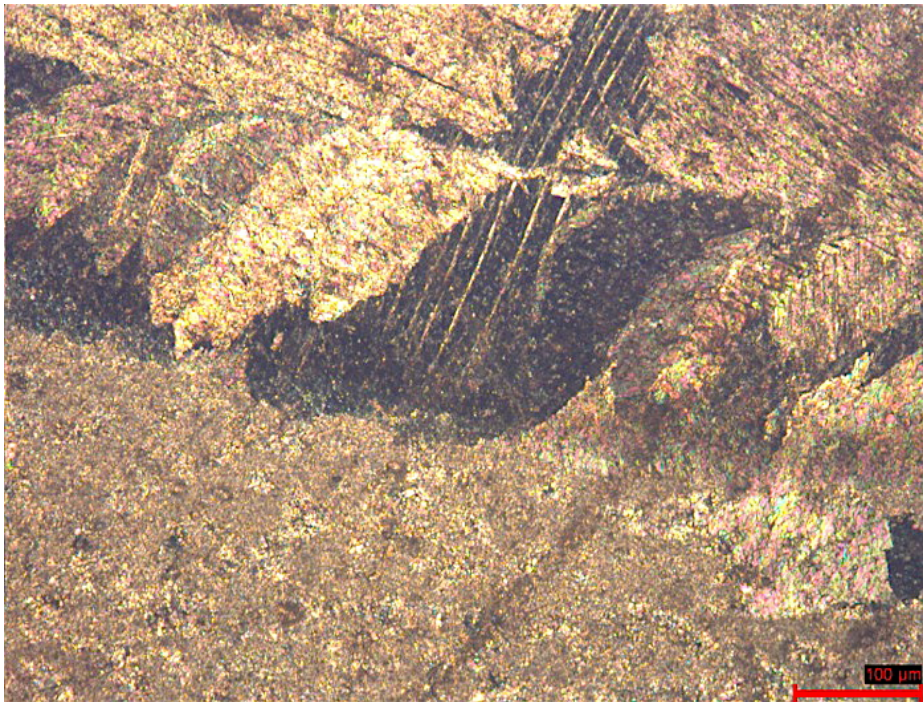
Fig.33 Nagyharsány Limestone Formation. Detail of sample HU19NQ: Beremend Quarry. Biosparite with detail of big bivalve.

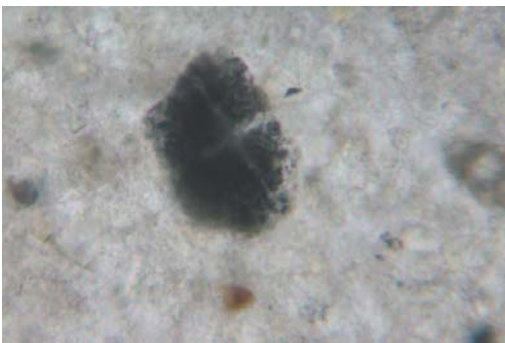
Fig.42-43 From the same mortar, on the right side picture it is visible a pozzolanic nucleus (magnification 10x, one N). On the left side picture it is visible a grain of Portland cement in bottom left and a dark pozzolanic nucleus at the top right (magnification 25x, one N).

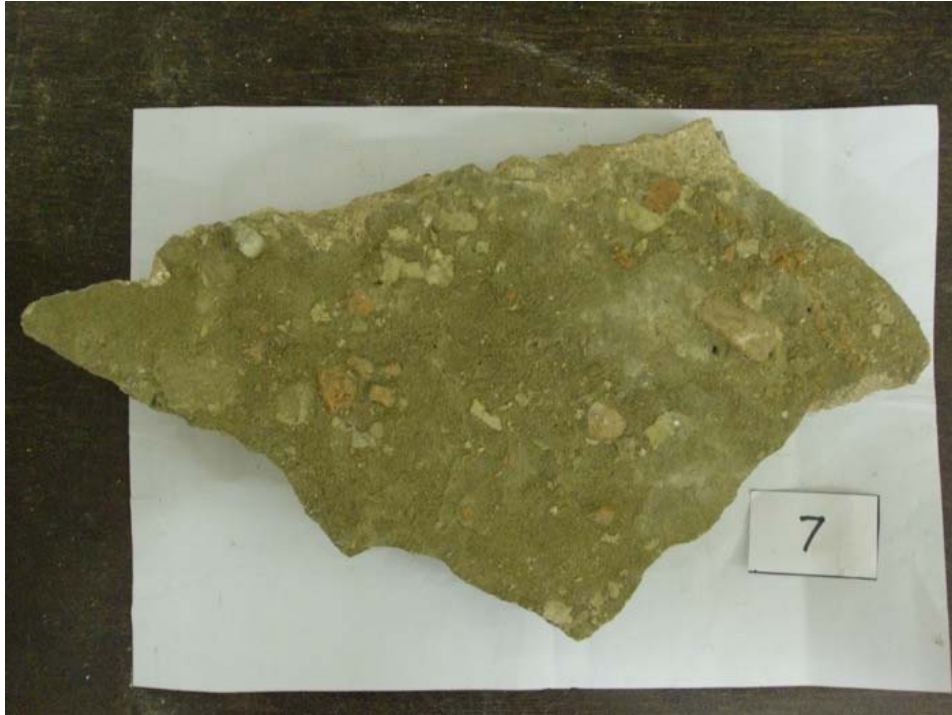
Fig.47 The back side of a mosaic fragment from Nagyharsány during the sampling in the Museum's basement. Pebbles and brick fragments maximum size is 2 cm.

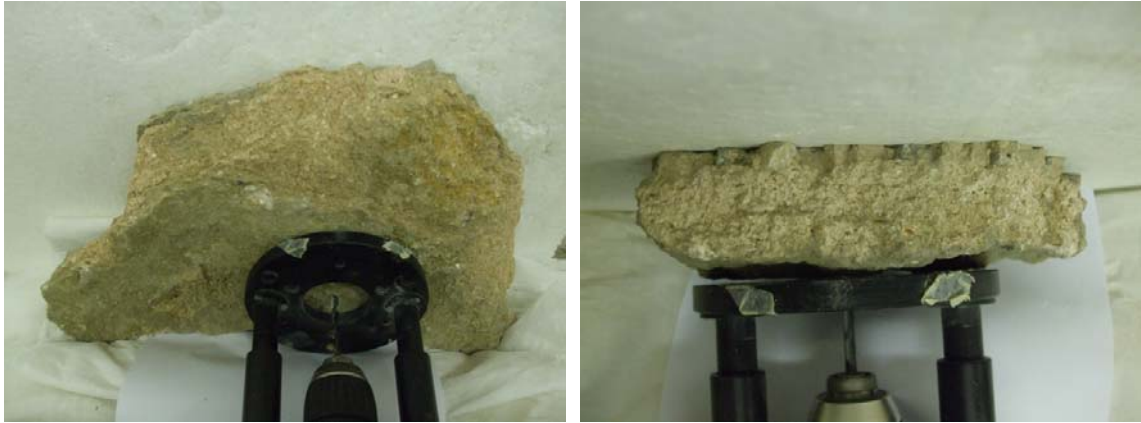
Fig.50-51 Two moments of the drilling test.

The second layer, 2 cm thick, is composed by a finer mortar, whitish in colour, characterized by the presence of pebbles and brick fragments with a size distribution between 200 μm and 0,5 cm. Drilling tests were performed on several different mortar from mosaic fragments (Fig.50-51). The tests took in account four fragments of geometrical mosaics and six fragments of figurative pattern mosaics. For each samples, three different holes were drilled and the average calculated accordingly.

Charts 8-11 refer to the drilling tests performed on mortars from mosaic with geometrical patterns. Although maximum values are rather different, varying from 80 N to 15 N, average curves show a rather homogeneous patterns and quite stable in the range 5 and 10 N. The subsequent six charts (charts 12-17) refer to drilling tests performed on mortars from mosaic with figurative patterns. Maximum values vary from 90 to 12 N and the patterns show less homogeneous trends.

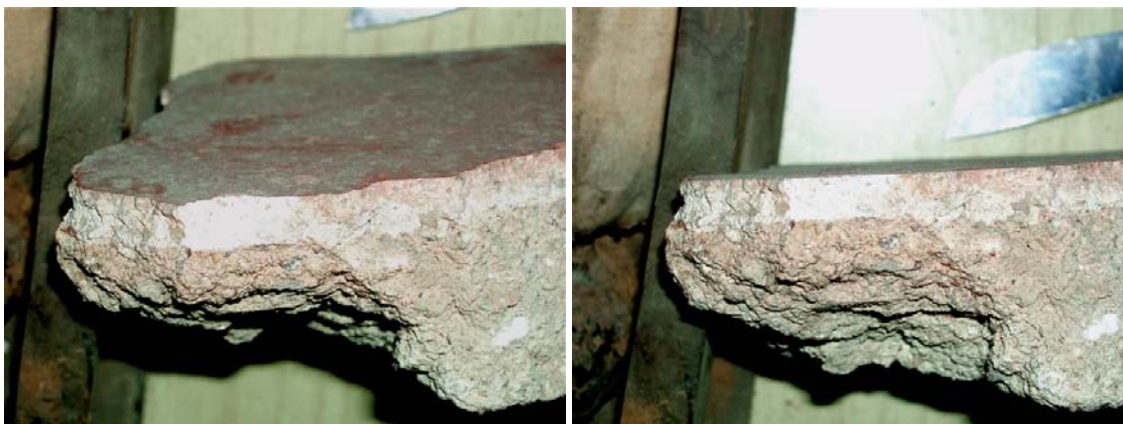
Mortars used as support for mural paintings (Fig.52 a) and b)) are usually composed by two different layers: one layer of mortar and one layer of plaster.

Fig.52 a) and b) The two different layers composing the structure of a mural painting fragment.

The mortar layer is thick, 4,5 cm, grey or pinkish in colour depending on the abundance of brick and tiles fragments (*cocciopesto*) and other aggregates (sand and gravels). The aggregates are rather coarse as size (between 1 and 2 mm) and includes Quartz crystals and Quartz-arenite grains. The mortar is resistant and quite compact. It is noticeable also the presence of some voids, clearly due to the presence of vegetable material, most probably straw remnants, added, as in the structural mortars, during the preparation of the mixture to avoid cracking processes.

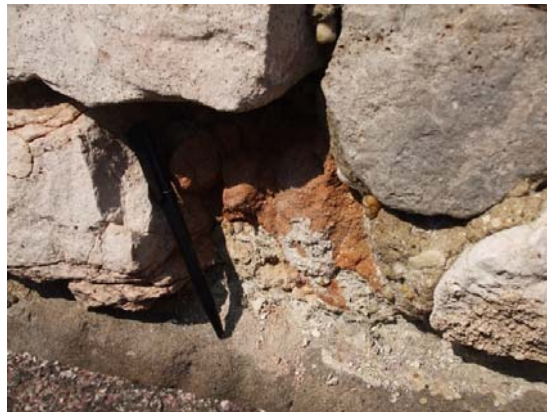
Fig.79 Detail of mortar during the sampling. Presence of brick as elements of the structure but not brick's fragments as aggregate in the mortar.

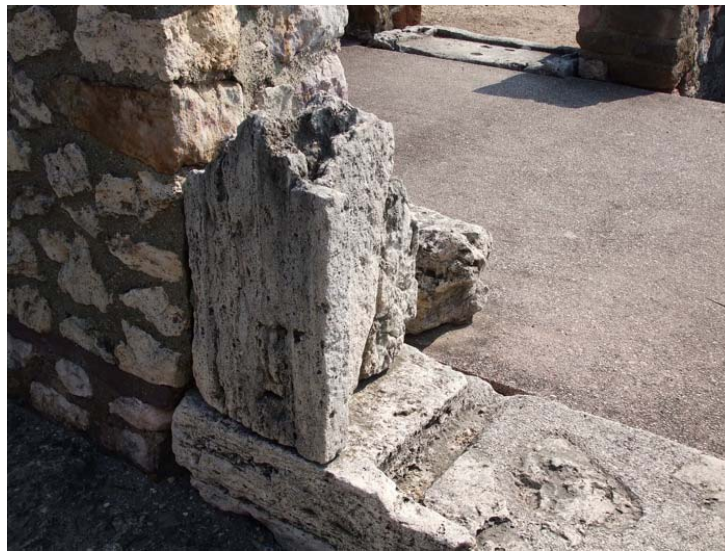
Fig.82 The use of travertine for structural elements.

Fig. 82 shows the use of Travertine as architectural element.

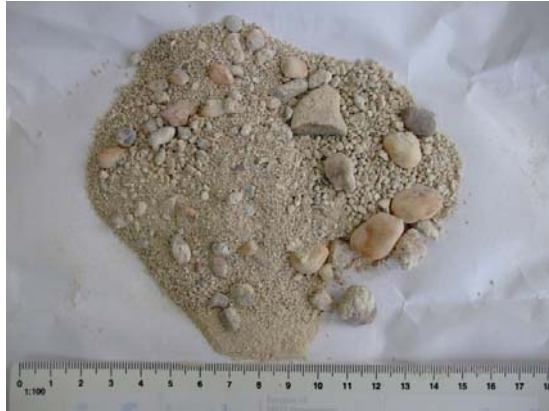
Fig.83 Sample HUAQ1

Mortars are lime-based, with a low content of MgO (see chart 22), with a variety of different pebbles, no evidence of presence of brick fragments was detected.

The granulometrical analyses (charts 23-24) shows that the size distribution of the two kinds of mortars appear very similar, and they are both into the range classified by the standards as high quality mortars (ASTM, E.L.O.T. 408.).

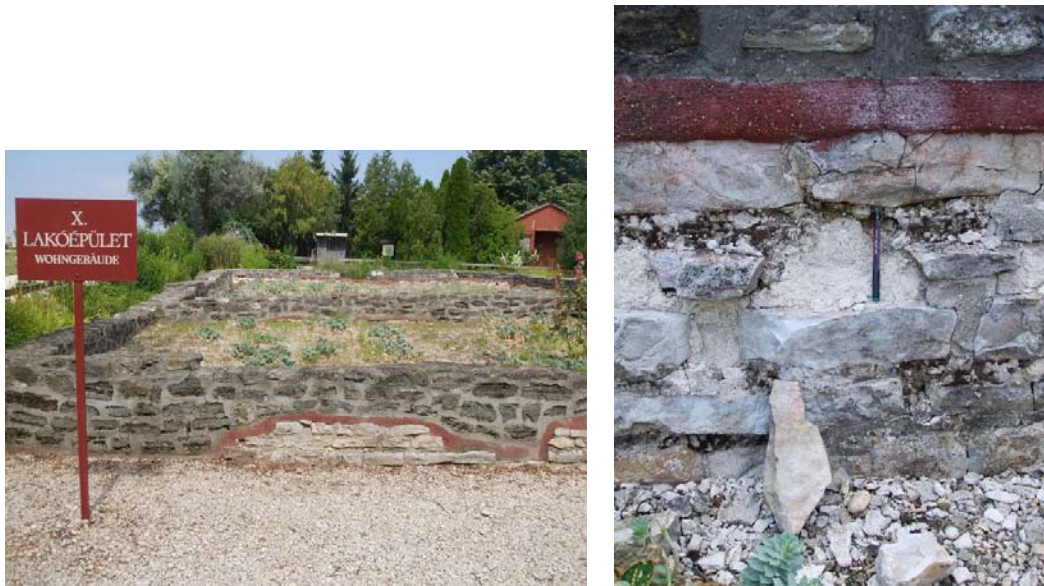
Fig.87 A view of the entrance of the site and the reconstructed walls. In the second picture a detail of the lowest part of the wall, supposed to be original. The red line (cement) is the marker of the replacing and restoring intervention.

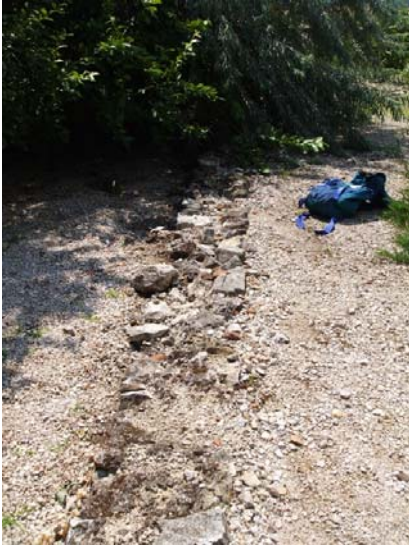
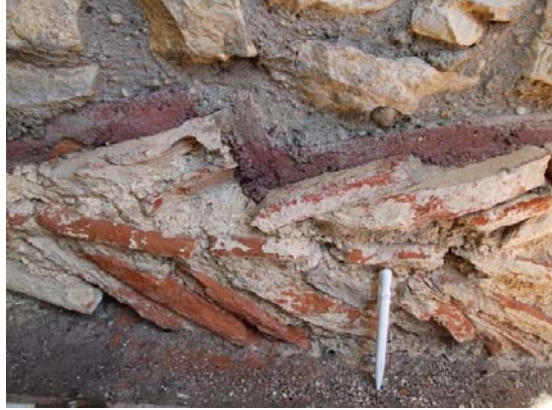
Fig.88-89 First picture is an example of remnants of the original wall approached for the sampling. Second one shows the presence of brick elements in the wall structures.

Fig. 88-89 show two details of original walls, where it is visible the use of bricks for the structure.

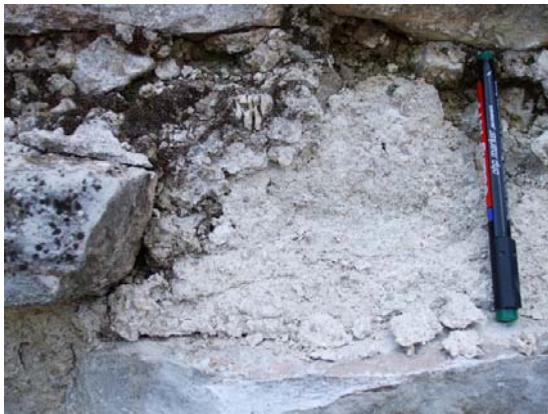
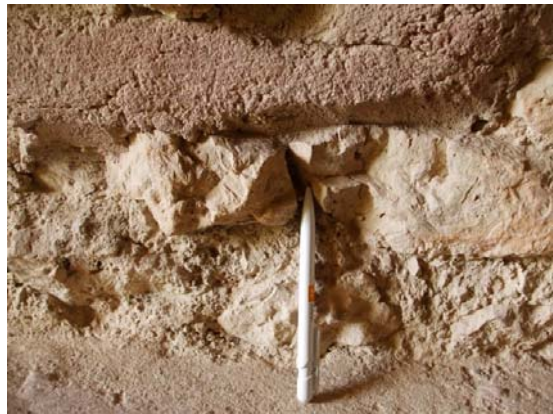
Fig.90 Example of structural mortars without the presence of brick fragments as aggregates, from walls in open air conditions. Fig.91 Detail of walls preserved in the covered area of the site (at the top of the picture the red line marker).

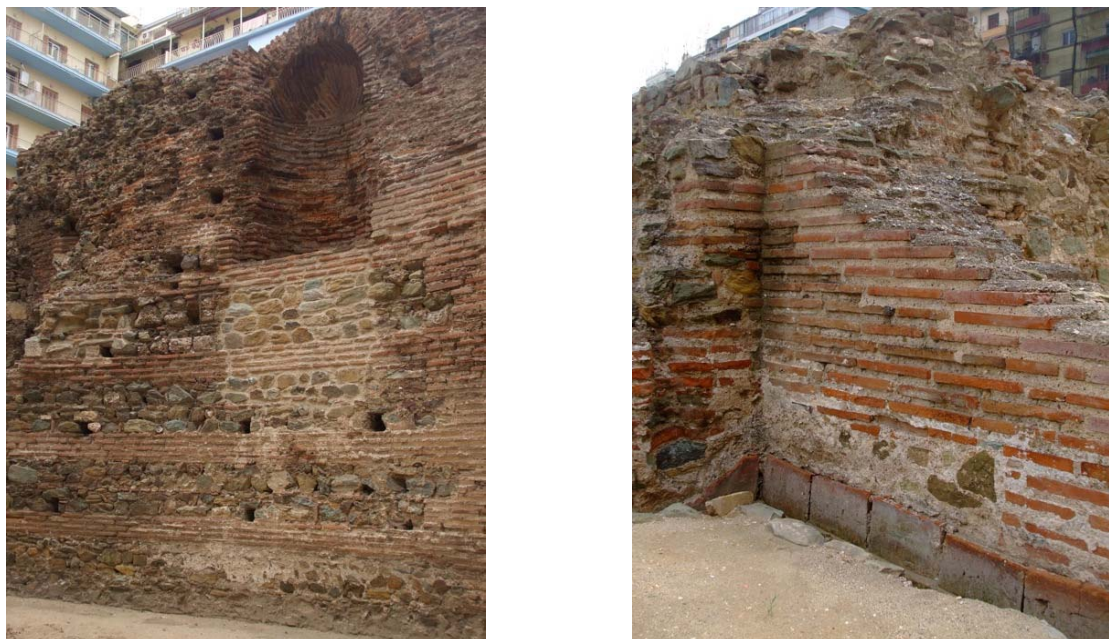
Fig.94-95 On the left a detail of a wall of the Basilica in *opus mixtum* (Galerius Palace in Thessaloniki) on the right bricks wall in *opus signinum* (lime based mortar with brick fragments as aggregates, *cocciopesto*)

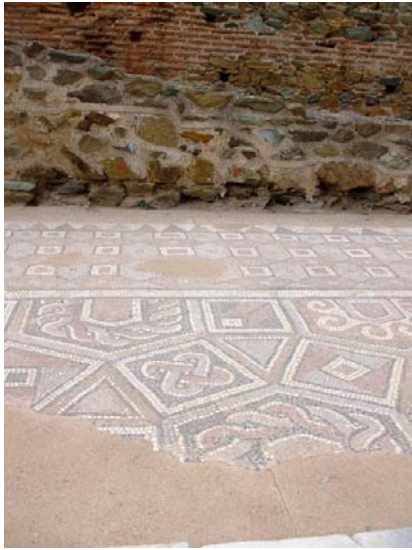
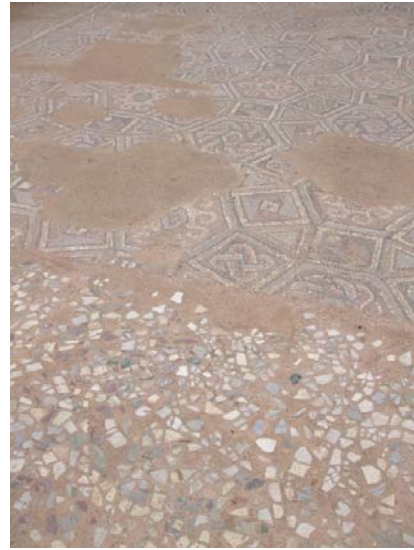
Fig.96-97 Details of floor mosaics, fine and coarse tessera (Galerius Palace in Thessaloniki)

Part of the earlier mosaics are now visible protected by glass shelters (Fig.96-97).

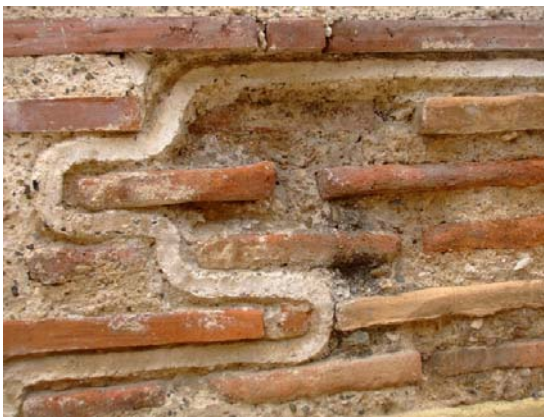
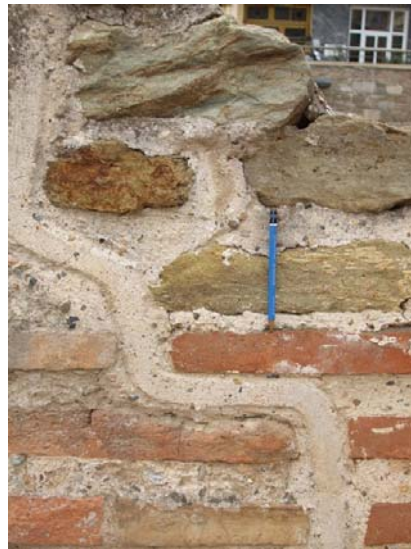
Fig.98-99 Details of the mortar strip used as marker of the reconstructive intervention (Galerius Palace in Thessaloniki)

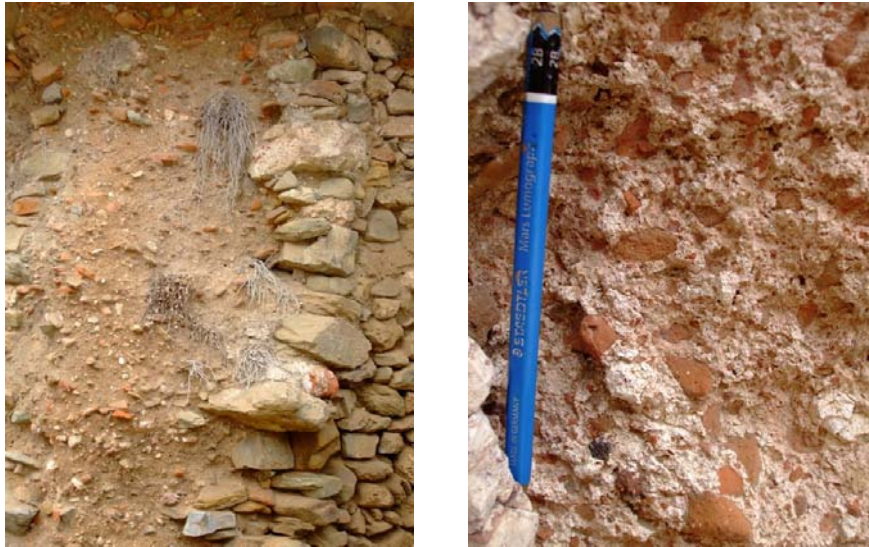
Fig.100-101 On the right a detail of wall in *opus caementicium*, on the right a detail of structural mortar with brick's fragments of different sizes (*cocciopesto*) (Galerius Palace in Thessaloniki)

Wall structure is built alternating courses of stones and bricks (*opus mixtum*) held together by mortar (lime-based with pozzolanic compounds and pebbles and gravel as aggregates). The use of bricks is limited to courses of walling, doorways, pillars and vaults (Fig.98-101).

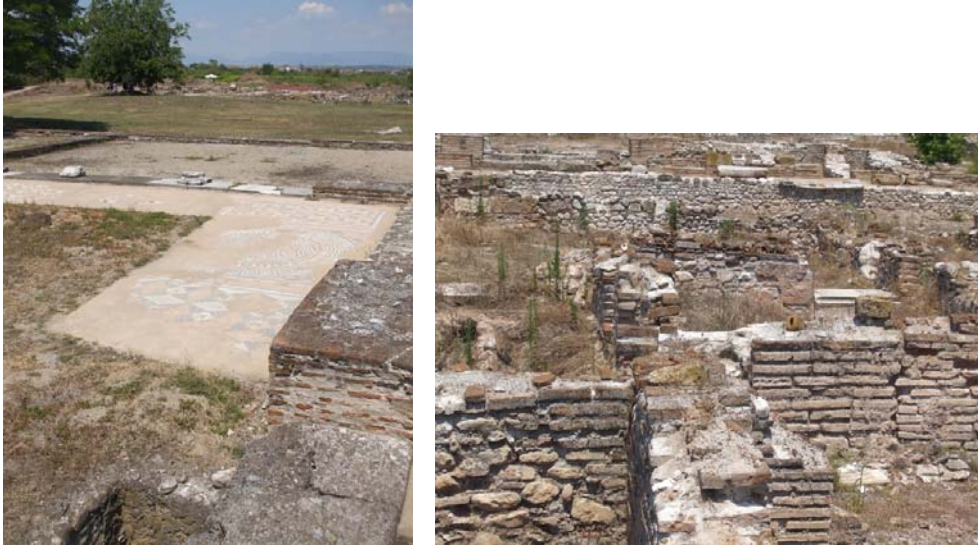
Fig.102-103 Views of the site showing the walls in *opus incertum*, *opus mixtum*.

Dion was a small city, dated from end of the V century BC, embraced by defensive walls, situated at the northern foothills of the Mount Olympus. The city comprised public baths, rich houses, shops and workshops, two theatres outside from the city walls, sanctuaries as well as cemeteries, dated by the archaeologists as remnants belonging to the V century BC to the V century AD. Most part of the site is nowadays excavated. From the first century AD it became a Roman colony. The walls were essentially built with shaped and unshaped stones, alternated with the use of bricks (*opus mixtum*) (Fig.104-105) as in Aquincum.

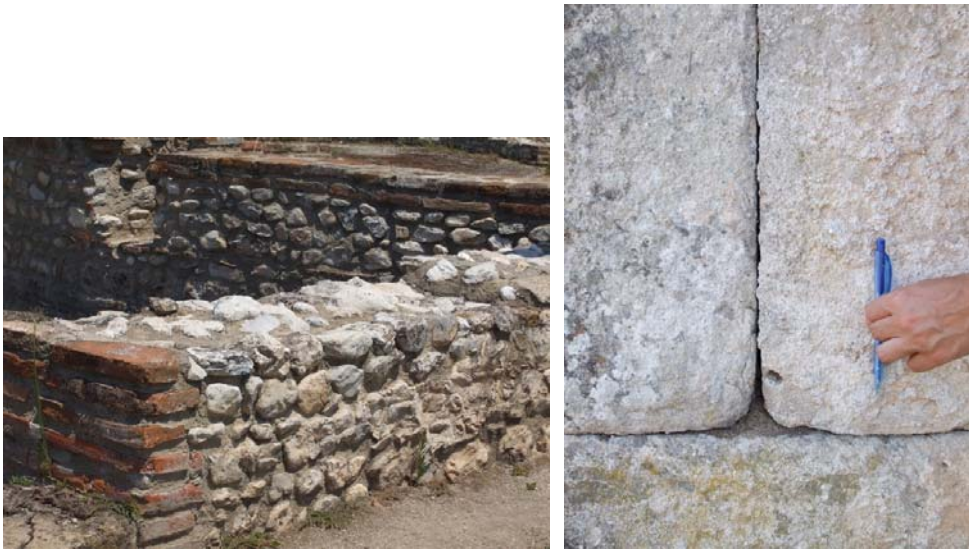
Fig.104 Detail of walls in *opus mixtum*, Fig.105 Detail of well shaped building stones constituting the wall without the use of any binder

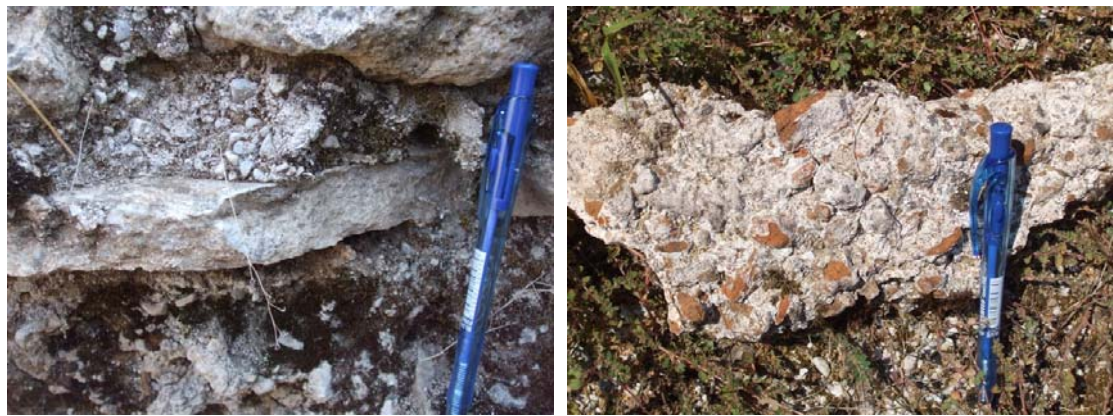
Fig.108-109 Details of different mortars: on the left a detail of structural mortar showing the absence of brick's fragments as aggregate, on the right a specimen of mortar used as support of mosaics, containing a large amount of brick's fragments of different sizes (*cocciopesto*)

Fig. 106-107 show that decorative elements as mosaics and paintings were common, while Fig.108-111 show details of mortars and walls also erected in *opus caementicium*, typical of a Roman civil town.

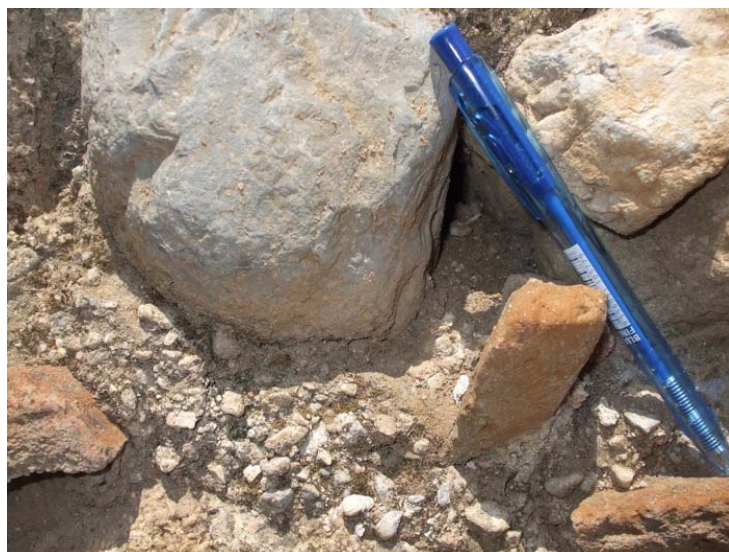
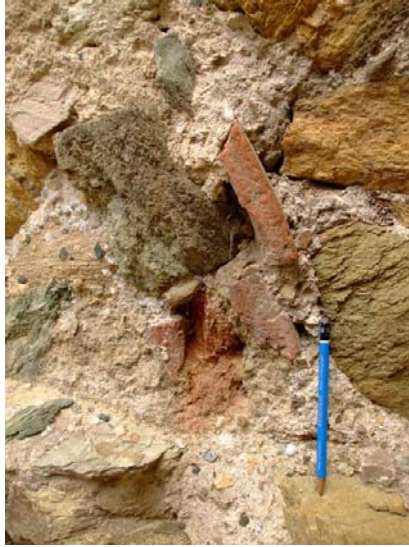
Fig.110-111 Details of *opus caementicium*: on the left detail from Dion, on the right detail from the Galerius Palace.

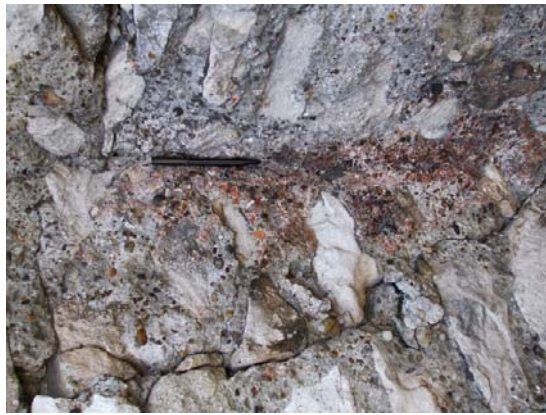
Fig.112 Detail showing the use of brick's fragments as aggregates in a repairing mortars. Aquincum.

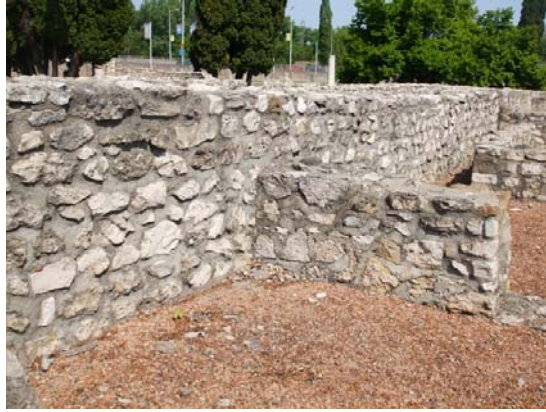
Fig.113 The large use of cement in the restoration of walls. Aquincum.

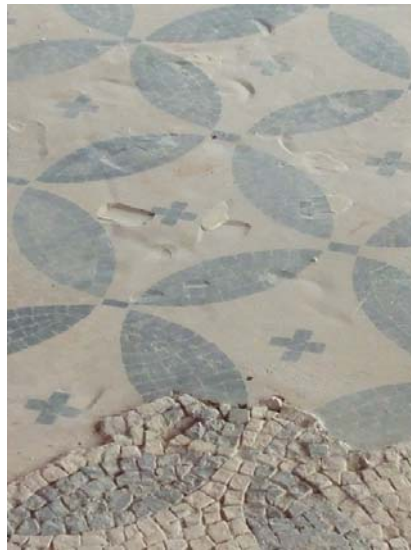
Fig.114 An attempt of restoring intervention and presentation to the public of a mosaic floors.
Nemesvámos-Balácapusztá Roman villa (Baláca)

Fig.114 shows an attempt of restoring intervention and presentation to the public of floor mosaic in Nemesvámos-Balácapusztá Roman villa (Balácsa). Despite the fact that polystyrene resulted to be a too soft and not durable material, its advantages are the low cost, the easy and practical setting and the possibilities to be easily decorated.
