The Cape San Blas Ecological Study

U.S. Geological Survey/Biological Resources Division
Florida Cooperative Fish and Wildlife Research Unit

Technical Report Number 57
1997

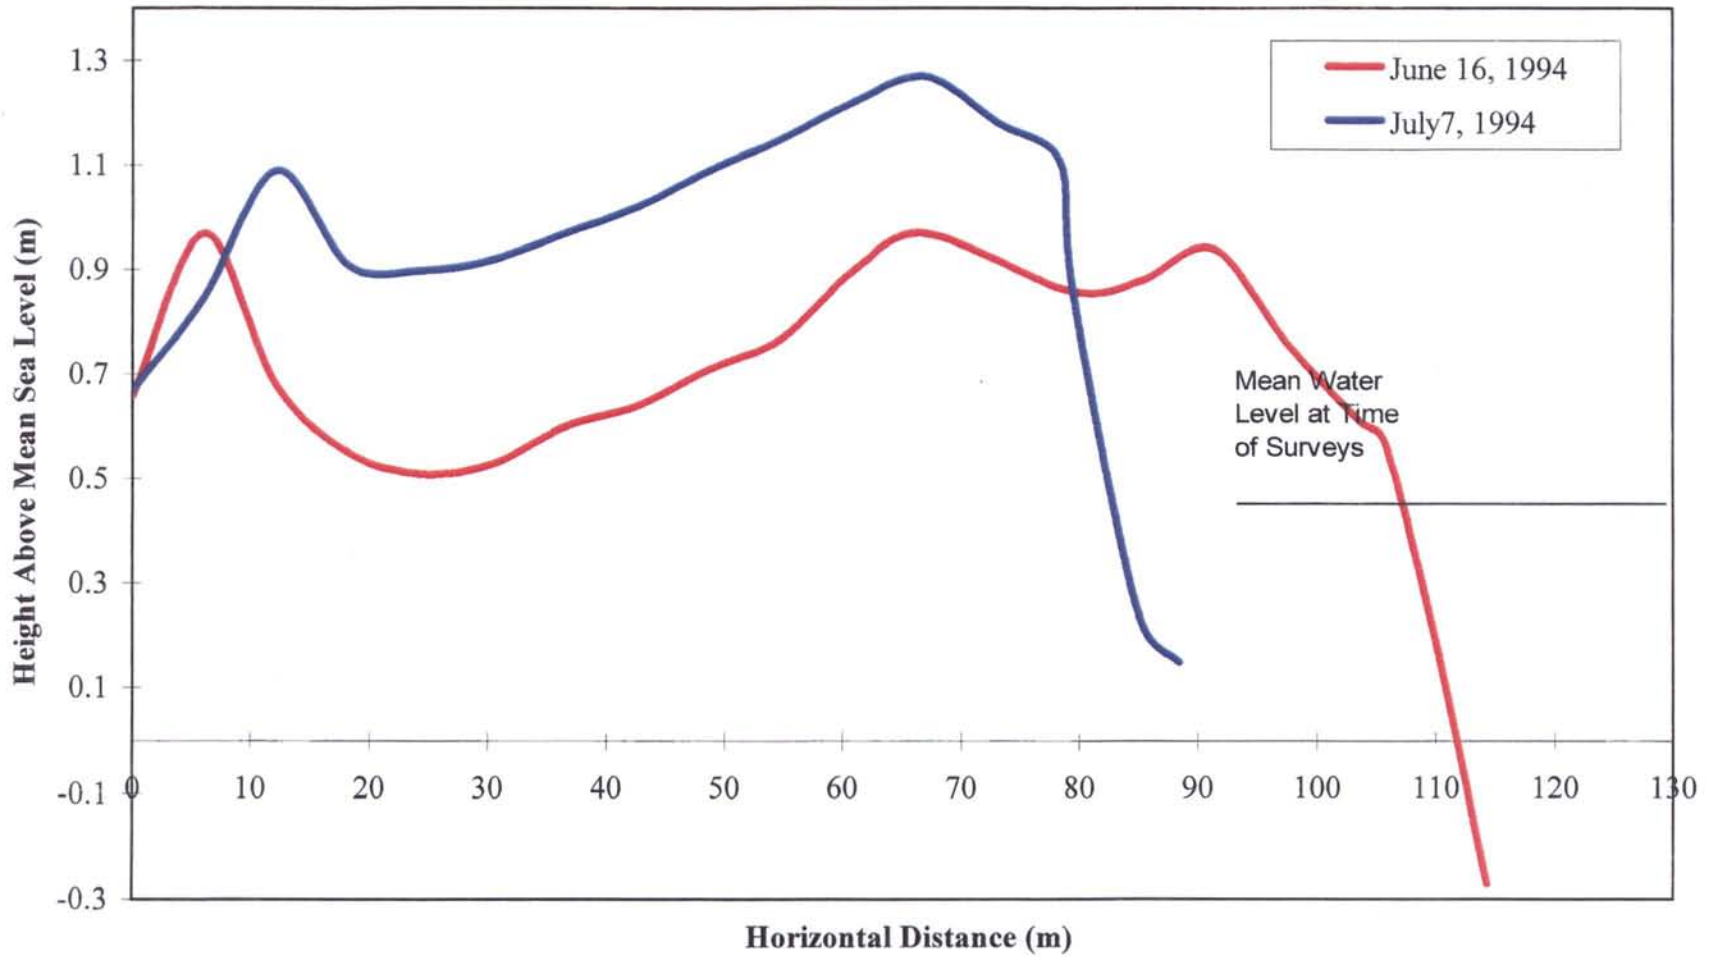
Figure 1-2a. Beach profile of the cape spit along Eglin Air Force Base on Cape San Blas, Florida indicating severe erosion from June 16, 1994 to July 7, 1994. Transects were conducted along DNR monument 115 at a 112° compass heading.

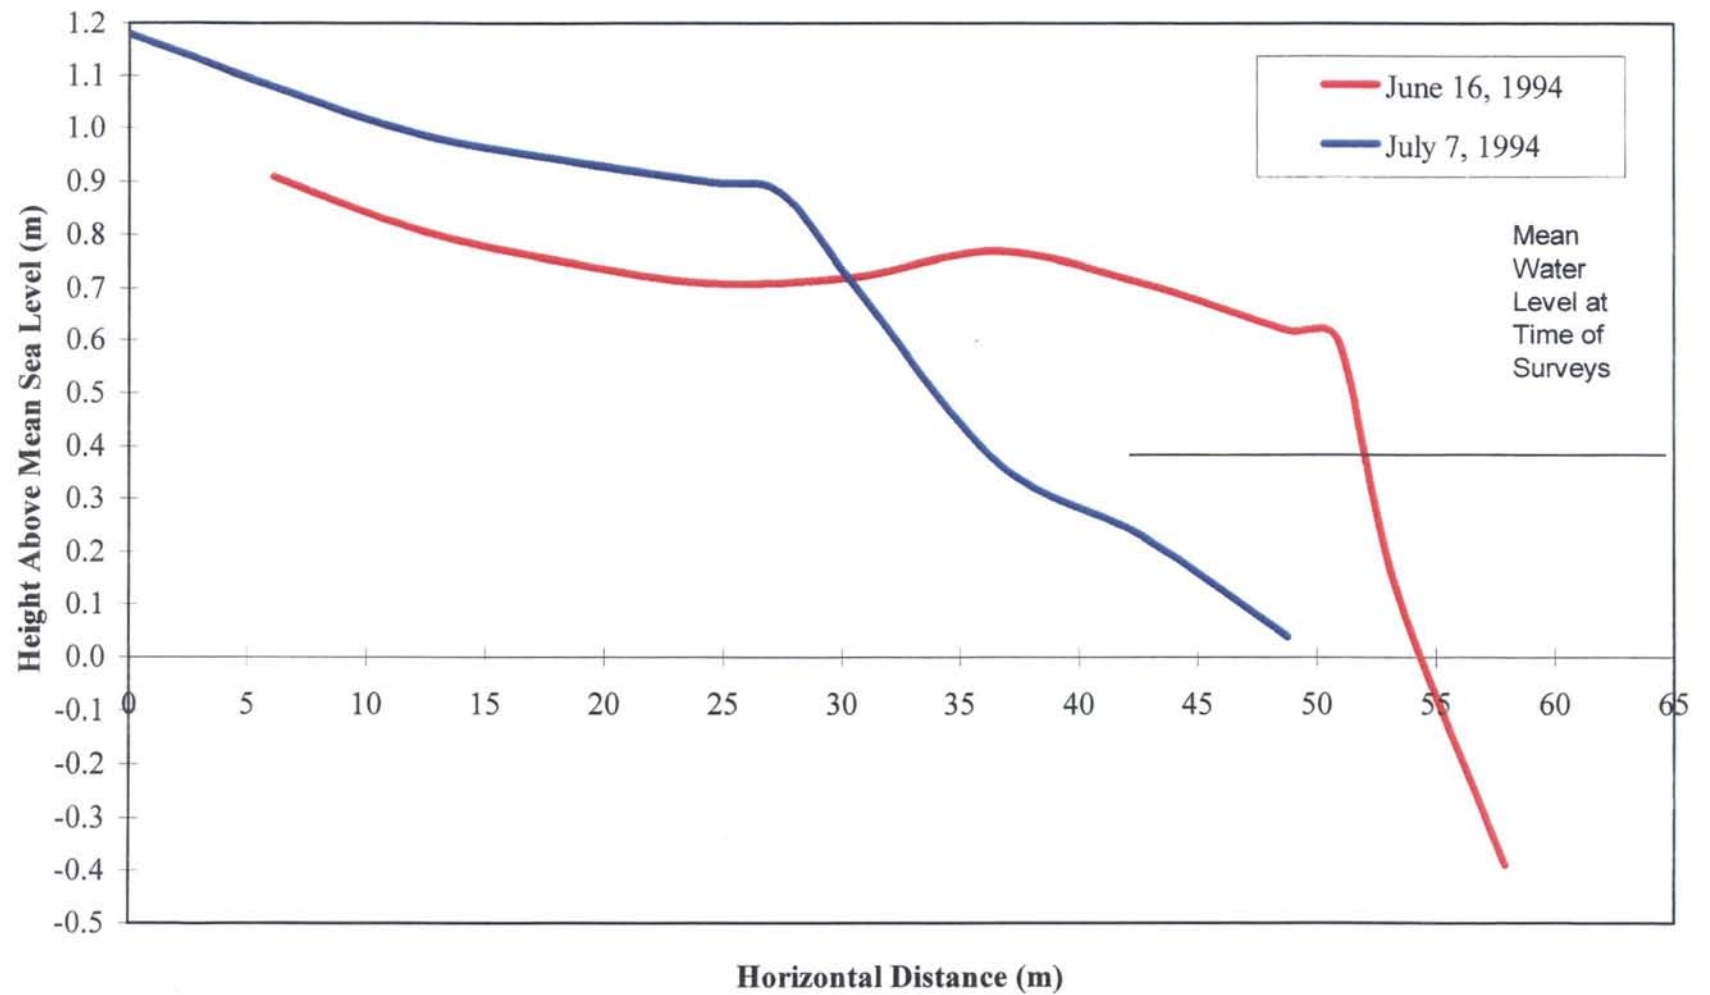
Figure 2b. Beach profile of the cape spit along Eglin Air Force Base on Cape San Blas, Florida indicating severe erosion from June 16 to July 7, 1994. Transects were conducted along DNR monument 115 at a 220° compass heading.

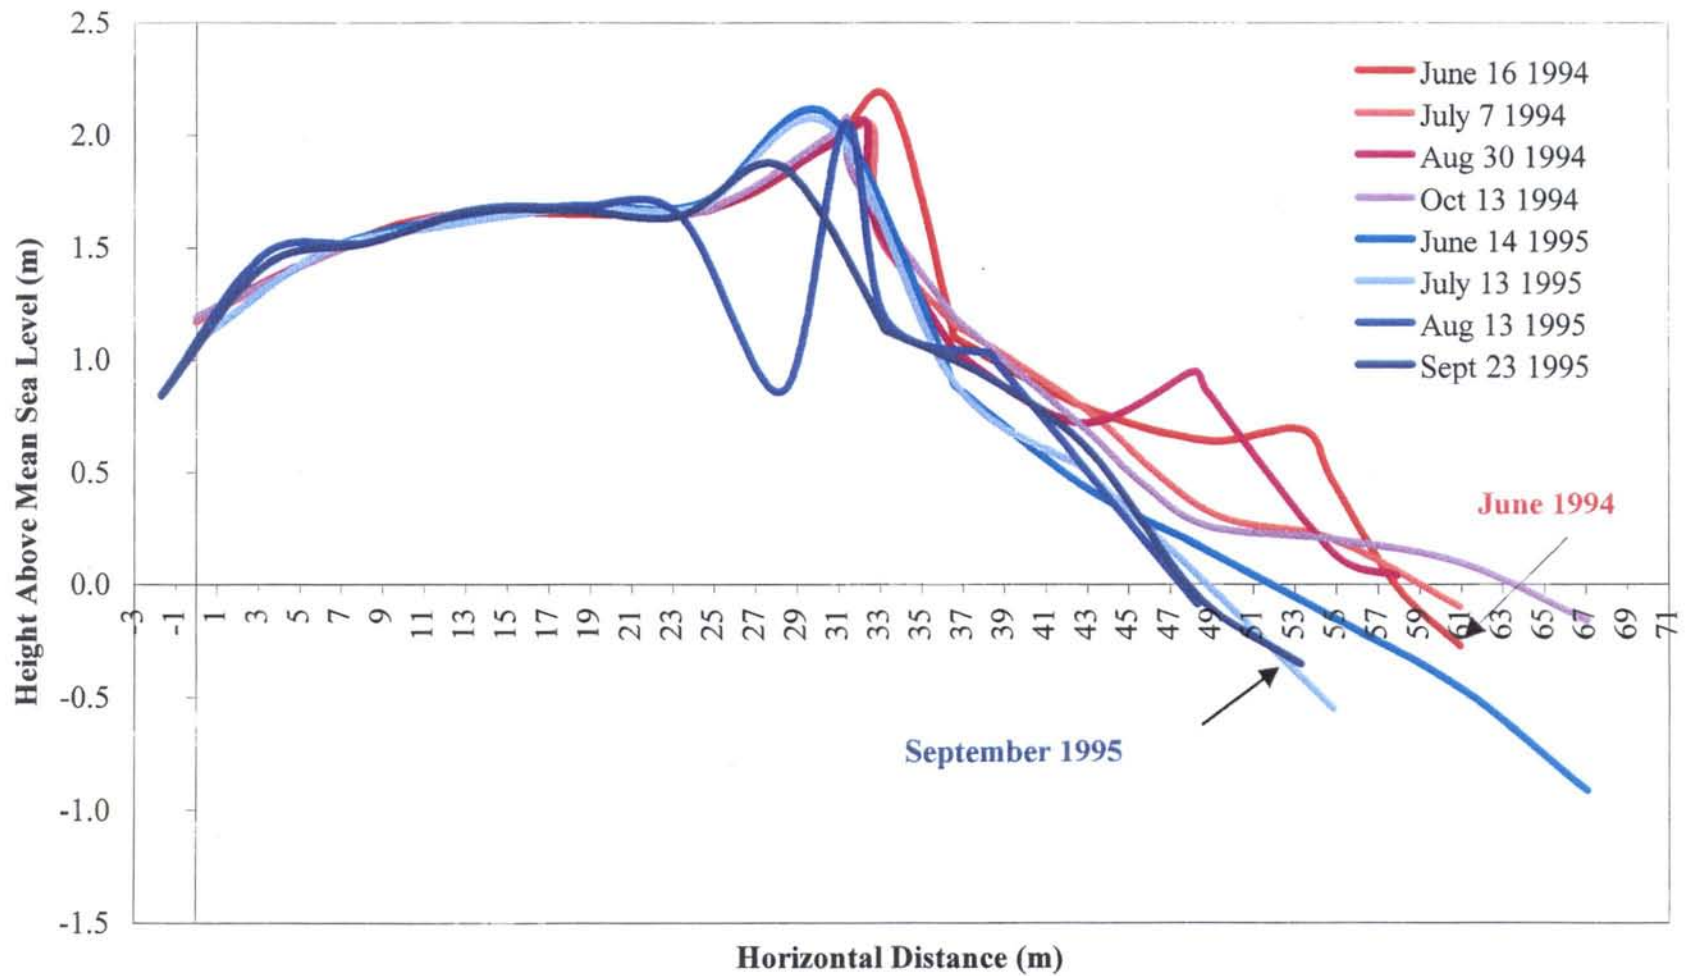
Figure 2c. Beach profile of the north beach along Eglin Air Force Base on Cape San Blas, Florida indicating severe erosion from June 16, 1994 to September 23, 1995. Transects were conducted along DNR monument 107 at a 40° and 220° compass heading. The red/purple lines represent 1994 data and the blue lines represent 1995 data.

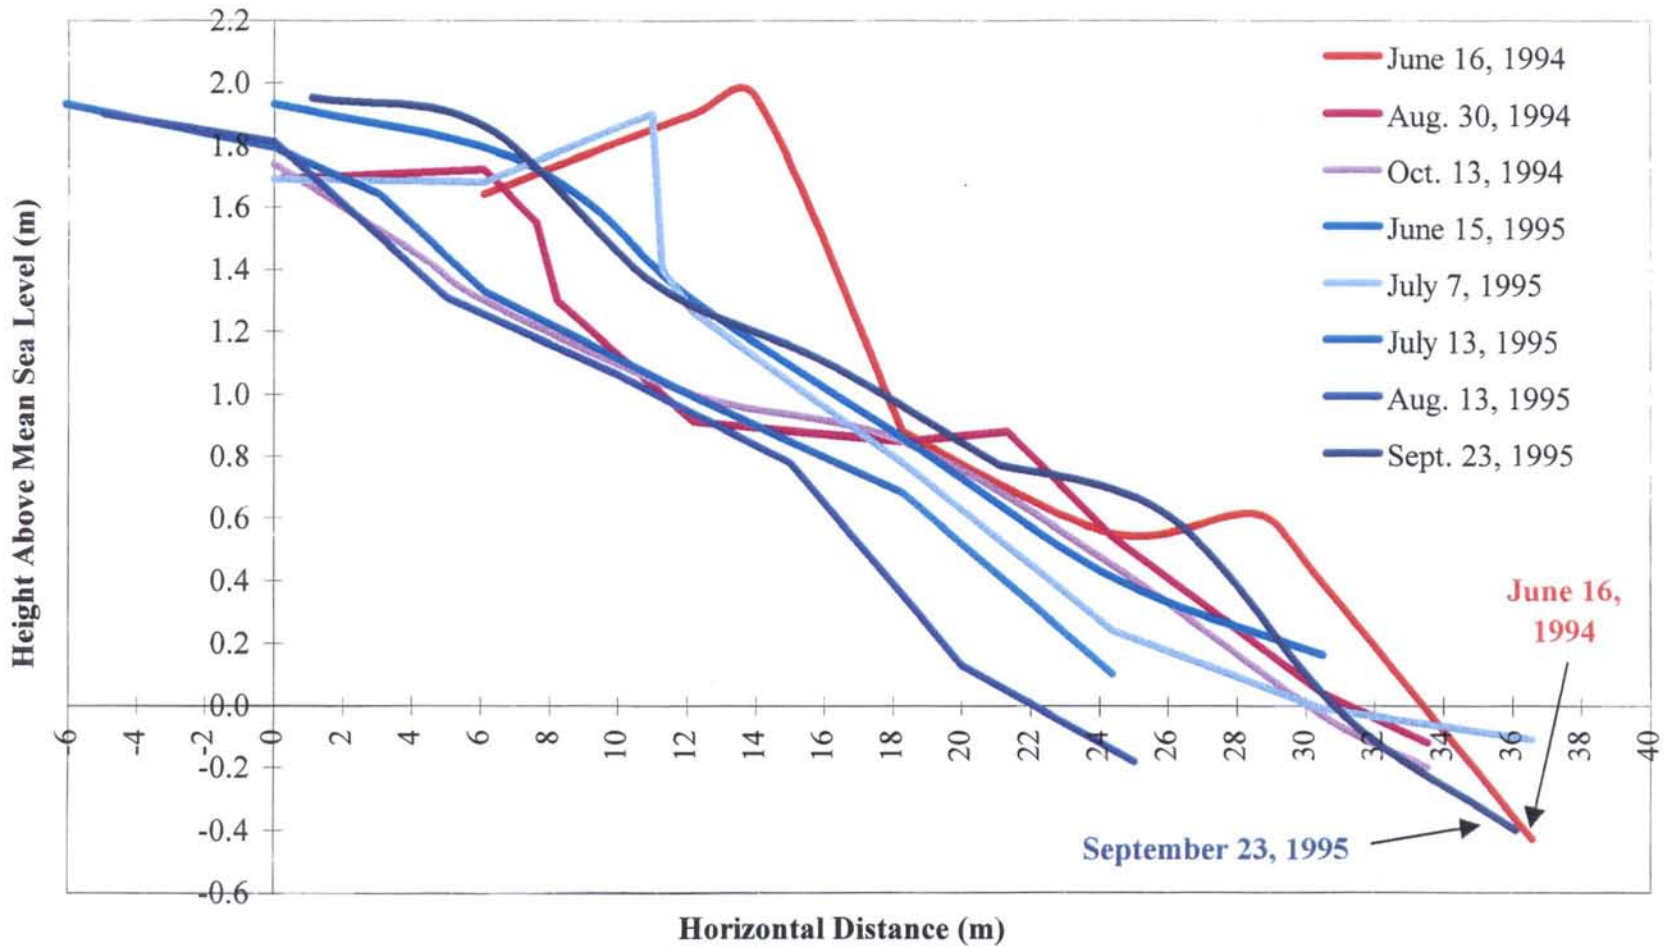
Figure 2d. Beach profile of the Coast Guard Station beach along Eglin Air Force Base on Cape San Blas, Florida indicating erosion occurred between June 16, 1994 and September 23, 1995. Transects were conducted along DNR monument 110 at a 234° and 54° compass heading. The red/purple lines represent 1994 data and the blue lines represent 1995 data.

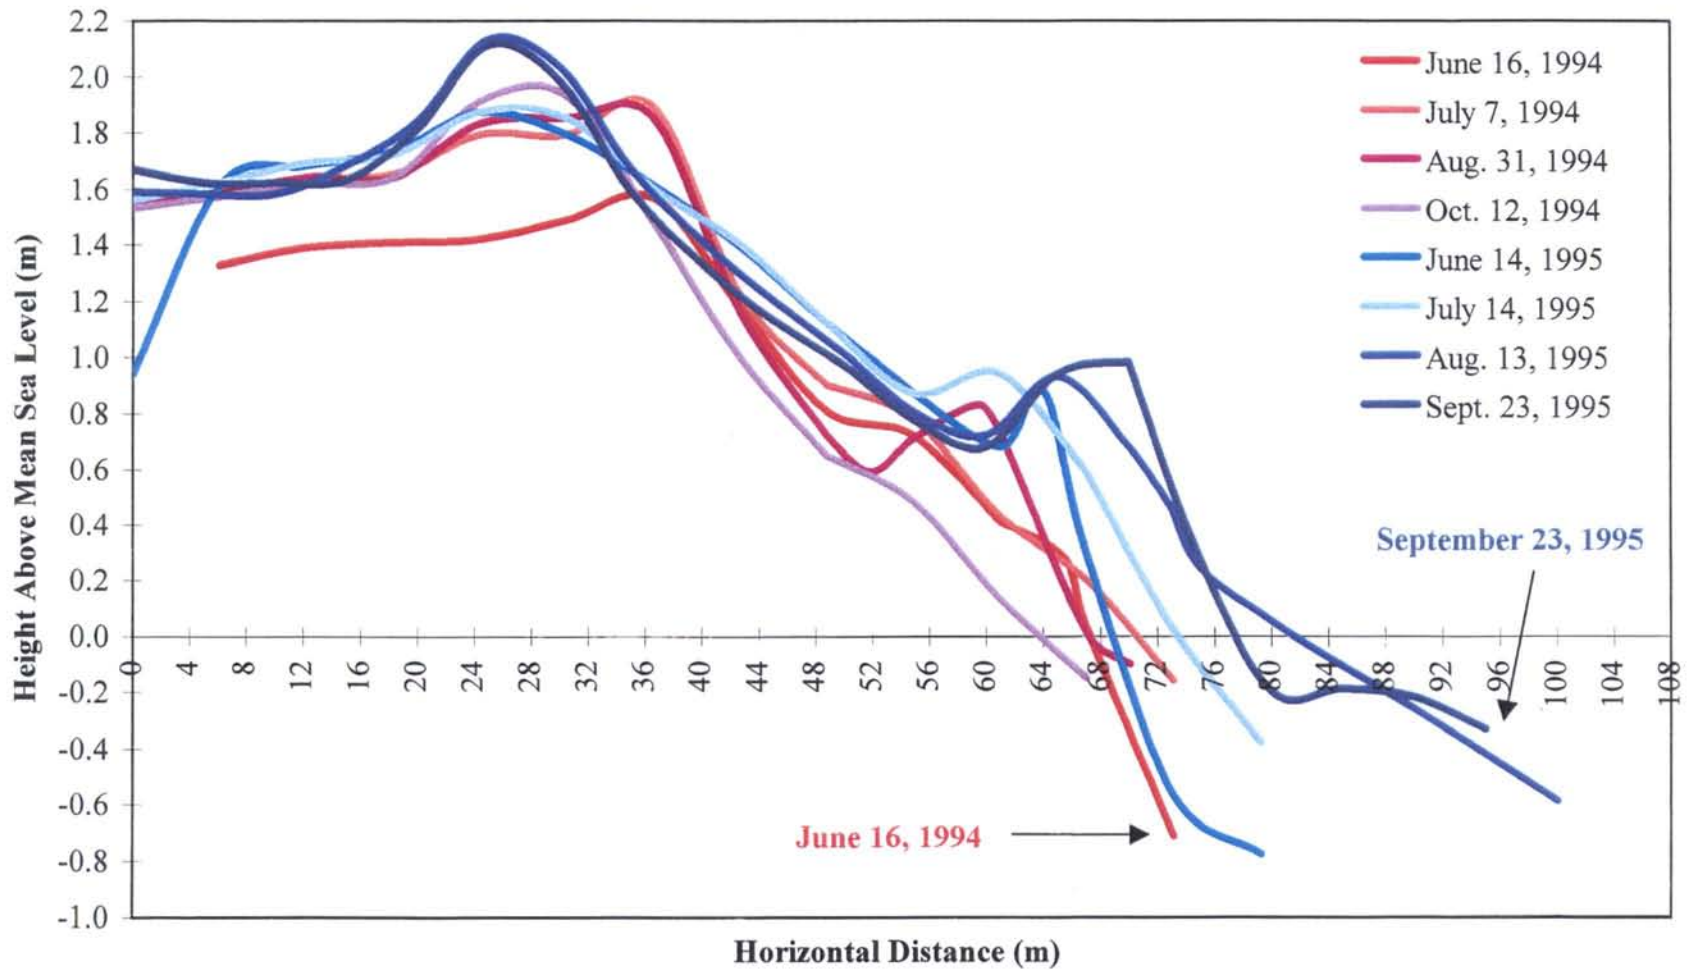
Figure 2e. Beach profile of the east beach along Eglin Air Force Base on Cape San Blas, Florida indicating accretion from June 16, 1994 to September 23, 1995. Transects were conducted along DNR monument 121 at a 143° compass heading. The red/purple lines represent 1994 data and blue lines represent 1995 data.

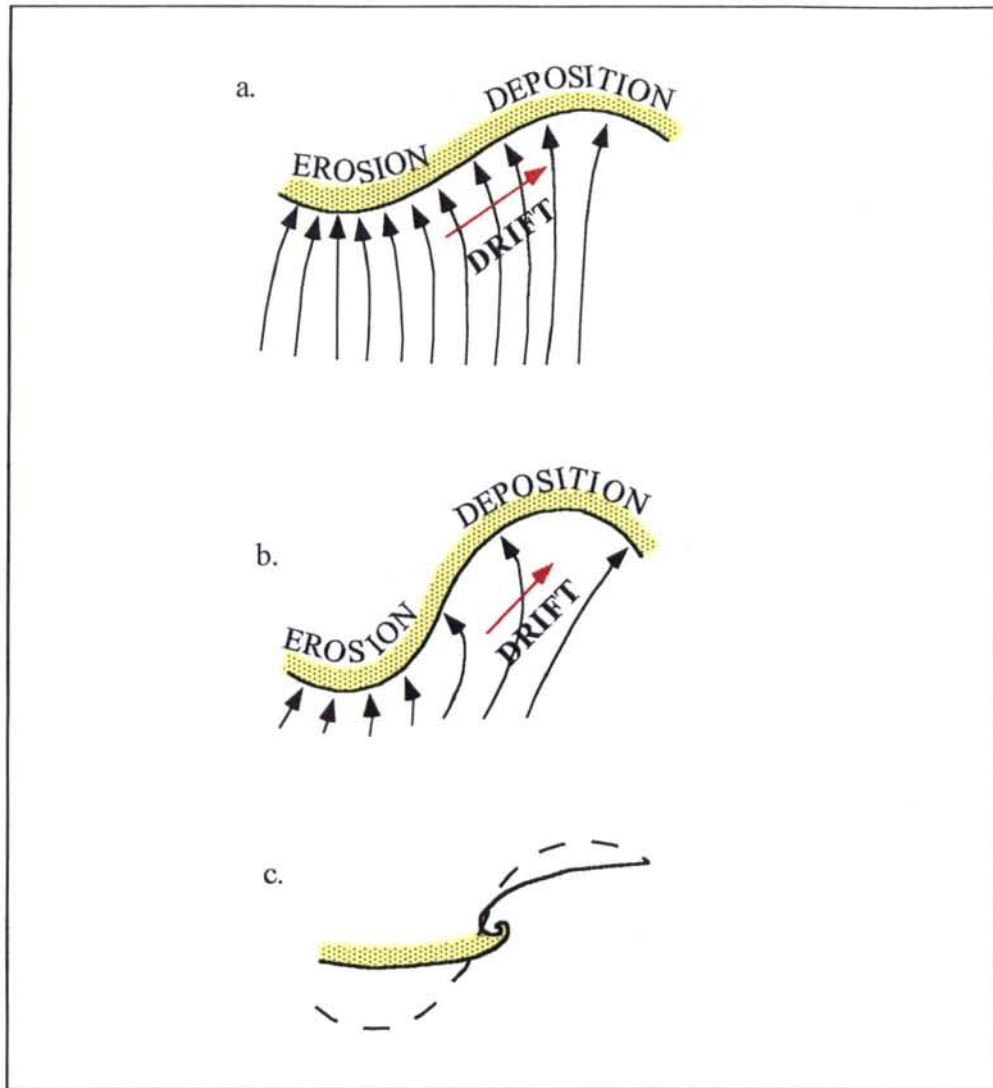
Figure 1-8. Model for littoral sediment transport. (a) Wave refraction pattern with wave approach normal to coast (b). Wave refraction pattern with a more deeply embayed coast and an oblique direction of wave advance and (c) the resulting coastline, similar to the pattern found along Cape San Blas, Florida. The direction of longshore drift is shown in red (from Swift 1975).

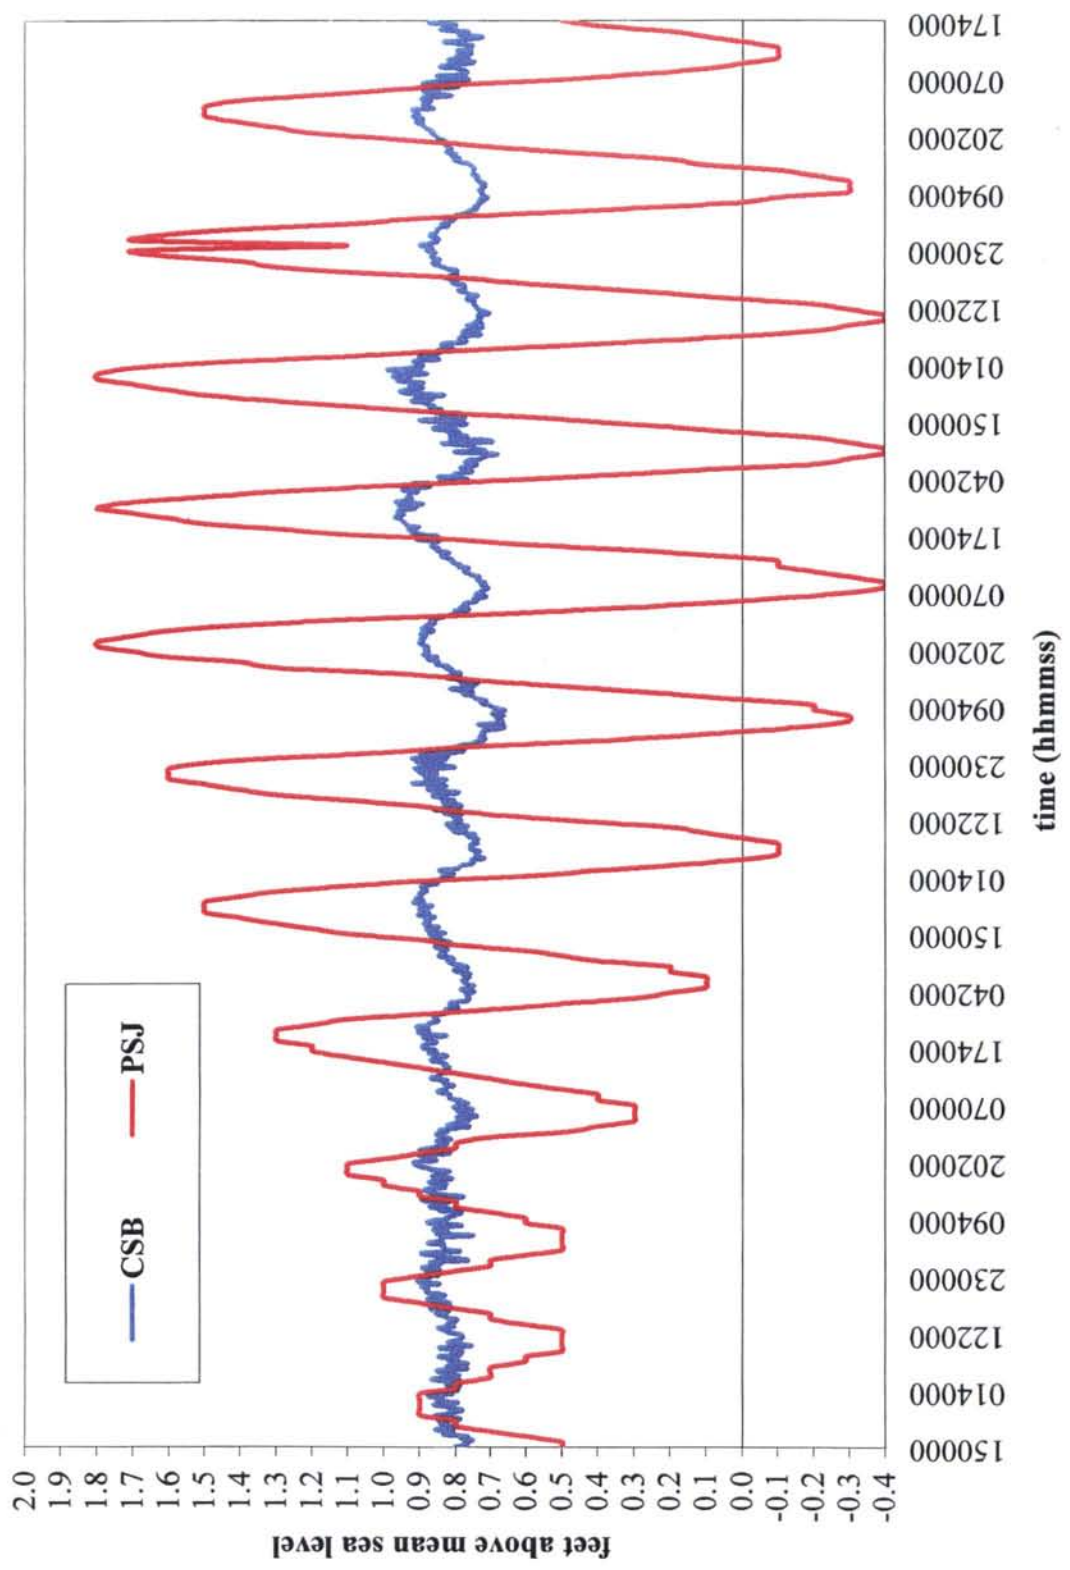
Figure 2g. Tidal ranges off Port St. Joe, Florida versus those off Cape San Blas, Florida from November 16 -27, 1995.
