Publication No. WI-2007-06

Initial Hydraulic Modeling and Levee Stability Analysis of the Triple M Ranch Restoration Project

Advanced Watershed Science & Policy:
CSUMB Class ESSP 660:

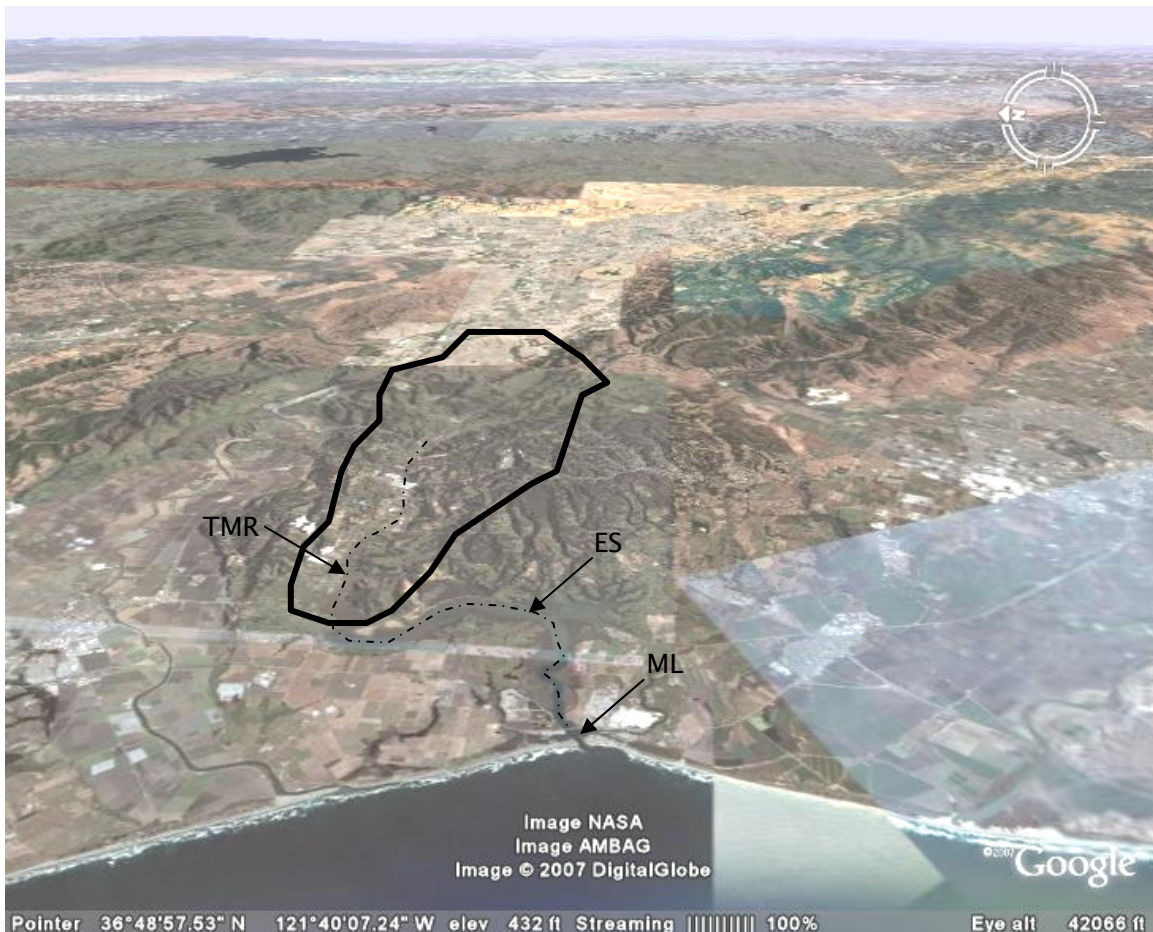
Figure 1. Oblique western view up the Carneros Watershed (outline). Study site is Triple M Ranch (TMR). Ancestral mouth of Carneros Creek is now flooded by high sea level to form Elkhorn Slough (ES), which drains to the sea at Moss Landing (ML). .

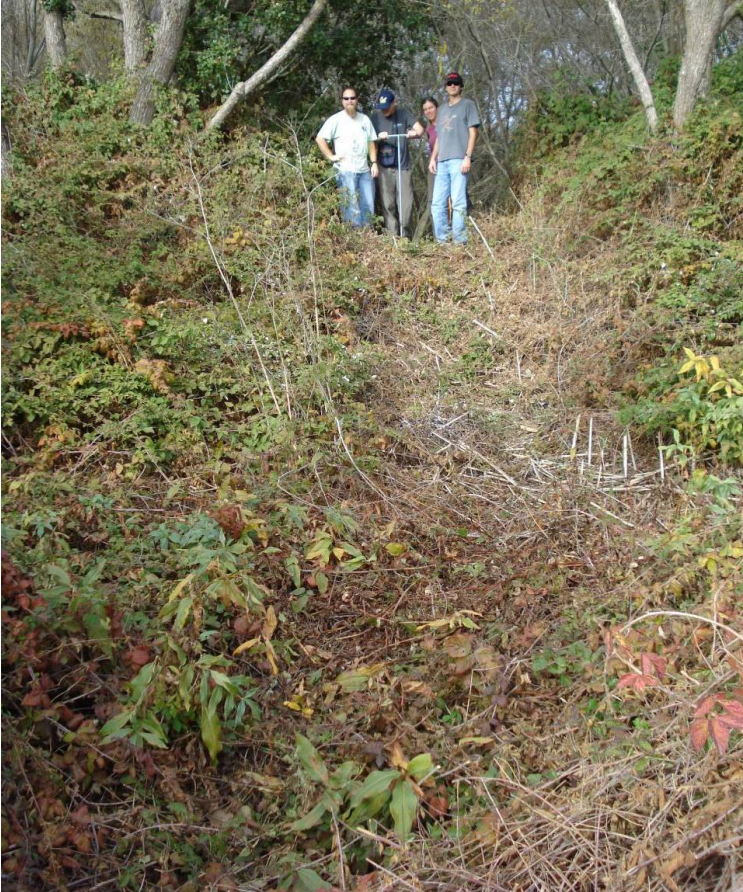
Figure 6: View of coring team at top of the berm from the floodplain upstream from XS275 (Figure 5).

We sampled sediment in two places, a deep vertical core into the berm, and along a transect down the surface of the berm. We cored vertically at the top of the left bank berm at approximately XS 275 (figure 5) to a depth of 1.35 m and collected 15 sediment samples at successive depths (Fig. 6). Surface sediment was also characterized along the near-channel side slope of the left bank berm near XS-275. Using a smaller coring device, 8 samples were collected at a depth of 0.15 m along a 3.5 m transect. Dominant sediment size and other parameters were determined with a standard sediment grain comparator. These samples are representative the materials composing the berm at the point of concern identified in Largay (2001).

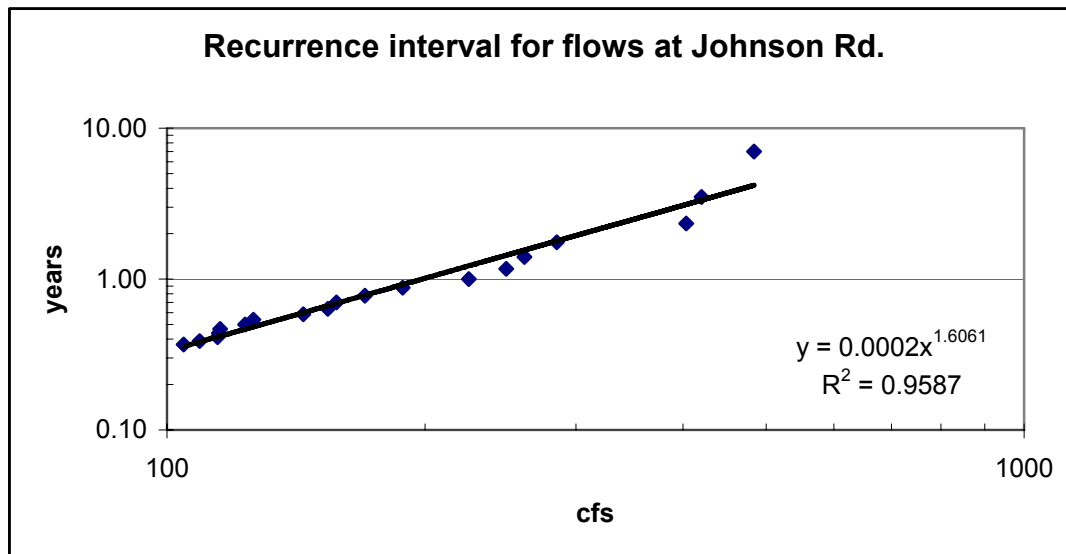
Figure 7: Partial duration series analysis for Carneros Creek at Johnson Rd.

Results from the partial duration series flood frequency analysis are presented in Table 2 and Figure 7.

The maximum flood for the period analyzed (water years 2002 – 2007) was 440 cfs and had a predicted recurrence interval of 7 years. Peak flows ranging from 205 cfs – 382 cfs had estimated recurrence intervals from 1 year to 3.5 years based on our analysis. Peak flows from 95 cfs – 171 cfs had recurrence intervals of less than one year, indicating flows in this range may occur multiple times in a given year. Results of a Log–Pearson III flood frequency analysis (using annual maximum flows from mean daily streamflow for water years 1986 – 1993) reported in Largay (2007) found peak flows with recurrence intervals of 1.01, 1.5, and 2 years to be 0.5, 37, and 83 cfs, respectively. The disparity between the two different flood frequency analyses illustrate both the poor results of modeling frequent events with Log–Pearson III analysis, and the enormous uncertainty that comes from a short period of record.

A 1400 cfs flow in Carneros Creek at Johnson Road, located just upstream from the property, has a return period of approximately 23 years according to the power function calculated for the relationship between peak discharge and return period

$$RP = 0.0002 * PQ^{1.6061}$$

where PQ is peak discharge (Table 2; Figure 7). In contrast Log–Pearson III analysis of Largay (unpublished data; Table 3) indicates that the 1400 cfs flow has an average return period of between 25 and 50 years. Both analyses are imprecise because seven years of data are insufficient for flood frequency analysis. Largay (2007) emphasized the uncertainty associated with analyzing short periods of record.

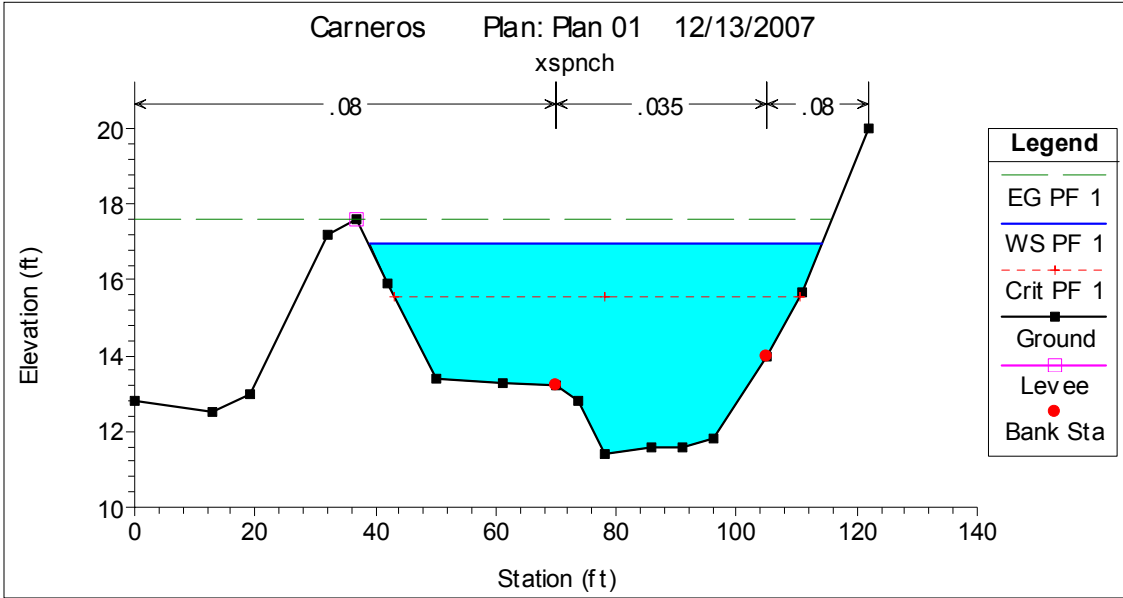
Figure 8: Cross-section 275 at a flow of 1400 cfs. Water surface elevation is within 6 inches of levee top which constitutes levee exceedence given the uncertainty inherent in or model.

Under the second scenario of a filled gap, the results of our model suggest that the channel could carry up to a 1400 cfs flow before the levees are overtopped. The highest energy grade at this discharge is downstream of the pinch, suggesting that this reach may be the most susceptible to undercutting and subsequent berm failure.

If the existing gap were repaired in place as part of the restoration implementation, high discharge flows will result in deep, swift flows along the length of the berm (Figures 8 through 11). This scenario could lead to failure from either overtopping when discharge exceeds approximately 1400 cfs (Figure 8, Table 3), or undercutting as high shear stress strongly exceeds the erosion threshold of the sand composing the berms (Table 5). Although we are not familiar with the history of the site, the presence of the berm gap suggests that our modeled failure may have actually occurred in the past when such high flows apparently occurred within the context of continuous berms.

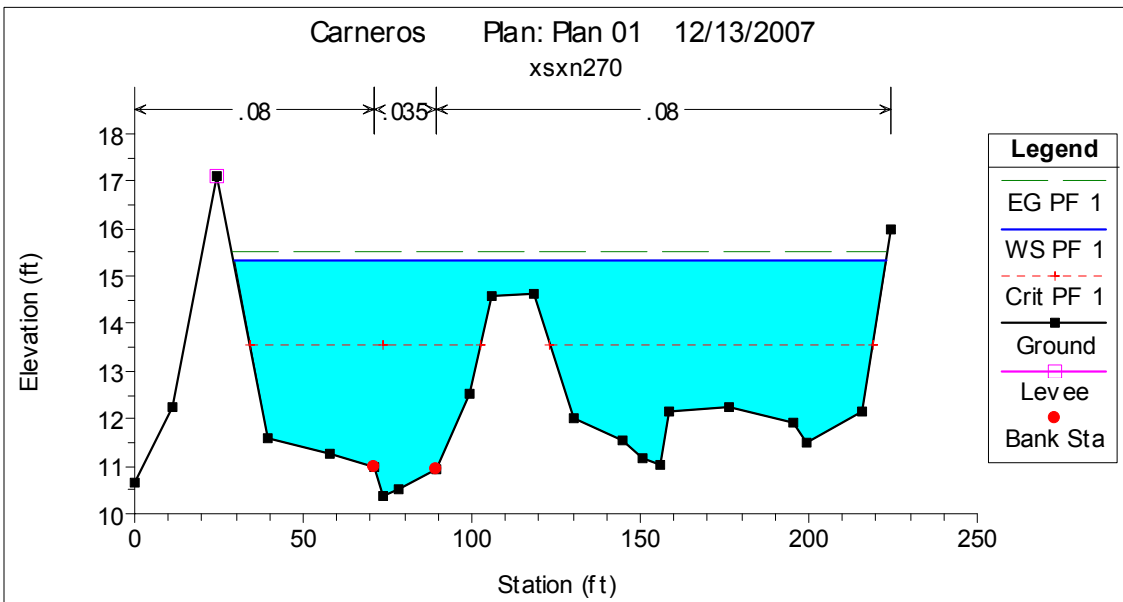
Figure 9: The channel and northwestern flood plain at a flow of 1400 cfs. at cross section 270 in Figure 5.

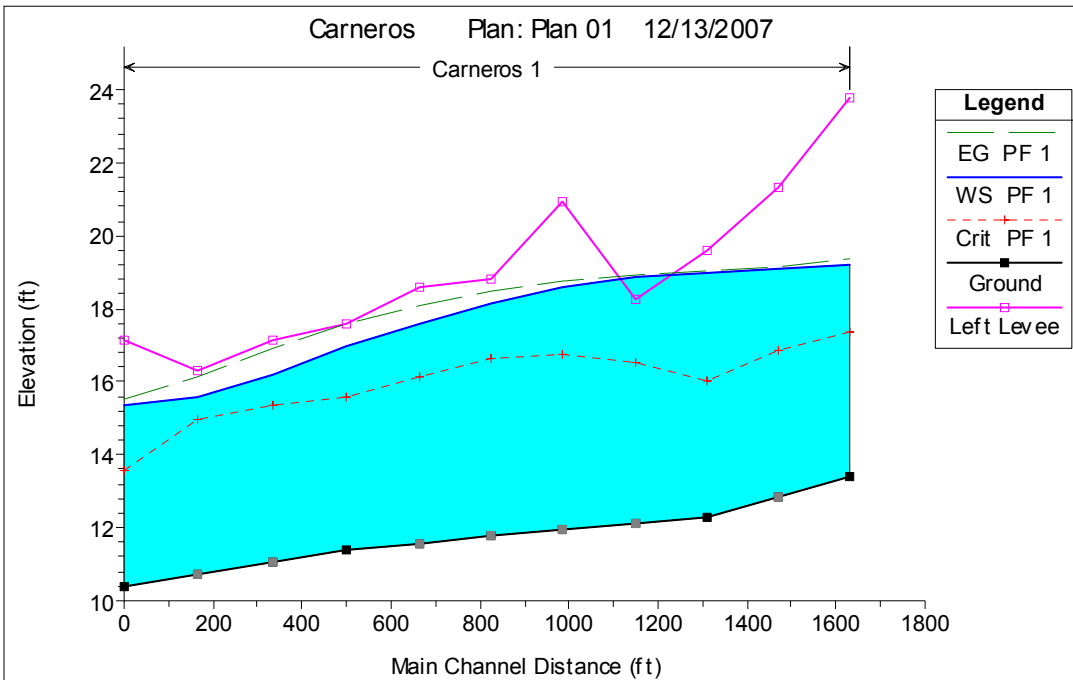
Figure 11: Energy grade (green dotted line), water surface elevation (blue line) and left levee elevation (purple line) profiles from downstream (x=0 ft.) to upstream (x near 1600 ft.).

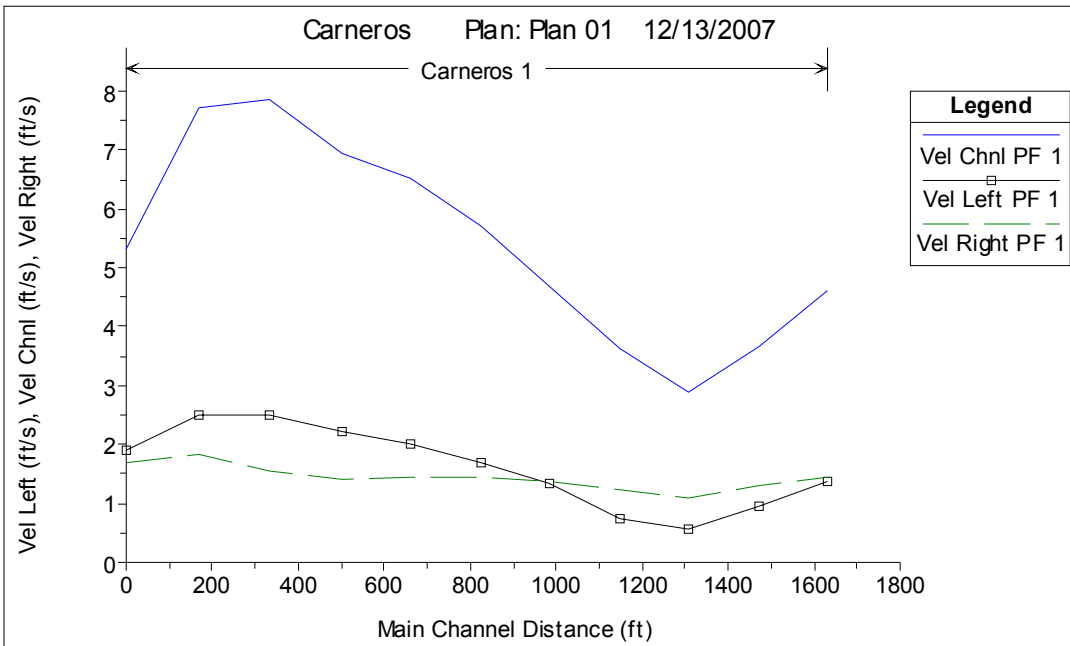
Figure 12: Channel velocity (blue line) velocity rising through pinch (Cross-section 275), and highest after the pinch. Channel velocity near the berm of concern is near 7 ft/s and the left floodplain, touching the berm, is near 3 ft/s downstream of the berm of concern.

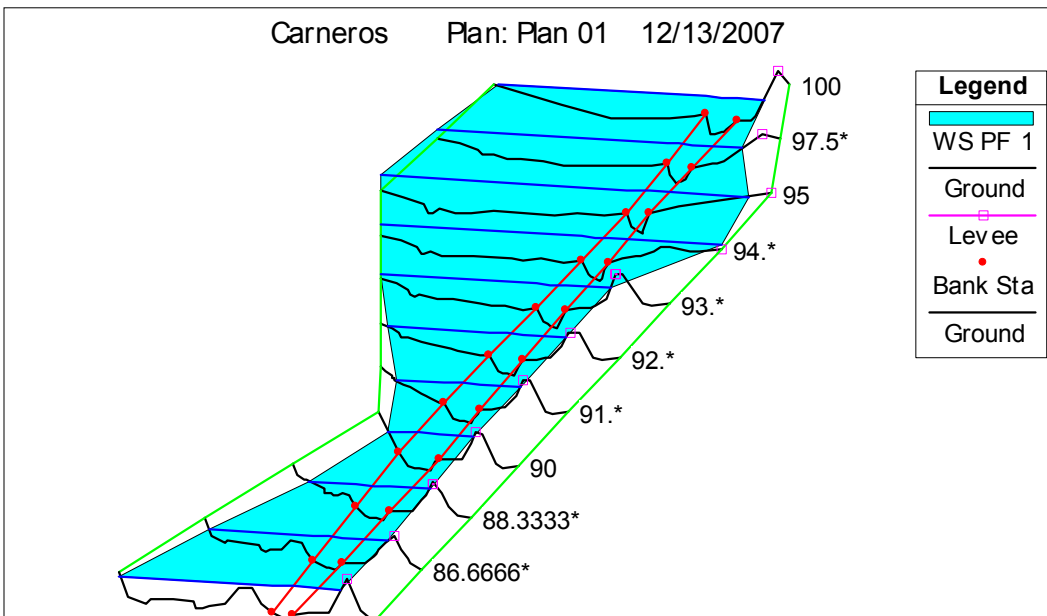
Figure 13: Oblique view of modeled channel at 1400 cfs with under Scenario 2 with no gap.
