Information Circular No. 79

**FLOOD OF SEPTEMBER 20-23, 1969**  
**IN THE**  
**GADSDEN COUNTY AREA, FLORIDA**

By  
W. C. Bridges  
and  
D. R. Davis

Prepared by the  
UNITED STATES GEOLOGICAL SURVEY  
in cooperation with the  
FLORIDA DEPARTMENT OF TRANSPORTATION  
and the  
FLORIDA DEPARTMENT OF NATURAL RESOURCES  
DIVISION OF INTERIOR RESOURCES  
BUREAU OF GEOLOGY  
TALLAHASSEE, FLORIDA  
1972

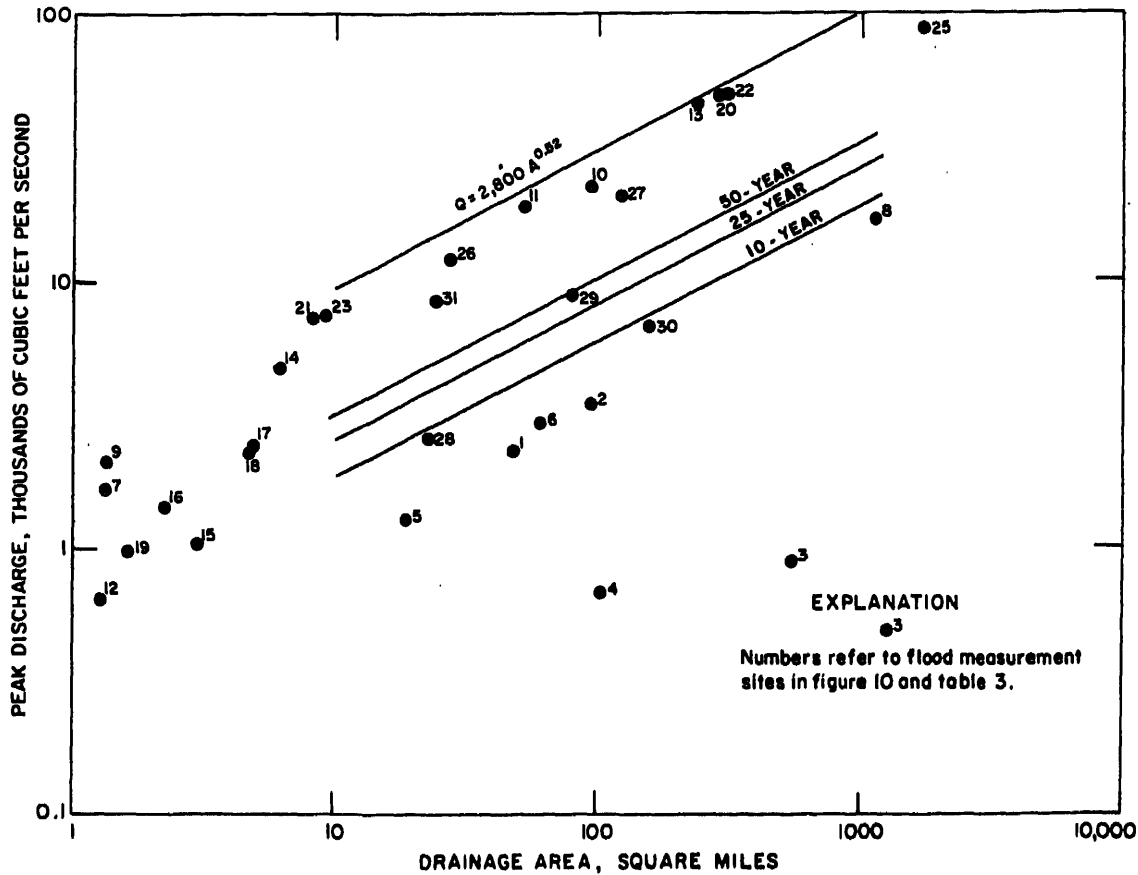
Figure 14.—Relation of peak discharges to regionalized flood-frequency curves—storm of September 20-23, 1969. Flood-frequency curves adapted from Barnes and Golden (1966).

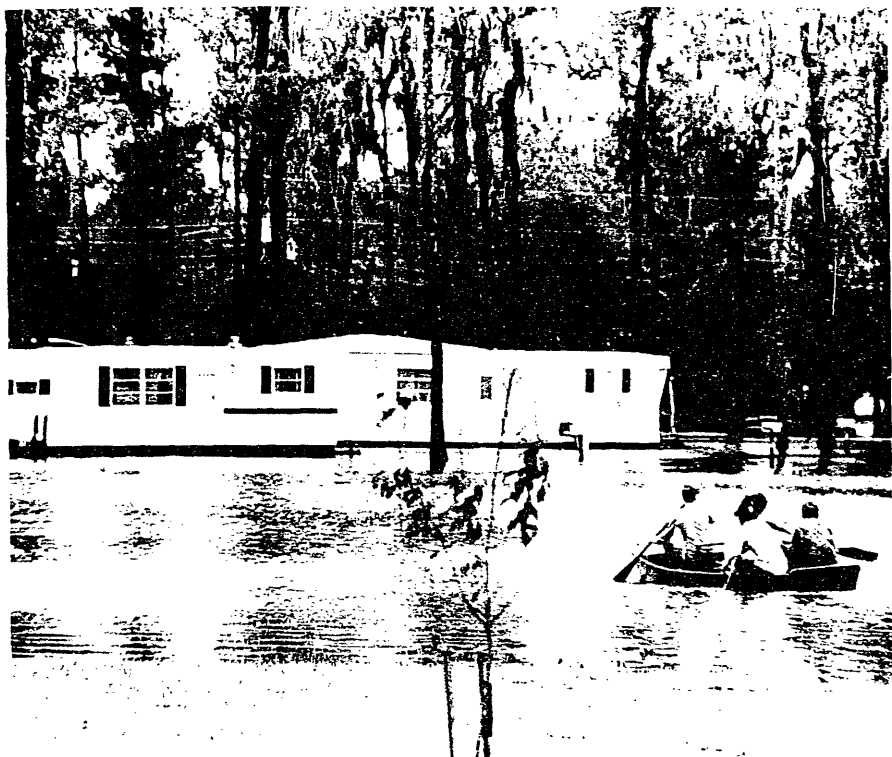
Figure 20.—Mobile homes at Bell's Trailer Park, U.S. Highway 20 west of Tallahassee—Photo by Tallahassee Democrat.

cially those along the Ochlockonee River valley below the Jackson Bluff Dam. As shown in figure 19, only the roofs of several mobile homes are visible in the lower left of the picture. Bell's Trailer Park on U.S. Highway 90 between Tallahassee and Quincy was flooded when a low area filled and the outlet was inadequate to remove the excess water. Many mobile homes were removed but those pictured in figure 20 were flooded to depths of 6 inches over floor level.

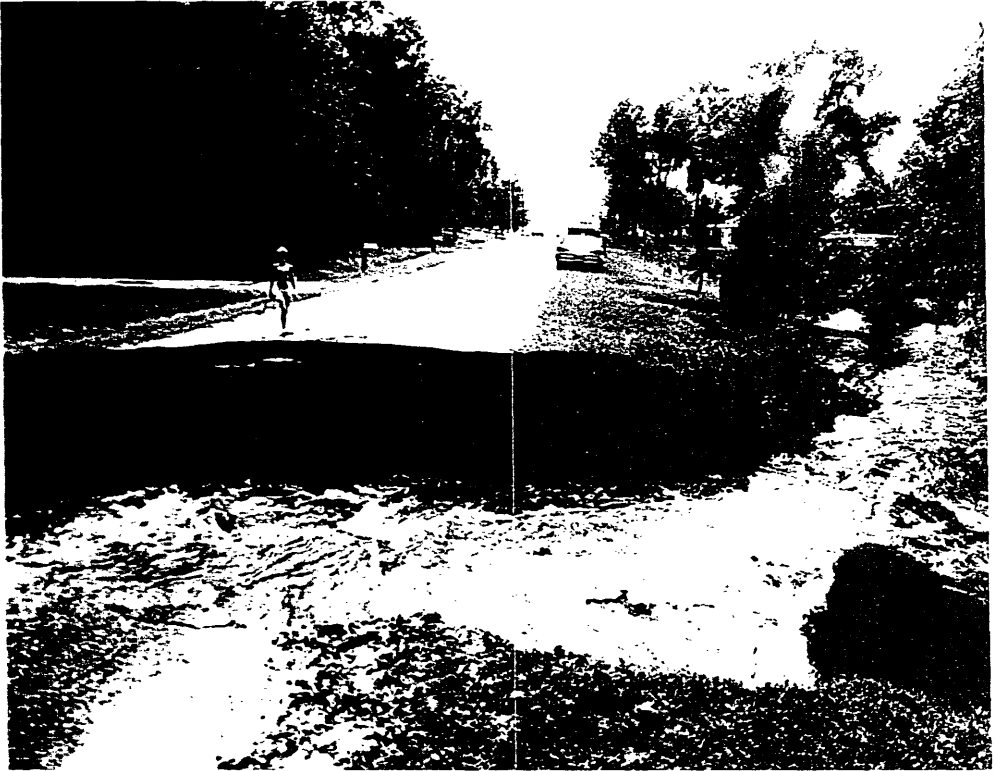
Figure 21.—Road washout at North Lake Drive between Old Bainbridge Road and Lake Jackson—Photo by Tallahassee Democrat.

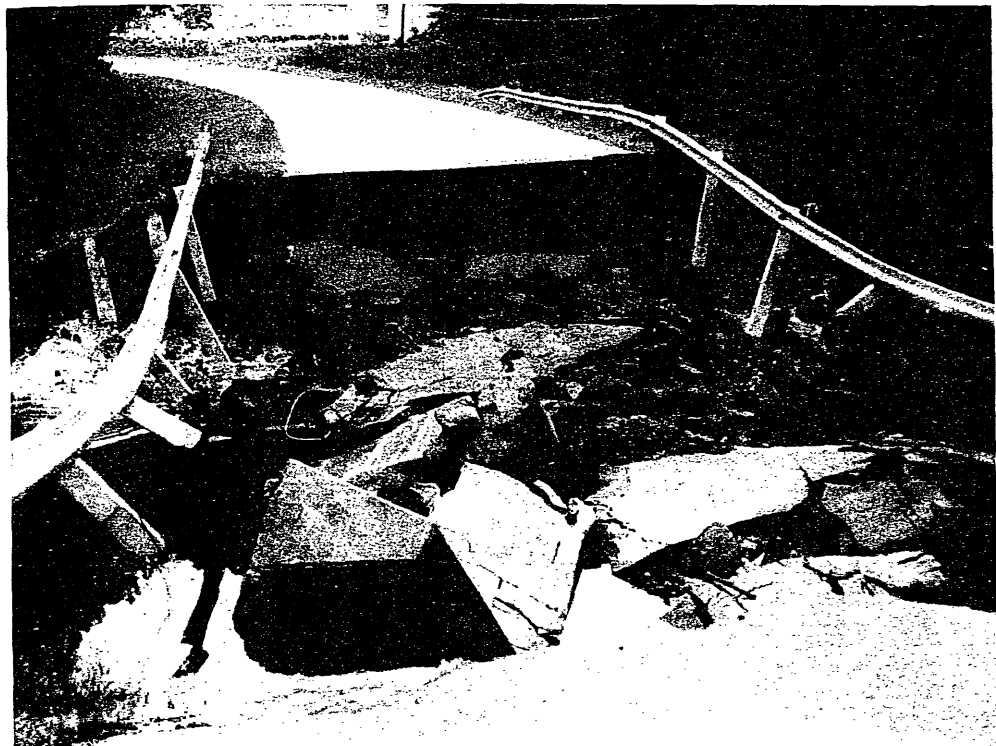
Figure 22.—Salem Branch at State Highway 159 near Havana.
