UFL/COEL-77/001

DETERMINATION OF DIRECTION OF LITTORAL TRANSPORT
ALONG THE NORTH SHORE OF SANTA ROSA ISLAND,
FLORIDA

Yu-Hwa Wang
T.H. Chang
Sidney L. Harrell

March, 1977

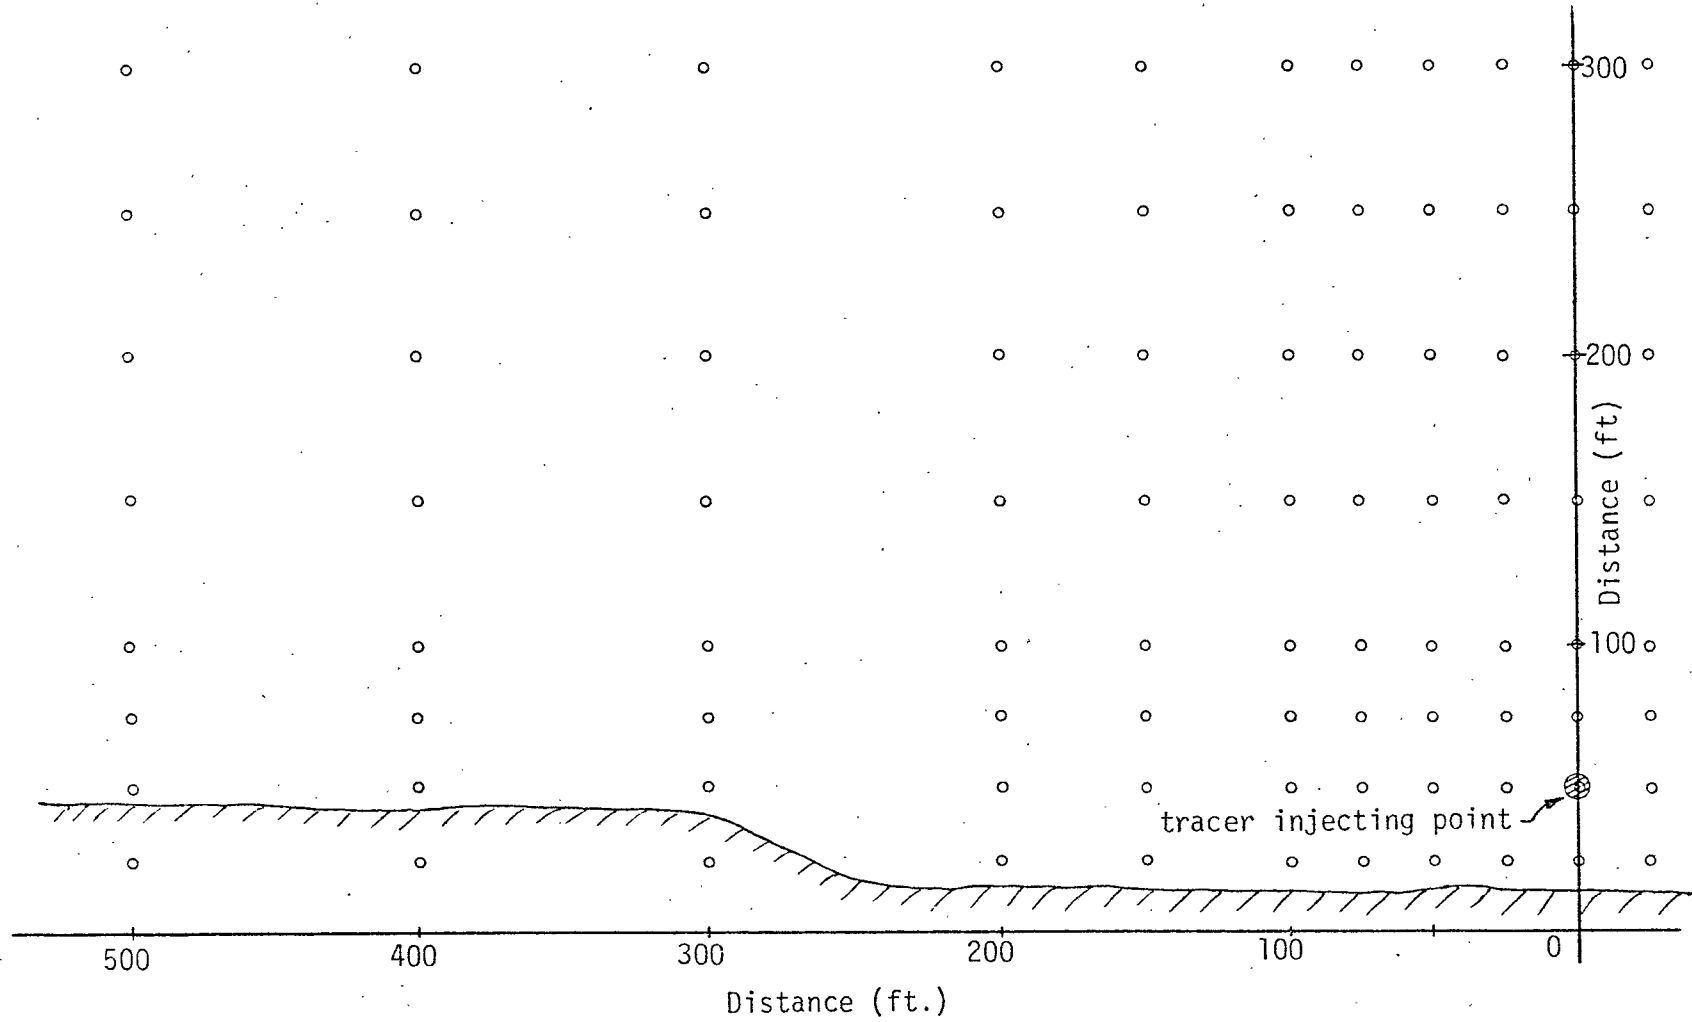
Figure 2. Sampling grid at site A, November operation, 1976

A. The November 1976 operation: The grid system established at site A is shown in figure 2. The initial spacing was 25 feet apart, but was expanded to 50 feet and finally 100 feet between sampling stations. A similar grid was established at site B as shown in figure 3.

C. Tracer sands: Sands were collected from site A and B shortly before the tracing operation. These sands were coated with fluorescent dye in the Coastal and Oceanographic Engineering Laboratory (COEL), University of Florida. These colored sands were then injected in the predetermined coordinate system as shown in figures 2 to 4.

A. November 1976 operation: Approximately 100 pounds of tracer sand was dumped instantaneously into the water at site A and B. The location of the injections are shown in figures 2 and 3. A dredge-type sand sampler was used for collecting the samples and the sampling stations were according to the predetermined coordinate system. The sampling frequency was based on the tidal cycles (approximately 24 hours). In this way, the field crew could work alternatively between sites A and B. Each sample was put into a sampling

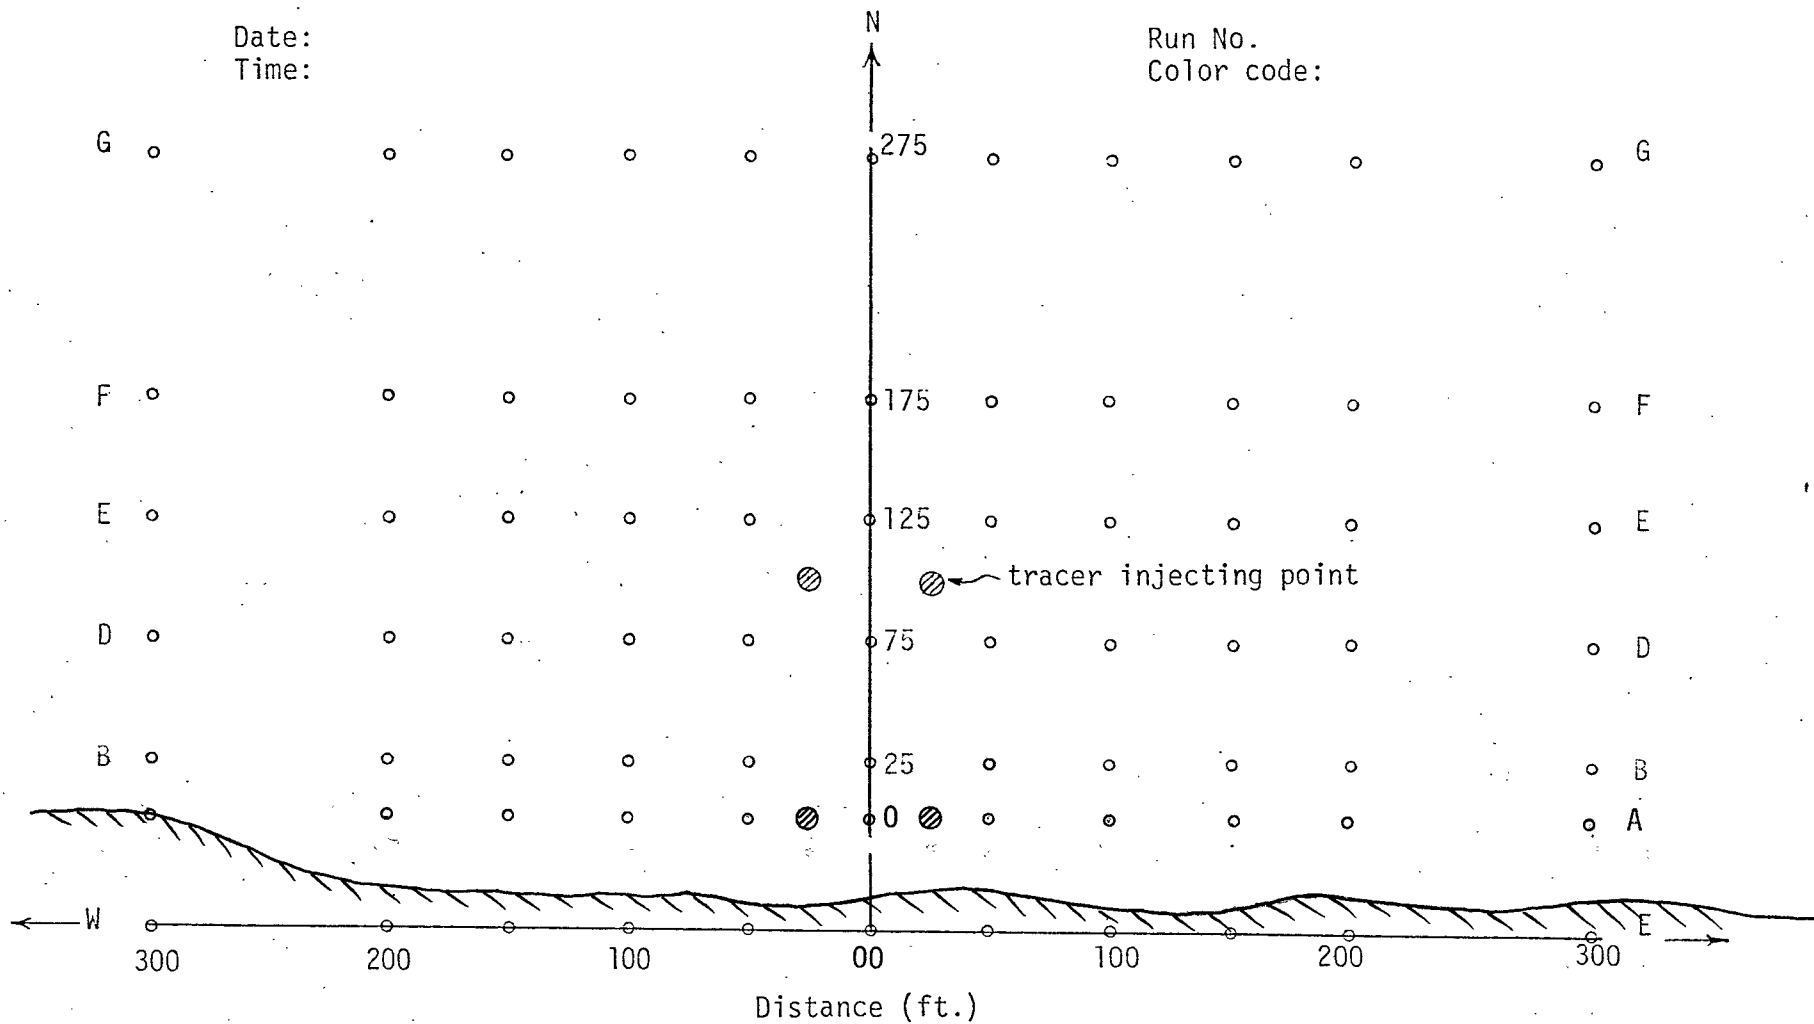
Figure 4a. Sampling grid at site A, February operation, 1977

B. The February 1977 operation: The initial spacing of 25 feet was too close. Therefore, 50 feet spacing between the sampling stations are adopted for site A. The grid system is shown in figure 4.

- F. Considerable bottom changes have taken place between November 1976 and February 1977. The shoals in figure 6b have grown both in size and in height, as shown in figure 4b. A transverse bar situated between 200 to 300 feet East (figure 4a) in the NE direction has grown out of the water surface. Sandpipers standing on the dry ridge of this transverse bar can be seen in figure 4c.

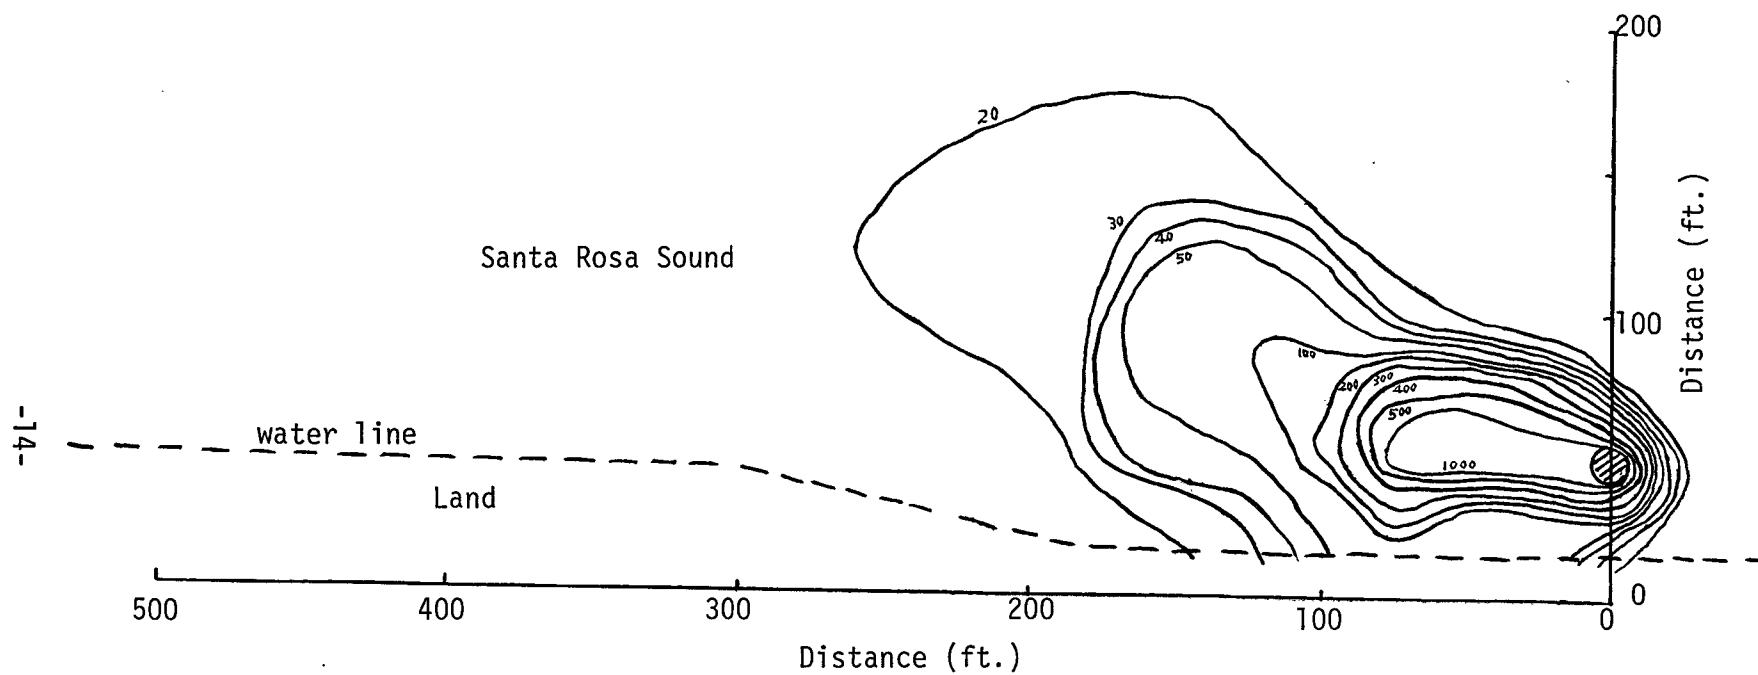
Figure 5a. Equal concentration contours for site A
Date: 11/13/76

Numbers = tracer sand count per 40 gm sample

⊙ = tracer sand injection point

- A. The observed wave parameters in Santa Rosa Sound are directly related to the wind conditions.
- B. There is an observable correspondence between the littoral transport and littoral drifting currents.
- C. Figures 5a and 5b have shown that the longshore movement was stronger than the on/offshore components.
- D. Figures 7a and 7b have shown that the tracer sands moved around the sharp land feature first and then towards the beach.
- E. Many distinctive land features have been observed in the project area, such as crescent sharp points (e.g. site B), and the semi-elliptical submerged sand bar which is superimposed with transverse bars in the NE and NW directions. It seems that all these have a strong indication of edge wave effects.

- G. Different patterns of tracer contour maps between November 1976 and February 1977 are clearly observable. Contour map figures 5 and 7 are characterized by one peak region while figures 11a to 11f have many peaks and valleys.

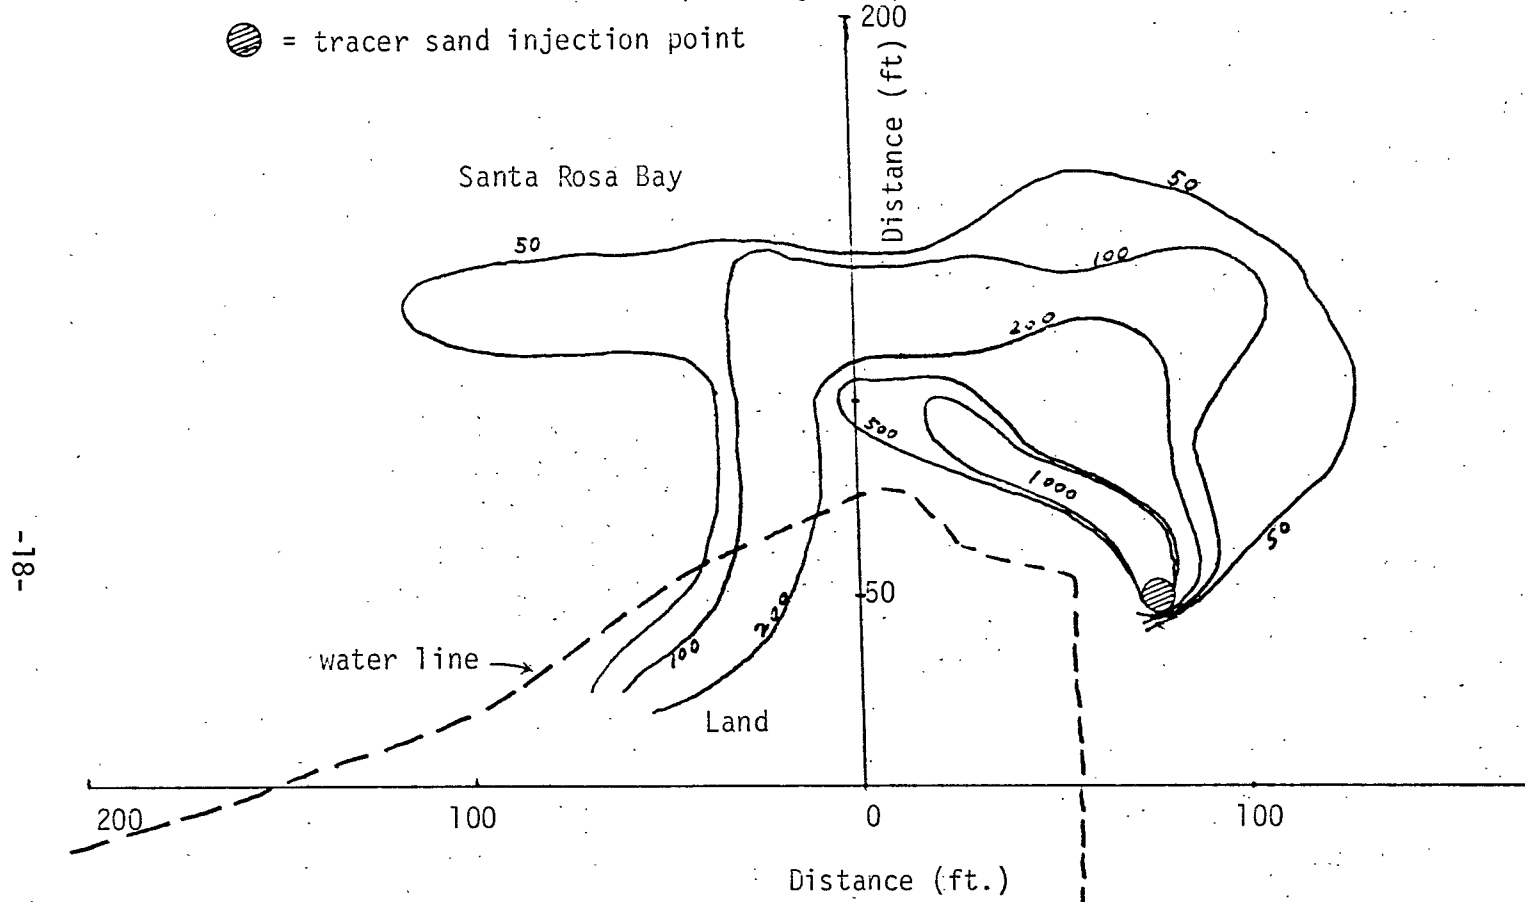
Figure 7a. Equal concentration contours for site B
Date: 11/13/76

Numbers = tracer sand count per 40 gm sample

● = tracer sand injection point

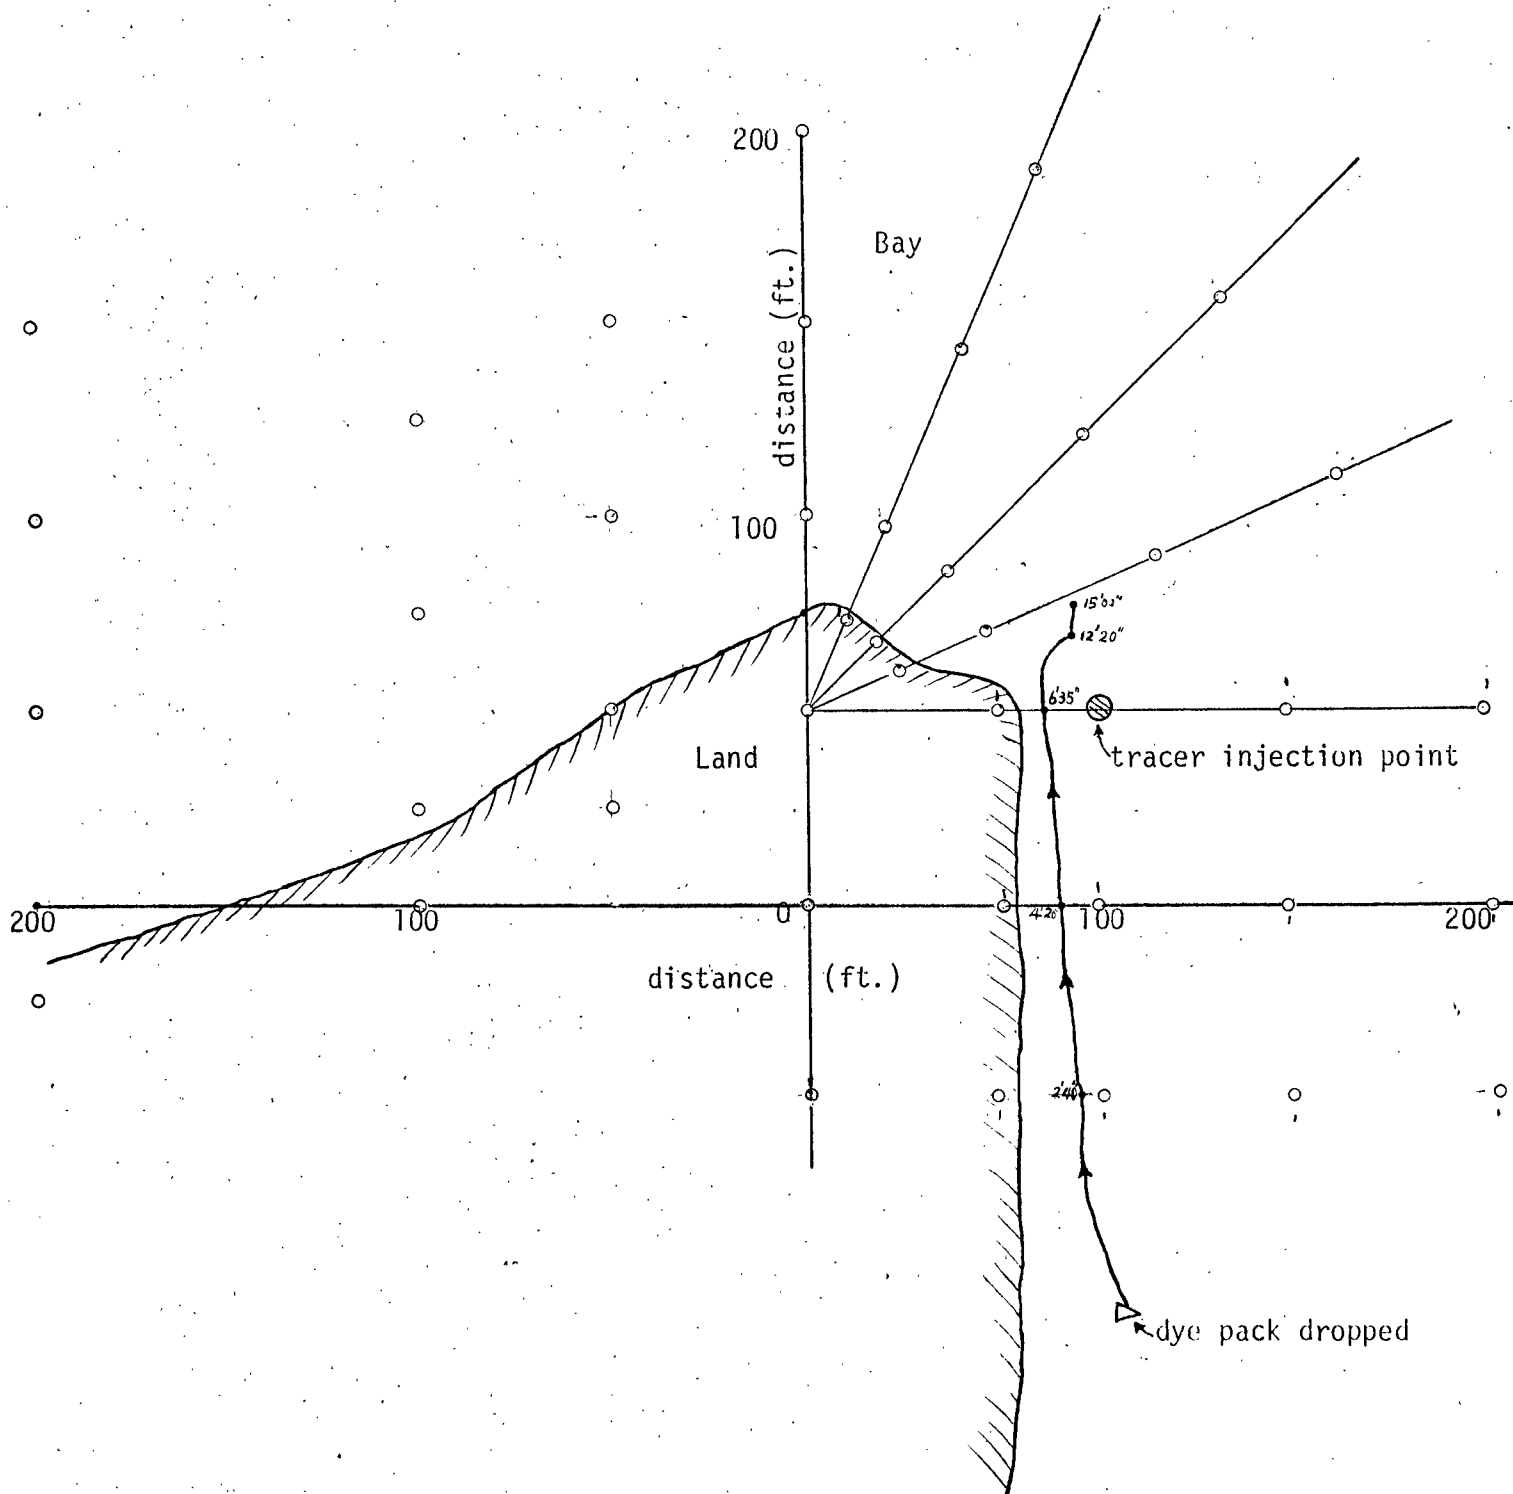
Figure 8a. Observed littoral current and wave parameters at site B

wave length: 15 ft.
 wave height: 7 in.
 wave period: 1.6 sec.
 wave direction: NE
 Average current speed $V = 0.25$ ft/sec
 Date: 11/13/76 Time: 15:37 - 17:00

○ represents sampling stations

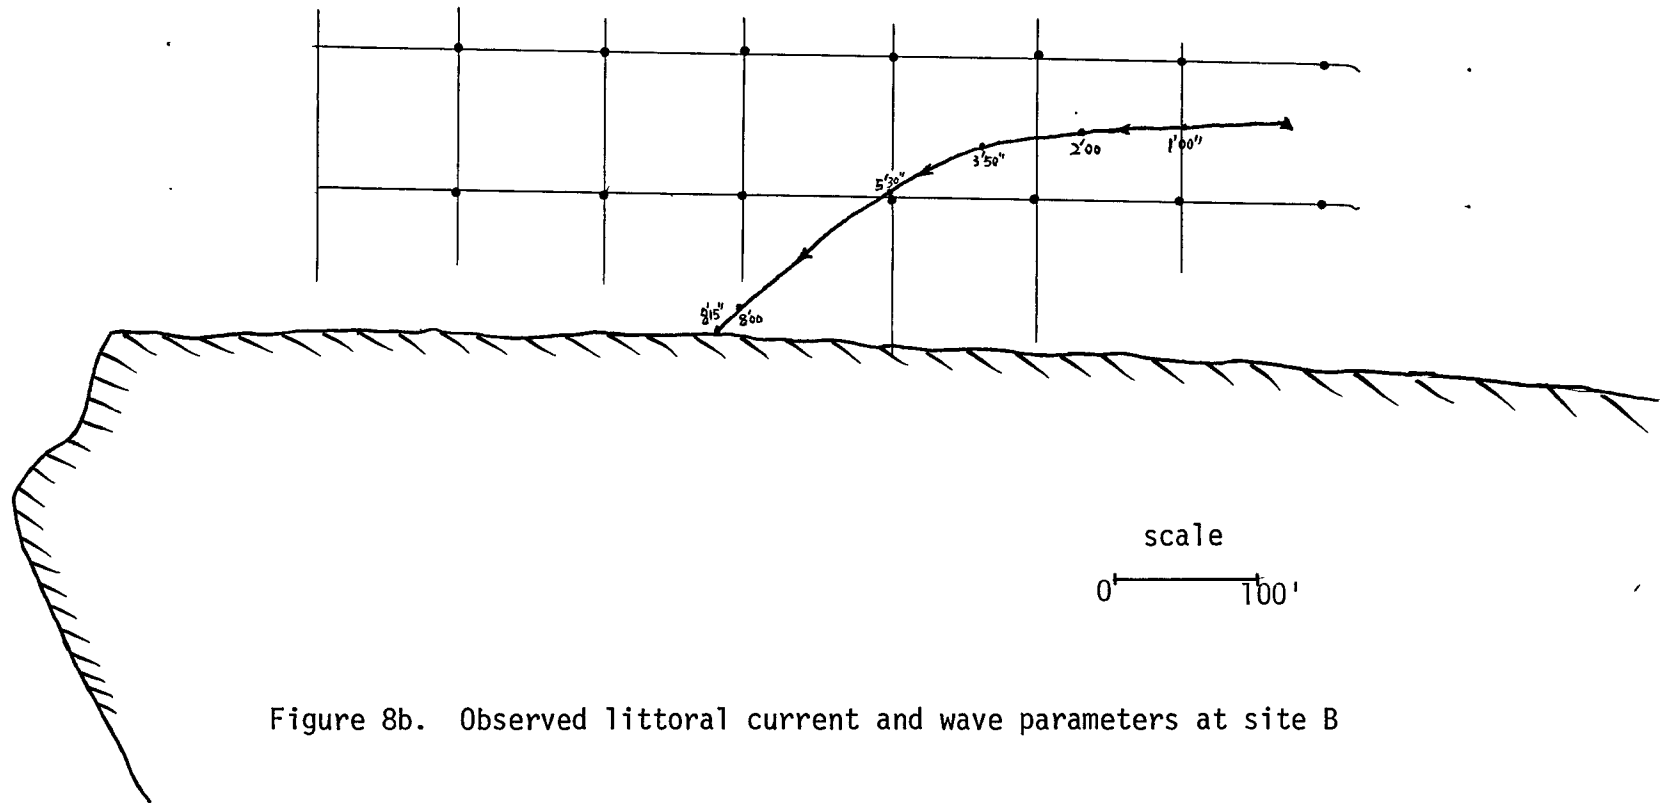
Figure 8b. Observed littoral current and wave parameters at site B

wave length: 25 ft.
wave height: 1 ft.
wave period: 1.6 sec.
wave direction: NE
date: 11/14/76

Average current speed 0.77 fps
