UFL/COEL-77/001

DETERMINATION OF DIRECTION OF LITTORAL TRANSPORT
ALONG THE NORTH SHORE OF SANTA ROSA ISLAND,
FLORIDA

Yu-Hwa Wang
T.H. Chang
Sidney L. Harrell

March, 1977

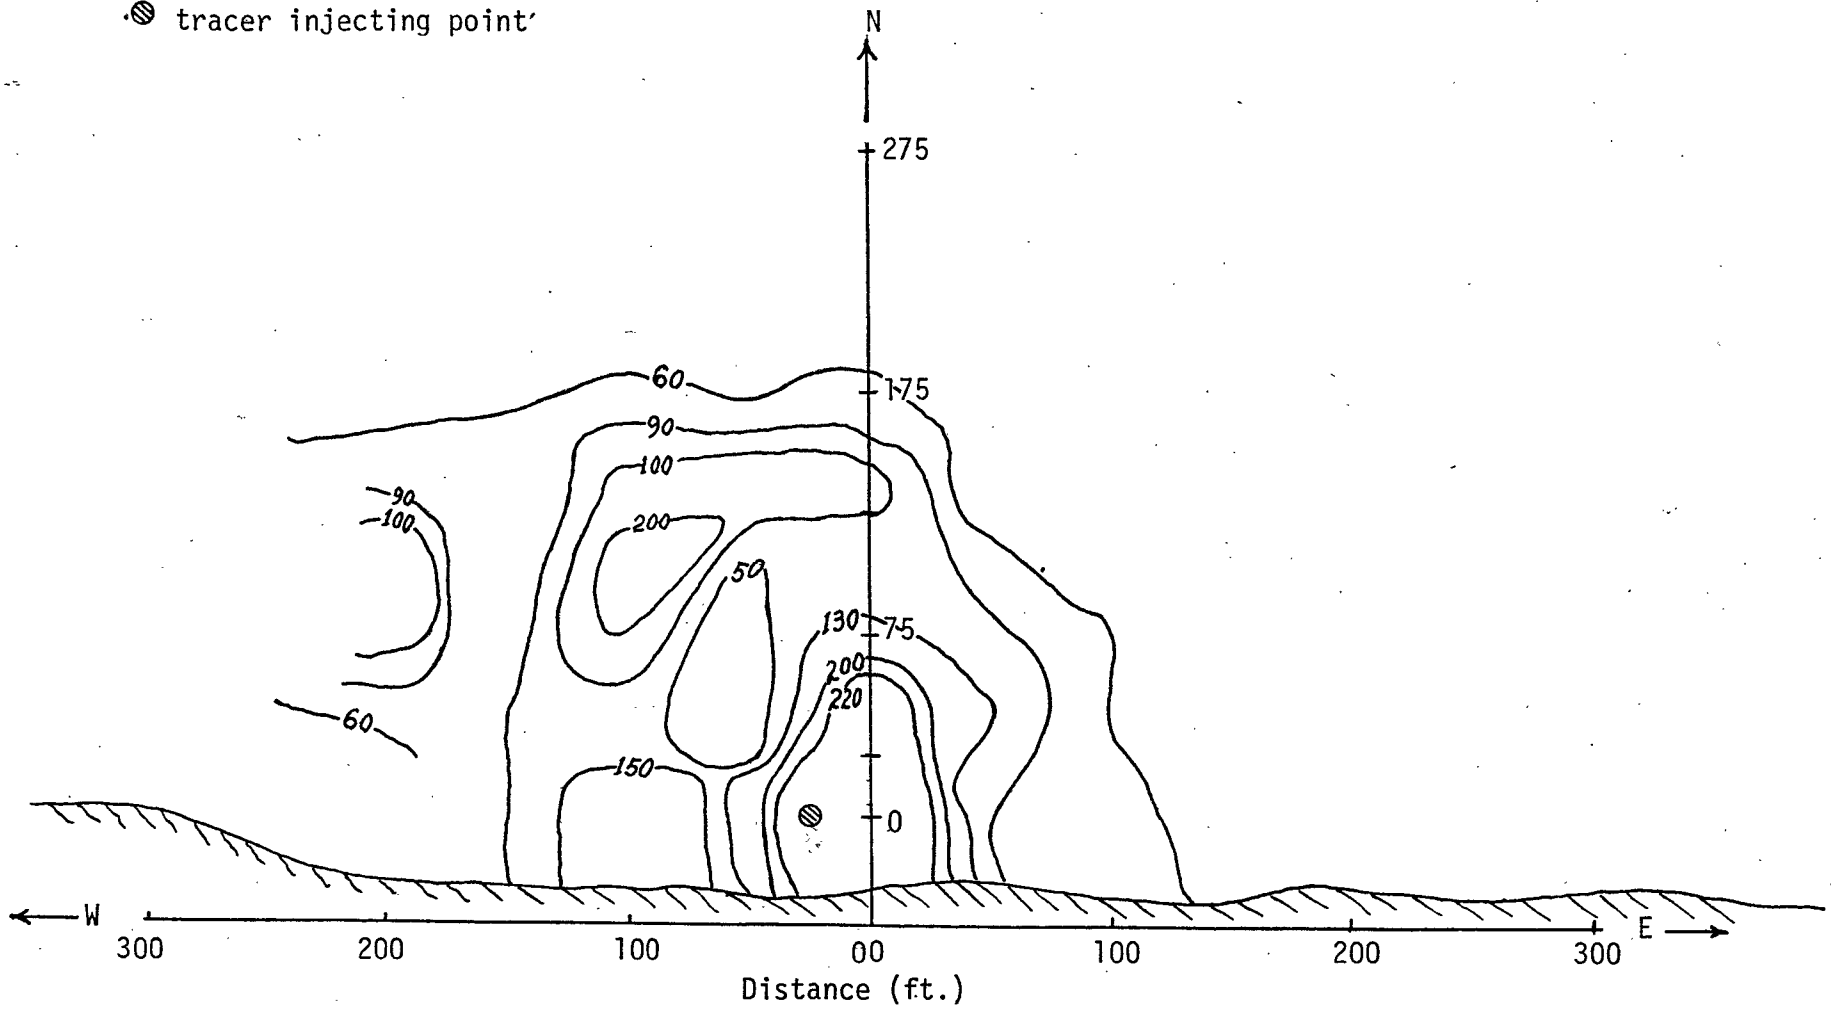
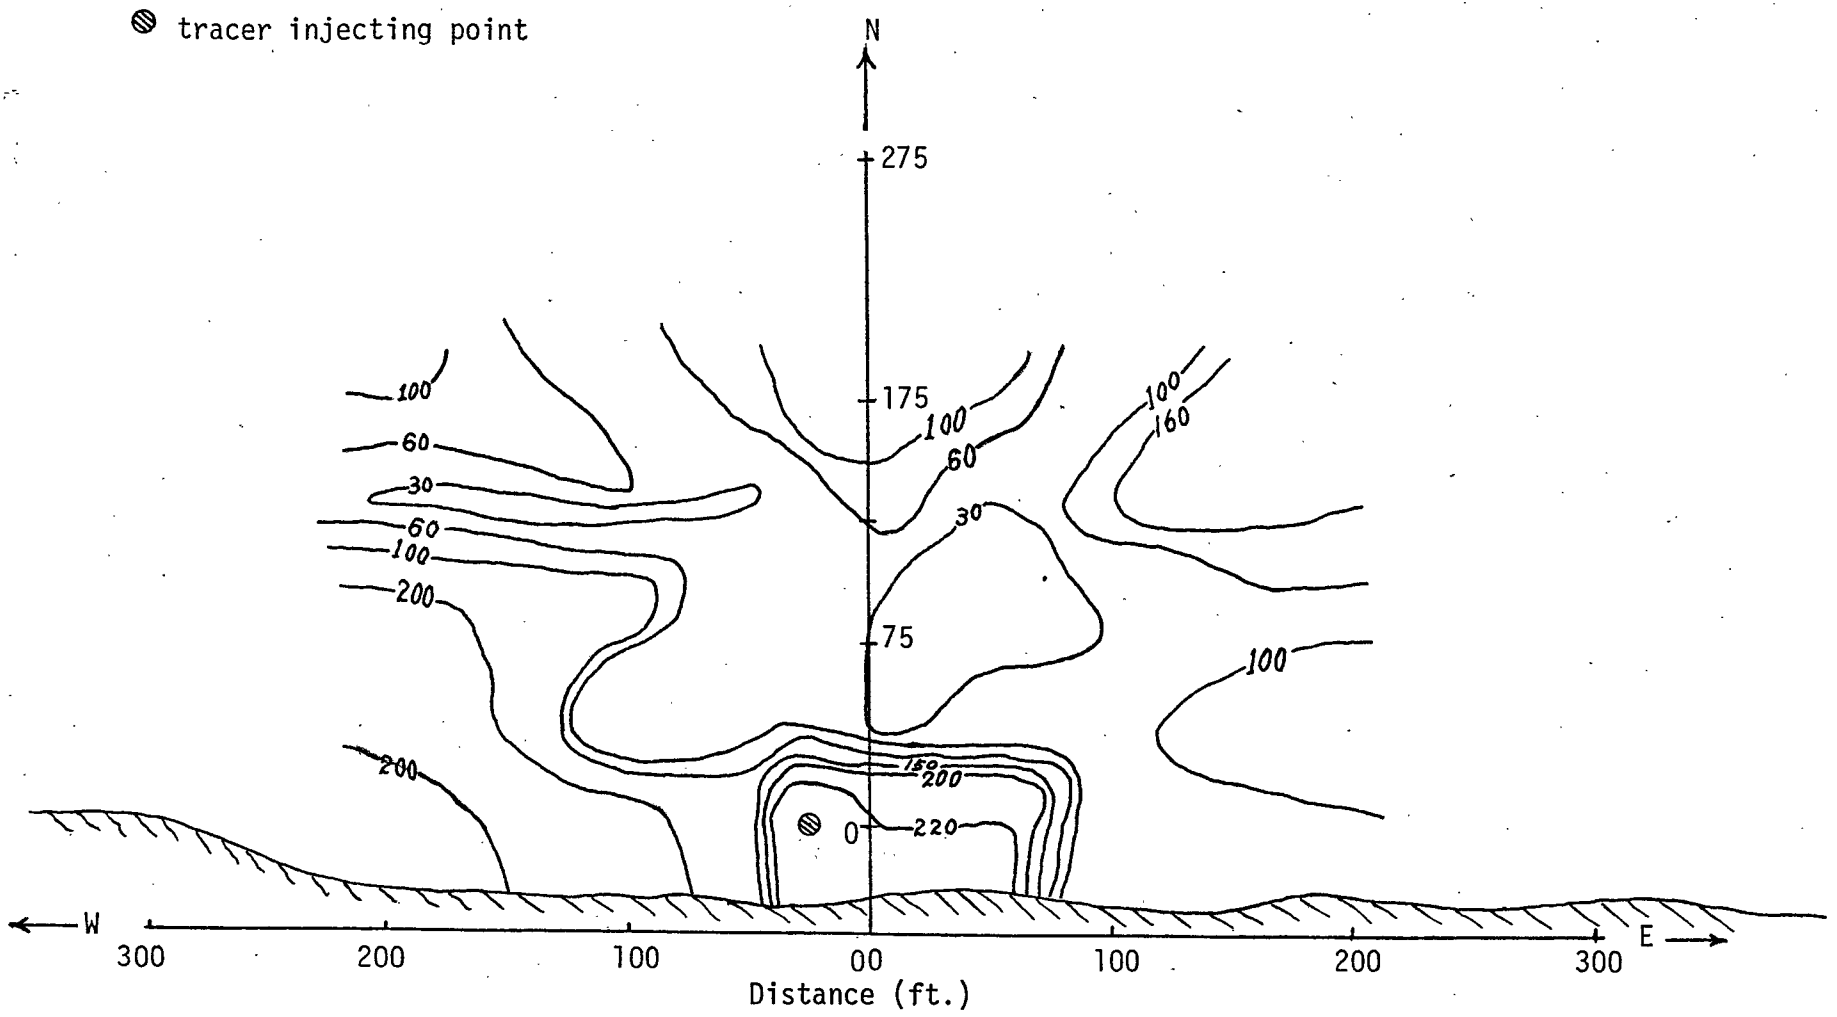
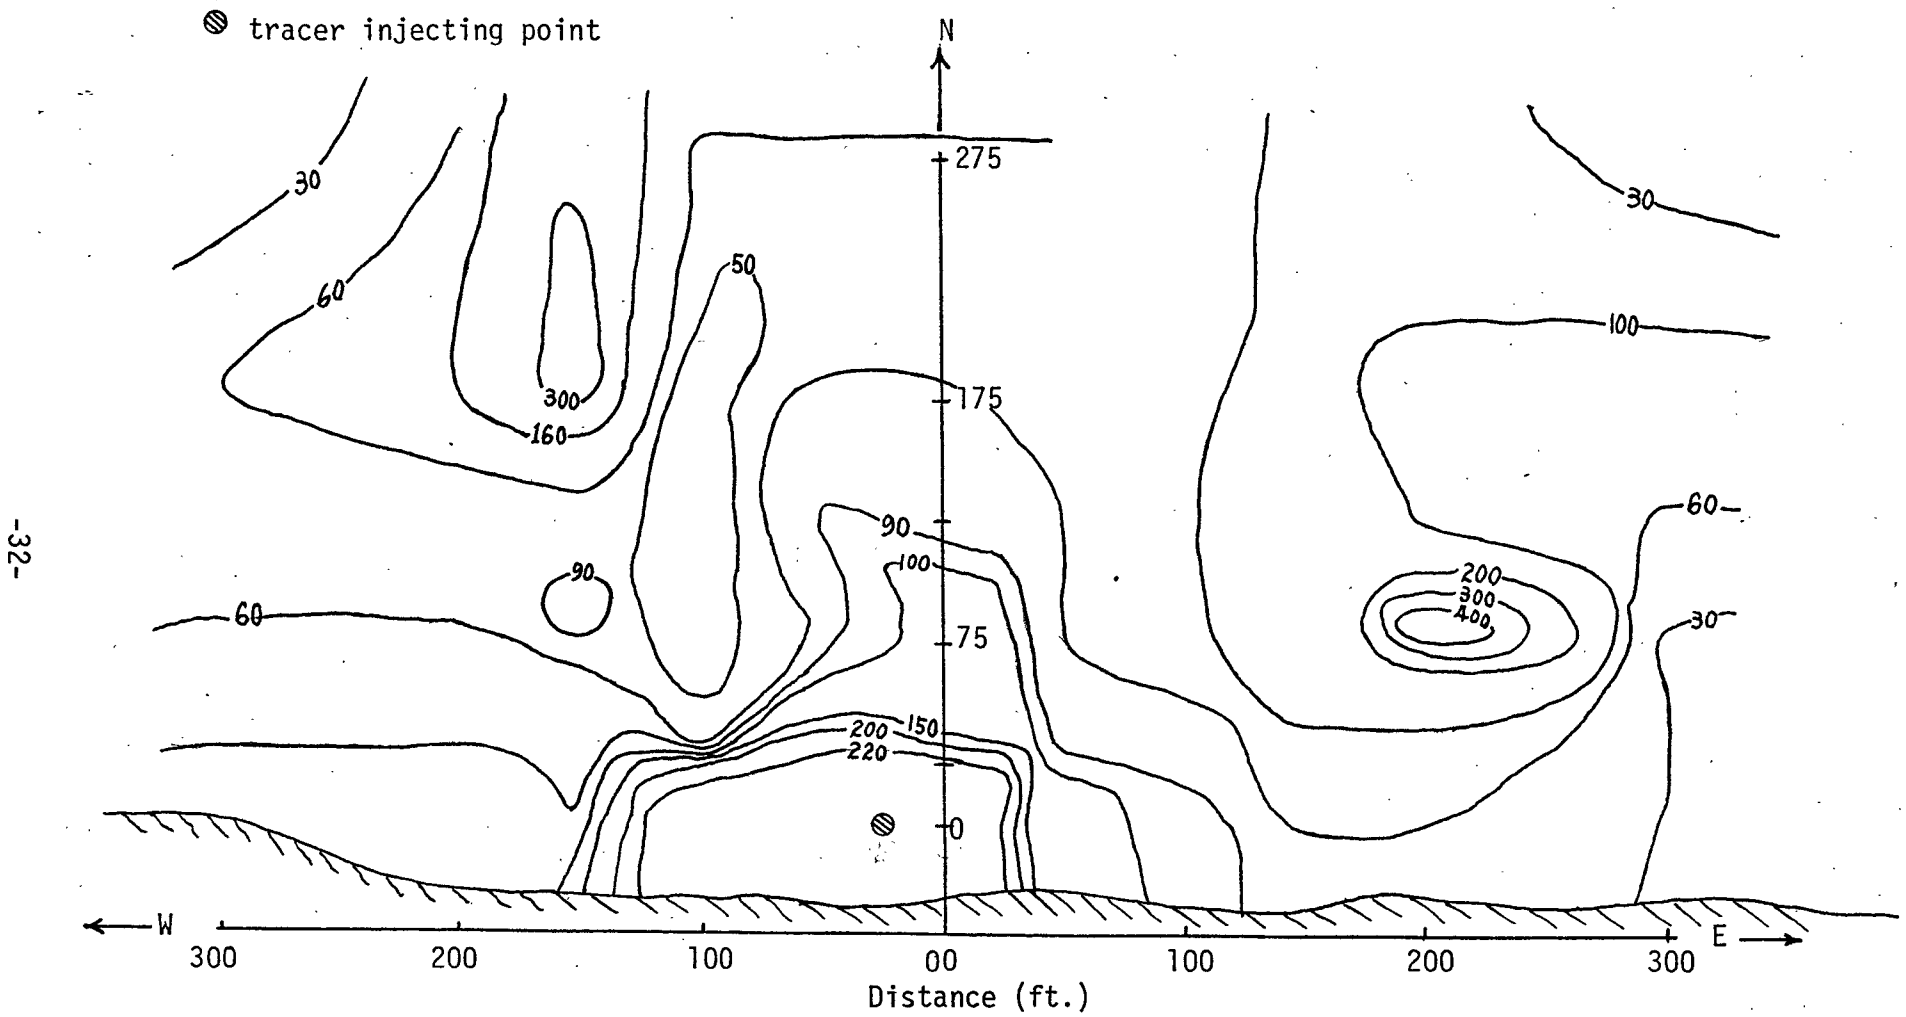
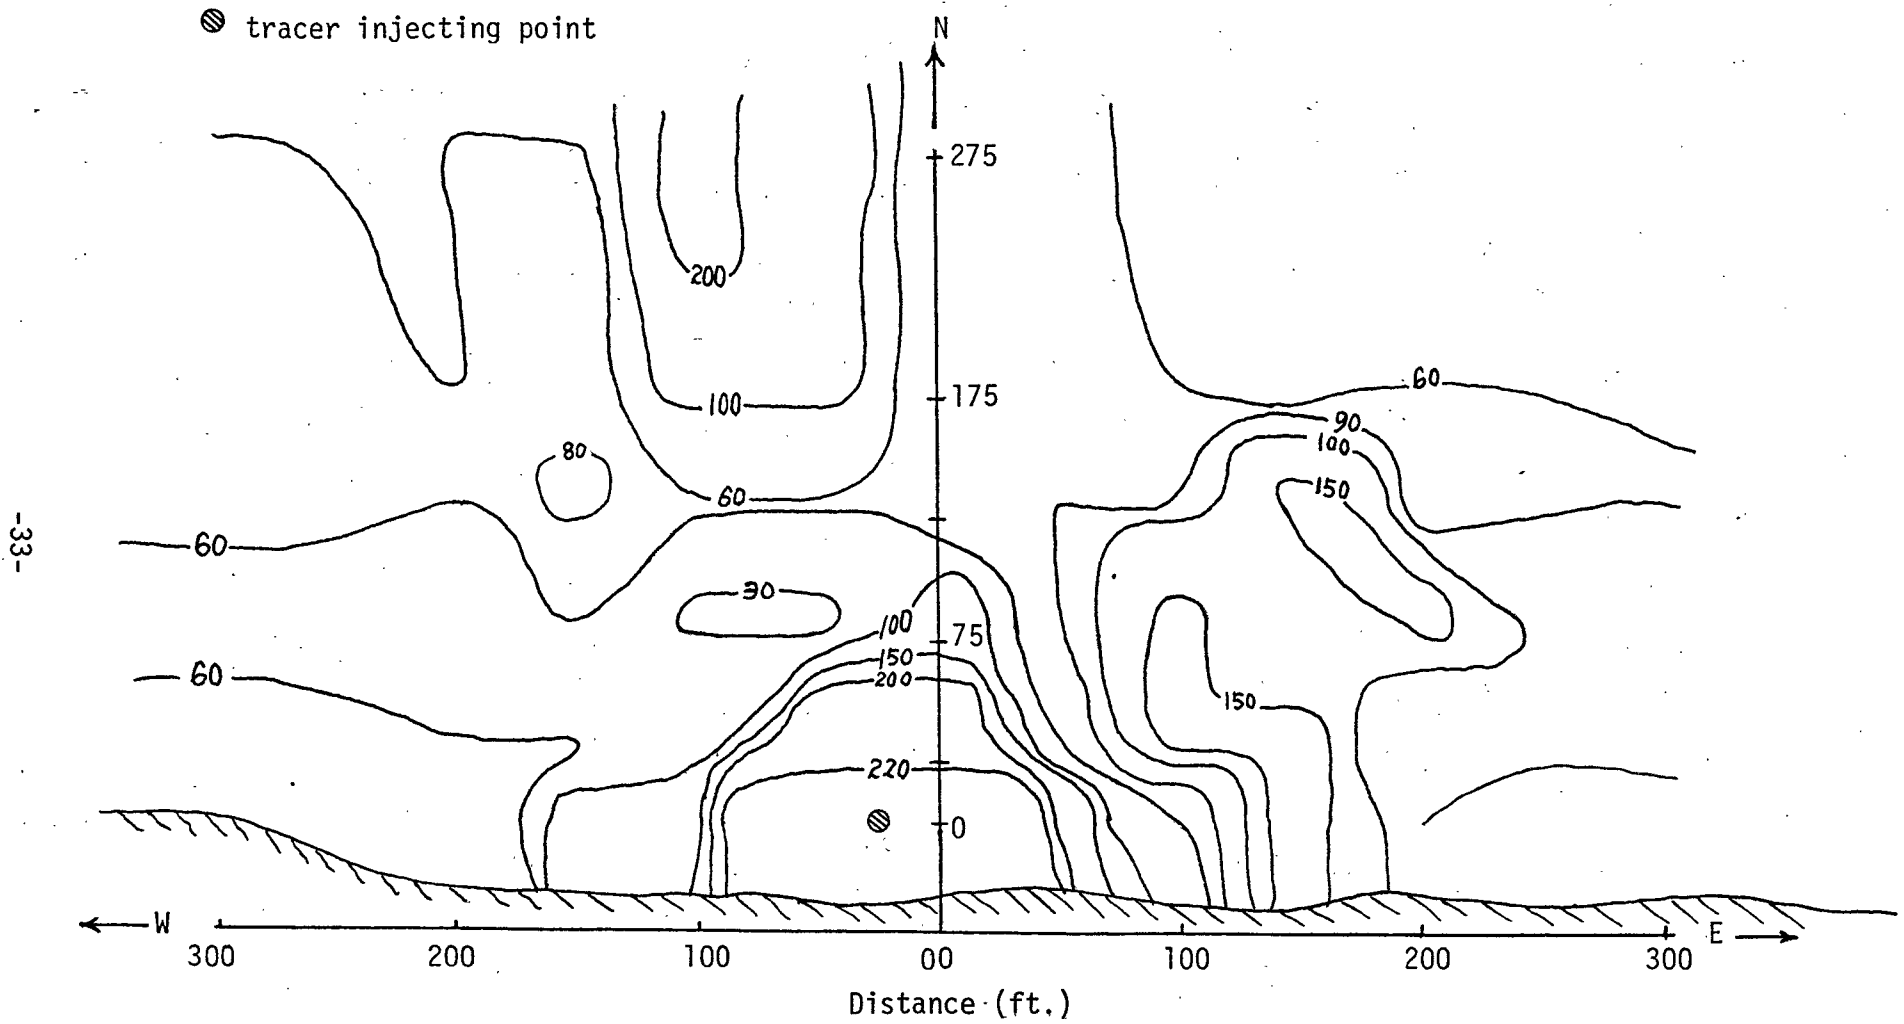
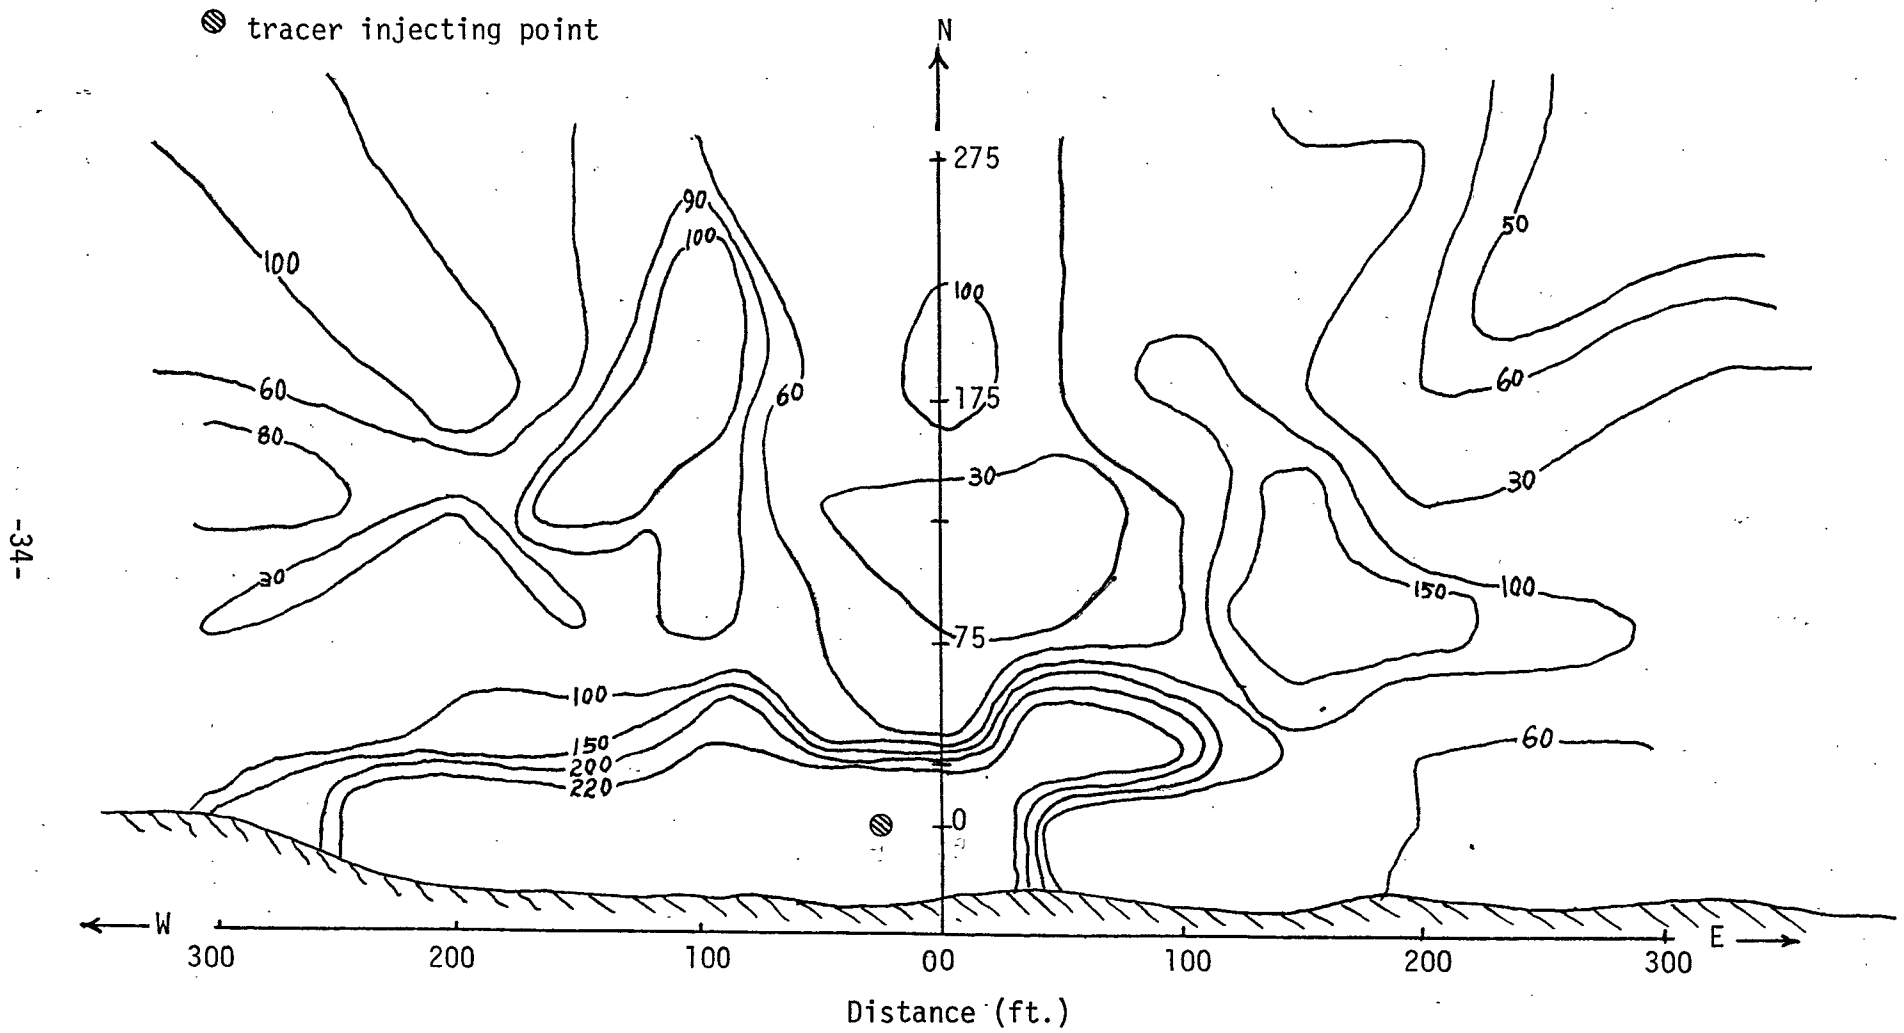
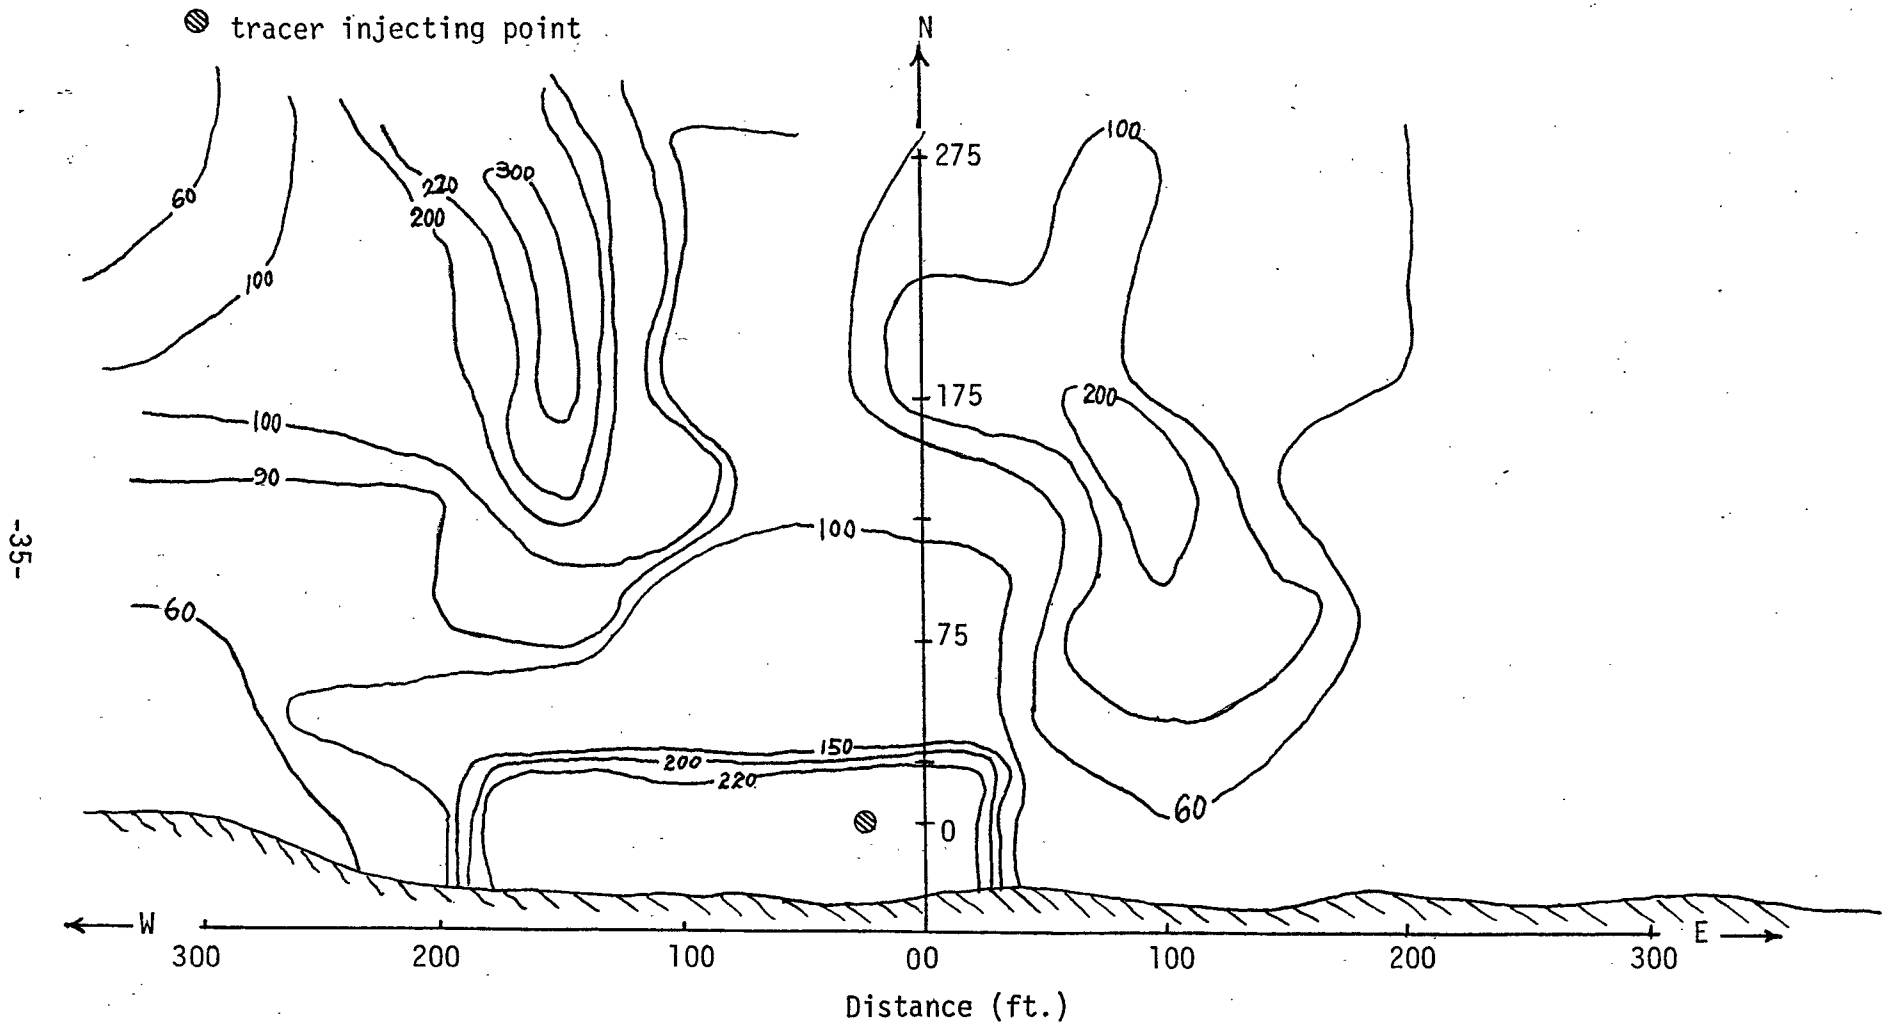
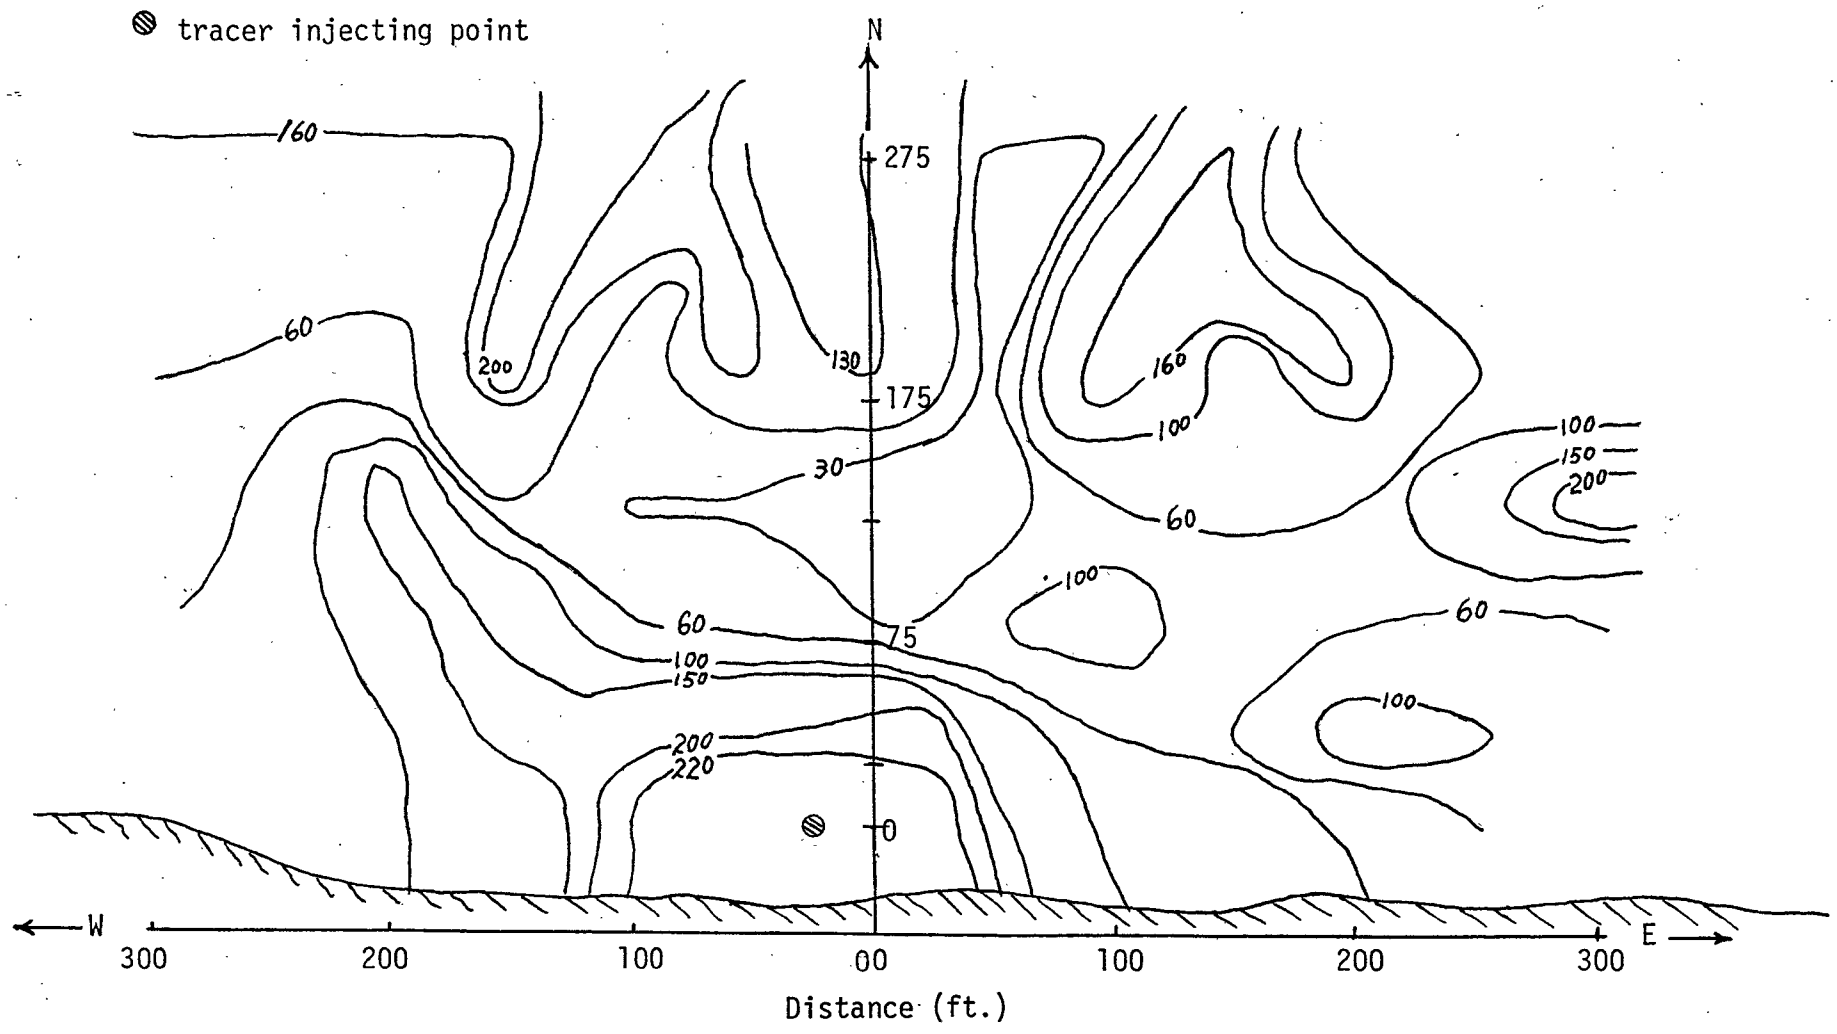
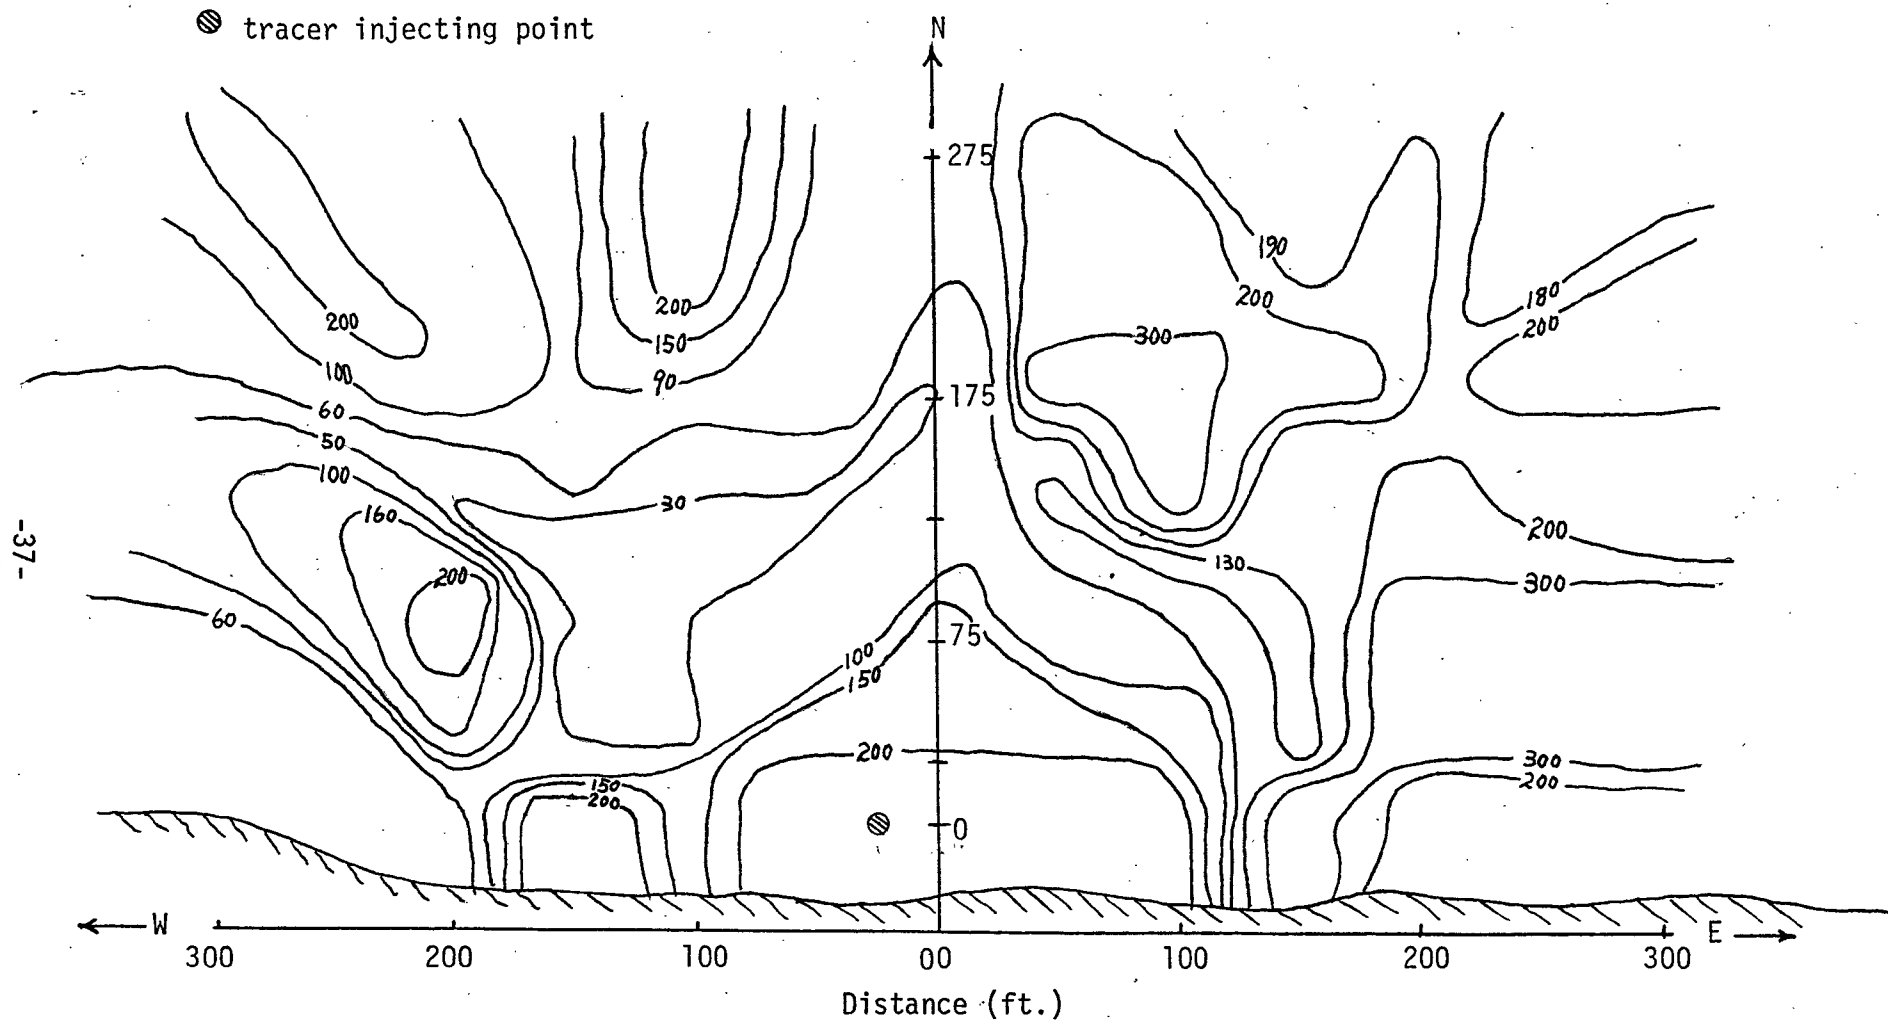
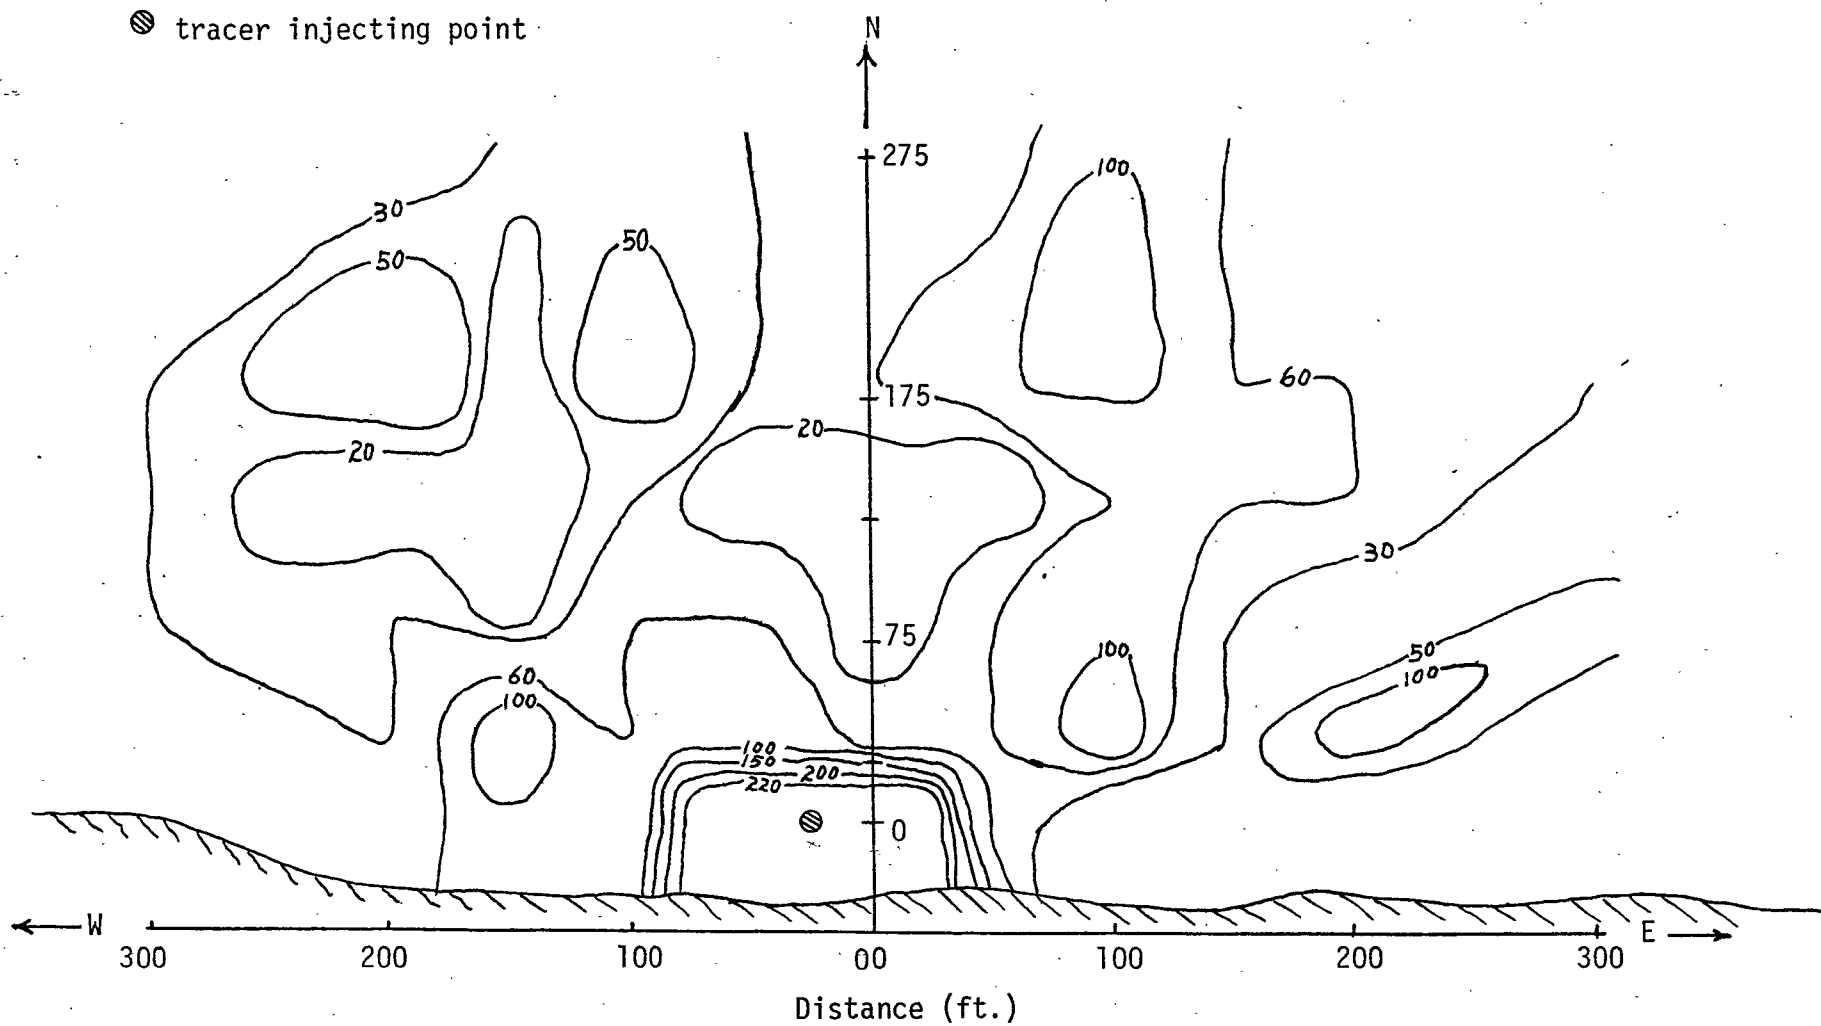
⊗ tracer injecting point

- G. Different patterns of tracer contour maps between November 1976 and February 1977 are clearly observable. Contour map figures 5 and 7 are characterized by one peak region while figures 11a to 11f have many peaks and valleys.

- H. Peaks of the contour map, figures 11a to 11f, correspond to the shoals in figure 4b and transverse bar in figure 4c very well. It may be explained that the tracers left the point of injection and moved along various route until they stopped at the shoals and transverse bar.

- J. A study of the sequence of figures 11a to 11f may shed light for bar formation in that area.

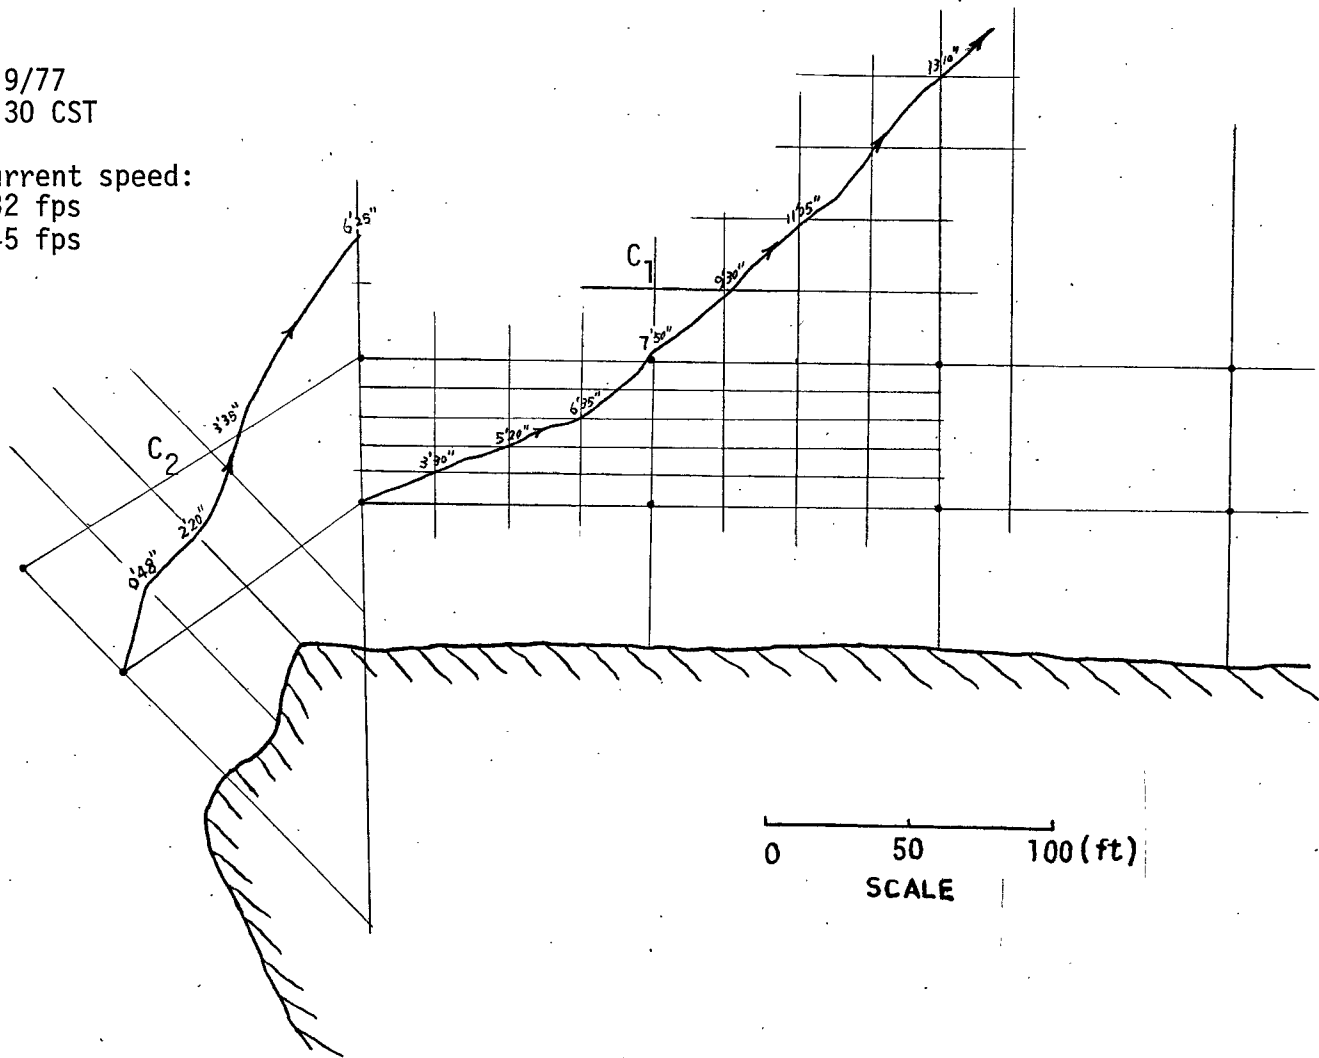
Figure 13a-1. Observed littoral current and wave parameters at site B

Date: 2/19/77
Time: 17:30 CST

Average current speed:
 $C_1 = 0.32$ fps
 $C_2 = 0.45$ fps

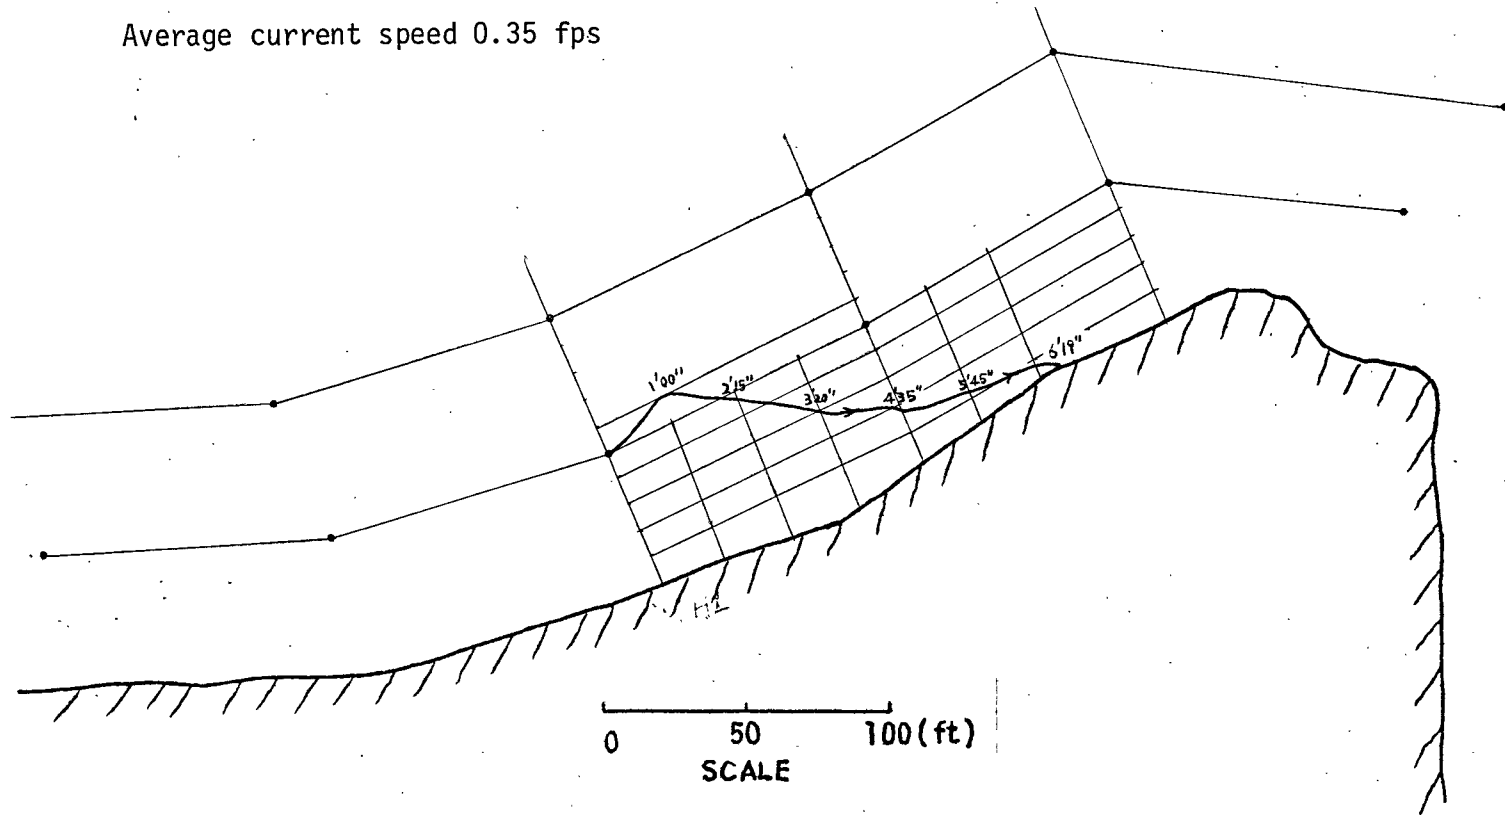
Figure 13a-2. Observed littoral current and wave parameters at site B

Date: 2/19/77
Time: 17:30 CST

Average current speed 0.35 fps

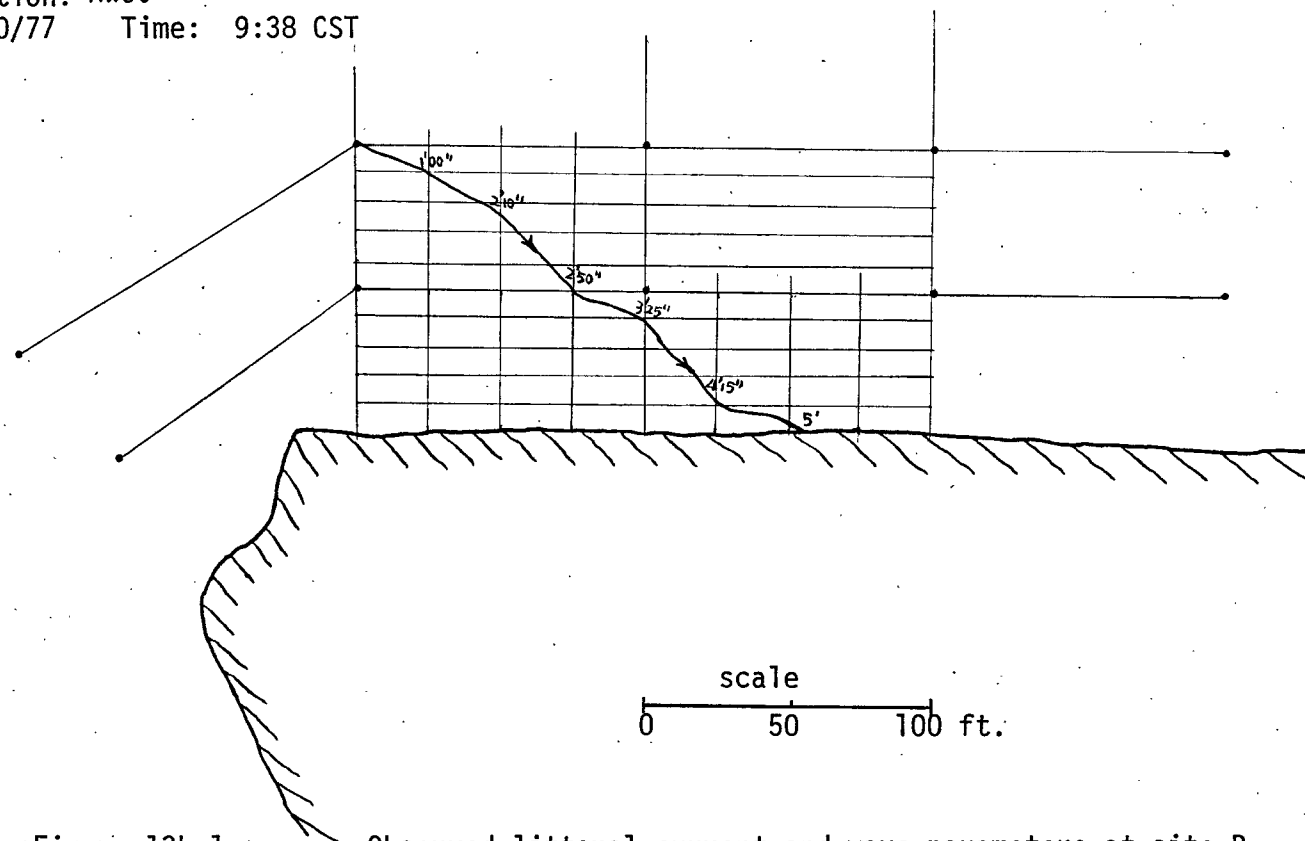
Figure 13b-1. Observed littoral current and wave parameters at site B

Wave length: 12.5 ft.
wave height: 10 in.
wave period: 0.5 sec.
wave direction: NW60°
Date: 2/20/77 Time: 9:38 CST

Average current speed: 0.51 fps

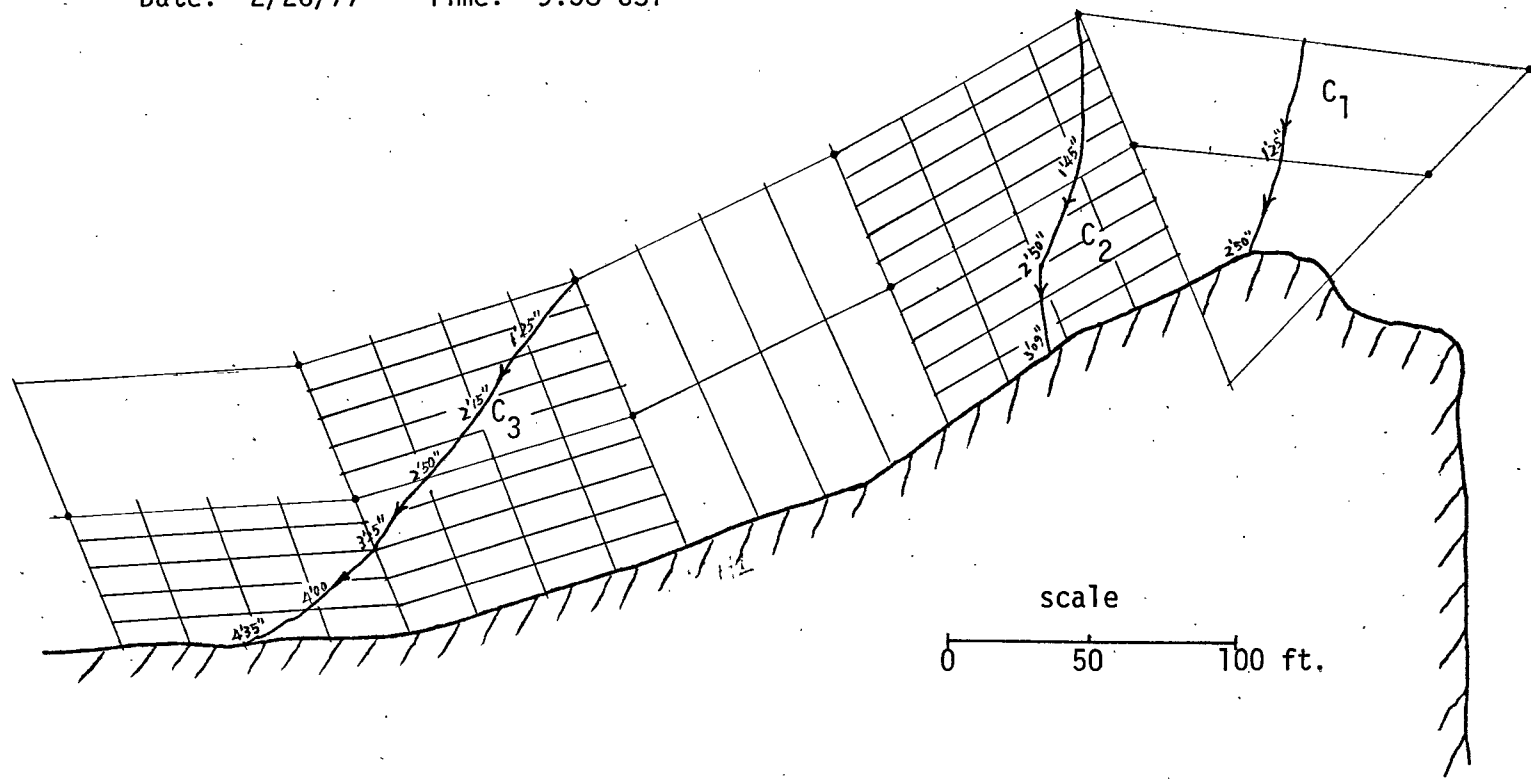
Figure 13b-2. Observed littoral current and wave parameters at site B

wave length: 12.5 ft.
wave height: 10 in.
wave period: 0.5 sec.
wave direction: NW60°
Date: 2/20/77 Time: 9:38 CST

Average current speed: $C_1 = 0.44$ fps
 $C_2 = 0.36$ fps
 $C_3 = 0.58$ fps
