UFL/COEL-77/001

DETERMINATION OF DIRECTION OF LITTORAL TRANSPORT
ALONG THE NORTH SHORE OF SANTA ROSA ISLAND,
FLORIDA

Yu-Hwa Wang
T.H. Chang
Sidney L. Harrell

March, 1977

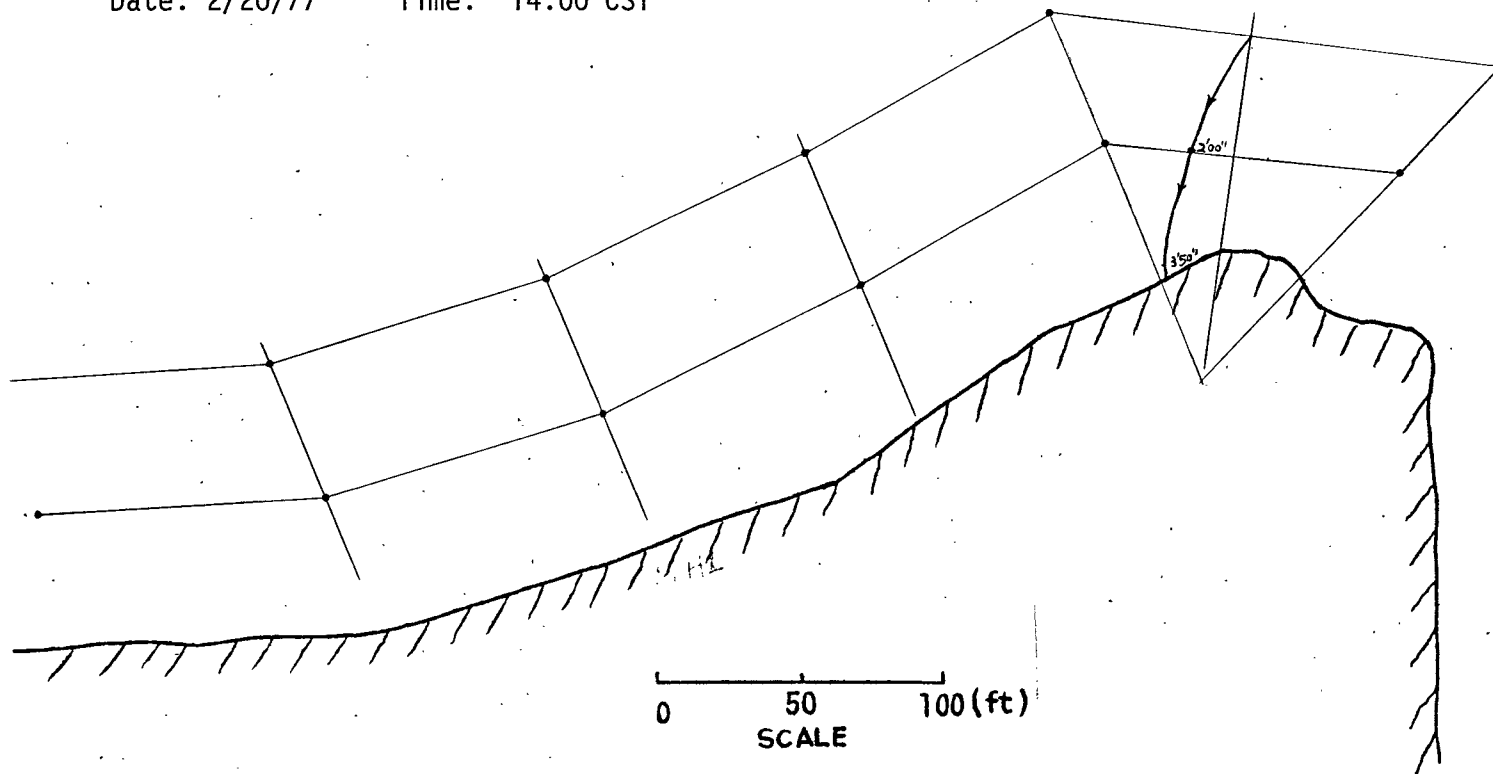
Figure 13b-3. Observed littoral current and wave parameters at site B

wave length: 8 ft.
wave height: 0.7 ft.
wave period: 0.5 sec.
wave direction: NW30°
Date: 2/20/77 Time: 14:00 CST

Average current speed 0.43 fps

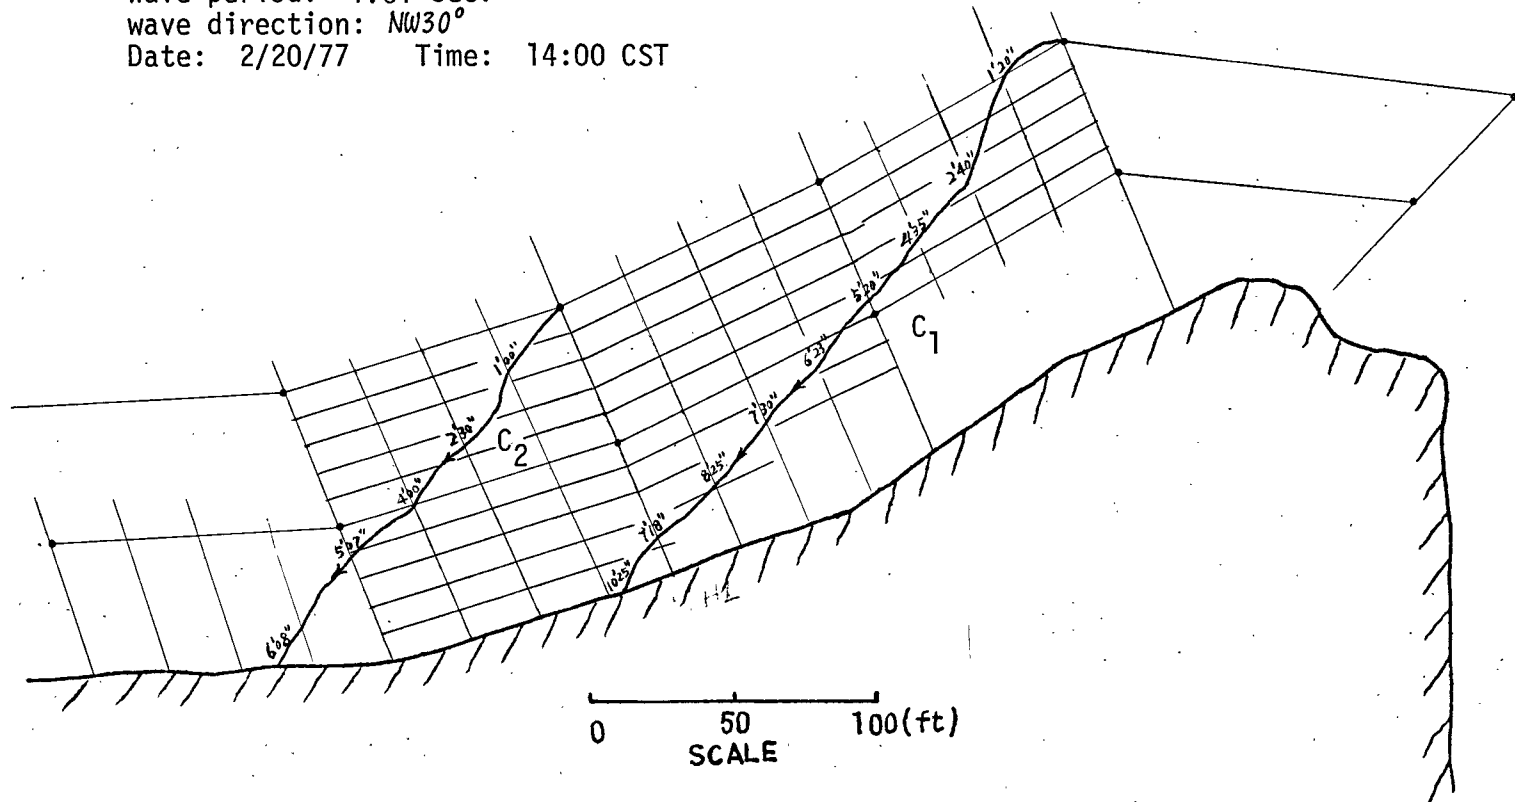
Figure 13b-4. Observed littoral current and wave parameters at site B

wave length: 8 ft.
wave height: 0.7 ft.
wave period: 1.61 sec.
wave direction: NW30°
Date: 2/20/77 Time: 14:00 CST

Average current speed: $C_1 = 0.31$ fps
 $C_2 = 0.40$ fps

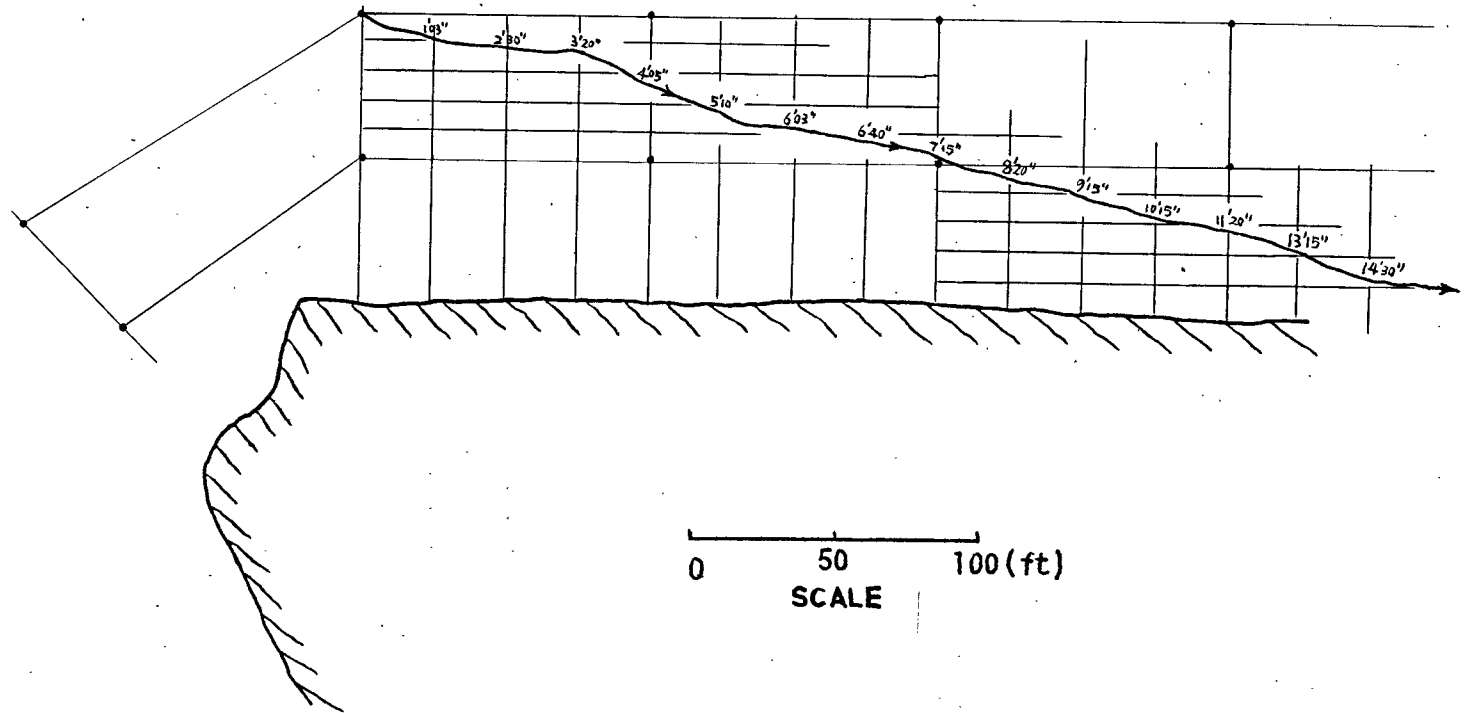
Figure 13b-5. Observed littoral current and wave parameters at site B

wave length: 8 ft.
 wave height: 0.7 ft.
 wave period: 1.61 sec.
 wave direction: $NW30^\circ$
 Date: 2/20/77 Time: 14:00 CST

Average current speed 0.41 fps

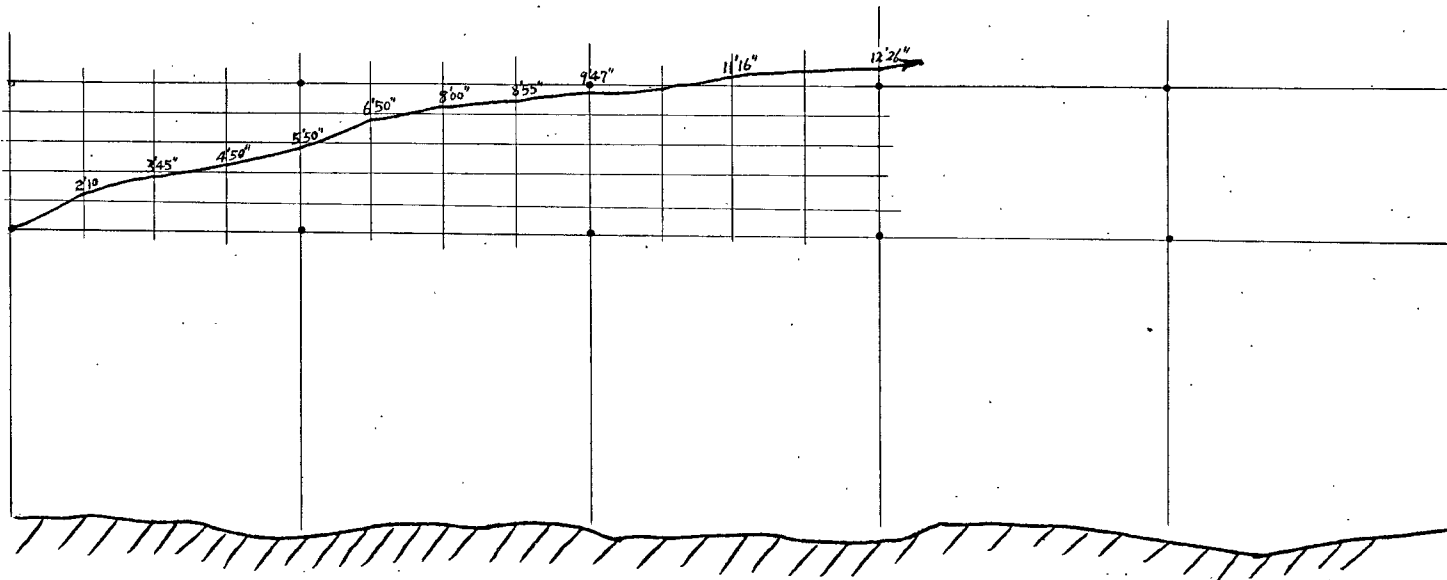
Figure 14a. Observed littoral current and wave parameters at site C

Date: 2/19/77 Time: 16:03 CST

Average current speed 0.40 fps

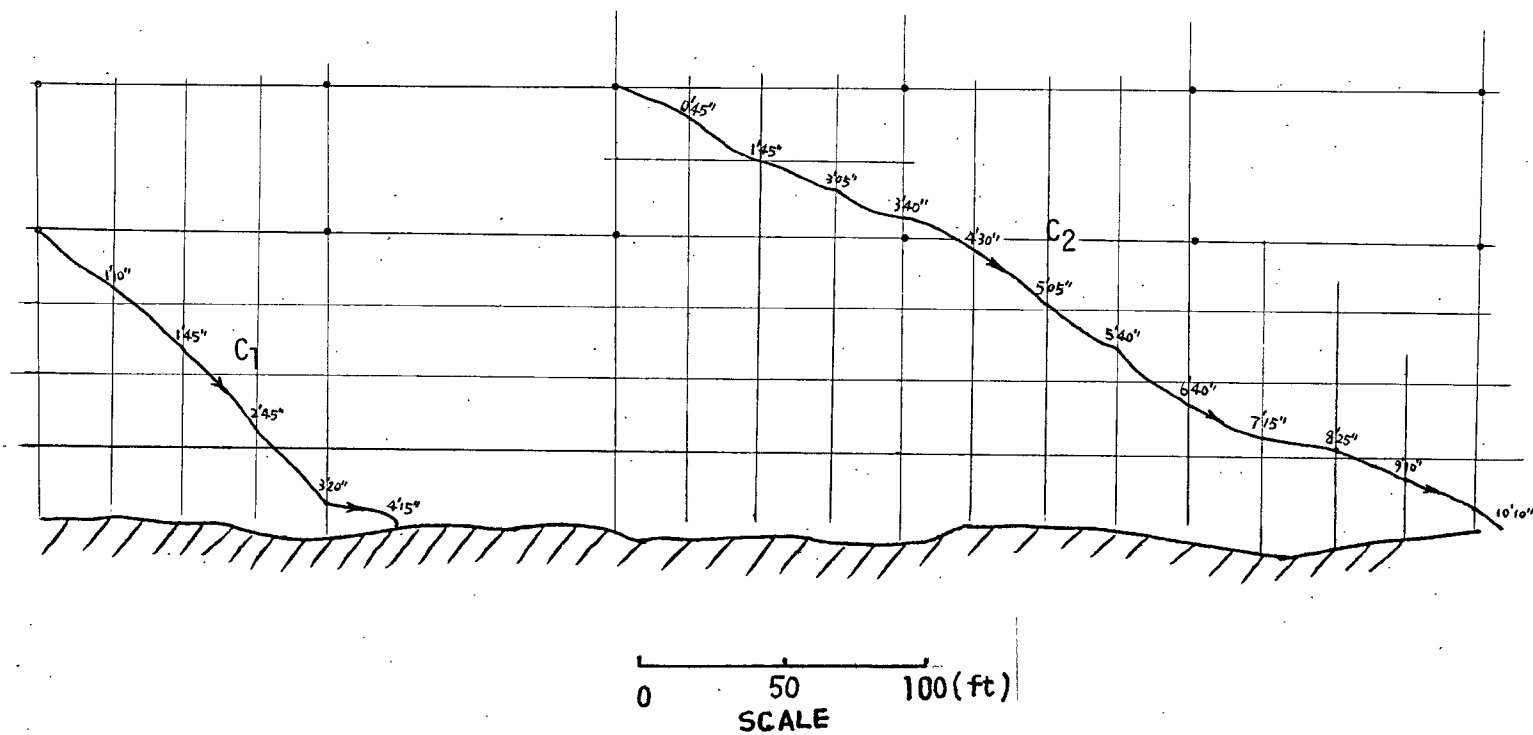
Figure 14b. Observed littoral current and wave parameters at site C

wave length: 10 ft.
 wave height: 0.7 ft.
 wave period: 1.75 sec.
 wave direction: NW30°
 Date: 2/20/77 Time: 13:00 CST

Average current speed: $C_1 = 0.67$ fps
 $C_2 = 0.57$ fps
