INFORMATION CIRCULAR NO. 17

FLOOD OF JUNE 9, 1957, AT PERRY, FLORIDA

By
Rufus H. Musgrove
Hydraulic Engineer, U. S. Geological Survey

Prepared by
U. S. Geological Survey
in cooperation with the
Florida Geological Survey

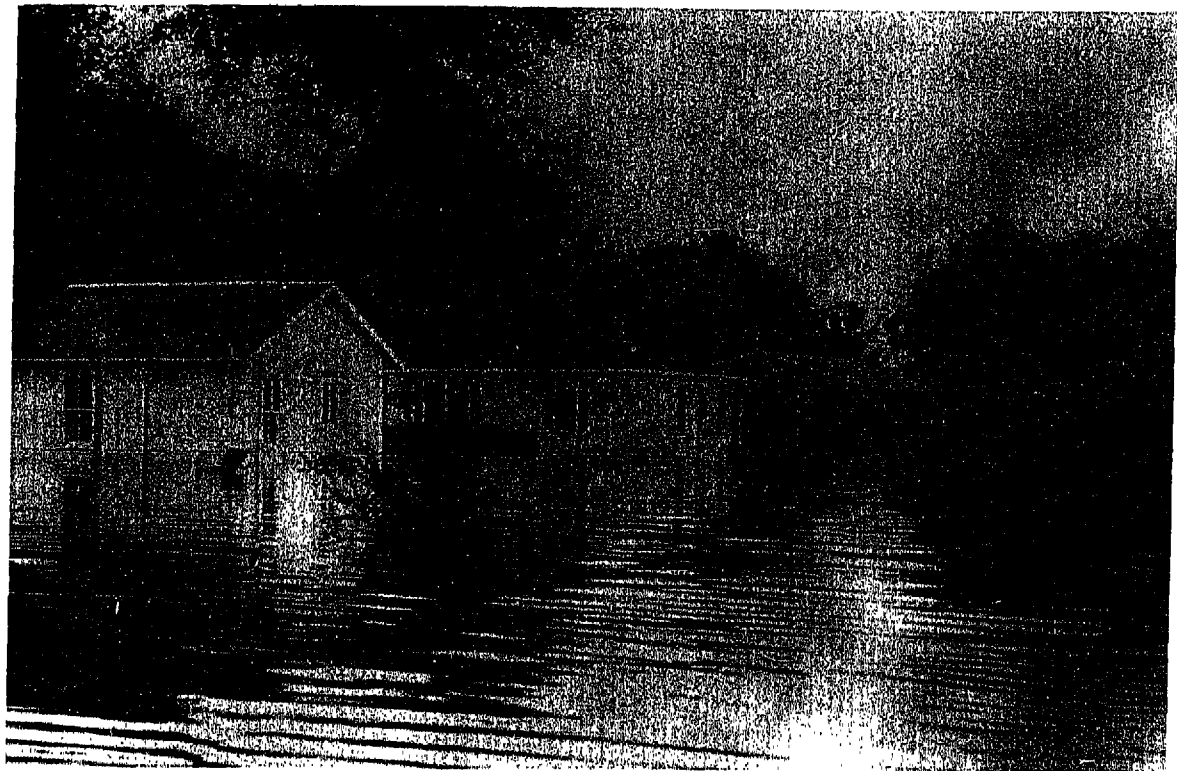
Figure 2. Flooded area in residential section in Perry, Florida, June 9, 1957. (Photo courtesy of R. M. Bryant)

Floods occurred on streams in the vicinity of Perry, Taylor County, Florida, on June 9, 1957, as a result of heavy rains from a tropical disturbance. Serious flooding occurred in Perry along Spring and Pimple creeks as outlined by the shaded area in figure 1, requiring the evacuation of about 200 families from the lowland area. No loss of life was reported. The damages to residential and commercial properties were estimated at several million dollars. Most of the damage was confined to residential areas (fig. 2); however, several stores in the area were damaged by flood waters (fig. 3).

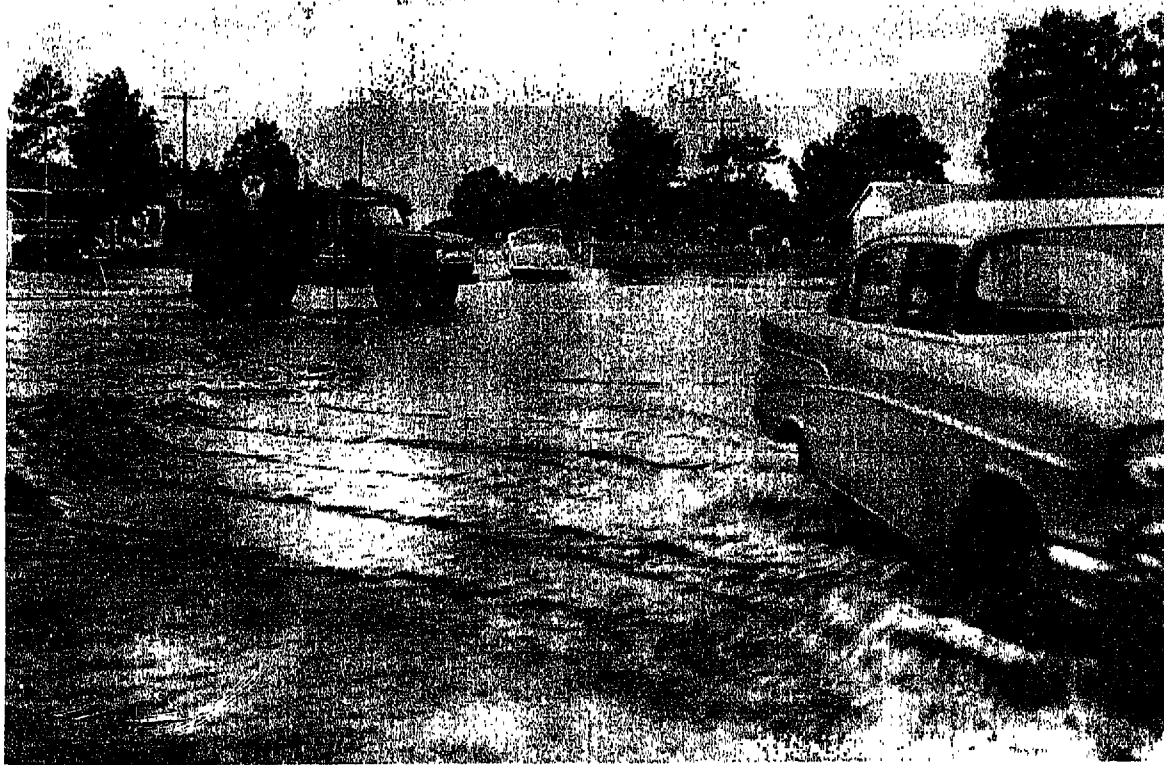
Figure 7. Flooding by Pimple Creek at intersection of Ash and Jefferson streets, Perry, Florida, June 9, 1957. (Photo courtesy of R. M. Bryant)

An indirect measurement of peak discharge was made on Pimple Creek at the North Jefferson Street crossing (fig. 1). Jefferson Street was flooded (fig. 7) to a depth of half a foot for a distance of 500 feet and a fall across the street of 1.0 foot was measured from high-water marks (fig. 8). Flow over the street was computed using U. S. Geological Survey procedures developed from Yarnell and Nagler data. Flow through the bridge opening was computed by two methods, flow-through-culvert and contracted-opening, with comparable results. The peak discharge through the bridge opening was 1,610 cubic feet per second, and over the street, 250 cubic feet per second, giving a total peak discharge of the stream of 1,860 cubic feet per second.
