Wastewater Treatment Plant Inspection Program Fiscal year 2006 and 2007 Data Report

**Prepared by: Stacie Greco
Alachua County Environmental Protection Department**

November 2008

**Alachua County Environmental Protection
Wastewater Treatment Plant Inspection Program
Fiscal Year 2006 and 2007 Data Report**

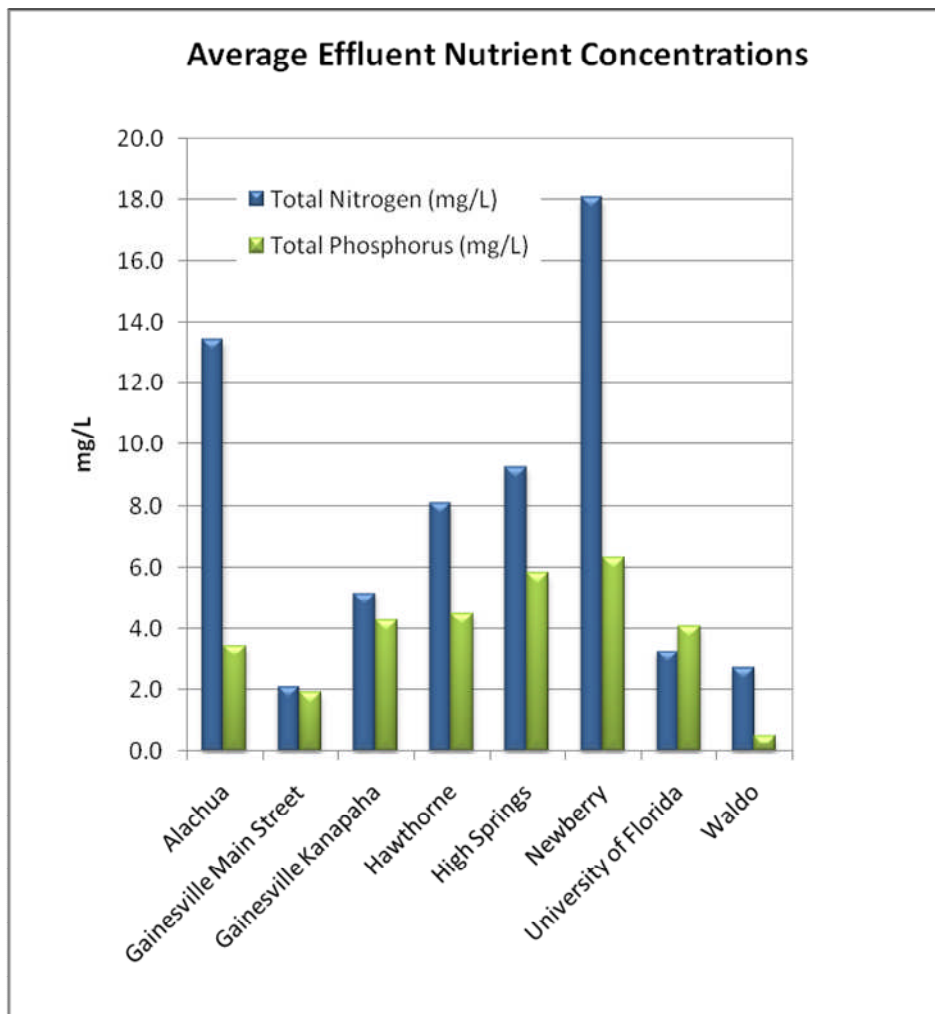
Figure 1: Average effluent data from grab samples collected during ACEPD inspections during the 2006 and 2007 fiscal years.

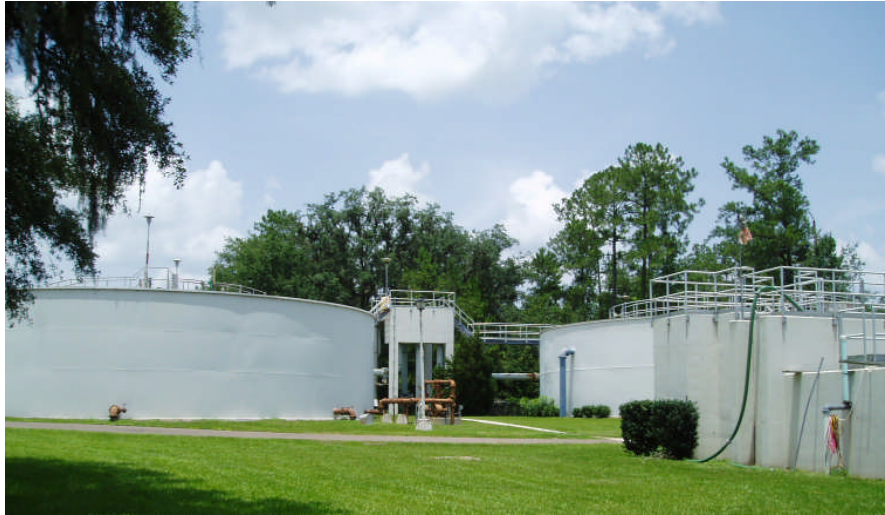
The City of Alachua WWTP

The City of Alachua municipal wastewater treatment plant consists of two separate plants (a complete mix activated sludge and extended aeration activated sludge) operating in parallel to treat the waste from the city of Alachua. The facility was found to be in compliance during the six ACEPD inspections conducted in the 2006 and 2007 fiscal years. However, effluent quality varied among the inspections (Figure 2). The high nitrate concentrations that are often observed in the effluent are a concern in this karst area.

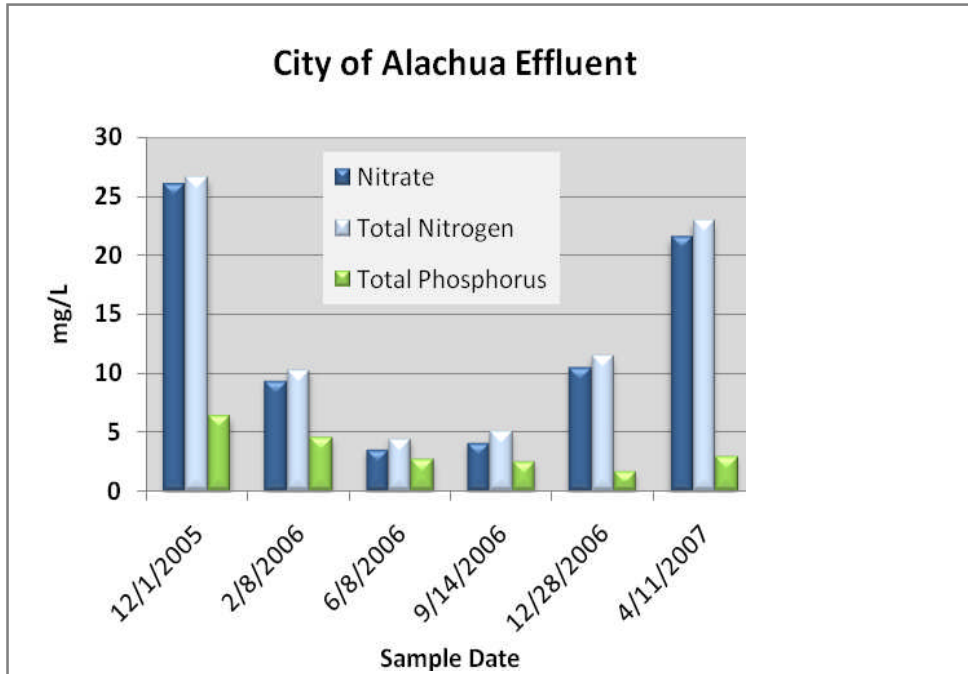
Figure 2: Effluent data from grab samples collected during ACEPD inspections at the City of Alachua WWTP during the 2006 and 2007 fiscal years

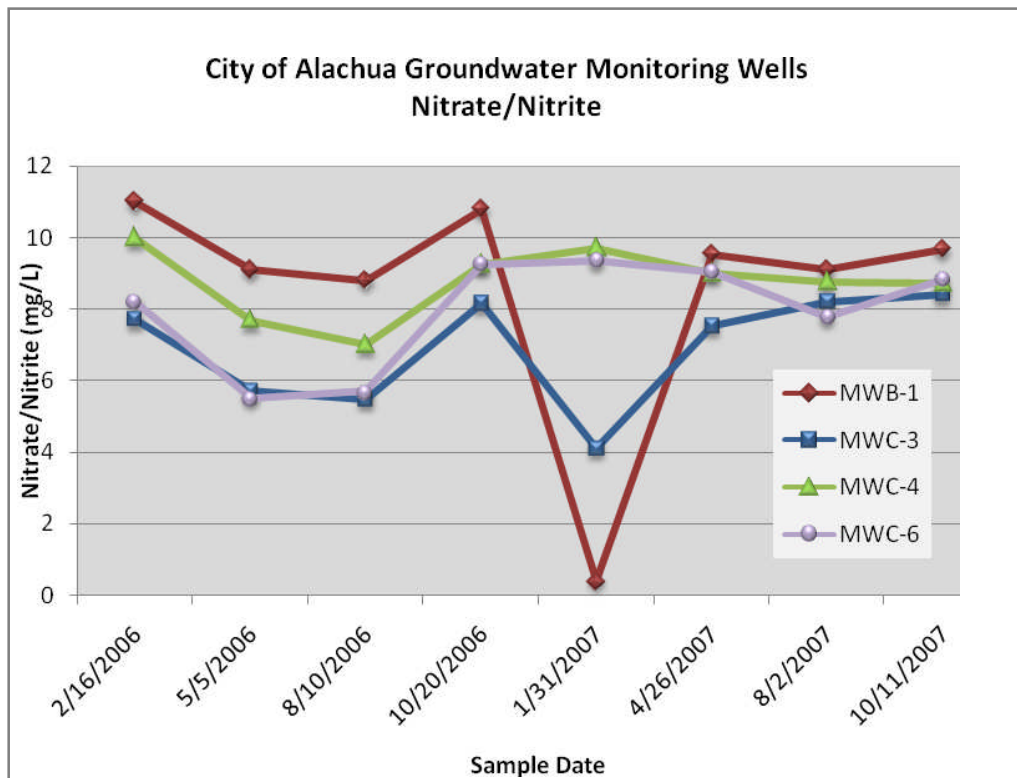
The City of Alachua is required by FDEP to sample their groundwater monitoring wells on a quarterly basis. The background wells are labeled with a B, compliance wells are labeled with a C, and intermediate wells are labeled with an I. High nitrate values were consistently measured at Compliance Well One (MWC-1), and the City of Alachua argued in 2006 that this well is up-gradient of their effluent disposal. FDEP worked with the City of Alachua and re-designated this well as a background monitoring well (MWB-1 in Figure 3). The high nitrate values detected at this well are thought to be influenced from the adjacent site which is the former Copeland Sausage Plant. The elevated nitrate levels, regardless of the source, are a concern in such close proximity to the Santa Fe River and its springs. A dye trace study conducted by Karst Environmental Services for ACEPD found a connection from nearby Lee Sink and Mill creek to Hornsby Springs, a

first magnitude spring on the Santa Fe River (Butt et al 2006). The City of Alachua is looking to expand this plant and is researching ways to maximize de-nitrification at the facility.

Figure 3: Nitrite + Nitrate data from the City of Alachua WWTP Groundwater Monitoring Reports from 2006 and 2007.

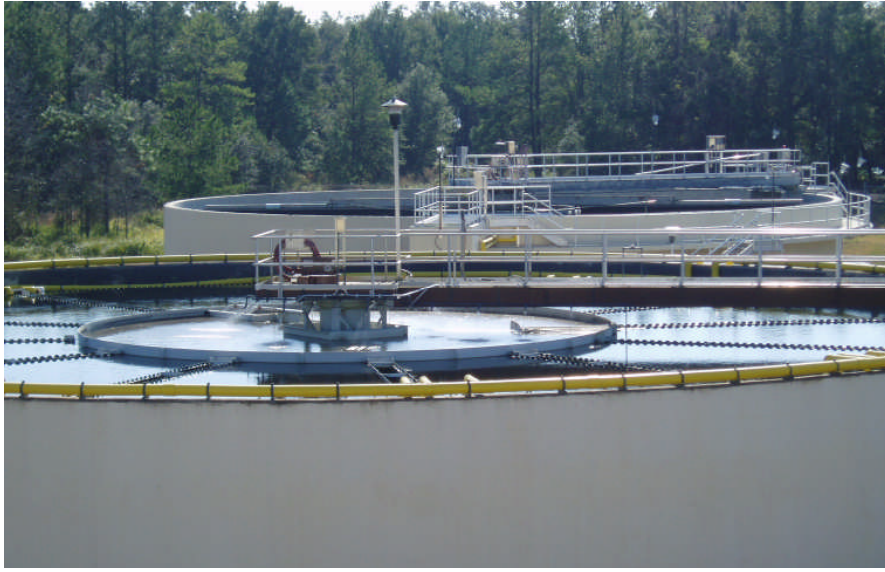
The clarifiers at the GRU Kanapaha facility

The wastewater from the City of Gainesville is treated at two wastewater facilities operated by Gainesville Regional Utilities (GRU). The Main Street facility is an advanced secondary activated sludge plant and the Kanapaha plant is a Modified Ludzak-Ettinger extended aeration activated sludge with pre-denitrification biological nitrogen removal plant. Each plant is inspected annually by ACEPD. The plants appeared to be operating effectively during the 2006 and 2007 ACEPD inspections and were found to be in compliance. The effluent appeared to be within the FDEP permit limitations and the nutrient concentrations were relatively low (Figure 4).

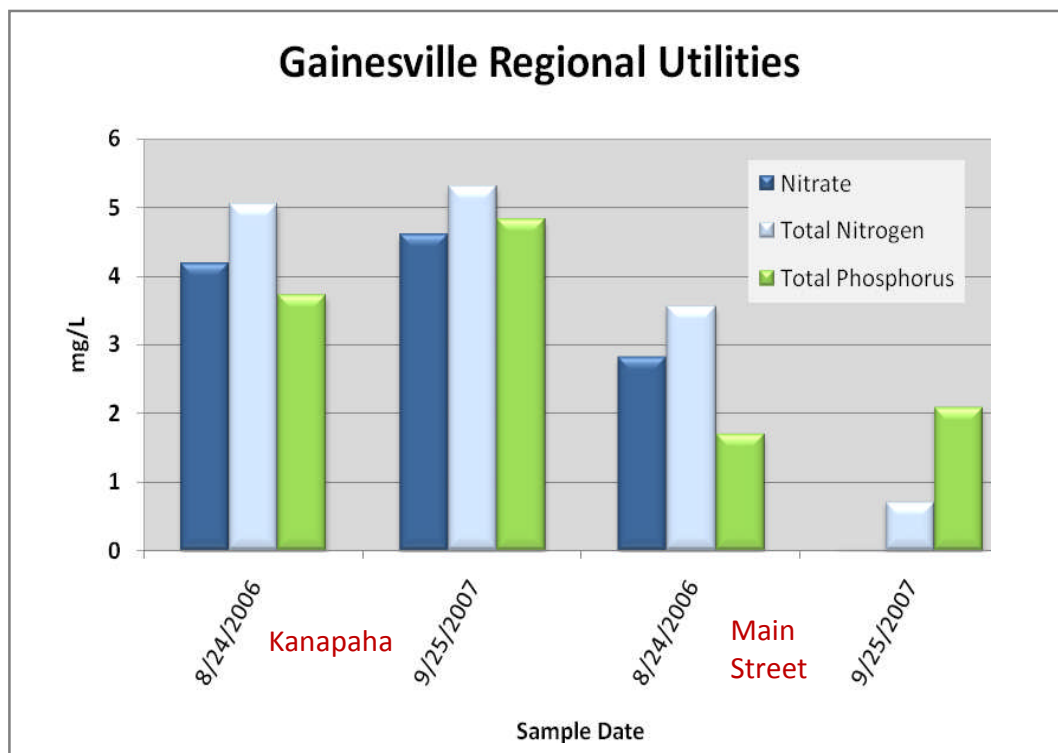
The effluent from the Main Street facility is discharged to Sweetwater Branch which flows through Paynes Prairie State Preserve before entering the aquifer via Alachua Sink. In 2007 the actual average flow discharged to Sweetwater Branch was 5.51 MGD (Hutton 2008). The majority of the Kanapaha effluent is injected into the aquifer via deep well injection. In 2007 an average of 6.79 MGD was injected into the aquifer (Hutton 2008). Up to 6.89 MGD of Kanapaha effluent is permitted for re-use for applications such as schools, residential lawns, parks, fire protection, Kanapaha Botanical gardens, and tanker trucks for pesticide application, dust control, and other activities. In 2007 re-use of reclaimed water increased to an average of 3.15 MGD from 2.96 MGD in 2006 (Hutton 2008).

Figure 4: Effluent data from grab samples collected during ACEPD inspections at the GRU WWTPs during the 2006 and 2007 fiscal years

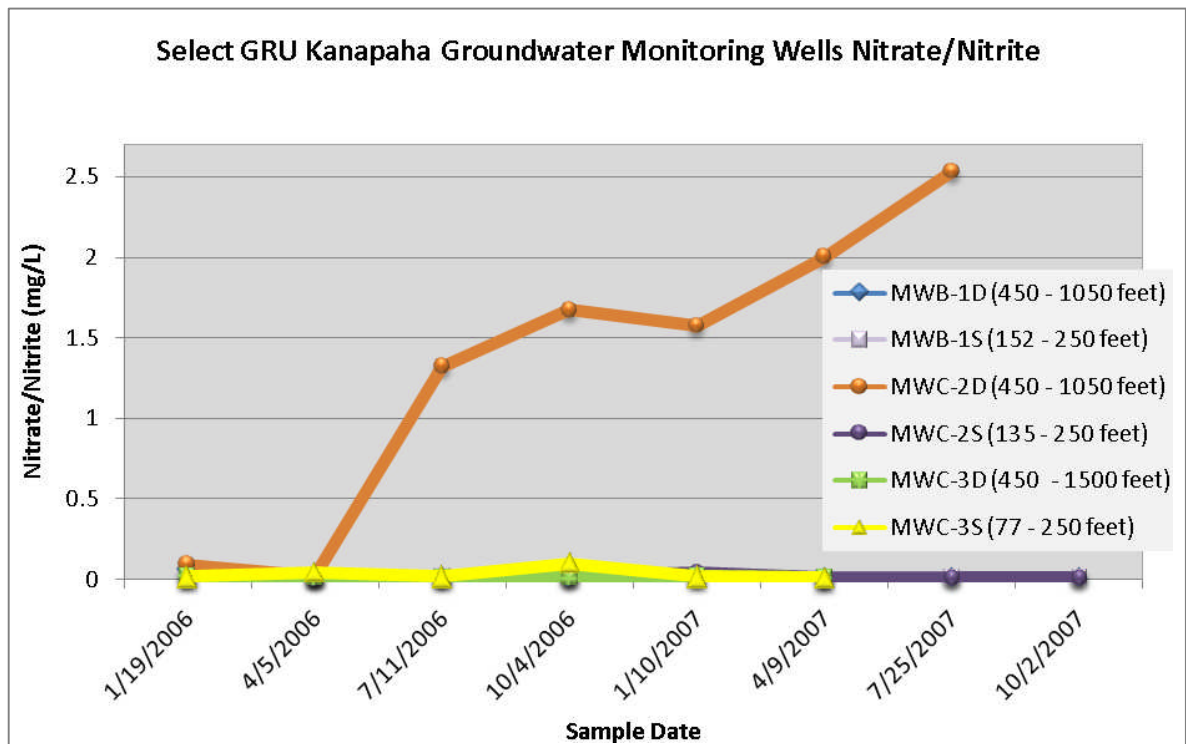
GRU is required to sample their groundwater monitoring wells at the Kanapaha plant and submit the results to FDEP. The background wells are labeled with a B and the compliance wells are labeled with a C. The nitrite + nitrate concentrations at monitoring well MWC-2D appear to be increasing, but a longer period of record would be needed to confirm this observation. There are no groundwater monitoring wells associated with the Main Street facility, since this plant discharges to a surface water.

Figure 5: Nitrite + Nitrate data from the GRU Kanapaha WWTP Groundwater Monitoring Reports from 2006 and 2007. The distance below the land surface is denoted in feet after each well ID in the legend.

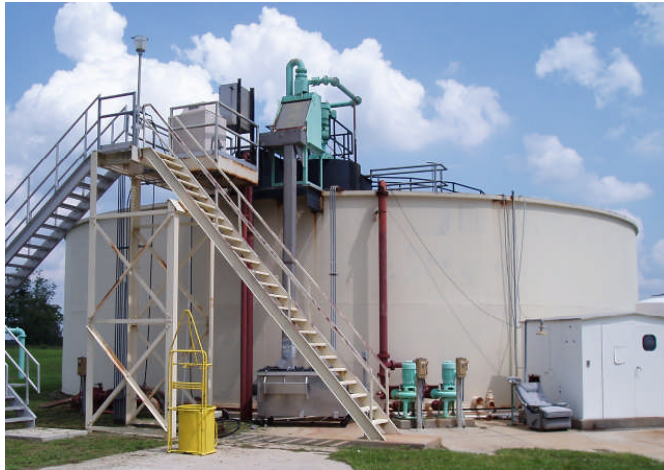
The City of Hawthorne Wastewater Treatment Facility

The City of Hawthorne municipal wastewater treatment plant is an extended aeration secondary treatment plant. This facility was found to be in compliance during all seven of the ACEPD inspections conducted in the 2006 and 2007 fiscal years. Effluent nitrogen values were relatively low for the majority of fiscal year 2006, but rose in August of 2006 (Figure 6). The higher nitrate concentrations and phosphorus levels are a concern with the proximity of Little Orange Lake. However, the effluent was in compliance with the FDEP permit, as this permit does not have numeric limitations for nutrients.

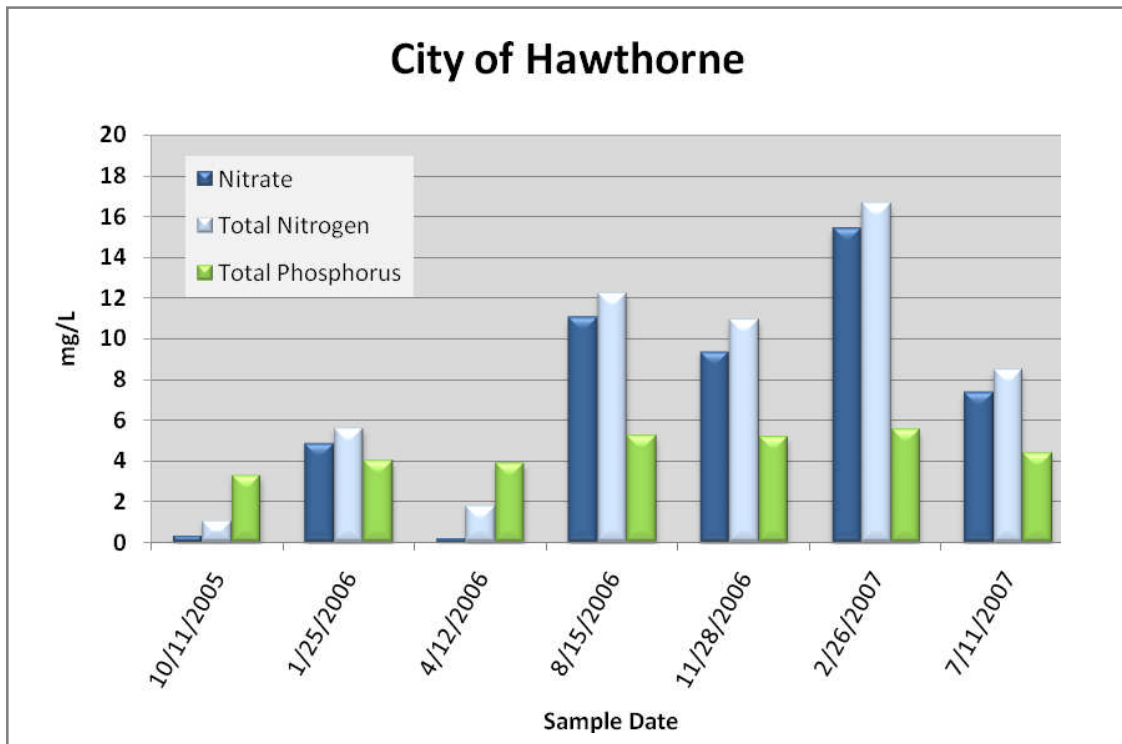
Figure 6: Effluent data from grab samples collected during ACEPD inspections at the Hawthorne WWTP during the 2006 and 2007 fiscal years

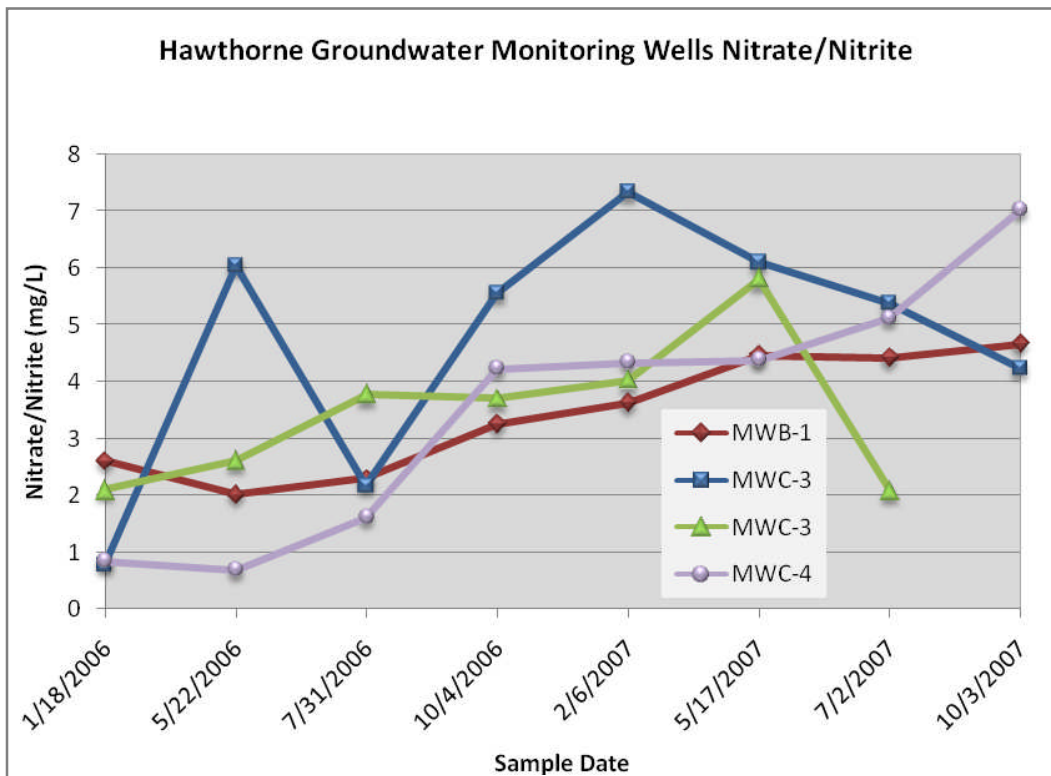
The City of Hawthorne is required to sample their groundwater monitoring wells and submit the results to FDEP on a quarterly basis. The background well is labeled with a B and the compliance wells are labeled with a C. The nitrate + nitrite concentrations varied among the wells and the sampling events. There appears to be a slight trend of increasing nitrate + nitrite levels in all of the wells, including the background, over time. A longer period of record would be required to verify this observation (Figure 7).

Figure 7: Nitrate + nitrite data from the City of Hawthorne WWTP Groundwater Monitoring Reports from 2006 and 2007

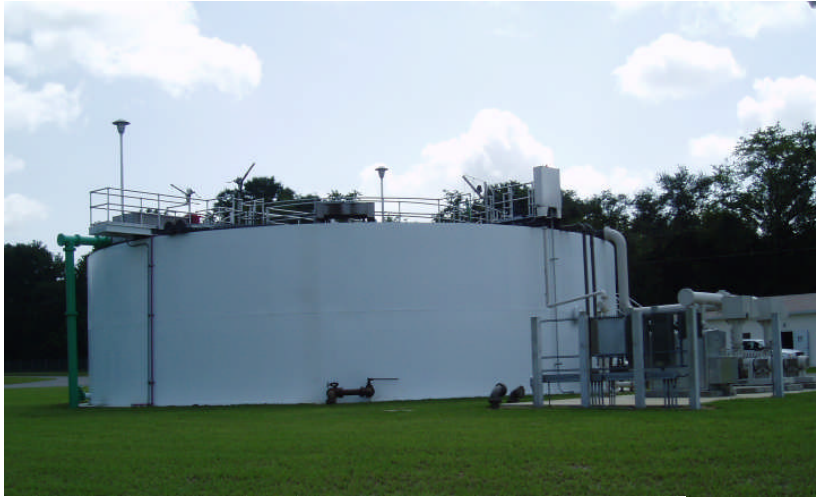
The City of High Springs WWTP

The City of High Springs municipal wastewater treatment plant is a Ludzak-Ettinger activated sludge plant. This facility was found to be in compliance during all six of the ACEPD inspections conducted in fiscal years 2006 and 2007. However, the occasional elevated nitrogen and phosphorus concentrations in the treated effluent (Figure 8) are of concern in the karst setting of the plant's sprayfield in such proximity to the Santa Fe River and its springs. The cover crop on the sprayfield was not well established during 2006 and 2007, so it likely utilized very little to none of the excess nutrients in the treated effluent. FDEP has required The City of High Springs to demonstrate an established cover crop on the existing sprayfield before the sprayfield can be expanded as planned.

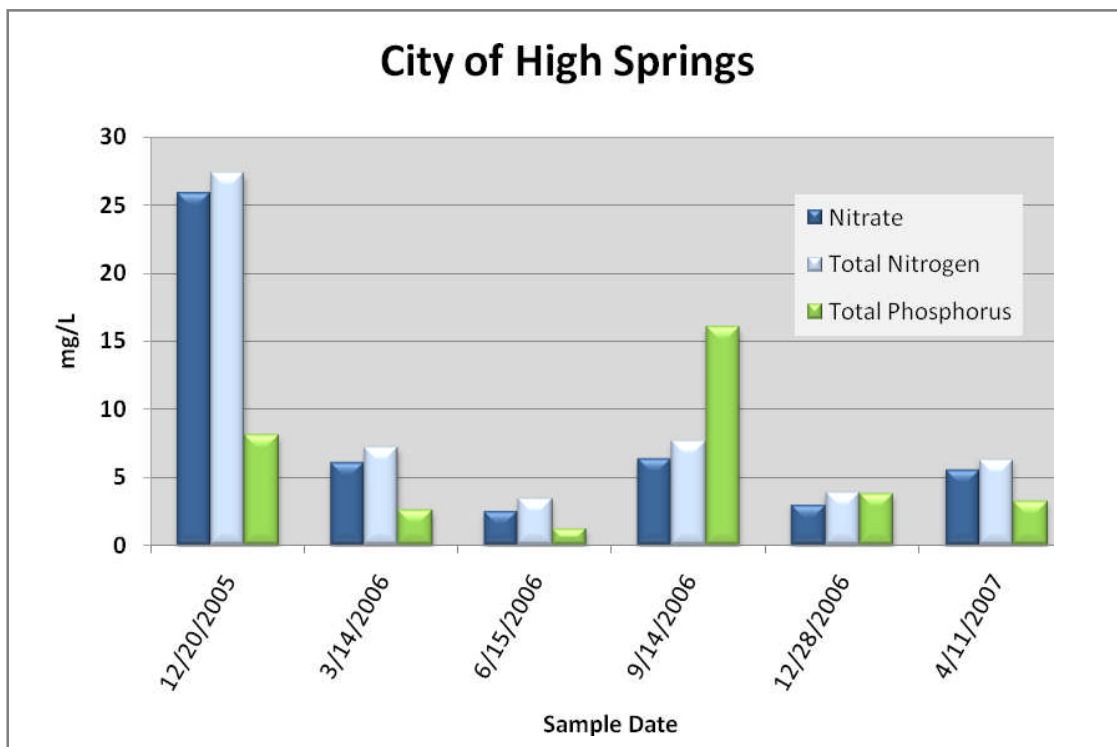
Figure 8: Effluent data from grab samples collected during ACEPD inspections at the High Springs WWTP during the 2006 and 2007 fiscal years.

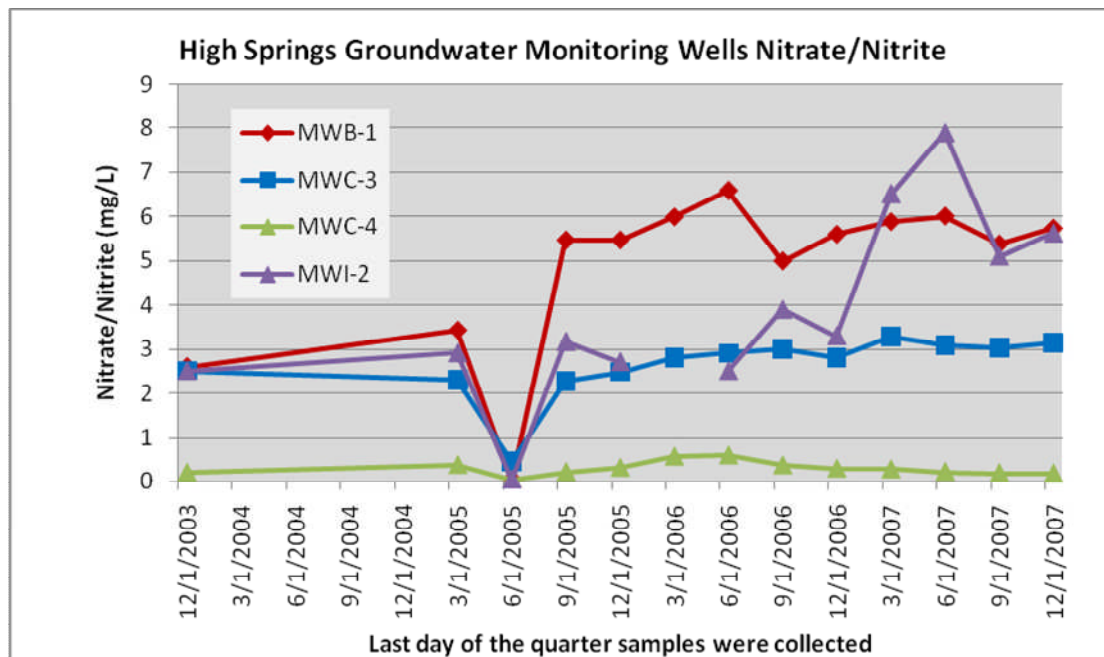
The City is required to sample the groundwater monitoring wells and submit the results to FDEP on a quarterly basis. The background well is labeled with a B and the compliance wells are labeled with a C. The elevated nitrate + nitrite concentrations in the background well are a concern and makes one question if this well is actually down gradient of the sprayfield. Figure 9 displays the groundwater data from the startup of this plant in 2004 through 2007. It seems that nitrate + nitrite values are increasing in all of the wells except compliance well 4.

Figure 9: Nitrate + nitrite data from the City of High Springs WWTP Groundwater Monitoring Reports from 2004 through 2007.

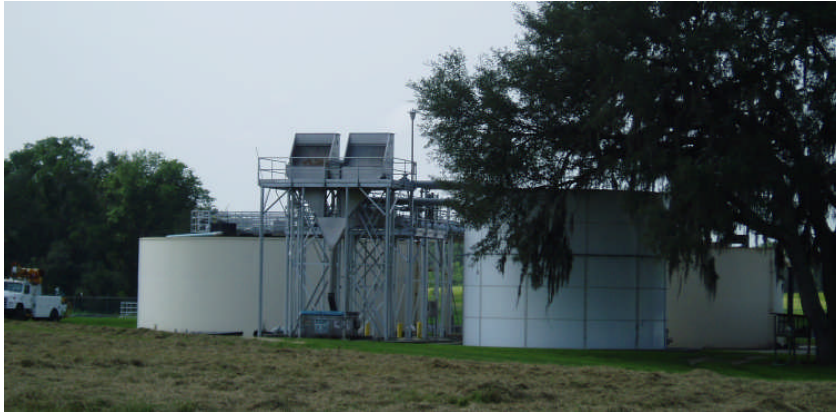
The headworks, carousal, and equalization basin at the City of Newberry WWTP

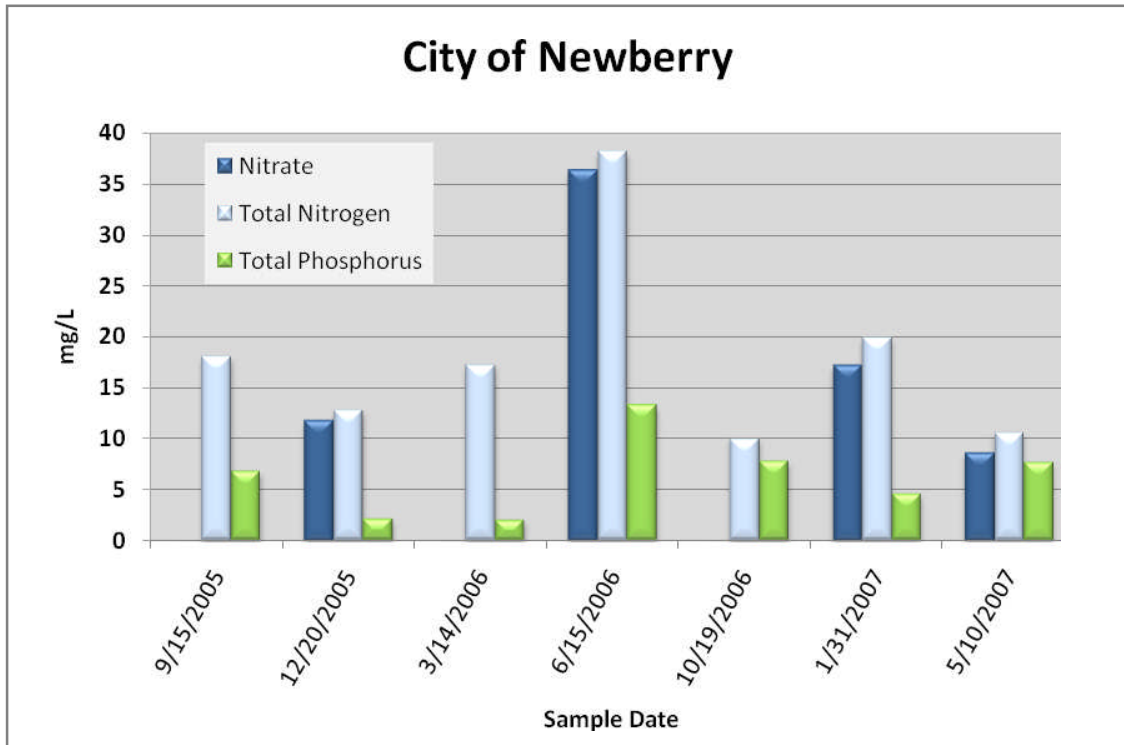
The City of Newberry's municipal wastewater treatment plant is an activated sludge secondary treatment plant. This facility was inspected by ACEPD six times during the 2006 and 2007 fiscal years. During four of the inspections compliance issues were noted: carousal one was malfunctioning, carousal two was malfunctioning, the screenings dumpster was uncovered, and the effluent exceeded fecal coliform permit limitations. The plant had several upsets during 2006, although the grab samples of the effluent tended to meet FDEP's permit requirements. ACEPD met with City staff on 11-29-06 to discuss compliance at the plant along with the County's springs protection program. Plant appearance and compliance has improved since this meeting.

Figure 10: Effluent data from grab samples collected during the ACEPD inspections of the City of Newberry WWTP in 2006 and 2007

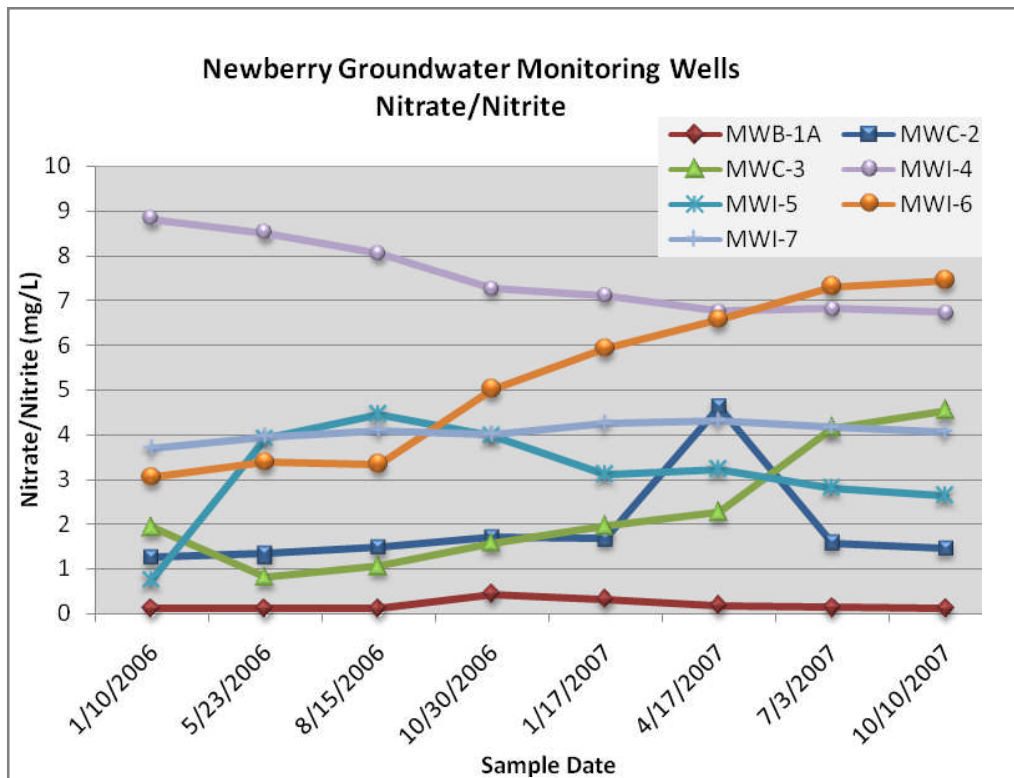
The City is required to sample their groundwater monitoring wells and submit the results to FDEP on a quarterly basis. The background wells are labeled with a B, compliance wells are labeled with a C, and intermediate wells are labeled with an I. Elevated nutrient concentrations in the effluent and the groundwater monitoring wells (Figures 10 and 11) are of concern in the karst setting of the plant's sprayfield. Nitrate + nitrite levels are higher at all of the monitoring wells in comparison to the background well.

Figure 11: Nitrite + Nitrate data from the City of Newberry WWTP Groundwater Monitoring Reports from 2006 and 2007.

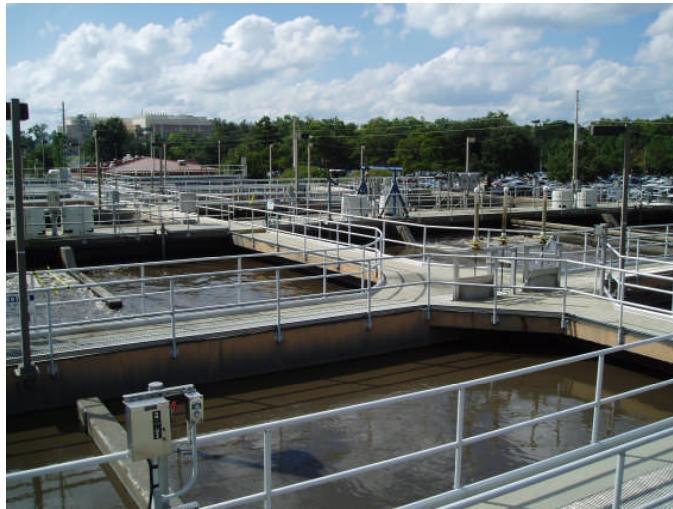
University of Florida WWTP

The University of Florida wastewater treatment plant is an advanced treatment Kruger Process (phased isolation oxidation ditch) treatment plant. This facility was inspected annually by ACEPD in the 2006 and 2007 fiscal years. The plant was found in compliance; however the dumpster receiving screenings and grit was uncovered. A cover for the dumpsters has since been constructed and is in use. The effluent from the plant met FDEP permit limitations when select regulated parameters were collected as grab samples and is relatively low in nitrogen (Figure 12).

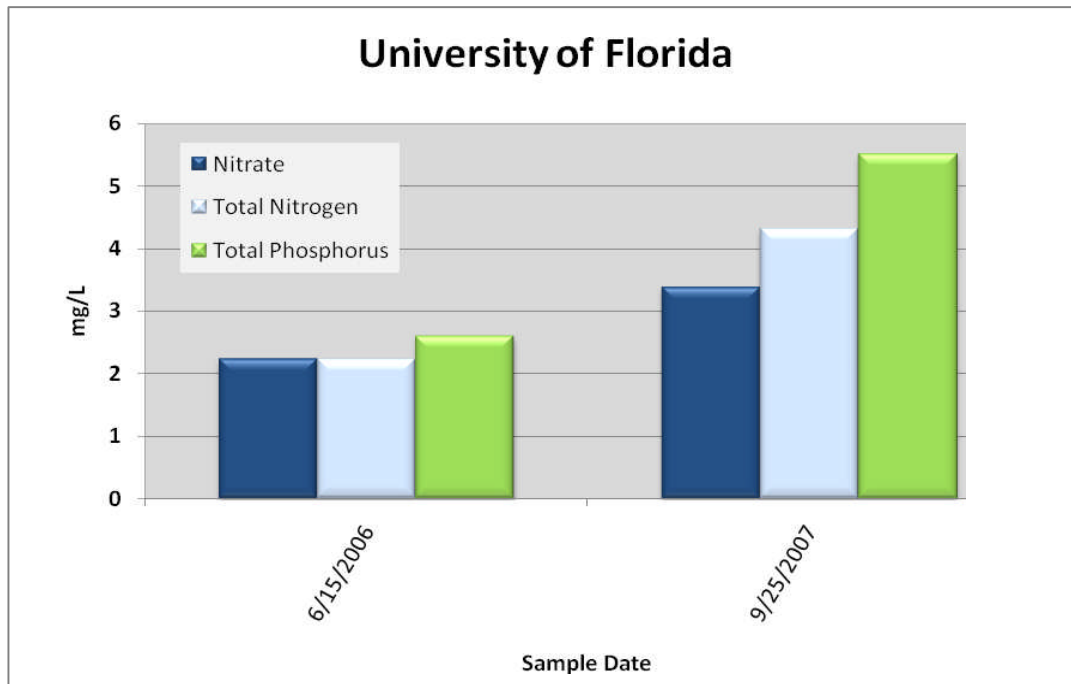
Figure 12: Effluent data from grab samples collected during the ACEPD inspections of the University of Florida WWTP in 2006 and 2007

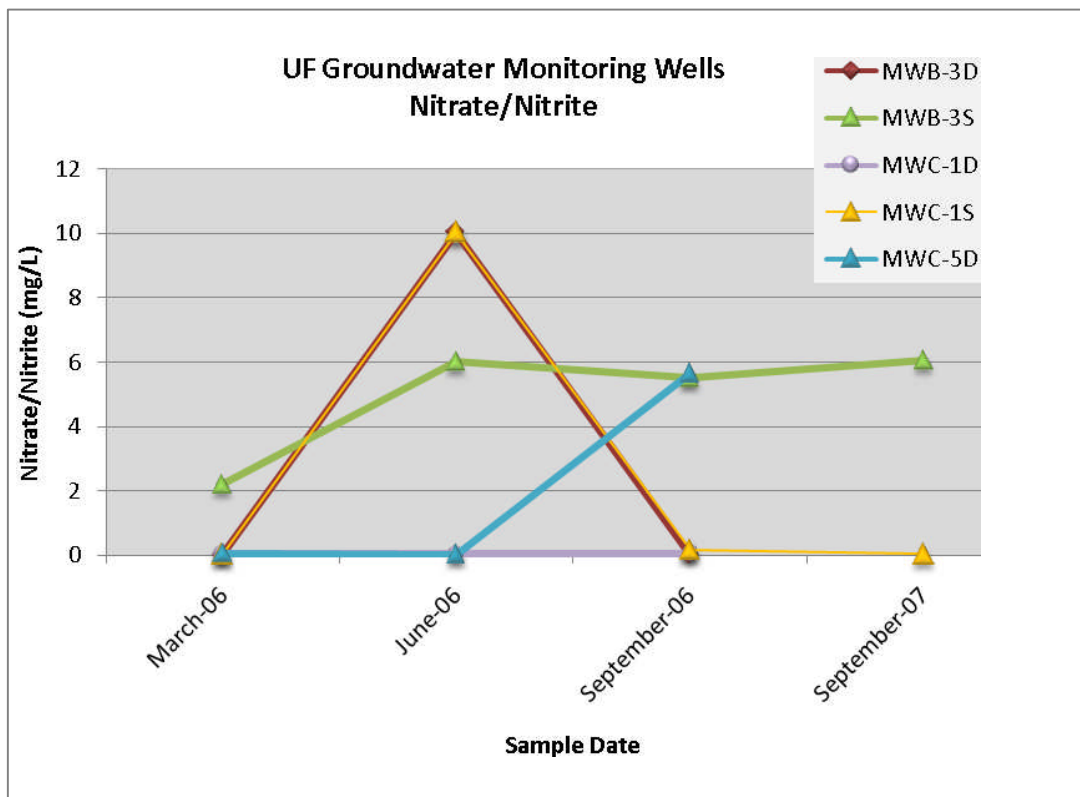
The University of Florida is required to sample their groundwater monitoring wells and submit the results to FDEP. The background wells are labeled with a B and compliance wells are labeled with a C. Monitoring well data was not available for the complete period of record. Nitrate + nitrite levels appear to be elevated, especially in the background wells (Figure 13). However, a larger period of record would be needed to verify any trends.

Figure 13: Nitrite + Nitrate data from the University of Florida WWTP Groundwater Monitoring Reports from 2006 and 2007.

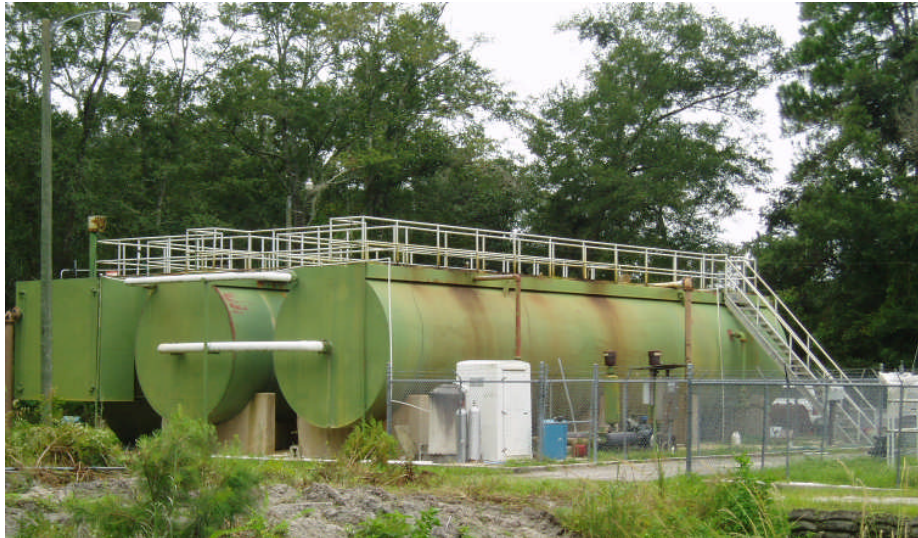
The aeration basins, digester, and clarifier at the Waldo WWTP.

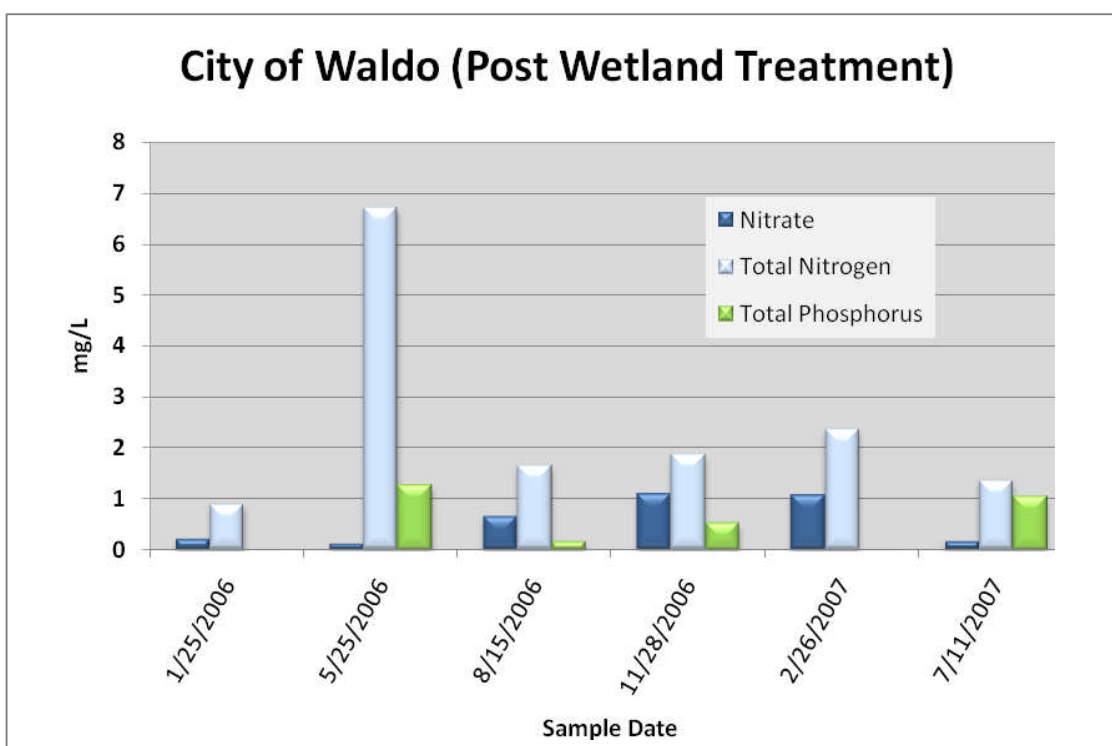
Figure 15: Effluent data from grab samples collected from the treatment wetland during the ACEPD inspections of the City of Waldo WWTP in fiscal years 2006 and 2007

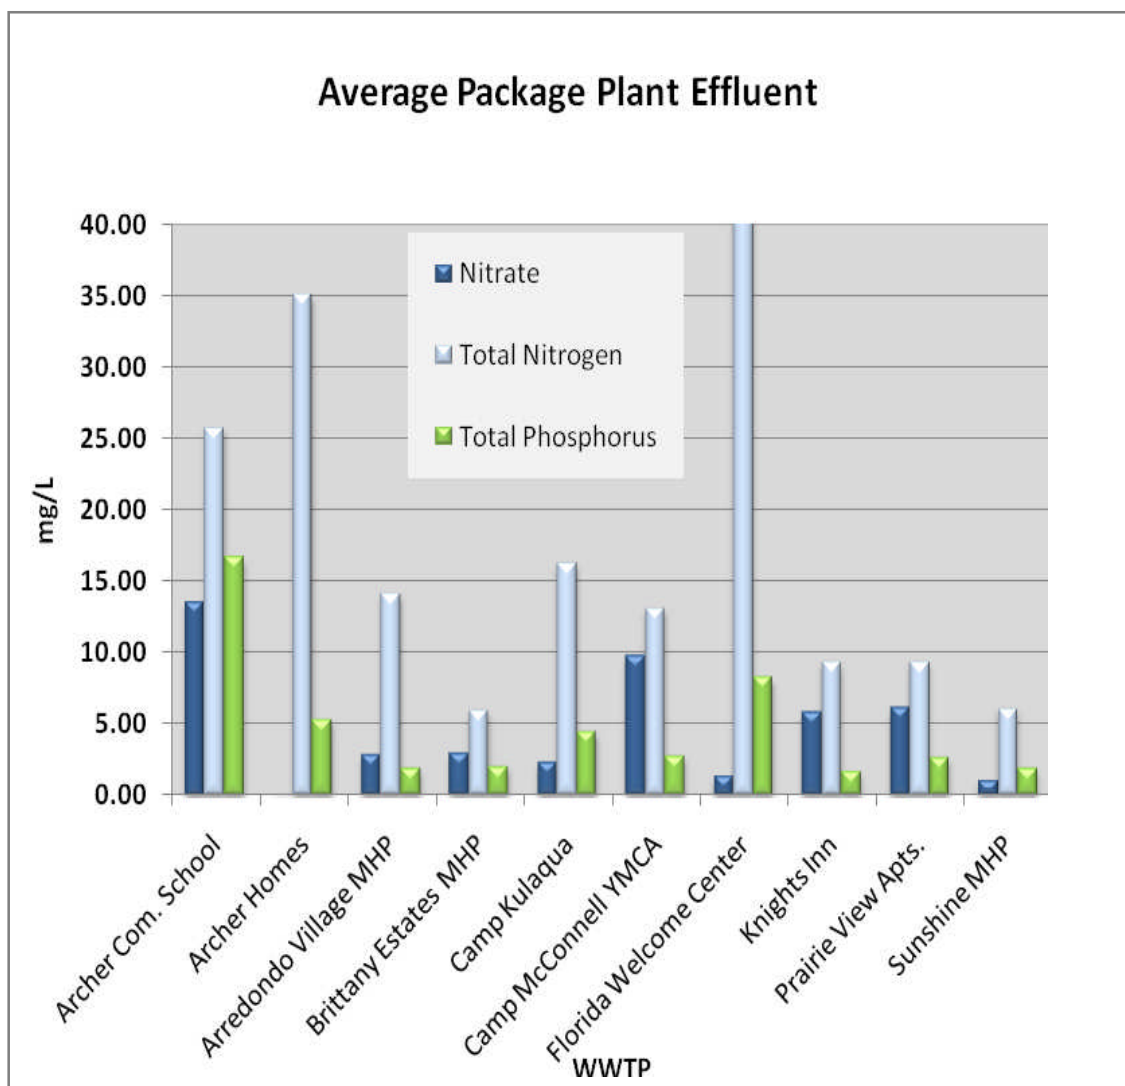
The effluent quality varies among the package plants (Figure 16). The level of treatment tends to be lower at package plants compared to municipal plants; however, the volume is much less at package plants. The high total nitrogen concentrations at many of the plants are a concern. Even though most of the nitrogen is not in the mobile nitrate form, it is likely to get converted to nitrate once released to the environment. The individual package plants are discussed in the following sections of this report.

Figure 16: Averages of the effluent data from grab samples collected during the ACEPD inspections at package plants in 2006 and 2007.

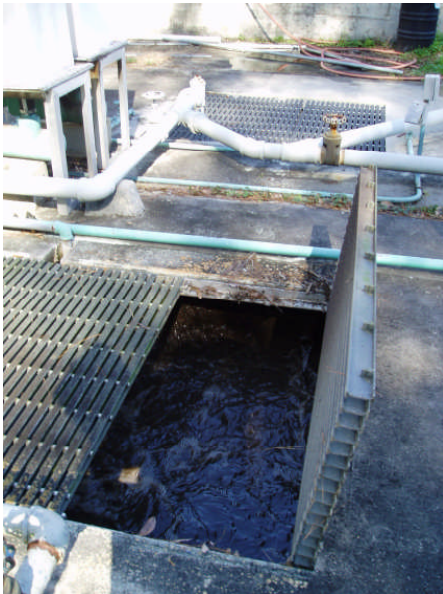
An aeration basin at the Archer Community School WWTP.

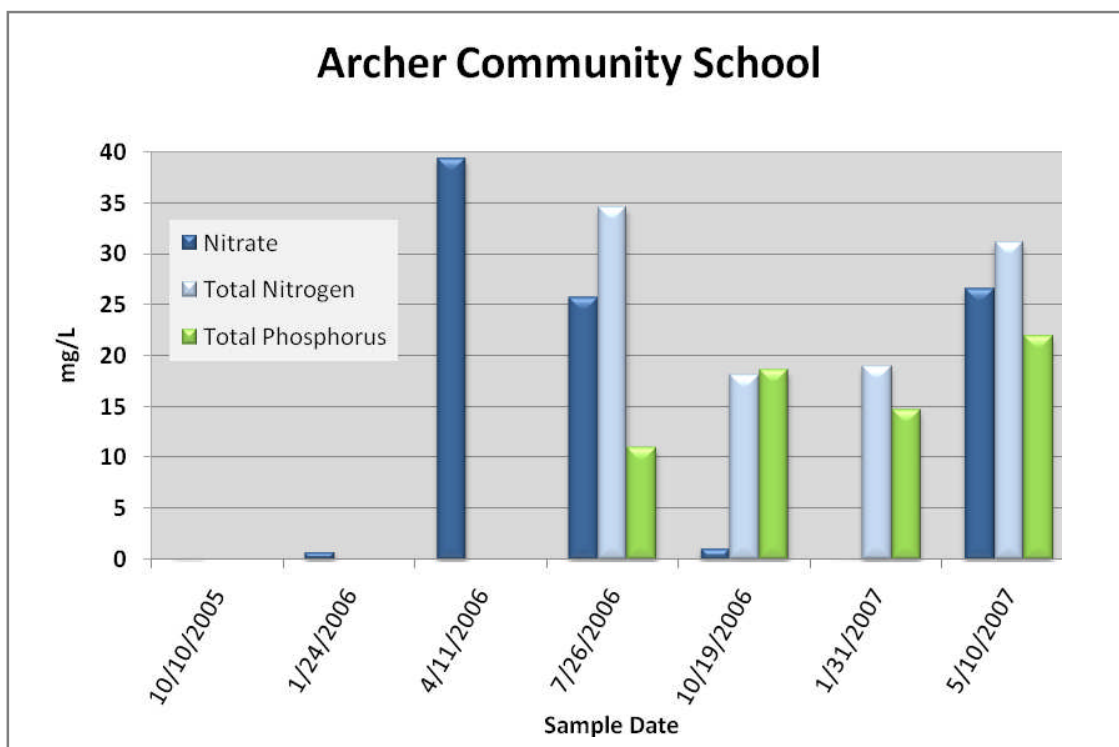
The package plant at the Archer Community School is an extended aeration activated sludge plant. This facility was inspected seven times in the 2006 and 2007 fiscal years. The parameter coverage analyzed was expanded in July of 2006 to include nitrogen species and phosphorus (Figure 17). Total nitrogen values at this plant were high during the sampling events and nitrate levels exceeded the FDEP permit limitation of 12 mg/L during three of the sampling events. FDEP was notified concerning these permit violations.

Figure 17: Effluent data from grab samples collected from the Archer Community School WWTP during the ACEPD inspections in 2006

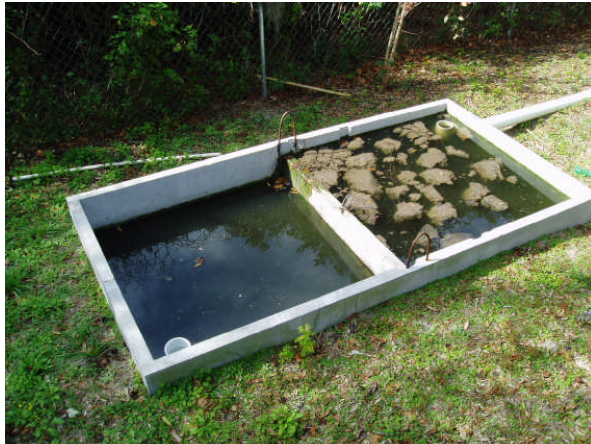
Solids in the final basin at the Archer Homes WWTP.

The total suspended solids (TSS) permit limitation of 10 mg/L was exceeded in six out of the seven sampling events, and solids were consistently found in the chlorine contact chamber. The effluent was high in ammonia, indicating the oxygen levels in the plant may not be sufficient to support de-nitrification. High nitrogen values in this effluent (Figure 18) are a concern in this area where the aquifer is unconfined. Although the nitrogen in the effluent is not in the mobile nitrate form, it is likely to get converted to nitrate under the aerobic conditions in the unsaturated zone of the unconfined Floridan aquifer. The permit violations and nutrient concerns have been expressed in the inspection letters sent to the operator, owner, and FDEP.

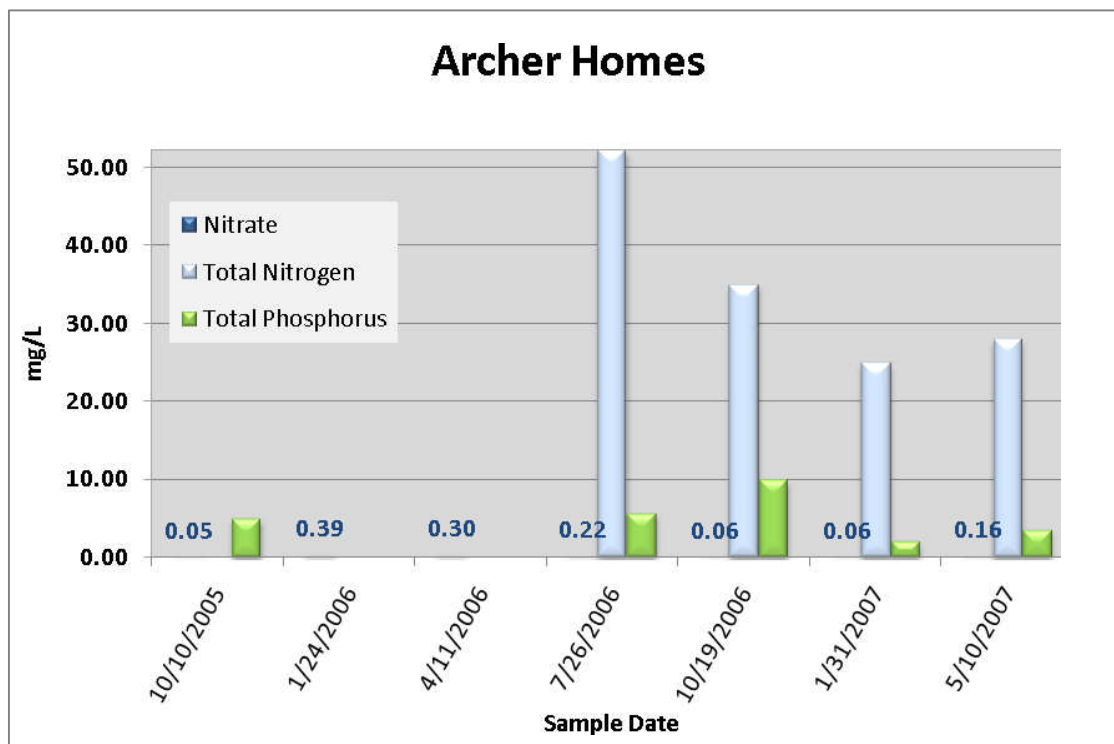
The package plant at Archer Homes is an extended aeration treatment plant. This facility was inspected seven times by ACEPD in the 2006 and 2007 fiscal years. The parameter coverage was expanded in July of 2006 to include nitrogen species and phosphorus. Sand filters were installed and permitted in 2006 to improve the effluent quality leaving this plant. However, the sand filters did not operate properly during 2006 and 2007.

Figure 18: Effluent data from grab samples collected from the Archer Homes WWTP during the ACEPD inspections in 2006 and 2007. The nitrate concentrations are denoted on the graph.

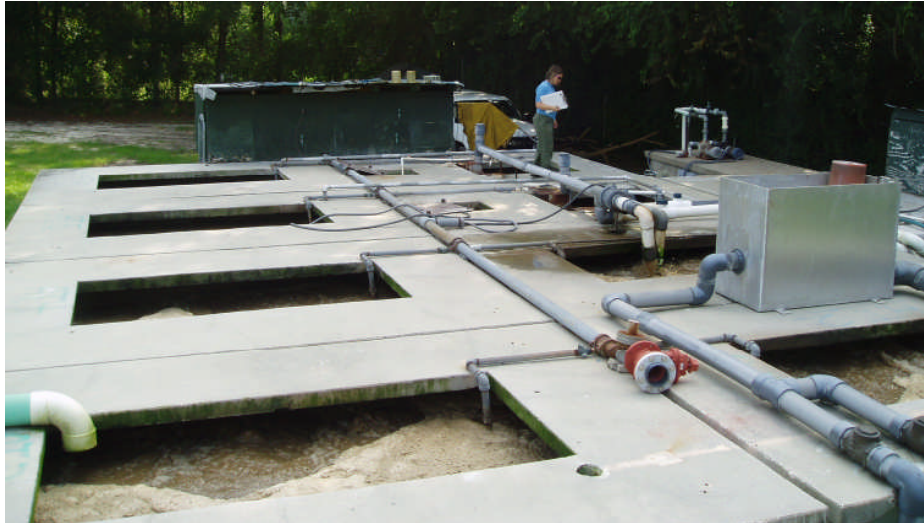
Inspector looking at one of the clarifiers at the Arredondo WWTP

The package plant at Arredondo Farms MHP is an extended aeration treatment plant. This facility was found out of compliance by ACEPD during four of the seven inspections conducted during the 2006 and 2007 fiscal years. Non-compliance was caused by: solids in the rapid infiltration basin, uncovered screenings containers, a residual chlorine level less than the FDEP permit requirement, and an exceedance of the total suspended solids (TSS) permit requirement.

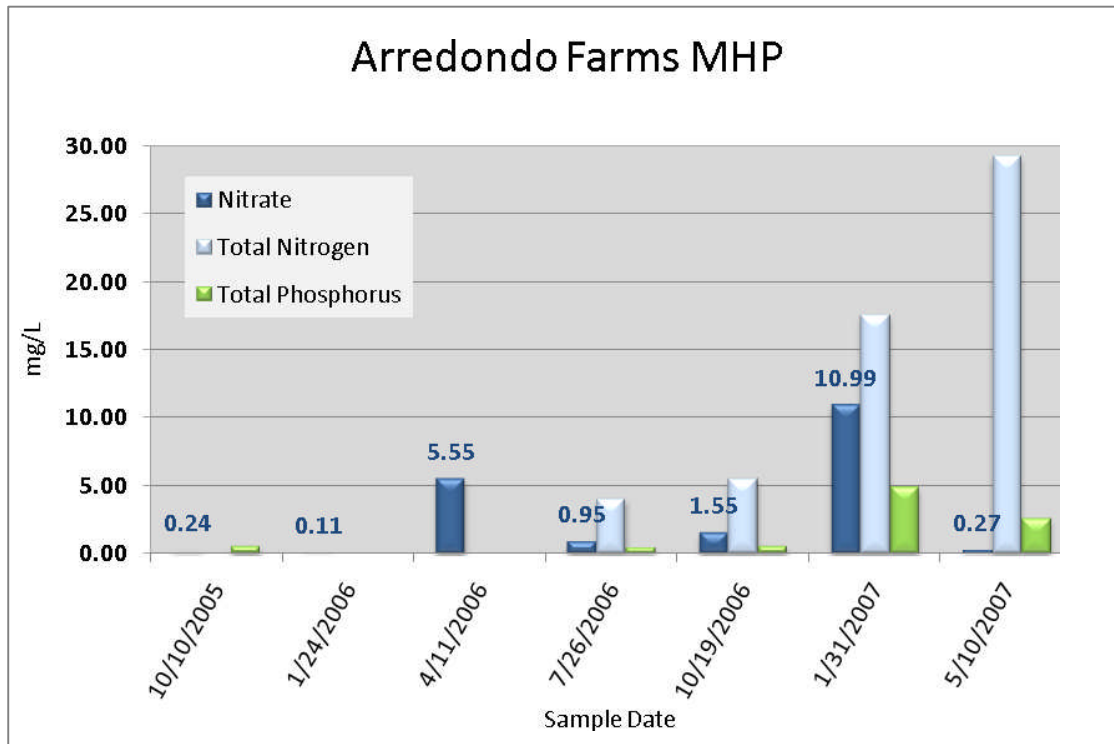
The parameter coverage was expanded in July of 2006 to include additional nitrogen species and phosphorus. Total nitrogen levels appear to be rising (Figure 19); however a longer period of record would be needed to confirm this possible trend.

Figure 19: Effluent data from grab samples collected from the Arredondo Estates WWTP during the ACEPD inspections in 2006 and 2007. The nitrate concentrations are denoted on the graph.
