Wastewater Treatment Plant Inspection Program Fiscal year 2006 and 2007 Data Report

**Prepared by: Stacie Greco
Alachua County Environmental Protection Department**

November 2008

**Alachua County Environmental Protection
Wastewater Treatment Plant Inspection Program
Fiscal Year 2006 and 2007 Data Report**

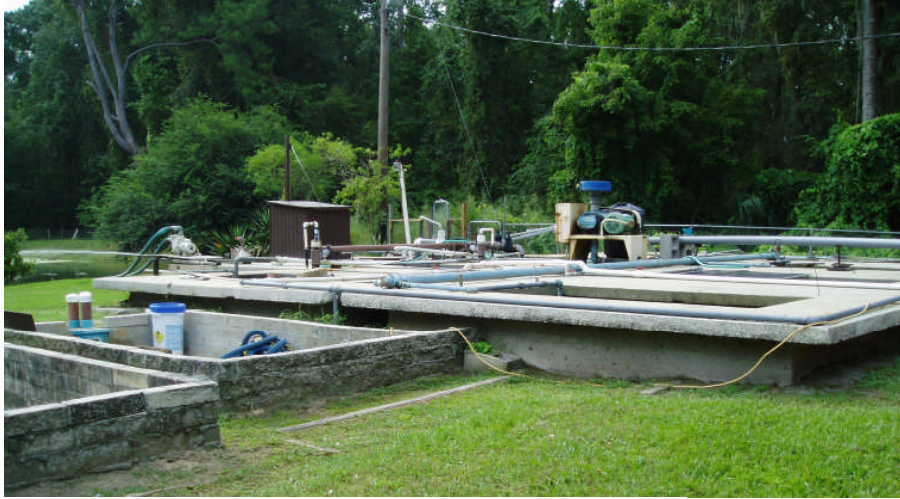
The Brittany estates Package WWTTP

The package plant at Brittany Estates MHP can be operated as an activated sludge extended aeration or contact stabilization plant. This facility was found out of compliance during three of the six inspections conducted by ACEPD during the 2006 and 2007 fiscal years. The violations were caused by residual chlorine levels less than or greater than the FDEP permit limitations. Effluent nitrogen levels tend to be very low at this plant, which is important since this plant discharges to a tributary of Little Hatchet Creek. Nitrate + nitrite levels were high (10.2 mg/L) in May 2006 (Figure 20), but the operator adjusted the plant to address the issue. The nutrient levels increased again in July 2007.

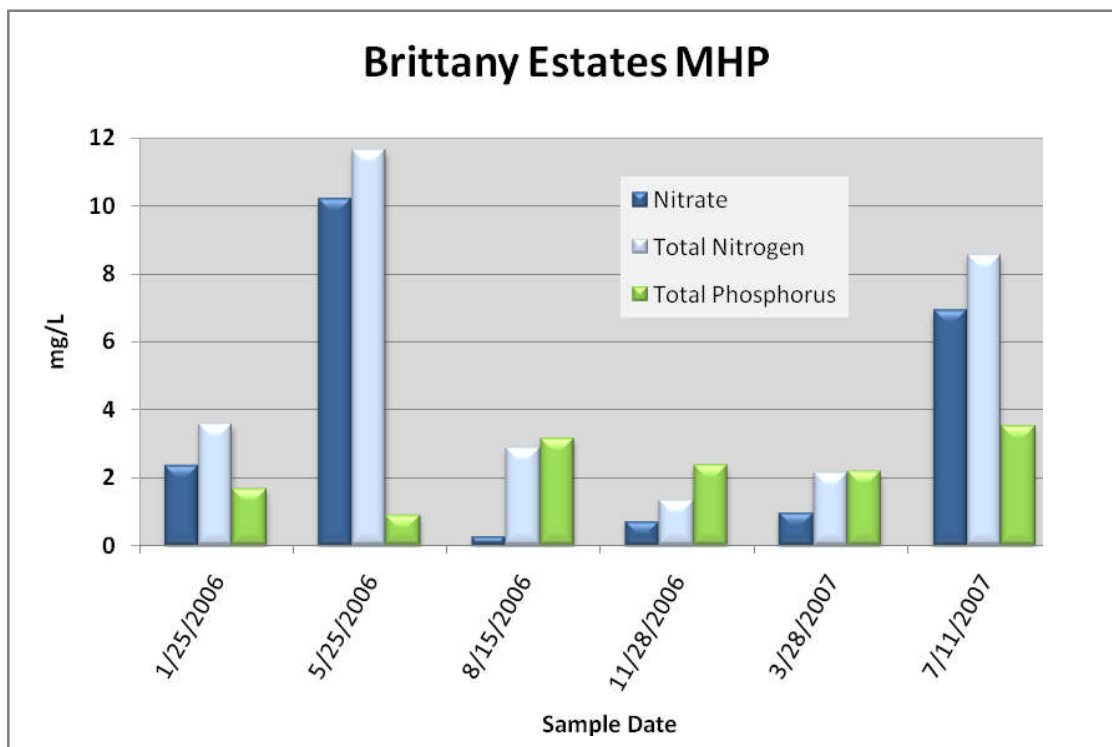
Figure 20: Effluent data from grab samples collected from the Brittany Estates WWTP during the ACEPD inspections in 2006 and 2007.

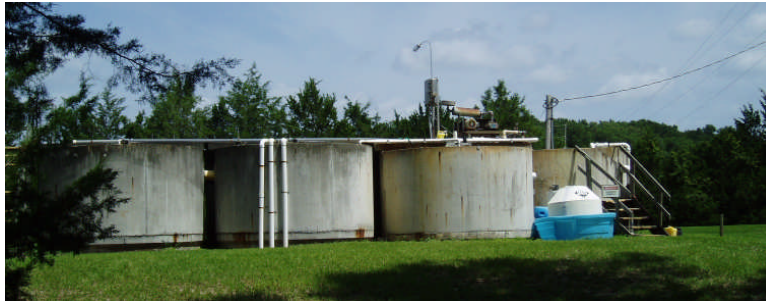
Aeration basins, clarifier, and chlorine contact chamber at the Camp Kulaqua WWTP.

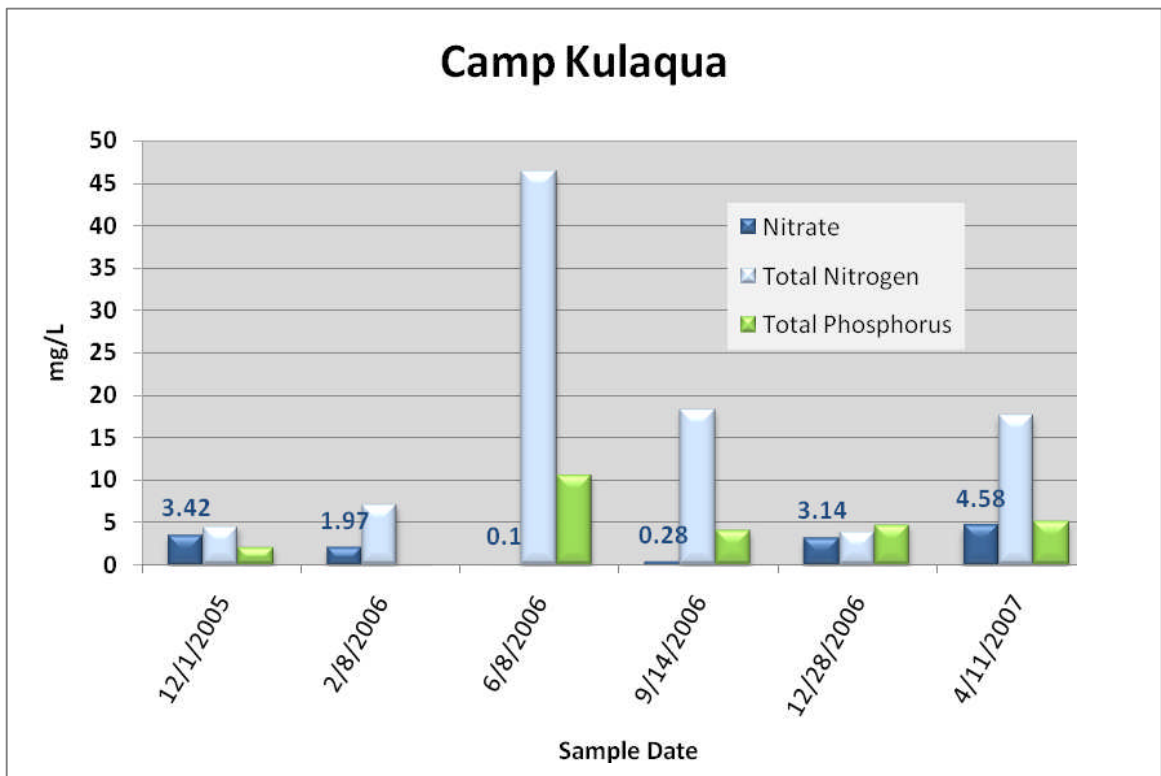
The high nitrogen values during some of the sampling events (Figure 21) are a concern with the proximity of Hornsby Springs and the Santa Fe River. Although the nitrogen in the effluent is not in the mobile nitrate form, it is likely to get converted to nitrate under the aerobic conditions in the unsaturated zone of the unconfined Floridan aquifer. In 2009 the City of High Springs will look into connecting this plant to its centralized wastewater collection system. Permit violations and nutrient concerns were expressed in the inspection letters sent to the plant owner, operator, and FDEP.

Figure 21: Effluent data from grab samples collected from the Camp Kulaqua WWTP during the ACEPD inspections in 2006 and 2007. The nitrate concentrations are denoted on the graph.

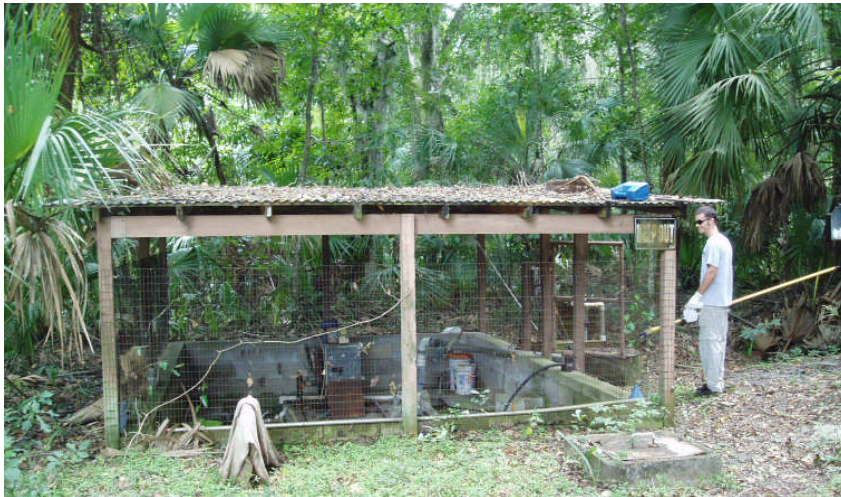
An inspector looking towards the aeration basins at the Camp McConnell WWTP

The package plant at Camp McConnell is an extended aeration plant. ACEPD conducted seven inspections at this facility during the 2006 and 2007 fiscal years. Effluent exceeded the FDEP permit limitation for total suspended solids (TSS) of 10 mg/L during the October 2005 inspection and exceeded the nitrate limitation of 12 mg/L during the August 2006 (26.6 mg/L) inspection. High nutrient concentrations in the effluent (Figure 22) are a concern with the proximity to Georges Pond. However, the nutrient levels dropped in 2007. The flow rate at this facility is intermittent and is dependent on the programming at the camp. The operator often adds dog food as food for the microbes that are essential to the proper operation of this plant. Permit violations and nutrient concerns were expressed in the inspection letters sent to the plant owner, operator, and FDEP.

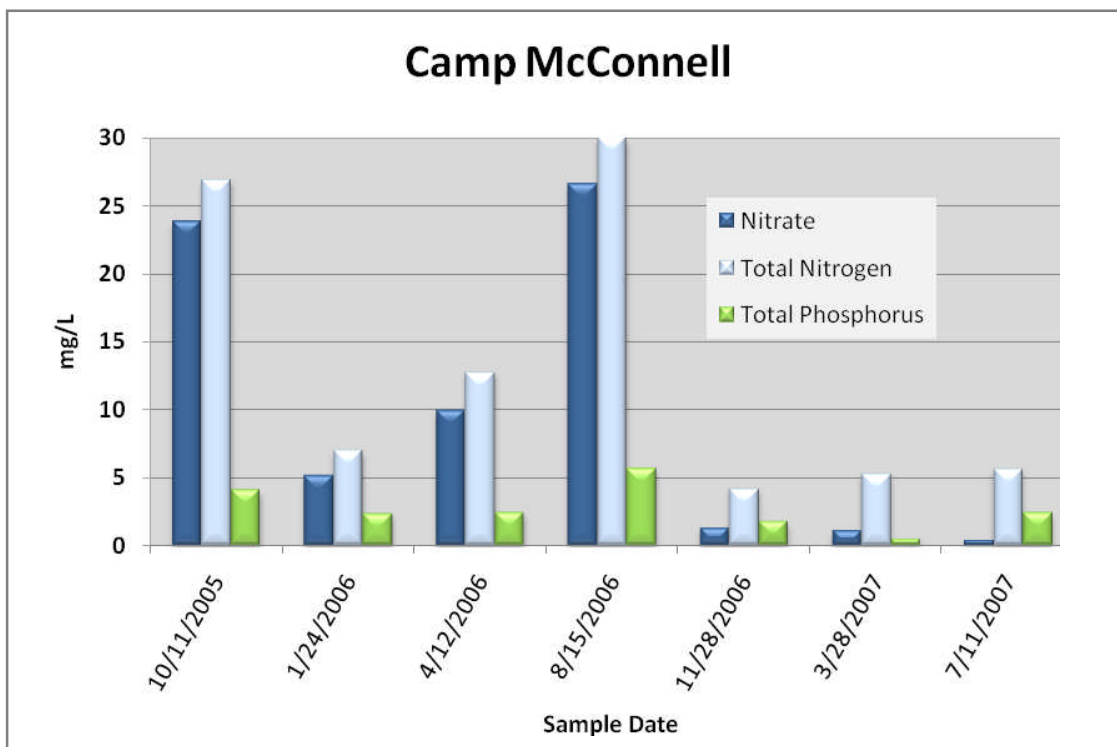
Figure 22: Effluent data from grab samples collected from the Camp McConnell WWTP during the ACEPD inspections in 2006 and 2007

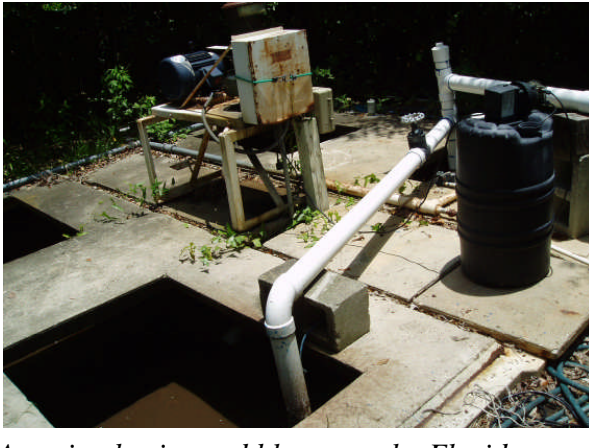
Aeration basins and blower at the Florida Welcome Center WWTP

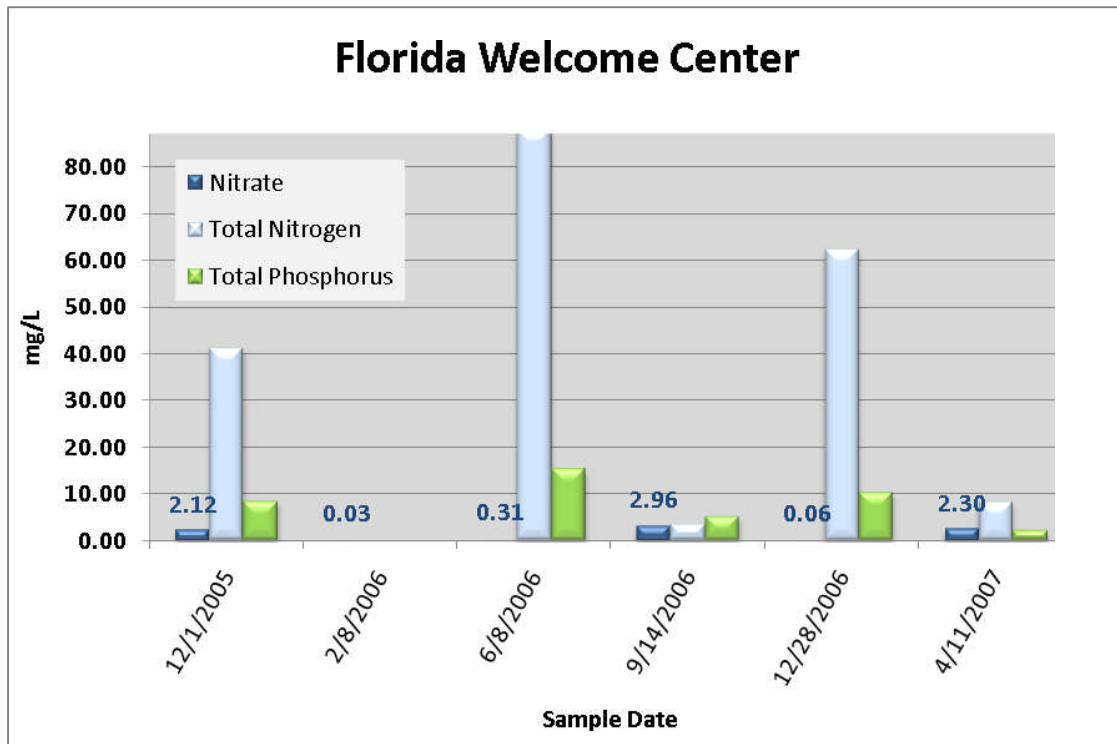
The effluent was normally in compliance with the nitrate limitation set by the FDEP permit, but the high total nitrogen concentrations (Figure 23) are of concern in such close proximity to the Santa Fe River and its springs. Although the nitrogen in the effluent is not in the mobile nitrate form, it is likely to get converted to nitrate under the aerobic conditions in the unsaturated zone of the unconfined Floridan aquifer.

Figure 23: Effluent data from grab samples collected from the Florida Welcome Center WWTP during the ACEPD inspections in the 2006 and 2007 fiscal years. The nitrate concentrations are denoted on the graph.

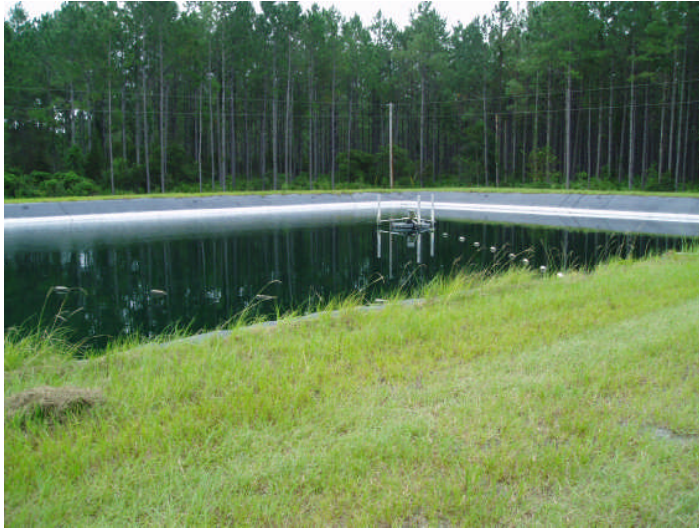
An aeration basin at the Gainesville Raceway WWTP

The Gainesville Raceway plant is an extended aeration batch treatment system that was designed to treat the intermittent flows of the Gainesville Raceway including the extreme flows of Gator Nationals. This facility was not inspected during 2006 or 2007. This plant operates during special events at the Gainesville Raceway and receives and treats wastewater pumped from portable toilets. This plant is over-designed and historically has been found to be in compliance. Due to its intermittent nature, this plant is not required to pay wastewater fees to the County. This plant was inspected in 2005 and will be inspected again in 2008.

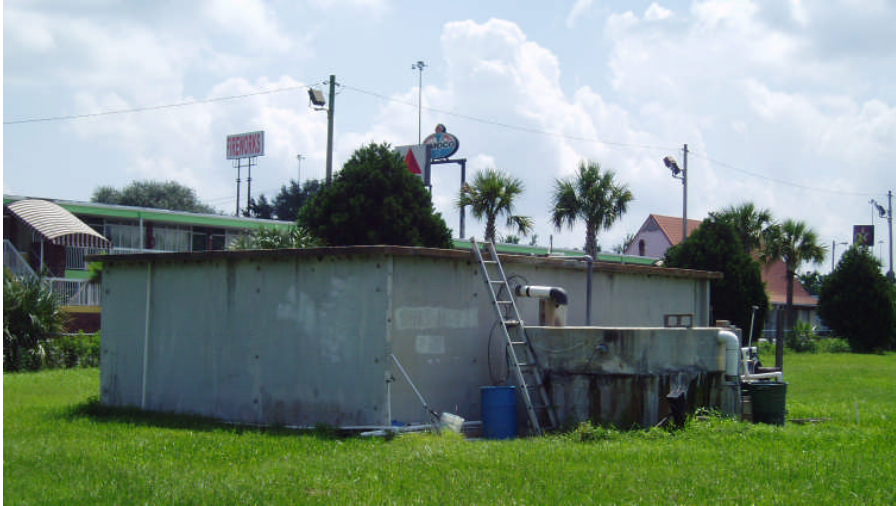
The Knights Inn Package WWTP

The package plant at the Knight's Inn Hotel in Micanopy is an extended aeration plant. This facility was inspected seven times by ACEPD during the 2006 and 2007 fiscal years. The plant was found in non-compliance during two of the inspections due to an uncovered container for waste screenings and solids in the chlorine contact chamber. During all of the inspections the effluent was in compliance with the FDEP permit limitations. There is no nitrate limit set by the FDEP permit. The elevated nutrients in the April 2006 and July 2007 effluent (Figure 24) are of concern.

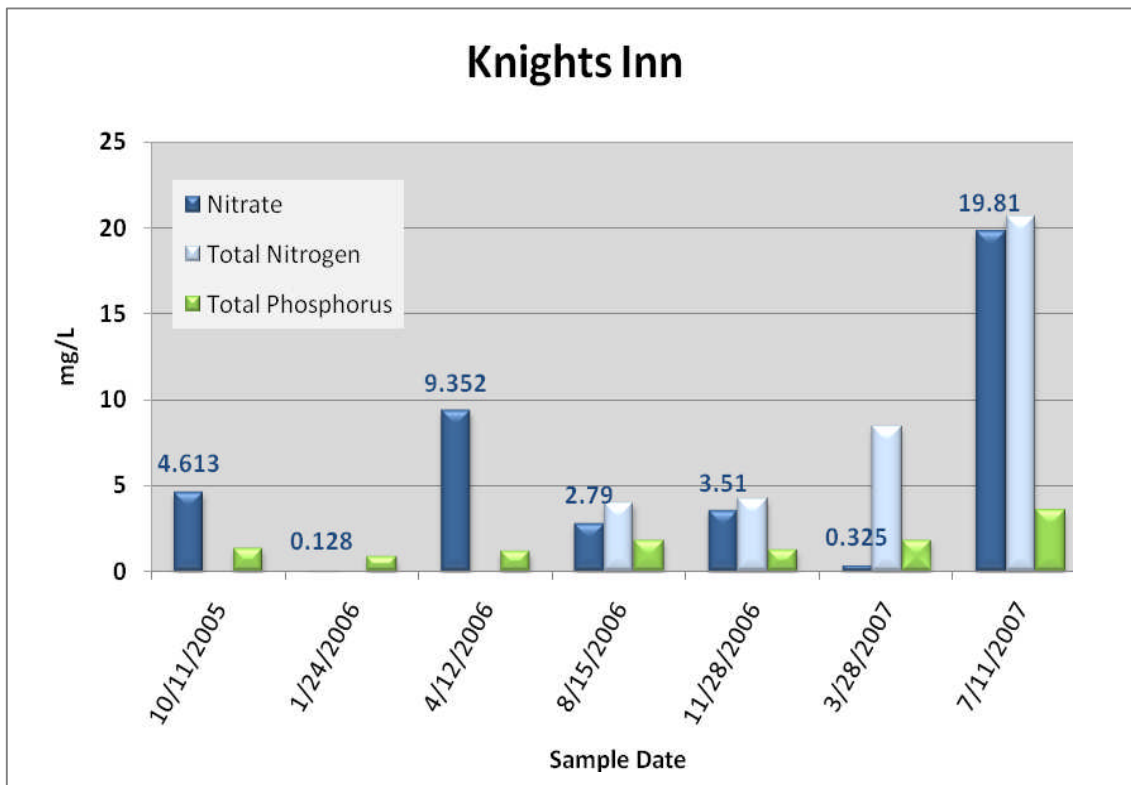
Figure 24: Effluent data from grab samples collected from the Knights Inn WWTP during the ACEPD inspections in the 2006 and 2007 fiscal years. Nitrate values are denoted on the graph.

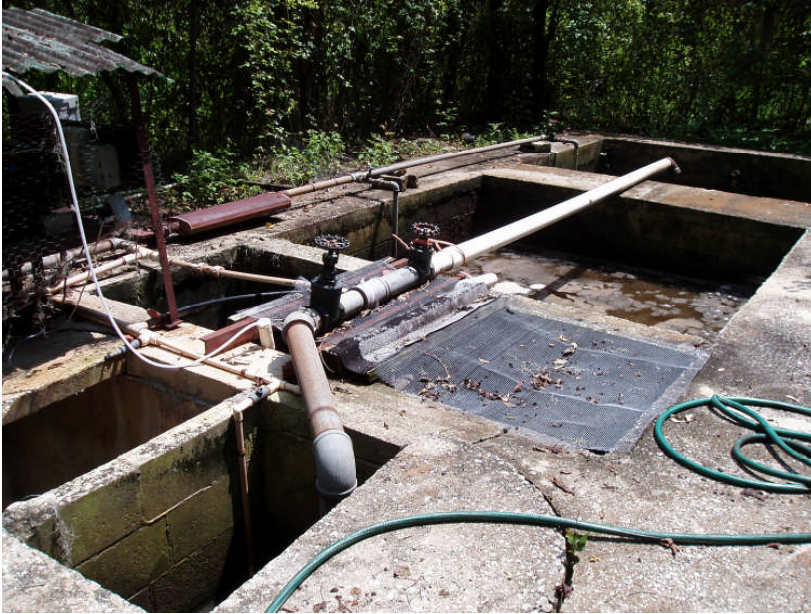
Prairie View package WWTTP

The package plant at Prairie View Apartments is an activated sludge secondary treatment plant. This facility was found out of compliance during all seven of the inspections conducted by ACEPD during the 2006 and 2007 fiscal years. During five of the inspections the chlorine residual was less than the FDEP permit minimum concentration of 0.5 mg/L. During the July 2006 inspection the total suspended solids (TSS) in the effluent was very high at 138 mg/L and exceeded the 10 mg/L permit limitation. Solids were observed in the chlorine contact chamber during half of the inspections. During the March 2007 inspection, the effluent had a fecal coliform concentration of 4,000 CFU/100 ml, which exceeded the FDEP one time maximum concentration of 800 CFU/100 ml.

The operator, plant owner, and FDEP were notified concerning these compliance issues. The poor effluent quality (Figure 25) is of concern because when Paynes Prairie is under high water conditions, the effluent disposal is directly connected to the prairie, an Outstanding Florida Water. The effluent is permitted as discharging to a rapid infiltration basin, but due to high water and the soil conditions, it acts more like a wetland or a surface water discharge.

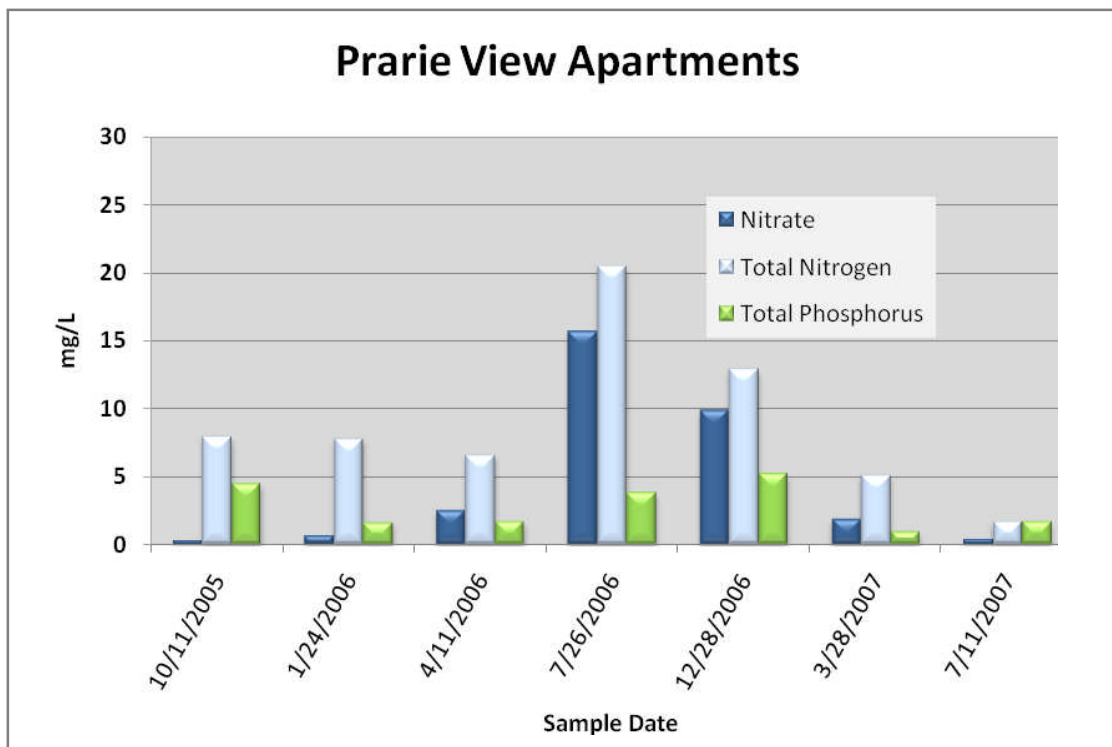
Figure 25: Effluent data from grab samples collected from the Prairie View WWTP during the ACEPD inspections in 2006 and 2007
