THE RIVER ENDRICK - THEN AND NOW, MONITORING BY PHOTOGRAPHY

PETER MAITLAND

*(Dr P. S. Maitland, Fish Conservation Centre, Easter Cringate,
Stirling, FK7 9QX, Scotland.)*

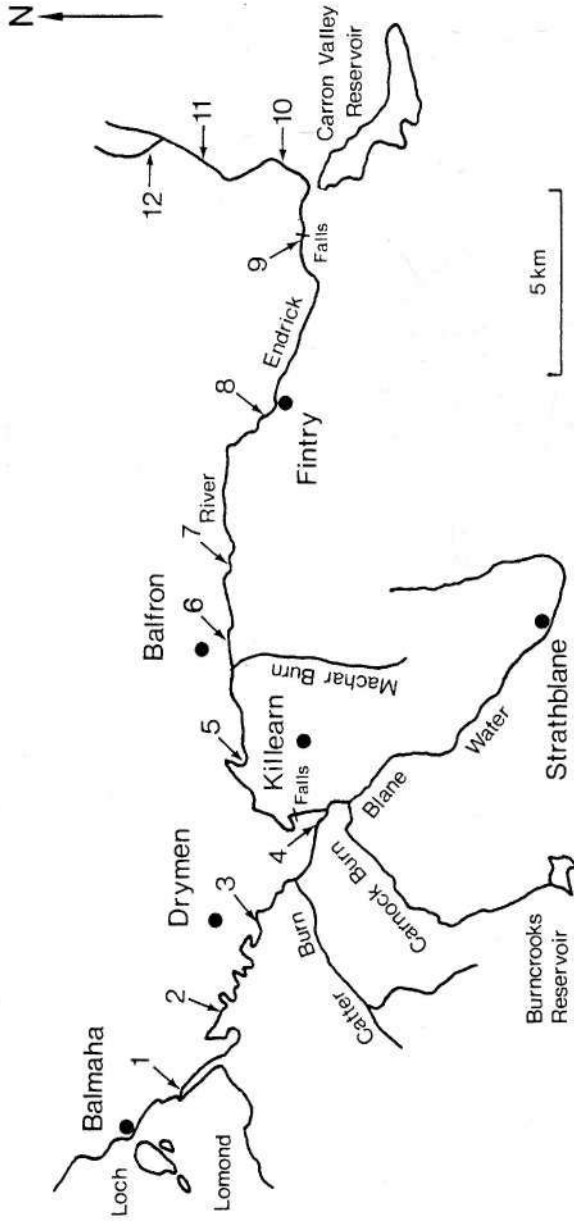
FIG. 1. An outline map of the River Endrick, showing the main stream network and the sites mentioned in the text.

Full details of the two main surveys carried out in 1959-60 and in 1989-90 are given by Maitland (1966) and Doughty & Maitland (1994) respectively. Twelve sites on the main stem of the river, from source to mouth (Fig. 1), were sampled for invertebrates on each occasion, using standard timed handnet collecting. At two of these sites (Woodend (Site 2) and Drumtian (Site 6)) quantitative studies were carried out (Maitland 1964).

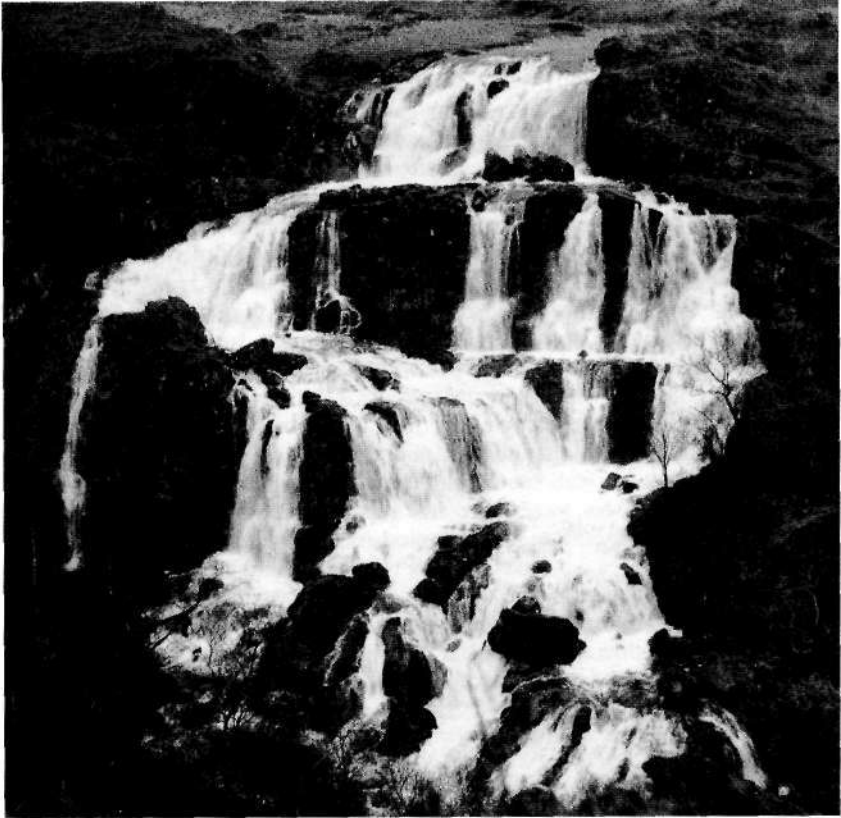
FIG. 2. The River Endrick: the Loup of Fintry, looking upstream at site 9, where the river cascades down over 30 metres. This is the approximate junction of the upper and middle reaches and a complete barrier to migratory fish. Very old photographs indicate that the river has changed very little here over the last 100 years.

plunges over 30 m in a broken series of waterfalls (Fig. 2). At the Pot of Gartness (near Killearn), the drop is only 2 to 3 m, but the waterfall here is a local attraction in the autumn when Atlantic salmon *Salmo salar* and sea trout *Salmo trutta* are leaping.

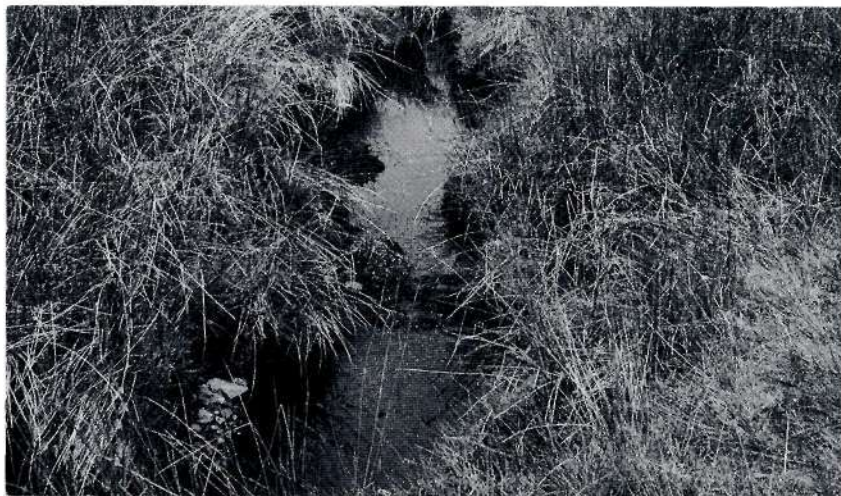
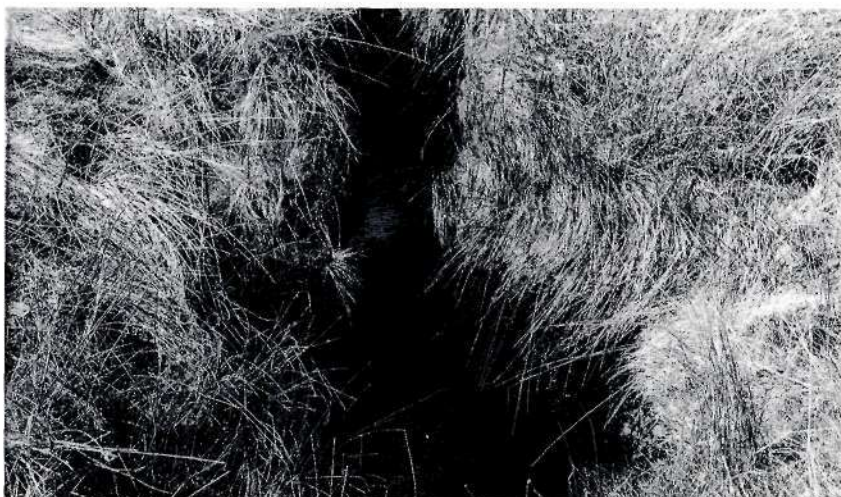
FIG. 3. The River Endrick: upper reaches at site 12 (source) in 1960 (upper photo) and 1990 (lower photo), looking upstream. The river has changed little here over recent decades and several small headwater burns like this arise among *Juncus* and *Sphagnum* bog.

Minor changes can be seen at all sites - some to the river channel itself, others to the riparian zone or neighbouring catchment. In general, there have been few changes in the upper reaches where the river channel is made up of bedrock and boulders in many places and grazing is relatively light (Figs 3 to 5). In the middle reaches, however, there are relatively few places where boulders occur and the channel and river bank are potentially much less stable. Where trees are well rooted in the riparian zone and grazing is light the river is stable (Fig. 6), but where trees are absent and there is intensive grazing pressure, sometimes accompanied by ploughing almost to the river bank, massive changes can take place (Figs 7 and 8). These usually take the form of extensive widening of the river channel accompanied by a loss of riparian soil, gravels and vegetation, swept downstream. In the lower reaches where the current slows there can be large deposits of such gravels (Fig. 9). Here too, however, where the banks are unprotected by tree roots and exposed to intensive grazing there can be substantial erosion and channel changes.

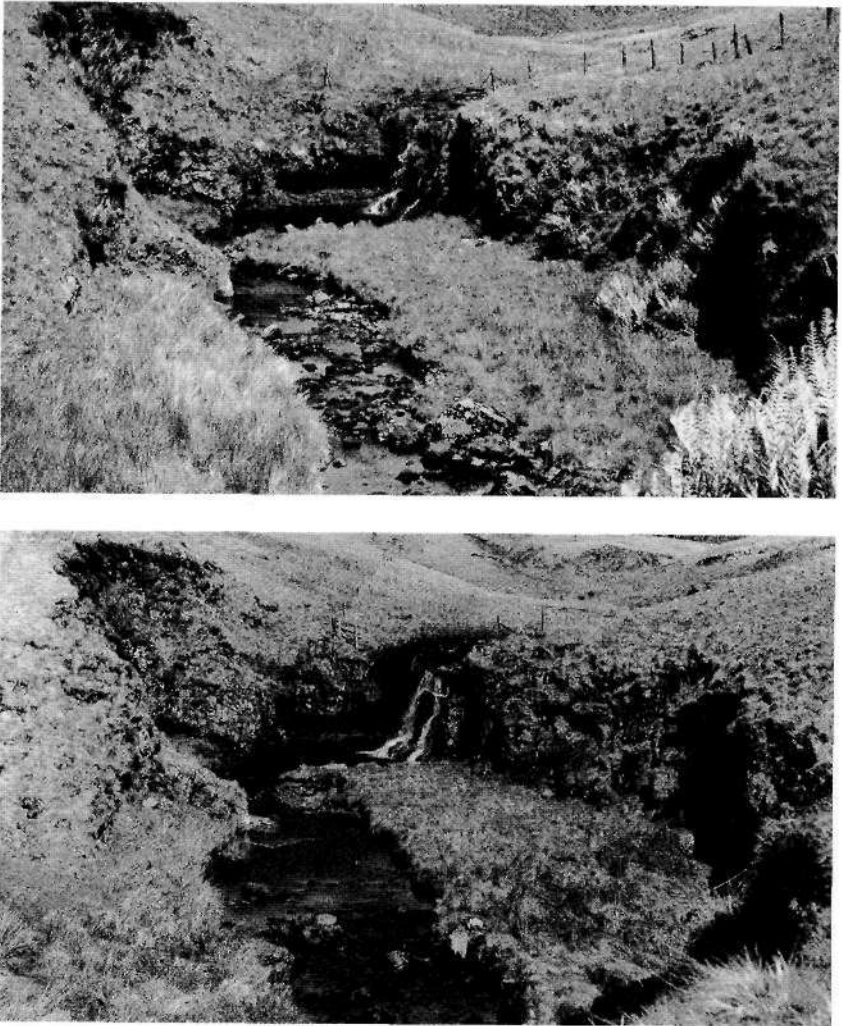
FIG. 4. The River Endrick: upper reaches at site 11 (Burnfoot) in 1960 (upper photo) and 1990 (lower photo), looking upstream. Note the subtle changes in the river channel, with slight erosion in some places and bank encroachment in others.

some feature which is likely to be permanent (e.g. a large boulder or some bedrock (as in Fig. 4) rather than a tree or a soft bank).

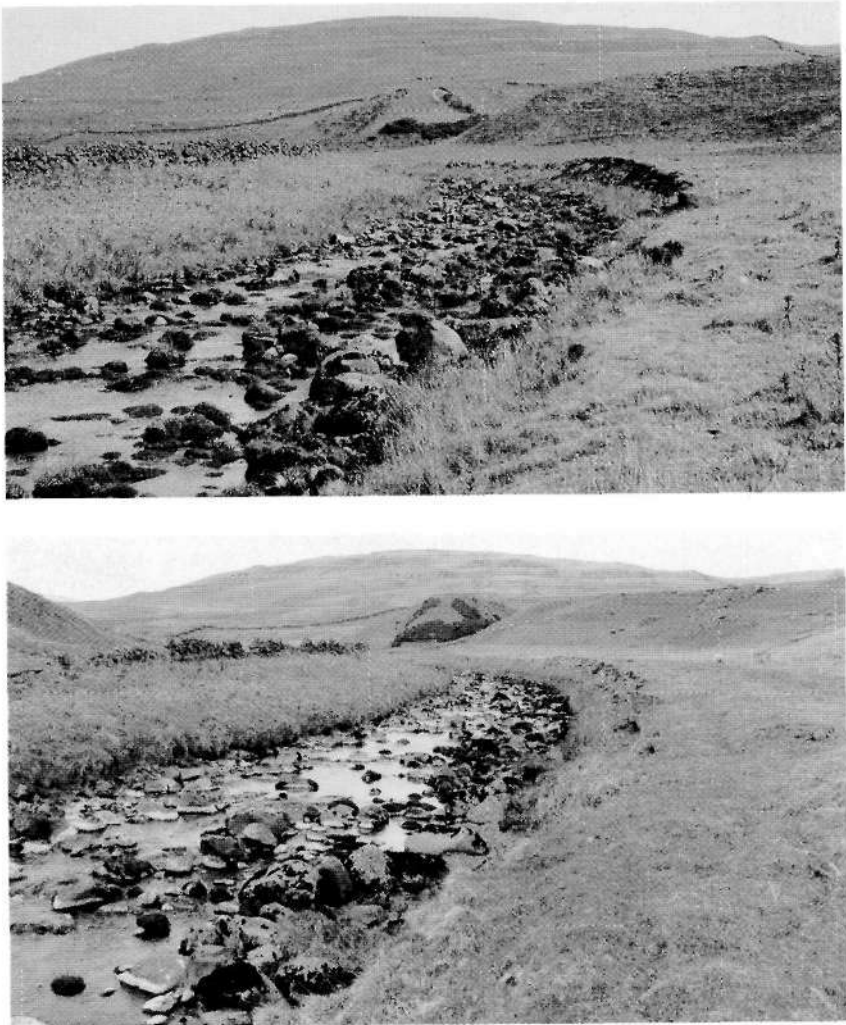
FIG. 5. The River Endrick: upper reaches at site 10 (Cringate) in 1960 (upper photo) and 1995 (lower photo), looking upstream. Changes are few here over 35 years and more obvious on land (with encroaching gorse *Ulex europaeus* in the middle distance and the collapse of a nearby wall) than in the minor riparian changes beside the river.

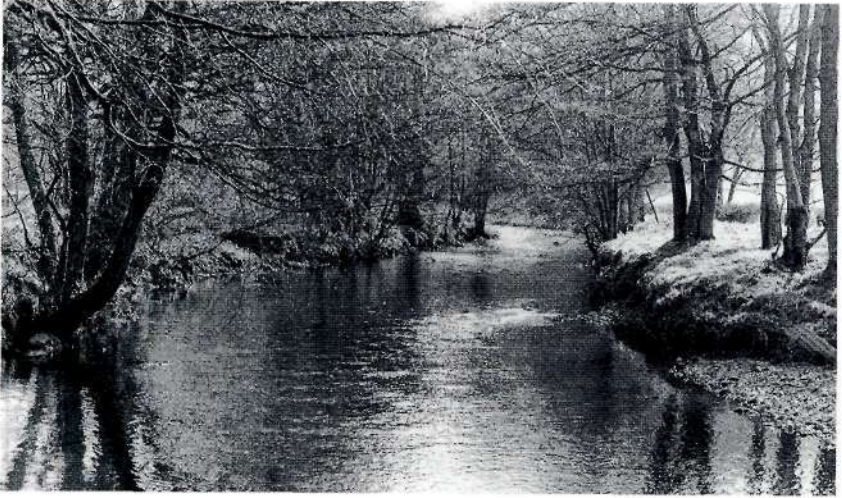
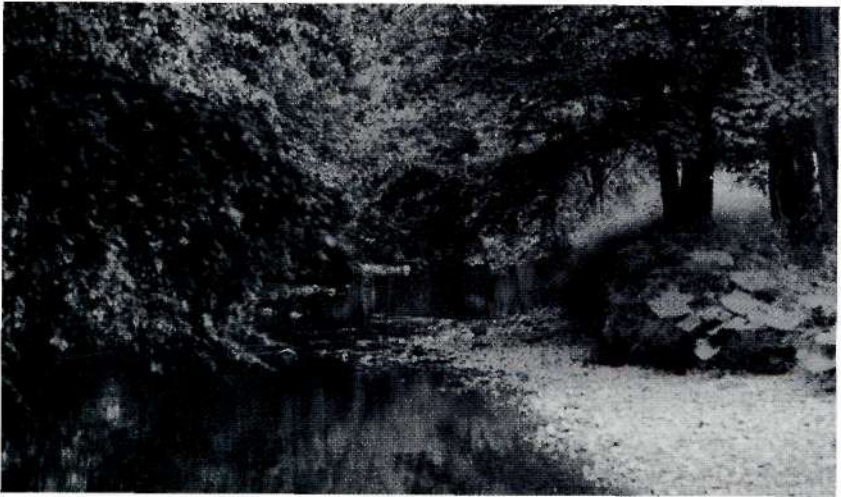
FIG. 6. The River Endrick: middle reaches at site 8 (Culcreuch) in 1990 during winter (upper photo) and summer (lower photo), looking upstream. Note the lesser flow but poorer view of the river during summer.

The season during which photographs are taken can be important. Although photographs taken during the vegetative season are clearly of value ecologically, much of the river can be obscured at this time - especially if there are many riparian trees and shrubs (Fig. 6). Ideally, photographs should be taken at more than one season of the year. This is especially true if photographs are intended for site evaluation in future years, perhaps in relation to synoptic limnology (Maitland 1979) or conservation evaluations such as SERCON (Boon et al. 1994).

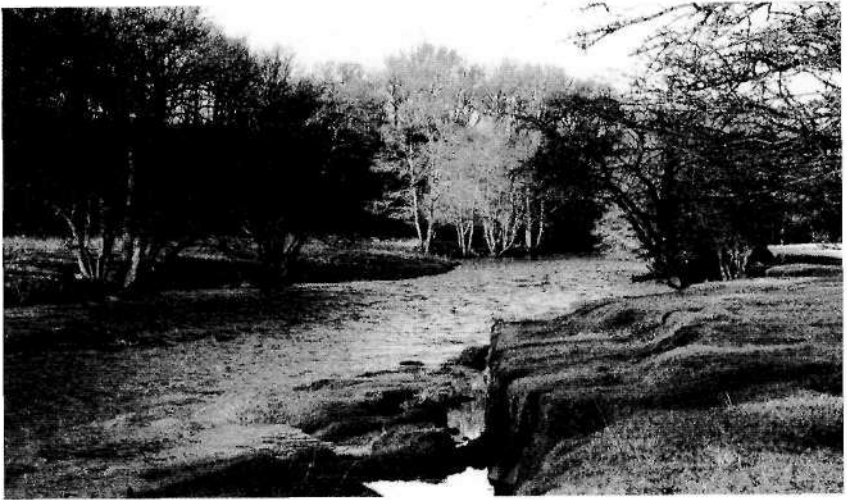
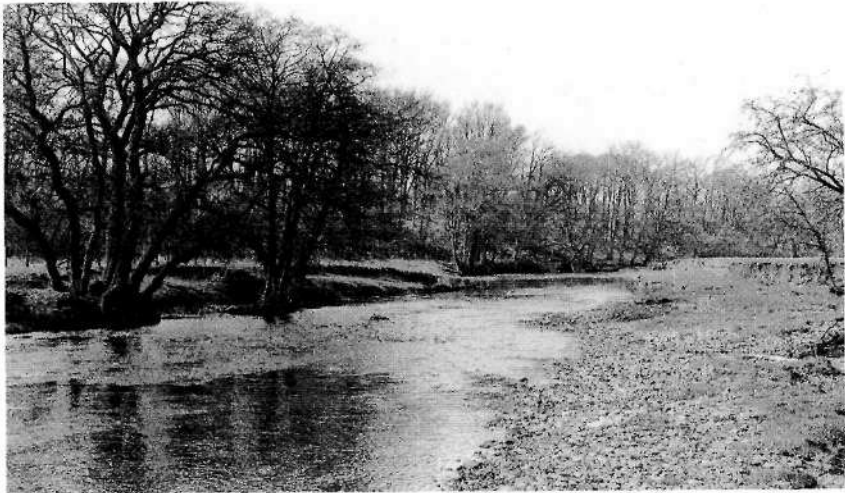
FIG. 7. The River Endrick: middle reaches at site 6 (Drumtian) in 1960 (upper photo) and 1990 (lower photo), looking downstream. Note the extensive erosion on the right bank, including the loss of numerous riparian trees further downstream.

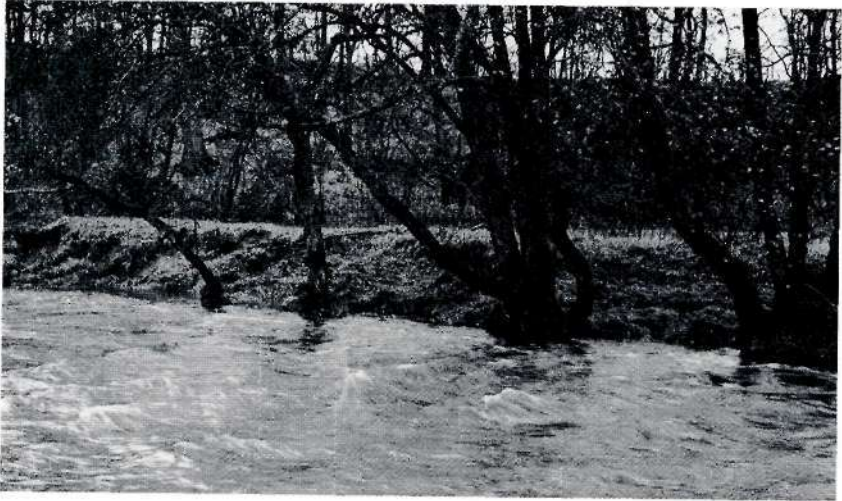
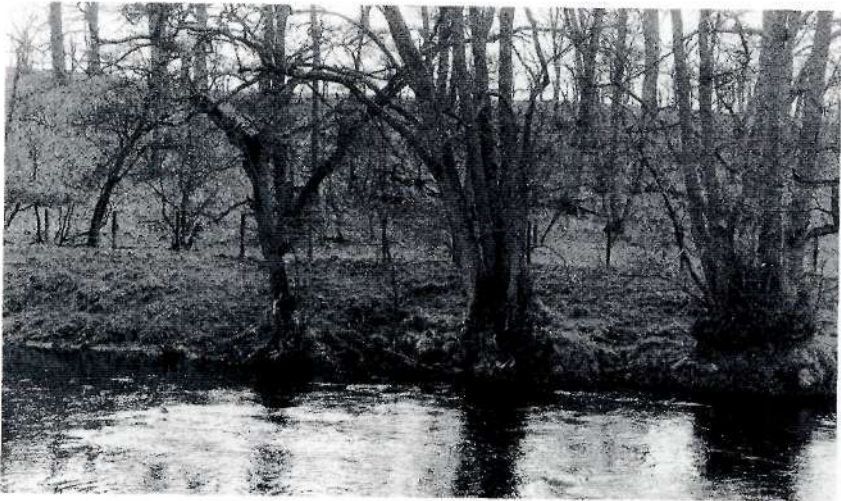
FIG. 8. The River Endrick: middle reaches at site 6 (Drumtian) in 1960 (upper photo) and 1990 (lower photo), looking across the river to the left bank. Note the stability here over three decades in contrast to that on the opposite bank (Fig. 7).

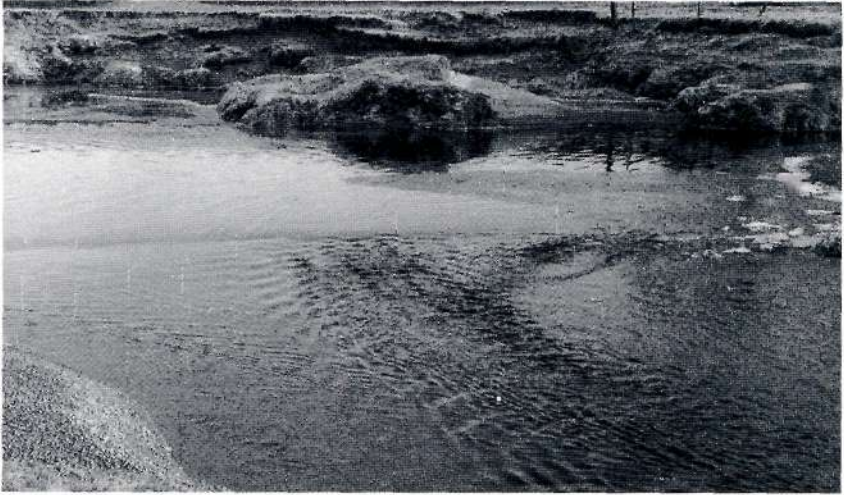
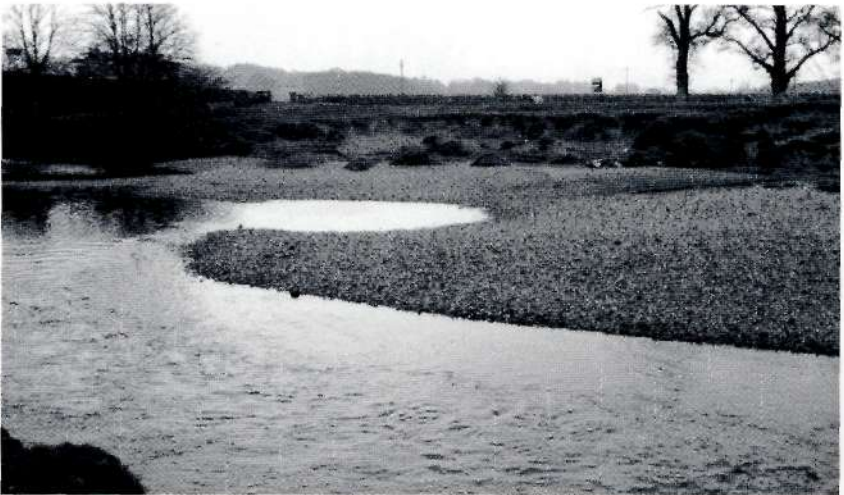
FIG. 9. The River Endrick: lower reaches at site 3 (Drymen) in 1960 (upper photo) and 1995 (lower photo). Note the continued erosion here on the far bank and the extensive deposits of gravel brought down from upstream.

Even when large numbers of photographs are taken along the length of a river, spectacular geomorphological events can be missed. One such took place only a few hundred metres below Drymen Bridge (Fig. 9) when, in October 1983, a large spate caused about six metres of the river bank to collapse (Mitchell 1994), leaving behind a characteristic ox-bow section, which is now completely cut off from the river and is the newest of several ox-bows on the flood plain, in various stages of succession. Photographic comparisons of unpredictable major events of this type can probably only be made by the use of aerial photographs taken before and after.

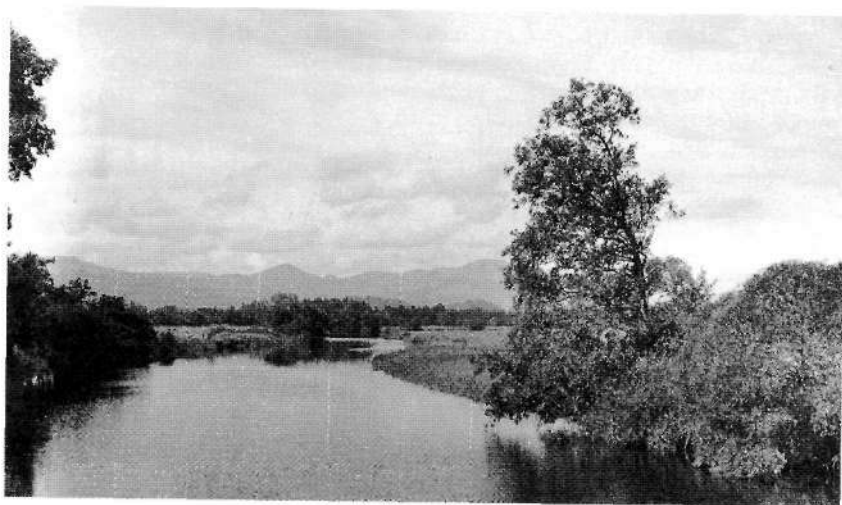
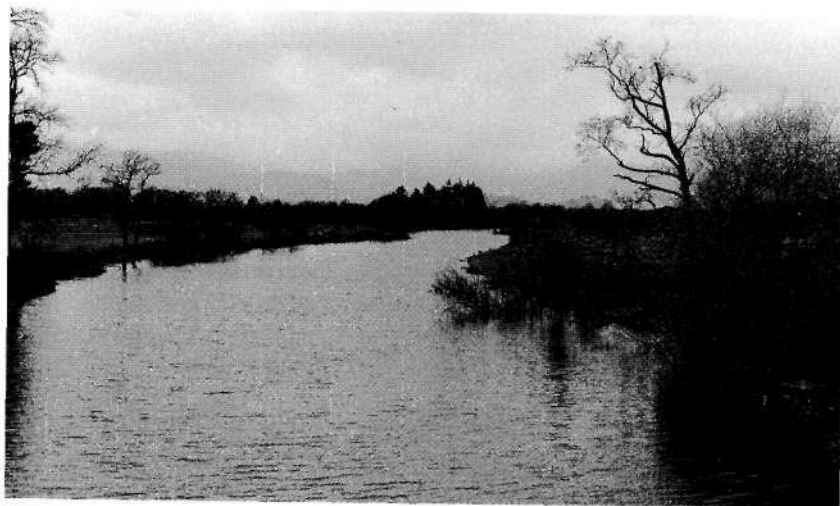
FIG. 10. The River Endrick: lower reaches at site 2 (Woodend) in 1960 (upper photo) and 1990 (lower photo). The changes here have largely been in the riparian zone, with the growth of some trees and the death of others – notably the alder *Alnus glutinosa* in the right foreground.

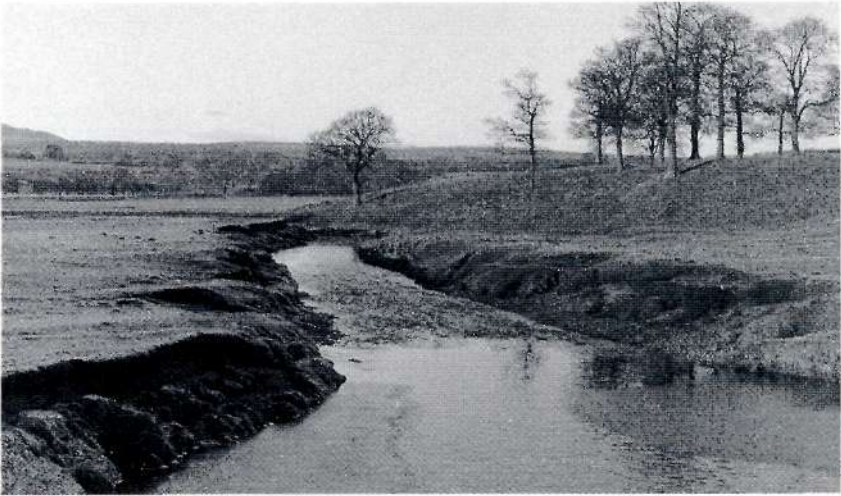
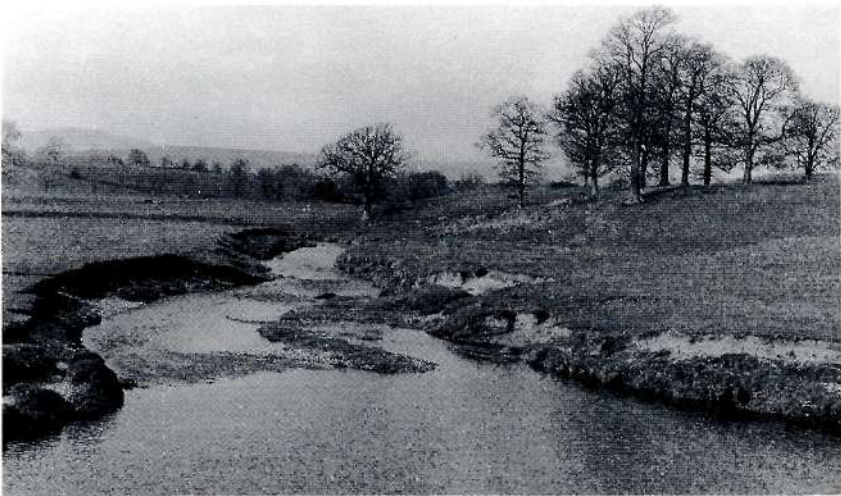
FIG. 11. The Blane Water (just above its junction with the River Endrick): in 1960 (upper photo) and in 1990 (lower photo). Note the extensive erosion of both banks here – most notably that of the left bank where the main channel has moved sideways by many metres.

The ideal spot to choose from which to take standard photographs is an exact point which is likely to be permanently recognisable and from which a good (preferably slightly elevated) view of the river is possible. Stone or concrete bridges are often ideal for this (Fig. 11 was taken from a bridge over the Blane Water, near Killearn Smiddy), or alternatively, large boulders or elevated bedrock are also ideal (Fig. 4 was taken from the top of the same steep ground to the right of the photograph). The view should ideally include
