Report on The 2001 Stock Assessment Of The River Darwen Catchment

Darren Wilson

March 2002

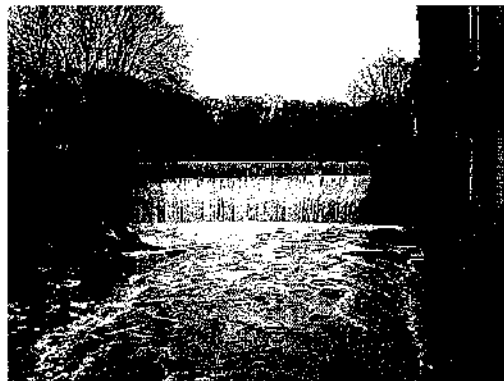
There are a number of areas of the Darwen that are effectively impassable to both salmonid and cyprinid fish species. There are weirs at Roach Bridge (right), Salmesbury Bottoms and Lower Darwen and culverted sections through Blackburn which are likely to present an impassable barrier because of poor water quality, high velocities and lack of suitable habitat. The impassable areas effectively isolate large areas of river and prevent movement of fish species between them. Fish passes could make these weirs passable, however, the cost of these are not justified given the existing water quality in the middle and upper catchment at present.

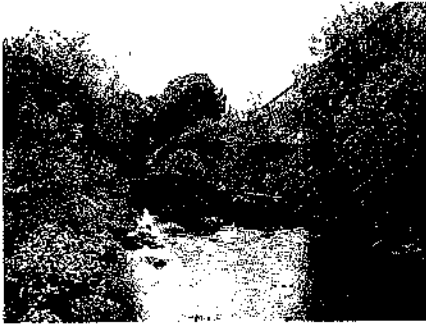
fishing team and other persons on site. This site was therefore left out of the survey. Site Dw06 was identical but again site Dw07 could not be surveyed due to health and safety issues. Site Dw08 was below Ewood Park, off Aqueduct Street, Blackburn in 1996 (right). This site was changed for the 2001 survey as this site has very high, steep gradient banks so was changed on health and safety grounds during the risk assessment process. This site was changed to behind Blackburn Rovers Football Club at Ewood Park (left). The land use is different than the 1996 site with a distance of approximately 0.5 km upstream so cannot be used as a comparison between the two surveys. Site Dw09 was changed slightly in the 2001 survey as it was felt the new site was more representative of the

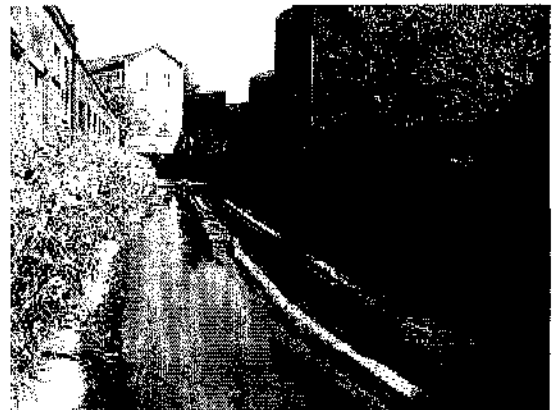
In addition to the sites selected in 1996, sites on Sunnyhurst Brook (left) and Arley Brook, both tributaries of the River Darwen were selected as these had never been surveyed before. These would give broader coverage of the catchment area.

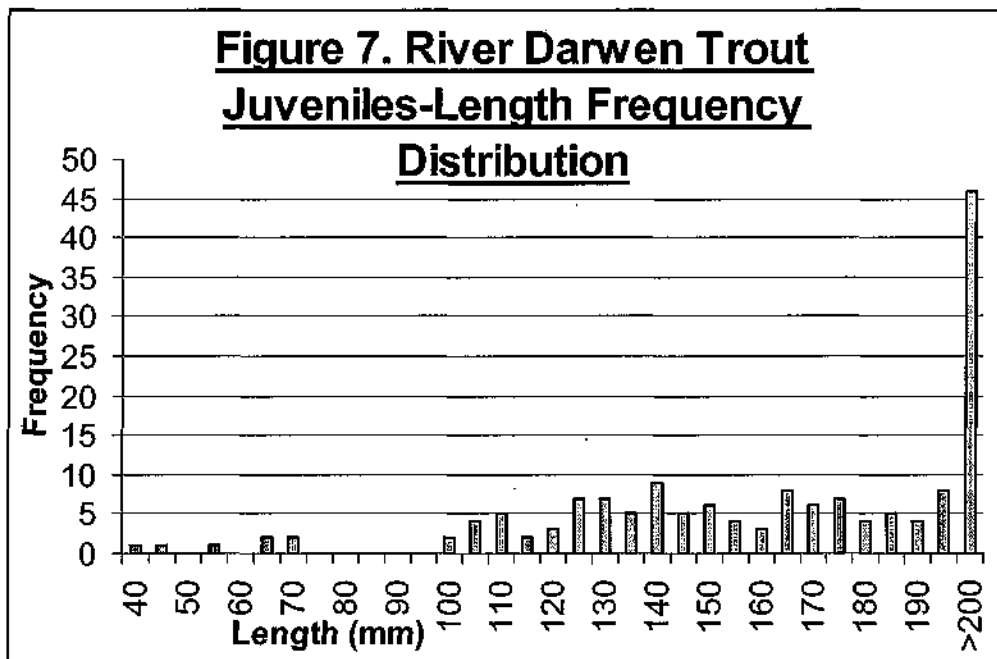
Brown trout were caught at thirteen of the sites surveyed in 2001, nine sites on the main river, all three of the sites on Davyfield Brook and on Sunnyhurst Brook. At the majority of the sites, they were present in low densities, site Da03 being the exception. Relative and absolute classification for brown trout for each site are indicated in Figure 6. The length frequency distribution of brown trout, Figure 7, show all brown trout less than 95 mm in length were considered as being of the 0+ age class.
