**VISUAL SURVEY OF EXPOSED RIVERINE SEDIMENTS (ERS) IN THE  
DANE, WEAVER AND BOLLIN CATCHMENTS**

**Adam Bates**

**February 2005**

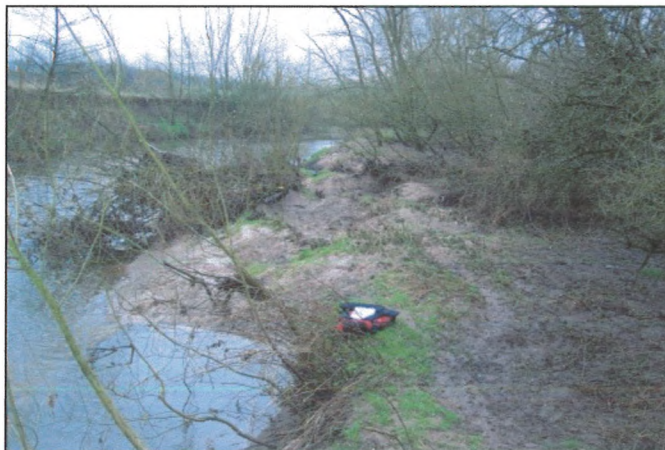
*Woodhouse Farm 2 (6/2/05) D4*

Habitat summary: Medium sized, heavily shaded complex habitat dominated by sand, with some silt. Trampling most probably by sheep, although they are not on, likely to become heavily damaged.

Habitat quality: **Low**

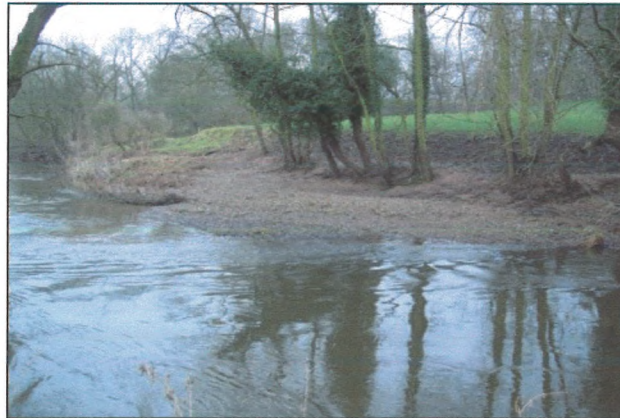
*Saltersford Hall 2 (6/2/05) D9*

Habitat summary: Heavily shaded medium sized bar dominated by pebbles, with sandy edges. Easy livestock access may cause heavy damage in the summer months, and this, together with the level of shading make it unsuitable for survey.

Habitat quality: **Medium**

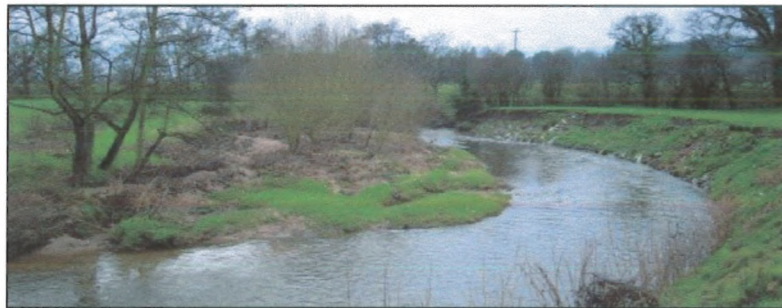
*Holmes Chapel 4 (6/2/05) D15*

Habitat summary: Large, heavily vegetated, partly shaded, complex sand bar, with a few small areas of pebbles. There is no public access to this site, and the bar will be protected from livestock damage to some degree by the willow vegetation and the bars' large size. Additional coarse rubble, which could act as an alternative habitat, can be found on the opposite bank. Surveyable, and good example of a large, almost purely sand bar.

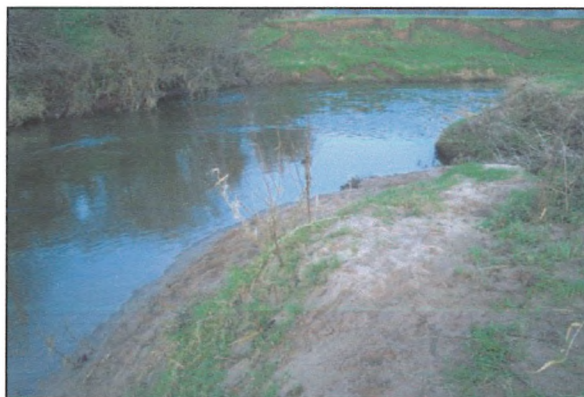
*Cotton Farm 2 (7/2/05) D17*

A medium sized, partly shaded, partly vegetated, sand bar, with some small areas of small pebbles. Cattle and anglers might cause significant levels of disturbance.

Habitat quality: **Medium**

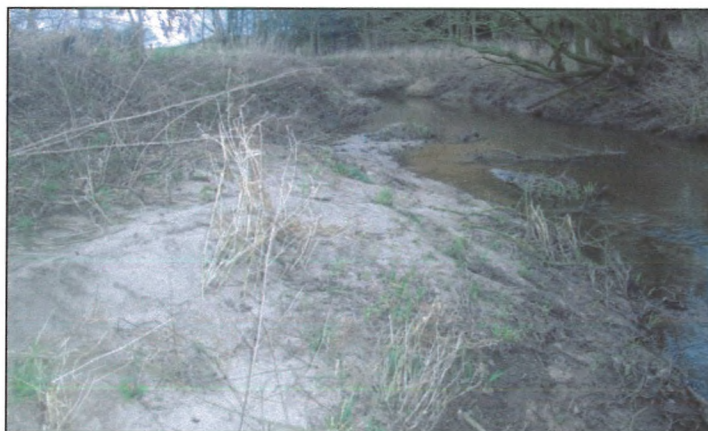
*Coole Hall 2 (4/2/05) W4*

Habitat summary: Shaded, quite open, small elevated area of mixed fine sediments, ranging from medium sands to silt. Small, dirty pool at the back of the bar. Protected from livestock damage by fencing. It will vegetate over to some extent, but some areas should remain open. In close proximity to small open grazed bar just upstream on the opposite bank.

Habitat quality: **Medium**

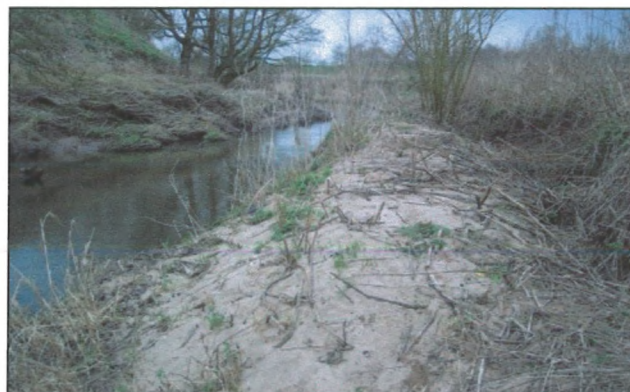
*Batherton Hall 4 (5/2/05) W13*

Habitat summary: Virtually unshaded, although quite highly vegetated, clean sand bar with silty areas. It will be untrampled, and has good quality, loose eroding banks for some distance on both sides. This is a very nice piece of habitat in the context of the rest of the river and adjoins nice wet-woodland habitat with a pond.

Habitat quality: **Medium**

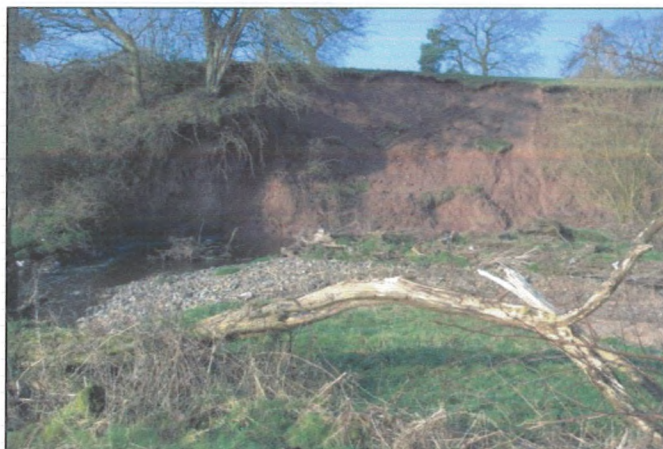
*Sewage Works 3 (8/2/05) B3*

Habitat summary: Quite large high quality complex point bar with little shading and vegetation cover, next to a 10m high loose eroding sand bank. Bar composed of a relatively even mix of cobbles, pebbles, gravel, and sand. Fenced on this side, but livestock access from the other. Access to livestock from other side, should not do huge amount of damage, but if they do this should be fenced. Very high invertebrate survey priority.

Habitat quality: **Very high**

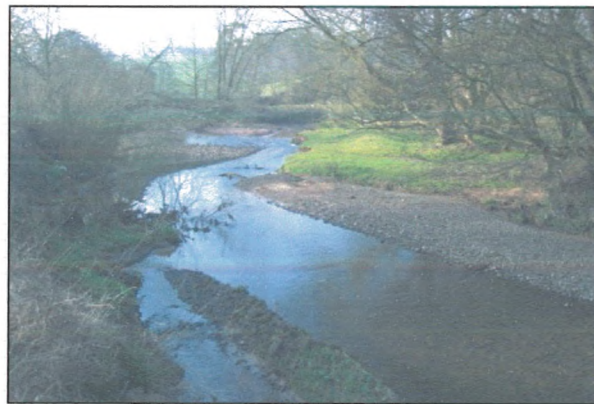
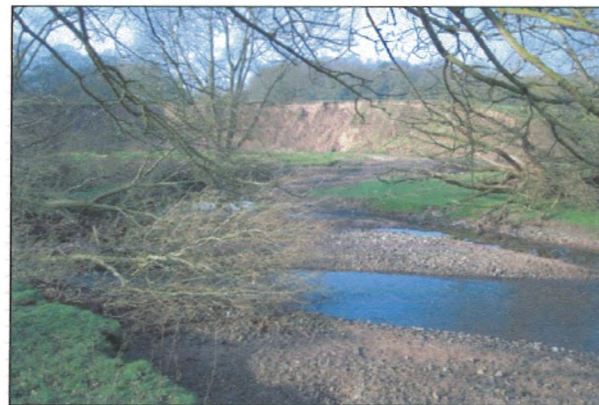
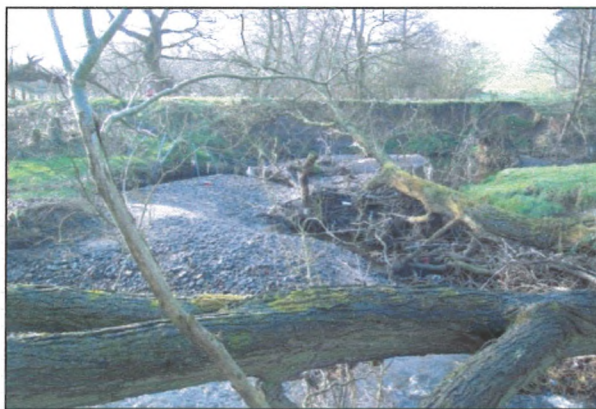
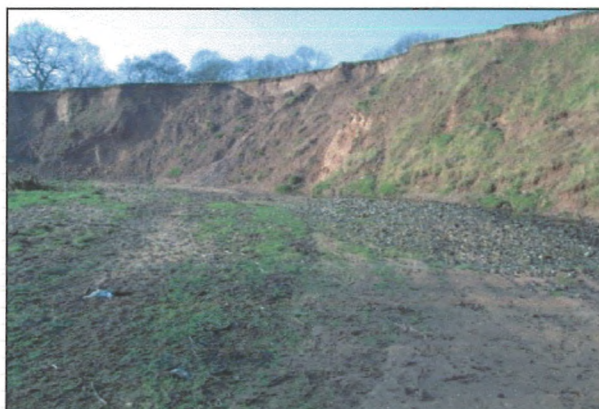
*Sewage Works 4 (8/2/05) B4*

large that it will be resistant to a lot of this damage, but if it gets severe this area should be fenced. There is a mix of shaded and open, and lightly vegetated and un-vegetated habitats. This site is of very high invertebrate survey priority, but would require a large amount of survey effort to sample completely.

Habitat quality: **Very high**

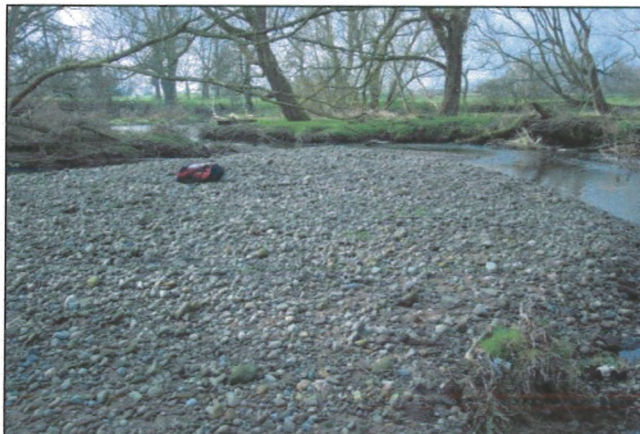
*Golf course 3 (8/2/05) B8*

Habitat summary: Medium sized, heavily shaded, un-vegetated, island bar, mainly composed of cobbles and pebbles but with small areas of gravel and sand. No livestock access from this side, and bar is coarse enough to resist trampling damage from livestock crossing the river.

Habitat quality: **High**

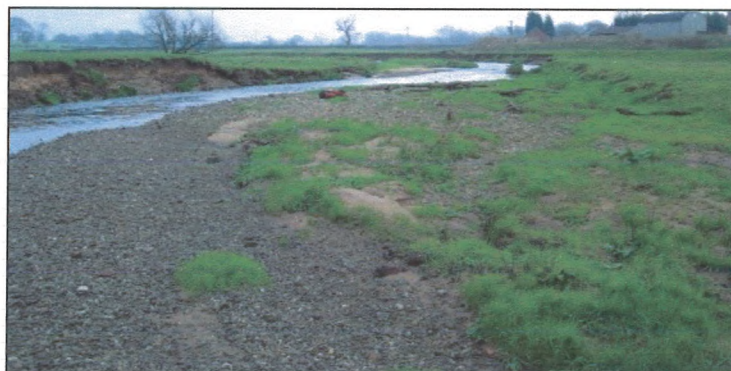
*Golf Course 4 (8/2/05) B9*

Habitat summary: Quite large, unshaded, barely vegetated, diverse point bar, in close proximity to several nice smaller bars and nice eroding banks, dominated by pebbles, but with significant areas of cobble, gravel and sand. Only weakness is the lack of fencing on both sides, there could be significant trampling damage.

Habitat quality: **High**

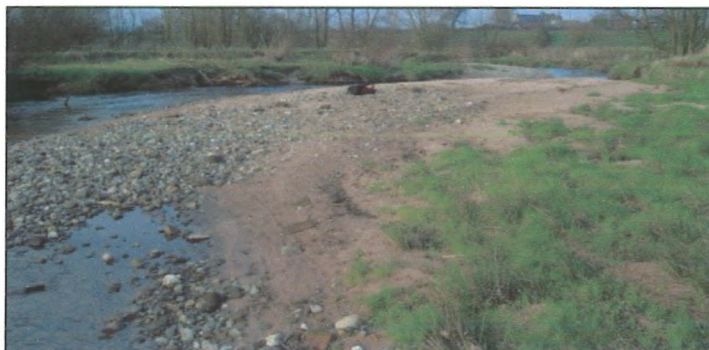
*Newton Hall 1 (8/2/05) B10*

Habitat summary: Quite large, high quality, un-shaded, un-vegetated, point bar in a large point bar complex, dominated by sand but with significant amounts of cobbles, pebbles and gravel. It is fenced on this side, but not on the opposite bank. However, the size of the bar and the low banks which make it easy for livestock to drink along the entire stretch will limit the amount of trampling damage. High invertebrate survey priority.

Habitat quality: **Very high**

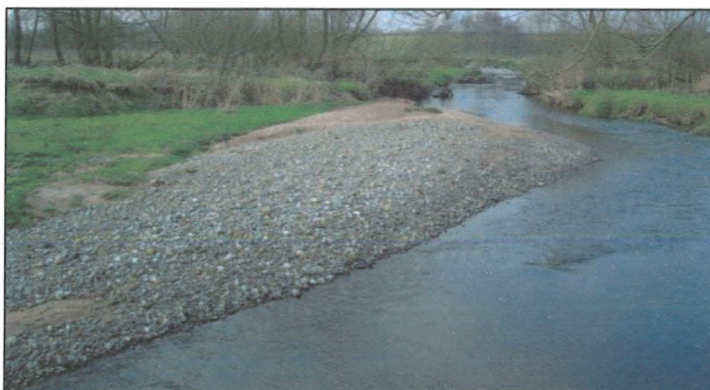
*Newton Hall 2 (8/2/05) B11*

Habitat summary: Quite large, virtually un-shaded, un-vegetated high-quality point bar, within a large high quality point bar complex, mainly composed of pebbles and sand, but with significant areas of gravel and cobbles. It is only partly fenced, however, the size of the bar and the low banks which make it easy for livestock to drink along the entire stretch will limit the amount of trampling damage. High invertebrate survey priority.

Habitat quality: **Very high**

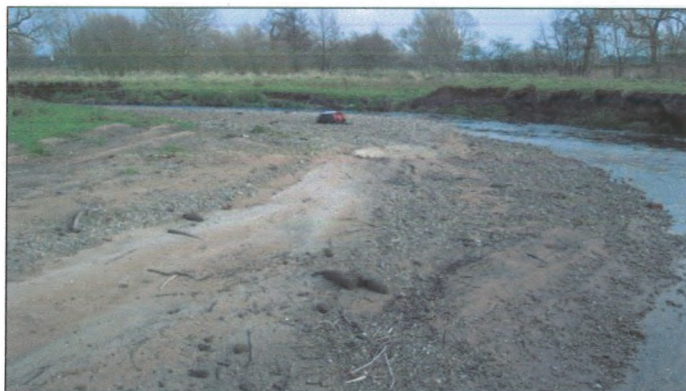
*Newton Hall 3 (8/2/05) B12*

Habitat summary: Another high quality, large, un-shaded, un-vegetated point bar, dominated by gravel but with significant areas of cobbles, pebbles, and sand. It is not fenced, but the size of the bar, and the easy access to water by livestock should limit the amount of trampling damage. There is also an almost identical bar downstream on the other side, which I did not survey. Both are high invertebrate survey priorities.

Habitat quality: **Very High**

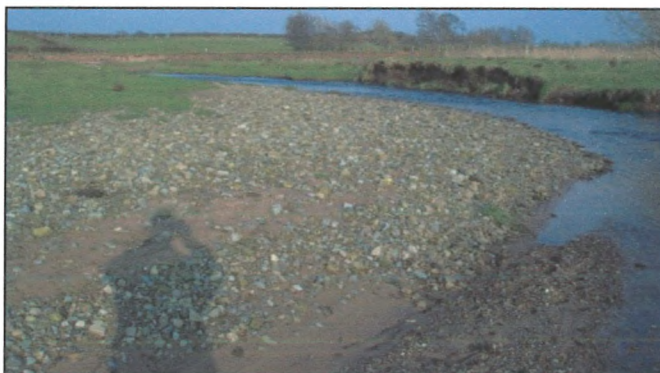
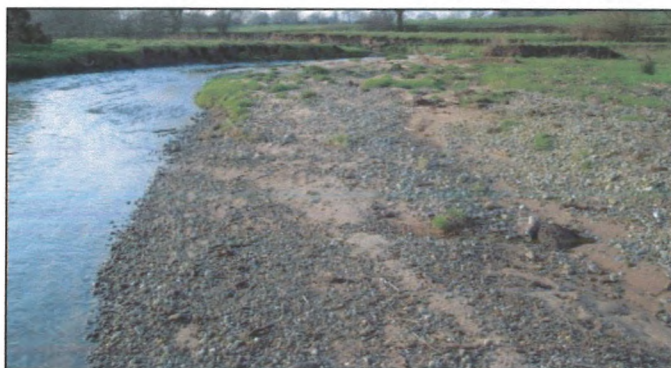
*Newton Hall 4 (8/2/05) B13*

Habitat summary: Very large, un-shaded, un-vegetated, high quality point bar in a high quality point bar complex, composed of a reasonably even mix of cobbles, pebbles, gravel and sand. The bar is open to livestock on both sides but trampling damage is likely to be light. Very high invertebrate survey priority.

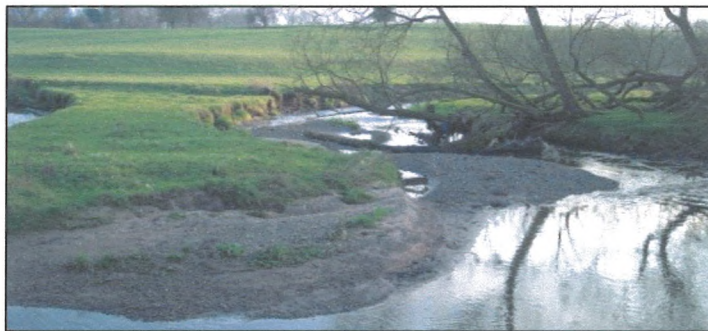
*Newton Hall 6 (8/2/05) B15*

Habitat summary: A small, complex, lightly shaded, open bar mainly composed of sand and gravel, with a significant amount of pebbles. This bar is unfenced and, given its small size and fine nature, could be heavily damaged by grazing

Habitat quality: **High**

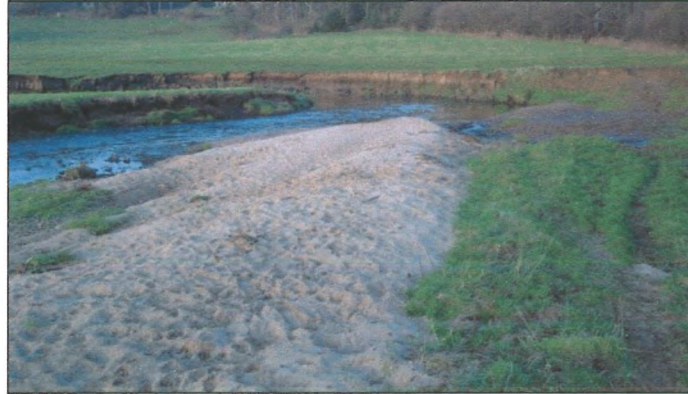
*Newton Hall 7 (8/2/05) B16*

Habitat summary: A medium sized, un-shaded, virtually un-vegetated bar dominated by sand, with areas of gravel and silt. An interesting feature of the bar is the small stream at its downstream end, which has deposited quite a large area of silt on the bar. This bar is however open to grazing and on a footpath close to Wilmslow, and has already suffered quite severe trampling damage so is probably unsuitable for survey.

Habitat quality: **Medium**

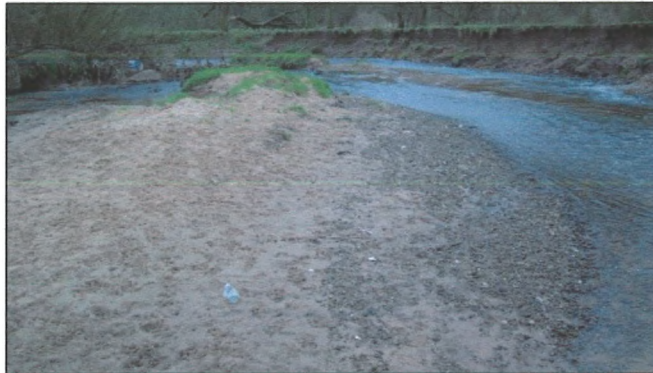
*The Carrs 2 (9/2/05) B18*

Habitat summary: A small, very lightly shaded, virtually un-vegetated mid-channel bar complex composed of sand and gravel. The high level of public disturbance and trampling make it impossible to sample using pitfalls, but this is still quite a nice area of habitat which would be likely to contain many of the small ERS specialist staphylinids if the level of trampling is not too high. The area has large areas of loose eroding banks in close proximity, and many more smaller, mid-channel bars of similar quality.

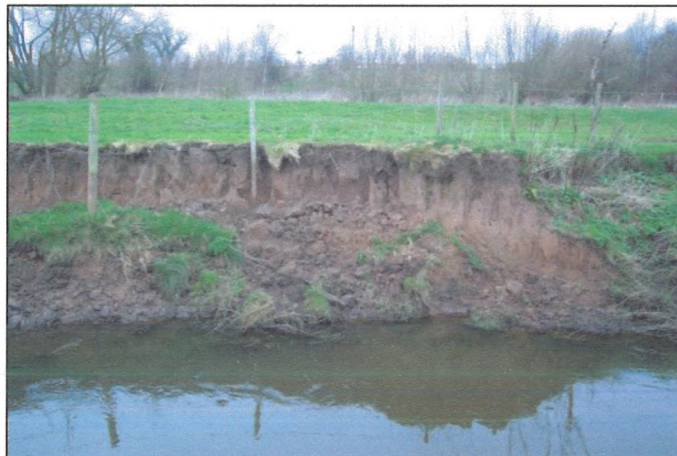
ERS quality is generally low along the river, with most of the open sediments only remaining so due to either trampling, or heavy shading. Only five patches (W4, W13, W15, W16 and W17) were classified as of medium quality, and probably then only just. Of these, W15 and W17 are mainly sections of eroding bank and would be difficult to sample due to livestock interference. It is unlikely that there are any better quality sediments in other sections of the river; all additional areas of ERS are likely to be of similar quality to those surveyed. Most of the upper section surveyed was characterised by a large number of very old alders, many of which are now dying, these possibly represent important resources for saproxylic invertebrates, and contribute large amounts of large woody debris to the river, which collected as log jams in some areas. The section of river owned by Batherton Hall (W10-13) runs through a recently planted area of mixed woodland and marshy/pond land. This section thus provides the greatest potential to capture non-ERS specialist invertebrates of conservation importance and also has the best examples of loose, undisturbed eroding banks surveyed (see photo above).
