River Leith Fluvial Audit

FINAL PROJECT REPORT

RIVER LEITH GEOMORPHOLOGICAL/ RHS DATA COLLECTION

Report Date: December 1998

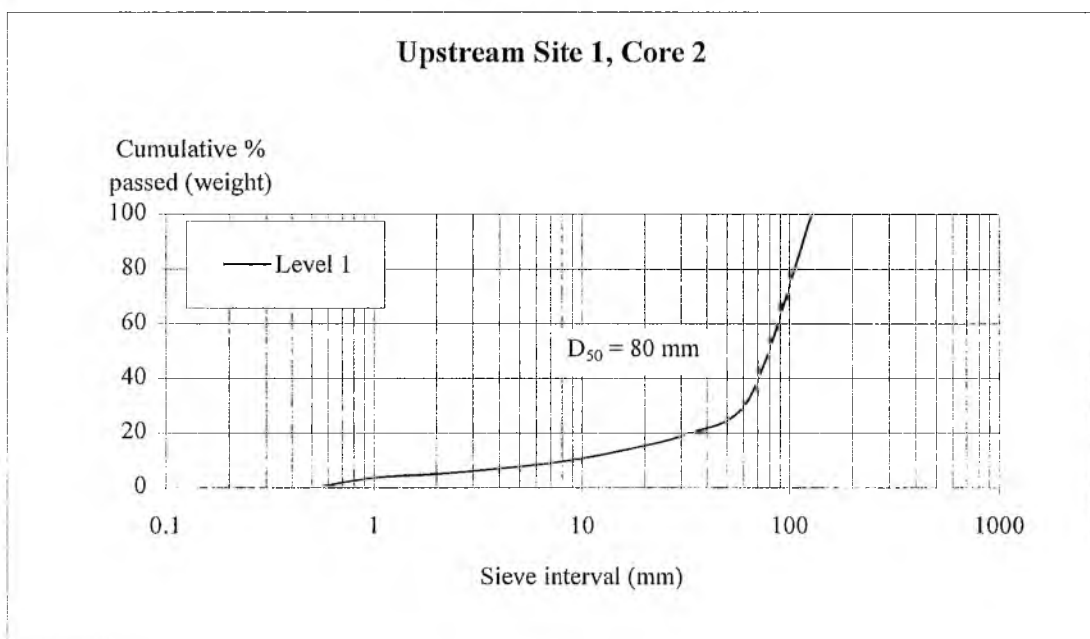
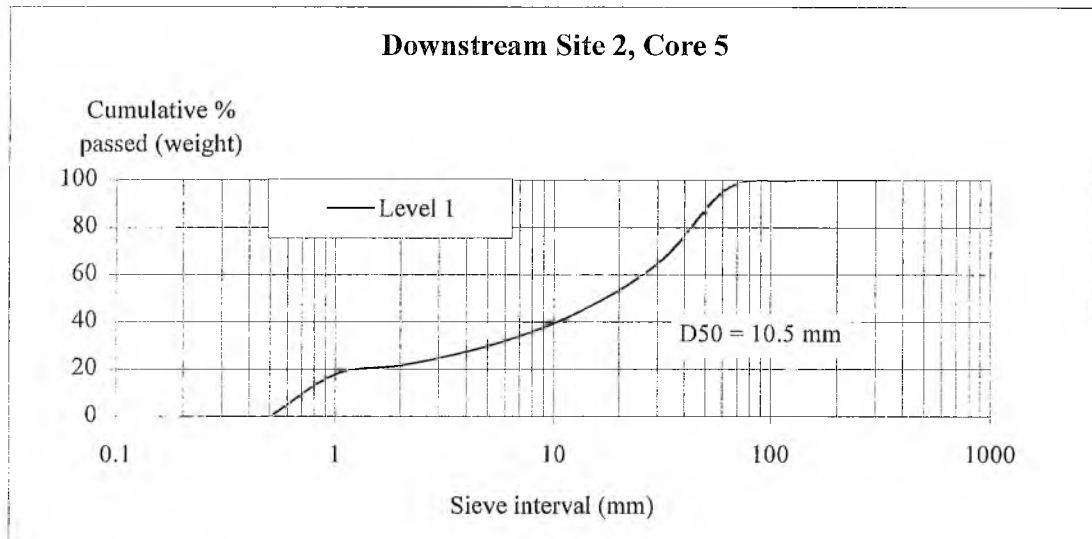
The relative importance of fine material in the gravel matrix can be expressed as a percentage of material less than 1 mm in diameter, known to be detrimental to fish, these figures are listed in the results tables. It is also clear that the fine material dominates in another way as shown in the grain size accumulation curves presented below for all cores from each site.

Grain size accumulation curves can be used to read off values of D₅₀ and D₈₄ etc. for further analysis. Clearly the fine sediment fraction dominates the grain size distribution at site two however the distribution at site one is also slightly bimodal. For further information on grain size distributions see: Carling and Reader (1982), Crisp and Carling (1989) and Kondolf (1992).

For comparative purposes, a table of the percentages of fines (< 1 mm) from other spawning gravels in the UK is presented in Table 2. The River Leith compares well with the Hampshire Chalk rivers which were known to be suffering the impacts of siltation and compaction at the time of the survey.

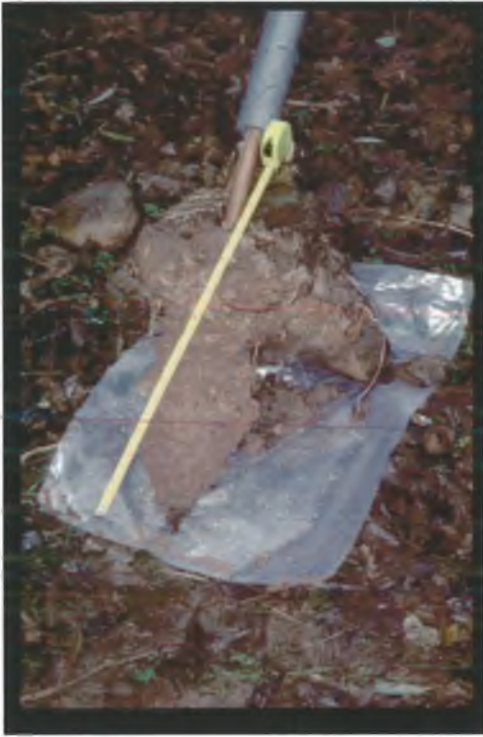
Core 1

Core 1: The total core length of 49cm is divided into three sections. The upper two levels representing the fluvial sediments and the final section being underlying till. The upper 8cm (level 1) consisting of cobbles, large pebbles and finer gravels with a population of finer sand and silt. The next 12cm (level 2) contains mainly small gravels, with the exception of one single large cobble, contained within a matrix of fine brown sand and silt. The bottom 39cm (level 3) appears to be a typical unsorted mix of material consistent with the local glacially derived tills.

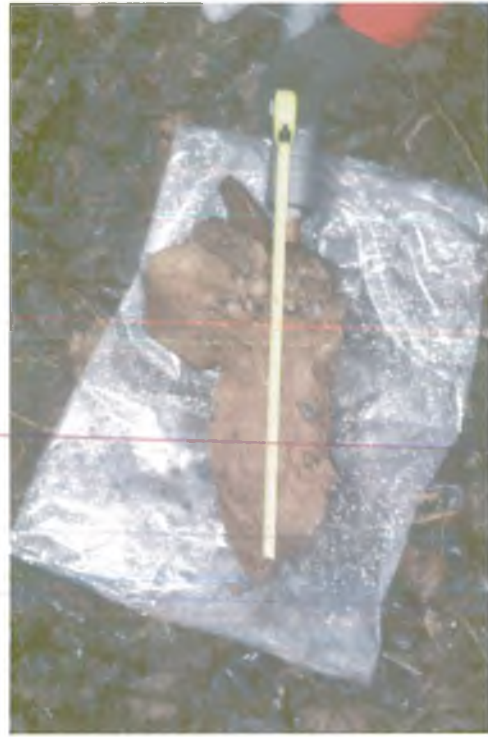
Core 2

Core 2: Total core length 41cm divided into two sections, the upper being fluvial sediment lying on top of an underlying till level. The upper 11cm (level 1) containing small pebbles within a matrix of fine brown sand and silt. The lower 30cm of the core (level 2) again is a typical unsorted mix of material consistent with the local glacially derived tills.

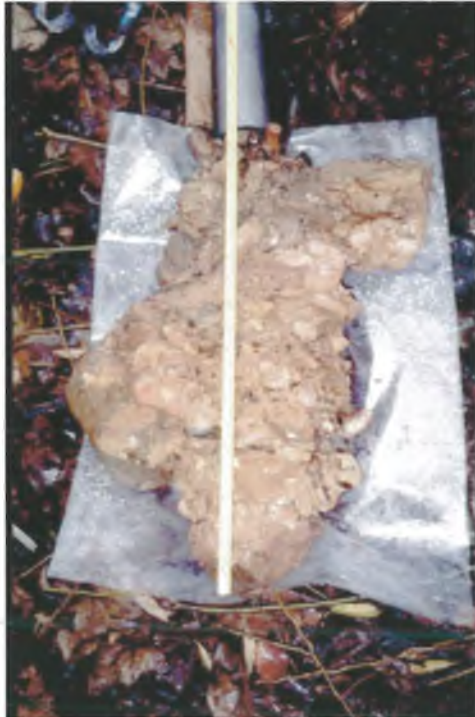
Core 3

Core 3: Total core length 53cm with three distinct layers, two levels of fluvially derived material with a basal level of till. The upper 16cm (level 1) contained a few larger pebbles with a greater number of smaller pebbles contained within a fine matrix of brown sand and clay. The middle section 31 cm (level 2) again contained pebbles of varying size but the finer matrix of sand and silt was redder in colour. The basal layer of 6cm (level 3) once again is a typical unsorted mix of material consistent with the local glacially derived tills.

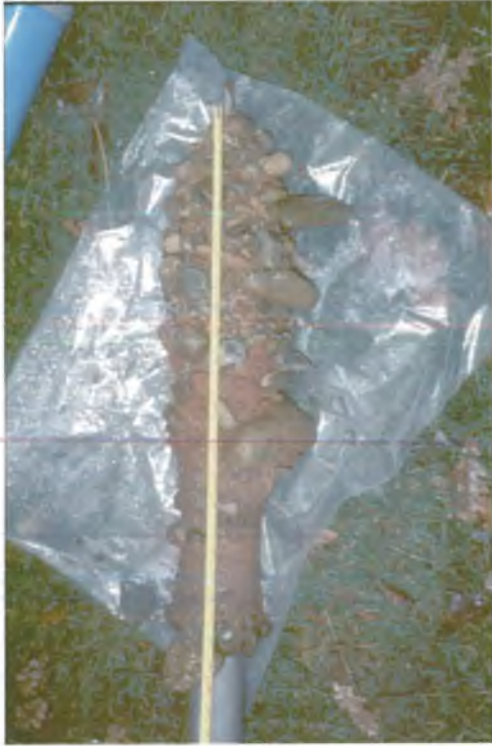
Core 4

Core 4: Total core length 59cm with four layers. The upper 5 cm (level 1) contained small gravels within a dense matrix of dark brown sand and silt. The second 12cm (level 2) contained only small gravel within a very dense matrix of red and dark brown sand and silt. The third section 30cm (level 3) again contained smaller gravel along with larger clasts of locally derived sandstone all within a dense matrix of red sand and silt. The lower section 12cm (level 4) contained gravel within a light brown matrix. All levels appear to contain fluvially derived material.

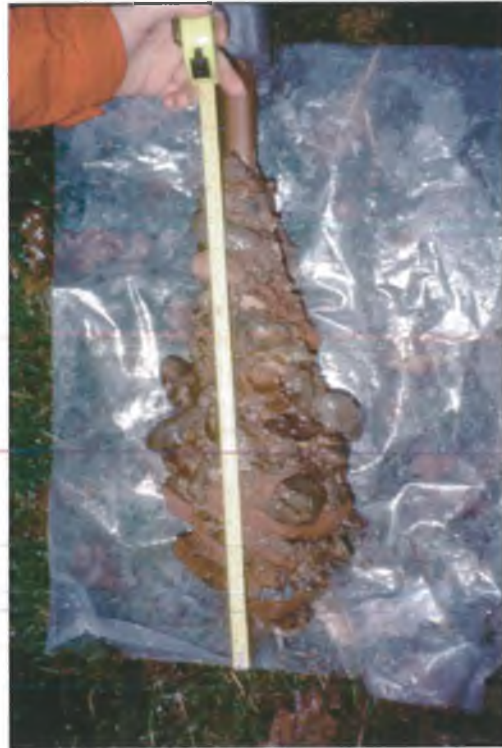
Core 5

Core 5: Total core length 42cm in one single unit consisting of a mix of fluvially worked gravel and angular sandstone clasts with a matrix of red sand and silt.

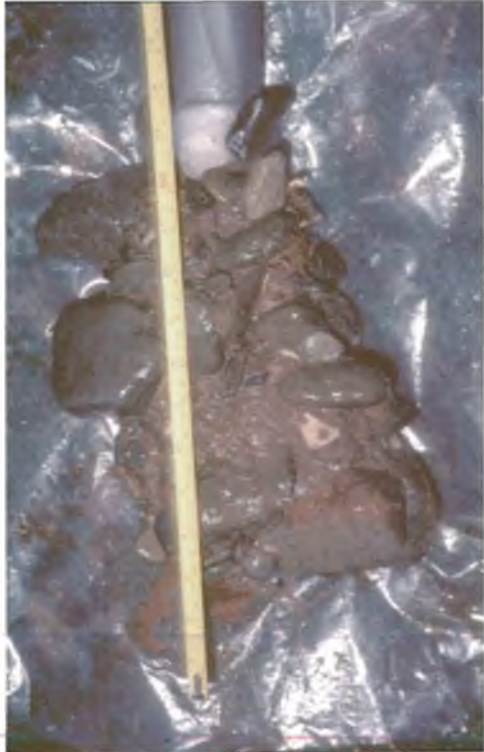
Core 6

Core 6: Total core length 32cm in two sections. The upper 28cm (level 1) contained fluvially derived material consisting of gravel within a fine matrix of red sand and silt. The basal layer of 4cm (level 2) appears to be sandstone bedrock detached in the freeze coring process.
