University of Southern Queensland
Faculty of Engineering and Surveying

Traffic Induced Moisture Entry Into Road Pavements

A dissertation submitted by

Bachelor of Engineering (Civil)

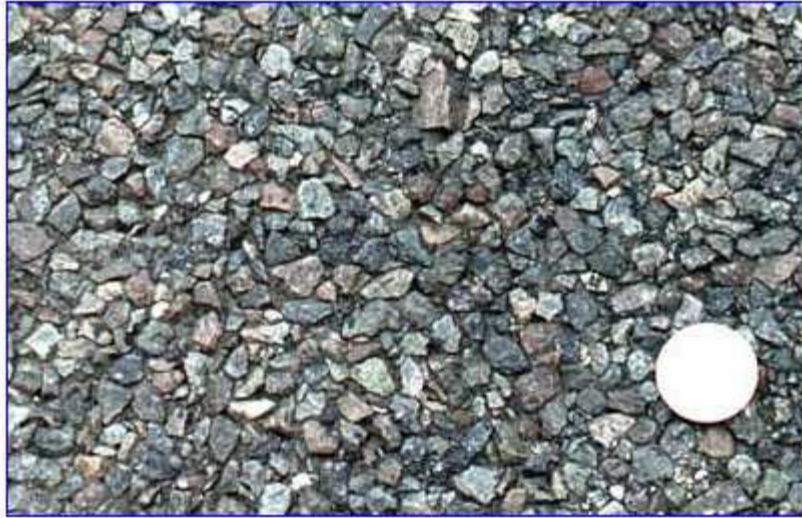
(3) Figure 2.5.1 – Typical 10mm chip seal surface

Chip seals are used for restoring skid resistance, protecting a surface from ageing, restoring a running surface, eliminating dust, and sealing gravel pavements (re-seals). Different stone sizes are used for different surface textures and different traffic situations. The aggregate size is usually sand, 7mm, 10mm, 14mm, 20mm or 25mm. (Austroads,2004)

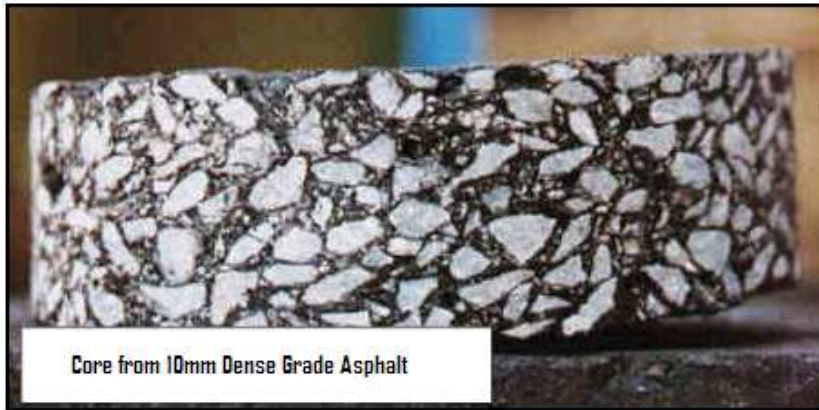
(4) Figure 2.4.1 – Core sample of dense graded asphalt

A core of 10mm dense graded asphalt (Figure 2.4.1) is shown below as well as a cross section (Figure 2.4.2).

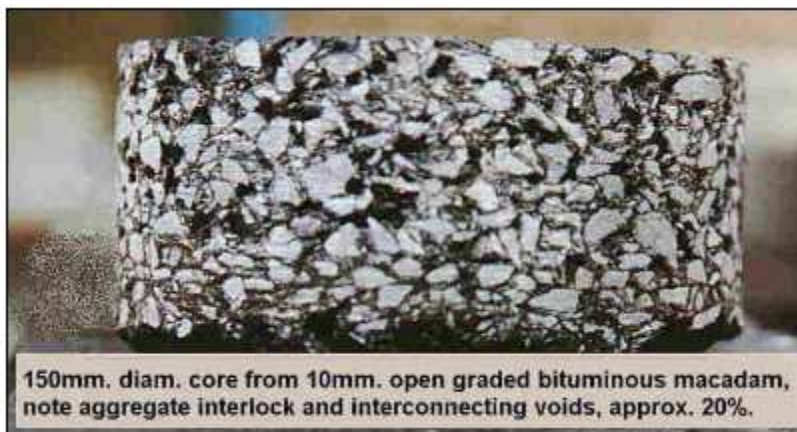
(6) Figure 2.3.1 – Core sample of open graded asphalt

As seen above, there are approximately 20% air voids allowing the force of the water to disperse through the layers and reach the impermeable seal at the bottom of the OGA.

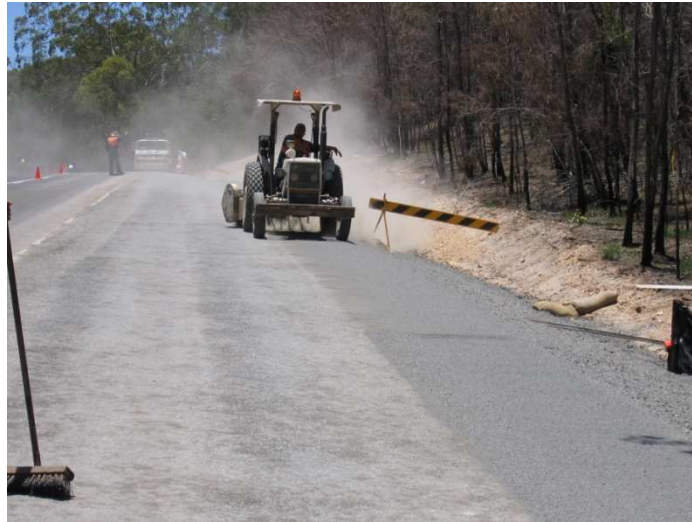
(8) Figure 2.3.1.1 – Sweeping the surface in preparation for spraying bitumen

If the pavement surface is too dry, the bitumen will not coat the surface evenly. A light coat of water from a water truck will wet the road surface allowing the bitumen to bond to the road surface properly. (Nichols, 1998)

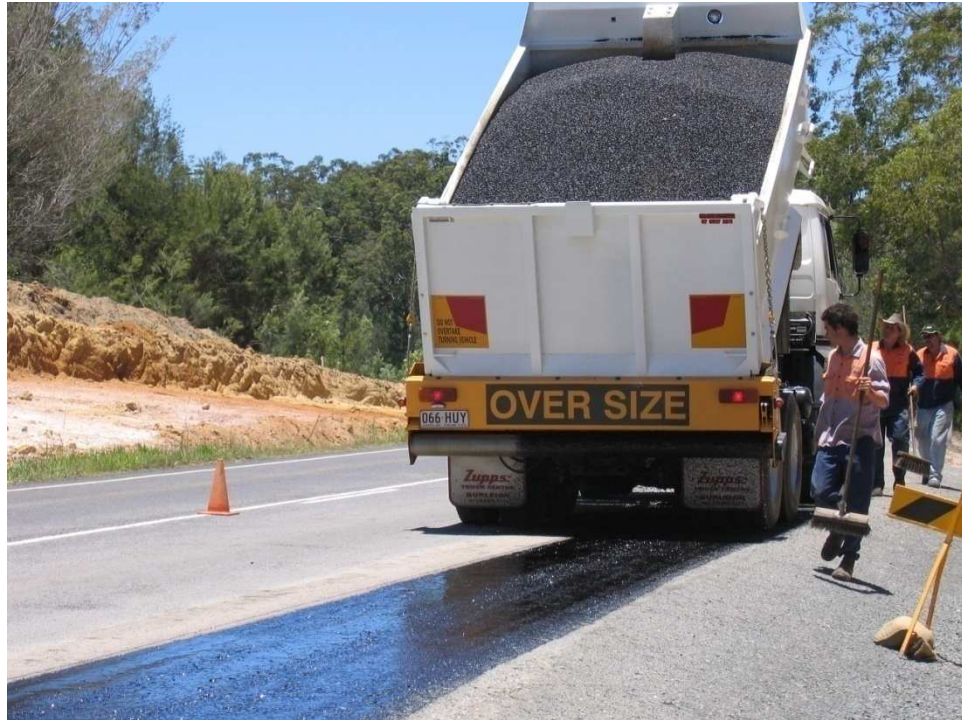
(9) Figure 2.3.2.1 – Aggregate spreading onto sprayed bitumen

Rolling is to commence as soon as possible after the aggregate spreading, paying special attention to the number of roller passes. Rolling is to continue until the aggregate has properly bonded. The traffic is then allowed to drive over the new surface at low speeds until the loose stones have been removed by sweeping the road surface. (Austroads 2004)

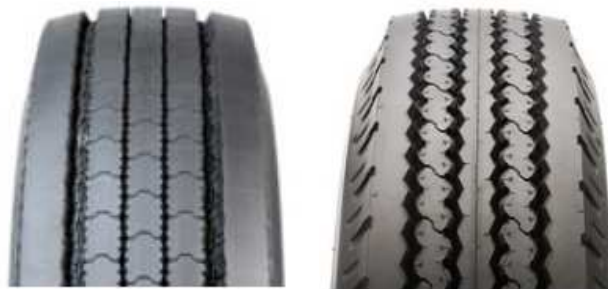
There are many different types of tread for all types of vehicles. After a brief analysis comparing the tread on trucks tyres and car tyres, it can be assumed that truck tyres do not disperse water as well as car tyres due to different tread configurations, as shown below.

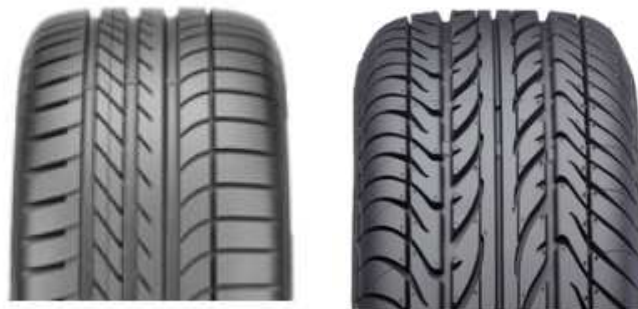
Below are typical passenger tyres:

Tyre A

Tyre B

- Active Corner grip Technology
- Superior driving performance on straight roads and on cornering. Impressive wet handling and reduced risk of aquaplaning.
- Racing compound Technology
- Excellent grip performance in wet and dry conditions.
- Asymmetric tread design
- Delivers superior control and comfort for a quiet and secure ride.

- Silica based tread compound
- Superior braking, cornering and handling in wet and dry conditions. Also reduces rolling resistance, which can enhance fuel economy.
- Low noise generation pattern
- Promotes a quieter and smoother ride
- Circumferential grooves
- Disperses water to reduce the risk of losing control in wet conditions.

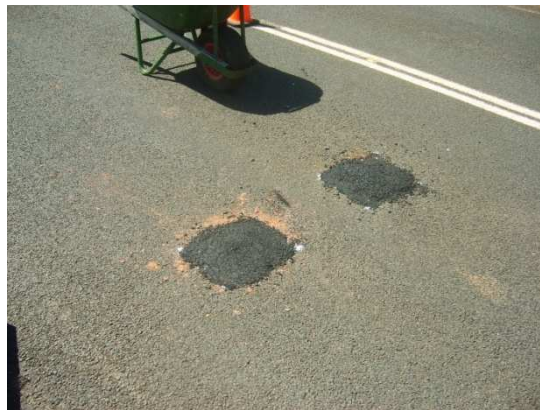
(15) Figure 3.3.4.2 – After samples have been taken

All loose material was removed from the sample hole. Using the wheelbarrow and shovel, the cold mix was then placed into the sample hole and compacted with the crow bar, making sure the cold mix was heaped above the hole to account for further compaction by traffic.

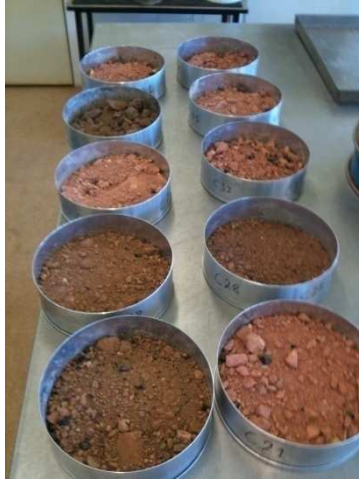
(16) 3.3.4.1 – Samples placed in specimen containers

QDTMR laboratory permitted use of their equipment to test the moisture content of the samples. The samples were taken into the laboratory and placed into specimen containers as shown in Figure 3.3.4.1 below.

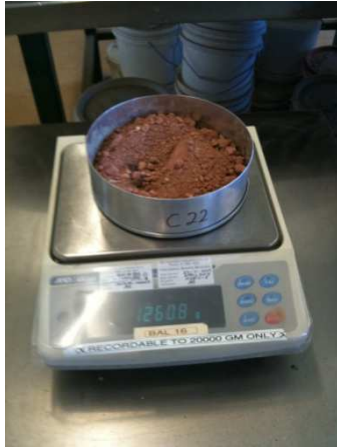
(17) Figure 3.3.4.2 – Weighing the specimens

After the wet specimen was placed in the specimen container, it was then weighed to find the mass of the wet soil as shown in Figure 3.3.4.2. The specimen was then placed in a drying oven at 100°C (Figure 3.3.4.3) for a period of approximately 24 hours.

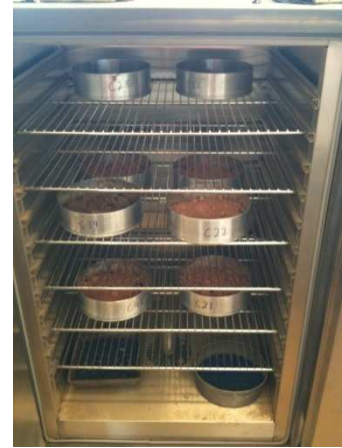
(18) Figure 3.3.4.3 – Specimens placed in oven

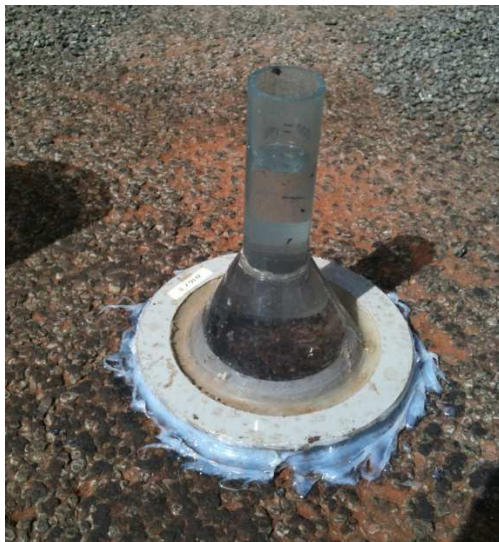
(24) Figure 3.5.3.1 – Even-flow Permeameter

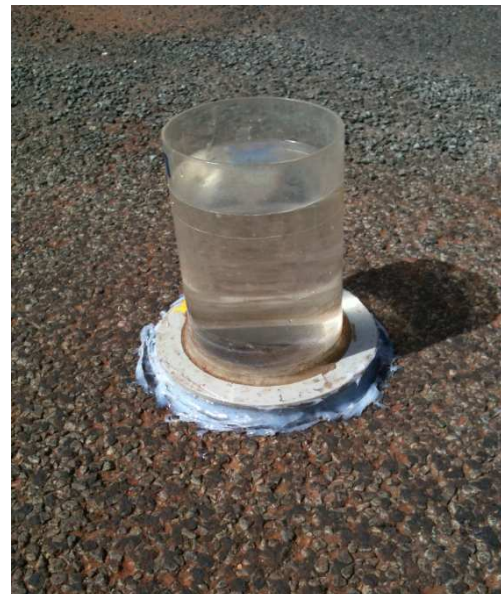
(25) Figure 3.5.3.2 – Rapid-flow permeameter

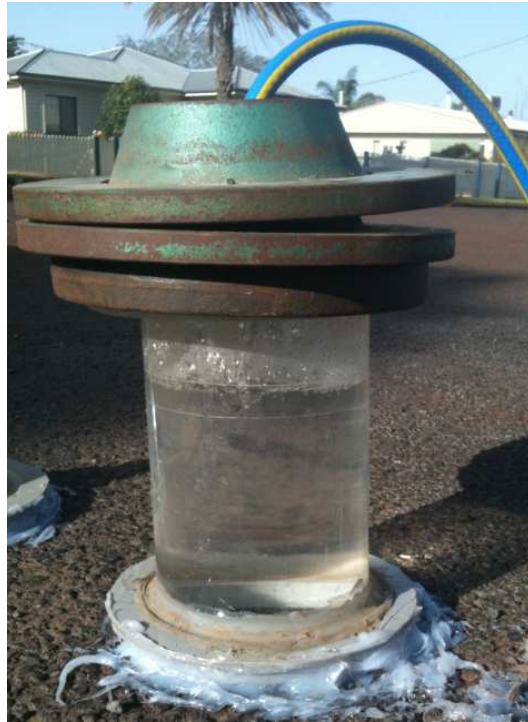
(26) Figure 3.5.4.1 – Permeameter under pressure

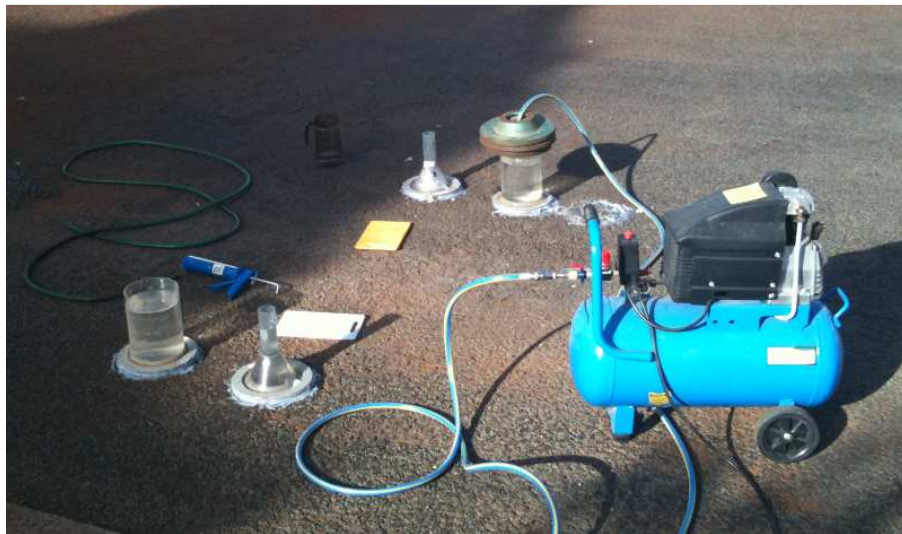
(27) Figure 3.5.4.2 – Pressurised testing in process

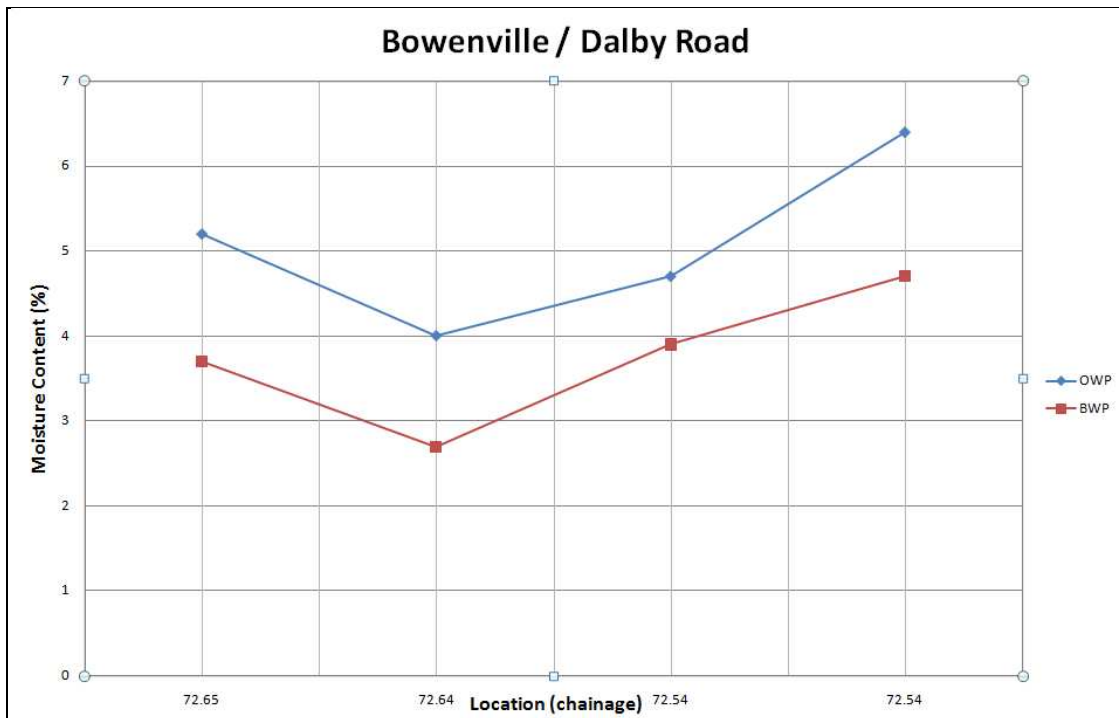
(31) Figure 4.1.2.2 – Bowenville / Dalby Road (Warrego Highway)

Figure 4.1.2.2 clearly shows that the M/C in the OWP is significantly higher than BWP. Between the four locations there is approximately 1% difference in M/C's. There is a good chance that the difference in M/C's is due to the long rain event that occurred in November and December prior to the samples being taken. As the shoulders at this location are not completely sealed, there is a chance that this moisture difference could be due to infiltration through the shoulder. As this is a highly trafficked road with a large number of heavy vehicles, traffic may have assisted in the high moisture readings.

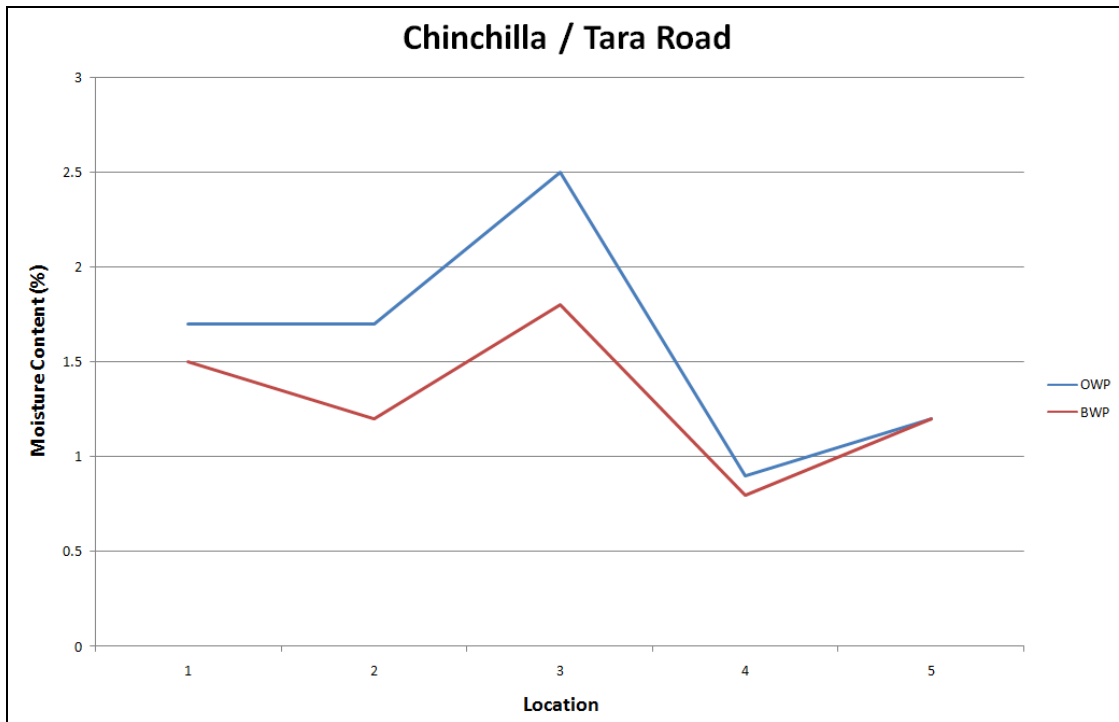
(42) Figure 4.2.2.3 – Chinchilla / Tara Road

Figure 4.2.2.3 shows that the M/C is very low with an OWP average of 1.6% and an IWP average of 1.3%. The recent dry weather may be a reason for the low M/C data. It is clear that the OWP has higher M/C than the IWP. As the shoulders are not sealed infiltration may have occurred during the last rain event, however traffic may have contributed to this moisture difference as well.

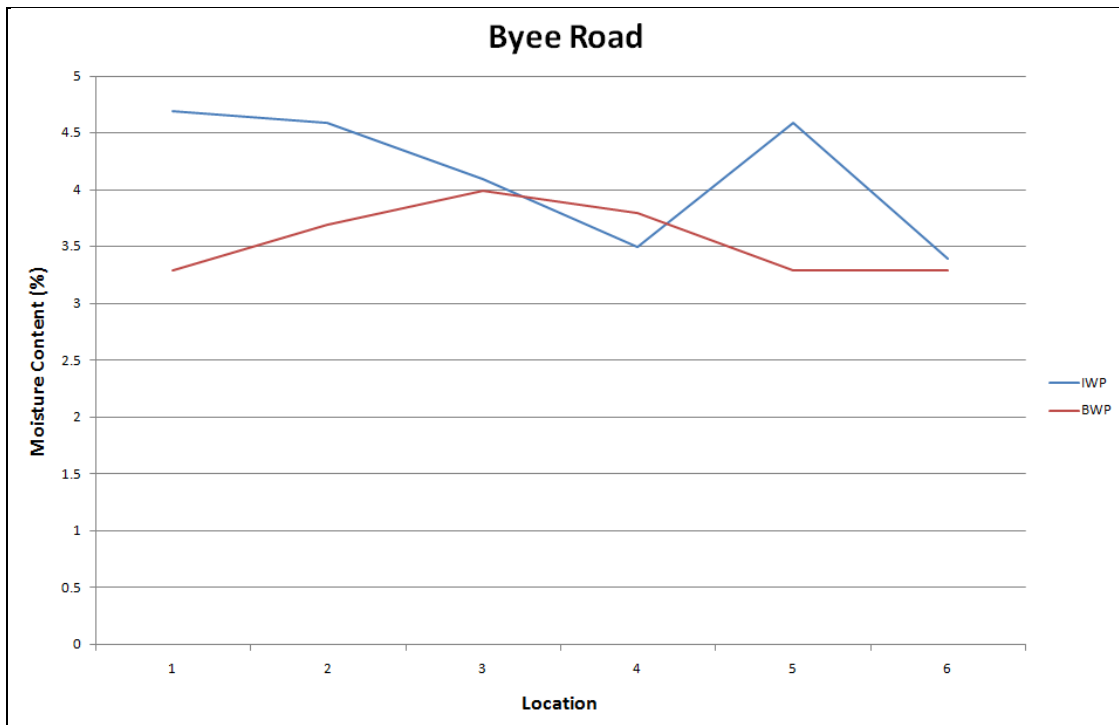
(44) Figure 4.2.3.2 – Byee Road

The test results in Figure 4.2.3.2 show that the IWP has higher M/C than BWP. There is an overlap in some areas showing that the recent dry weather may have an effect on the moisture conditions within the pavement. Overall it is clear that the IWP has higher M/C than BWP. The average IPW compared to the average BWP is IWP=4.15% and BWP=3.6%.

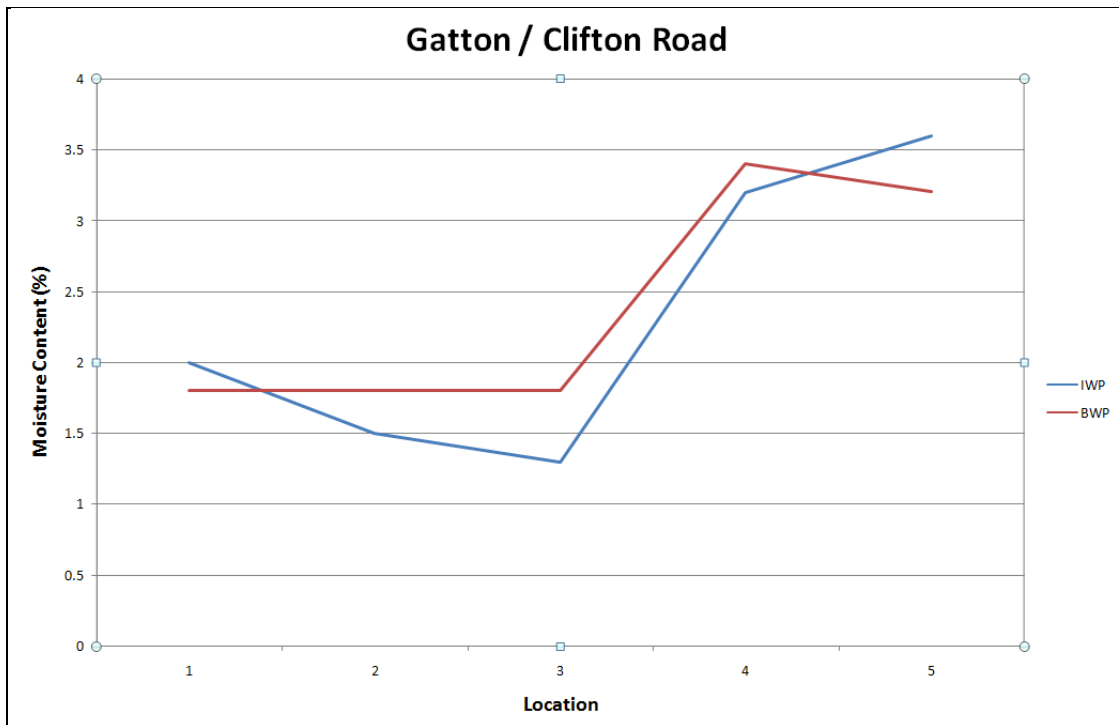
(47) Figure 4.1.4.3 – Gatton / Clifton Road

Samples were taken at the OWP, IWP and BWP as shown in Figures 4.1.4.3 and 4.1.4.4. Figure 4.1.4.3 shows a comparison between IWP and BWP at various locations. It can clearly be seen that location four, is significantly higher than locations one, two and three. This indicates the change in road type from old to new gives a direct comparison between seal thicknesses and M/C's. The soil types do differ between these locations which may also have an effect on the M/C. For locations one, two and three the M/C in the IWP is lower than BWP indicating that the dry weather and thickness of the seal have a direct relationship with M/C.
