University of Southern Queensland
Faculty of Engineering and Surveying

Effective Road Pavement Design for Expansive Soils in Ipswich

Bachelor of Engineering (Civil)

Submitted: November, 2010

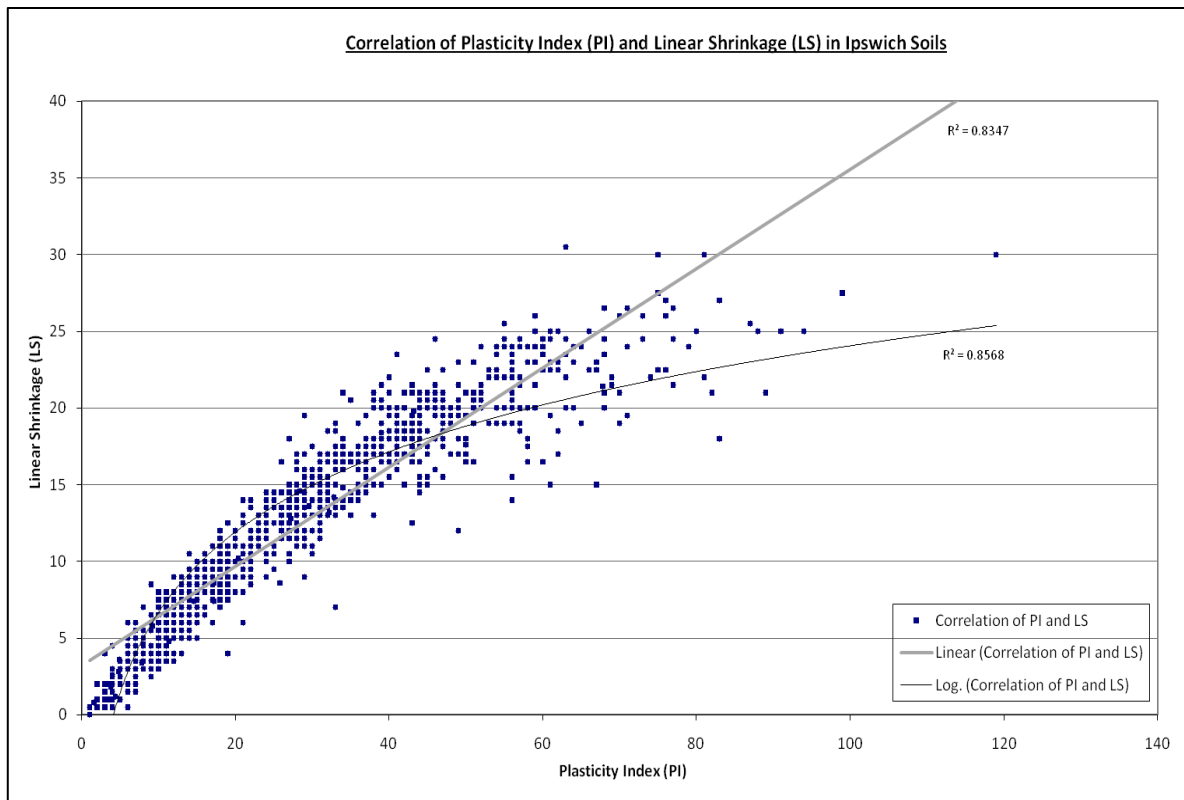
Figure 4.6 Correlation of PI and LS for Ipswich subgrade soils

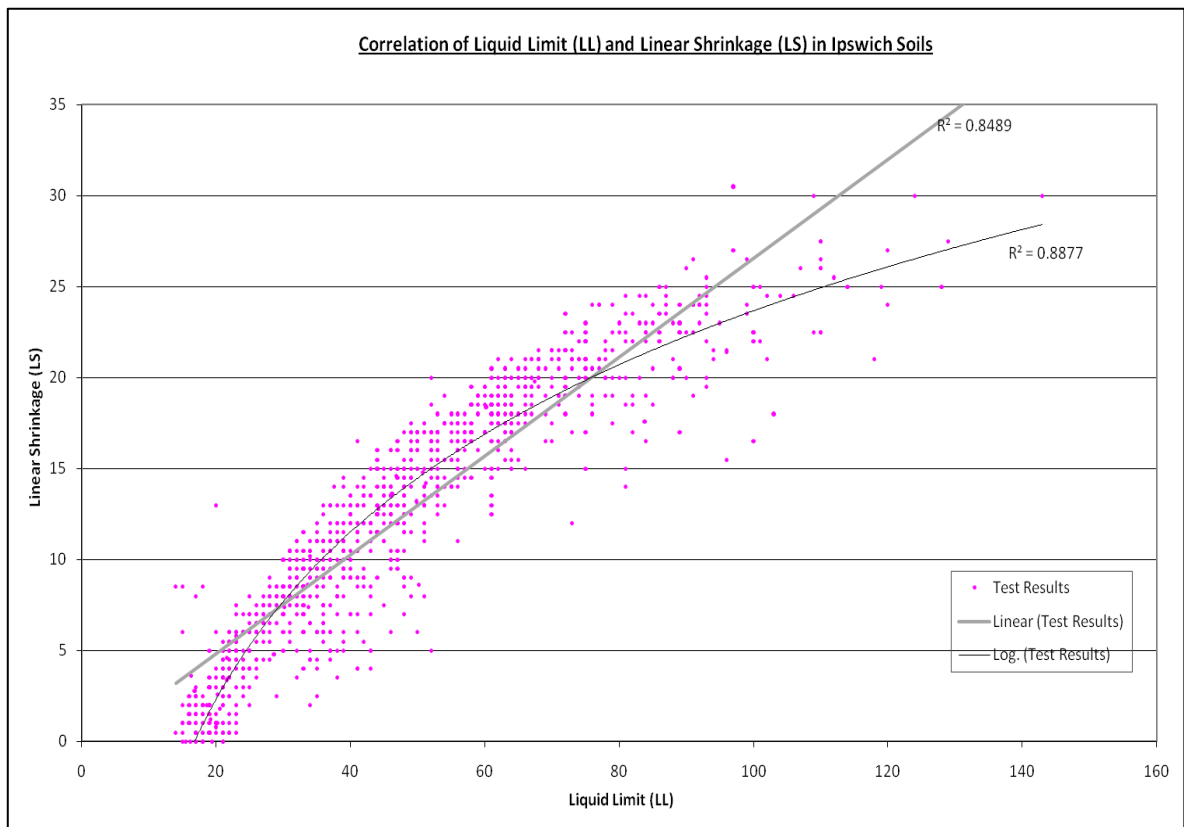
Figure 4.7 Correlation of LL and LS for Ipswich subgrade soils

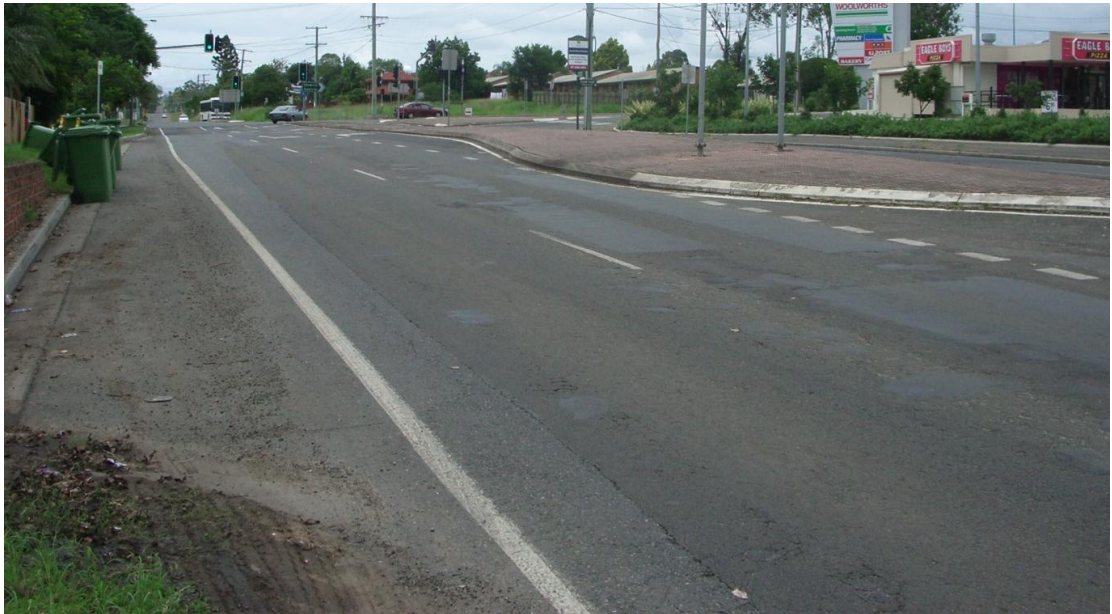
Figure 5.3 Pavement failures at Redbank Plains Rd, Redbank Plains

Redbank Plains Road had become a major sub-arterial road connecting the older areas of Goodna and the heart of Ipswich with the relatively newer areas of Springfield (seen in Figures 5.3 and 5.4). The traffic volumes experienced on this road today are a far cry from those ever projected when the road was first constructed. Over the years there have been numerous upgrades and a variety of rehabilitation undertaken in an effort to provide for current traffic volumes. Testing of this road found that the subgrade conditions varied from being at optimum moisture (OMC) to half of OMC and from soaked CBR of 0.6 to 19. According to Austroads (2009), crocodile cracking and rutting are more indicative of structural deficiencies rather than the subgrade behaviour.

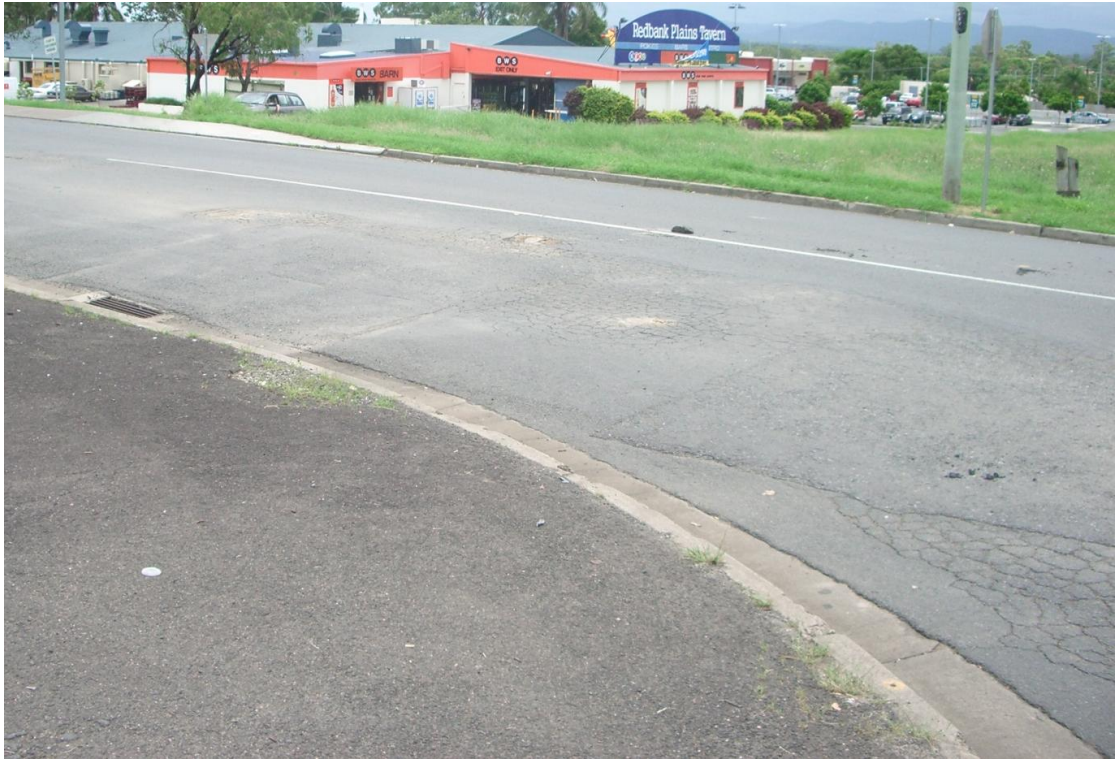
Figure 5.4 Severe crocodile cracking and rutting on Redbank Plains Rd, Redbank Plains

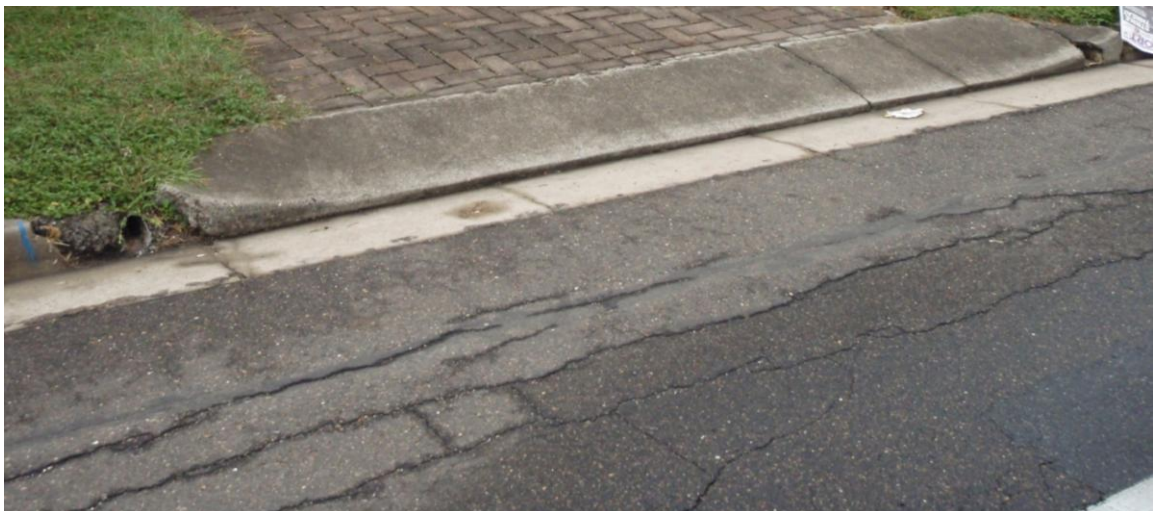
The longitudinal cracks coincide with the outer wheel paths where rutting has occurred. This demonstrates a wide spread inability of the base materials and subgrade to support the loads. Austroads (2009) state that the moisture changes in an expansive subgrade manifest as longitudinal cracks usually 1 to 2m from the edge of the pavement. Asphalt fatigue has become apparent followed by moisture ingress, leading to further swell-shrink behaviour.

Figure 5.5 Longitudinal cracking and rutting on Whitehill Road, Raceview

Whitehill Road is situated in a residential area, though experiences significant heavy vehicle movements as it is a trunk collector. A large portion of the road is low-lying and experiences drainage issues. The subgrade consists of black clay with a very low CBR, classified as CH. The surface consists of asphalt, varying in thickness, overlying a variety of gravel including cement treated. The ICC Laboratory Manager explains that this road had been cement treated several times in the past but the treatments have only lasted 10-15 years, after which time the concentration of lime in the pavement has diminished. As seen in figure 5.5, the pavement shows significant rutting, longitudinal cracking and crown heave and the subgrade is very moist with poor bearing strength.

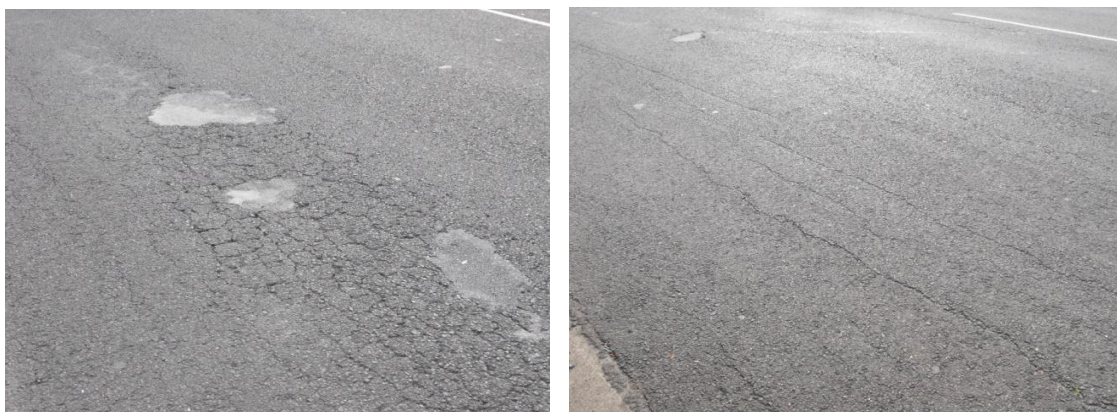
Figures 5.6 & 5.7 Robertson Road pavement failures

This sub-arterial road, constructed in the 1960's, experiences traffic of approximately 2×10^6 ESA's. In 1994 and 1995 (and some sections as recent as 2009) the surface had been overlaid with asphalt. Currently the pavement appears distorted and undulating with numerous types of cracking across the surface (seen in Figures 5.6 and 5.7). Current asphalt surfacing varies between 30mm and 180mm (deeplift) and the pavement consists of unbound materials of average thickness 295mm. The highly plastic subgrade appears to have contributed greatly to the failures observed. The pavement depths in total do not appear to be satisfactory for the given traffic volumes.

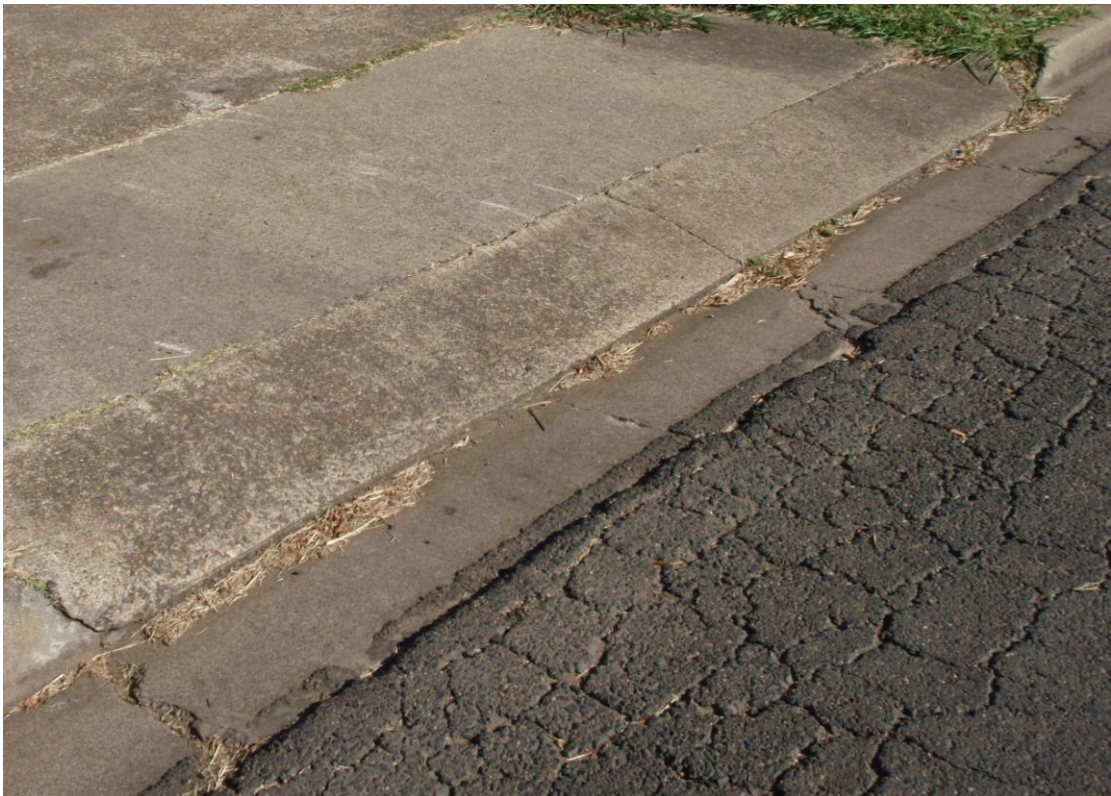
South Station Road is a sub-arterial road spanning several suburbs of Ipswich. The pavement has considerable cracking and loss of formation as seen in the representative section in figure 5.8. The existing pavement consists of 70-90mm of asphalt over 240-280mm of crushed soil aggregate with a soaked CBR 74. At some point there has been a fly-ash blend added to the aggregate to improve strength. The subgrade consists of CI soil overlying black CH soil. Deformation and failure appear to be due to the inadequate drainage and subgrade movement.

Figure 5.8 Crocodile cracking and kerb and channel deformation on South Station Rd

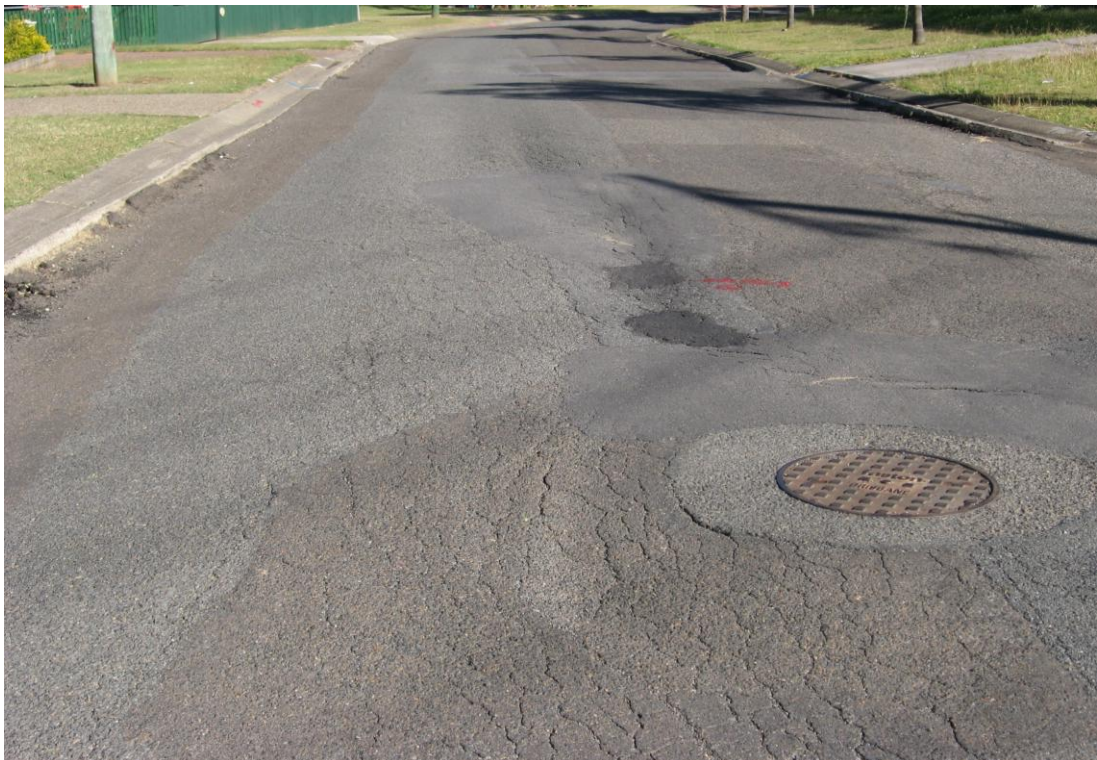
Josey Street is a local access road that has a low traffic volume servicing areas of Redbank Plains and is a bus route. The pavement as seen in Figure 5.9 was constructed in 1983 and is approximately 7.1m wide. There is layback kerb with channeling at the edges and stormwater (as seen by the manhole) down the centre of the road. The existing pavement predominantly consists of 30-45mm of asphalt surfacing over an average 210mm of poorly graded gravel with a CBR52. It appears the kerb and channel is sitting on approximately 100mm of lean-mix. The subgrade is a medium to high plasticity CH soil with an estimated CBR1 - CBR7 and a soaked CBR 2.5. There were differential moistures throughout the pavement subgrade.

The seal has failed and there is considerable longitudinal and crazing cracking and pavement distortion. It seems there is differential settlement particularly around the manhole and underground services within the pavement area. Cracks between the lean-mix concrete and the unbound pavement have allowed moisture ingress.

Figure 5.9 Josey Rd pavement condition

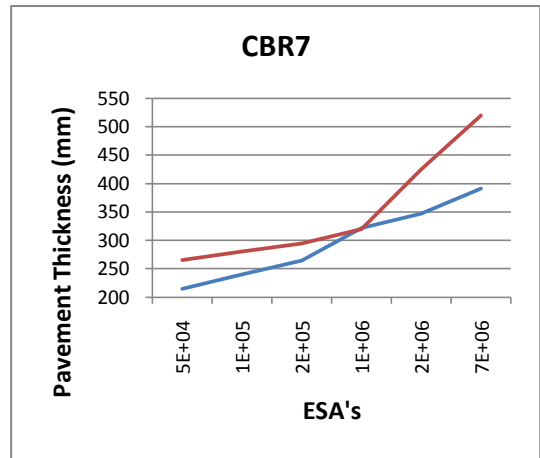
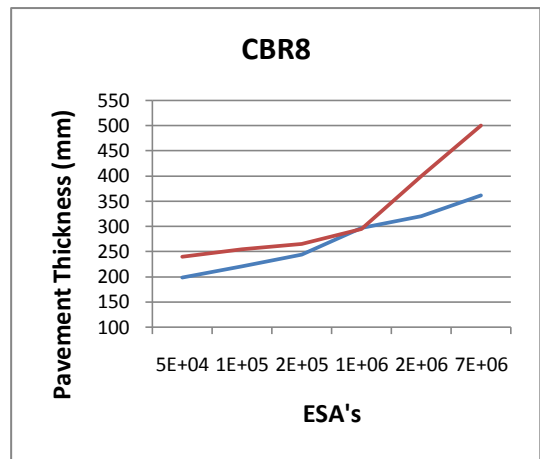
Figure 8.5 Comparison graphs of minimum thickness for flexible pavements between the Ipswich City Council Planning Scheme Policy 3 and the Austroads Guide to Pavement Technology

Comparisons show that the Planning Scheme underestimates the unbound minimum pavement thickness for CBR3; however, progressively over states the thickness as the CBR approaches 20.

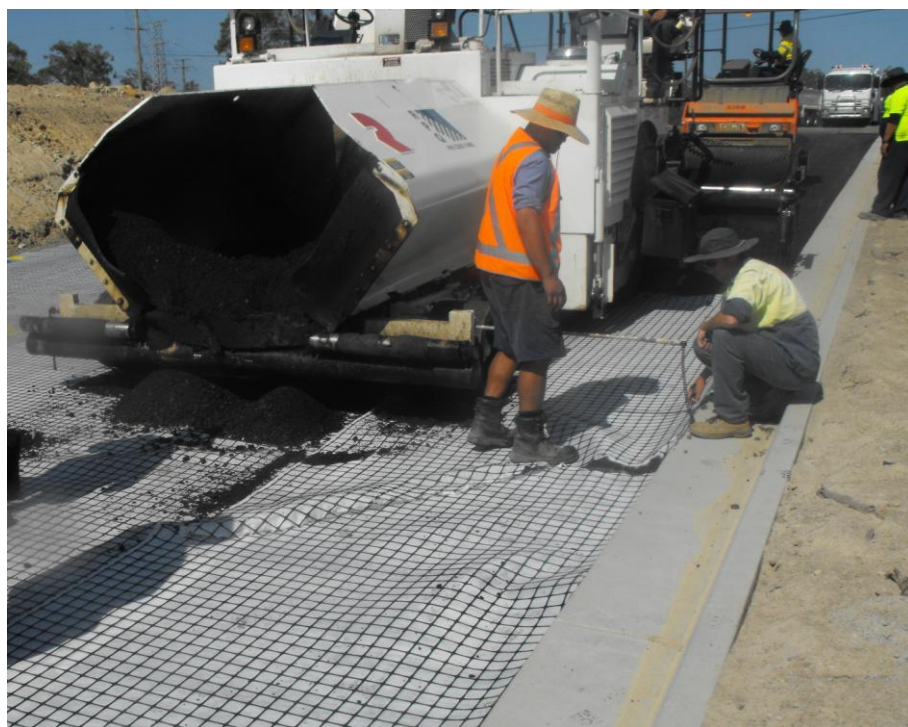
Figure 8.6 Rippling affect during placement of the Tensar ARG Asphalt Reinforcement Grid

This section of road has been open to traffic since February 2010 and will be monitored for performance over the coming years. The need to cut and overlap the fabric may limit the effectiveness of the geofabric in resisting movement.

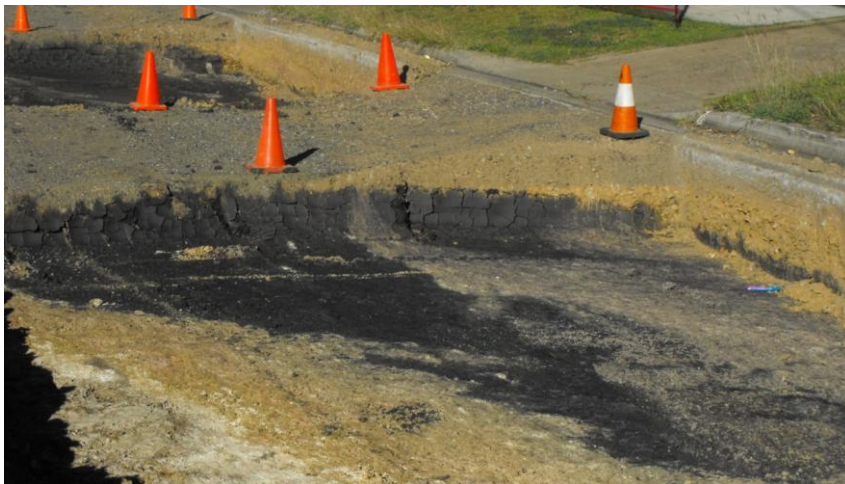
Figure 8.7 Blacksoil on Whitehill Rd

The area of Raceview and Flinders View is well known as one of the worst black soil areas in Ipswich (see Figure 8.7). The road in question has been rebuilt several times since opening and many older experienced staff had been involved in these works. During the design process for this Blackspot funded intersection upgrade, testing and previous experiences indicated that the subgrade would be poor (seen by current pavement performance) and consequently the pavement design was based on a CBR 1. Other construction issues were considered such as service locations and the expected increase in ESA's due to future development. This stage of construction was the first of two for the ultimate design. The future traffic alignment and potential rework requirements were taken into account.

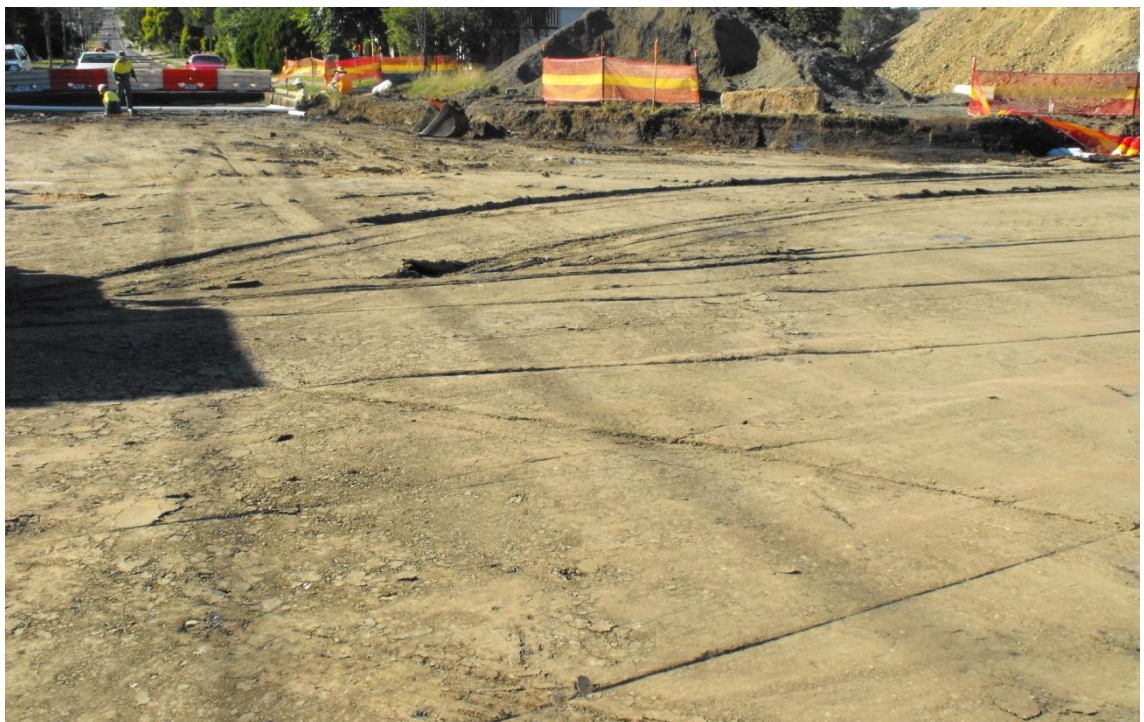
Figure 8.9 Subgrade surface following a proof roll with a laden water truck

During construction the subgrade was found to behave exactly as predicted, with proof rolls failing throughout the intersection area, as seen in Figures 8.8 and 8.9. A few days following the proof roll an unfortunate water main break on southern corner (near the pole seen in Figure 8.6) flooded the subgrade. This made it very difficult to control the moisture content of the soils and construction was limited due to the gas main, which was more shallow than expected.

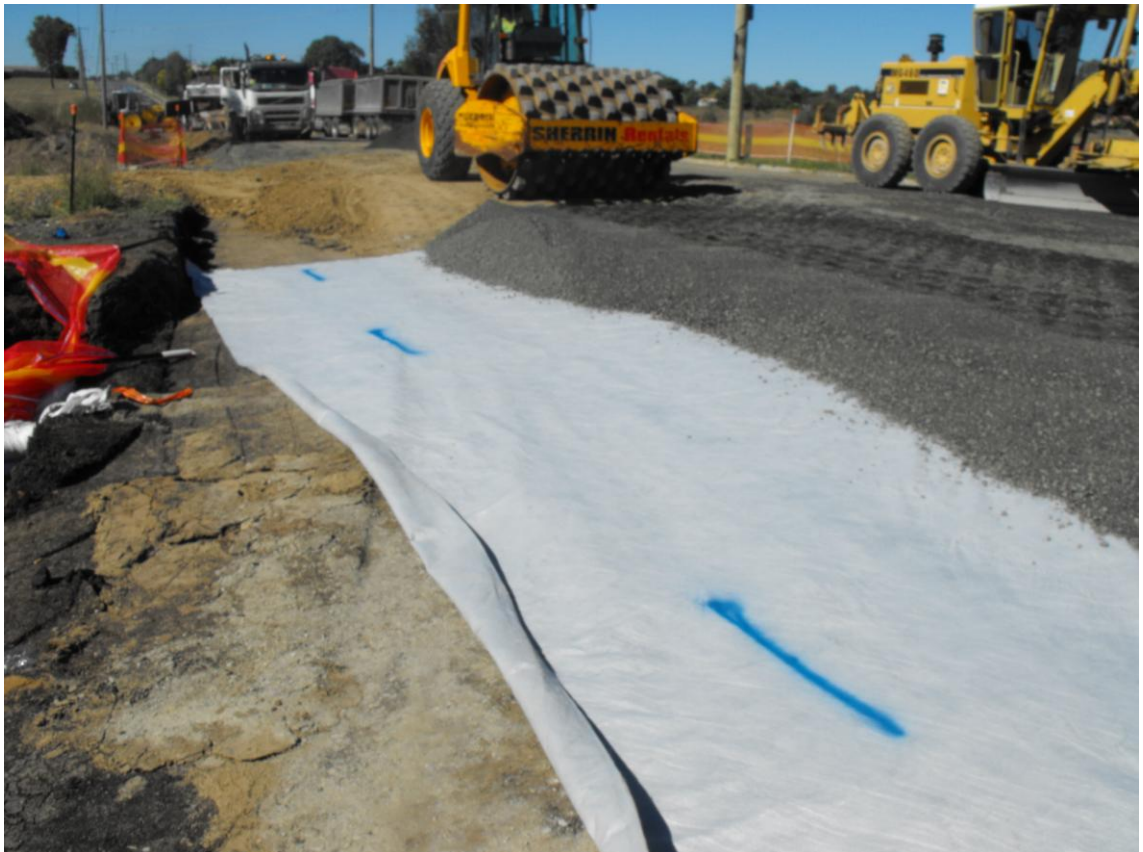
In order to provide a working platform for the pavement construction it was decided that a layer of Bidim geofabric would be placed under Pavement 3 on the subgrade, as seen in Figure 8.10. Compaction was achieved on the subbase layer of gravel, however, movement was still seen during rolling. Asphalt placement demonstrated little or no movement and pavement construction was completed with a certain degree of satisfaction. ICC have planned to construct stage 2 of these works over the coming 5-10 years, this will provide an opportunity to observe the performance of each pavement type and the particular geofabrics that have been used.

Figure 8.10 Placement of a geofabric on the clay subgrade to provide a working platform
