DRIVEABILITY OF COMPOSITE PILES

GUADES, E. J. *, ARAVINTHAN, T. & ISLAM, M. M.

Abstract: Deep foundation has historically involved the use of traditional materials such as concrete, steel and timber. However, these materials suffered from strength degradation and its repair cost is significant especially if installed in harsh marine environment. A relatively new trend in piling industry is to use composites as substitute material. Composites present a novel solution without most of the traditional materials' shortcomings. The basic advantages of composites among other construction materials include lightweight, high strength-to-weight ratio, corrosion resistance, chemical and environmental resistance, and low maintenance cost. Apart from the mentioned advantages, composite materials face impediments since they do not have a long track record of use in piling system. To partially address the aforementioned barrier, this paper presents information on the driveability of composite piles which is one of the first steps toward understanding its behaviour during driving. Additionally, experimental impact test result conducted by the authors on fibre reinforced polymers (FRP) hollow pil

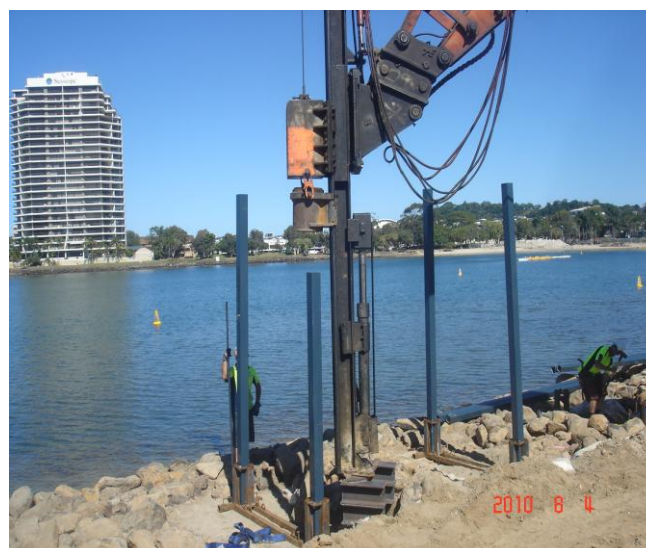
FIGURE 01: Application of composite pile.

Composite piles have been available in the North American market since the late 1980s, though their use has been limited mainly to marine fendering applications. To date, a number of load bearing composite piles were already used in bridge rehabilitation including Route 40 Bridge over the Nottoway River in Sussex County, Virginia and Route 351 Bridge project in Hampton, Virginia (Pando, Ealey, Filz, Lesko, & Hoppe, 2006). In Australia, application of composites in deep foundation is still in its infancy. There are however few appliance of composites undertaken but with only limited information. For instance, pultruded tubes were applied as FRP pile in an elevated walkway along the shoreline of Tweed Heads, New South Wales (Fig. 01).

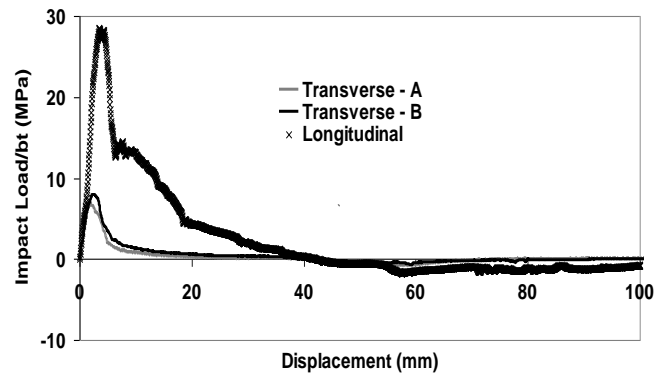
FIGURE 05: Impact load per unit area versus displacement curves

Fig. 05 & 06 show the comparison of impact load and total energy versus displacement. Both specimens demonstrated splintering break failure as evidently shown in Fig. 05. This type of failure is common for brittle materials like composites and usually initiated by unstable cracking and followed by splintering (total rupture). Zhou (1995) also observed such failure mode on the impact behaviour of a composite laminate. This study characterized the damage effect of impact on laminate made from polyester resin reinforced with glass fibre. Longitudinal specimen demonstrated a higher impact load per unit area (bt) compared to transverse specimens due to a much greater stiffness. This was also the findings of the study conducted by Canteli, Arguelles, Vina, Ramulu and Kobayashi (2002) on a composite laminate in which the impact load increases with increasing material stiffness. On the other hand, specimens transverse A and B showed an almost identical impact behaviour trend and its peak impact loads are comparable (see Tab 04 and Fig. 05). Fig. 06 shows the behaviour of the specimens under total energy. Relationship between the total energy, rebound energy and the absorbed energy was discussed in the work of Belingardi, Cavatorta and Paolino (2008). It is interesting to note that all specimens attained its maximum total energy after the impact load's initial dissipations (i.e. impact load approaches zero). After the specimen reached its peak total energy, it started to damp the energy until total dissipation. Longitudinal specimen generated a remarkable total energy compared to the other specimens. Both specimens showed less rebound energy which implied that the impact energy was mostly absorbed by the specimen and most pronouncedly on transverse specimens. Contrary to impact load curve, specimens transverse A and B showed a visible difference on its total energy capacity as seen in Tab. 04 and Fig. 06.

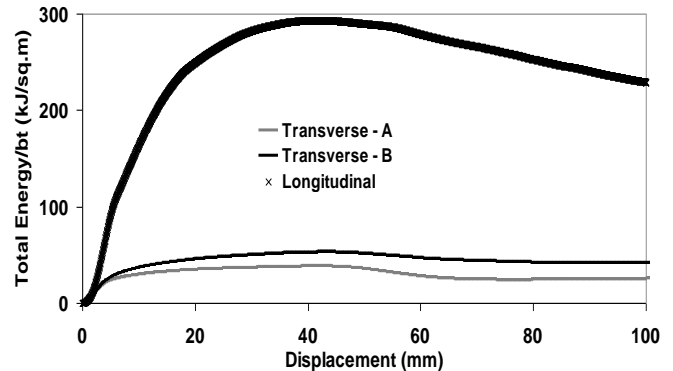
FIGURE 06: Total energy per unit area versus displacement curves

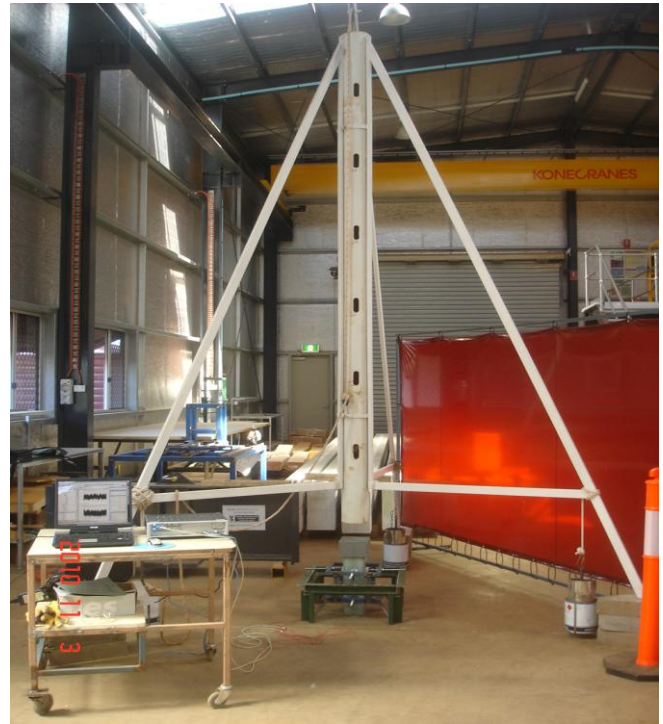
FIGURE 07: Testing set-up and drop impact test apparatus.

No standard was published to suit this type of set-up and test; however, impacting test apparatus under AS 4132.3 (1993) was adopted except some modification on the set-up of the specimen. The 500mm long tube was supported by a steel frame mounted on the solid base (i.e. concrete pavement). Testing set-up and impact apparatus are shown in Fig. 07. Impact test was performed using an un-instrumented free-fall-dart testing apparatus with a total mass impactor of 14.72 kg. The falling height of the testing apparatus is 3.2, 2.7, and 2.2 m, which corresponds to incident energies of 460, 390, and 318 J respectively. The section was impacted up to maximum impact cycles of 75 impacts. The specimen was instrumented with 2 uni-directional strain gages mounted on the mid-height of the pultruded section. This distance is normally sufficient, as it is away from the direct mass impact. An LMS data acquisition device and a personal computer were used to capture
