THE KERAMIK THERMAL PROTECTION SYSTEM EXPERIMENT ON THE FOTON-M2 MISSION

T. Reimer⁽¹⁾

⁽¹⁾*DLR, Institute of Structures and Design, Stuttgart, Germany*

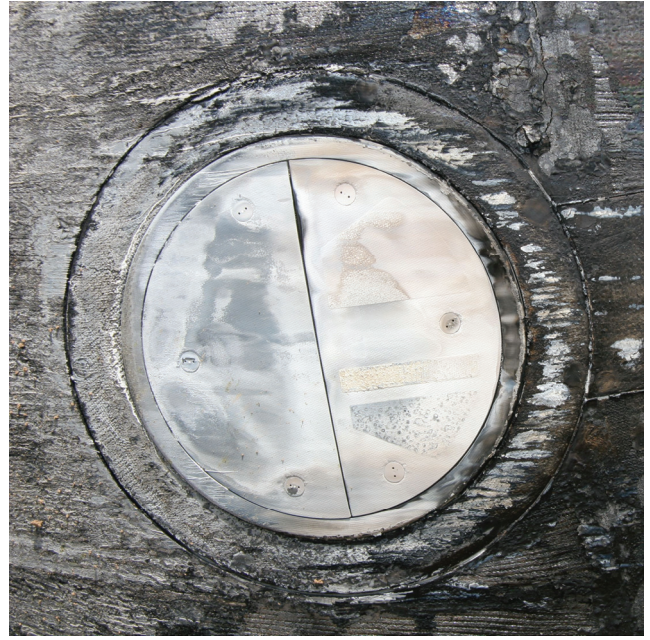
Figure 7: The KERAMIK experiment after flight.

The capsule impacted the ground quite close to the experiment location. Due to the wind drift it had rolled for about 1m after the initial impact but luckily not over the experiment visible in Fig. 8. The first visual inspection saw the experiment in a very good overall condition with no unexpected issues. All components were firmly in place and deposits of a white to light-gray colour were visible on large areas of the experiment, see Fig. 7.

The ablative thermal protection around the experiment was of a black, charred color with a clearly visible gradient in the degree of charring and ablation with much more severe charring in the areas upstream of the experiment, and less charring on the downstream side. An upward step at the upstream edge of the interface ring had formed due to the ablator recession in that area. At the interface ring in this area, surface erosion was visible as a sign of increased temperatures due to the step formation.

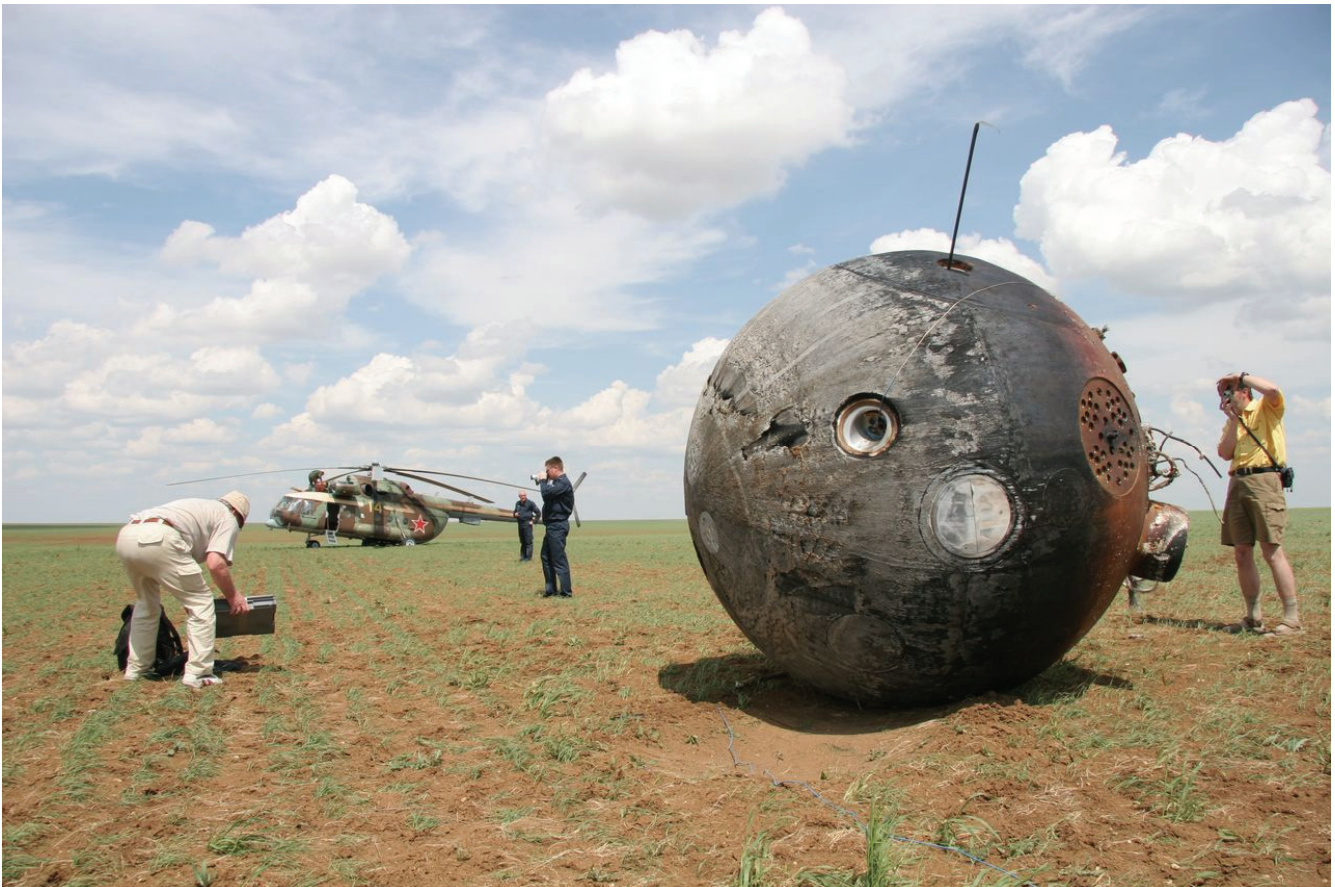
Figure 8: The FOTON-M2 spacecraft after touchdown with the KERAMIK experiment near the center of the craft.

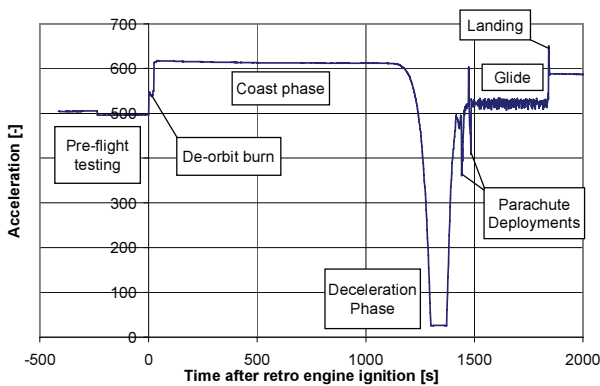
Figure 12: Main acceleration events during re-entry.

In the beginning of the recording the retro engine firing of 24 seconds is discernible in Fig. 12 which is followed by a period of low deceleration until values increase during the flight in the dense atmosphere. The maximum deceleration value can not be determined since the accelerometer goes into saturation during peak deceleration. After the peak deceleration phase the spikes of the parachute releases can be identified, followed by the glide phase under the parachutes and the landing impact after which the signal stays constant at a medium level due to the tilted position of the capsule. For this experiment the most relevant time frame is the one between 1100 seconds after retro engine ignition when the heat load begins to build up and 1416 seconds when the first drogue parachute is released.

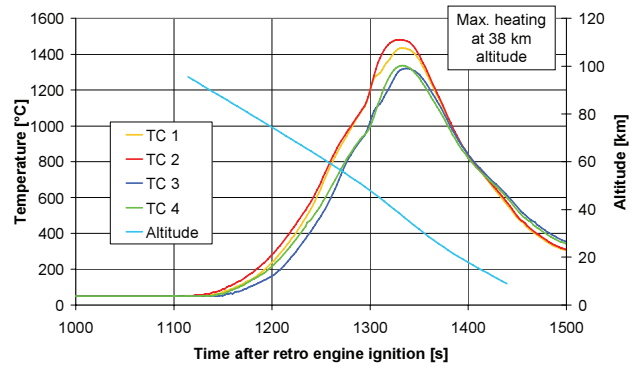
Figure 13: Temperature history of TC1 – TC4.

Thermocouples TC1 through TC4 were measuring the surface panel temperatures at their inner face. In Figure 12 the time history of these measurements is presented. The curves show a steep increase of temperatures right from the beginning, followed by an

Some interesting features about the temperature recordings at the surface panels can be noticed. In Fig. 13 the graphs of TC1 through TC4 initially follow the same pattern of temperature increase within certain bounds up to roughly 1260 seconds. After that it can be noticed that TC1 and TC2 follow almost identical tracks up to 1300 seconds and also TC3 and TC4 are quite close together up to that time. In the the close-up in Fig. 14, after 1300 seconds TC1 and TC3 show a remarkable deviation from the graphs of TC2 and TC4 at practically identical times and in a similar fashion. Since the thermocouples TC1 and TC3 were located at different components, it was concluded that the effect had to be triggered by a change in the heat load.

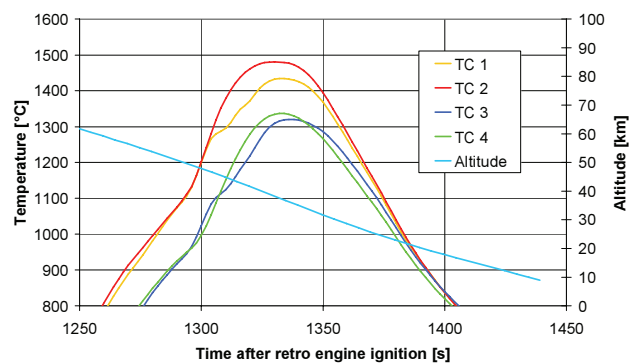
Figure 14: Temperatures of TC1 – TC4 near peak loading.

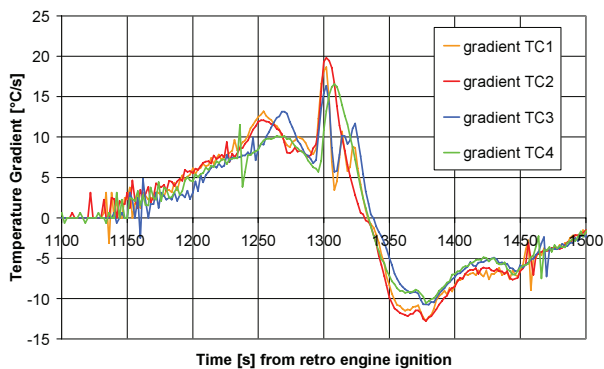
Figure 15: Temperature gradients of TC1 – TC4.

When the temperature gradients of the thermocouples TC1 through TC4 are determined, it can be seen in Fig. 15 that there are distinct changes in the gradients which are not uniformly increasing but show a local maximum at roughly 1260 seconds followed by a decrease and then a steep increase at 1290 seconds.

From Fig. 15 it can be concluded that all surface panel thermocouples are affected and that the reason is probably a change in the heat flow into the panels. A reverse analysis was carried out in order to determine the heat flow necessary for producing the recorded temperature data. For this purpose a simple one-dimensional finite-element model was used. The model consisted of 3 layers of material, representative of the panel structure on top, the aluminum carrier structure on the lower side and the high temperature insulation in between. A transient thermal analysis was repeatedly carried out with the heat flux being the input variable and the resulting temperatures the correlation item between analysis and measured data.

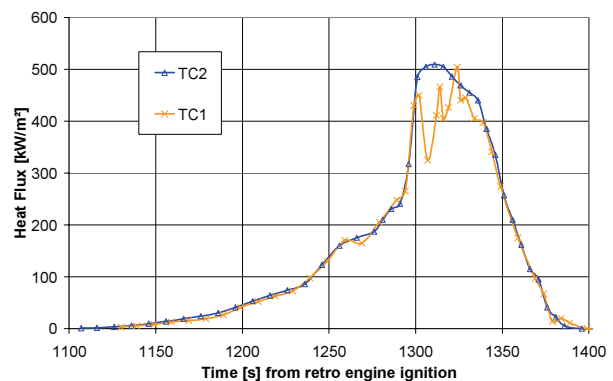
Figure 17: Calculated heat flux for TC1 and TC2.

The procedure was applied to the measured data of TC1 and TC2. The results of these analyses are presented in Fig. 17. It can be noticed that the heat fluxes show considerable oscillations, especially the graph of the calculated heat flux for TC1 shows a lot of spikes around the maximum loading.

It can be noted that for both of the calculated heat flux profiles there is a considerable increase in the rate just before 1300 seconds. This is preceded by some smaller oscillations in the increase rate which also can be found in both profiles. These features are still investigated, but it seems very likely they could be produced at least in part by spacecraft oscillating motions, which leads to a changing position of the experiment with regard to the stagnation point and thus the heat flux values. There remains the question why the temperature profiles and the calculated heat fluxes of TC1 and TC2 show a different behaviour between 1300 and 1340 seconds around maximum heating.

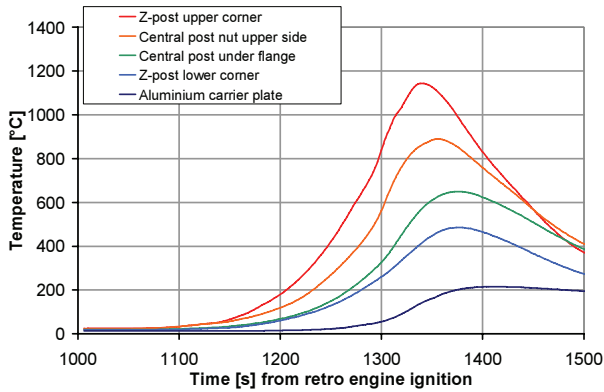
Figure 18: Central post and z-post temperatures.

The temperatures that were measured in the structural attachments are depicted in Fig. 18. In general the profile is similar to the one for the surface panels from Fig. 13, with the peak values at lower temperatures and slightly moved to later times due to the lag because of the internal placement of the thermocouples. A close view to the data reveals that also the graph of TC7 at the z-post upper corner has an increase in the temperature gradient just before 1300 seconds, like it can be observed for the surface panels.

The temperatures measured at the attachment components show that the approach selected in the design of the attachments and their fastening to the carrier structure was appropriate. The available experiment thickness was very small with only 23.5 mm overall. Therefore it was decided not to fix the C/C-SiC attachment components directly to the aluminum carrier structure but to use an intermediate steel plate, which was inserted into cut-outs in the aluminum plate. In the case of the central post which has a larger conducting cross section there was in addition a thin layer of ceramic insulation paper between C/C-SiC component and steel insert. These measures proved to be working well and even though the temperature of the aluminum carrier plate rose to slightly over 200°C.

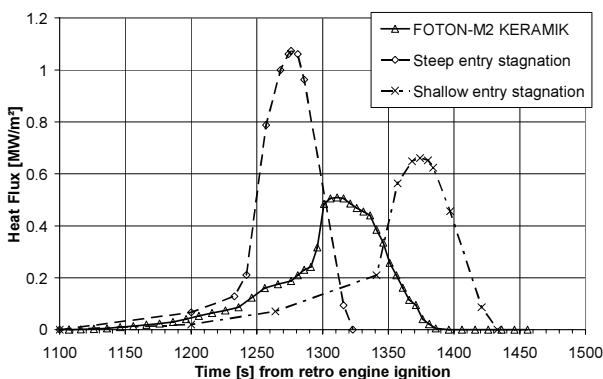
Figure 19: Comparison of the FOTON-M2 trajectory with predicted extremal trajectories.

In general it can be stated that the entry of FOTON-M2 was a medium-level flight with regard to the possible extreme values of the heat flux and the flight duration. In Fig. 19 the possible extreme trajectories are depicted as they were predicted by TsSKB. The graphs for the steep and the shallow entry trajectory are valid for the stagnation point whereas the graph for the FOTON-M2 mission is the one of the calculated values for the KERAMIK experiment location.

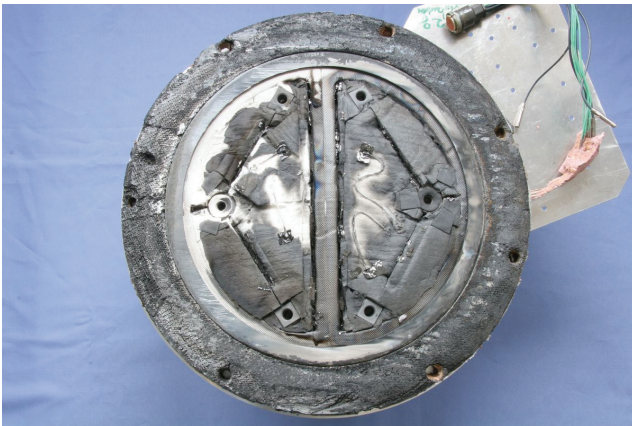
Figure 21: Post-flight view with removed panels.

After removal of the surface panels the internal condition of the experiment could be examined. Most striking was that the insulation had turned from white to black colour in most areas. This is attributed to the

deposition of soot from ablator reaction products throughout most of the upper layers of the insulation. It is assumed that the soot deposit is the result of a venting process of the experiment with gas saturated with soot entering the experiment internal volume through the sealed gaps between the panels and possibly beneath the interface ring on the upstream border of the experiment. The fact that certain areas appear in white colour is assumed to be the result of an oxidizing process that removes the soot deposit in those areas where temperatures are still high towards the end of the re-entry when the atmospheric pressure is rising quicker and a sufficient amount of oxygen is present to reverse the process of soot deposition.

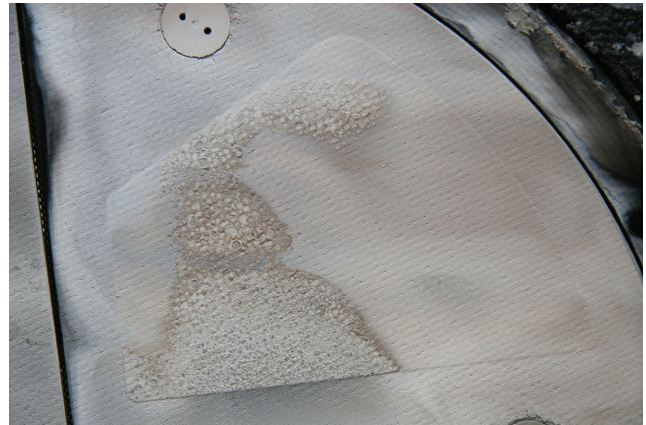
Figure 22: Yttrium-silicate coating after flight.

The coatings that were applied on the downstream panel were found in a mixed situation. It was obvious that all of them had at least in part experienced major surface alterations. The Yttrium-silicate coating pictured in Fig. 22 showed an area with a distinctive border in which a process with the formation of surface bubbles had taken place. It is not yet clear whether this process includes the coating itself or just the layer of deposit material. The investigation is still going on.

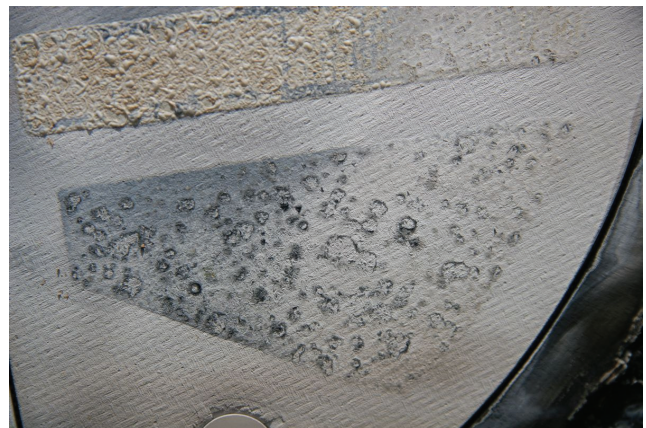
Figure 23: Titanium-dioxide and Yttrium-titanium coating after flight.

In the case of the titanium-based coating the picture is slightly different which is notable from Fig. 23. The coating seems to be affected all over its surface with a process resulting in a kind of pockmarks.

The combination layer also in Fig. 23 shows a surface with a gradual change in its topology from the upstream to the downstream end. On the upstream half of the coated area the surface shows signs of a liquid phase with a solid skin on top including bubbles. Towards the downstream end these features disappear and the topology is quite similar to the structure of the titanium-based coating with the pockmarked surface.
