# The Reality of Fish Passage in Concrete Flood Channels

# THE REALITY OF FISH PASSAGE IN CONCRETE FLOOD CHANNELS

**INTERNATIONAL CONFERENCE ON ENGINEERING  
AND ECOHYDROLOGY FOR FISH PASSAGE**

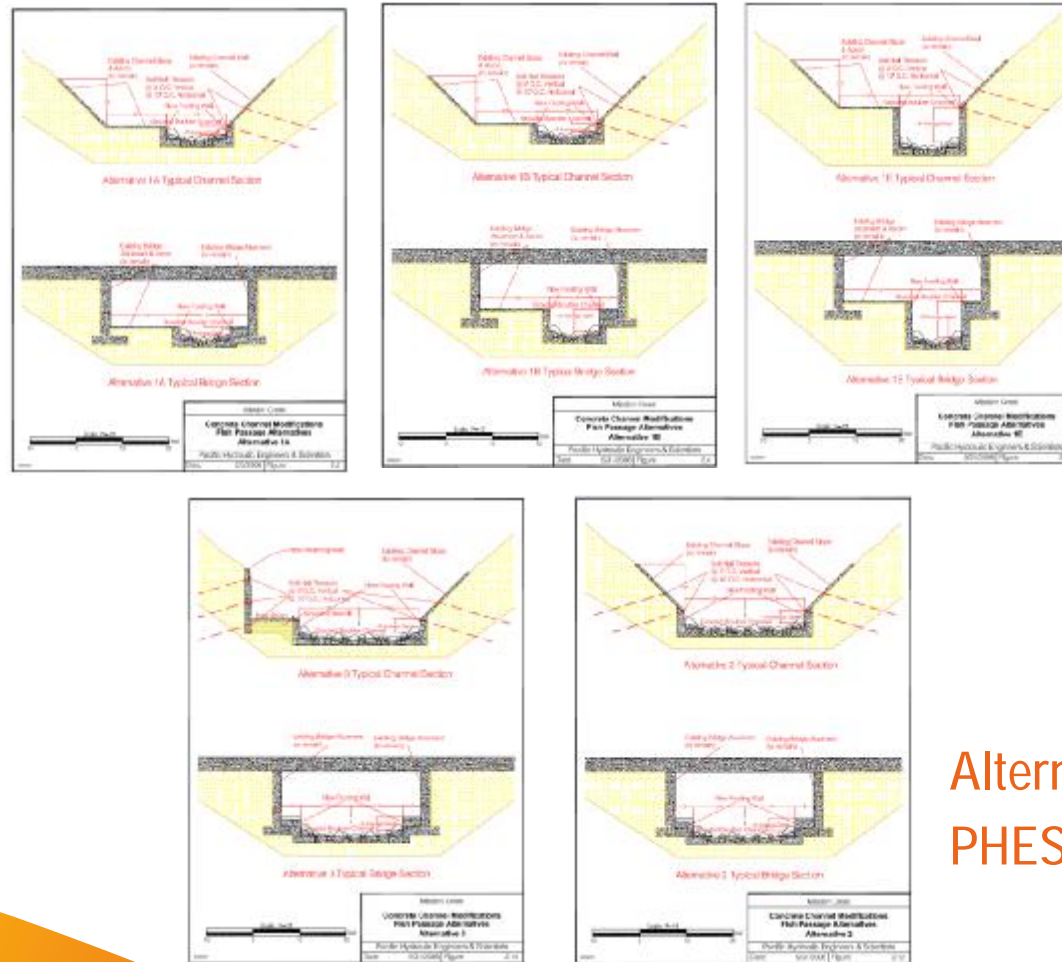
Alternative development,  
PHES 2006

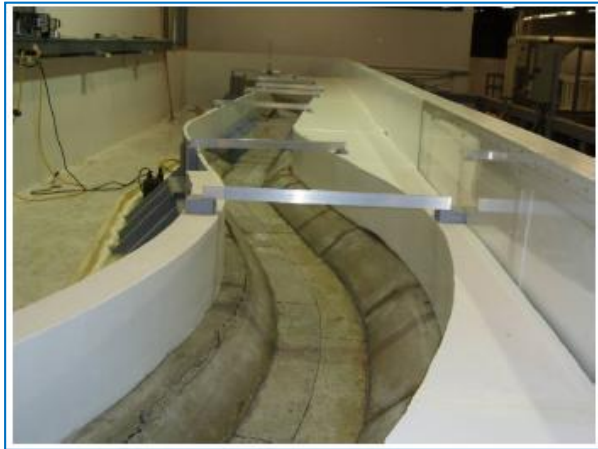
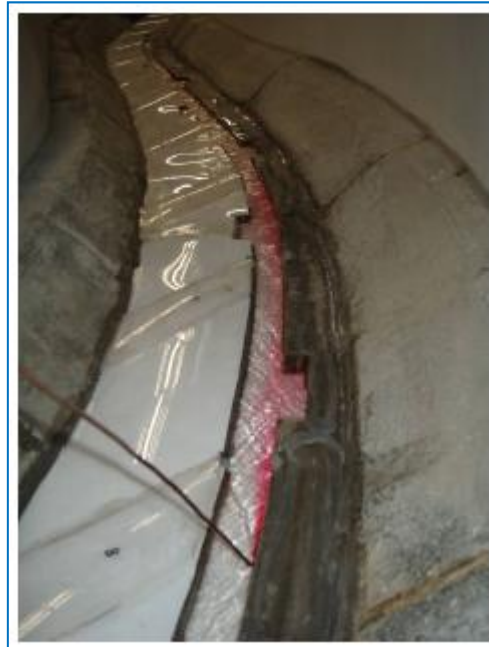
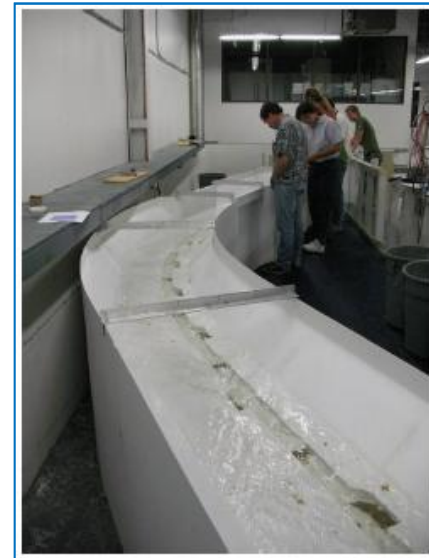
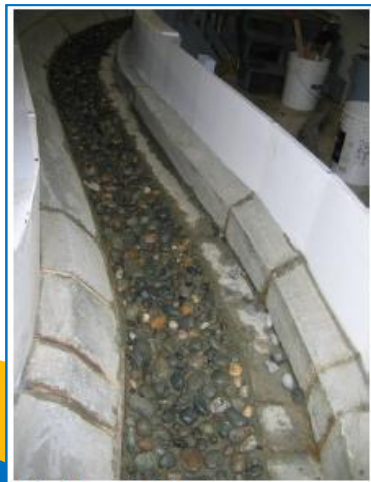
Physical modeling,  
NHC 2008

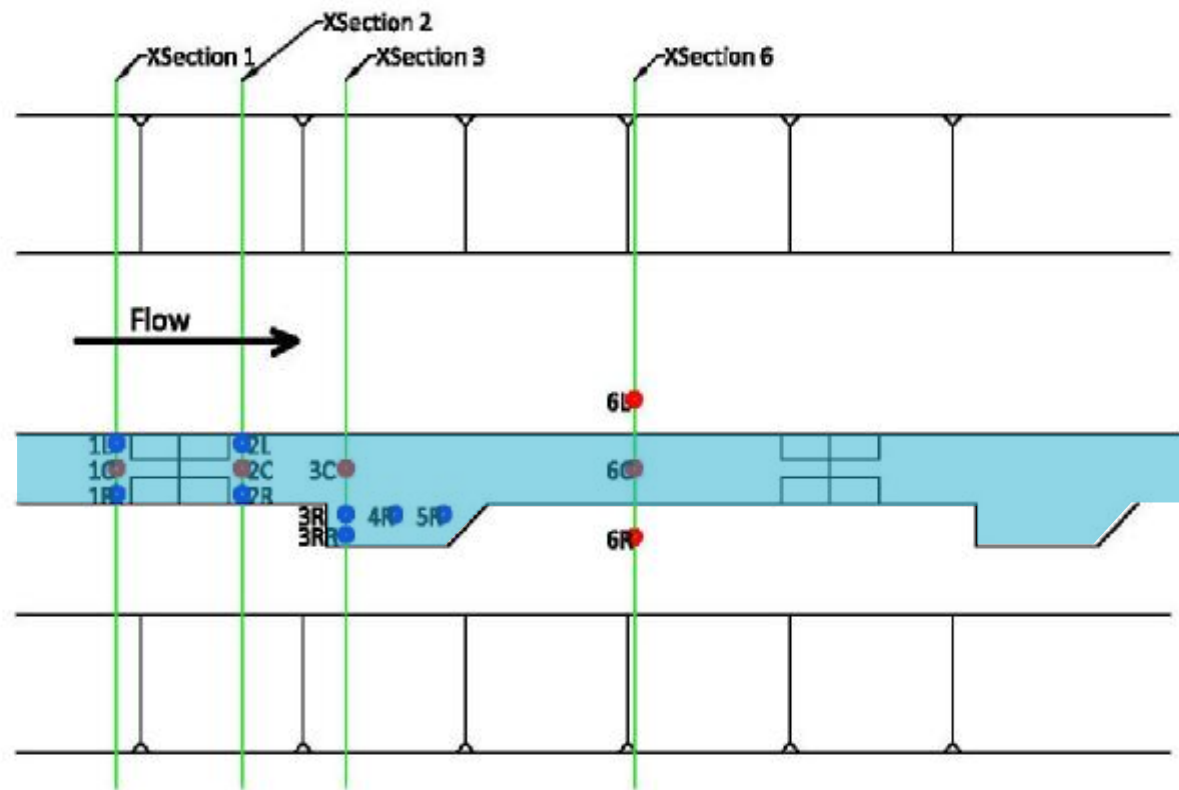
## Point Notation

1L - XSection 1, Left (facing D/S)

3RR - XSection 3, Far Right

● - High and Low Flow Data

● - Low Flow only Flow Data

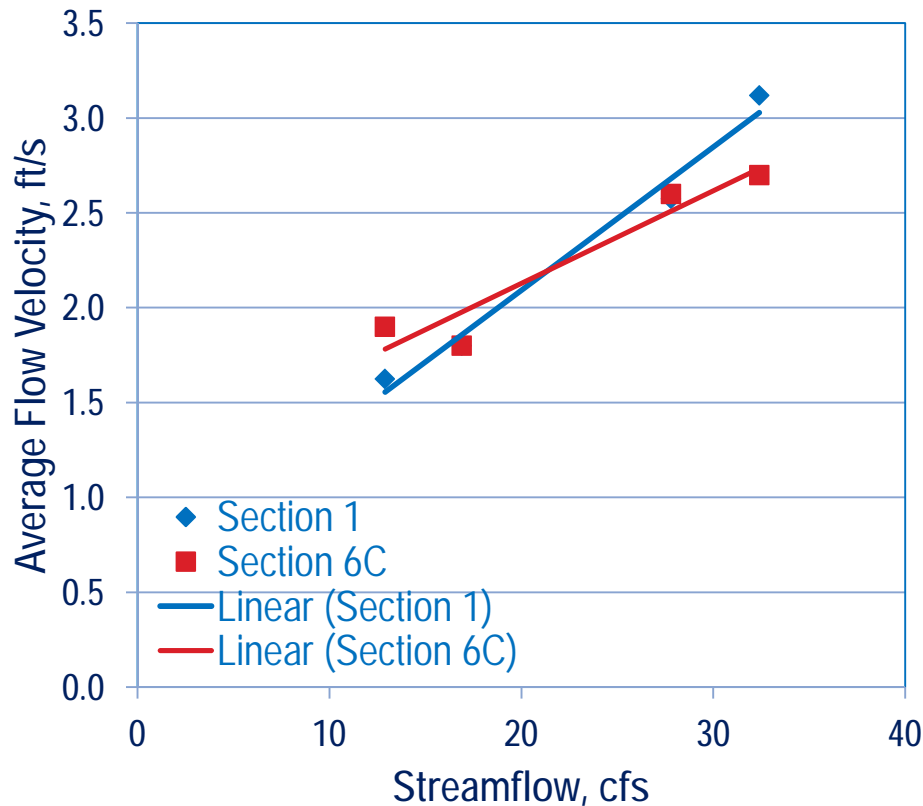
} Measured channel velocities range from 1.6 to 3.1 ft/s at flows ranging from 10 to 35 cfs.

} Anticipated channel velocities range from 2 to 5 ft/s at a flow of 25 cfs.

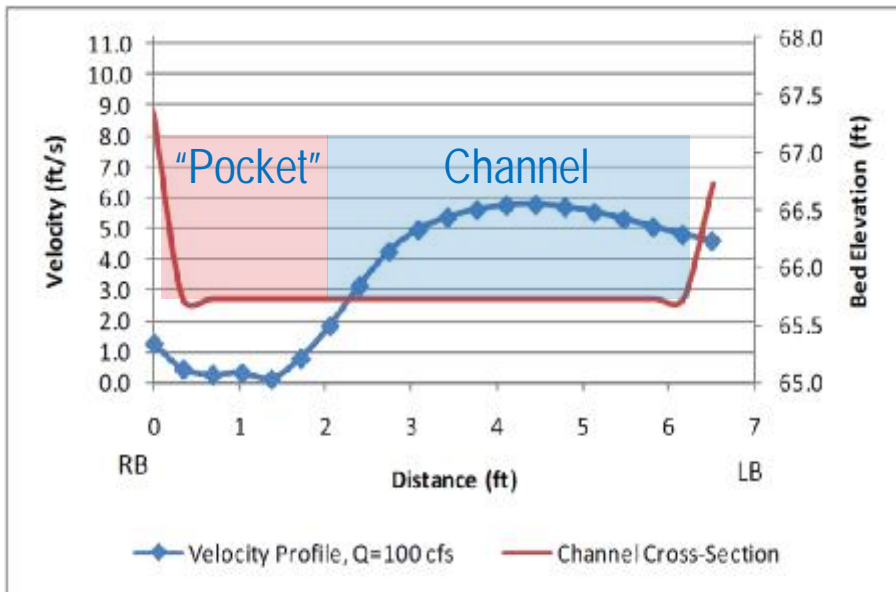
Predicted results using 2-D model (HDR, 2010).

Flow 100 cfs

V Channel = 2.0 to 5.9 ft/s

V Pocket = -1 to 1.5 ft/s

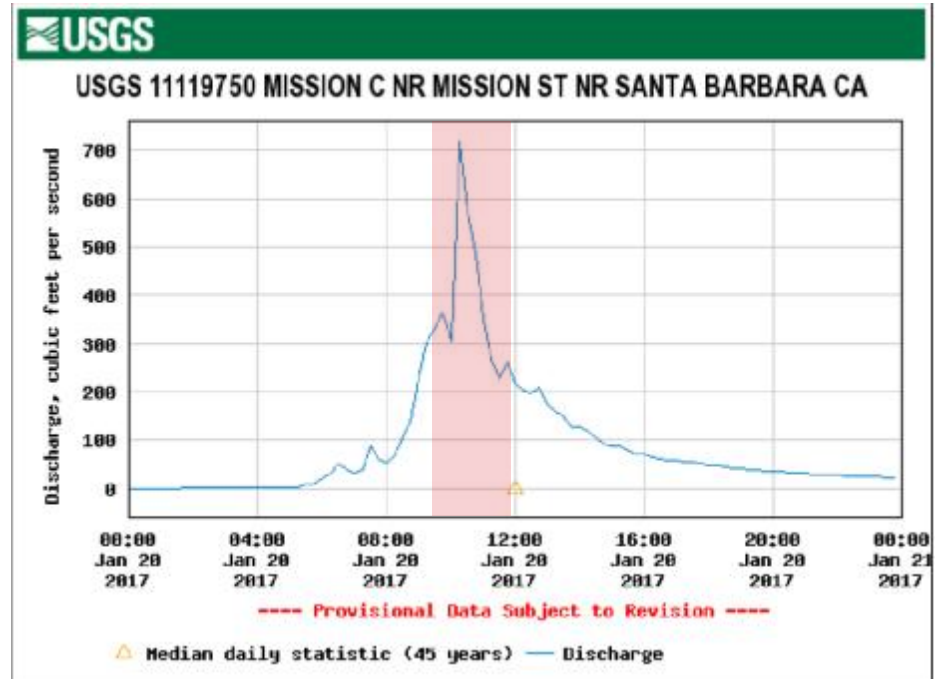
Flow Observation 1/20/2017

Flow Range 200 - 700 cfs

Time Range 10:00 AM to 12:00 AM

V Channel = 2.7 to 6.7 ft/s

V Pocket = 0.4 to 1.2 ft/s

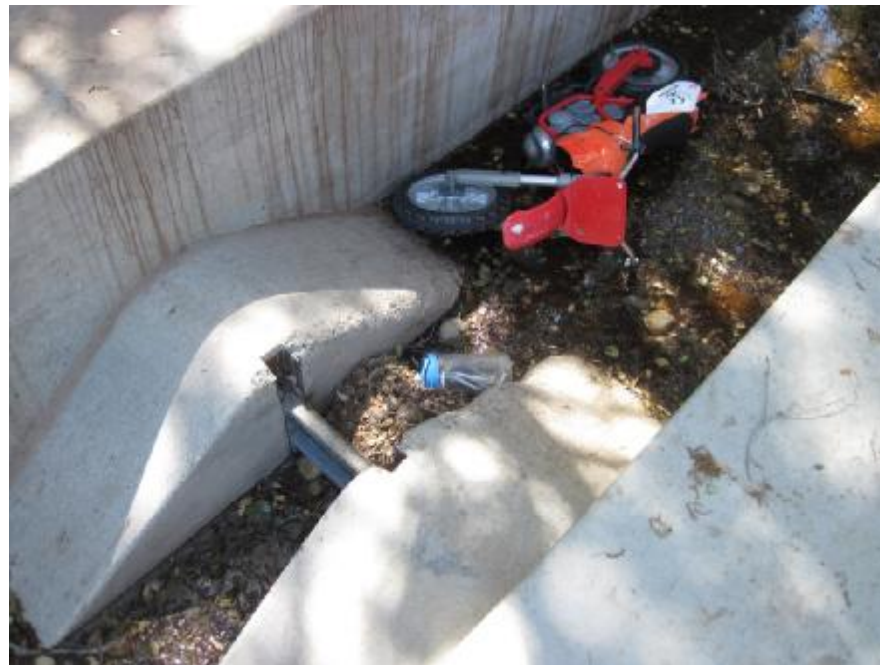
- } Low-flow observations ( $Q < 100$  cfs)
  - Small accumulations of sands and gravels
  - More effort to remove urban debris than sediment

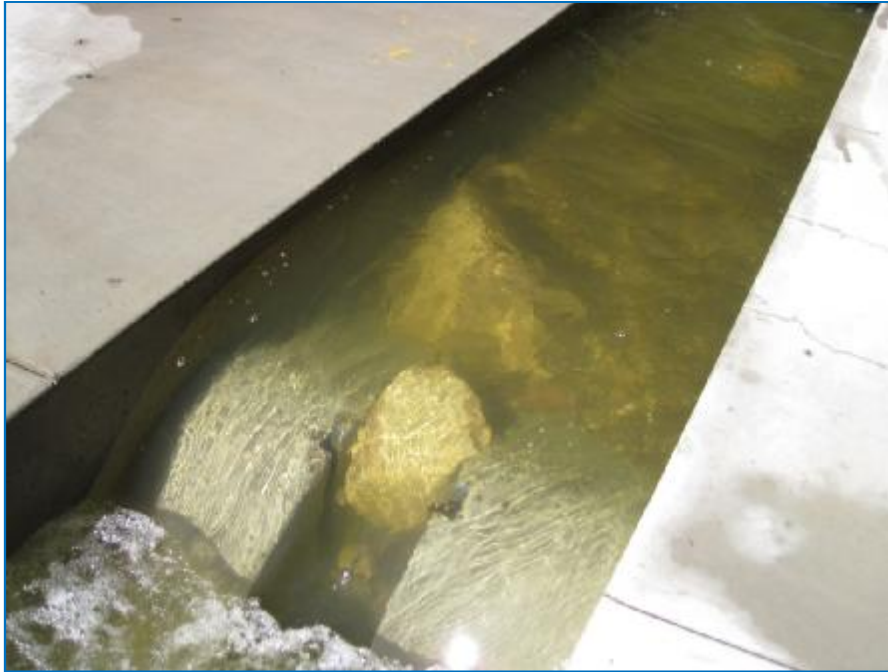
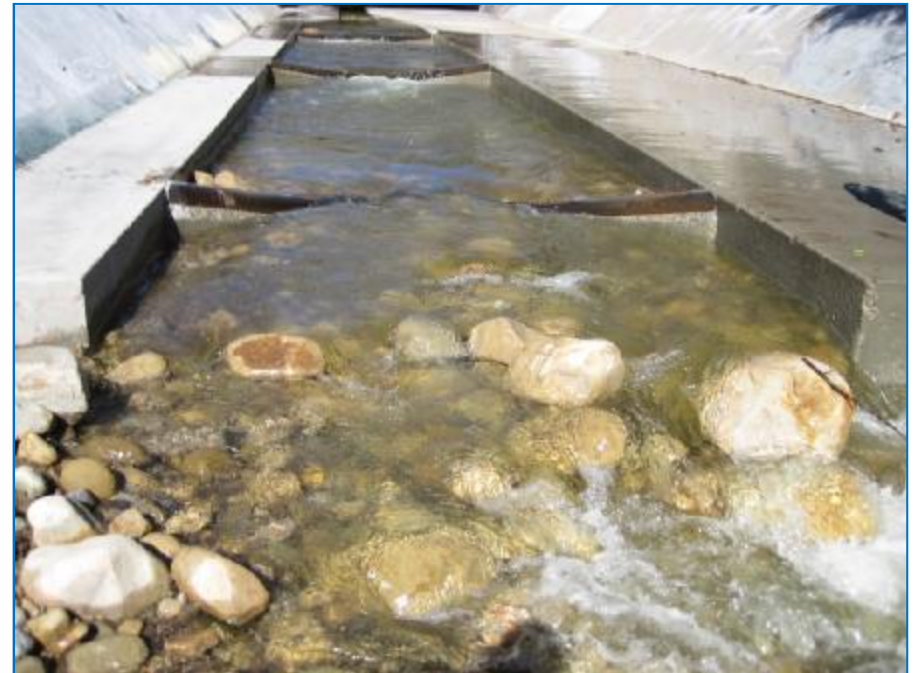
- } High flow observations ( $Q > 1,500$  cfs)
  - No sands and gravels – small particles sizes evacuated from the channel
  - Larger proportion of boulders and large cobbles
  - Accumulation of cobbles and boulders at sills near upstream extent of both Phase I and II reaches – not significant enough to influence passage
  - Additional accumulations appeared at locations where there were apparent additions of flow from stormwater outfalls or changes in cross-sectional geometry
