# **An Automated Cleaning System for Hospitals**

**M.Eng in Mechanical and Manufacturing Engineering**

**Student: Colin Griffin {B.Eng in Mechatronic Engineering}**

**School of Mechanical and Manufacturing Engineering**

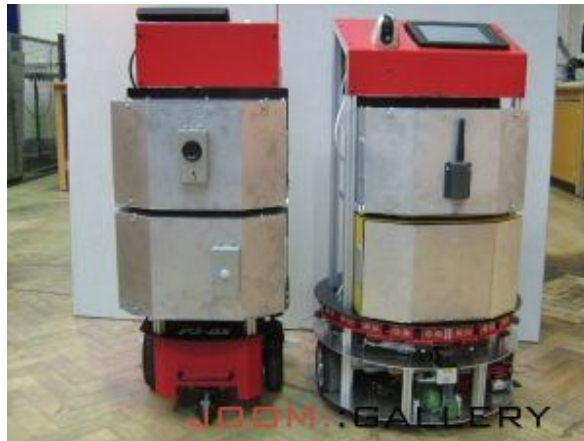
The IWARD base robot consisted of an aluminum chassis that held all essential drive components. In order to navigate, the robots utilized a semi-circular array of sonar sensors on the front, which was located above a laser scanner capable of measuring numerous distances along a single horizontal axis. An impact sensor was attached along the leading edge of the robot in the event of a malfunction of the wireless sensors occurring or in the rare instance where an obstacle was, for any reason, not detected in advance. For reasons of prototyping two robot platforms were developed which differed slightly in design, but both robots contained identical sensors and functionality. Figure 1 below shows two of the IWARD robots side by side

**Figure 1: IWARD robots [2]**

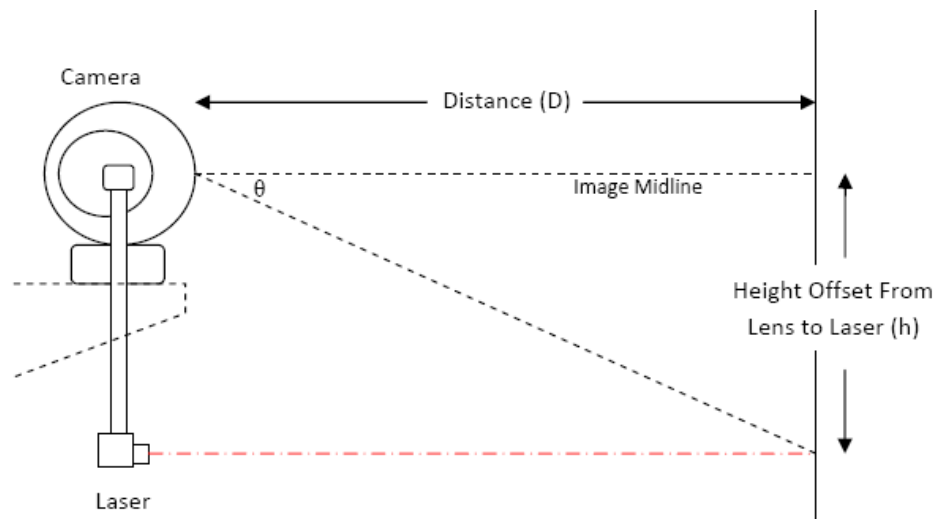
**Figure 2: Distance vs. Height [7]**

measuring the vertical height from the camera lens to the laser diode ( $h$ ) one can use simple trigonometry to calculate  $D$ , the distance from the camera to the object by utilising the equation  $D=h/\tan \theta$ , where  $\theta$  is the angle between the projected dot and the middle of the image.

RoboRealm was used to determine the value for  $D$  in the above figure after the red dot was correctly identified. The location of the laser dot was obtained by assuming that all associated pixels would be of a bright red colour. The laser point was, as shown below in Figure 3, assumed to be within a centre margin below the centerline of the image. The distance between the laser dot and centerline was then measured by RoboRealm and returned as a corresponding height ( $h$ ). That value was then inserted into the mathematical formula previously mentioned to determine  $D$ , the distance from the camera to the object.

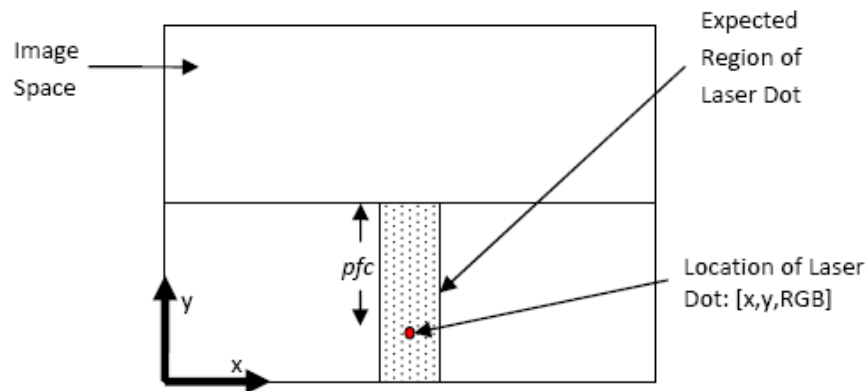
**Figure 3: Location of red dot [7]**

\*" *pf<sub>c</sub>*" in Figure 3 is "pixels from centre"

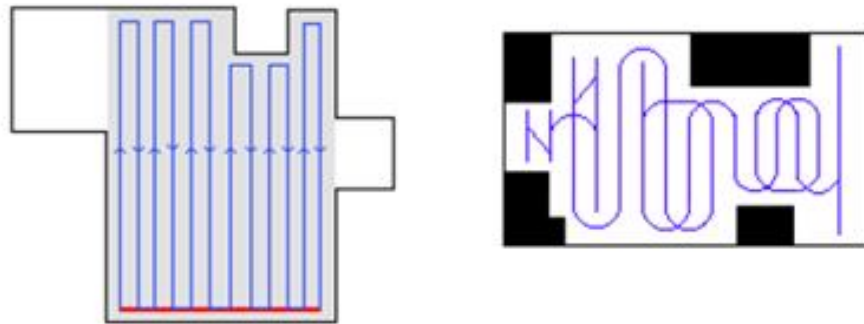
**Figure 4: Cleaning Patterns A & B [11]**

Chapter two of the report described the potential methods of surface coverage available for use by a vacuum cleaner. A planning approach entails keeping a world map from which movement must be planned, a behavioural approach that involves the robot reacting to the outside world using sensors such as an insect and finally a random motion approach. Within the heading of a planning approach are a number of sub-categories, which enable a variety of cleaning patterns to be implemented. Figure 4 below illustrates two patterns in a planning approach: part A represents a simple strip filling pattern with a red base line shown which defines the beginning and end of the

strips for that region. Part B shows a serpentine pattern with overlapping trails to cover areas missed on the first pass.

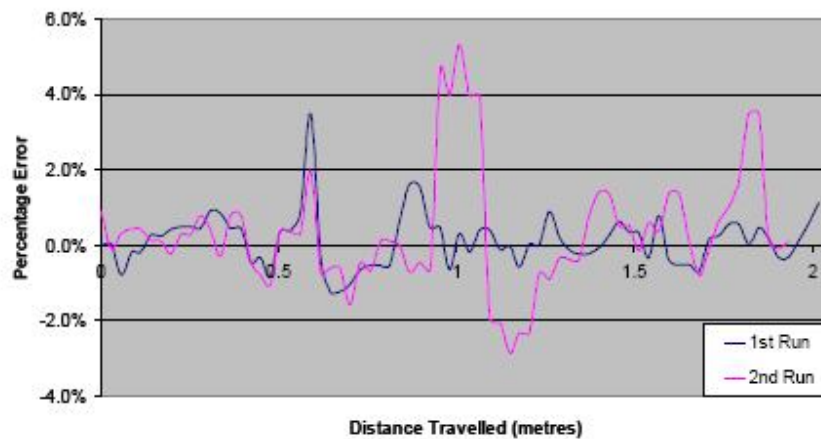
**Figure 5: Sonar Percentage Error [11]**

The “RoboVac” utilised a behavioural approach to cleaning in an attempt to develop a reliable method of covering the entire area of an unknown room without the use of any world map. Harding discussed the various approaches to compensate for a cavity that was detected, an area that was missed and the required wall following procedure. In order to be able to follow a wall, a set of sonar sensors were faced towards the surface in question and the software algorithm was instructed to maintain a consistent measurement in relation to the wall. The testing conducted during trials indicated that the sonar sensors in use were not sufficiently accurate to allow a consistent straight line to be followed. Figure 5 below is a record of the results

produced by Harding after two consecutive tests occurred; the aim of the testing was to determine the error present when the “RoboVac” endeavoured to follow a straight wall at a distance of 2 metres.

Both the above test, and another test measuring the deviation from a straight line when not following a wall, proved that the robot hardware could often not return a performance necessary to effectively execute the software programming.

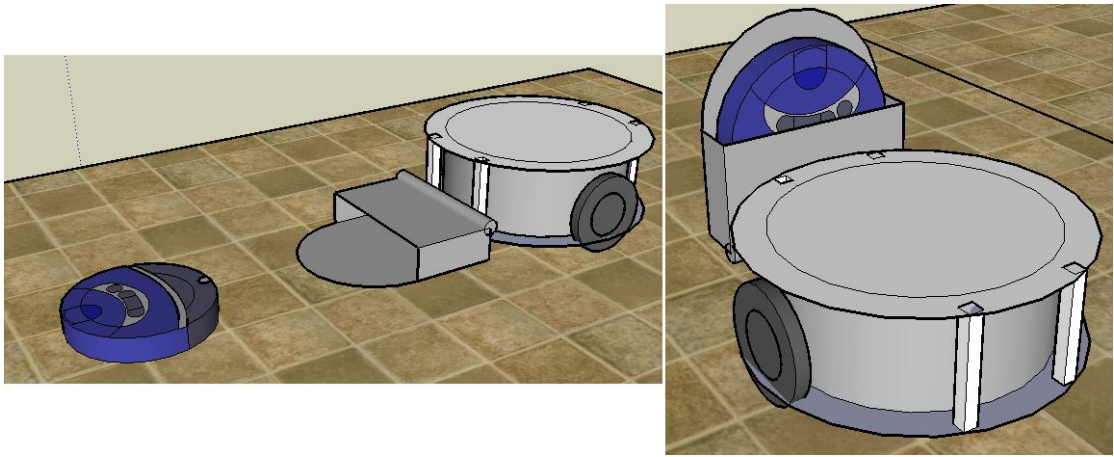
**Figure 6: Sketch of Roomba Transport, Part A & B**

The primary robot would require a hinged shelf on the rear of the platform that would have a motorised mechanism to lower and raise  $90^{\circ}$  to allow the Roomba to drive onto it. Figure 6 (part A) displays the shelf in the lowered position, which would enable the vacuum robot to enter and exit the storage shelf. Figure 6 (part B) shows

the storage shelf in the raised position with the Roomba vacuum cleaner being transported.

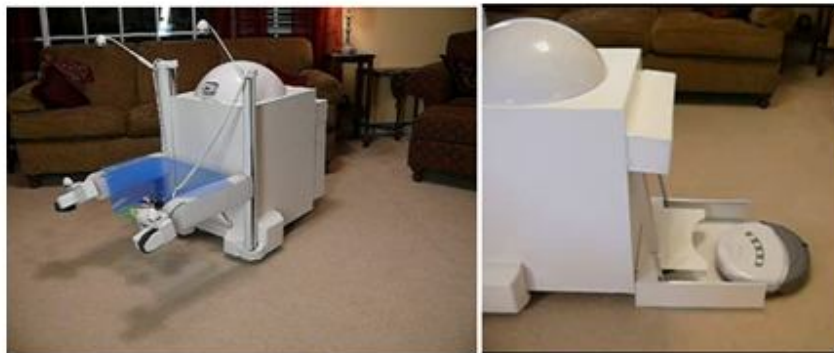
**Figure 7: Existing Home Cleaning Robot [14]**

Of the two ideas suggested the former has already been put into practice in a domestic cleaning robot as shown below in Figure 7. However, as is visible, the robot is quite large and merely serves to reinforce the point that addition of a compartment to house the Roomba results in a larger than necessary over-all structure. Images courtesy of "Blog about Robots life in our world" [14].

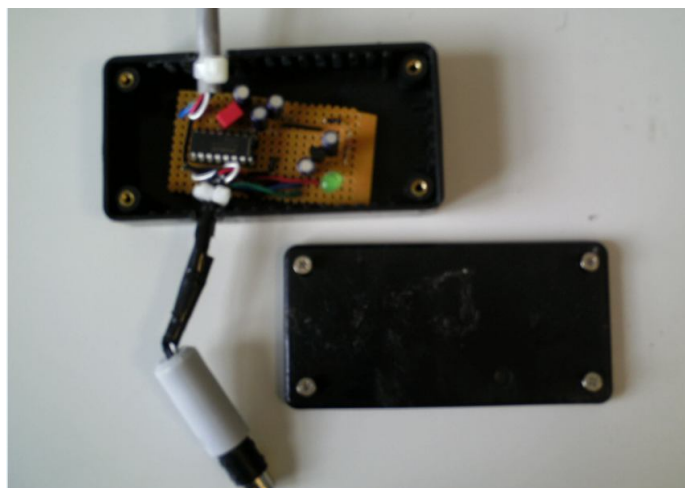
**Figure 8: Photo of Power Regulator/Serial Cable**

Initial trials proved unsuccessful however and the expected transfer of commands from PC to robot was not occurring. Electrical testing illustrated that the schematic provided by the website [15] was incomplete. The connection missing from the diagram online is to connect pin 5 on the DB-9 serial cable to Ground. This missing wire has been included in Appendix A. Figure 8 below shows a photo of the completed voltage regulator/communications circuit.

Appendix A contains the wiring schematic that was used to construct a serial cable used for direct communication between a desktop PC and the Roomba vacuum cleaner. Since the Roomba operated on a DC power of 14.4VDC and the serial port in a PC operates at 5V a voltage regulator was also required to be incorporated into the cable. The wiring diagram was found online [15] and solved the problem of 2-way communication and the varied voltage levels.

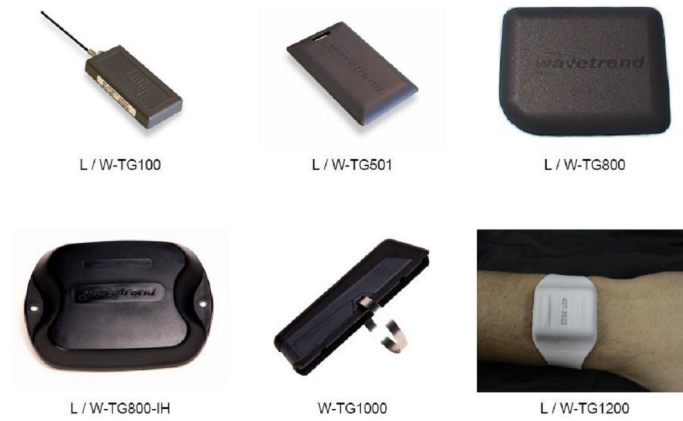
**Figure 9: Photo of Rfid Tags [16]**

would be proportional to the distance the tag was from the reader. Figure 9 below shows the 6 active Rfid tags utilised in the following experiments.

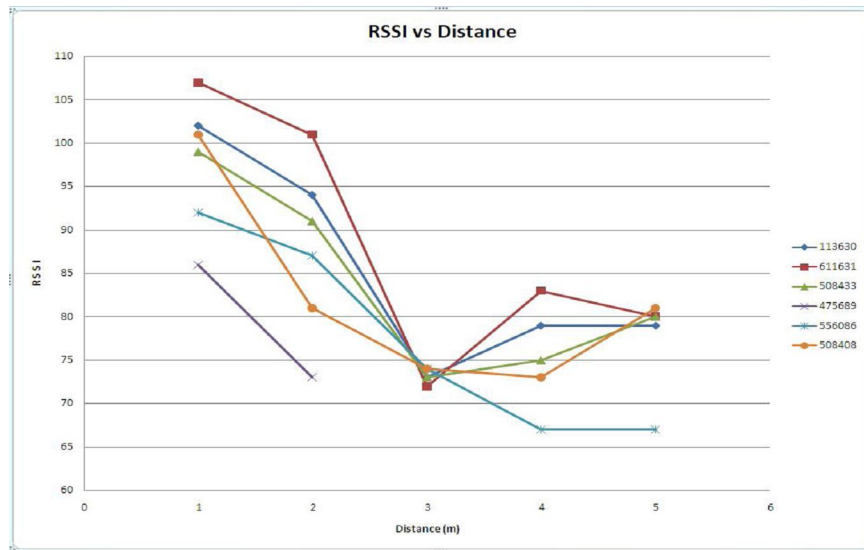
**Figure 10: RFid Tag Performance [16]**

Above in Figure 10 are the graphical results for a test carried out using 6 different RFid active tags in the same testing environment. The experiment consisted of manually moving each tag individually along a single axis away from the reader from 1 metre up to 5 metres while RSSI values were continually being recorded. Each line on the graph corresponds to a different tag, the identification numbers of which can be seen on the left hand side of the graph.

The expected results were a set of lines moving uniformly from a high RSSI value at 1 metre to a low RSSI value at 5 metres. As illustrated above the actual results did not match the expected results and proved that a linear relationship between distance and signal strength was not present. Further testing was carried out, the results of which can be found in the document titled "Developing a patient guidance module for hospital robots" [17]. The other tests consisted of rotating the tag reader and also introducing an obstacle to the test environment, however the results still

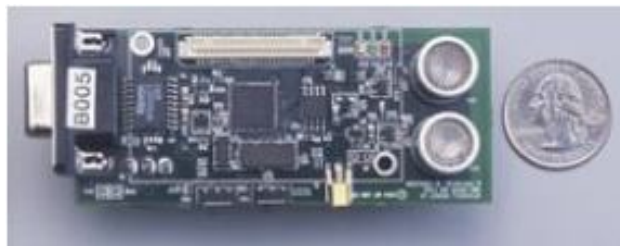
Figure 11: Cricket Device [18]

As mentioned above, the beacon periodically transmits a signal. This signal consists of two individual parts: Radio Frequency (RF) and Ultrasound. Since the speed of light (RF) and the speed of sound are both known, this property plays the integral role in the over-all system. Once the listener receives the first part of the RF signal it begins to actively listen for the Ultrasound signal. The time delay between the two signals is then used to compute the linear distance between the beacon and listener. If multiple beacons were detected a listener could determine the exact location by means of triangulation, however this aspect of the technology was not utilised. Figure 11 below shows an individual Cricket device as illustrated in the Cricket manual alongside an American quarter for size comparison.

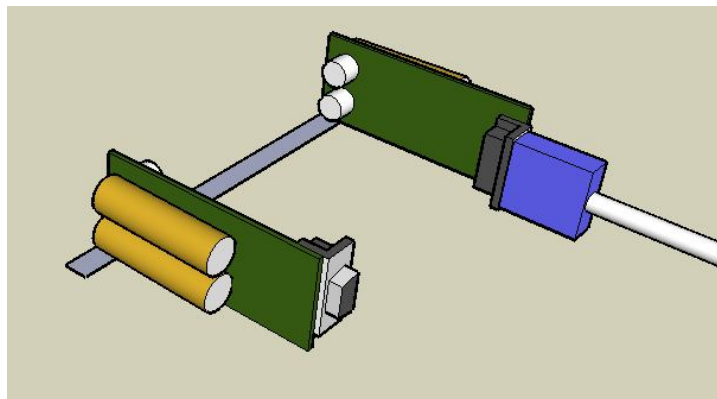
**Figure 12: Illustration of Cricket Testing**

The accuracy of the linear distance between beacon and listener was briefly tested to determine how much error was present under normal conditions. To investigate this, a simple experiment was laid out as shown in Figure 12 below: the listener is set at a fixed point and connected to a computer where the distance values

can be read. A standard measuring tape is laid out, as represented by the grey strip, and the beacon is moved linearly back and forth along the measuring tape. The actual values obtained using the measuring tape and the expected values obtained from the Cricket devices were compared to check the error between the results. Based on that simple test the Cricket devices were deemed acceptable despite a small error being present. For example up to 1.5m the difference between actual and expected results was a maximum of 4 cm. In some instances this would be a huge percentage of error, but for the role that these devices would play in the cleaning system it was thought to be within reason.

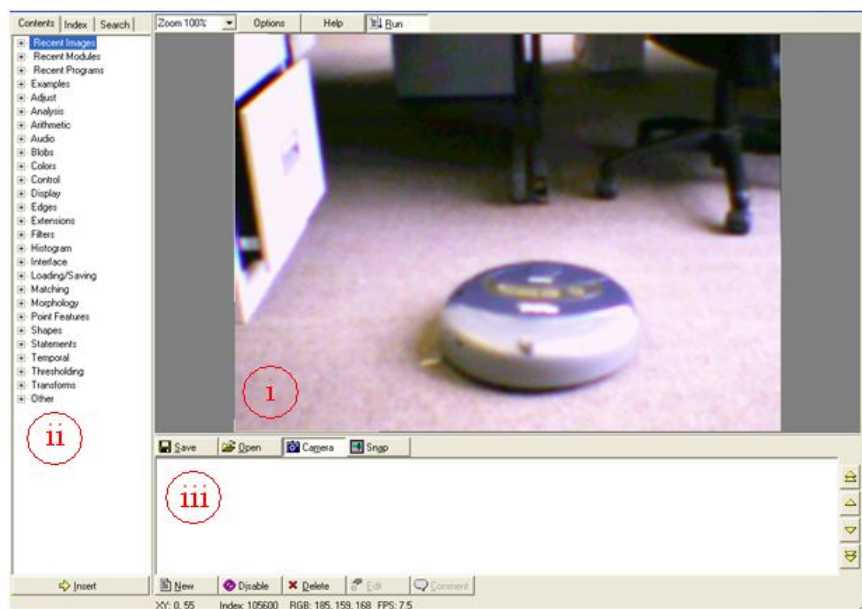
**Figure 14: RoboRealm Software**

Figure 14 above is a screen-shot taken of the RoboRealm software while in use. The area labelled "i" on screen is the view from the camera with the current step of analysis/manipulation available for viewing by the user. In this particular view no steps to manipulate the video stream had been added so the stream is as seen by the video

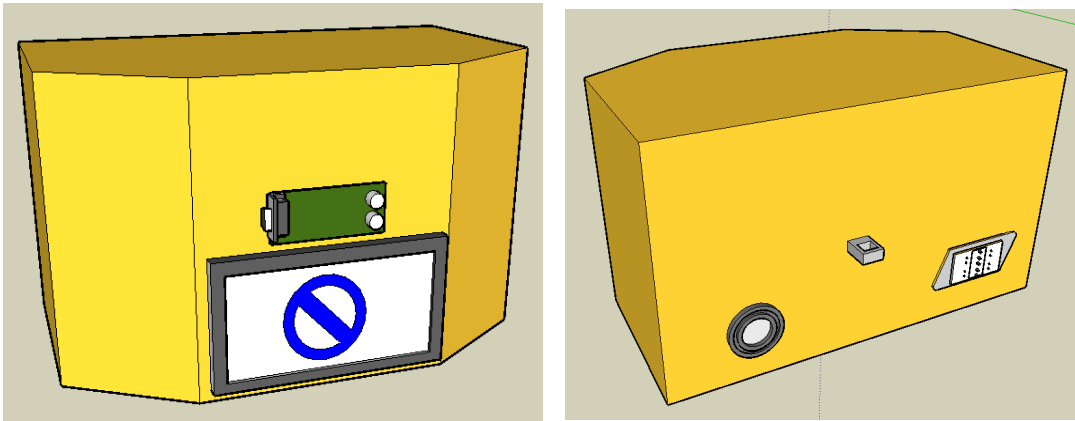
**Figure 15: Illustrations of Module Box Concept**

The module box for the cleaning system consisted of a small monitor recessed into the front of the module box as shown, with the interior of the box securing all power and data cables. As with all other modular boxes, this would enable any authorised person to merely insert the box into the labelled compartment on the core robot without the need for an engineer to connect all components individually.

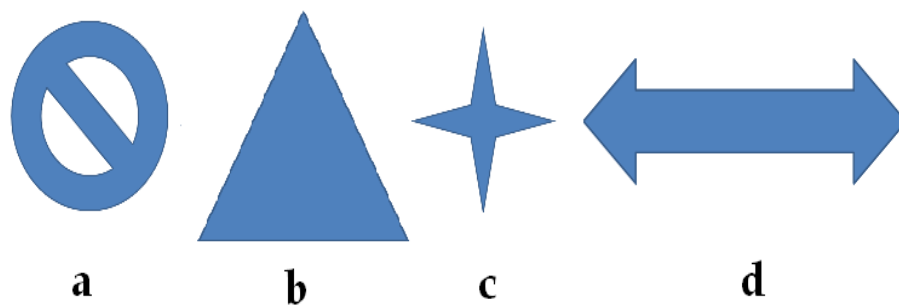
**Figure 16: Command Symbols**

In order to reduce the level of error in the recognition portion of the program the words used were replaced with a series of very different symbols with as little similarity as possible. Figure 16 below illustrates the four symbols used to signify the various commands in use by the system. Labelled A-D the commands are pause, spot clean, regular clean and follow respectively.

To enable the system to operate at full potential the system was trained using images in an ideal environment. A perfect binary image of each shape was stored and

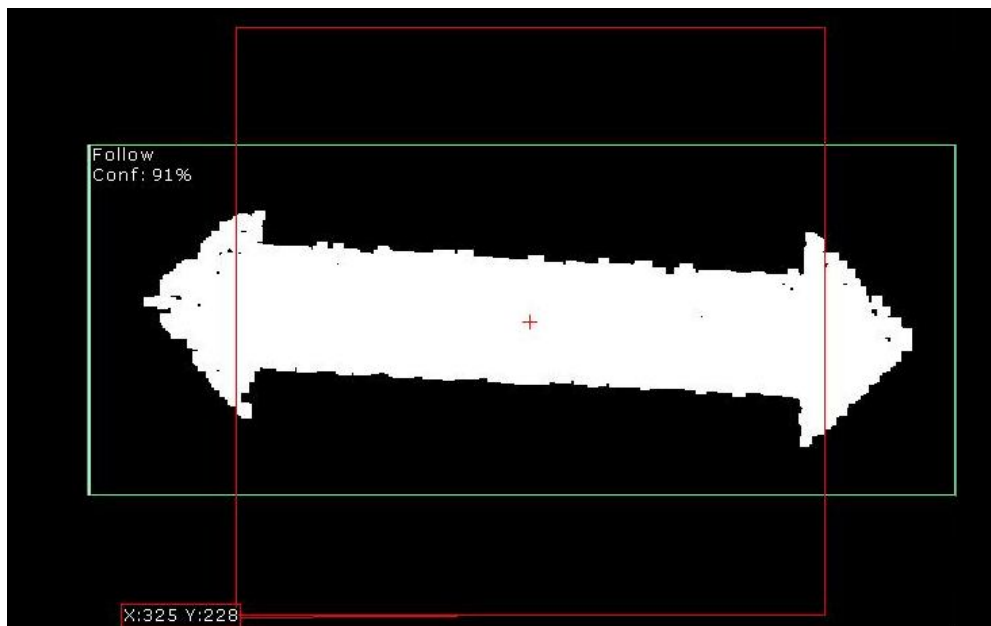
**Figure 17: Command as Recognised by RoboRealm**

Below is an image taken from the RoboRealm software once the symbol for the “follow” command has been successfully detected. Included in the image are the surrounding boxes for the centre of gravity of the blob (required in the Visual Basic script file) and the confirmation box that the symbol has been correctly identified. Appendix C contains the RoboRealm pipeline program used in the sequence to enable the Roomba vacuum robot to follow the main robot.

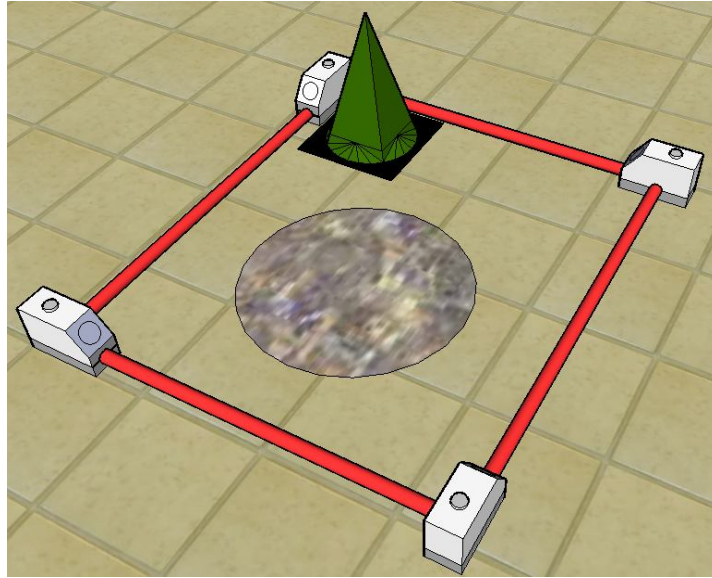
**Figure 18: Spillage Marked for Attention**

However the concept was discontinued for a number of reasons; for the Roomba to enter the area to clean the spillage the IR barriers would need to be deactivated upon approach of the vacuum and activated once the Roomba was within the required area. This would have required that some additional components be added to enable the barrier system to be able to detect the presence of the Roomba. The purchase of a minimum of three virtual wall emitters would have raised the cost, and would have been deemed excessively complicated to enable a small area to be cleaned. The additional problem was a means by which the robot would still detect the area of the spillage and travel towards it.

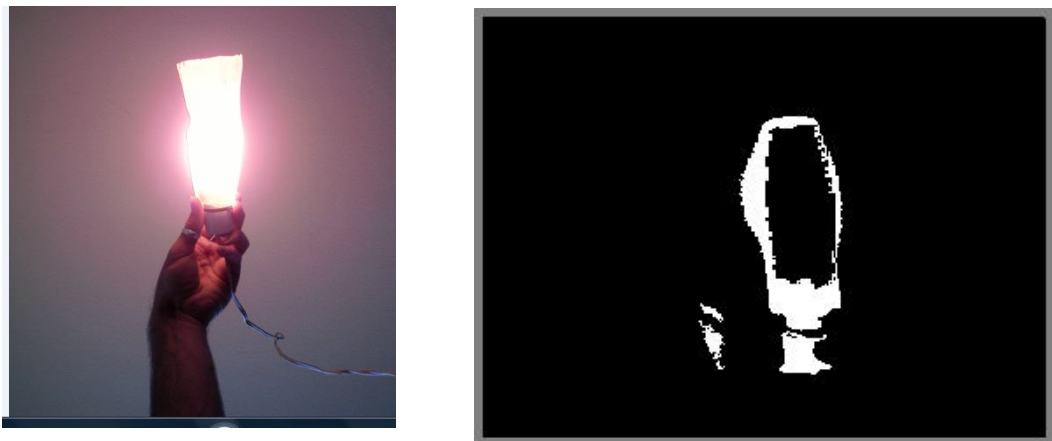
**Figure 19: Anomaly as viewed normally (left) & by RoboRealm (right)**

Once a light source was present the colour of the object would also be much more vivid and, in theory, create more of a contrast between it and surrounding colours. Taking a brightly coloured yellow cone and placing a light source within it investigated this concept. The software was trained to isolate objects matching a particular RGB (Red Green Blue) value as seen by the camera. The results were unexpected and unusable within the scenario. The object was indeed illuminated, however once the camera attempted to detect and isolate the object and convert it to a binary image, the on-screen result was not as expected. The light source saturated the image, thus giving a false reading. The right hand image below (Figure 19) illustrates the resulting image, which is similar to the "halo" effect noticed by another researcher in trying to detect a bright red spot. The left hand image is merely for comparison

The light source used was not only causing a "halo" to form around the object of interest, but once the object came close to another surface the camera was falsely detecting that secondary surface as an area of interest. This was due to the particular

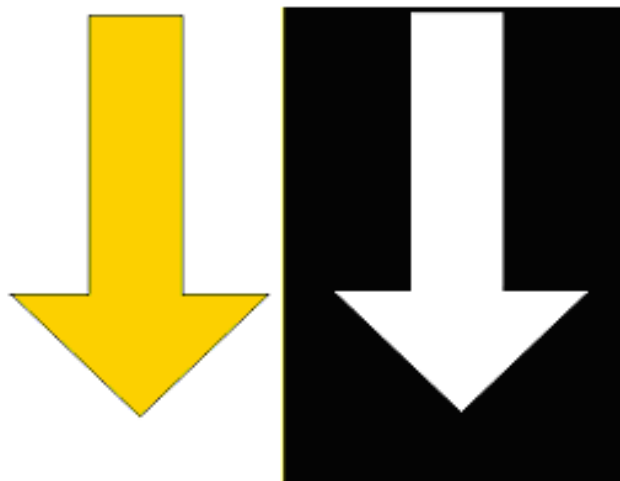
**Figure 20: Symbol Prior to (left) and Post (right) Detection**

Figure 20 above shows the yellow symbol displayed on the screen to be used for tracking and shape matching in order to determine the location of the area in need of

Based on the success achieved with the two robots, a similar solution was employed for the spot-cleaning scenario. This was initially avoided due to the hardware required for the application of this system. The aim was to keep the cost as low as was feasible while still achieving the desired goals, which resulted in the lower cost solutions being investigated prior to the addition of more costly measures to this scenario in the project. The intention was to use a small movable structure that would support any hardware necessary to allow a small monitor to display a symbol in exactly the same manner as the lead robot did while the Roomba was in pursuit.

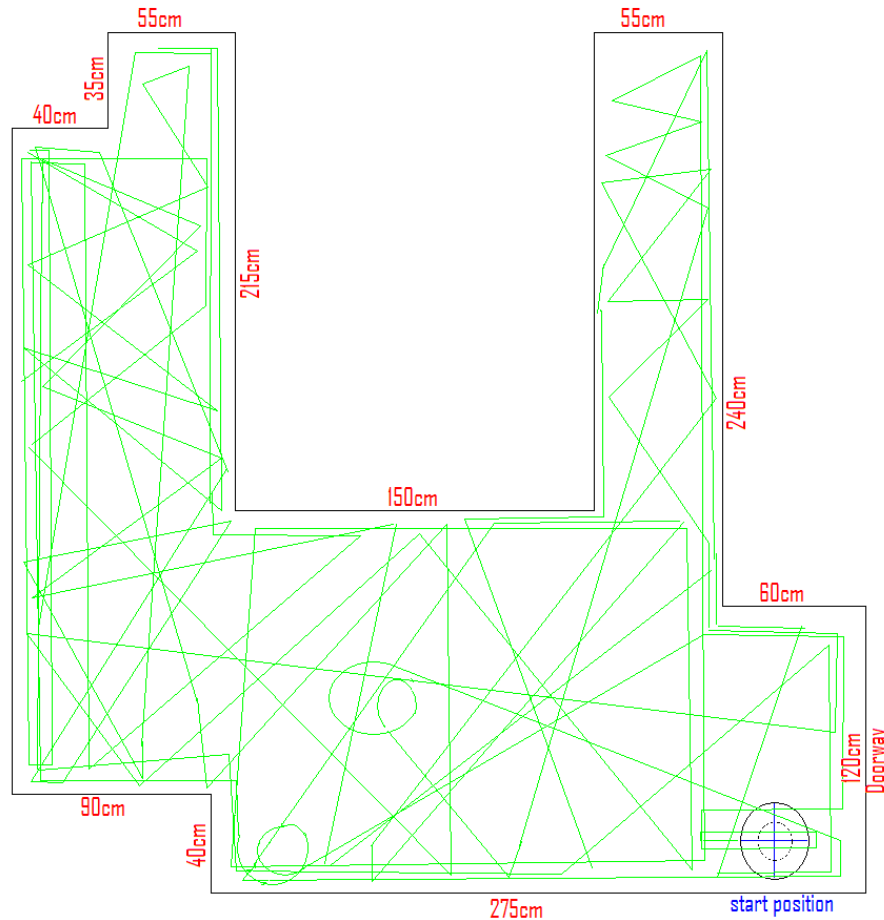
**Figure 21: Tracking path of Roomba**

complete a satisfactory level coverage throughout the entire room, however due to the random nature of the pattern, 100% coverage could not be guaranteed.

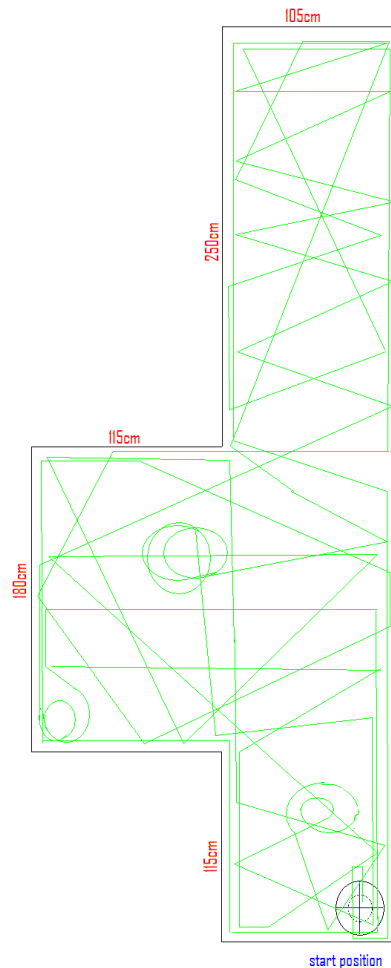
**Figure 22: Hallway testing of Roomba**

To compare the cleaning of a standard room with a section of uninterrupted hallway, testing was repeated elsewhere. Since the area of operation to be tested was significantly smaller, the time required for a successful clean was limited. The results for the hallway testing were more successful than the testing in a bedroom. The longer, straighter surfaces resulted in all areas being cleaned during all five tests ensured greater freedom for the Roomba to operate with ease. The entire area of the hallway

was cleaned each time, however efficiency of the pattern was still of concern due to numerous area being repeatedly covered.
