# Evaluation of Rumble Stripes on Low-Volume Rural Roads in Iowa— Phase II

**Final Report**  
**November 2011**

# EVALUATION OF RUMBLE STRIPES ON LOW-VOLUME RURAL ROADS IN IOWA—PHASE II

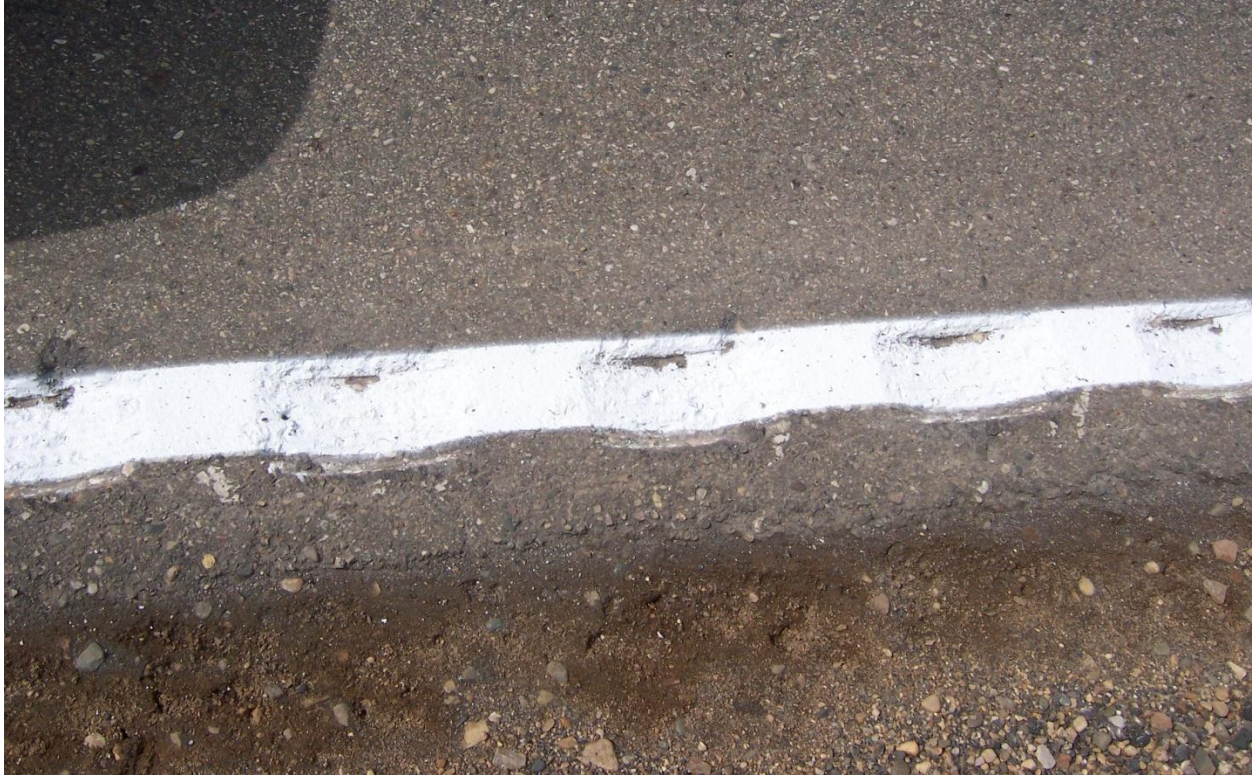
**Figure 1.1. Completed edge-line rumble stripe on a rural highway in Iowa**

Some agencies are using edge-line rumble strips on two-lane paved roadways with unpaved shoulders. Rumble strips grooved into the pavement edge can provide some alert to drivers crossing the edge line. In addition, when the edge-line pavement marking is painted through the rumble strip, the grooved surface of the rumble strip facing the driver can provide a near-vertical surface, which enhances edge-line pavement marking visibility at night and during rainy conditions. Figure 1.1 shows an example of this treatment.

Edge-line shoulder rumble strips/strips increase edge-line marking visibility and longevity because part of the line paint is located within the rumble strip/stripe depression. This feature is particularly advantageous in climates where ice and snow are present, where raised pavement markers cannot be used due to probable snowplow damage.

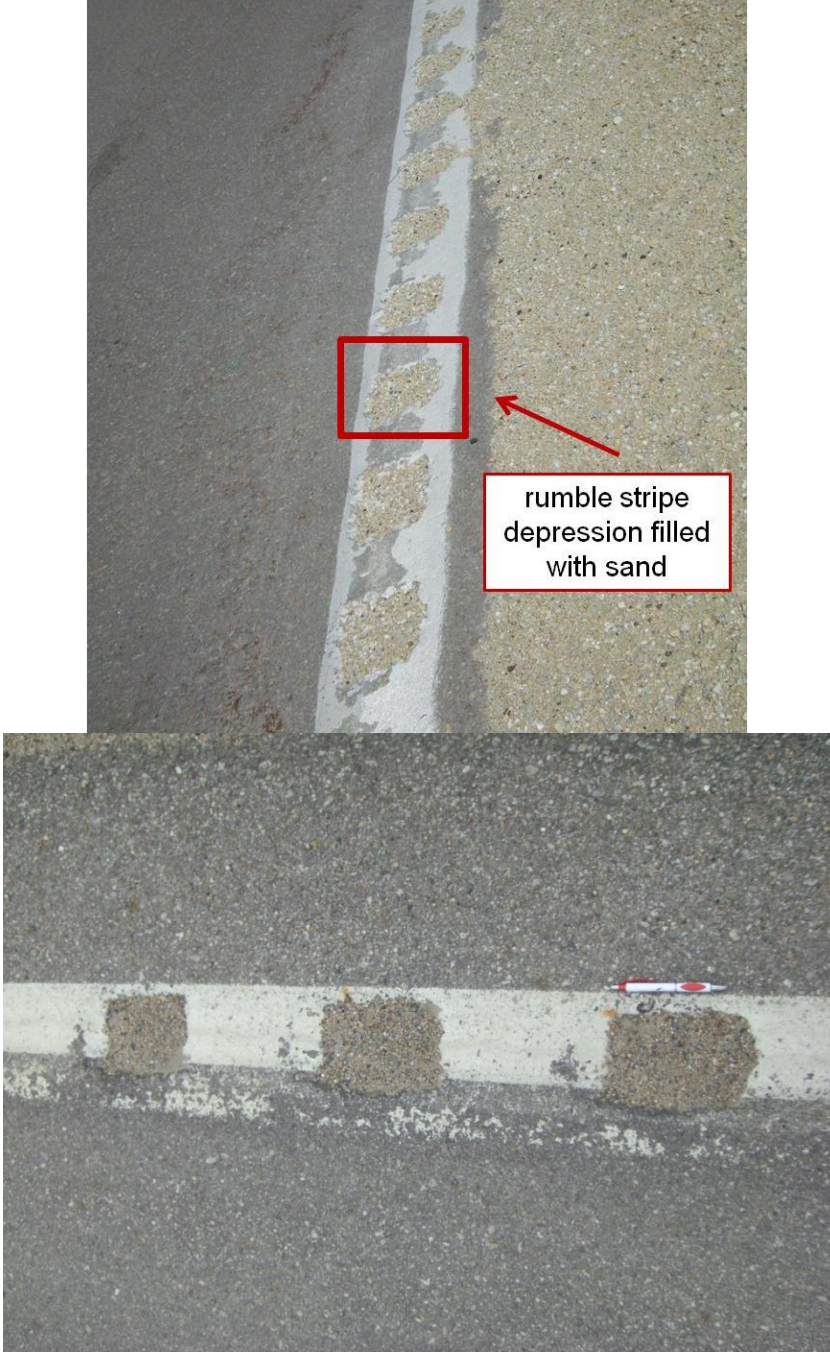
**Figure 3.4. Rumble stripe depression filled with material**

One problem that was noted with the rumble stripes was accumulation of material (sand, gravel, dirt) within the stripe as shown in Figure 3.4. The most likely cause is winter maintenance. As shoulder material is pulled up it is likely that the pavement edge is covered and the depression tends to trap the material. When this occurs, the pavement marking within the rumble stripe is not visible and the effectiveness of the treatment is compromised.

At all of the sites, a significant portion of the regular pavement markings that were flush with the pavement surface had been worn away by the snowplows. Much of the marking within the rumble stripe remained. As a result, the rumble stripe was successful in preserving the pavement marking, which will lead to improved visibility. One problem that was noted with the rumble stripes is that material (sand, gravel, and dirt) tends to accumulate within the stripe.
