AUTOMATED PAVEMENT IMAGING PROGRAM (APIP) FOR PAVEMENT CRACKS CLASSIFICATION AND QUANTIFICATION – A PHOTOGRAMMETRIC APPROACH

M. Mustaffar^{a*}, T. C. Ling^b, O. C. Puan^b

^aSurveying Unit, Faculty of Civil Engineering, Universiti Teknologi Malaysia - mushairry@yahoo.com

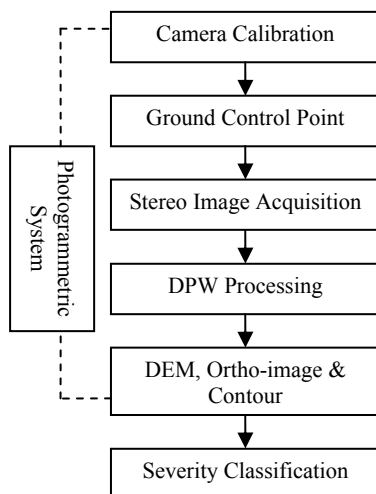
Figure 1. Schematic diagram of the photogrammetric system

An overview of the research procedure developed for pavement distress evaluation is presented. A combination of close-range photogrammetric and image processing metrology were developed in various stages and is illustrated in Figure 1 and 6, respectively.

In the first stage, a stereovision measurement technique is developed to evaluate and monitor the pavement conditions. To achieve this, several processes were conducted. These processes were categorized as, camera calibration, ground control, image acquisition and digital photogrammetry workstation (VirtuoZo) processing. The following sections describe these processes.

Ground control is currently provided by means of a frame that was calibrated in the laboratory. This arrangement was chosen because it is convenient to be used in the field.

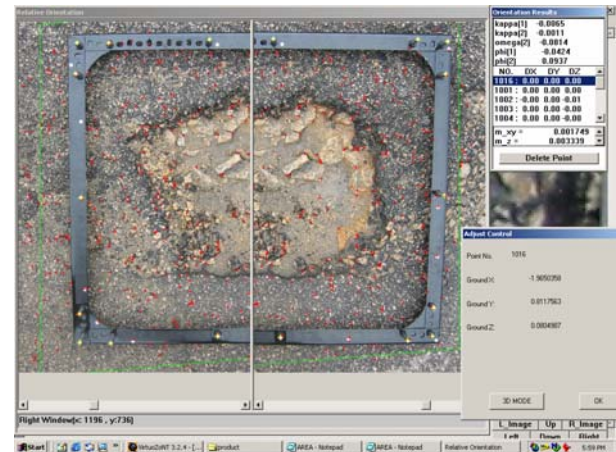
Figure 3. Relative orientation of stereo image

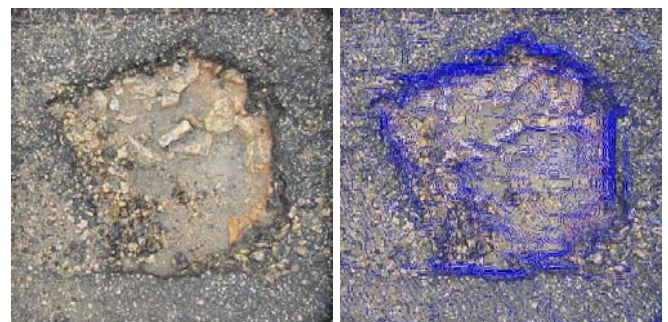
Figure 4. Ortho-image and contour overlap of pothole

After performing the steps in VirtuoZo digital photogrammetry workstation, ortho-image and contour overlay as well as 3D DEM data was generated. Figures 3 and 4 show the ortho-image and contour overlay of pothole (disintegration) distress respectively.

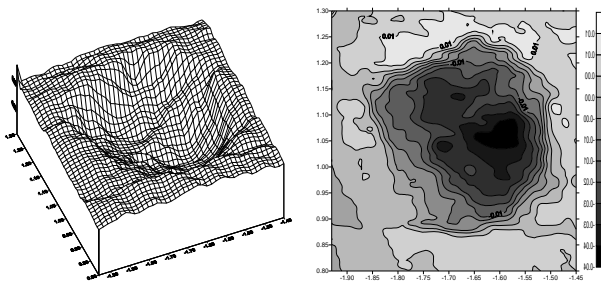
Figure 5. 3D model and contour plots generated by SURFER

3D DEM coordinates output from VirtuoZo became the input data for SURFER software and MATLAB to produce contour plotting and cross section plotting respectively. SURFER consisted of three programs: QGRID, TOPO and SURF. QGRID takes irregular data from ASCII file and created a regularly spaced 'grid'. The reformatted file was then entered into a graphics programs, TOPO or SURF. TOPO created topographic maps and SURF created three dimensional terrain surfaces. The 3D surface as shown in Figure 5 shows that the Y-axis coordinates were positive in the direction of traffic movement; the X-axis coordinates represented the measurements crossing the road; and the Z-axis coordinates area were positively upward.

Negative surface area of 3D model shown in figure was assumed as the bowl shaped cavity in the pavement surface (area of pothole). Volume and area of pothole was then calculated at about 0.00354 m³ and 0.1182 m² respectively, with the help of the program SURFER. Consequently, depth of the distress of about 29.95 mm could be easily determined by dividing the volume with the area. The severity of pothole was classified according to the DEM data based on guidelines set by the Public Works Department (JKR) of Malaysia. Based on Table 1, the pothole was classified as a moderate level.

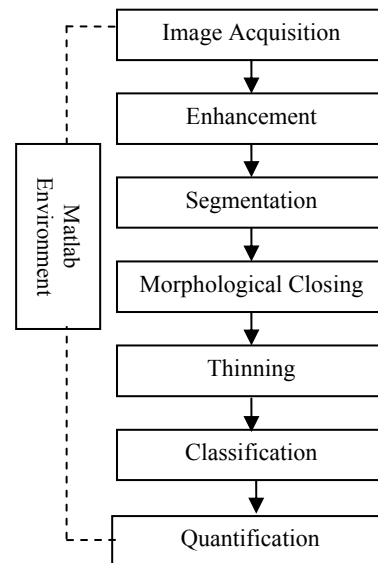
Figure 6. Schematic diagram of the Matlab environment

The second stage is to develop an Automated Pavement Imaging Program (APIP). The APIP for pavement crack analysis involved six major steps: image enhancement, image thresholding, morphology closing, thinning, distress classification and distress quantification.

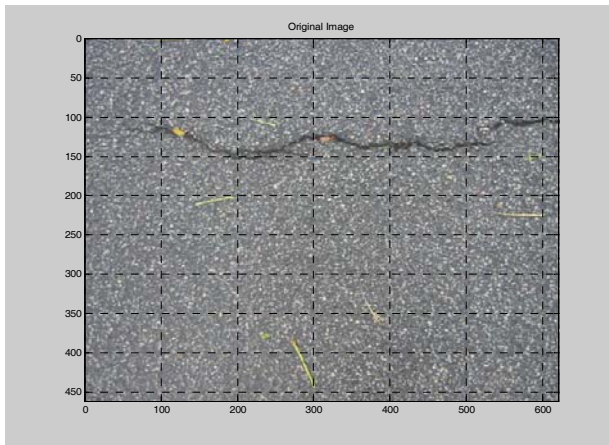
Figure 7. Original image of pavement cracks

Once the optimal threshold value was determined, the pixels with gray level below the threshold were referred to as distress pixels and pixels whose gray level value exceeded the threshold were referred to as background. The selection of an appropriate value played a very important role in the entire process since it was the value that ultimately defined the mapping of the distress features in the binary image. It is found that the simple image enhancement algorithm worked well in predicting the presence or absence of distress features on the image as shown in Figure 7. Figure 8 show the binary image obtained from proposed segmentation algorithm

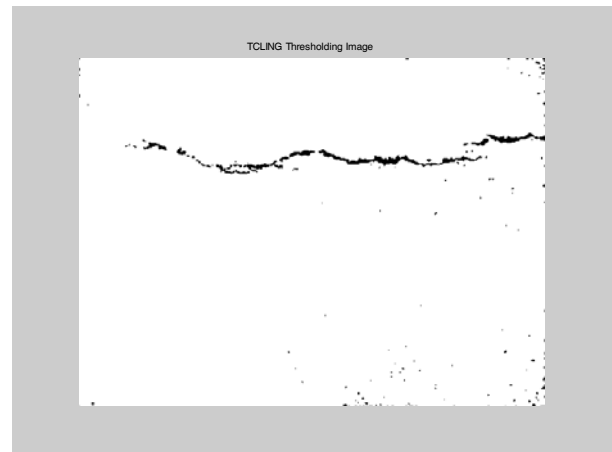
Figure 9. Image segmented of Figure 3 before closing and noise removal

Figure 9, which is a segmented image of Figure 7, shows how some noise cluster occupies open space corresponding to the background. Noise removal at the threshold of 10 pixels was applied, followed by performing morphological closing with structural element of size 5, than producing another binary image. The resulting aspect is shown in the sample of Figure 10, where it can be noticed that some of the noises have been removed and some holes being filled with object pixels.

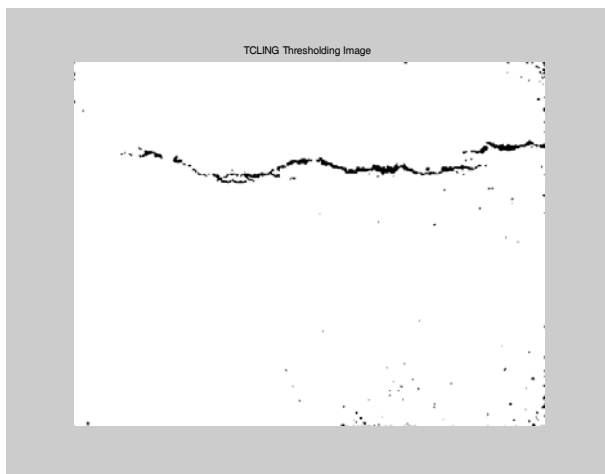
Figure 8. Binary image (proposed algorithm) of pavement cracks

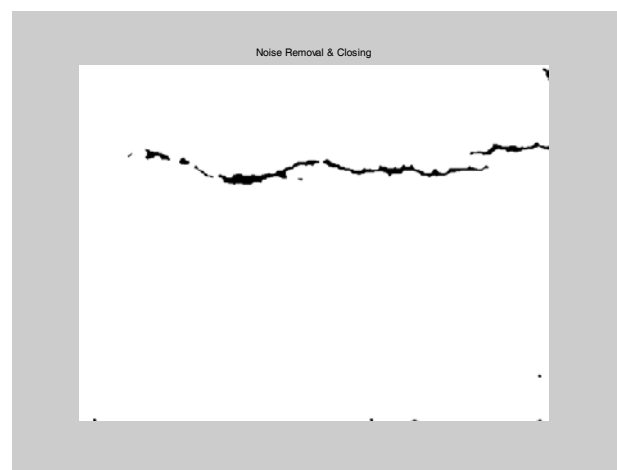
Figure 10. Image segmented of Figure 7 after closing and noise removal

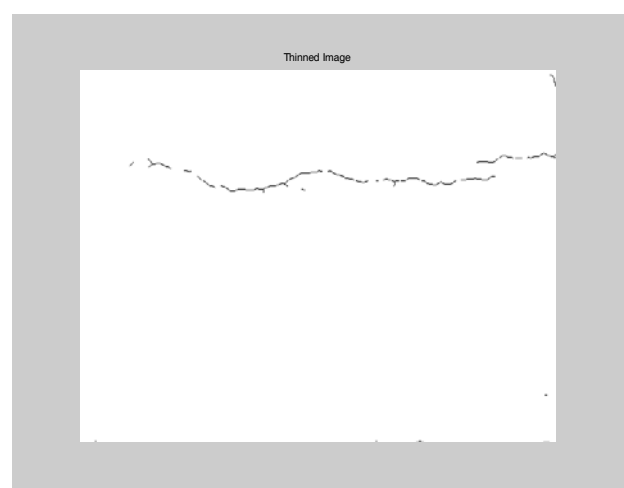
Figure 11. Image of Figure 6 after thinning

The binary image with clusters was not useful enough and had to be further processed by thinning. After thinning, a generic source image had the appearance as shown in Figure 11. Crack length was determined using the thinning algorithm based on the central lines with one pixel wide. Then, the average width of crack was obtained by dividing the area and the length. These parameters were found to be very beneficial for cracking quantification.
