## Different Properties of Coronary Stents

**Keywords:** coronary stent, mechanical properties, flaring, metallic surface area, radiopacity, fatigue test.

**Abstract.** Stents are mesh structured implants which are used to support the vessel wall in the balloon expanded vessel part. Several methods were developed and applied for the determination of mechanical properties of coronary stents, as a part of a complex pre-clinical in vitro diagnostic system: radiopacity, flaring, metallic surface area and fatigue tests. Three pieces of equipment were assembled for the examination of fatigue properties. The first method simulates the bending stress in the coronary arteries; the second method simulates the effect of the cylindrical mechanical strain which is equivalent to the systolic and diastolic pulse in the coronary arteries; and the third method is using the energy of the ultrasound concentrating to the stent. After fatigue tests stereomicroscopy, optical microscopy, scanning electron microscopy were used for the determination of surface quality and condition. The most frequent failures were scratches, pits and small shrinkage of materials originated from the manufacturing and fini

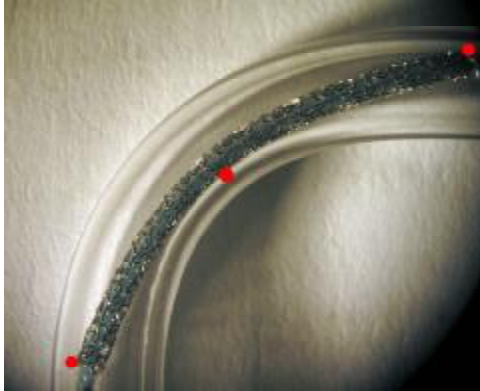
The motion of the stents was investigated and photographed under stereomicroscope to determine flaring. The implants tried to straighten the curves between the two ending points leant against the glass wall that is they showed the slightest possible bending (Fig. 5-6).

Figure 5 Stent in the tube

The examination method for assessing flaring properties of coronary stents is usable. However, the disadvantage of the model is stiffness. The vascular system embedded in the tissues is flexible, so it can suffer smaller deformations without injuries. At flaring tests the deflection of the rings depends on the strut thickness and the designs, the bent struts assist the expansion and the flexibility as well.

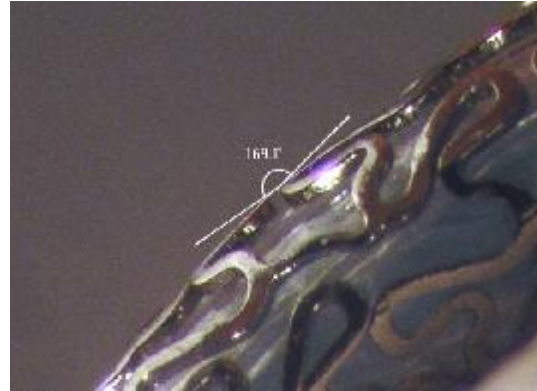
Figure 6 Deflecting rings
