National Conference on Scientific Achievements of SC & ST Scientists & Technologists  
14–16 April 2009, National Aerospace Laboratories, Bangalore-17

# Challenges in Static Testing of Co-Cured Co-Bonded Composite Aircraft Structures

Advance Composites Division, National Aerospace Laboratories, Bangalore-560017, INDIA

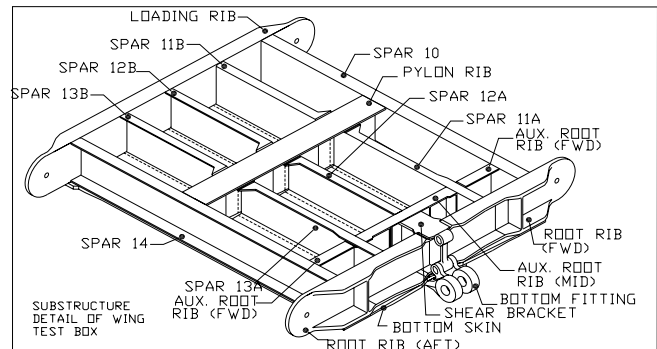
Fig. 1: Geometry of the Wing Test Box

The wing test box is designed for static loads in room temperature (RT) and hot-wet (HT) conditions. The geometry of the test box is shown in Fig. 1. The test box is about 1.6 m in length, 1.2 m in width and 236 mm in height. The structure consists of metallic and CFC (carbon fiber composite) components. The carbon fiber composite components are the spars, ribs, and skins. The thickness of the skins varies from around 16mm to 6mm. The metallic components include the root fittings, shear bracket, part of the auxiliary root rib (mid portion), and the fasteners. Spars 11 (11A and 11B), 12 (12A and 12B) and 13 (13A and 13B) and the Pylon Rib are co-cured with the bottom skin as shown in Fig. 2. A view of the partially assembled box is shown in Fig. 3.

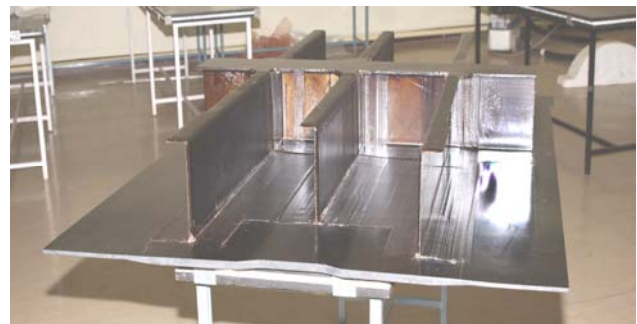
Fig. 2: A Photograph of the Co-cured Substructure

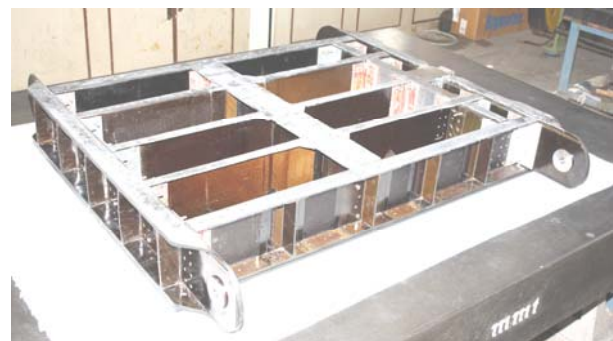
Fig. 3: A View of the Partial Assembly of the Wing Test Box

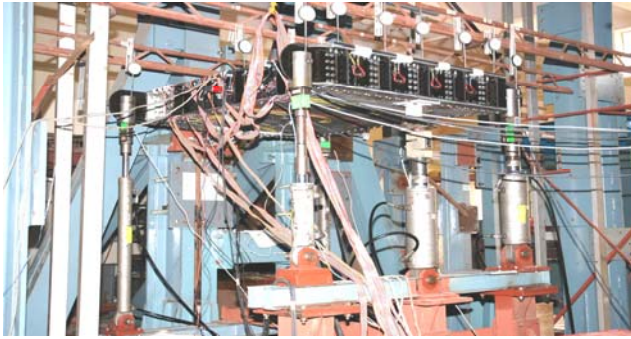
**Fig. 4:** The Co-cured Wing Test Box being Statically Tested Under Room Temperature Conditions

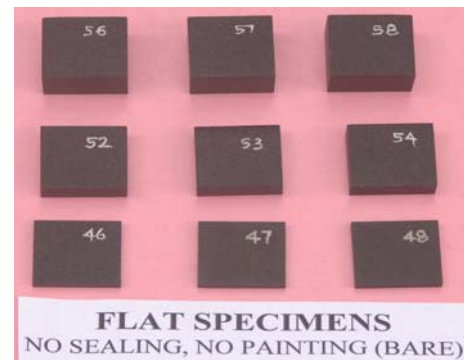
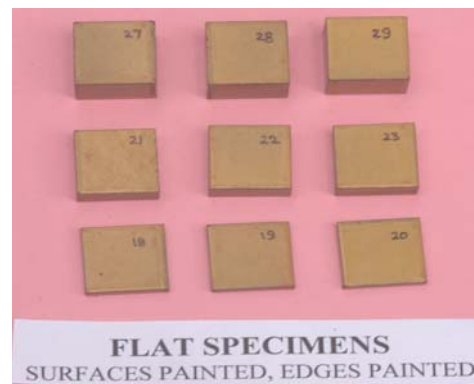
**Fig. 5:** Flat Specimens that were Saturated along with the Box. (a) Bare Specimens, (b) Painted Specimens. Each Row is a Specimen of Varying Thickness (from top to bottom, 3.6 mm, 9 mm and 15.9 mm)

specimens are shown in Fig. 5, respectively. T-joints were also fabricated and conditioned along with the test box. The schematic and the photographs are shown in Fig. 6 respectively. In addition to the flat laminates and T-joints, two sets of boxes were also fabricated and placed in the chamber. These were of the size 50 mm × 50 mm × 56 mm and of thickness 9 mm. One set was completely closed (Fig. 7). This was to study if the complete sealing of the box results in lower levels of moisture absorption. Another set had two holes of 10mm dia on two faces to allow for moisture to be absorbed from the inside of the box. Each of these specimens and features were periodically removed (once a week) and weighed and the moisture content noted. This was done until saturation in the moisture levels of all the features and specimens were observed, which took approximately 14 months. The comparisons of the moisture absorption rates for the flat specimens of thickness 9 mm and 15.9 mm with different treatments

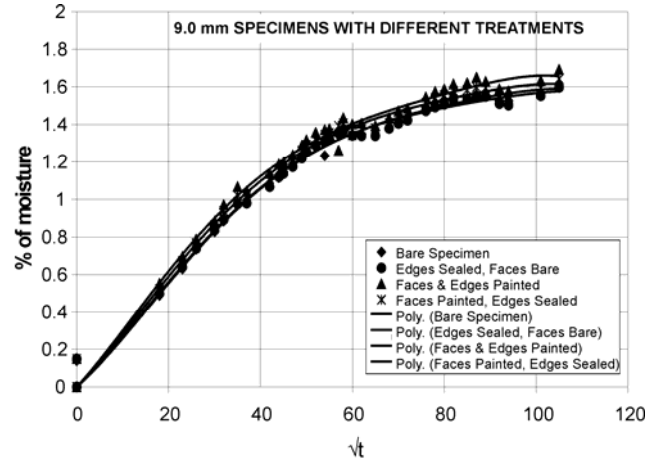
**Fig. 8:** Moisture Absorption Rates for 9 mm Specimens with Different Treatments

are shown in Fig. 8 and 9, respectively. It can be seen that the treatments do not substantially affect the rates. The effect of thickness of the specimens is shown for the bare specimens in Fig. 10. The thinner specimens absorb moisture at a faster rate than the thicker specimens although the saturation levels are the same. The moisture absorption rates for the box specimens and the T-joints are plotted in Fig. 11. The T-joints absorb moisture at a faster rate and also saturate at a higher level. The open box also absorbs moisture faster and saturates a level marginally higher than the closed box.

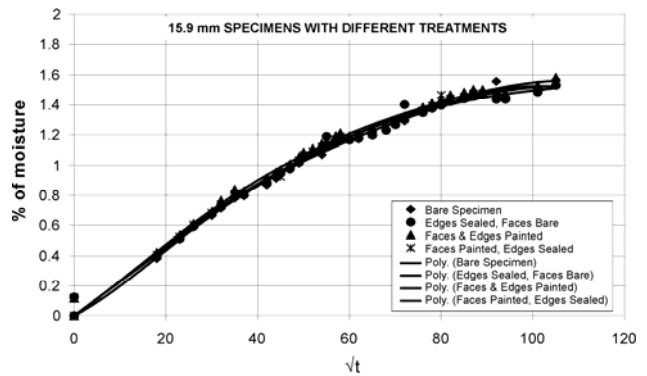
**Fig. 9:** Moisture Absorption Rates for 15.9 mm Specimens with Different Treatments

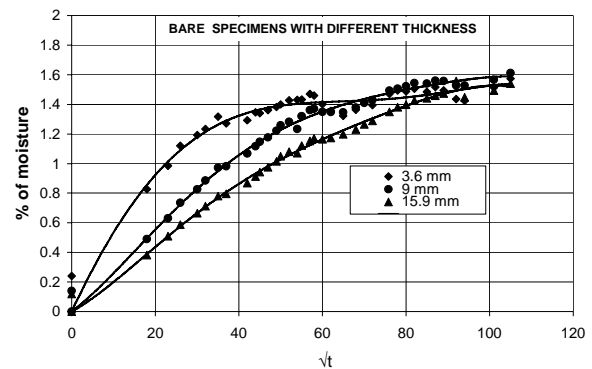
**Fig. 10:** Moisture Absorption Rates for Bare Specimens

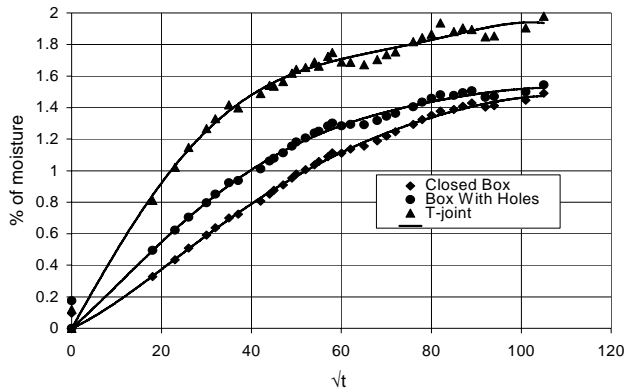
Fig. 11: Moisture Absorption Rates for Box and Joints

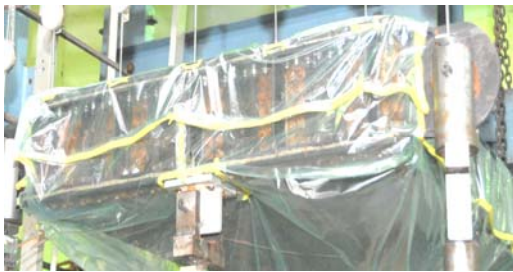
Fig. 12: Flexible Bagging Around the Box for the Steam

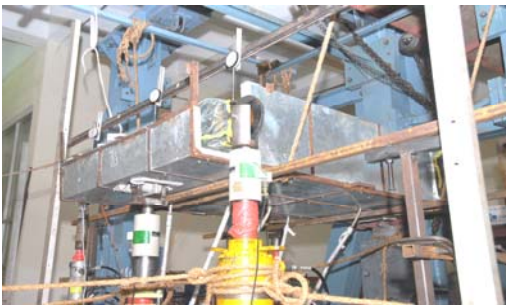
Fig. 13: Wing Test Box Enclosed in the Bag and the Insulating Outer Box

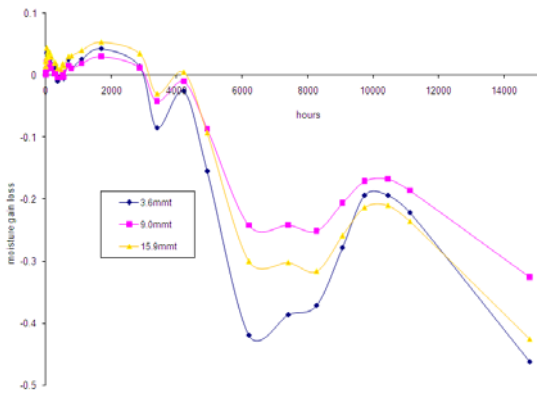
Fig. 14: Moisture Losses for Without Painting and Sealing Specimen

After the test the moisture gained, T-joints and boxes the plot specimens were kept in a room temperature environmental and periodically weighed and moisture content was noted. Similarly, the moisture losses was monitored up to 1500Hours and Fig. 14 shows the a continuous decrease in the moisture content.

A co-cured composite test box was designed, fabricated and tested. The objective of this study is to closely examine the feasibility of fabricating a large and complex structure such as a main root box of an aircraft using co-curing technology. The results of the static testing done under room temperature and hot-wet conditions are presented here. In order to conduct the hot-wet tests for such a large structure, a rational and systematic approach was conceived and applied. Specimens and features were placed along with the box in the environmental chamber for conditioning. Different treatments such as sealant and paint were applied on the specimens to study the effect of these in the moisture absorption rates. It was found that the treatments had no substantial effect on the rate or percentage of moisture absorption. To examine the effect of having a box construction on the moisture absorption, closed and open boxes were fabricated and conditioned with the test box. T-joints were also conditioned with the test box. These specimens and features were periodically inspected for the moisture content and upon their saturation the test box was tested. A special chamber using a combination of flexible bagging and insulating box structure was fabricated around the test box. Steam generators were fabricated and used to generate the steam that maintains both the humidity and temperature. The results of the hot-wet testing have shown that there is no appreciable change in the stiffness of the test box. Under these conditions, the test box was tested up to 200% of the limit load. The box was then inspected using ultrasonic scanning and it was found that the co-cured joint areas in the substructure were intact. This study thus clearly demonstrates the feasibility of fabricating a wing test box using the co-curing technique (Fig. 14). Moisture losses for without

painting and sealing specimen clearly shows that percentage of moisture will not come down drastically even if some unavoidable circumferences the chamber breaks down minimum one week during moisture absorption period.

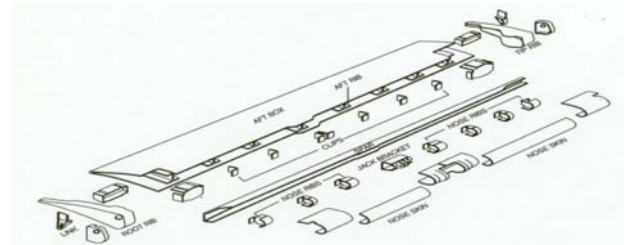
Fig. 15: Exploded View of SARAS out Board Flap

Outboard flap of SARAS aircraft is a chambered aerofoil structure with skin-rib-spar construction. It is fabricated with unidirectional carbon fiber prepregs. It has a nose box, a aft box, 10 chordwise I-section ribs and one c-section spar along the span. Exploded view of flap is shown in Fig. 15 and cross section of flap is shown in Fig. 16. The nose box, nose ribs and spar are fastened using rivets. The aft ribs are bonded to the aft skins using Redux 319 adhesive. The aft box assembly along with ribs is fastened to the spar using rivets. The secondary bonding between the aft skins and aft ribs are of the importance in this paper. Detailed A-scan, after the fabrication, revealed discontinuities in the bonding between ribs and aft box skin. Some regions are weak bonds and some regions are clear debonds. This test article was subjected to limit and ultimate load tests. Component withstood ultimate load successfully without any failure. Later detailed A-scan and thermo graphic scanning were carried out on the structure before starting the damage tolerance test. Fig. 17 shows the flap with initial debonds.

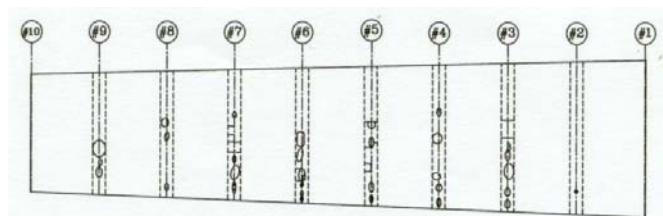
Fig. 17: Debond on the Flap before the Test

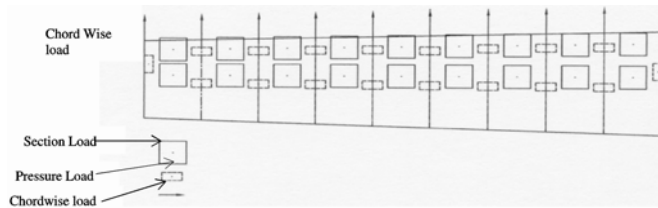
Fig. 18: Load Location on the Flap

The magnitudes of suction, pressure and chord wise loads are 394 kgs., 213 Kgs. And 106 Kg. respectively. The pressure and chordwise loads are distributed as concentrated loads at each rib location. The suction is also distributed as lumped loads to act between the ribs. This is done intentionally to avoid fouling between suction and pressure loading members. The suction and pressure loads at each rib were further divided into two loads such that their resultant lies on the center of pressure (c.p). Fig. 18 shows the all load locations on the flap.

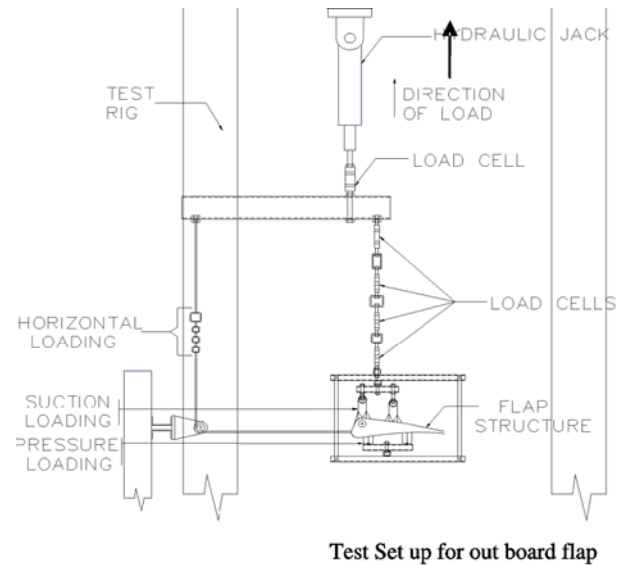
Test Set up for out board flap

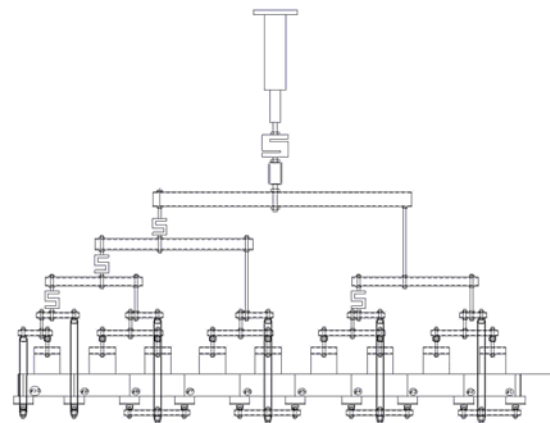
Fig. 19: Whiffletree Arrangement for Flap

The total aerodynamic load was redistributed as 46 concentrated loads (suction–18, pressure –18 and chord wise–10) for the purpose of structural testing. At least three actuators would be needed to apply suction, pressure and chord wise loads separately through independent whiffle tree systems. But, as all the loads must be applied simultaneously, synchronization of three actuators would become very difficult in cyclic loading. There should not be any phase lag between the actuators. To satisfy this condition, a special whiffle tree loading mechanism has been designed to reduce all the 46 loads to a single actuator. Pressure load at one rib is connected to the adjacent suction load. Chord wise load in the chord line direction is changed to normal direction through pulleys. Finally all the loads are carefully connected to actuator by avoiding fouling between the whiffle tree loading members. Fig. 19 shows the whiffle tree arrangement. Pressure loads are applied using the wooden pads (with rubber lining). Special canvas pads are prepared and bonded to the flap surface to connect suction and chord wise loads.

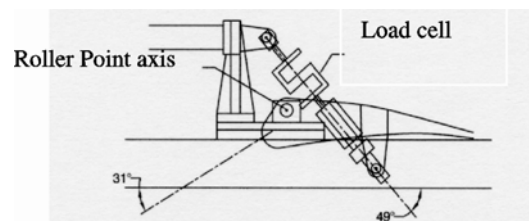
Fig. 20: Simulated Test Set Up

points in specific directions. The direction of these reactions depend on deployment position of the flap. Test is conducted for 30 deg. deployment case. The flap along with all the boundary conditions was rotated by 30 deg. in anticlockwise direction for the convenience of the testing. Flap is constrained at the roller points. Load cells are placed in the link rods to monitor the reactions. Fig. 20 shows the schematic view of the simulated test set up.

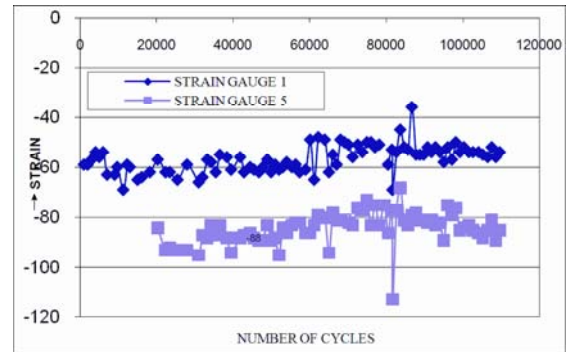
Fig. 21: Strain Plot of Strain Gauge 1 and 5

The debonds in the skin to spar interface have not shown any growth till 25000 load cycles. Later these debonds started growing slowly at various locations. Ultrasonic A-Scan revealed growth in debonds between some cycle blocks (1 cycle block = 1000 cycles). However it is found that the growth of debonds at any location is not continuous i.e., once the growth is noticed for any debond after one cycle block, further growth is not seen continuously in the next cycle blocks. Different debonds have grown by different magnitudes in different cycle blocks. Fig. 21 shows the strain plot of gauges 1 and 5 which were mounted on the debonds. Changes in strain could not be seen though these debonds have grown slightly during the test. Fig. 22 shows the strain plot of strain gauges 13 and 18 which were mounted on well bonded region, but close to the debonds. These debonds also have grown during the test but did not grow till the strain gauge. The strains of these gauges also have not changed as the growth is very small.

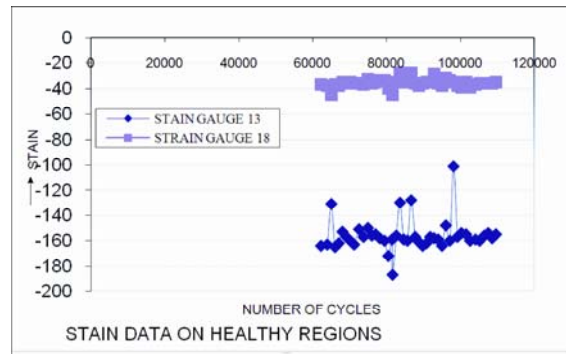
Fig. 22: Strain Plot of Strain Gauge 13 and 18

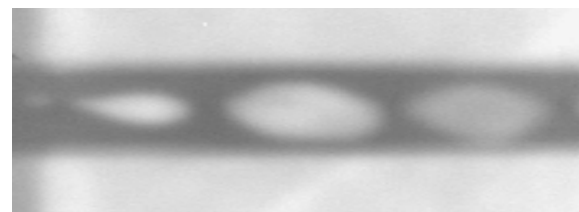
(a) Before The test

(b) After The Test

Fig. 23: Thermography Images at Rib 3

Thermography images were taken at each rib before and after the test. Fig. 23 shows

thermography images for rib 3 before and after the test. Thermography report at each rib is in good agreement with the ultrasonic A-scan report. Acoustic emission sensors are used to monitor the real time acoustic activity in the structure. It helped in the on-line assessment of damage initiation/growth and its intensity.

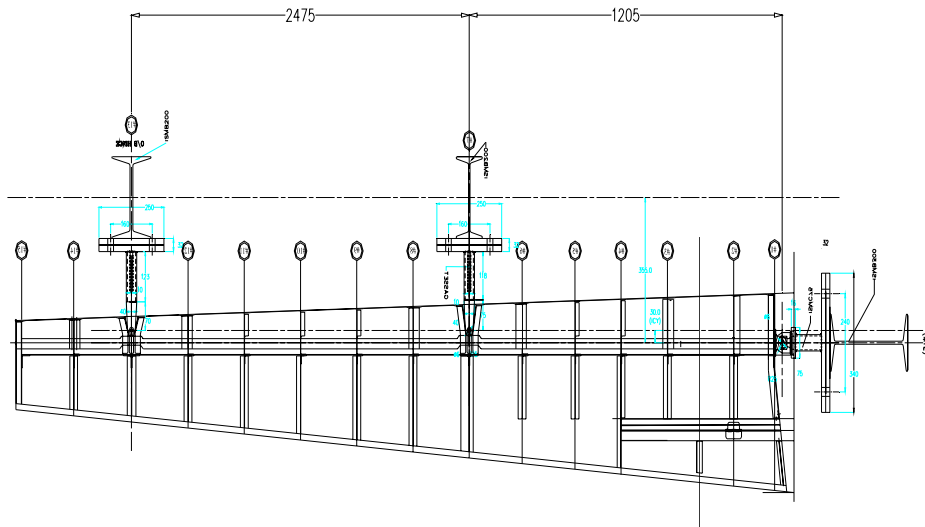
Fig. 25: Geometry of the Elevator

To demonstrate the structural integrity of the elevator, the elevator was subjected to static test. A test rig with adequate stiffness was specially designed and fabricated for elevator testing. Initial checks were made to ensure there is no rigid body displacement. The Geometry of the elevator shown in Fig. 25 The elevator is mounted to the horizontal stabilizer by means of three hinges namely Inboard hinge, mid hinge and

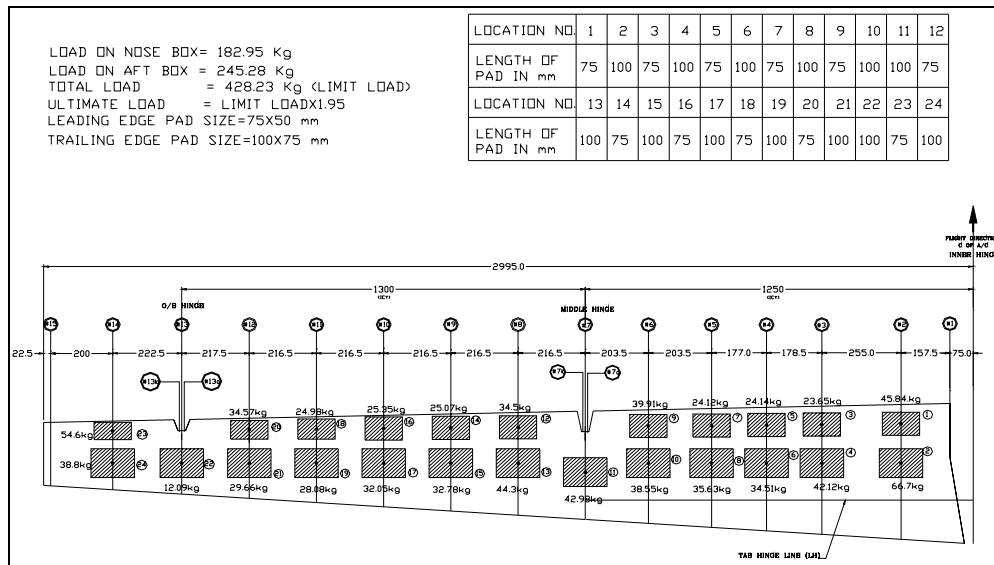
Fig. 26: Pad Location of Elevator

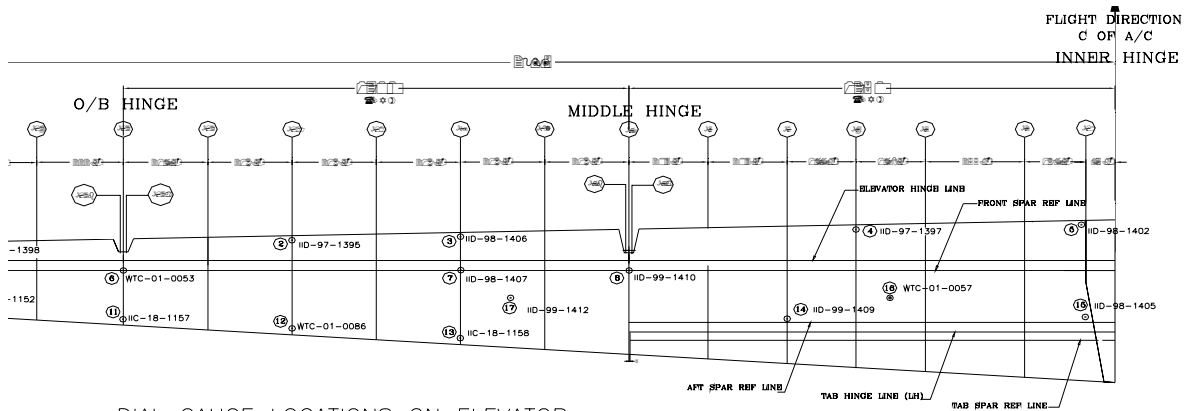
DIAL GAUGE LOCATIONS ON ELEVATOR

DIAL GAUGES 16&17 MEASURES DEFLECTIONS ON LOADED SURFACE

**Fig. 28:** Dial Gauge Locations for Elevator LH

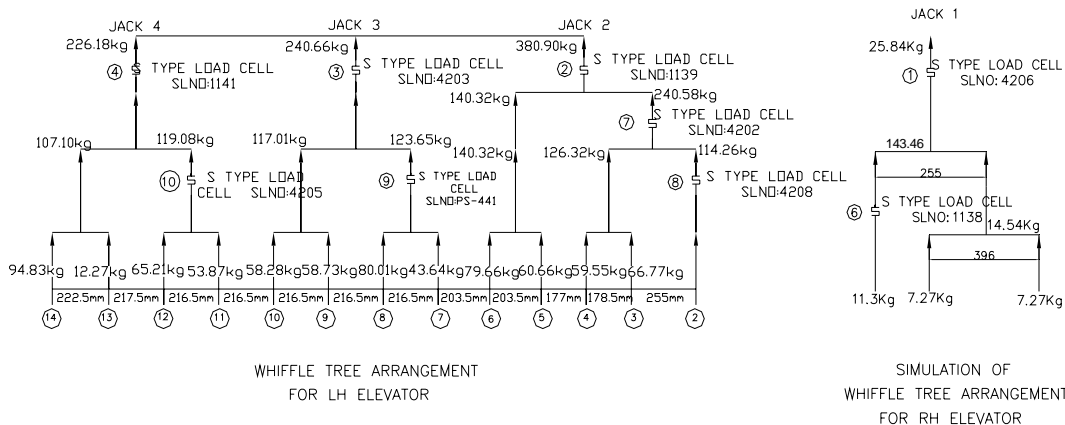
**Fig. 30:** Line Diagram for Whiffle Trees

The whiffle tree loading system is designed for various loads and reactions that are expected during the static test of elevator. The line diagram of whiffletree shown in Fig. 30. The test loads are applied through 3 jacks. The loads that are coming on the whiffle tree members are monitored using load cells at 7 locations. The directions of jack loads are such that the test loads at different stations will be acting on bottom side of the elevator in the upward direction. Simulation for the reaction & torque from the RH elevator is done by providing a suitable mechanism on the right hand side of the torque tube of elevator. The whiffle tree member, loading jacks and calibrated load cells were assembled in their respected positions. The loads were applied gradually in steps of 10% through the whiffle tree upto 198% of the limit load and unloaded to zero. The torque tube link reaction measured using a load cell during the

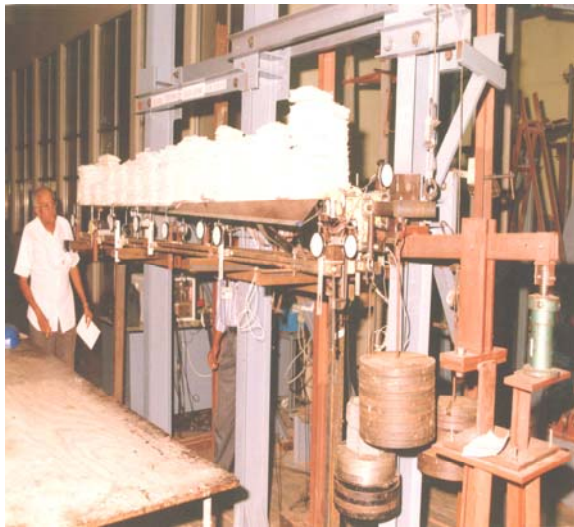
**Fig. 29:** Elevator LH Undergoing to 100% of Limit Load Test

Outboard hinge. All these supports are simulated in the static testing by suitable fixtures. The Inboard hinge of the elevator attached to the torque tube of the elevator just as it is mounted on the aircraft. Thirteen Load stations were selected for applying load and total aerodynamic load of 520 Kgs (limit load) into 24 places .Pad locations were marked on the elevator and Fig. 26 shows the pad locations. Dial gauges were mounted on leading edge, spar line and trailing edge. The exact locations for the measurement of deflections were shown in the Fig. 27. Foil type strain gauges supplied by Kyowa, Japan were mounted on the skin and attachment portions. The location of the strain gauges were given in the Fig. 28. Load was applied top surface of the elevator using lead shot bags simultaneously RH simulated loads also applied using suitable mechanism with dead weights and jacks. During loading and unloading strains, deflections and torque tube link reaction were measured during the test. The photograph Fig. 29 shows the elevator undergoing limit load test.

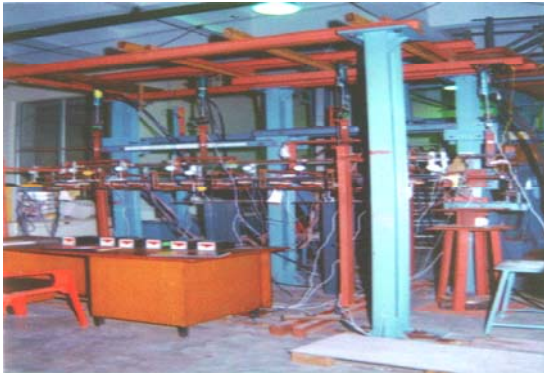
**Fig. 31:** SARAS LH Elevator Undergoing Static Testing 198% of Limit Load

test. The deflections and the strains were monitored during loading and unloading. The photograph shows the elevator is undergoing ultimate load test.

Deflections along the leading edge, spar line and trailing edge due to distributed loading were linear upto 150%. Maximum deflection recorded was 10.48 on the trailing edge. Strains at all locations were linear and maximum strain recorded was 4670 on the metallic Inner hinge link. Reaction load measured at the operating lever was 372 kg and the theoretical load expected was 363.3 kg. The test results and analysis results are compared and there is a good co relation between the test and FEM results. There is no permanent deformation in the component even though it undergone 198 % of limit load.

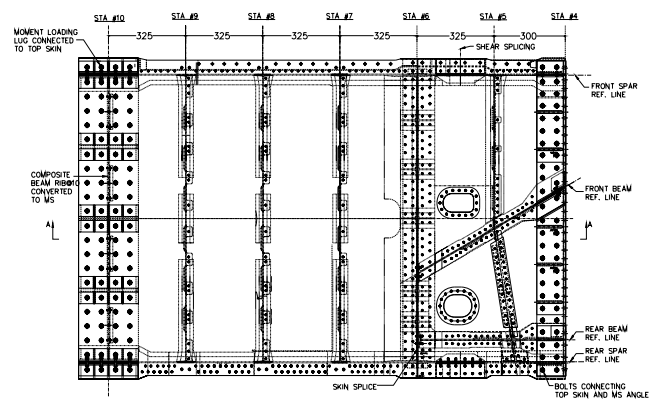
**Fig. 32(a):** Schematic Diagram of Wing Test Box-Top View

Composite test box (SARAS Composite wing) is basically a cantilever box beam structure with dimensions equal to  $1140 \times 275 \times 2050$  mm (width  $\times$  height  $\times$  span). Box contains top and bottom skins to take global bending and inplane shear, two spars to take transverse shear and six ribs to resist differential displacements between two spars at various sections of the box and also to prevent skin and spar buckling. The Geometry of the top skin and bottom skin are shown in Fig. 32(a) & 32(b) respectively.

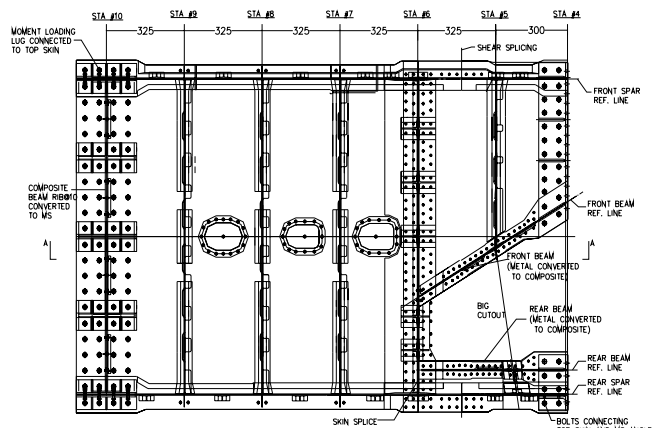
**Fig. 32(b):** Schematic Diagram of Wing Test Box-Bottom Skin

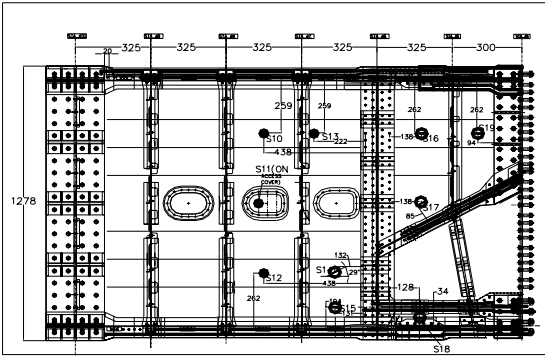
Fig. 33: Strain Gauges on Bottom Skin

gauges, dial gauges and Acoustic emission (AE) sensors were fixed on the component. Figs. 33–35 show the locations respectively. Load was applied for bending moment generating loads at Inboard and Outboard at #10 are 3034.5 kg and 3034.5 kg respectively and Shear Loads at front spar at #7, #8, #9 are 814.59 kg, 2223.46 kg, 2970.38 kg and rear spars at #7, #8, #9 are 2366.26 kg, 1094.51 kg, 3155.30 kg respectively using the hydraulic jacks and calibrated load cells in steps of 10% limit load till the design ultimate load reached. Monitored the strains, deflections and Acoustic emission (A.E.) output at every load step. Unloaded the structure in steps of 10% limit load to zero load. Monitored the strains, deflections and Acoustic emission (A.E.) output at every unloading steps. The photograph in Fig. 36 shows the component undergoing Static testing.

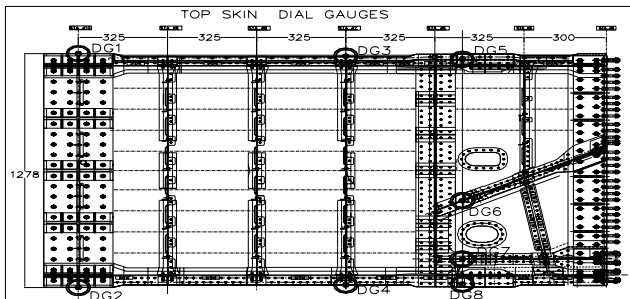
Fig. 34: Dial Gauges on Top Skin

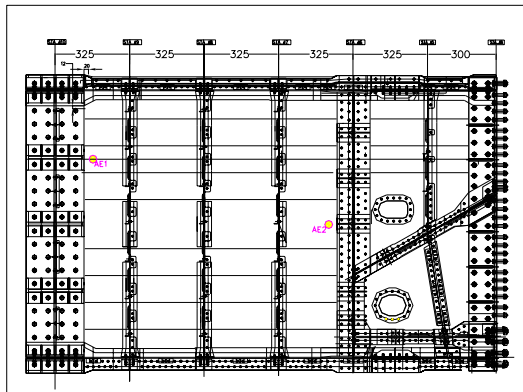
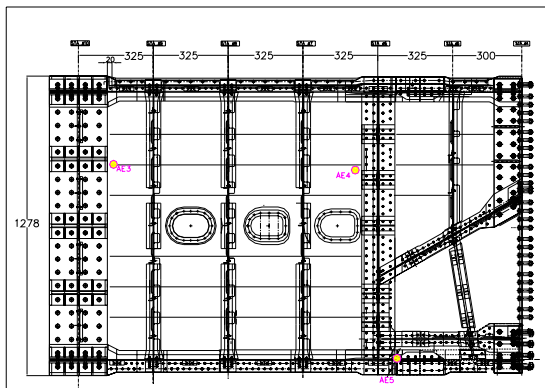
Fig. 35: Location of Acoustic Emission Sensors  
Top Skin & Bottom Skin

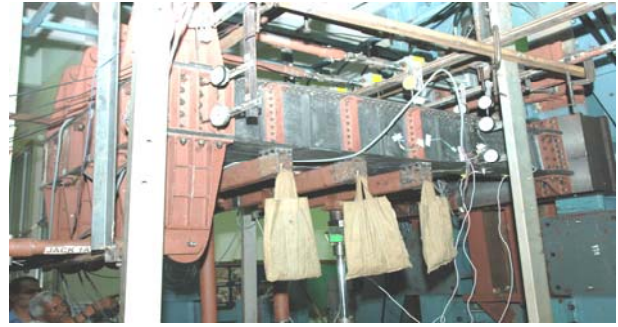
Fig. 36: Wing Test Box Undergoing Static Test

The test on wing test box has been conducted to prove the design of wing torsional box in the proposed composite wing for SARAS. The box has been subjected to the design ultimate load and the deflections, strains and AE response studied in detail. The results from the test and the analysis are compared and at majority of the locations, there is a good correlation between test and FEM results. No permanent deformations are observed in fasteners and fastener holes at skin and spar splice joints. The box withstood the ultimate load cases without any delamination or any major damage.
