EVALUATION OF TITANIUM ULTRALIGHT MANUAL WHEELCHAIRS USING
ANSI/RESNA STANDARDS

Submitted to the Graduate Faculty of
School of Rehabilitation Science and Technology in partial fulfillment
of the requirements for the degree of
Master of Science

University of Pittsburgh

2008

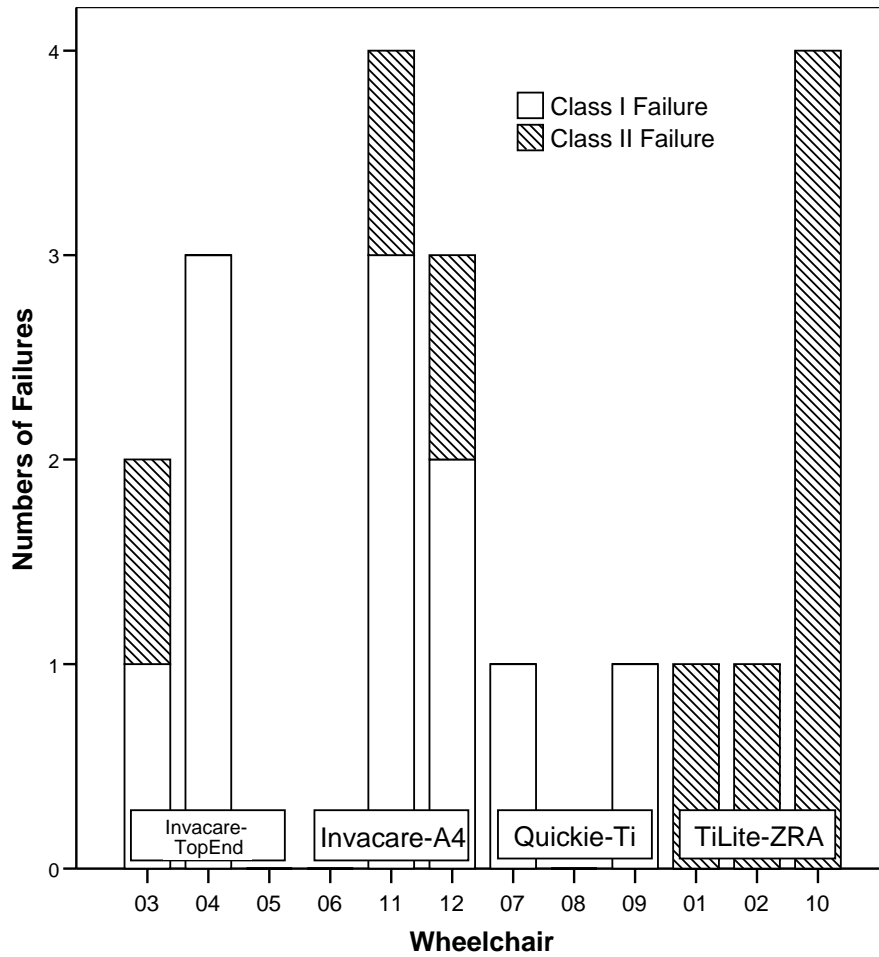
Figure 7. Numbers of Class I and Class II Failures before the Class III failure occurring during the Fatigue Tests

Numbers of Class I and II failures occurring before permanent damage are shown in Figure 7. Wheelchairs No.05, 06, and 08 had no Class I or Class II failures before the permanent frame failure occurred. The Invacare-A4 wheelchair No.11 and TiLite-ZRA wheelchair No.10 (TiLite-ZRA-10) experienced the highest number of failures (four times) before the final Class III failure. Three of the Class II failures of the TiLite-ZRA-10 were the spokes of the rear wheel, not a frame failure. If the wheel failures were not counted, eight wheelchairs experienced only

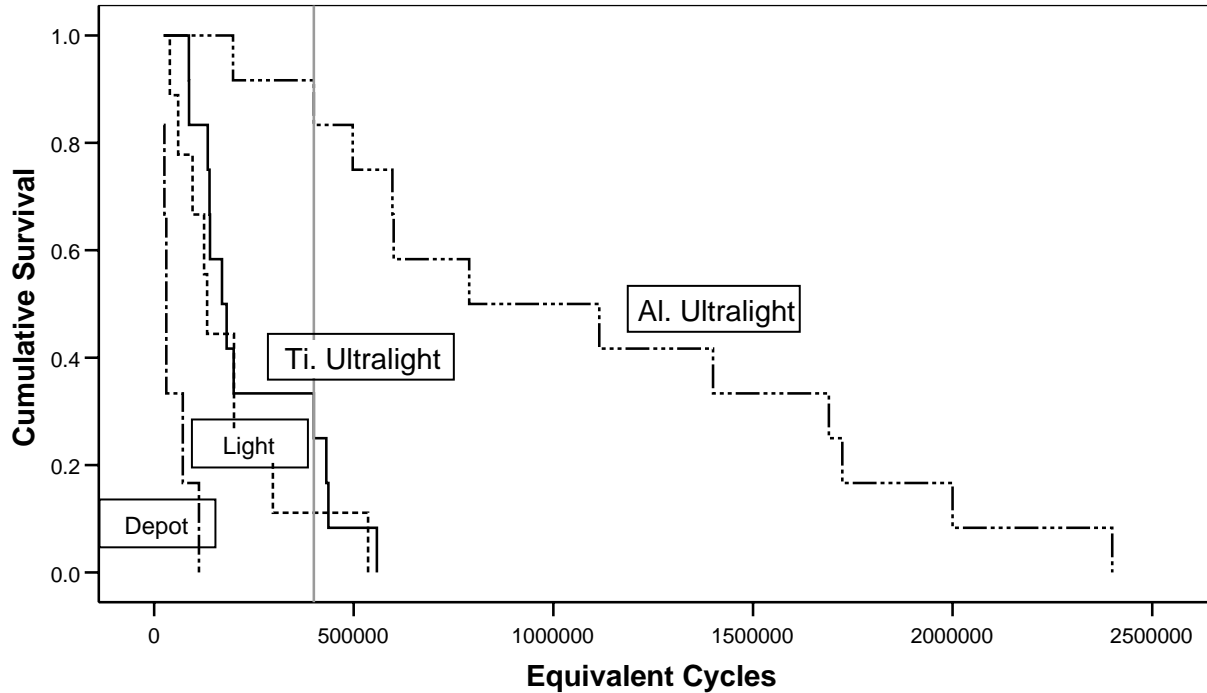
Figure 8. Survival curves for the titanium, ultralight, light-weight, and depot wheelchairs from this and previous comparison studies [7, 8, 17]. The gray vertical line indicates 400,000 cycles equivalent, which indicates passing the durability standard.

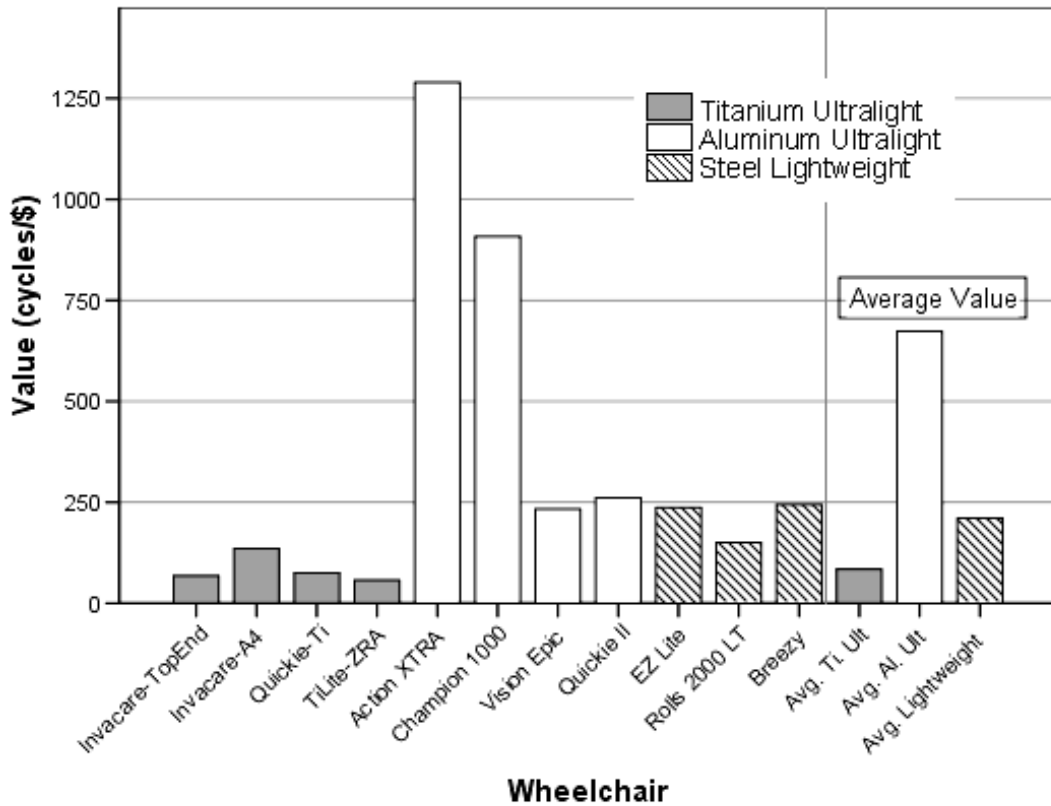
Figure 9. Value (cycles/\$) of the titanium, ultralight, and light-weight wheelchairs. The final three columns are the average value for the three types of manual wheelchairs, respectively. Standard deviation was also shown in each value.

In addition, this group of titanium wheelchairs exhibited less value than the aluminum ultralight and the steel light-weight wheelchairs (Figure 9). The aluminum and steel lightweight

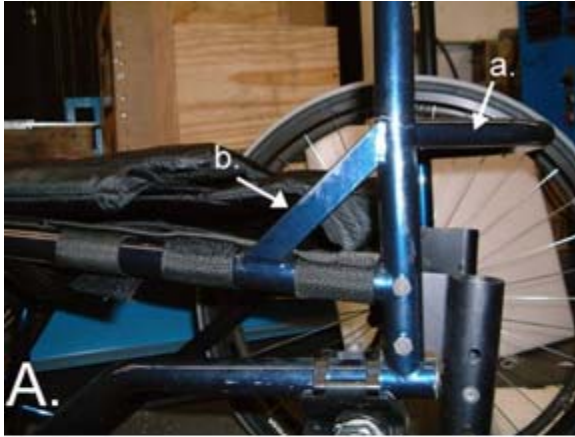
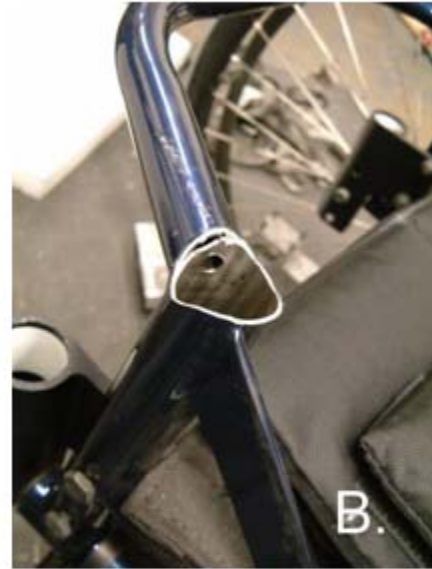
Figure 11. The structure nearby the fracture site of the Invacare-TopEnd wheelchairs. Picture A. shows the geometry relationship of the backrest cross-bar (a.) and reinforcing gusset (b.) with the backrest cane. B shows the position of the hole for inserting the gas shield. C shows one of the back rest cane fractured right at the gas insert hole.

Additionally there is a hole at the intersection of the backrest and the backrest cross-bar (b. and c. in Figure 11). This hole is purposely applied for inserting the gas flow to prevent the oxygen contamination from welding, but one of the backrest canes fractured at the hole (c. in Figure 11). Discontinuity in metal acts as a stress riser that decreases the strength of the material. The other three fractured backrest canes were broken at the superior edge of the weld area at the cross-bar. Although the weld at this site is quite thin compared with the gusset and has less chance to destroy the physical properties of the titanium, the backrest cane tended to break along the upper rim of the weld circle with the cross-bar. Heat treatment from welding likely decreased the strength of the titanium cane.

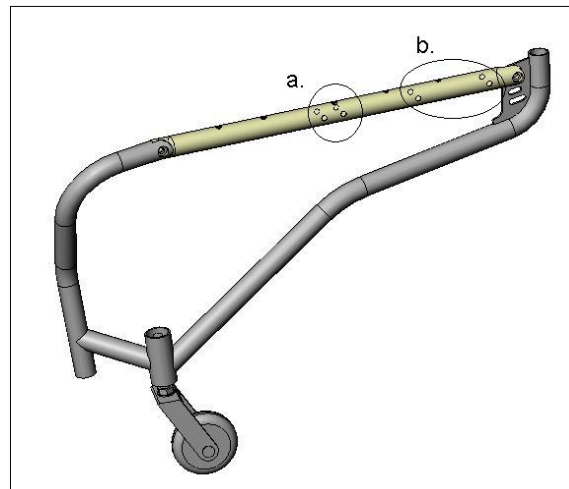
Figure 14. The left frame of the Invacare-A4 showing the locations of screw holes on the tube in the seat plane. Circle a. indicates the fracture site at the middle of the seat plane of the Invacare-A4 wheelchair with a caster stem fracture. Circle b. indicates the fracture site of the other two Invacare-A4 wheelchairs which went into the 2nd round of the DDT.
