SOLID DEPOSIT-INDUCED HIGH TEMPERATURE OXIDATION

Doctor of Philosophy

University of Pittsburgh

The present study is aimed at investigating the high temperature oxidation induced by ash deposition from use of alternative fuels. The alloys and coatings being studied are typical of those used in current power generating gas turbines, as well as those that may be used in advanced systems.

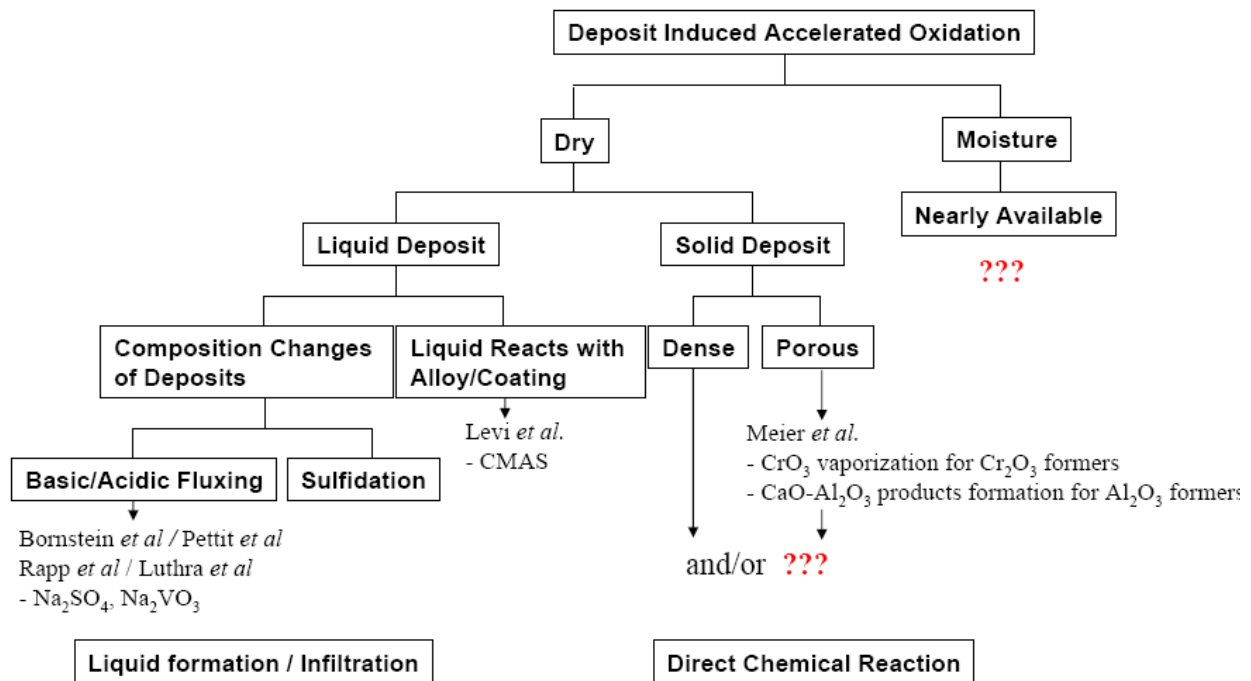
Figure 1.13 Summary of mechanisms for deposit-induced accelerated oxidation. Red question marks indicate regimes that were explored in the current study.

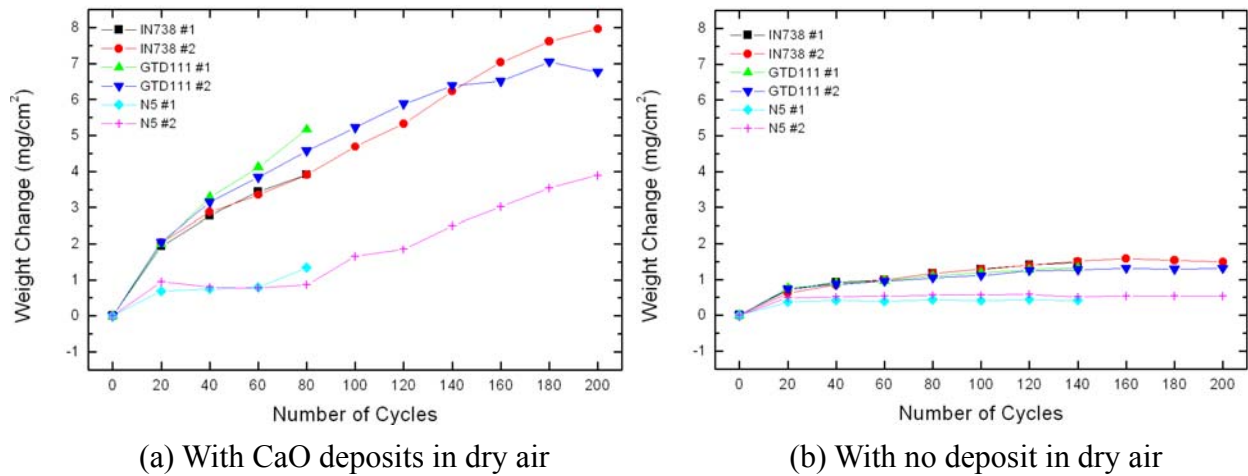
Figure 4.18 Comparison of weight change versus time measurements for René N5, GTD 111, and IN 738 exposed at 950°C in dry air (a) with and (b) without CaO deposits.

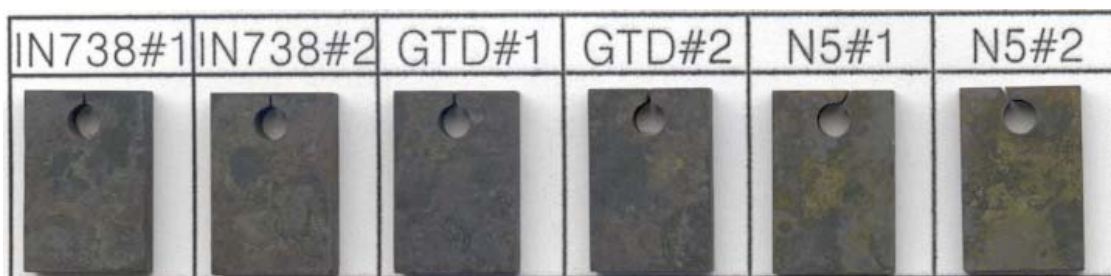
(b) After cleaning

Figure 4.19 Surface photographs of IN 738, GTD 111, and René N5 after 80 hours of cyclic oxidation at 950°C in dry air with CaO deposits (a) before and (b) after cleaning.

René N5, GTD 111 and IN 738 exposed with and without CaO deposits in dry air are presented in Figures 4.18 (a) and (b), respectively. The CaO deposits caused increased weight gains for all three alloys compared to the specimens with no deposit. The surface photographs of these alloy specimens after 80 hours exposure are presented in Figure 4.19 before and after removing the deposits. The cleaned specimens do not exhibit substantial differences between the three alloys.

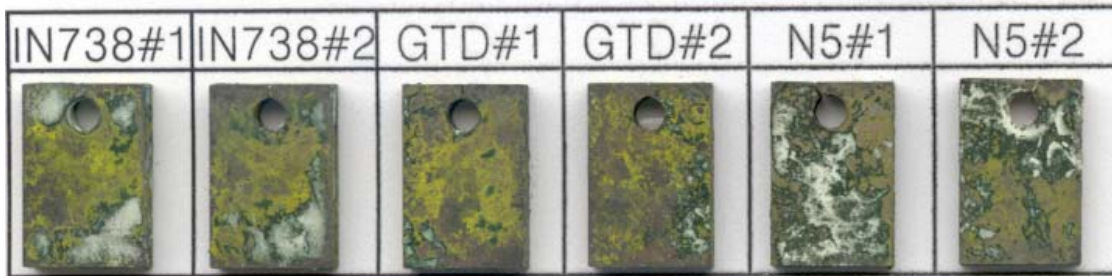
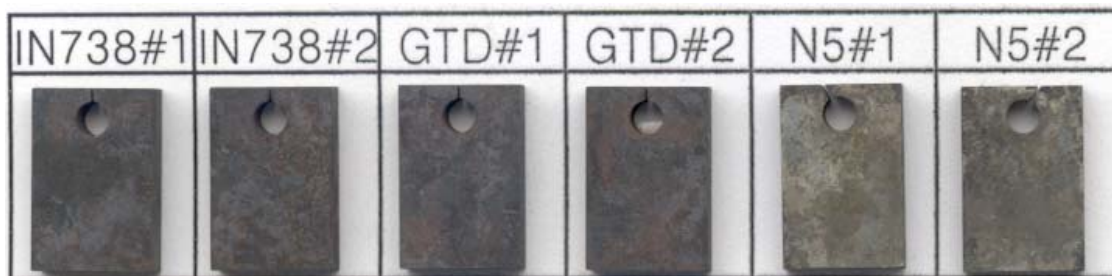
Figure 4.23 Surface photographs of the surfaces of coupon specimens after 80 hours exposure with CaO deposits at 950°C in wet air (a) before and (b) after cleaning.

The surface photographs of specimens with CaO deposits after 80 hours of exposure at 950°C in wet air are presented in Figure 4.23. The cleaned surfaces of the specimens show substantial attack. A comparison of micrographs showing cross-sections of René N5, GTD 111, and IN 738 after 80 hours in wet air with CaO deposits is presented in Figure 4.24. All three alloys show features indicating severe degradation. The René N5 specimen shows internal oxidation has occurred. The external scale is thin but it is apparent that much of the oxide has spalled. The internal oxide zone shows that the aluminum in this alloy is being oxidized

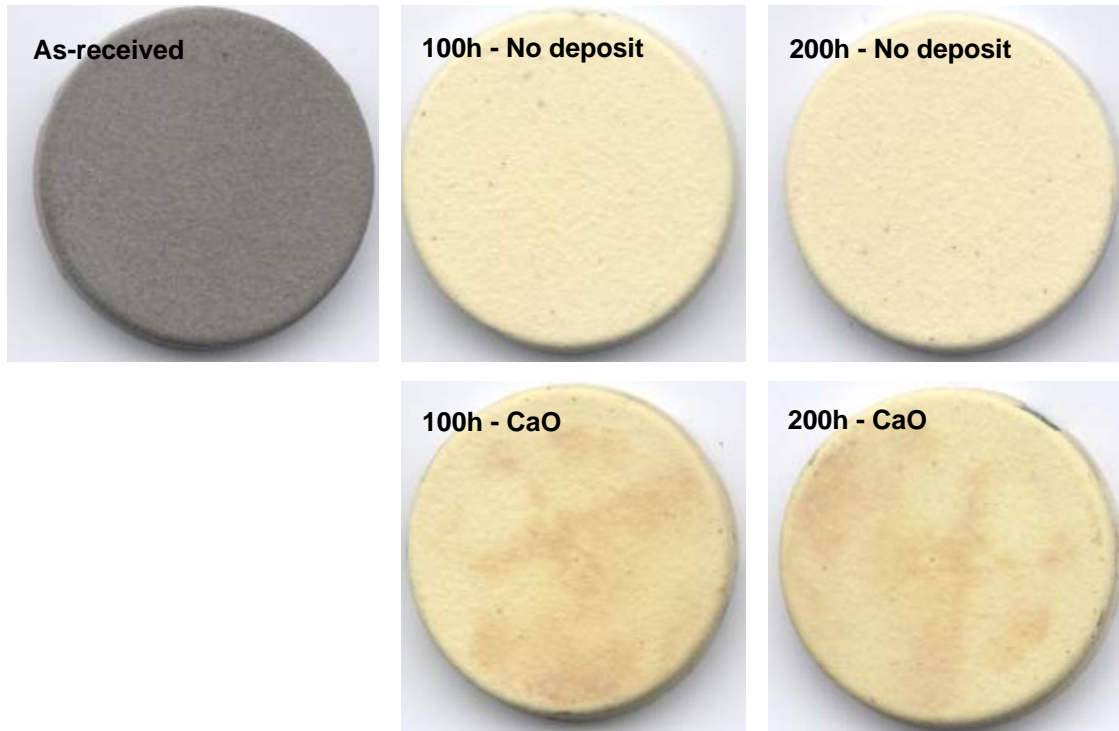
Figure 4.34 Surfaces of APS TBCs in the as-received condition and after 100 and 200 hours exposure with and without CaO deposits. The diameter of each coupon specimen is 2.54 cm.
