EARLY AGE RESPONSE OF JOINTED PLAIN CONCRETE PAVEMENTS TO  
ENVIRONMENTAL LOADS

Submitted to the Graduate Faculty of  
School of Engineering in partial fulfillment  
of the requirements for the degree of  
Master of Science

University of Pittsburgh

2005

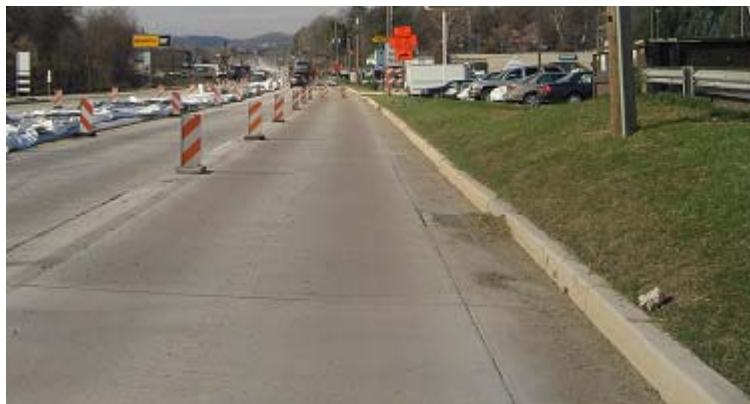
The new pavement structure is a JPCP with 15-ft transverse joints and 12-ft lanes. This section of roadway is crowned with a 2.0% transverse slope. The longitudinal slope along the research section is approximately 2.4%. The concrete medians vary in width from 14.4 ft to 2.0 ft with concrete mountable curbs. The Smart Pavement section contains 2.6-ft wide concrete curb-and-gutter-type shoulders at an 8% transverse slope, as shown in Figure 3.5.

**Figure 3.5 Test section in the westbound lanes.**

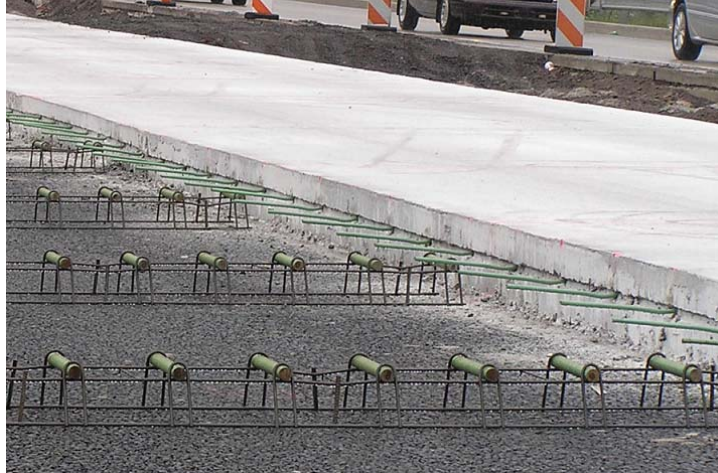
No. 5 epoxy-coated tie bars, were placed every 2.5 ft along both the lane/shoulder (l/s) and centerline joints. Epoxy coated 1.5-in dowel bars are spaced every 12” along transverse joints. The dowel and tie bar layout are depicted in Figure 3.7.

**Figure 3.7 Dowel and tie bar configuration on SR-22.**

While the sensor arrangements in these two sets of cells are repetitive, there is one key variable that sets them apart. Cells 2 and 3 are unrestrained by dowel and tie bars (see Figure 3.7) while Cells 1 and 4 contain dowels and tie bars. One of the key research objectives is to investigate the effects of the restraint condition induced by the dowel and tie bars on pavement response. Non-instrumented transition panels act to isolate the two unrestrained cells (Cells 2 and 3) from the restrained cells (Cells 1 and 4). Of the 14 panels that comprise the instrumentation section, twelve were instrumented with the remaining two acting as transition panels between the restrained and unrestrained sections. See Figure 3.30.

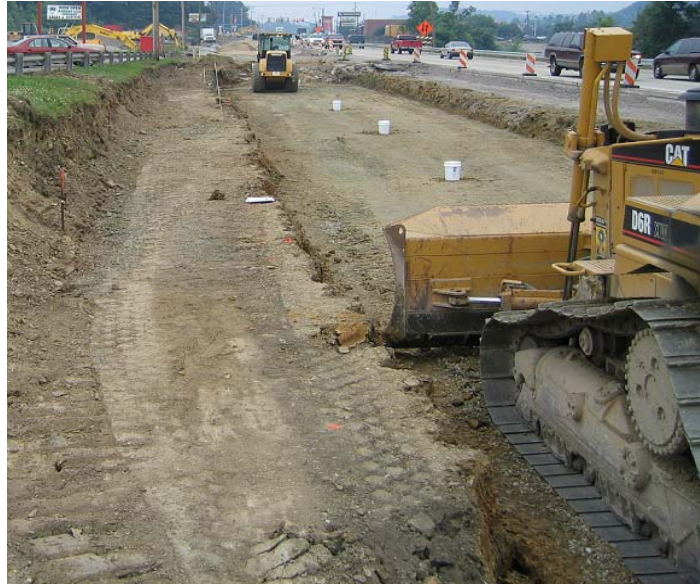
**Figure 3.9** Excavation of existing subgrade.

In order to provide a more suitable material, the existing material in the area of the Smart Pavement section was undercut to a depth of approximately 2 ft. The cut began approximately 4 to 5 ft off from the edge of the existing eastbound lane and extended the width of the lane and the curb and gutter in the westbound direction, as shown in Figure 3.9. During the site selection phase, a section for the test site was selected in a region that a cut/ fill was not originally planned. It was determined that the subgrade materials should be removed and replaced with more suitable material after the existing pavement structure was removed. However, due to project constraints, the location of the instrumentation could not be moved to an alternate location after this was discovered.

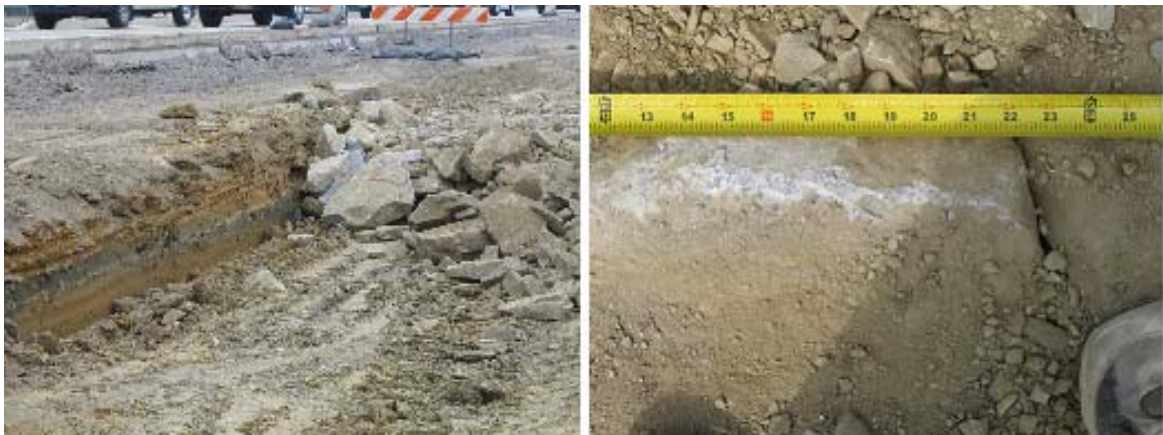
After the 2-ft cut was made, this area was then backfilled with a gap-graded soil and aggregate mixture, containing a significant amount of 206 rock. The fill material included large stone with diameters as large as 22 inches and greater as pictured in Figure 3.10.

**Figure 3.10** Backfill material containing large boulders.

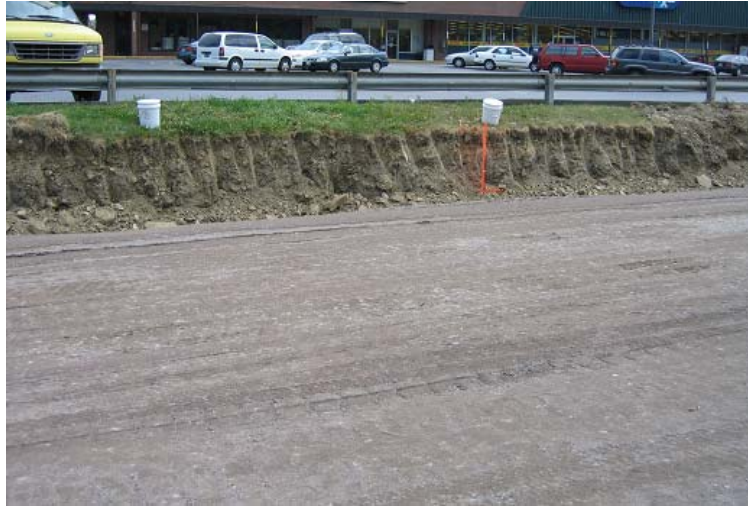
**Figure 3.12 Slag subbase placed on top of the fill material.**

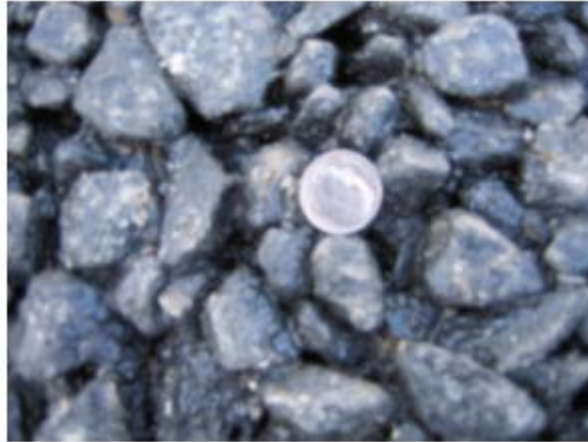
The mixture used, shown in Figure 3.13, is highly permeable since only 9.7% sand was added. Prior to placement of the PCC layer, it was noted that a 5 gallon bucket dumped on this layer would flow freely through the layer without ponding on the surface.

**Figure 3.13 Close up of the ATPB prior to placement of the concrete.**

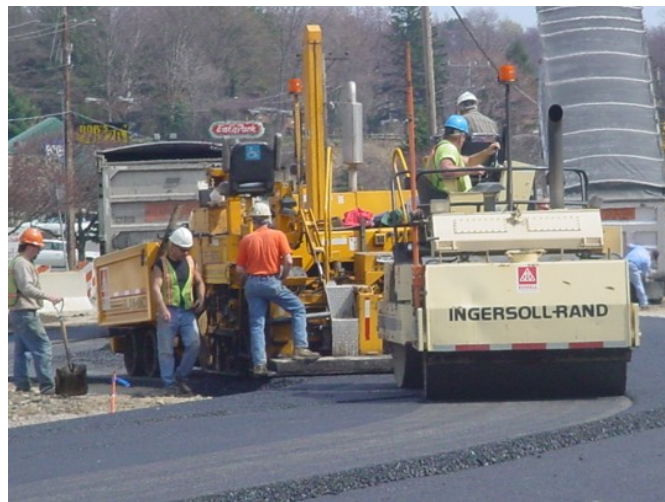
**Figure 3.14 Placement of the ATPB.**

The hot mix asphalt was plant-mixed by Better Materials Corporation located in Adamsburg, Pennsylvania and was delivered by dump truck to the project site. A photograph of the paving operation is shown in Figure 3.14.

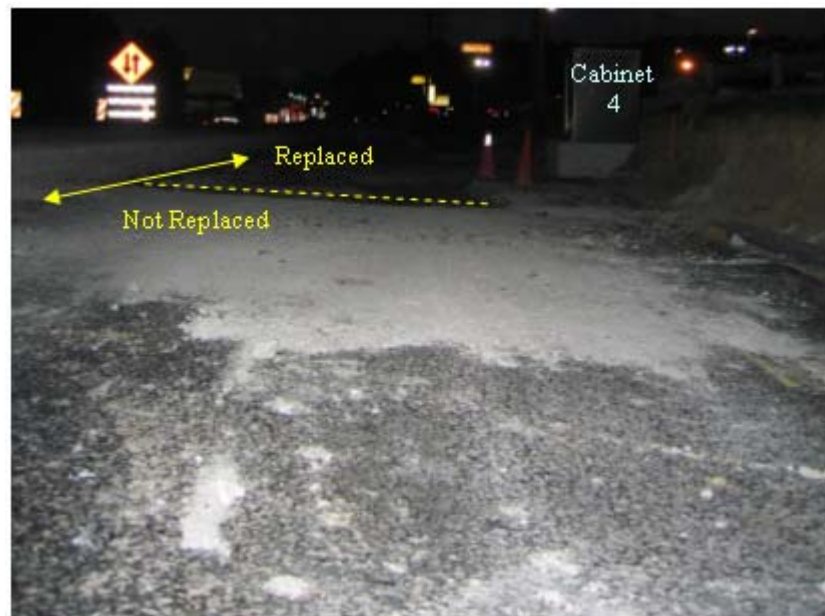
**Figure 3.15** Region PCC slabs were removed and a portion of the ATPB was replaced.

Furthermore, paving of the PCC was accidentally performed in the area of stations 94+82 to 95+42 prior to the installation of the sensors. The PCC was removed in this region. However, many of the voids near the surface of the ATPB were filled by the concrete debris created during the removal of the slabs, resulting in a less permeable base. These conditions also result in a lower degree of friction between the base and a newly placed pavement. Since these conditions would not be representative of those throughout the remaining portion of the test section, most of the ATPB in this area was removed and replaced. Some of the ATPB in an area that would not contain instrumentation was left in place, as pictured in Figure 3.15.

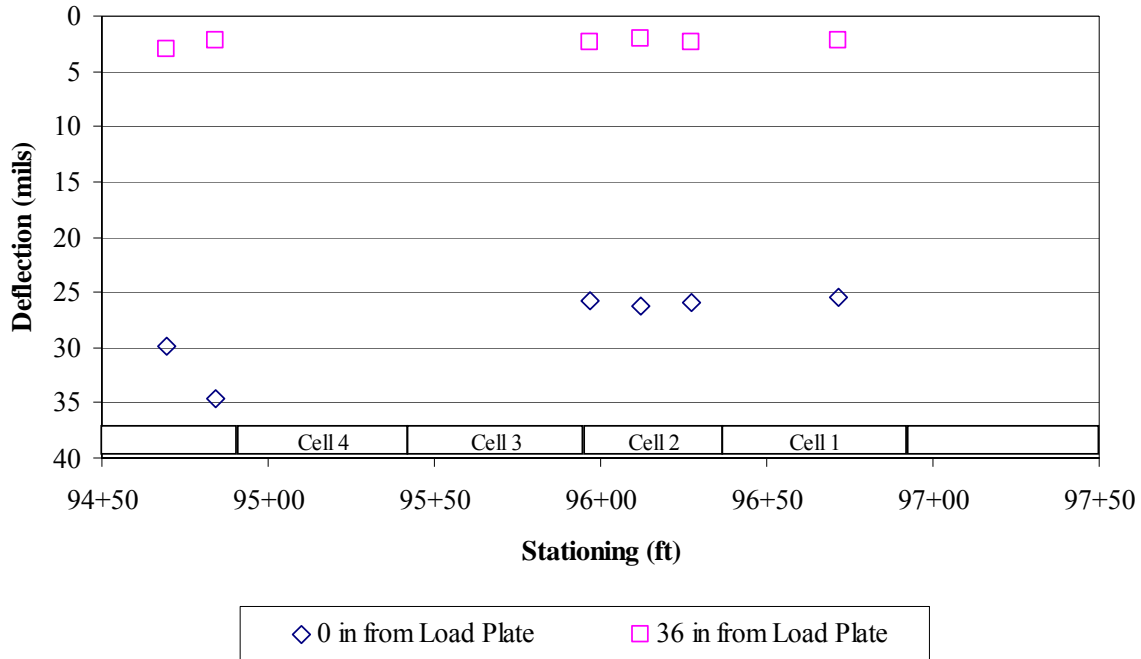
**Figure 3.19 Deflections measured on top of the ATPB .**

The average resilient modulus of the subbase and backfill near Cell 4 is 14,400 psi with a standard deviation of 3,060 psi and the average resilient modulus for Cells 1 and 2 is 19,500 with a standard deviation of 1,450 psi. The deflections from Figure 3.17 measured directly under the load plate and 36 in away from the applied load are summarized in Figure 3.18. The deflection directly under the applied load provides an indication of the stiffness of the upper layers in the pavement structure while the deflection measured further away from the applied load gives an indication of the stiffness of the lower layers. Figure 3.19 shows the deflections measured 36 inches away from the applied load to be relatively constant while the deflections measured directly under the applied load show greater variability. This indicates the lower layers have a relatively constant resilient modulus but the resilient modulus of the upper layers varies. Table 3.7 contains the average resilient modulus of each pavement layer.

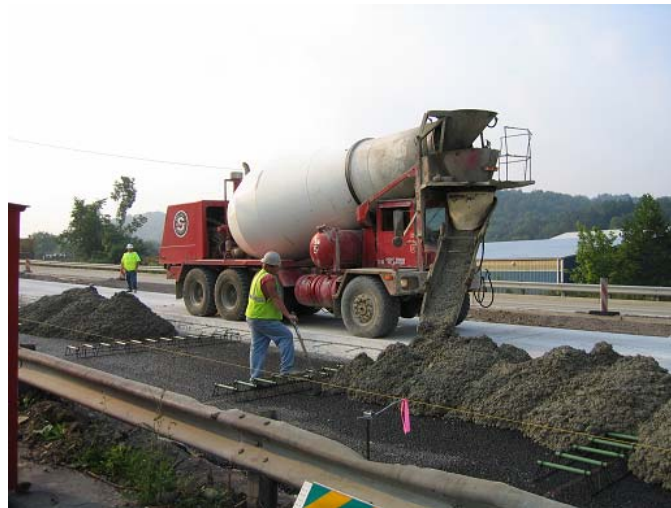
by Stone and Company. It was mixed at a portable plant located approximately five miles east of the project site in Export, Pennsylvania and was delivered to the site via front-discharge mixer trucks, as shown in Figure 3.20.

**Figure 3.20 Concrete truck delivering fresh concrete to site.**

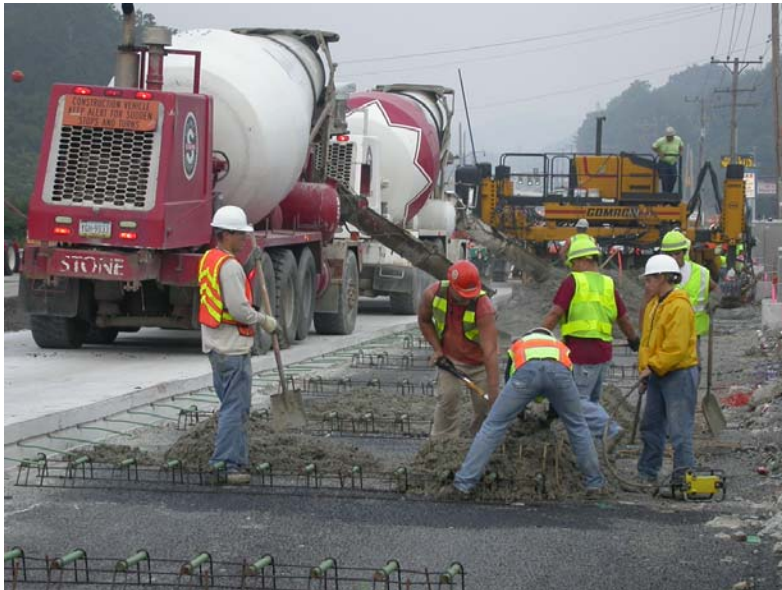
The eastbound pavement was previously placed so only the westbound lane was being paved on August 16. The curb and gutter was tied onto this outside lane at a later date. The Gomaco paver ran off a single string-line. During paving, great care was taken to protect the sensors located throughout the slab from damage associated with the paving equipment. Prior to the passing of the paver, fresh concrete was mounded around each sensor installation by hand and then consolidated using a flexible shaft vibrator. This procedure can be seen in Figure 3.21.

**Figure 3.21** Concrete was hand placement around the sensors.

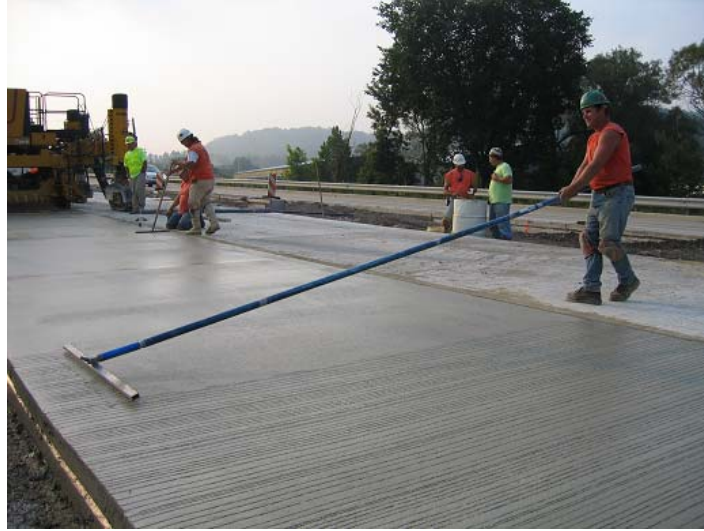
After the paver passed, transverse tining was performed, as shown in Figure 3.22, and a curing compound from W.R. Meadows, Inc., was applied to the surface. Sawing of the joints began at approximately 5:00 PM that evening. The joints were sawed to a depth of 1/3 the slab thickness.

**Figure 3.22 Application of transverse tining.**

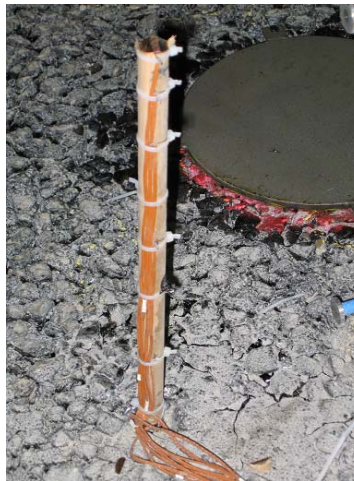
**Figure 3.23 Temperature sensor installation.**

**3.5.1.1 Temperature Sensor** Thermocouples, pictured in Figure 3.23, were selected for measuring temperature throughout the pavement structure. For the Smart Pavement project, 60 thermocouples were installed at four locations (two in the corner of the slab and two at midpanel).

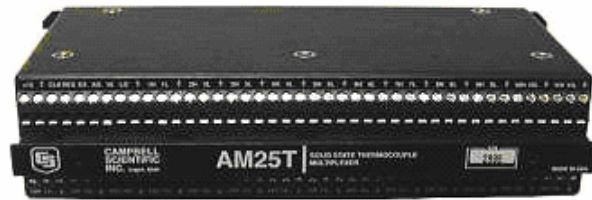
**Figure 3.24 AM25T thermocouple multiplexor,**  
([www.campbellsci.ca/CampbellScientific/Catalogue/AM25T.html](http://www.campbellsci.ca/CampbellScientific/Catalogue/AM25T.html), June 2005).

opposite ends of the thermocouples were wired to 3 separate 25-channel Campbell AM25T multiplexors. The AM25T, as shown in Figure 3.24, is wired to a Campbell CR23X datalogger.

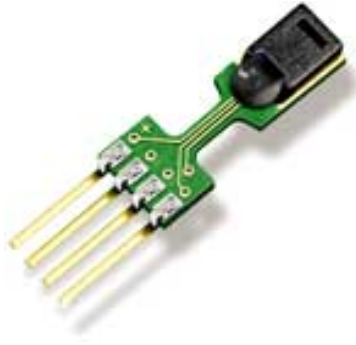
**Figure 3.25 Sensirion SHT75 Relative Humidity and Temperature Sensor, ([www.sensirion.com](http://www.sensirion.com), June 2005).**

**3.5.1.2 Concrete Moisture Sensors** In order to measure moisture levels within the concrete, 24 Sensirion SHT75 relative humidity and temperature sensors were installed in Cell 4. Procedures developed at the University of Illinois at Urbana-Champaign for the use of these sensors in concrete applications were followed (Grasely and et al., 2003). At Illinois, the sensors were used successfully in laboratory concrete embedment applications; however, a reliable procedure for the use of these sensors in large-scale field research applications had not been developed prior to the Smart Pavement Project. The SHT75 sensor is a relatively small (approximately 0.75 in by 0.25 in by 0.125 in) and cost effective means of measuring relative humidity in concrete. The module, pictured in Figure 3.25, utilizes a capacitive polymer sensing element to measure relative humidity and a band gap temperature sensor to measure temperature.

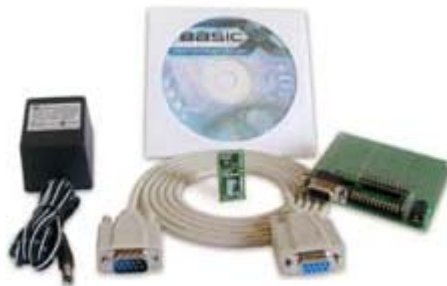
**Figure 3.26 BasicX24 microcontroller development kit, ([www.basicx.com/Products/BX-24/bx24devkit.htm](http://www.basicx.com/Products/BX-24/bx24devkit.htm), June 2005).**

In order to collect data in the field, the SHT75 must be wired to a data-collection system. For this purpose, a BasicX24 Microcontroller kit was programmed to retrieve data from the sensor. These relatively inexpensive microcontroller kits, pictured in Figure 3.26, include a wall power transformer, a 9-pin serial download cable, programming software for the microcontroller chip, and a development board, which can accommodate up to 15 Sensirion sensors.

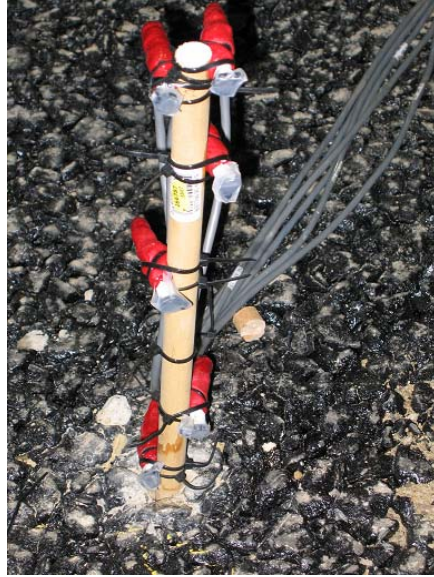
**Figure 3.27 Installation of relative humidity sensors.**

The membrane can be sealed to the cylindrical plastic enclosure using ordinary superglue. However, it is recommended to do this at least twenty-four hours prior to inserting the sensor because vapors given off from the adhesive may diffuse into the polymeric layers of the sensor, leading to unexpected errors in sensor offsets and sensitivity. After gluing, for additional support, the Gore<sup>TM</sup> Membrane Vents were tightly sealed around the circumference of the plastic enclosures using zip-ties. The opposite end of the tube is sealed using rubber electricians tape and an electricians waterproofing sealant. Similar to the thermocouples, the moisture sensors are attached to wooden dowels at given depths. The final result, shown in Figure 3.27, is a cost-effective, less invasive means of measuring PCC relative humidity than other options evaluated.

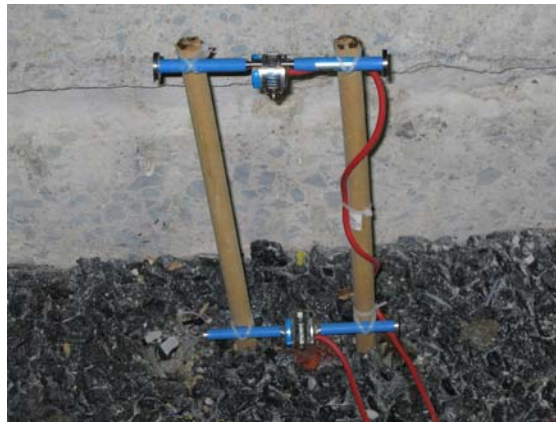
**Figure 3.28 Static strain gage installation.**

Figure 3.28 shows a typical VW strain gage configuration that was employed at the Smart Pavement study near the longitudinal centerline joint. This configuration consists of two rows of gages, one located near the top and one near the bottom of the PCC slab.

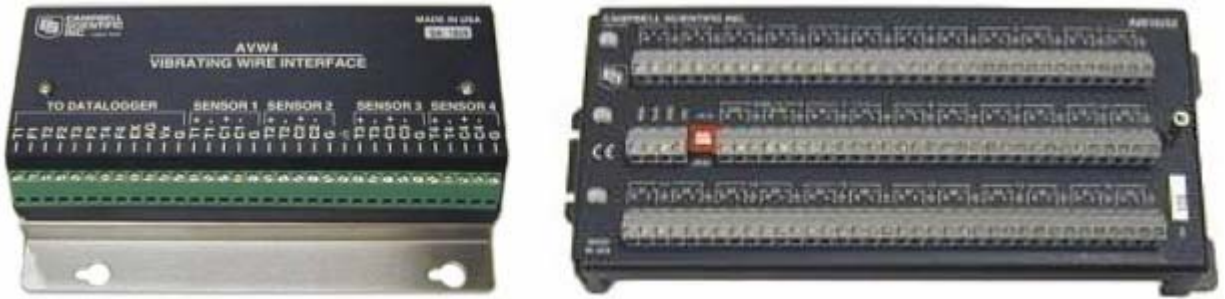
**Figure 3.29** Accessories for collecting data from the vibrating wire strain gages, (<http://www.campbellsci.ca>, June 2005).

Data from static strain gages is collected and stored on a Campbell CR10X datalogger for the Cell 3 VW gages and a Campbell CR23X datalogger for the Cell 4 VW gages. Additional components required to read the vibrating wire strain gages of the Smart Pavement project include Campbell AVW4 vibrating wire interfaces and Campbell 16-channel AM16/32 multiplexers, which are shown in Figure 3.29. The AVW4 interface contains circuitry that allows for frequency measurements taken from the strain gages to be read as voltage by the datalogger. The AM16/32 expands the number of channels that can be wired to the datalogging equipment, allowing for a multitude of sensors to be read.

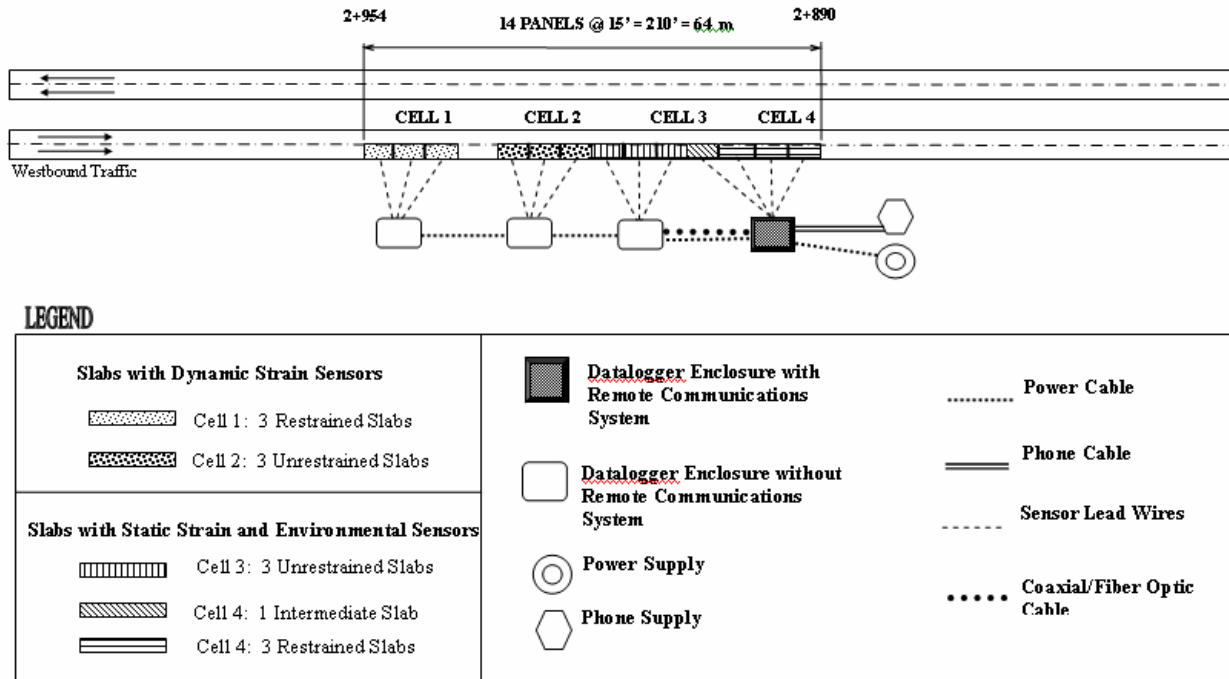
**Figure 3.30** Layout of the Smart Pavement section.

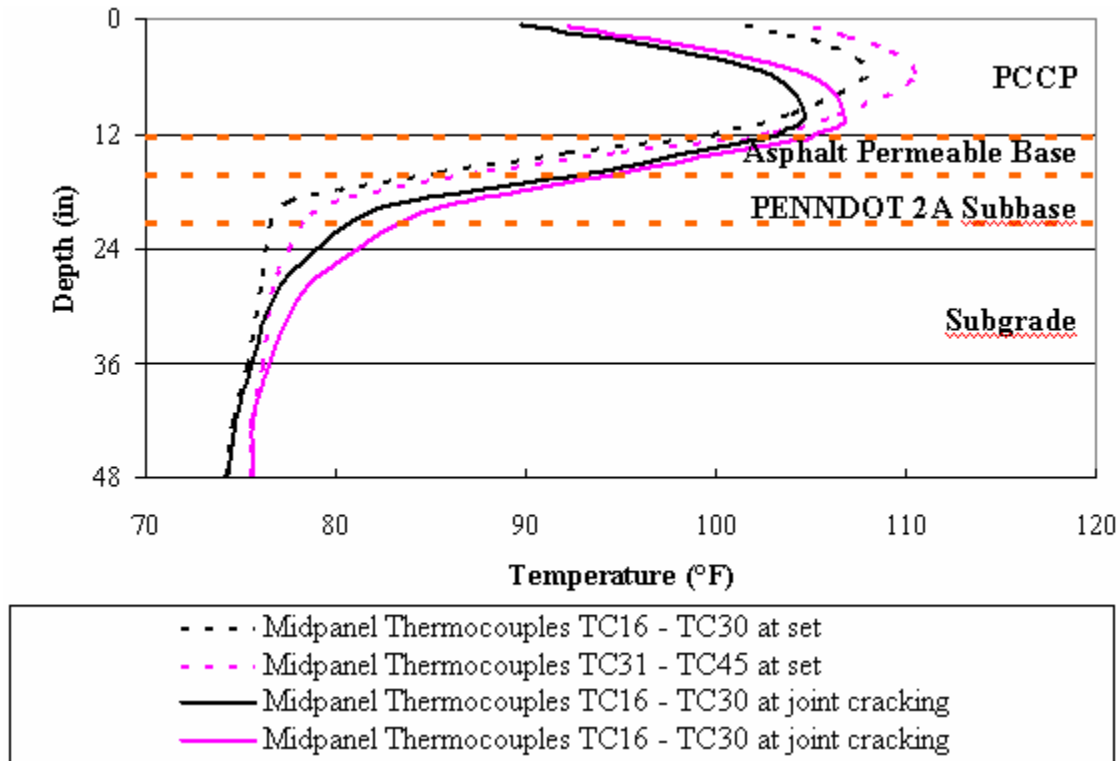
**Figure 4.1 Temperature gradients measured at midpanel in two separate slabs when the concrete set and when the joints cracked.**

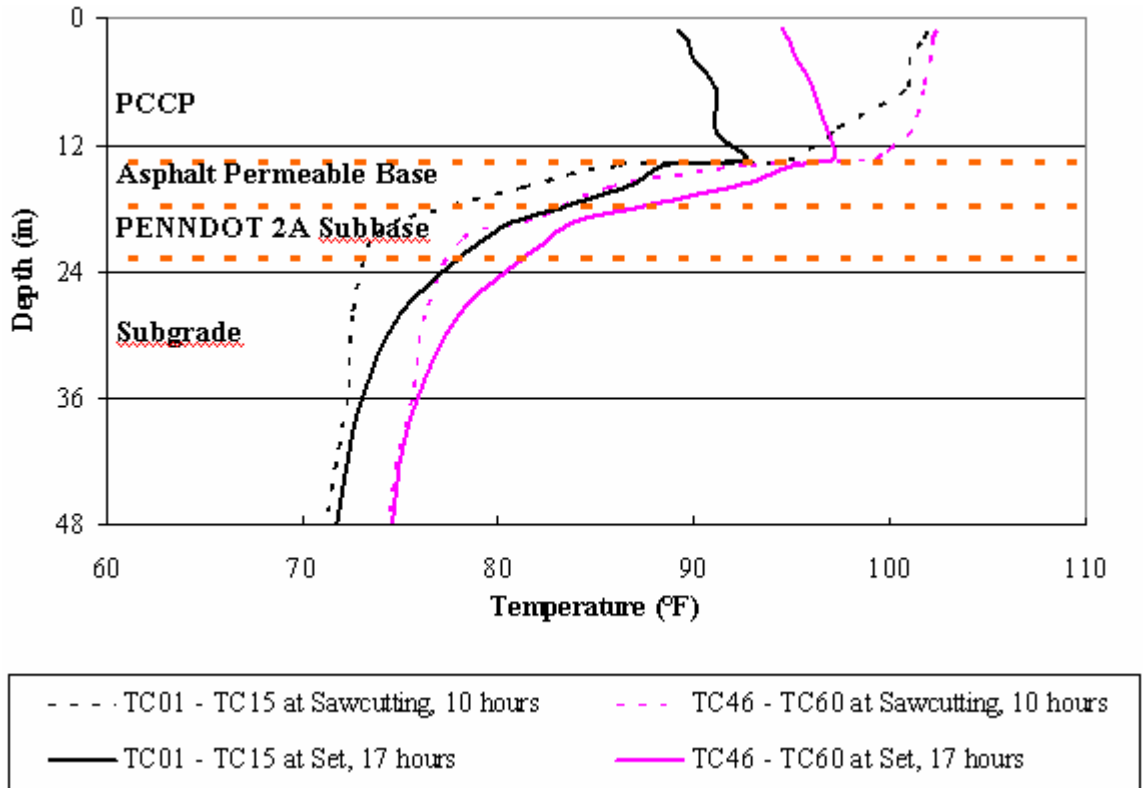
Figure 4.2 Temperature gradients measured at the slab edge in two separate slabs when the concrete set and when the joints were being sawed.

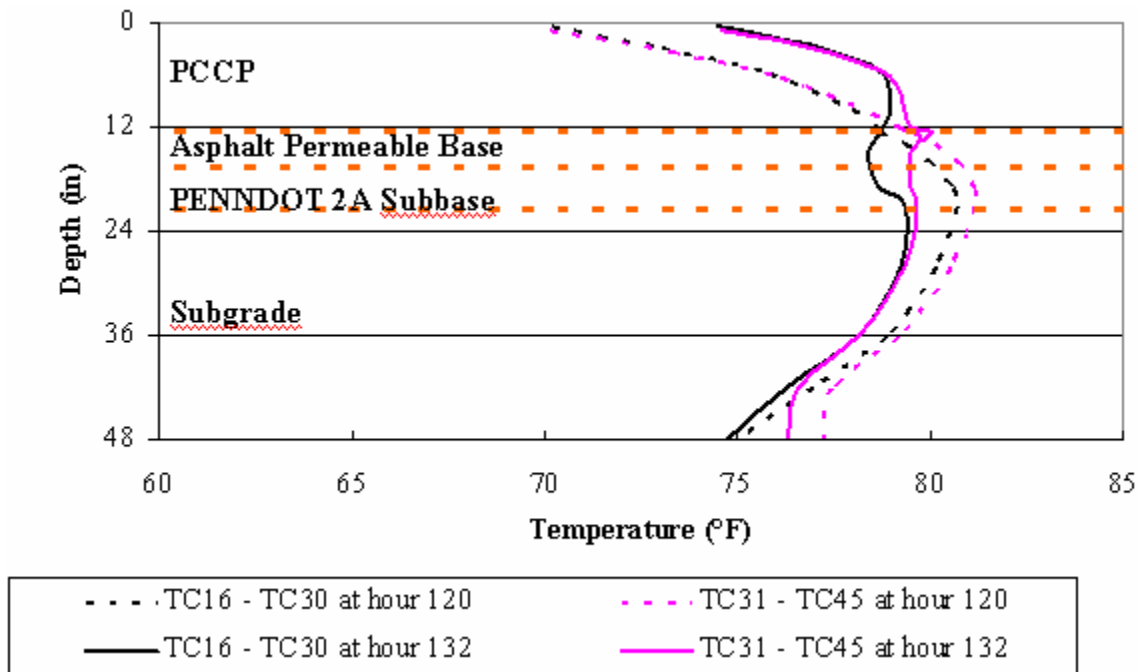
Figure 4.3 Temperature gradients measured at the slab edge in two separate slabs on October 31st, 2005, after the curb and gutter was constructed.

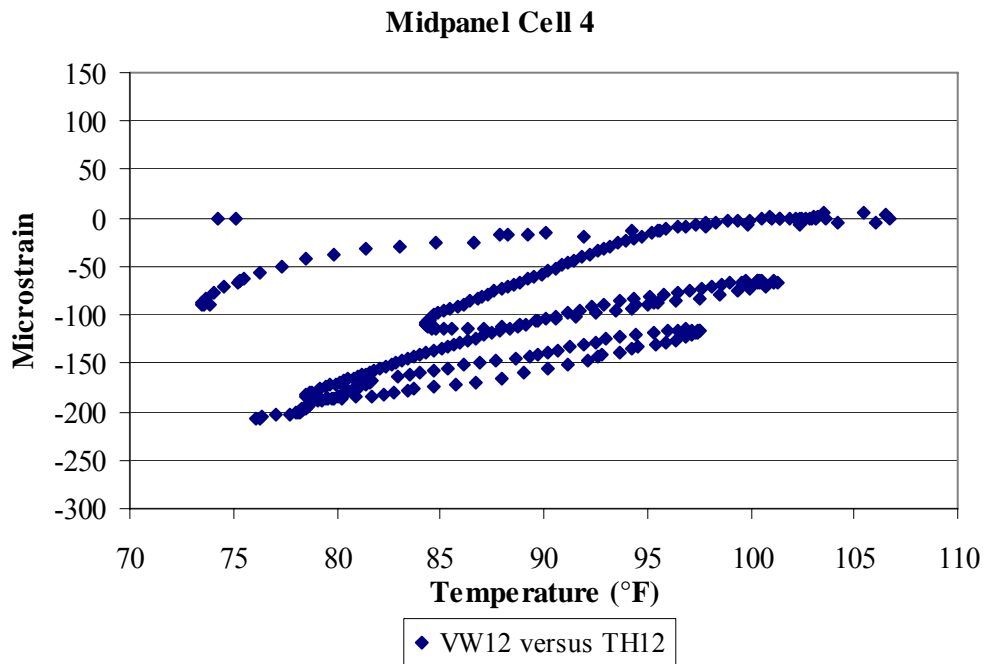
**Figure 4.4 Strain versus temperature at midpanel in Cell 4 for the first 72 hrs after paving.**

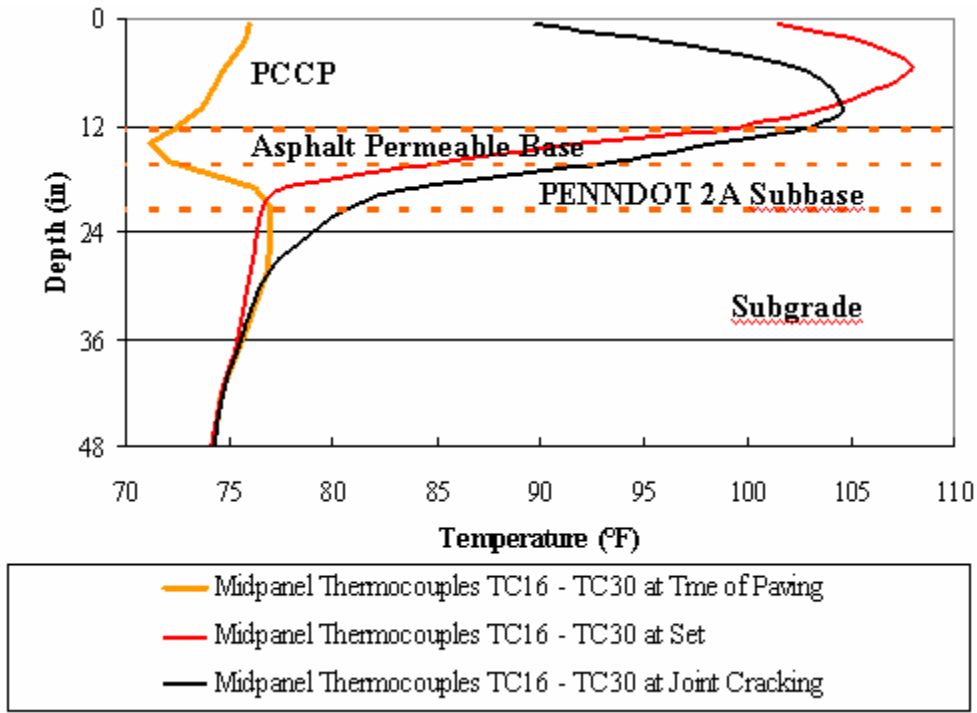
Figure 4.5 Temperature distribution throughout the depth of the pavement structure at midpanel.

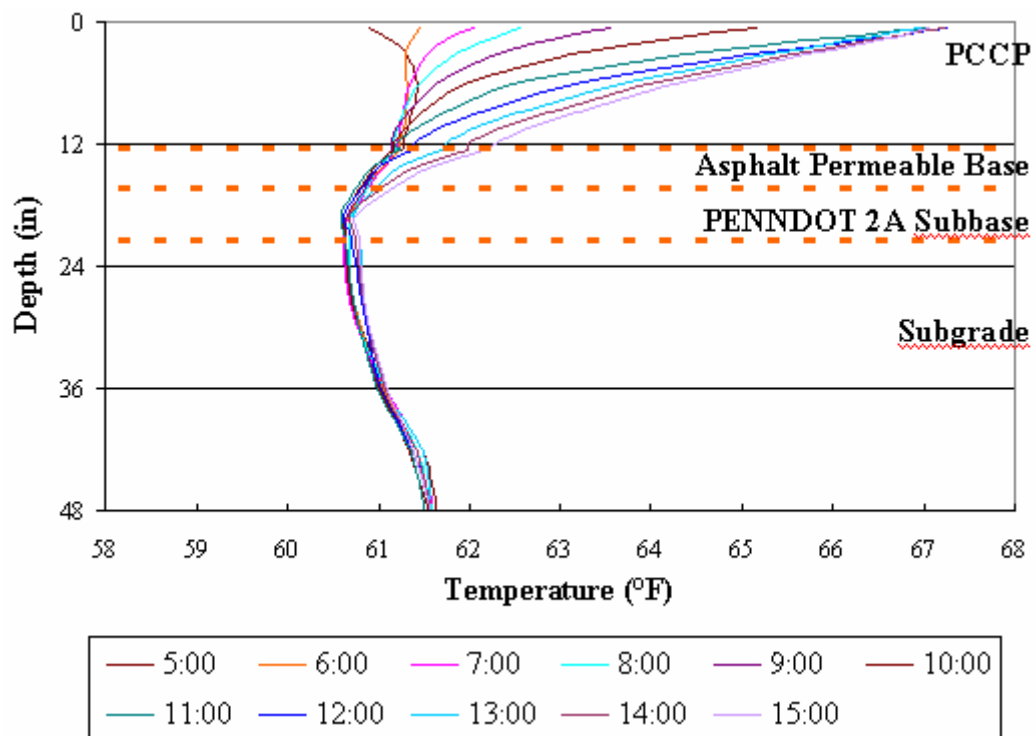
Figure 4.9 Temperature gradient at the midpanel during a 10- hour period on October 31, 2005.

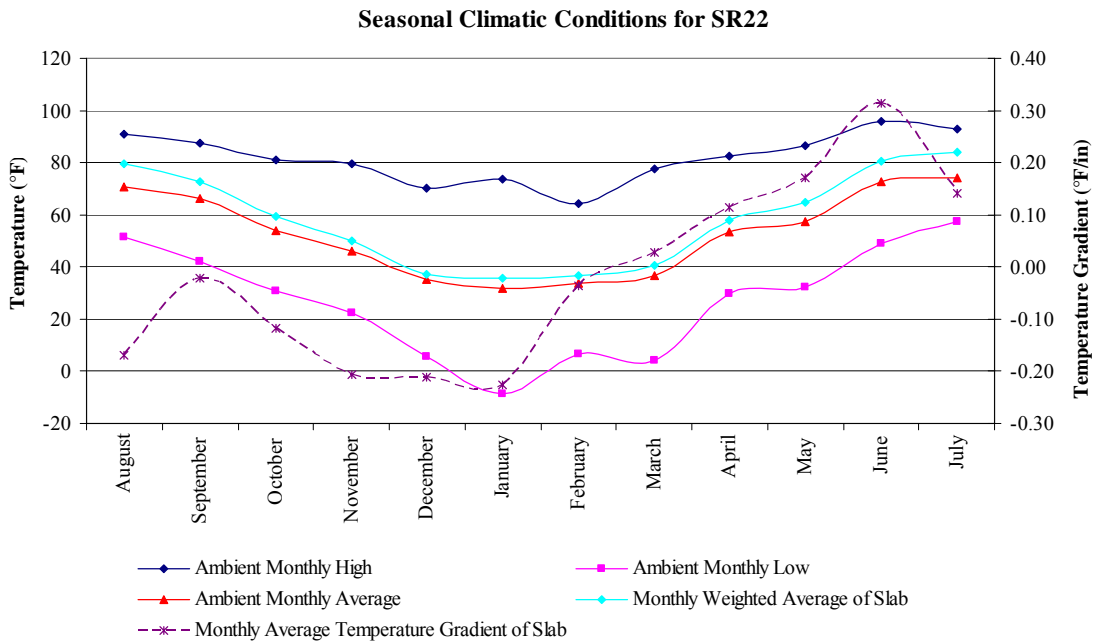
**Figure 4.11 Seasonal temperature conditions at the Smart Pavement site.**

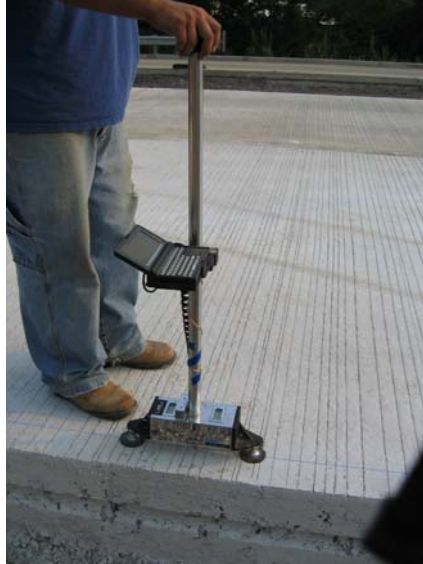
**Figure 5.1 Dipstick used to measure surface profiles.**

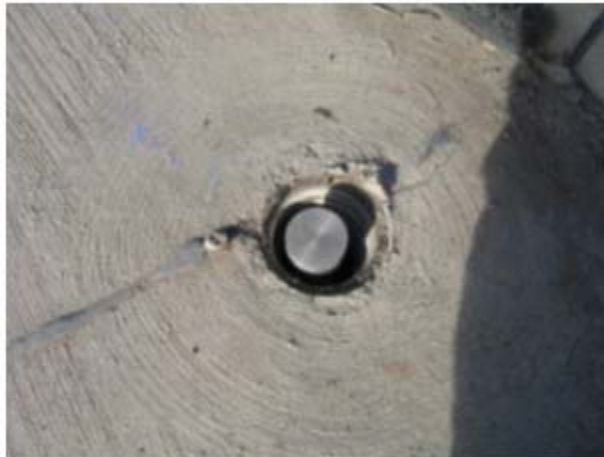
**Figure 5.3 Top of invar rod.**

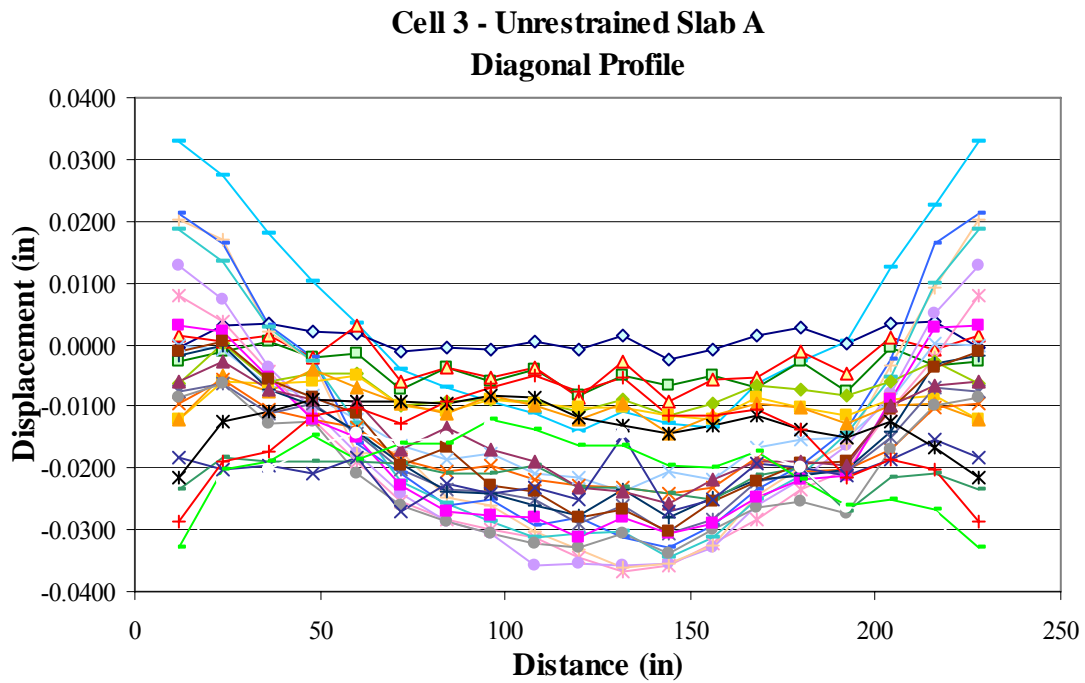
Figure 5.5 Diagonal profiles measured on Slab A in the unrestrained cell.

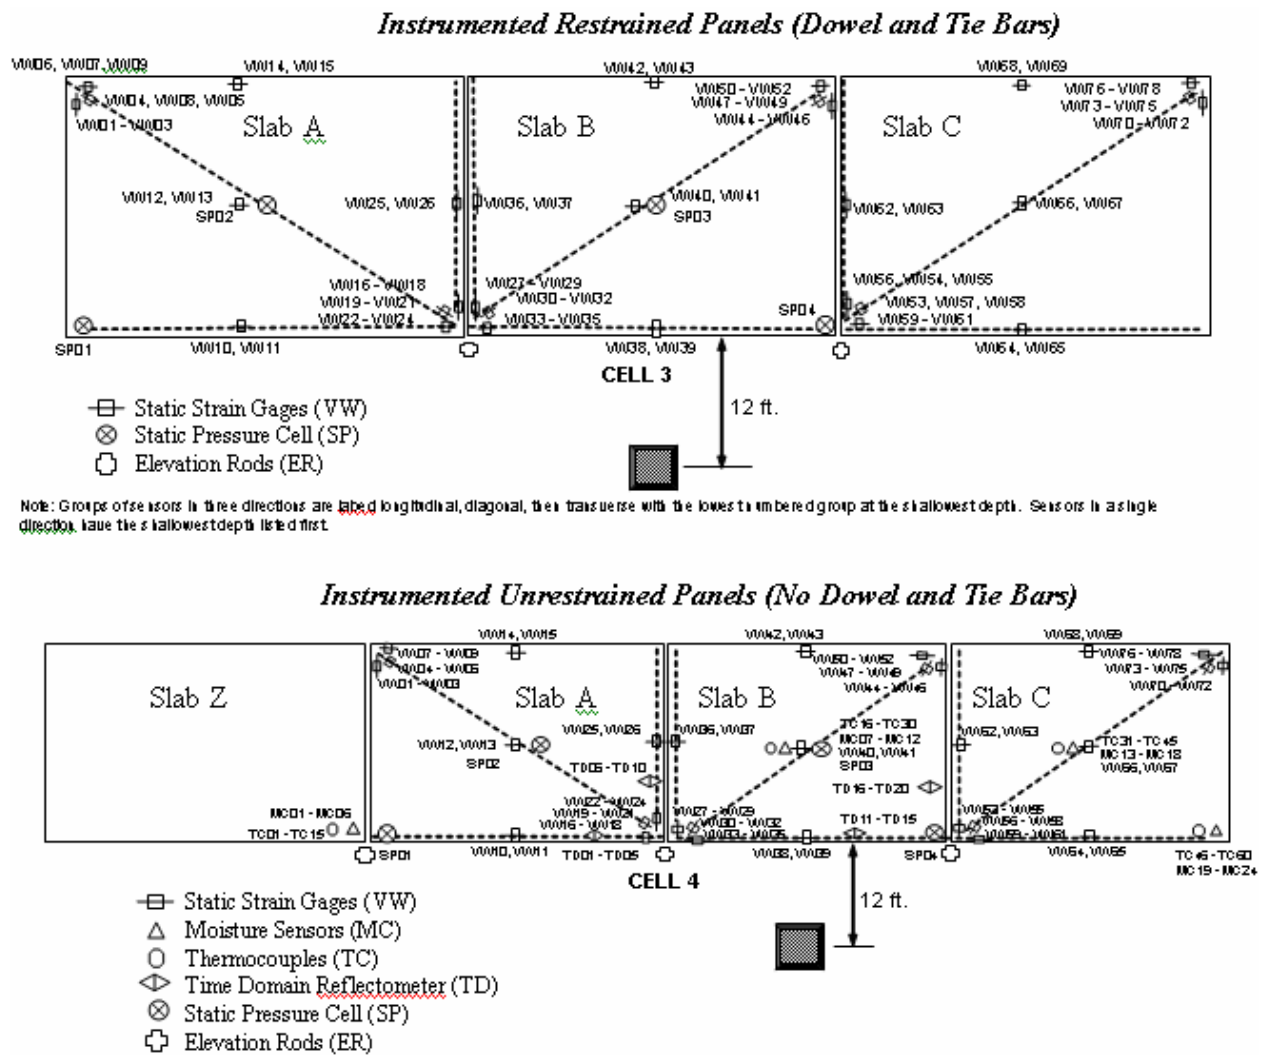
Figure A.1 Static strain gage and environmental sensor for Cells 3 and 4.
