Rearward visibility issues related to agricultural machinery: Contributing factors, potential solutions

Shawn Gregory Ehlers
Purdue University

A Dissertation

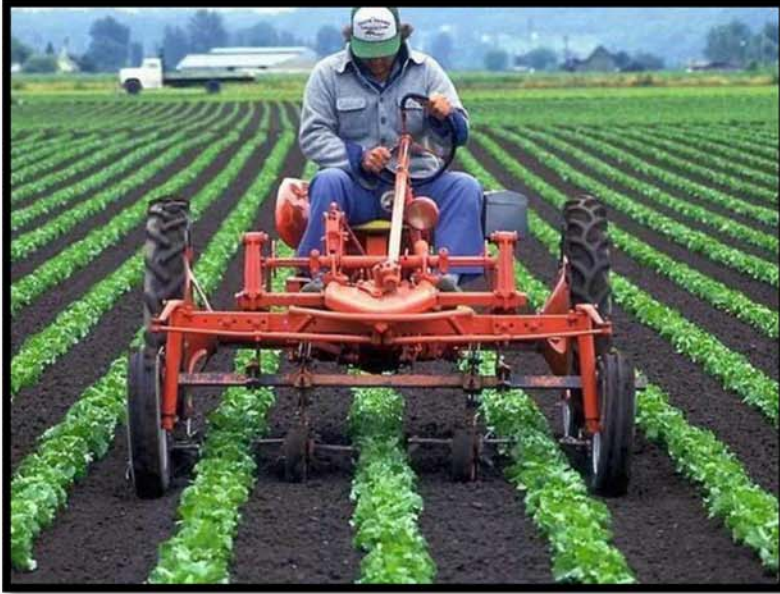
Figure 1.1. The open-frame design of the Allis Chalmers model G allows a nearly unobstructed view of the specific task (source: Delaware, 2010).

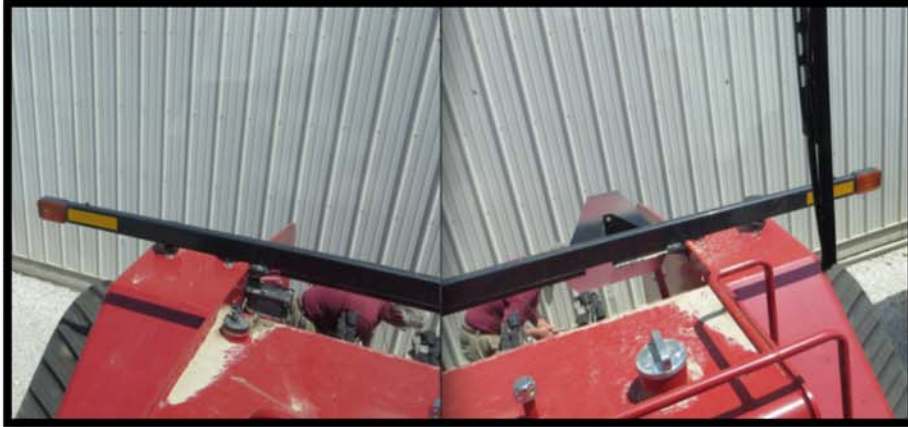
Figure 1.2. Driver's view of assistant at hitching point with full seat rotation in both directions.

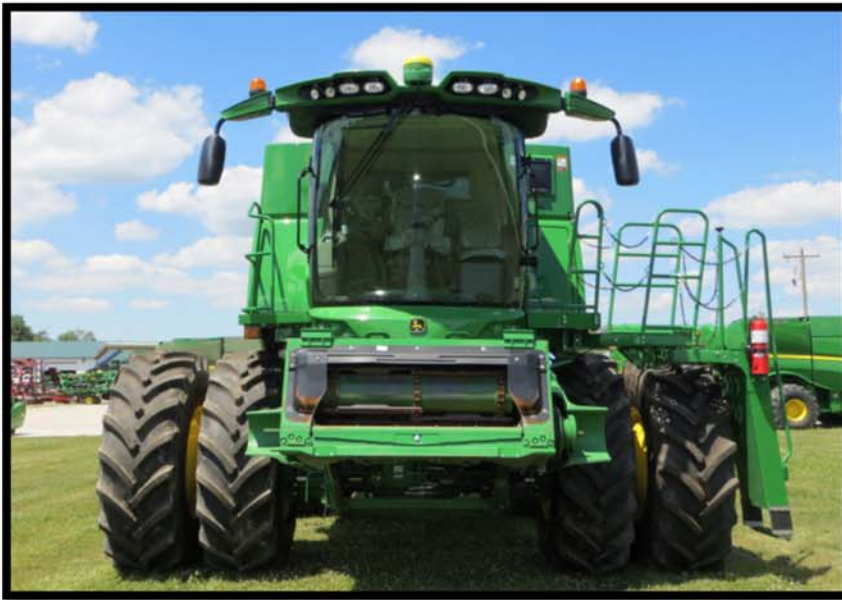
Figure 1.4. Modern combine harvester with exterior extended-arm mirrors.

During the transition to larger tractors and self-propelled machinery with enclosed cabs, the operator's limited ability to adequately monitor both the machine and the trailing implement became apparent. For example, operators were no longer fully subjected to all the elements of field operation, including sun, dust, temperature extremes, and wind. As a result of being more shielded from the operation, operators became less engaged and required assistance in monitoring the intended task. This was especially true when operating equipment on roadways. As a result, interior and exterior extended-arm mirrors were adopted, with many variations in mounting locations and convex curvatures (Figure 1.4).

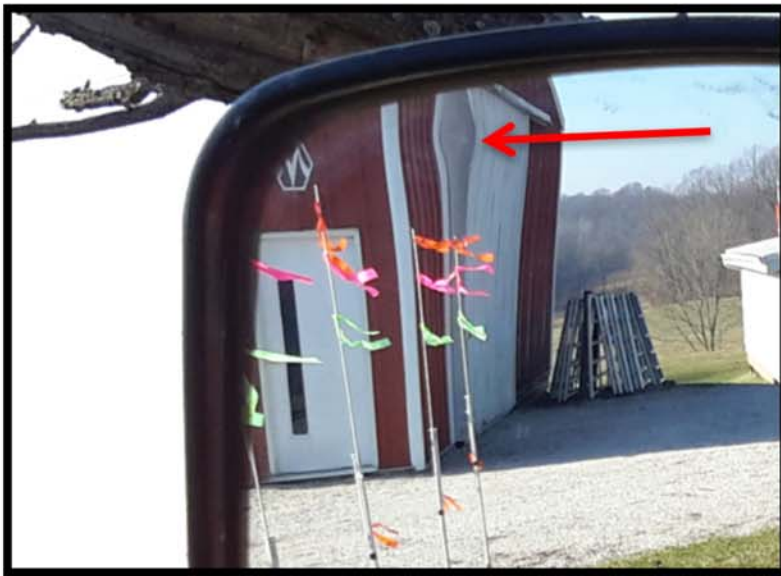
Figure 1.5. Distortion caused by convexity of the mirror surface.

looking backward to less than 4%. Convex mirrors allow the operator to see a wider area in comparison to a flat-surface mirror but sometimes adversely distort images, making it difficult for the operator to interpret the image (Figure 1.5).

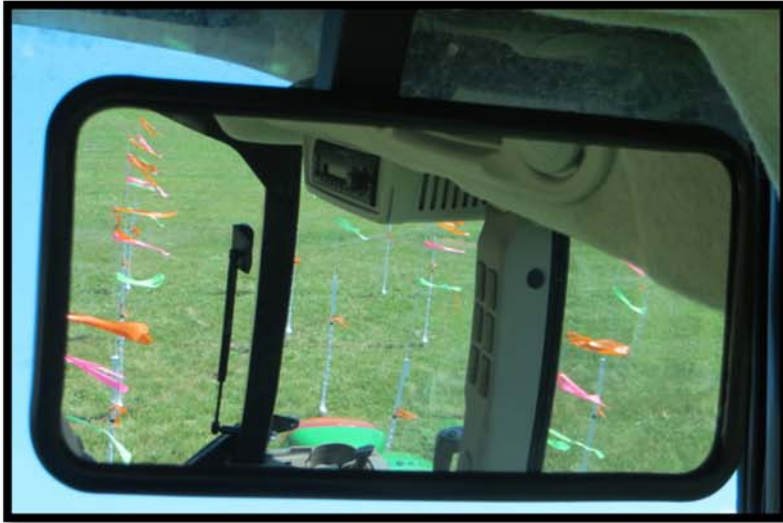
Figure 1.6. Interior tractor mirror with cab component obstructions.

Interior mirrors. Interior mirrors often demand a greater open area than is permitted by the cab design for the operator to realize the full benefit. For example, the mirror surface may be too close to the operator to maximize the viewing area. In many enclosed cabs, the operator's view in the interior mirror is obstructed by components mounted to the ceiling, such as a radio, climate controls, pull-down sunshades, and frequently the operator's own reflection (Figure 1.6).

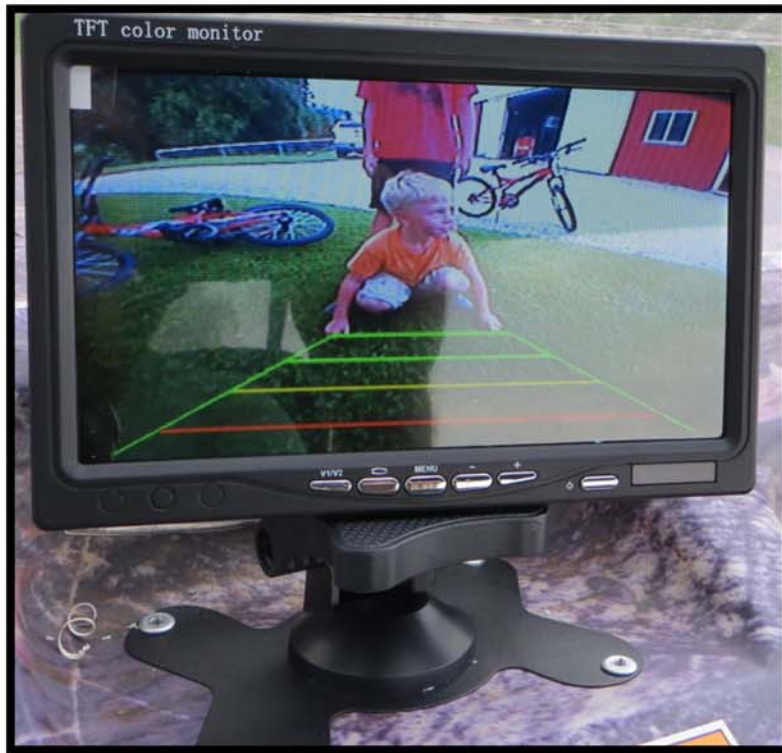
Figure 1.7. Rearview camera with a grid line depth reference mounted on UTV.

Depth perception. It is often difficult to estimate the distance to an object in the camera’s field of view due to the small lens, the “fish eye” effect, or the small display size. Some camera manufactures offer gridlines overlaid on the image (Figure 1.7). These gridlines allow the user to estimate the distance to objects and hazards in view. The grid lines are not necessarily calibrated distances, as the spacing between the lines changes with the

mounting location, thus requiring the operator to establish a reference if the camera is positioned at a new location.

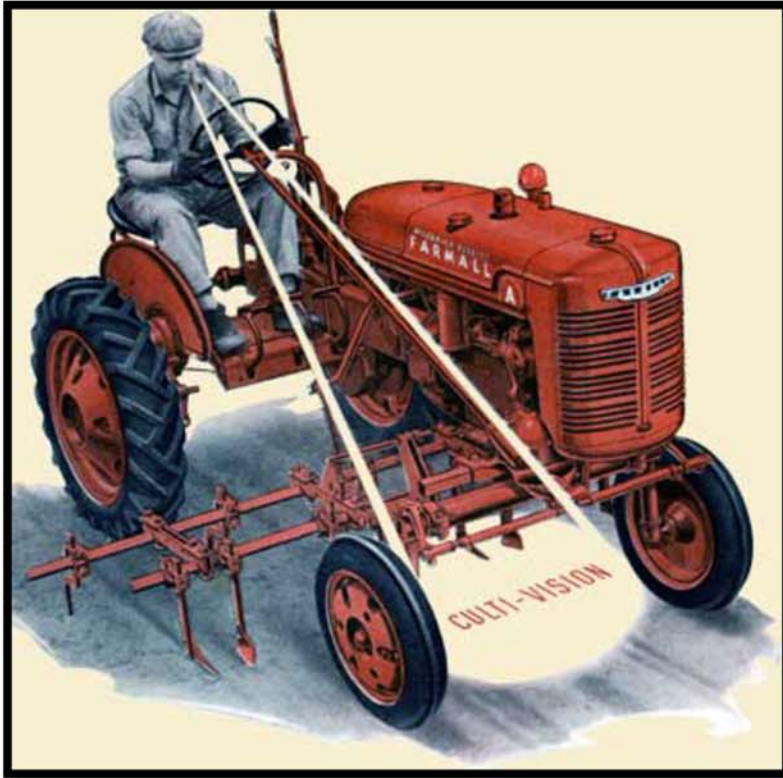
Figure 4.1. Farmall A featuring Culti-Vision; Offset frame design allowed for increased operator view of the specific task (Antique Farming, 2016).

In the early days of mechanized agricultural production, monitoring the area around one's tractor and trailing implement was not too difficult. The equipment was relatively small, traveling speed slow, and width at most only a few feet to either side of the machine. In addition, on most tractors, the operator's station was typically rather high up, open and unobstructed, often behind the rear axle, and on some models offset from its centerline (to aid in row-crop cultivation)—all of which helped maximize surrounding area visibility, including rearward, and allowed the operator to see, track, and quickly respond to individual tasks as they were being performed (Figure 4.1).

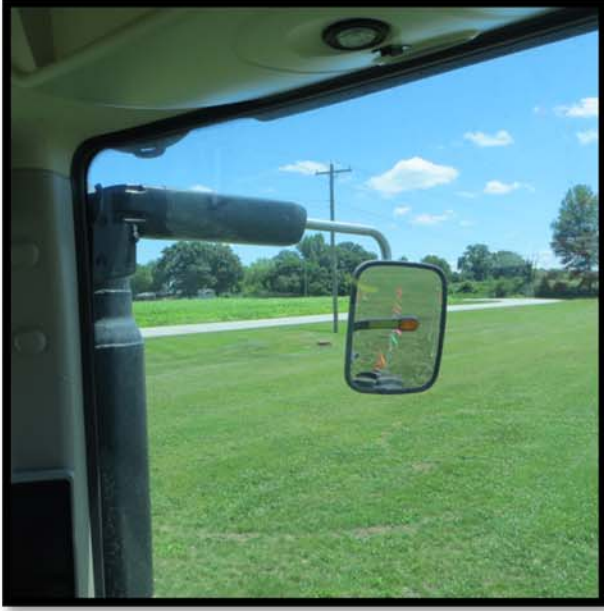
Figure 4.5. Right extended-arm mirror view of assessment grid from operators' forward facing position.

In each machine's enclosed cab, from the forward-facing position of the average height U.S. man, an indicator pendulum was suspended from the ceiling, marking the location of the midpoint of the operator's eyes (similar to point M_f of Figure 4.1). It was at this reference point that a 12.1 Mega Pixel Canon PowerShot model SX260 HS camera, with 20X optical and 4X digital zoom (80X combined zoom), was mounted to record the images from point M_f of all internal and external mirrors and the rearview camera (Figures 4.5 and 4.6).

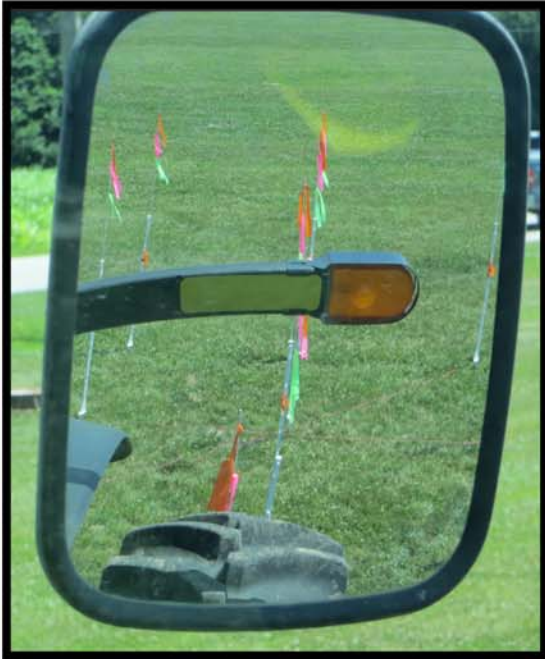
Figure 4.6. Full view optical zoom of right extended-arm mirror from operators' forward facing position.

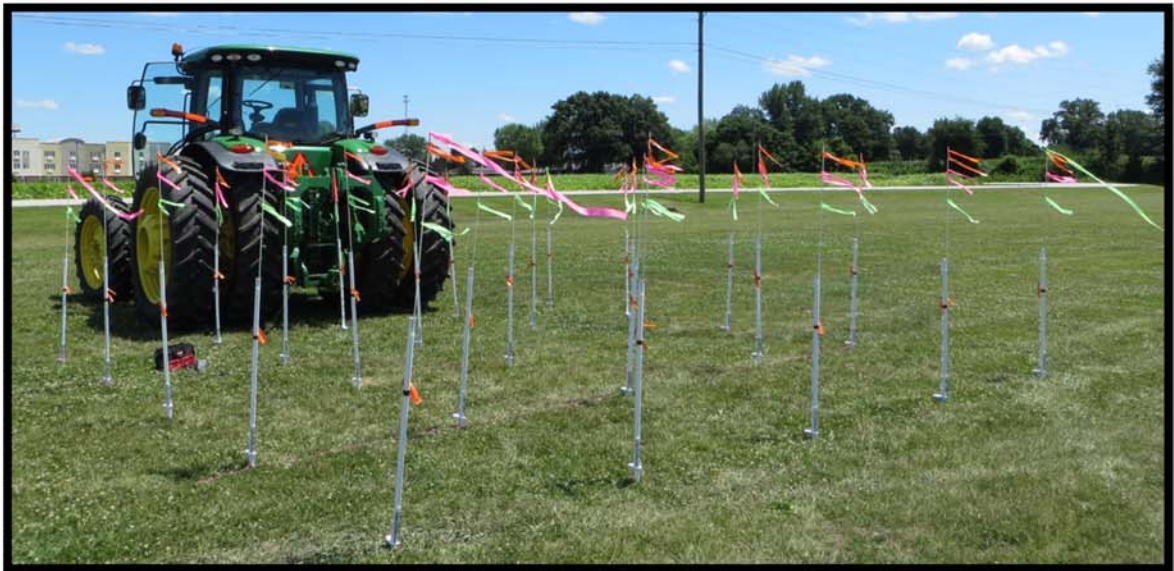
Figure 4.8. Agricultural machine rear visibility evaluation grid with height indicator flags.

The grid was composed of 25 cells, each 1.52 m by 1.52 m (5 ft. x 5 ft.). At the center of every cell was a height indicator pole on which was affixed four different colored fluorescent marking flags indicating the average height of a U.S. man, woman, 10-year-old child, and kneeling worker—1.76 m (69.2 inches), 1.62 m (63.8 inches), 1.42 m (56.1 inches), and 0.61 m (24 inches), respectively (CDC, 2012) (Figure 4.8).

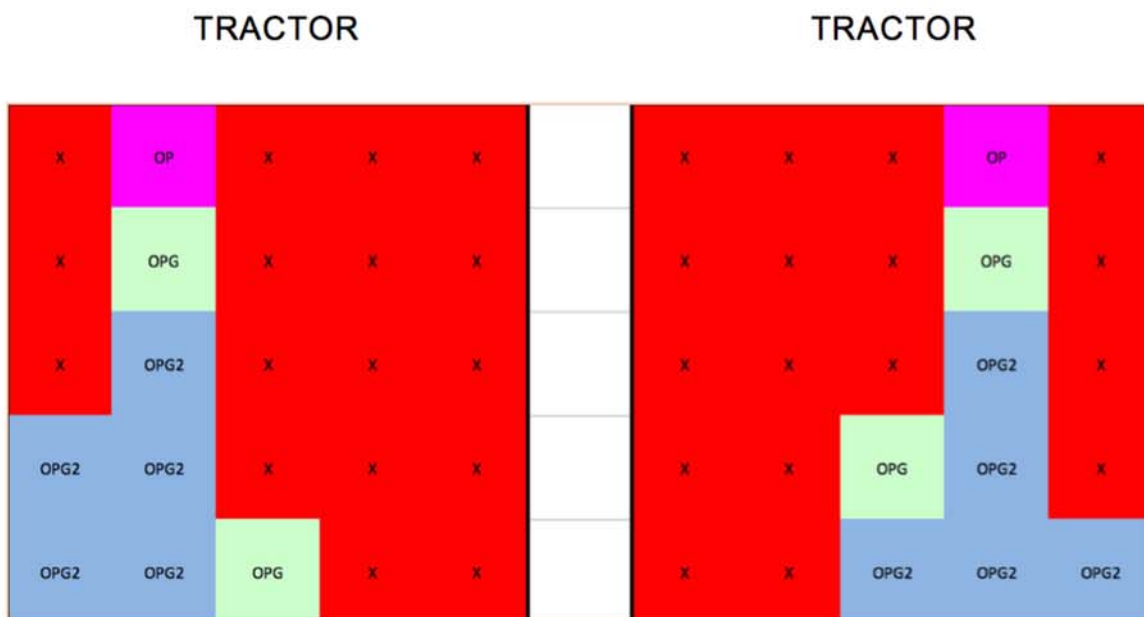
Figure 4.10. Tractor 2, left and right extended-arm mirrors.

The collected images were enlarged and analyzed using Mac iPhoto software. The lowest visible height (indicating the highest level of visibility) was recorded for each indicator pole and translated to a 5 x 5 table in Microsoft Excel, resembling the 5 x 5 grid used to collect data (Figure 4.9). A table was generated for every mirror and camera view for all nine machines. From the individual visibility-grid results, a master rearward visibility grid was generated to represent the area of visibility available to the operator utilizing all viewing modes. The Excel tables allowed for visual identification of limited or invisible locations to the rear of the tested machinery and immediate identification of hazardous area. Figures 4.10 & 4.11 represent the findings from tractor 2.

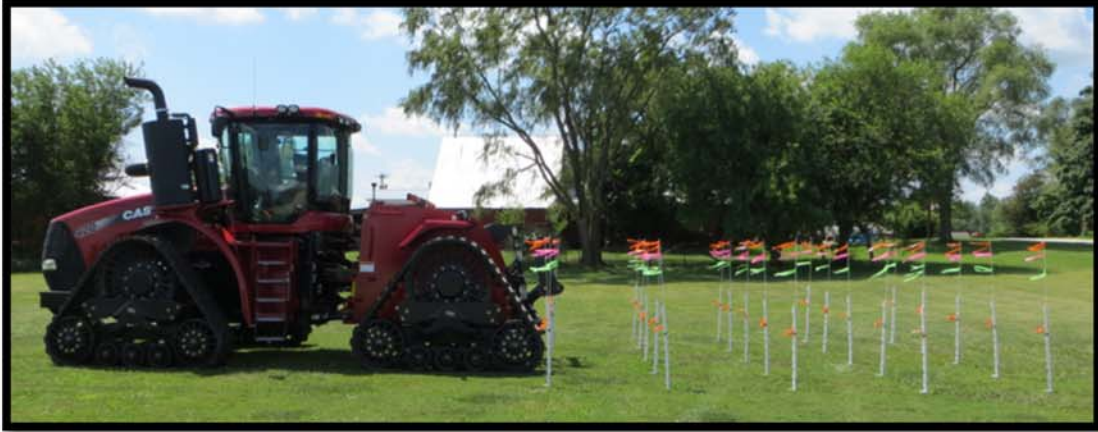
Figure 5.3. Case IH Quadtrac 420 –Tractor positioned adjacent to rearward visibility test grid.

The operator station is forward of the articulation point while the hitching point is located at the rear-most of the tractor (Figure 5.3). In comparison to non-articulated tractors, the operator station's forward position introduced a lower sloped line of vision to the hitching points for direct view of the rearward area. Without the use of mirrors or camera, this presents obstacles for the operator to observe locations immediately behind the tractor.

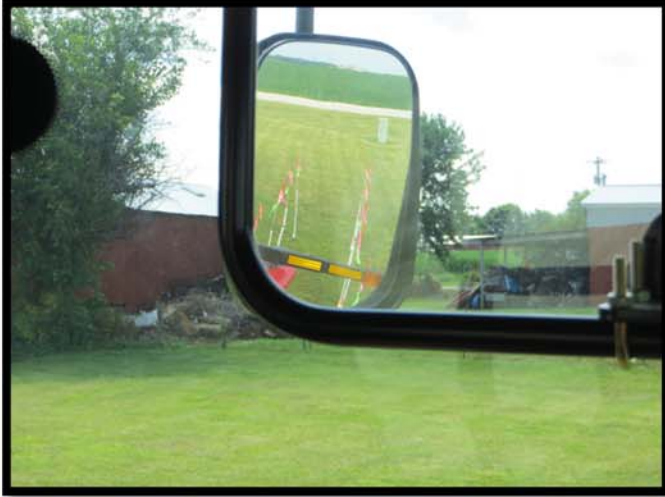
The right extended arm mirror had a convex curvature to allow for an increased field of view (Figure 5.4). Mounting hardware for in-cab monitors introduced a visibility obstruction of the left and lower sections of the mirror, preventing the operator to fully utilize the mirror without repositioning himself (Figure 5.4).

Figure 5.4. Case IH Quadtrac 420—Right extended-arm mirror view of rearward visibility test grid.

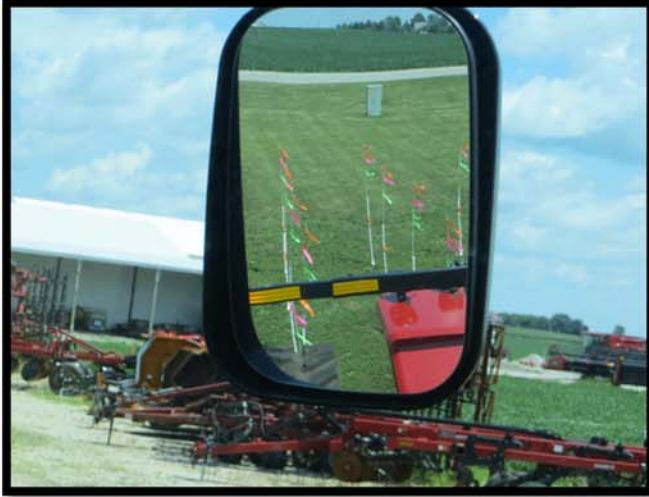
The view of the left extended-arm mirror was unobstructed by in-cab components with the cab door closed (Figure 5.6). However, 60% of the 58 m² (625 ft²) grid was completely obstructed. Cell 3 was undetectable, as so with the right extended arm mirror; and the 0.61 m (2 ft.) marker was not visible in any cell closer than 4.6 m (15 ft.) from the rear most point of the tractor (Figure 5.7).

Figure 5.6. Case IH Quadtrac 420—Left extended-arm mirror view of rearward visibility test grid.

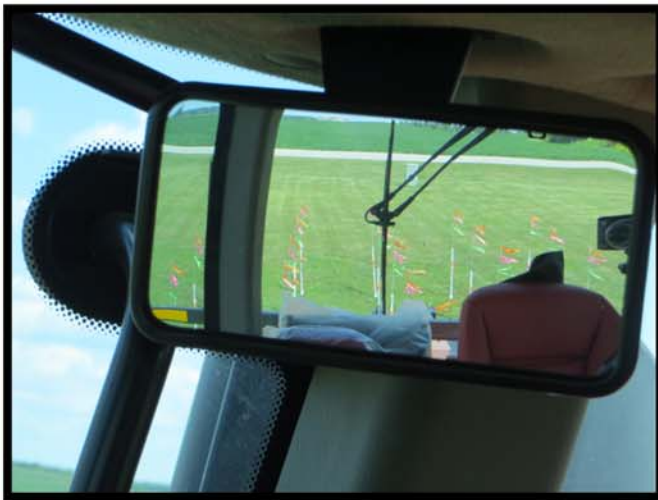
Figure 5.8. Case IH Quadtrac 420—Interior mirror view of rearward visibility test grid.

The convex curvature of the in-cab mirror had the highest level of visibility of the factory equipped mirrors (Figure 5.8). Nevertheless, an average sized man could be seen in Cell 3, but only if he was standing in a full upright position, while the height indicators of women, children, and kneeling markers were completely obstructed. During testing, 32% of the grid cells were obstructed. It should be noted that with both an operator, and assistant present in the cab, the level of visibility would be greatly reduced due to their silhouettes blocking part of the in-cab mirror. The in-cab mirror also did not provide any visibility for the kneeling indicator closer than 3 m (10 ft.) from the hitching point (Figure 5.9).

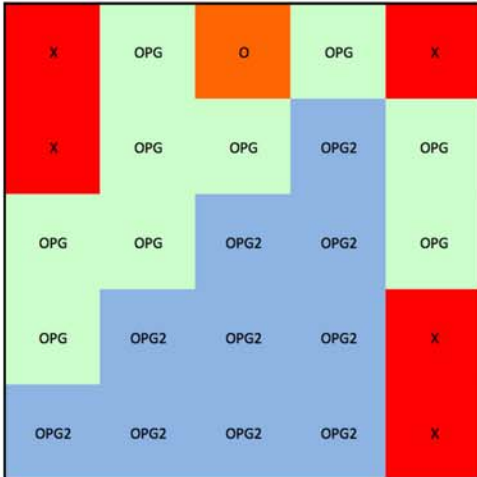
The overall operator visibility achieved through use of all equipped mirrors of the Quadtrac 420 was achieved via union of Figures 5.9, 5.7 and 5.5. This union depicts the potential overall visibility achieved by the factory equipped machine (Figure 5.10).

However, due to limitations in the operator's field of vision, being able to view each mirror simultaneously is not possible. Obstructed view accounted for 20% of the test area with 40% of the area allowing view of the kneeling indicators.

Figure 5.10. Case IH Quadtrac 420—Union of all equipped mirrors rearward visibility test grid results.

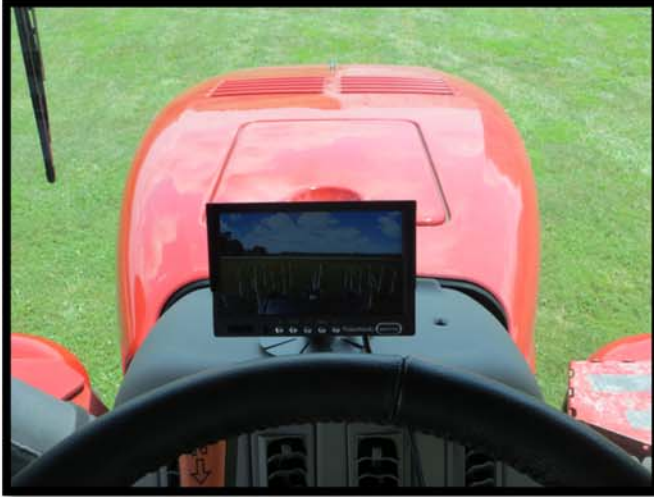
A VisionWorks 17.8 cm (7 inch) color display was positioned above the cab's center dash (Figure 5.11). A built-in sun shade helped reduce glare and improved the operators' ability to detect objects to the rear (Figure 5.12). A wide (170°) camera was positioned above the PTO shielding, which offered the highest level of un-obstructed visibility (Figure 5.13).

Figure 5.11. Case IH Quadtrac 420—Center dash camera monitor mounting position.

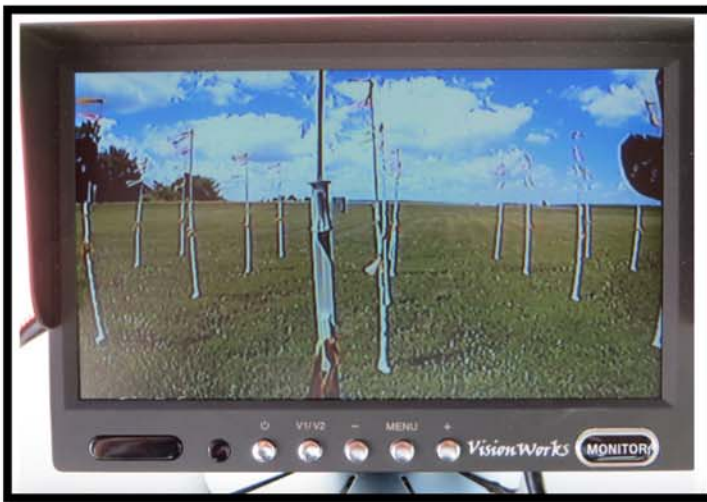
Figure 5.12. VisionWorks two input, 17.8 cm (7 in) color monitor with sunshade.

Also, in an effort to reduce the number of monitors in the cab, the rearward viewing camera display could be incorporated into one of the factory-equipped monitors found in this tractor (Figure 5.28), instead of having an additional monitor (see Figure 5.12). Wiring harnesses are readily available for many makes and models of agricultural equipment that are compatible to use with cameras and existing monitors.

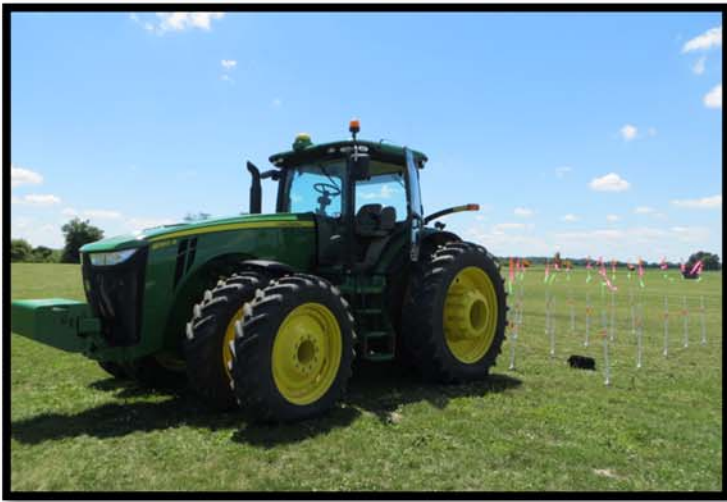
This was the largest mechanical front wheel drive (MFWD) row-crop tractor selected in the study (Figure 5.18). Basic specifications of the 8360R are as follows (Table 5.2):

The operator seating position proved more favorable for direct viewing (without assistance of a mirror or camera) than articulated tractor models due to a more rearward seat location and steeper viewing angles of the hitching area. Tests for this tractor included the two factory equipped extended arm mirrors and in-cab mirror, and the rear-mounted VisionWorks camera system mounted for test purposes.

Figure 5.18. John Deere 8360R—Positioned adjacent to rearward visibility test grid.

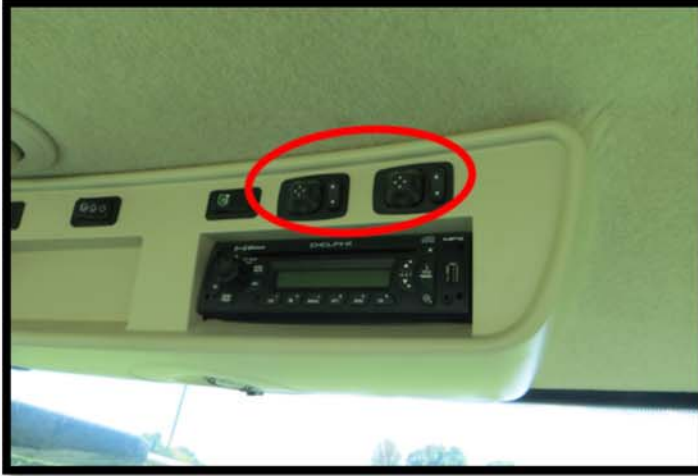
The external extended-arm mirrors of this model tractor featured electrically controlled mirror adjustments (Figure 5.19). This optional feature allowed the operator to adjust mirror positioning for the specific task being performed as manually adjusted mirrors may not be properly positioned due to the difficulty to access the mirrors or the need for an assistant to make adjustments.

Figure 5.19. John Deere 8360R—Electronically controlled external mirror adjustment.

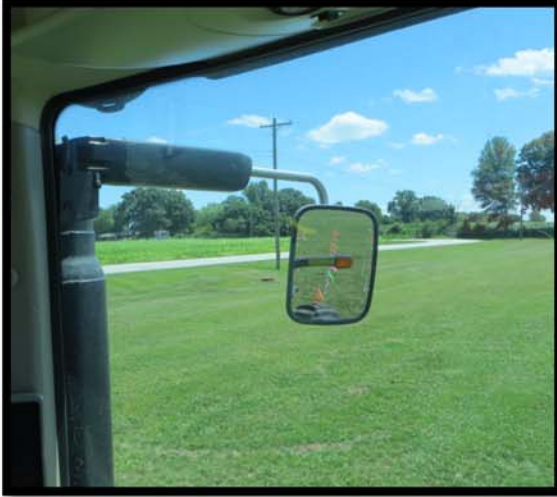
Figure 5.20. John Deere 8360R—Right extended-arm mirror view of rearward visibility test grid.

The right extended-arm mirror presented no obstruction from components or brackets inside the cab (Figure 5.20). However, a clear line of sight to the convex mirror offered limited rearward visibility, with 68% of the measured area obstructed (Figure 5.21) and with hazardous areas directly adjacent to hitching points (Cell 3) completely obstructed. The tractor's dual rear tires presented some obstruction of visibility at their base obstructing visibility of anything less than the average height of a woman. The mid-line of machine travel was completely obstructed from the right mirror's view as far back as 7.6 m (25 ft.) for the kneeling indicator (Figure 5.21).

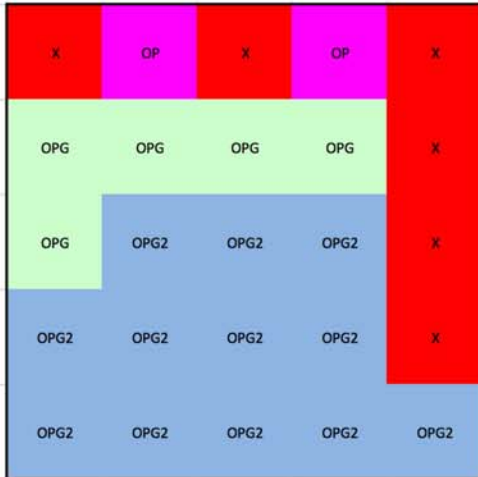
Figure 5.24. John Deere 8360R—Union of all mirrors rearward visibility test grid results.

The overall visibility achieved through use of all equipped mirrors of the John Deere 8360R was achieved via union of the best achieved visibility levels from Figures 5.21, 5.22 and 5.23. This presented the overall visibility achieved by the factory equipped machine (Figure 5.24). Again, as noted earlier, the limited field of vision of an operator prevents full use of all mirrors simultaneously. Obstructed view accounted for 24% of the test area with 48% of the area allowing view of the kneeling indicators.

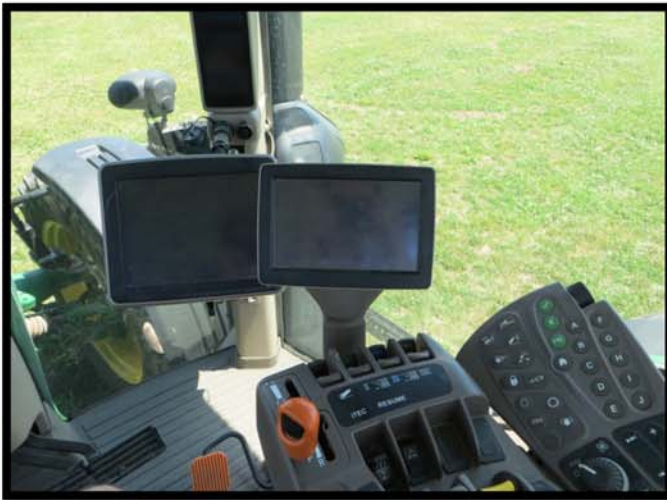
Figure 5.28. John Deere 8360R—OEM monitors mounted to control arm and front cab pillar.

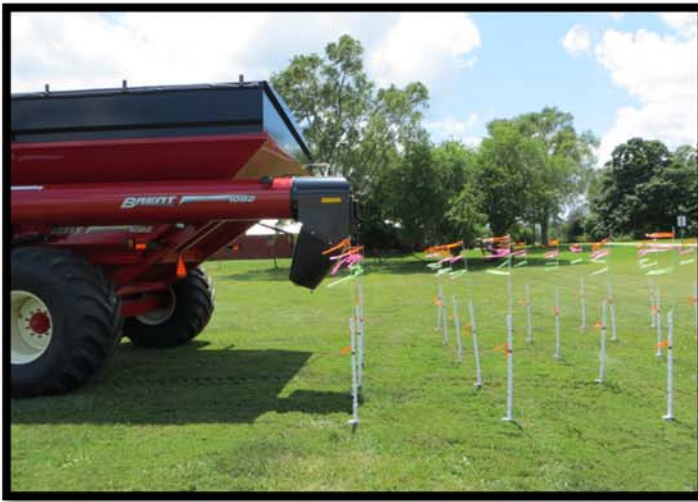
As with the testing of the bare machine, flags were positioned at the farthest rearward point (Figure 5.29). A grain cart was selected to represent implements because of its solid

construction, as opposed to a disk, toolbar or similar implement, which allows for windows of visibility, but also is highly variable as to configurations of individual types and models. In other words, an operator of a tractor towing a large grain cart has almost no ability to view what is behind the cart using factory equipped vision aids such as mirrors.

Figure 5.29. Case IH Magnum 310 with Brent 1082 grain cart in tow positioned adjacent to rearward visibility test grid.

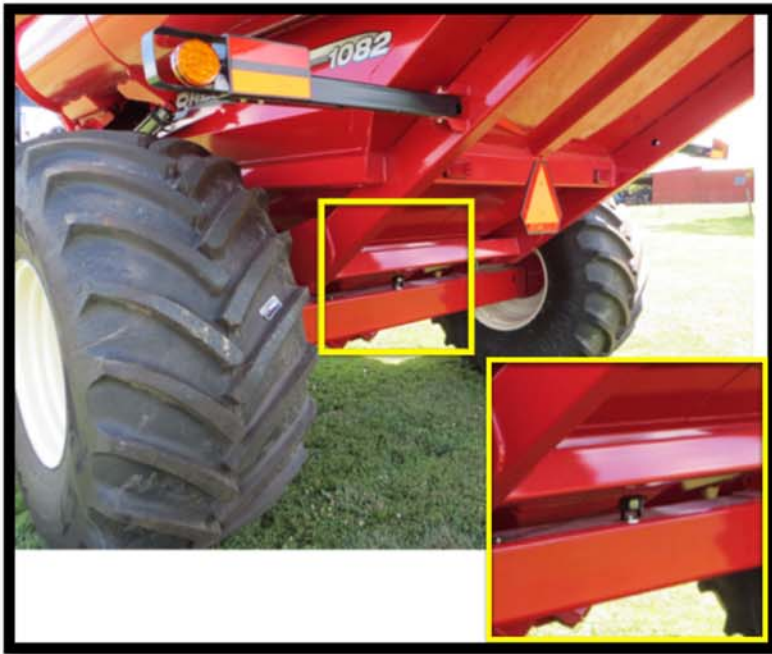
A VisionWorks 17.8 cm (7 inch) color display was positioned above the cab's center dash paired with a wide (170°) camera which was tested in two locations (beside the SMV sign and on the frame cross member). The most effective location was atop the frame cross member, which not only provided shielding from in-field hazards (e.g. corn stocks), but also provided the operator with only 4% obstructed view (Figure 5.34). This

Figure 5.34. Case IH Magnum 310 with Brent 1082 grain cart, central frame cross member camera mount location.

The second location tested on the grain cart featured a higher mounting location with the camera positioned next to the SMV sign (see Figure 5.34). This location was further to the rear and did not offer the same level of visibility, as side obstructed views were recorded nearest the cart as seen (Figure 5.36). These obstructed views were caused due to the camera being located further back on the cart which did not allow for the view 170° angle to include areas on either side of the cart.

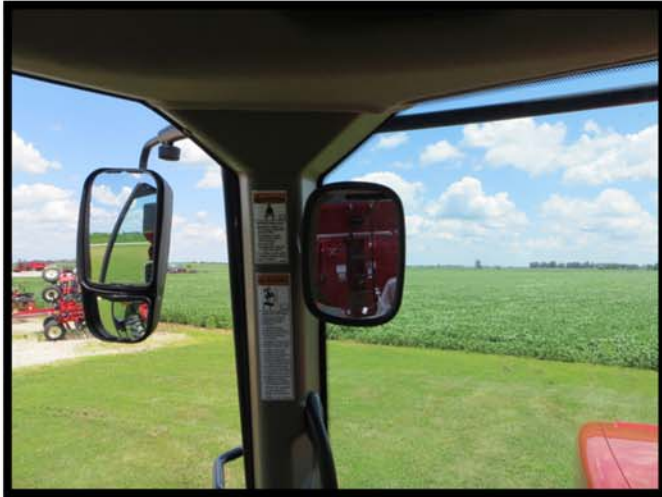
Each of the Case Magnum 310's external extended-arm mirrors featured double-stacked convex mirrors in a single housing, which were electronically controlled. This design offered the operator a level of visibility superior to a single mirror configuration, allowing one to see behind the tractor as well as to the side of its rear tires – locations that were otherwise undetected in the other tested vehicles (Figure 5.37).

Figure 5.37. Case IH Magnum 310 dual stacked extended-arm mirror view of rearward visibility test grid.

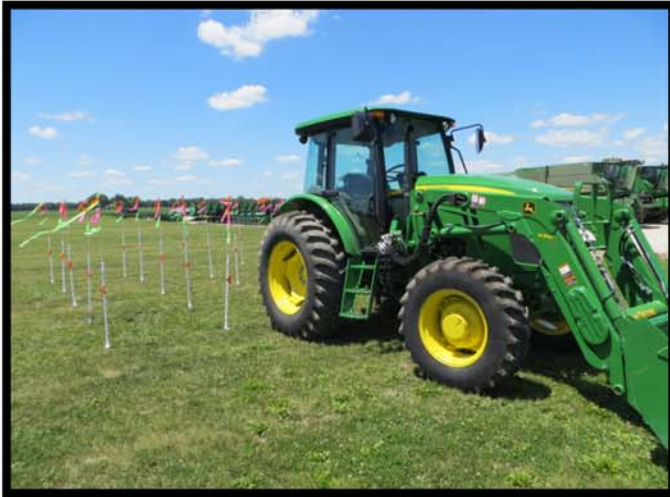
Selected to represent mid-sized row-crop tractors, the John Deere 6140D MFWD was factory equipped with two manually adjusted extended-arm mirrors mounted at the front two cab corners (Figure 5.38).

Figure 5.38. John Deere 6140D MFWD mid-sized tractor positioned adjacent to rearward visibility test grid.

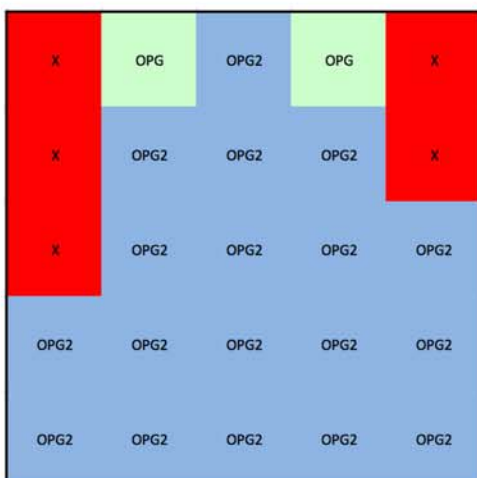
The optimum level of visibility was achieved via the union of all viewing mediums – i.e., the two exterior extended-arm mirrors, the one interior mirror, and one camera mounted above the PTO shielding. This configuration allowed for a 20% obstructed view of the test area, with 72% of the kneeling indicators visible (Figure 5.44). The midline of the test grid was completely visible to the kneeling level throughout the entire test area; and by combining the best of all viewing mediums, the width of the tractor (excluding Columns 1 and 5) was visible at a minimum of the height of the average 10-year old child.

Figure 5.44. John Deere 6140D—Best union of all viewing mediums rearward visibility test grid results.

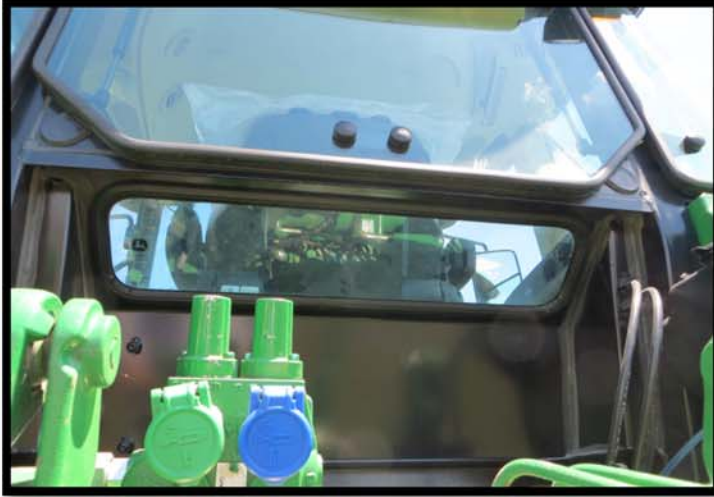
Operators of many models of row-crop tractors often open the rear window to allow for a less obstructed view of the hitching area and/or for better communication with an assistant during hitching. While opening the rear window may enhance a direct view of the tractor's rearmost area, this movement requires almost 180° rotation of the operator's upper body. Physical limitations of some operators can reduce their ability to rotate sufficiently to acquire this direct view. Cab design of the 6140D incorporated an additional window to allow for improved direct view of the rear area (Figure 5.45). This cab design can be found on other makes and models of tractors, but not all.

Figure 5.45. John Deere 6140D—Low rear cab window for improved direct viewing of hitch area.

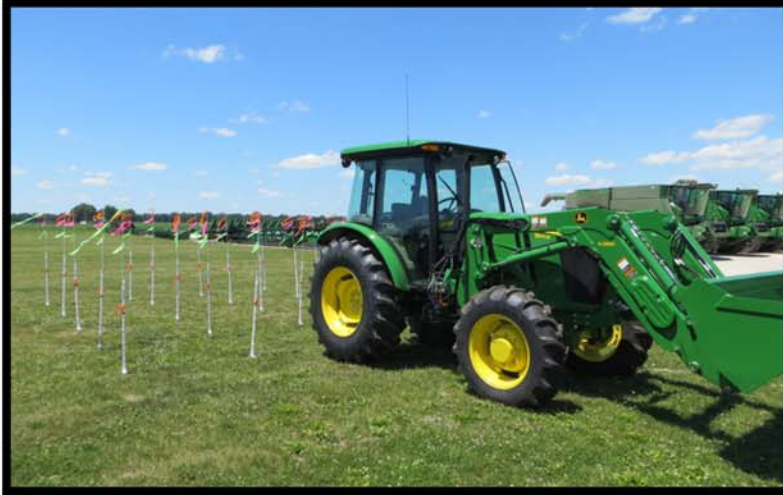
The John Deere 5100E was selected as a 100 horsepower utility tractor, and was the only tractor tested that did not have extended arm mirrors (Figure 5.46).

Figure 5.46. John Deere 5100E utility sized tractor positioned adjacent to rear visibility test grid.

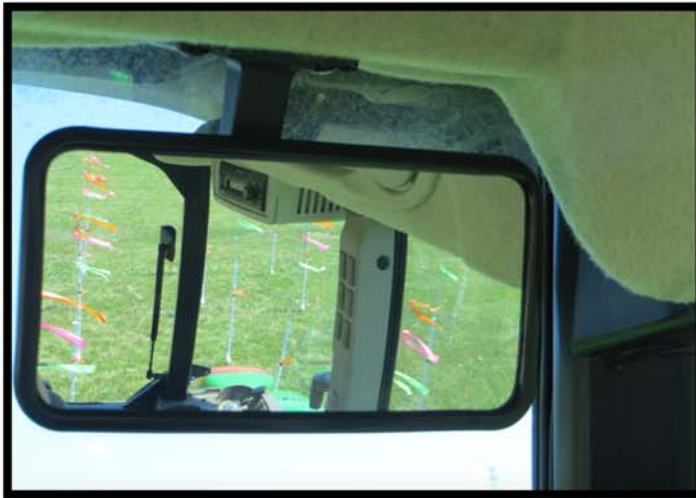
The John Deere 5100E did feature one interior mirror to assist with rearward visibility (Figure 5.47). However, the tractor's smaller cab limited optimal placement of the interior mirror, which due to other interior components (e.g. radio, climate control venting, silhouette of the operator himself) contributed to rearward view obstructions (Figure 5.47).

Figure 5.47. John Deere 5100E—Interior mirror with impeding cab components view of rearward visibility test grid.

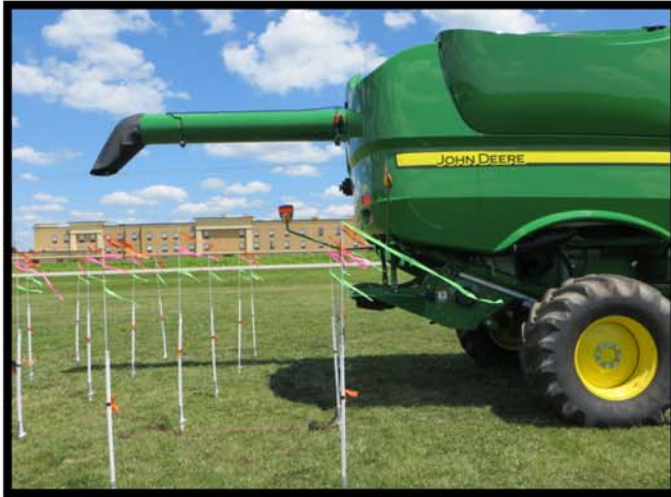
As described in the methods of testing, the test grid was centered on the rear most location of the self propelled vehicle. For tractors, this location correlated with the drawbar. However, the rear most location of a combine is the unloading auger, which does not pose an immediate threat to a bystander as it is located more than 3 m (10 ft.) off the ground (Figure 5.51). This location also neglects nearly 4.6 m (15 ft.) between the rear of the machine and the rear of the unloading spout. For this reason, the test grid was centered on the rear most location of the body of the combine, not the unloading spout. The inability of the operator to determine, in some cases, the position of the auger could result in machine damage.

Figure 5.51. John Deere S660 combine—Adjacent to rearward visibility test grid.

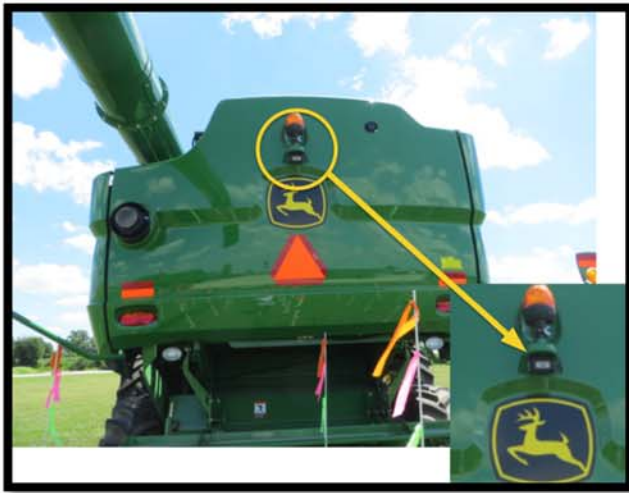
This S660 featured an optional factory installed camera package located in a high central location, as seen in (Figure 5.55). This was one of two machines tested which did not utilize the VisionWorks camera kit. However, this was the only combine evaluated that came equipped with the camera and monitor.

Figure 5.55. John Deere S660 combine—Optional camera location.

This mounting height affected the visibility of locations in close proximity to the base of the machine, however it did provide increased protection of the camera from ejected crop material and dust.

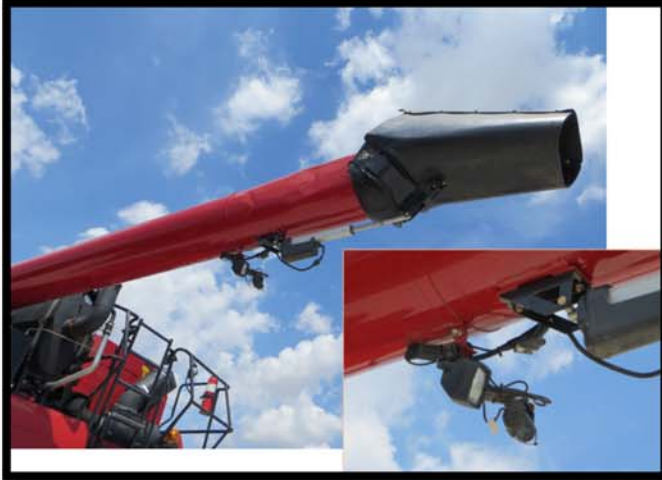
Another camera mounting location observed on some combines is on the unloading spout (Figure 5.58). This location provides the operator a rearward view while the auger is folded back for transport or a direct view of the unload locations, such as a semi-truck or grain cart. This allows the operator to maintain forward attention while unloading ‘on the go’, or the ability to see the grain levels and stream positioning when the unloading location is too high for direct view.

Figure 5.58. Case IH combine with optional unloading auger camera mount.

While providing two tasks with the camera mounted in this location, rearward visibility is reduced as the camera is mounted more than 3 m (10 ft.) from the rear of the machine with a rearward orientation. No rearward observation is possible when the combine auger is in the unloading position.

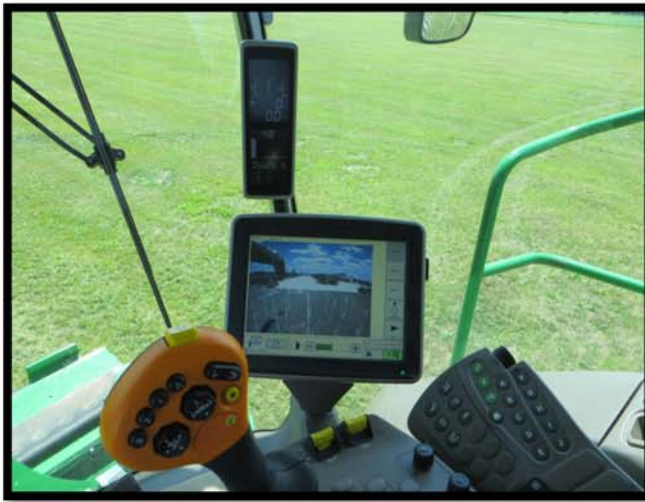
For the John Deere S660 combine used here, the factory-equipped monitor doubled as the camera monitor (Figure 5.59). As technology advances, these monitors are becoming common on most self-propelled machines and tractors. In fact, currently many factory and third party providers allow operators to utilize existing monitors in coordination with camera technology to avoid the need for multiple displays inside the cab.

Figure 5.59. Factory monitor utilized for camera display.

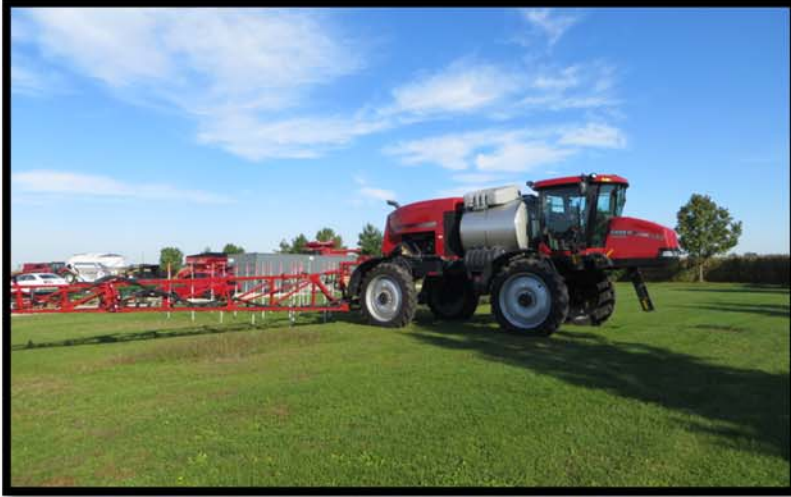
A Case Patriot 4430 self-propelled sprayer with a 36.6 m (120 ft.) boom was tested with the boom in both transport and field operation position (Figure 5.60). Basic specifications of the 4430 are as follows (Table 5.8):

This sprayer featured two sets of left and right exterior extended-arm mirrors (no in-cab mirror). The first set of extended arm mirrors were attached to the cab corners similar to other tested agricultural machinery. The second set was only visible when the spray booms were folded into transport mode, as they were attached to the mid-section of the booms.

Figure 5.60. Case Patriot 4430 Self-Propelled Sprayer with 36.6 m (120 ft.) booms adjacent to rearward visibility test grid.

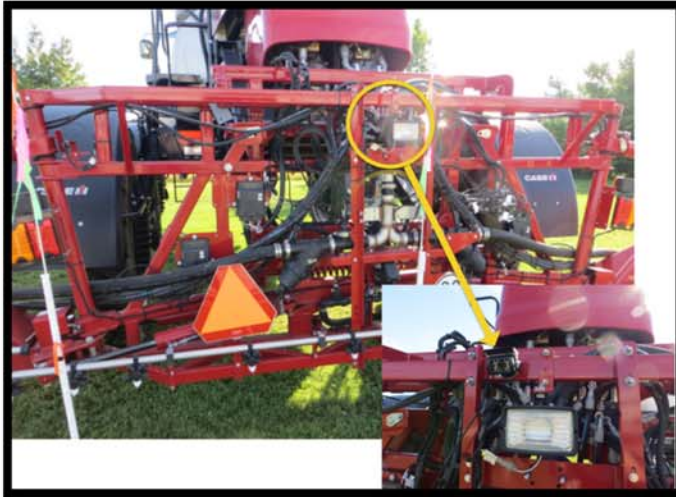
A VisionWorks 17.8 cm (7 inch) color display was positioned above the cab's center dash paired with a wide (170°) camera which was positioned in several locations, with the least obstructed view found to be the center of the upper portion of the boom near the rear-facing field light (Figure 5.66). Placement on the machines' body created unpredictable obstructions as boom height position was adjusted during operation.

Figure 5.66. Case Patriot Sprayer—Center boom frame camera mount location.

A weakness associated with mounting the camera on the boom was seen as the boom height was adjusted during operation and transport. The adjustment of the camera height during operation changed the operator's perspective of the camera view, which made it difficult to see the low-height indicators and thus eliminated a consistent frame of reference for estimating the distance to an object.

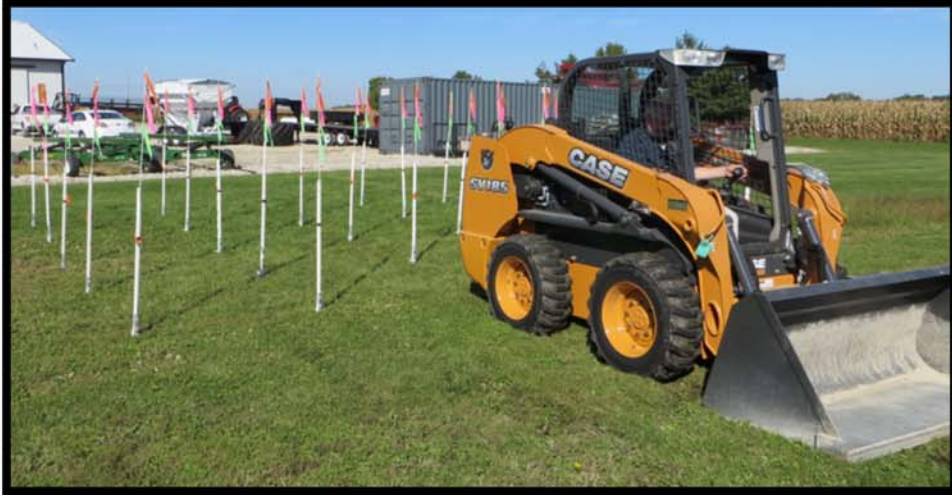
Figure 5.69. Case SV185 skid-steer, mid-sized 840 kg (1,850 lb.) operating load positioned adjacent to rearward visibility test grid.

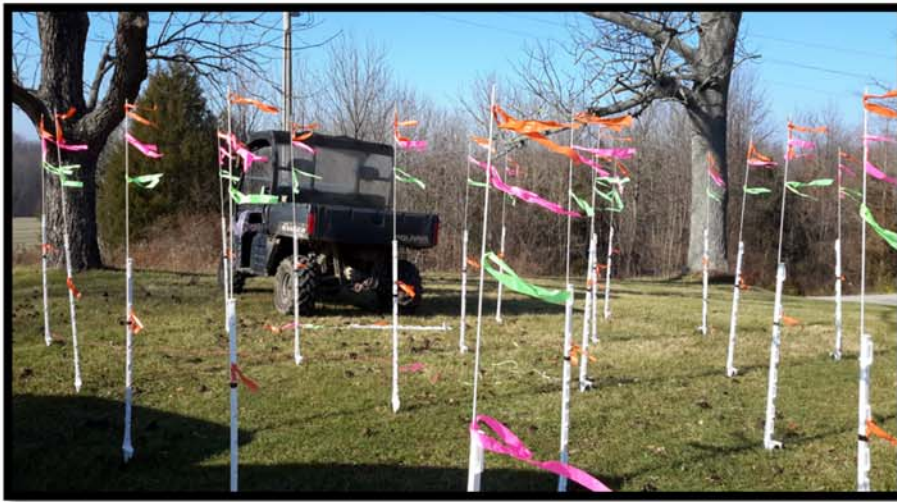
A Polaris Ranger was chosen as the representative for this category (Figure 5.72). This UTV did not feature factory-equipped mirrors in its factory original configuration, however they were added after purchased.

Figure 5.72. Polaris Ranger UTV positioned adjacent to rearward visibility test grid.

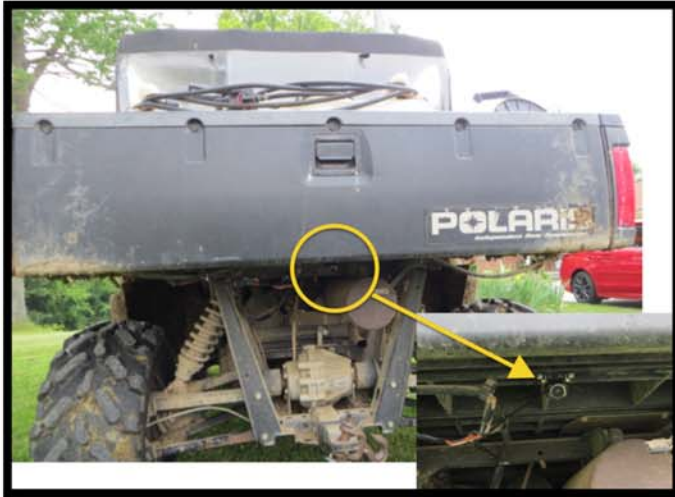
The camera mounting location for the UTV was chosen to be centrally located to the underside of the utility bed (Figure 5.76). This location provided ample shielding from encountered hazards.

Figure 5.76. Polaris Ranger UTV—Under utility bed camera mount location.

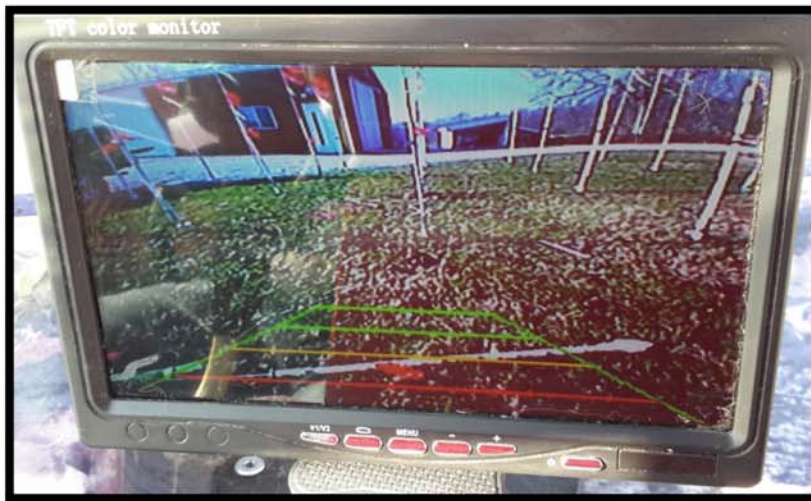
Figure 5.78. TFT dual input, 17.8 cm (7 in) color monitor paired with 170° waterproof camera with overlaid distance estimating grid.

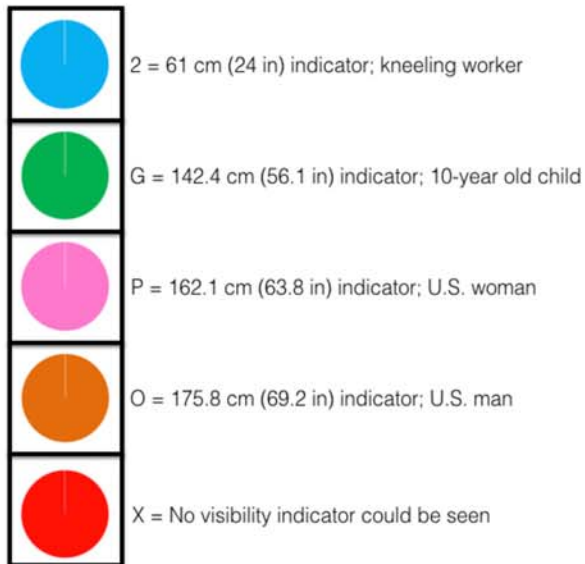
Figure 6.1. Color and letter key for grid results.
