Rearward visibility issues related to agricultural machinery: Contributing factors, potential solutions

Shawn Gregory Ehlers
Purdue University

A Dissertation

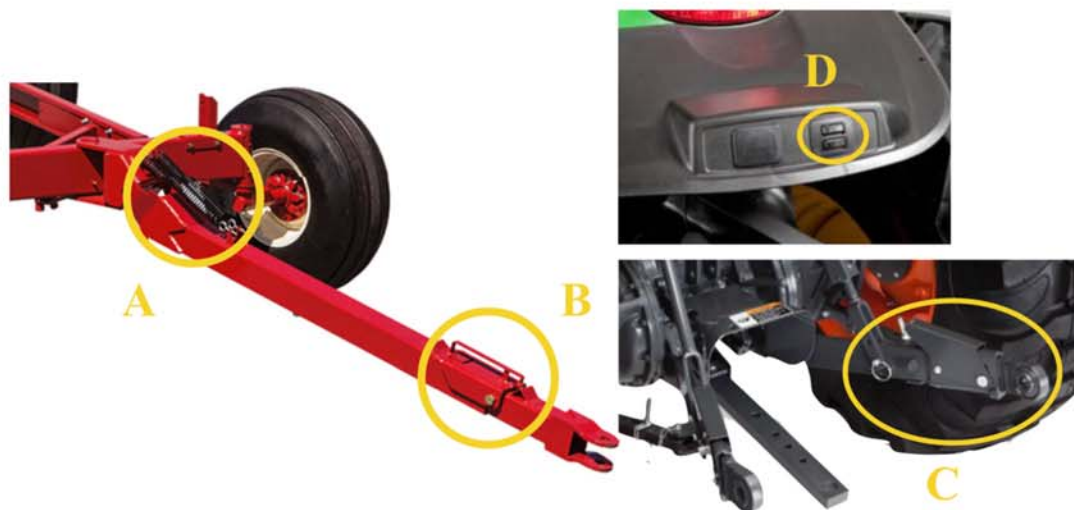
Figure 6.8. Hitching assistive devices—A. spring assisted tongue, B. telescoping tongue, C. telescoping tractor lift arms, D. fender mounted lift arm controller.

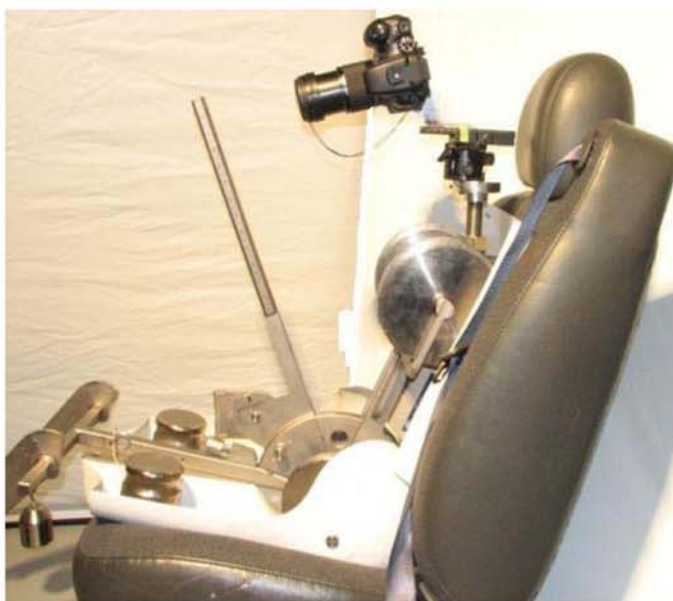
For measurements performed in this work, each vehicle's driver's seat was adjusted to the midpoint of its longitudinal adjustment range and to the lowest point of the vertical adjustment range. An H-Point machine was installed in the vehicle driver's seat per the installation procedure outlined in SAE J826³⁴. An image quality measurement fixture, described in detail in Appendix 1, and a camera attached to the H-Point machine as shown in Figure 5. The driver's seat seatback angle was adjusted to 25 degrees³⁵ at the vertical portion of the H-Point machine's torso weight hanger. If a seatback angle of 25 degrees was not selectable due to the location of seatback angle detents for a particular test vehicle, the seatback angle position corresponding most closely to 25 degrees was used. Once the seat was properly adjusted, the camera and fixture were adjusted to simulate the geometry of a driver's head turning to look at a rearview image. Specifically, the point M_f was rotated about the head/neck rotation point (J2) until the camera lens was pointed at an angle corresponding to the lateral position of the rearview image. This new, rotated location of M_f was referred to as M_r . Lastly, the camera was rotated about a horizontal axis containing M_r to create pitch that served to simulate the driver's eyes looking upward or downward as needed to cause the line of sight to intersect with the center of the rearview image (which might be mounted higher or lower than M_r . No head pitch was simulated as it was assumed to be unlikely or negligible.

Figure 5. Rearview Image Measurement Fixture

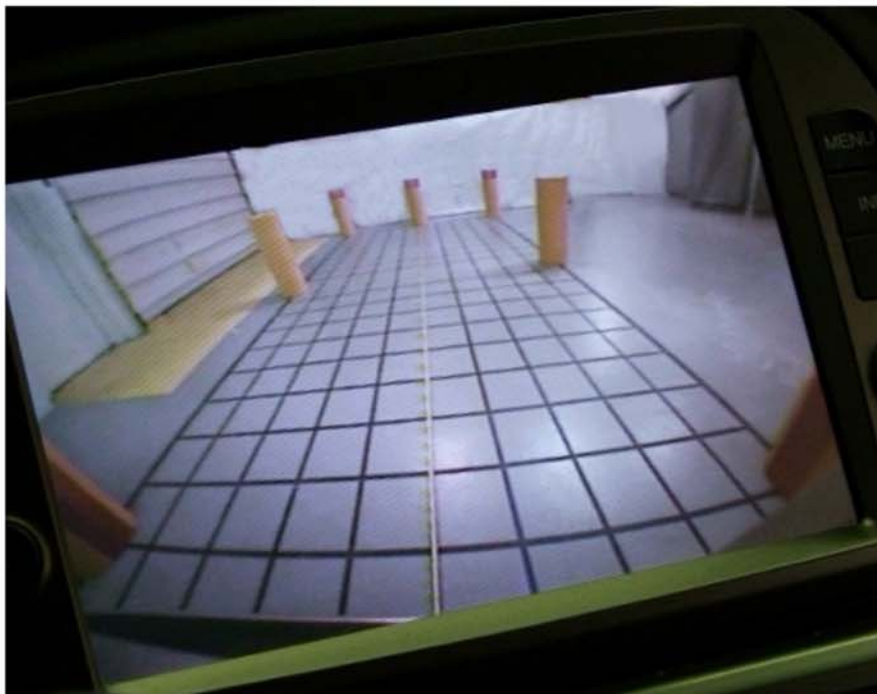
The cylinders are pictured in their test positions as displayed in a rearview image in Figure 8. The centerlines of Cylinders F and G were located 5.0 feet (1.52 meters) laterally from the center of the vehicle's rear bumper and 12.0 inches (305 mm) longitudinally aft of the rearmost point of the bumper face with the contrasting stripe oriented toward the vehicle's video camera. Between these sets of cylinders, the centerlines of Cylinders D and E were located 5.0 feet (1.52 meters) laterally and 10.0 feet (3.05 meters) longitudinally from the center of the vehicle's rear bumper.

Figure 8. Test Object Arrangement as Displayed in Rearview Image

In summary, for a rearview image to meet the current test procedure's criteria, two conditions must be met: First, the front surfaces of Cylinders A, B, C, D and E have to be fully visible in the display (the entire height and width of each cylinder). In addition, the full width of the 5.9 inch-wide (150 mm) vertical stripe on Cylinders F and G must be visible at some point along the height of the cylinder. If both conditions are met, then the system meets the field of view criteria established here. Figure 7 shows an image of a rearview image that meets these criteria, where Cylinders A through E are the ones furthest away in the image and Cylinders F and G have a substantial portion of their vertical stripes showing in the front corners.

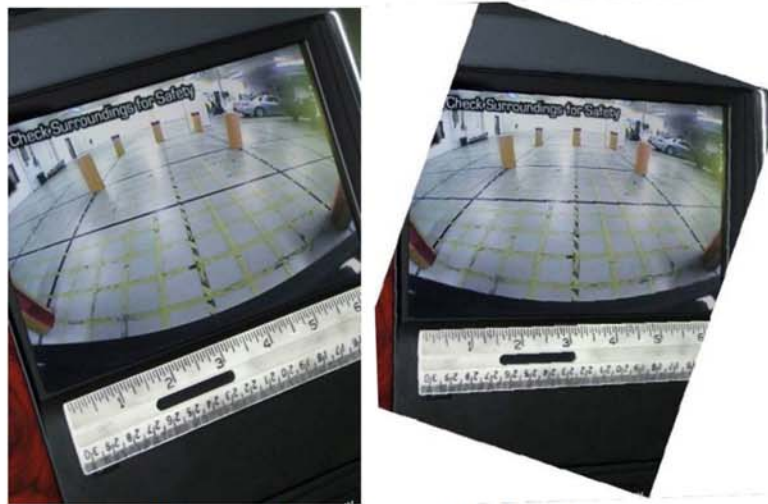
- In-vehicle rearview video system display screens are commonly located so they do not directly face the driver but are offset from the driver's direct forward line of sight. The human eye can compensate for this and interpret the image as "normal", whereas a camera lens tends to make images appear a bit skewed and not quite horizontal when the image is offset, as shown in Figure 9. For this reason a working copy of each digital photo was first rotated to make it appear approximately horizontal. It is important to ensure that any modifications to the digital photos (including rotations) do not distort the relative distances between points in the image.

Figure 9. Example of Photographic Image, Before and After Image Rotation.

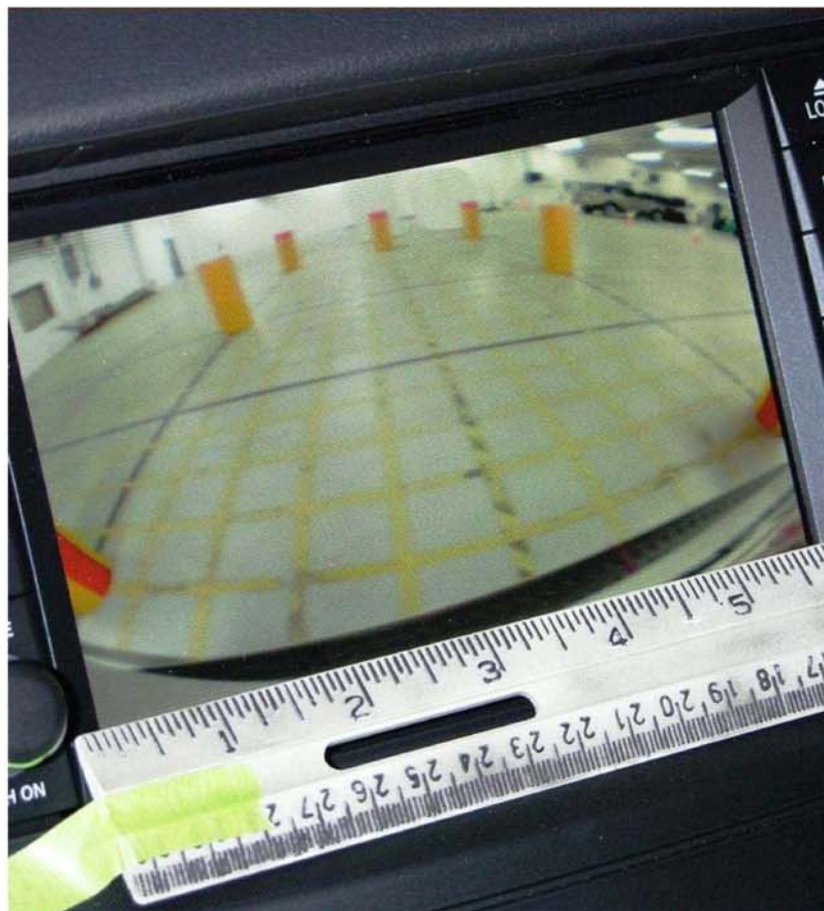
Figures 11 through 16 show photographs of each test vehicle's rearview video system display. These photographs were used to determine whether each rearview image met the field of view specified in Section 2.2 and Section 3.3 as well as the image quality requirements described in

Figure 11. Field of View and Image Quality Assessment Photo for the 2010 Dodge Grand Caravan

Section 3.4. As can be determined from an examination of these figures, all six test vehicles rearview video systems met the field of view requirements described in Section 2.2.

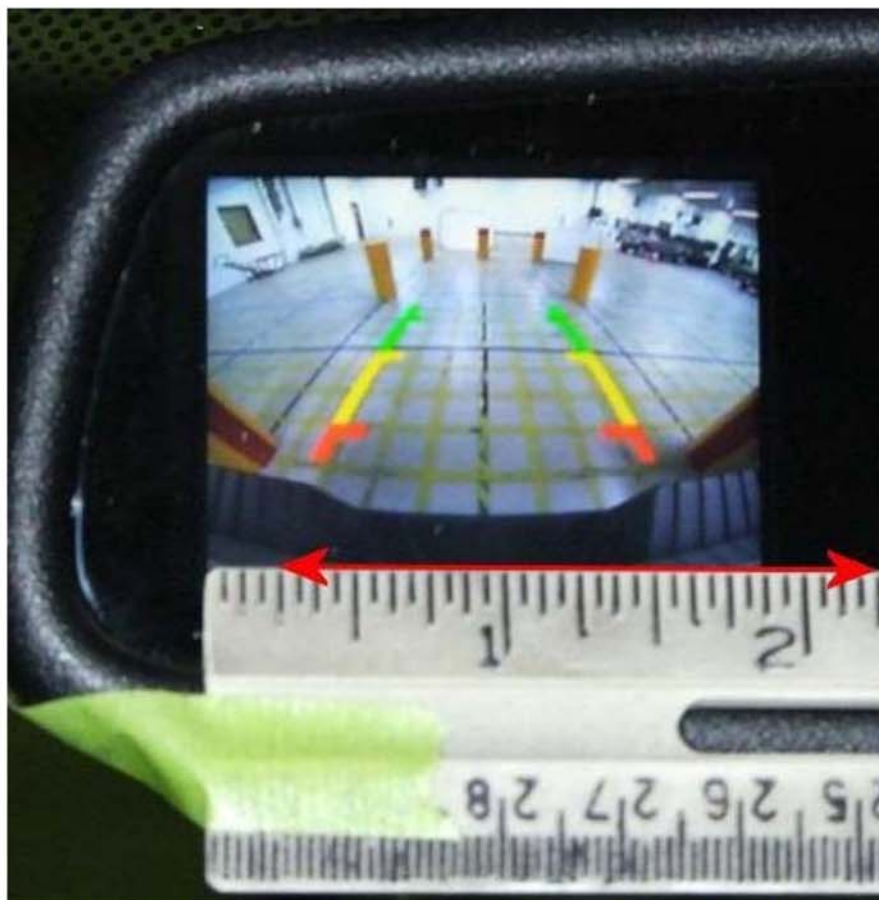
Figure 12. Field of View and Image Quality Assessment Photo for the 2010 Ford F150

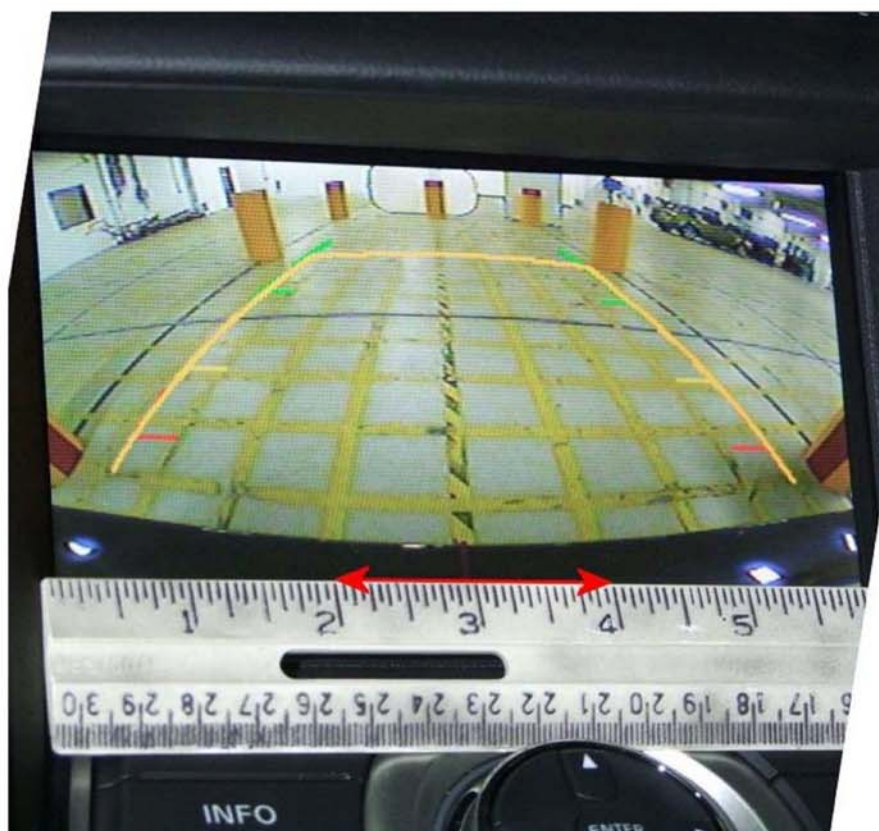
Figure 13. Field of View and Image Quality Assessment Photo for the 2010 Nissan Maxima

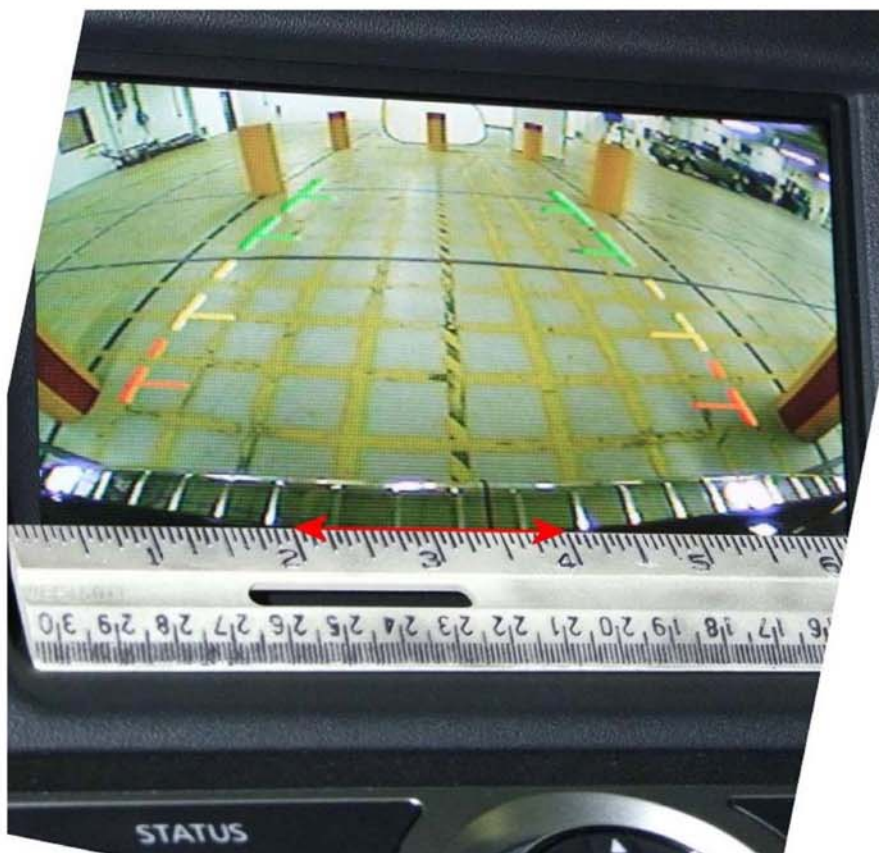
Figure 14. Field of View and Image Quality Assessment Photo for the 2010 Nissan Murano

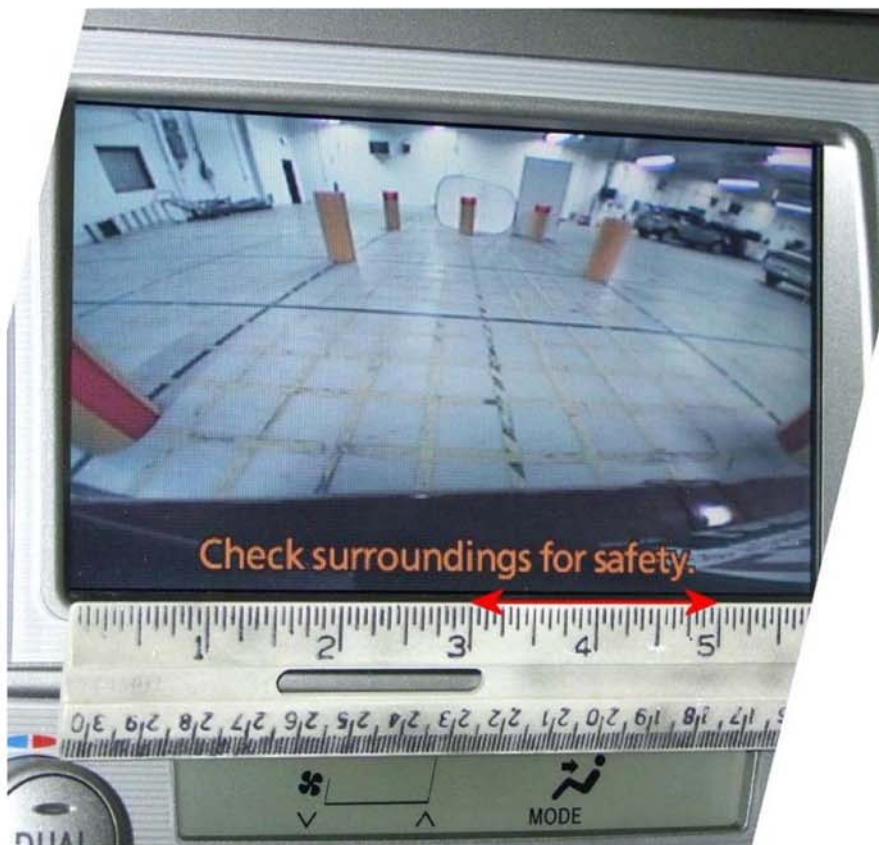
Figure 15. Field of View and Image Quality Assessment Photo for the 2011 Toyota Camry

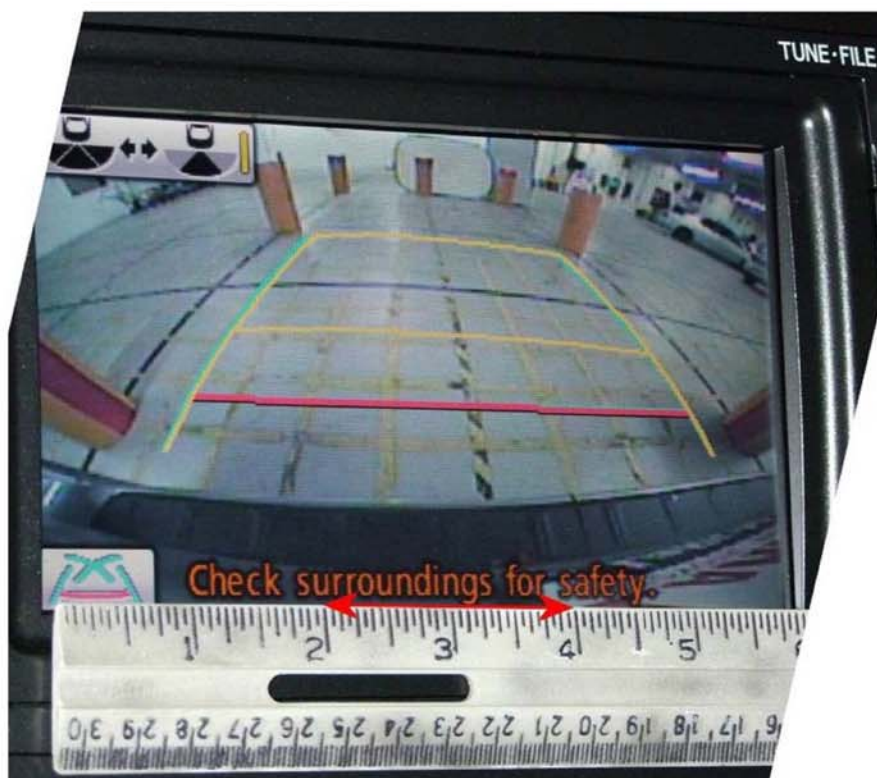
Figure 16. Field of View and Image Quality Assessment Photo for the 2011 Toyota Sienna

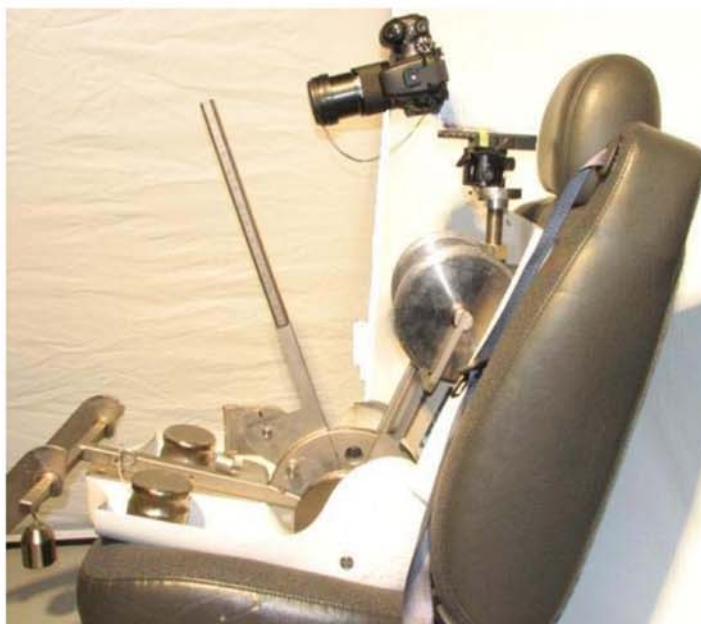
To facilitate a repeatable test procedure, an H-Point machine representing the 50th-percentile adult male was used as the base for the fixture. The H-Point machine was selected as the base to provide a standardized representation of the seated posture of an adult male driver. The H-point machine's standard configuration was modified to incorporate a fixture mounted in place of the device's neck, as seen in Figure 17. The fixture has multiple points of adjustment such that it can be adjusted to hold the camera in a specific position that corresponds to the selected eye midpoint of a 50th-percentile adult male driver.

Figure 17. Camera & Mounting Fixture on Neck of H-Point Machine

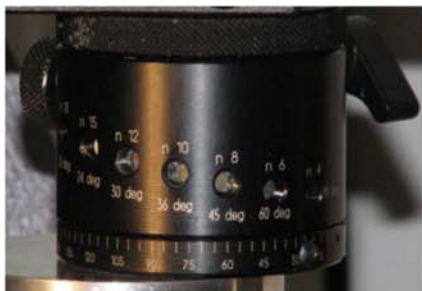
In addition to the forward-looking eye midpoint (M_f), the fixture also needed to have points of head and neck rotation similar to a 50th percentile adult male. The fixture was designed to rotate about the head/neck joint center (J) in a horizontal plane. To accomplish this rotational capability, a panoramic head (a camera mount typically used for taking panoramic photos) was mounted to the centerline of the neck. This provided the rotation with the ability to lock the fixture into a desired location. The panoramic head included graduated markings to provide a record of the rotation angle used, as shown in Figure 18.

Figure 18. Neck of Fixture, a Panoramic Head

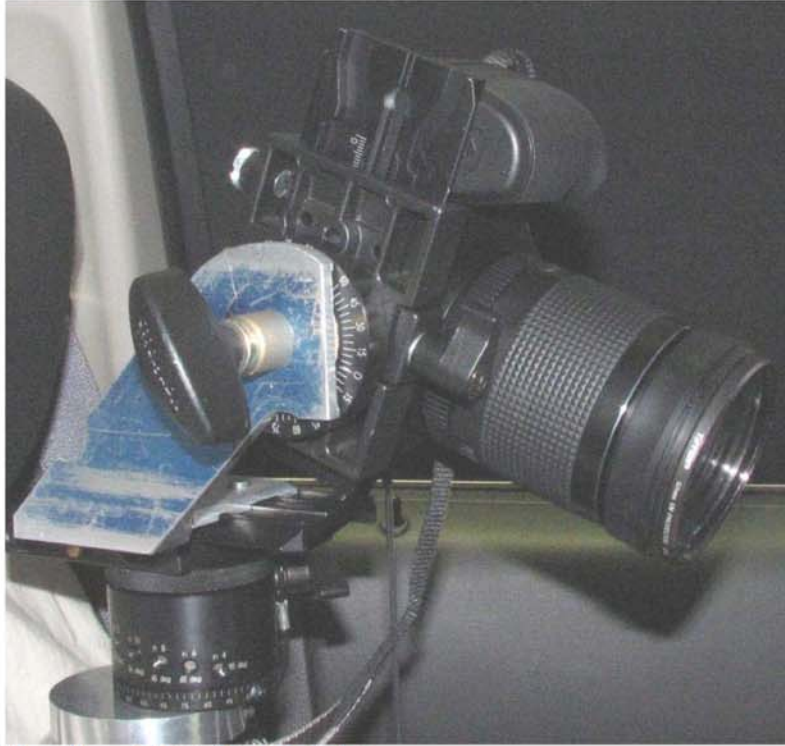
A close-up image of the camera mounting system (adapters, sliding plates, rotation index guide, section of aluminum and panoramic head) is presented in Figure 19. Engineering drawings of the fixture design can be found in Figures 20 through 25.

Figure 19. Camera Mounting System.

To allow for fine adjustment and future versatility, two quick release adapters with sliding plates and a rotation index guide (from a Manfrotto Virtual Reality SPH/Cubic Head) were used in conjunction with a mounting plate made of a section of angled aluminum. While in the forward-looking position, the first quick release adapter, sliding plate and section of aluminum allowed for making fine longitudinal adjustments. The horizontal portion of the section of aluminum provided a 2.91 inch lateral offset to center the camera lens with the center of the body line. The vertical portion of the section of aluminum produces the majority of the longitudinal offset to position the CCD of the specific camera used at the approximate M_f point. The vertical portion of the section of aluminum also has a rotation index guide mounted to the second quick release adapter and sliding plate combination. These parts mount the camera to the section of aluminum and allow the CCD to pitch about a horizontal axis containing the point M_f (rotated M_f) to

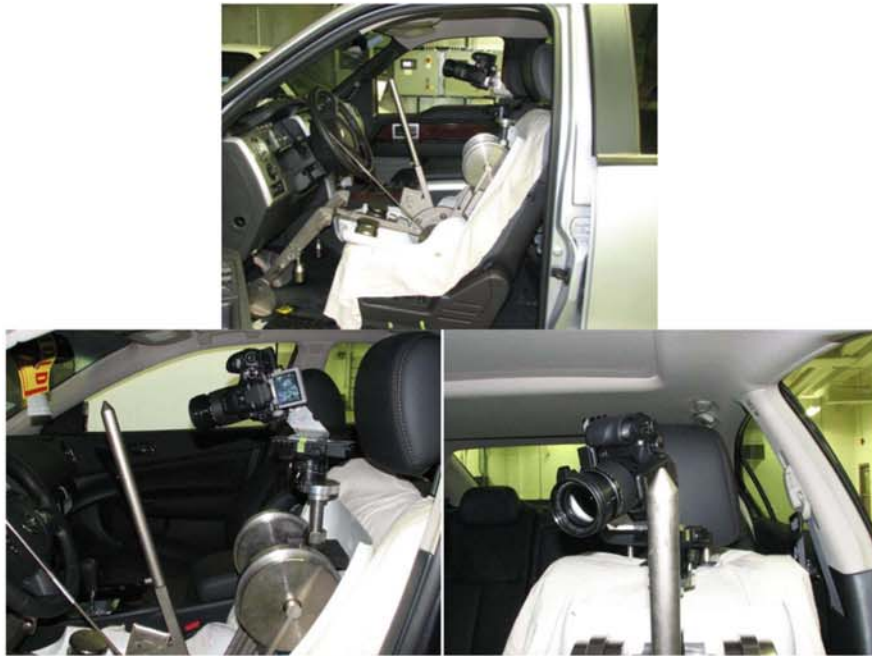
Figure 26. Photos of the Image Quality Assessment Camera Fixture Installed in Test Vehicles

Top: 2010 Ford F-150, Side View
