Material effects on strawbale wall seismic capacity

Margaret Ackerson

McKenna Williams

SANTA CLARA UNIVERSITY

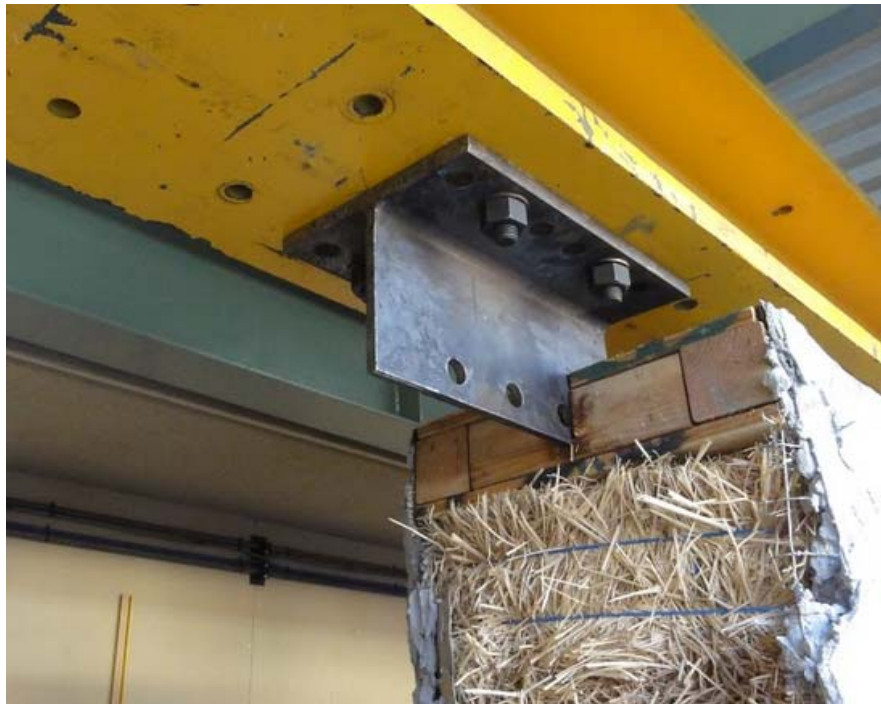
Figure 6: T-Plate slotted into the cap of the Welded-18 wall.

The same standard test protocol was followed for each strawbale wall in this seismic test series. The wall was pinned at the top, and two structural T-shapes served as stability guides, located at the top on either end of the wall to prevent possible twisting during the test (Figure 6).

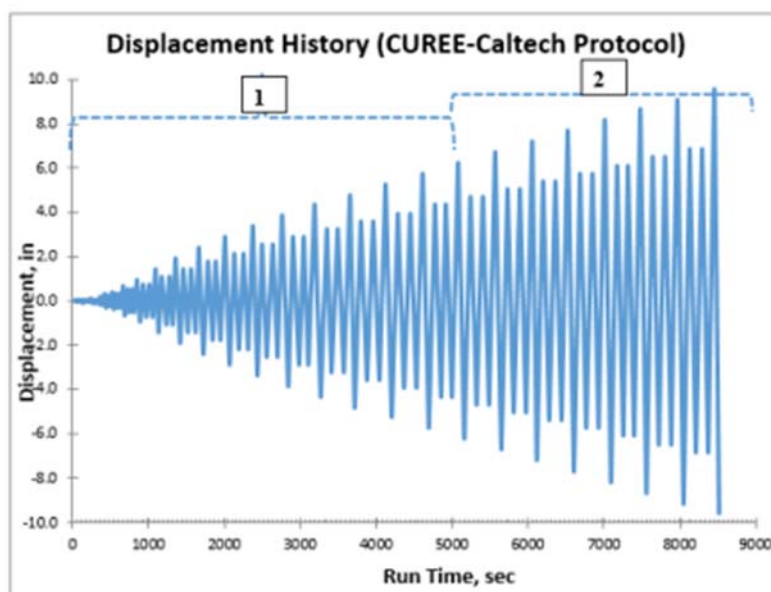
Figure 7: Applied reversed cyclic lateral displacement history, based on CUREE-Caltech Protocol (Section 1 of the graph) with an extension (Section 2 of the graph). Taken from Heckert, et al. (2015).

The testing protocol was a modified CUREE Caltech protocol found in ASTM E 2126-02A (Krawinkler, 2009; Heckert, et al, 2015). The reversed cyclic loading provided one leading cycle with two trailing cycles at 75% of the leading cycle (Figure 7). A “leading cycle” is defined as a cycle that reaches a new peak displacement within the test, whereas a “trailing cycle” follows a leading cycle, and does not reach a new peak displacement. The reference drift limit is approximately 1% of the wall’s height, taken as 0.96” for all four walls, even though the Welded-14 and Welded-9 walls were respectively 6” and 8” shorter than the Welded-18 and Woven-18 walls. Individual tests were terminated at arbitrary displacements based on the condition of the wall.

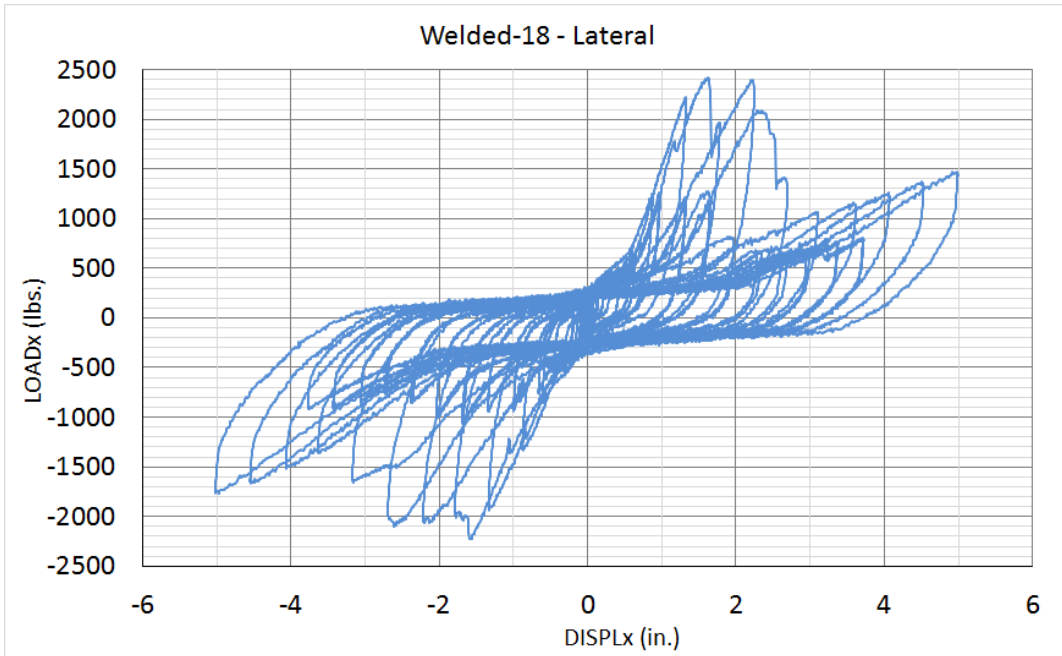
Figure 8: Load versus displacement for lateral test of Welded-18 wall.

The graph of the lateral load-lateral displacement response from the seismic test shows a significant reduction in carried load after the peak was reached at 1.6% drift (Figure 8). Its

failure, like all of the walls, was governed by flexure due to the walls 2:1 aspect ratio (8' tall to 4' length).

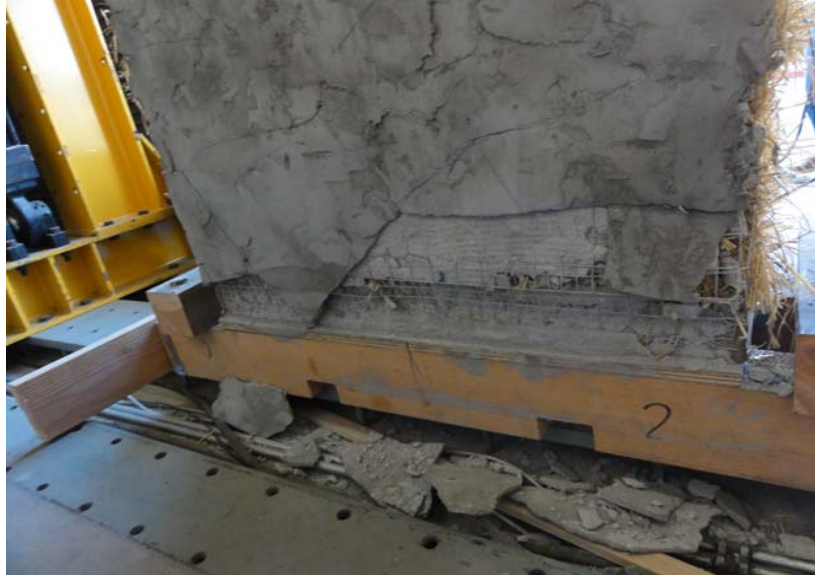
Figure 9: Outer layer of plaster delaminated from the inner layer of plaster at the base of the wall. The stapled connections of mesh to the sill plate seem to still be intact.

During the Welded-18 lateral test, the plaster delaminated where the first applied coat met the second applied coat, i.e. the two layers encasing the wire mesh. This was especially evident on the back side of the wall, where chunks of the outer plaster layer spalled off the inner layer at the bottom left and right corners. The second layer of plaster spalled off the wooden base at the bottom of the wall, though the first layer remained intact, protecting the staples (Figure 9).

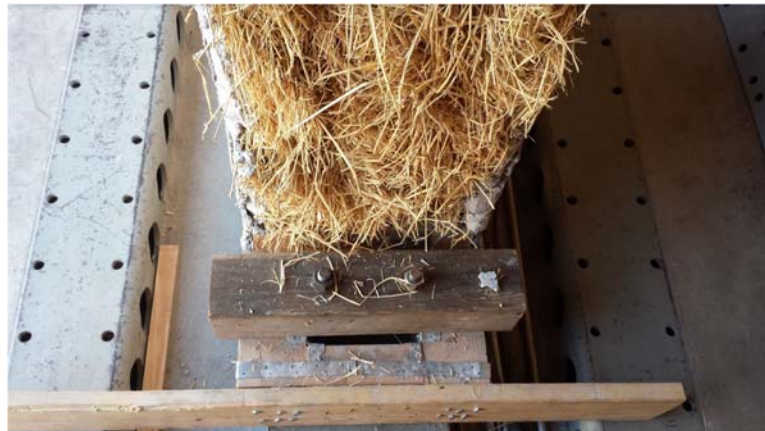
Figure 10: Connection of the base of the wall to the floor of the test frame.

During the later cycles, when the top of the wall was subjected to lateral displacements of 5” or more, the base (or sled) of the wall slid relative to the test floor a maximum of ½” laterally at the peak of each loading cycle. Figure 10 shows the two 1-inch diameter threaded rods restraining a 6x6 member across the base of the wall. The bearing between the 6x6 and wall base was not strong enough to prevent slippage as the test progressed (Figure 10). Subsequent tests employed plates affixed to either side of the sled, shimmed tight to the sled and bolted to the test floor, to prevent sliding.

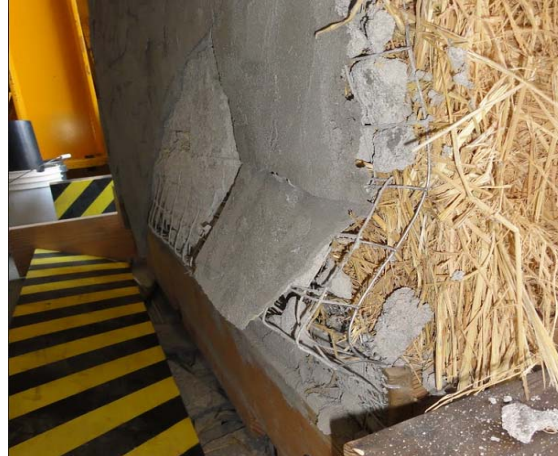
Figure 11: Wire mesh buckling at the base of the wall near the end of the lateral test, after peak displacement had been reached. Each side was repetitively subjected to compression and then tension.

The bottom half of the plaster skin buckled, especially near the connection at the base (Figure 11). Except where the plaster buckled outward and delaminated, most of it

remained bonded to the wire and straw. Cracks in the plaster mainly proliferated near the bottom of the wall, and those that formed higher up did not grow much after initial formation.

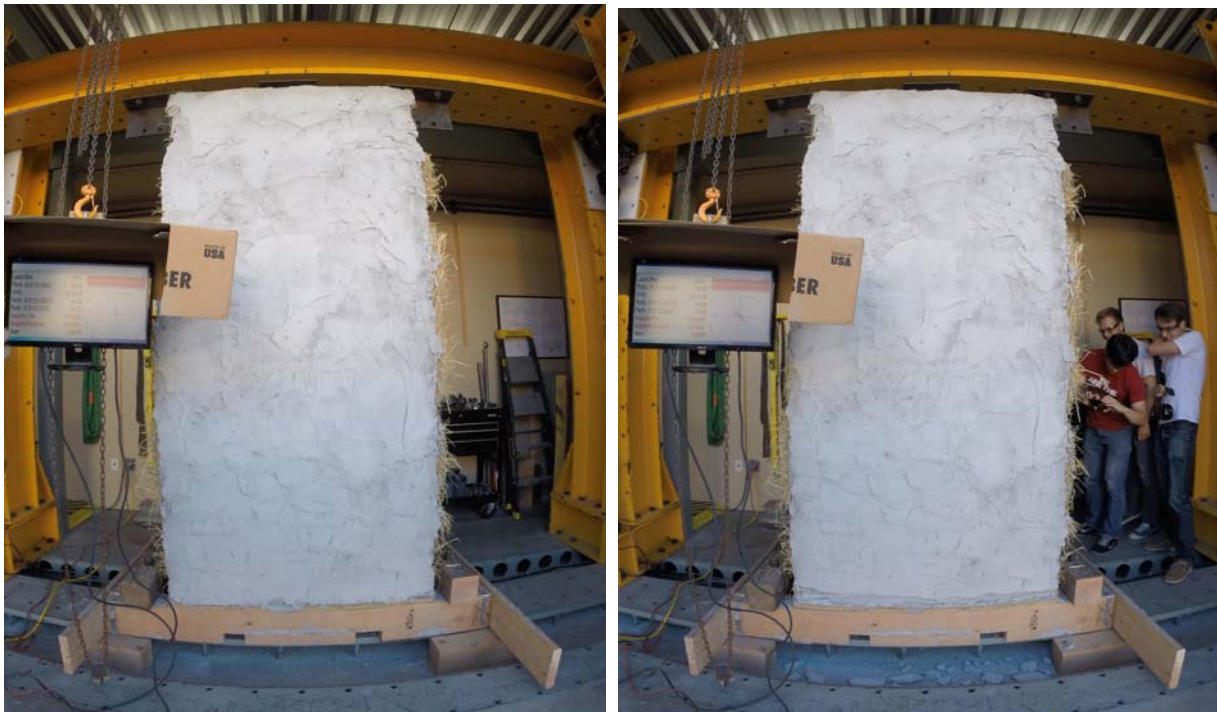
Figure 12: Welded-18 wall at (a) 1.28” lateral displacement with lateral load 998 lbs and (b) 2.88” lateral displacement with lateral load 1567 lbs. These photos were taken during a leading cycle.

The following images present the wall at approximately 1%, 3%, and maximum displacement. These values will be compared across all walls in the “Discussion” section.

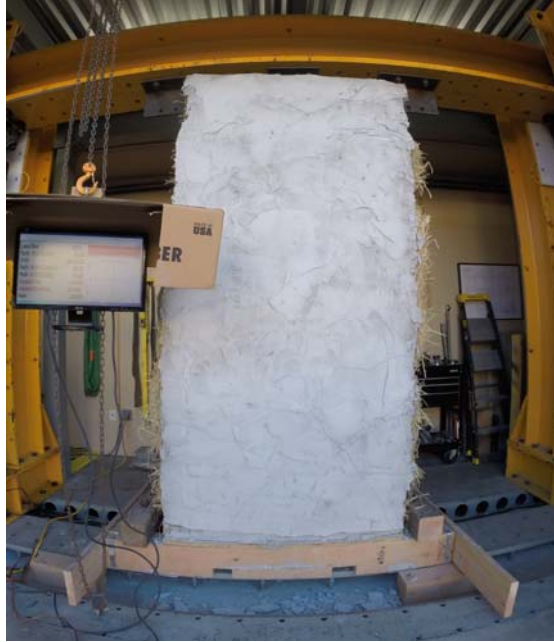
Figure 13: Welded-18 wall at 4.3” lateral displacement with lateral load 521 lbs. Taken during a leading cycle.

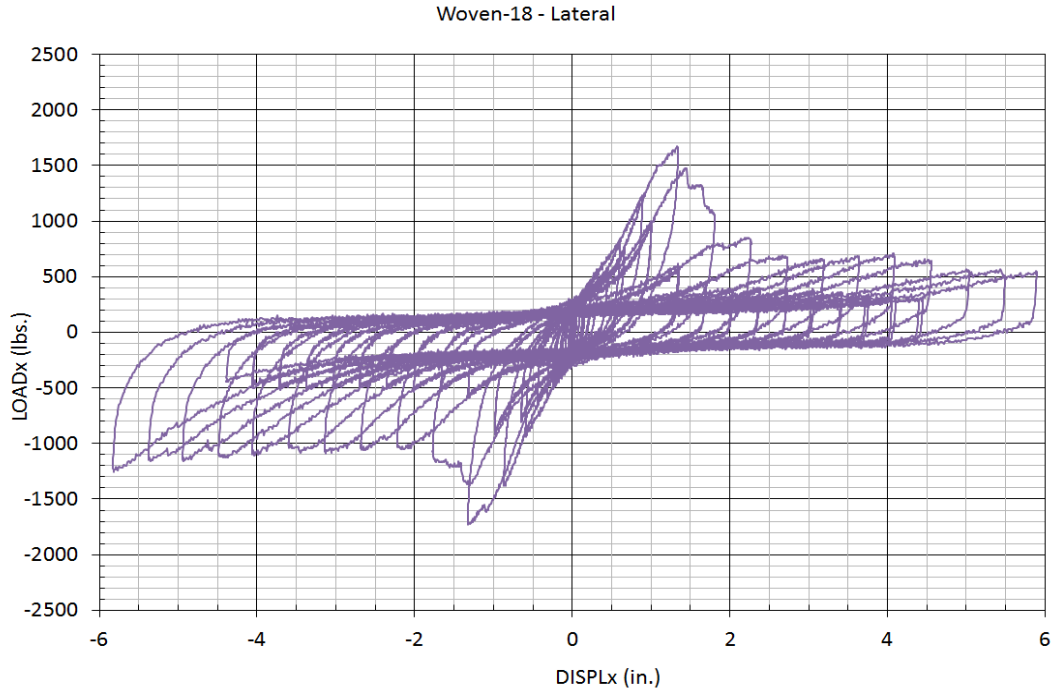
Figure 14: Lateral test results of the Woven-18 wall.

Its graph shows a significant reduction in lateral load (Figure 14). It reached 73% of the capacity of the Welded-18 wall, and it also lost approximately 50% of its lateral resisting strength after reaching a peak.

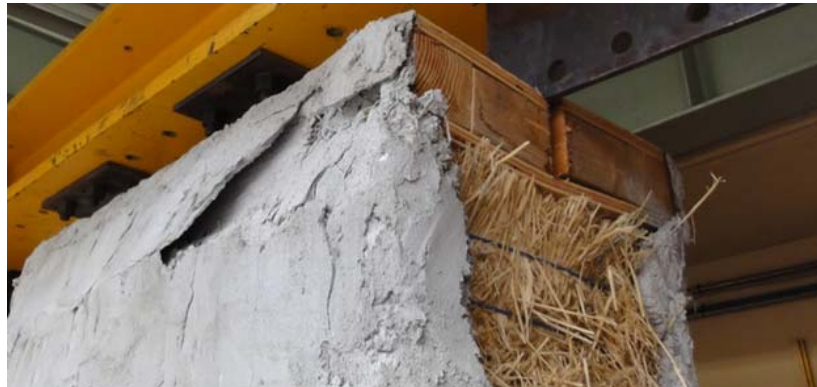
Figure 15: Crushing damage done to the top right corner of the wall prior to the lateral test.

Prior to the Woven-18 lateral test, the test frame crushed the top right corner of the wall, damaging the plaster (Figure 15). The top one (1) foot of plaster was removed from the wall and replaced with new plaster made to the same specifications (Figure 16). A small crack formed at the interface between old and new plaster, but it didn't propagate during testing. The demarcation of darker old plaster and lighter new plaster is visible in the images below.

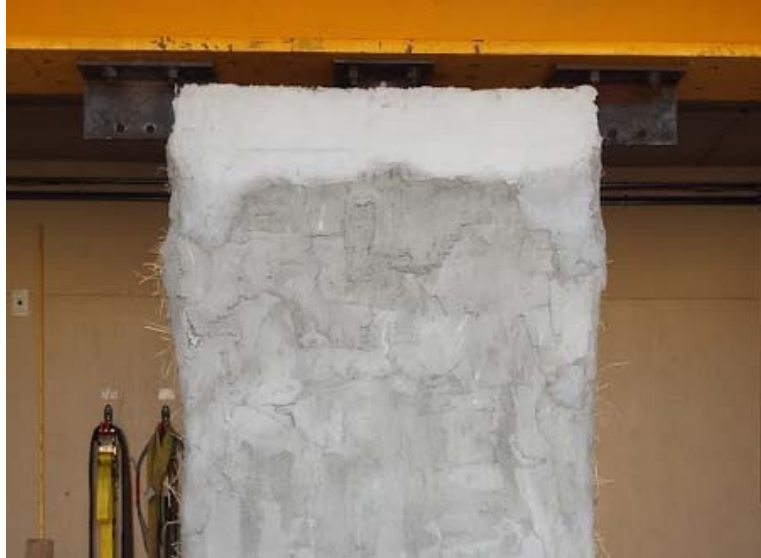
Figure 16: The new plaster can be seen here as a band of lighter plaster at the top of the wall.

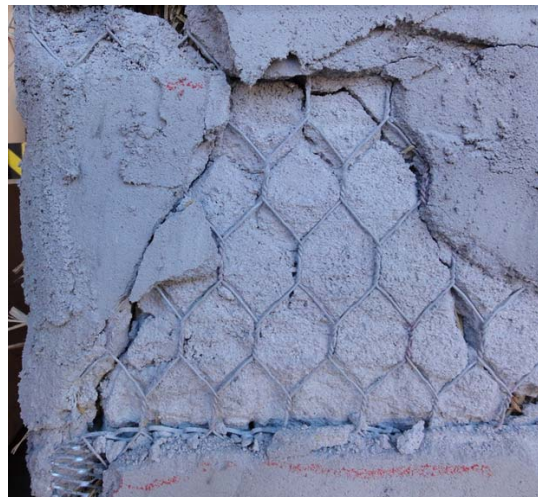
Figure 17: Taken post-lateral test. Cracks in the plaster following the “diamond” pattern of the woven mesh. Delamination is evident here where the outer layer popped off to expose the woven wire, while the inner layer remained in place.

During the Woven-18 lateral test, the damage was concentrated at the bottom. The exterior layer of plaster delaminated from the interior layer of plaster and popped off due to bending of the wire mesh. The mesh elongated in flexural tension and bent out of plane when loaded in compression. Most of the interior layer of plaster remained attached to the straw bales. Cracks in the plaster followed the “diamond” pattern of the woven wire mesh, and propagated diagonally from the bottom corners and edges of the “diamonds” (Figure 17). This is attributed to the net plaster section being reduced at the location of a wire, thus leading to higher tensile stresses at the location of a wire.

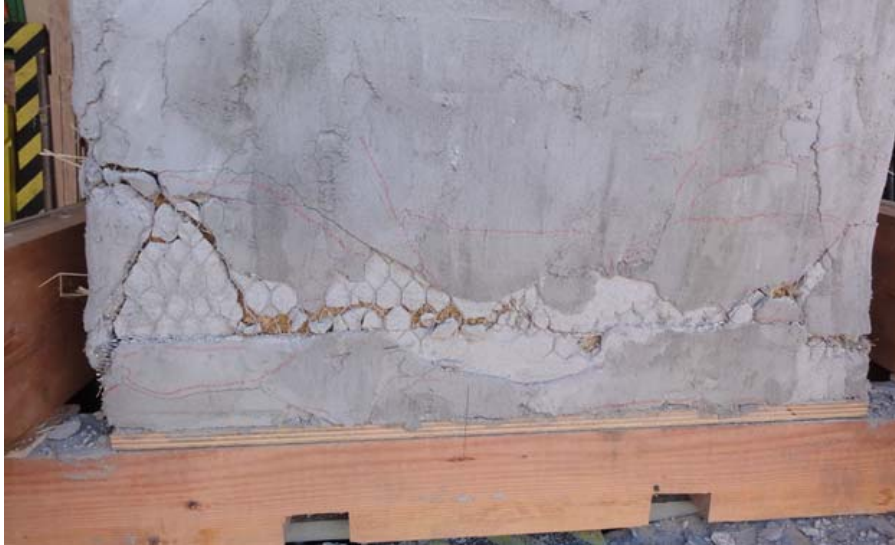
Figure 18: The damage was concentrated in a line approximately 10” above the base, due to the extra 10” band of wire mesh added to the modified workhorse connection detail, also termed the “Heckert detail.”

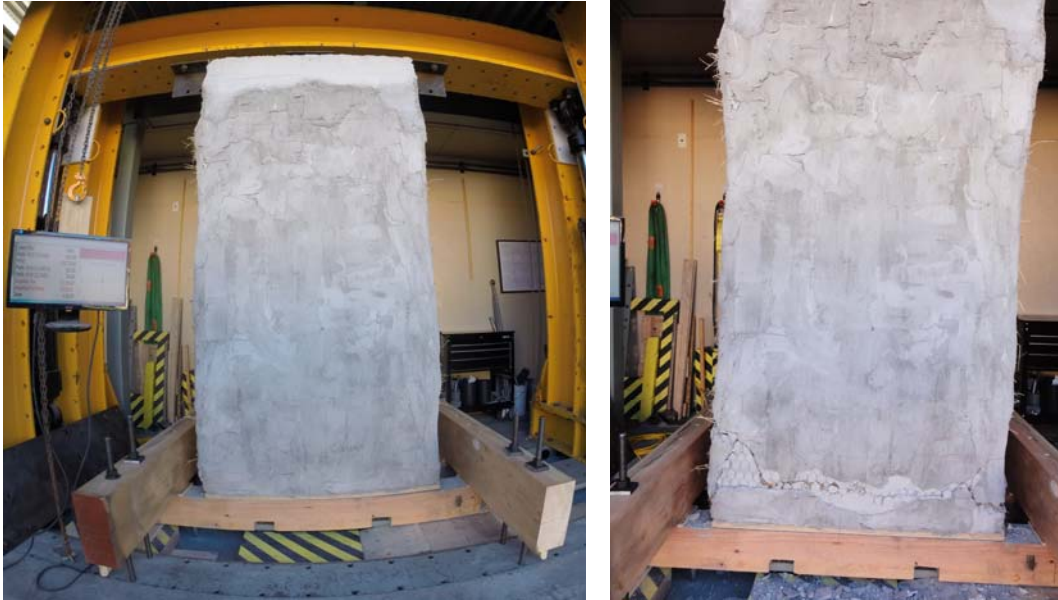
Figure 19: Woven-18 wall at (a) 1.06” lateral displacement with lateral load 1402 lbs and (b) approx. 3” lateral displacement at an unspecified lateral load. Figure 19(a) was taken during a leading cycle, and Figure 19(b) was taken during a trailing cycle.

The following images present the wall at approximately 1% and 3% displacement (Figures 19a and 19b). These values will be compared across all walls in the “Discussion” section. Figure 20 shows damage of the wall at the end of the lateral testing.

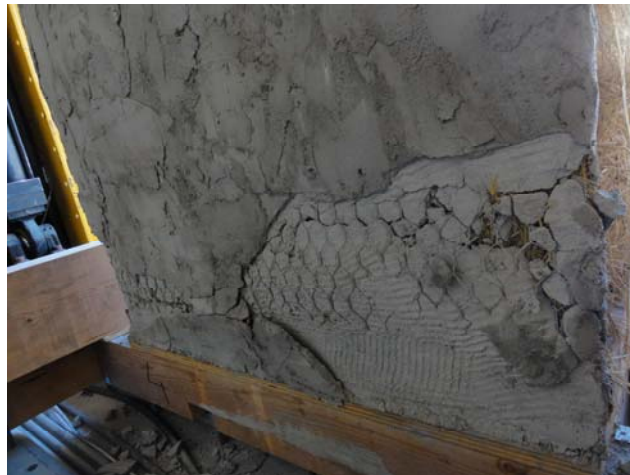
Figure 20: Backside of the Woven-18 wall, post-lateral test. Extensive delamination of the outer plaster layer has revealed the inner plaster layer. Plaster at the base remains intact and seemingly protects the stapling at the connection underneath.

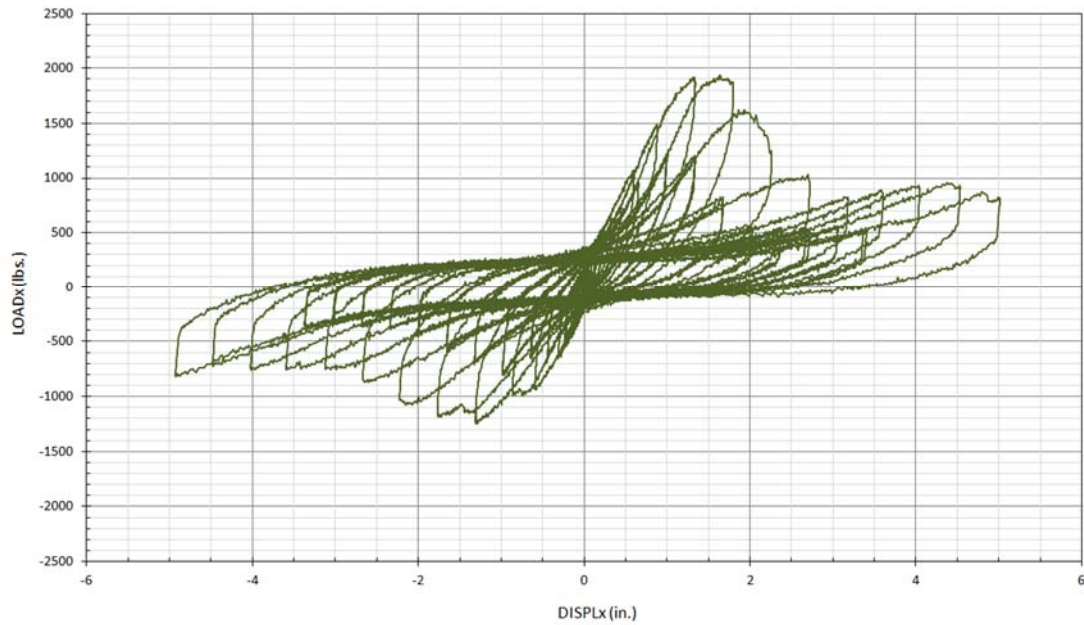
Figure 21: Welded-14 lateral test hysteresis test.

From the graph (Figure 21) it appears that the peak lateral forces in both directions were reached in the same leading cycle. Both peaks occurred at approximately 1.5% drift.

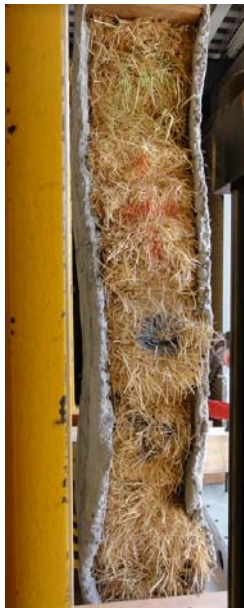
Figure 22: A picture of the Welded-14 wall prior to testing. The wall was not uniform and bore a distinct vertical warp.

During the Welded-14 lateral test, the wall's irregular, wavy shape contributed to a higher tendency to buckle in compression, even during the lateral test (Figure 22). The lack of tension in the welded wire caused the wall to “breathe” during the test, where both sides of the plaster buckled outward.

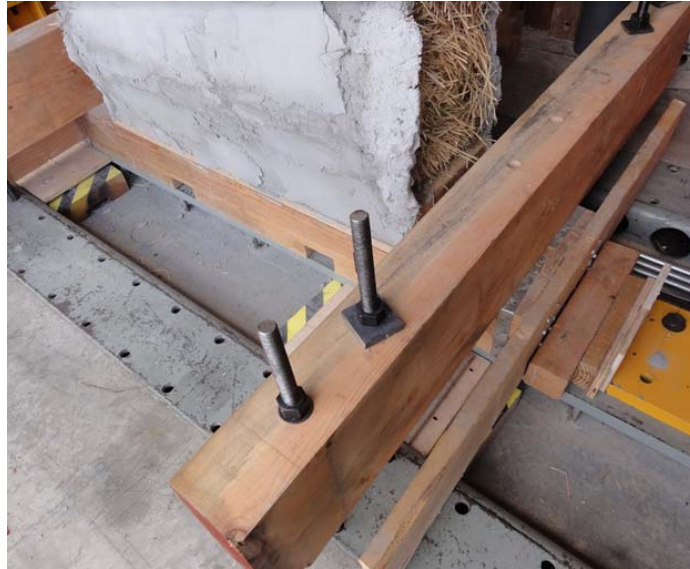
Figure 23: The new restraint system implemented in the Woven-18 and Welded-14 walls.

For this test, a new restraint system used 8x10 Douglas-Fir beams to resist overturning moment and to keep the base of the wall in place. The combination of the 8x10 Douglas-Fir beams and plates bolted to the test floor and shimmed to block sliding at end of the wall successfully kept the base of the wall in place and prevented the slippage that had occurred during the Welded-18 test. See the Welded-14 wall results for an image of the restraint system (Figure 23), as the same system was implemented for the Woven-18 and Welded-9 as well.

The base, however, remained secure and did not slide laterally due to improved overturning and sliding restraints (Figure 23). The modified “workhorse” connection details at the base of the wall performed well, concentrating the damage in a line 10” above the base, protecting the staples at the base connections (Figure 24).

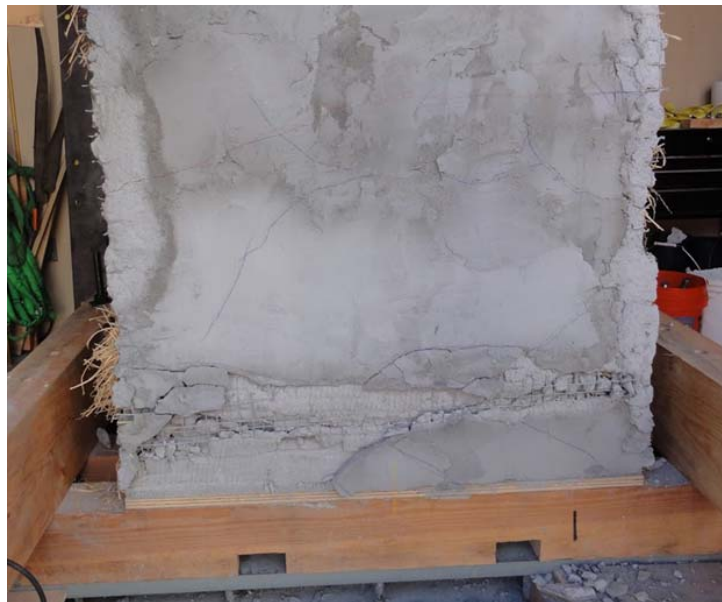
Figure 24: Damage at the base of the Welded-14 wall post-lateral test was concentrated approximately 10” above the base of the wall, due to the extra 10” band of wire added to the modified workhorse connection detail. The outer layer of plaster delaminated from the left side, but the inner layer remained intact, protecting the staples underneath.

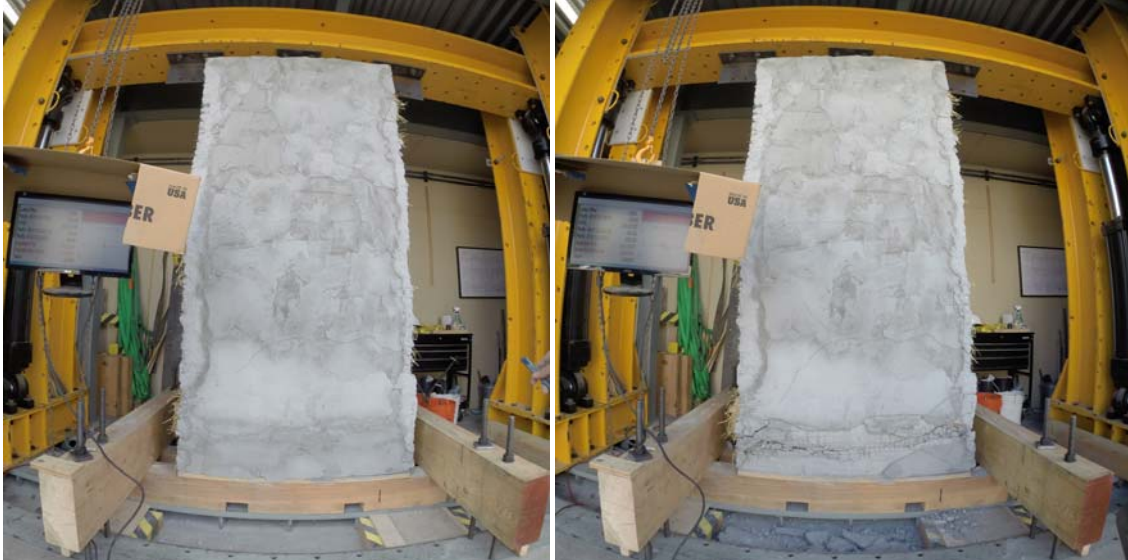
Figure 25 Welded-14 at (a) 1.17” lateral displacement and load 1704 lbs and (b) 3.26” lateral displacement with load 520 lbs. Both images were taken during a leading cycle.

The following images present the wall at approximately 1%, 3%, and near maximum displacement (Figures 25a, 25b, and 26). These values will be compared across all walls in the “Discussion” section.

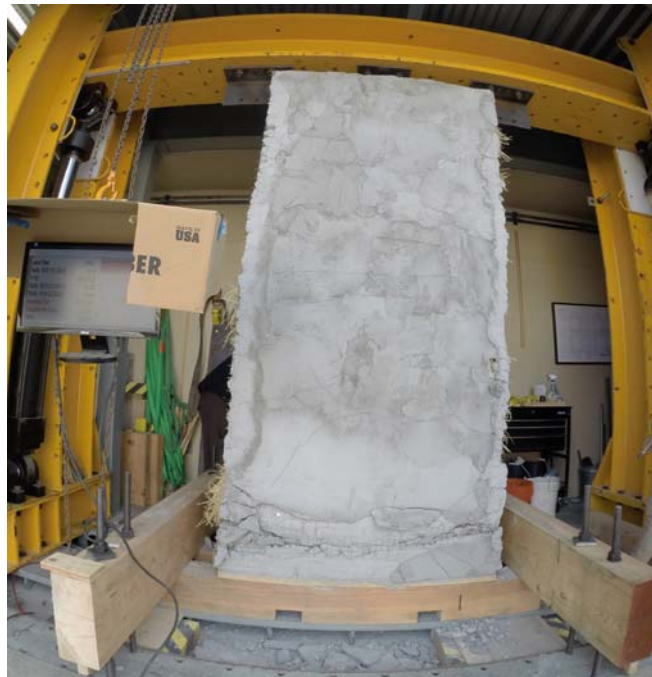
Figure 26: Welded-14 at 3.70” lateral displacement with load 229 lbs. Taken during a trailing cycle.

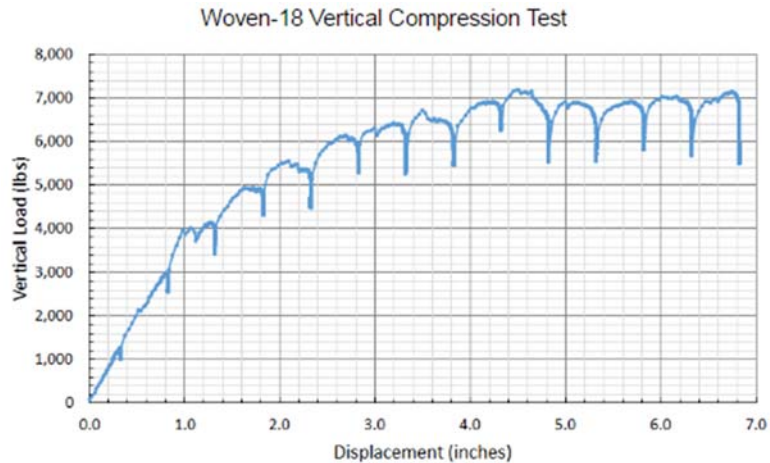
Figure 27: Vertical test of Woven-18 wall in load vs. displacement.

The Woven-18 wall reached a peak vertical load of 7100 lbs (Figure 27). Over the duration that a displacement was held, the vertical load decreased, suggesting creep (Figure 28). The expected load was 1200 lbs (see Discussion for details). The woven wire wall was tested to a maximum vertical displacement of 6.8 inches. The Woven-18 wall was able to maintain a load of 6900 lbs even as it was compressed almost seven (7) inches; this load is called the “Sustained Vertical Load” in Table 5.

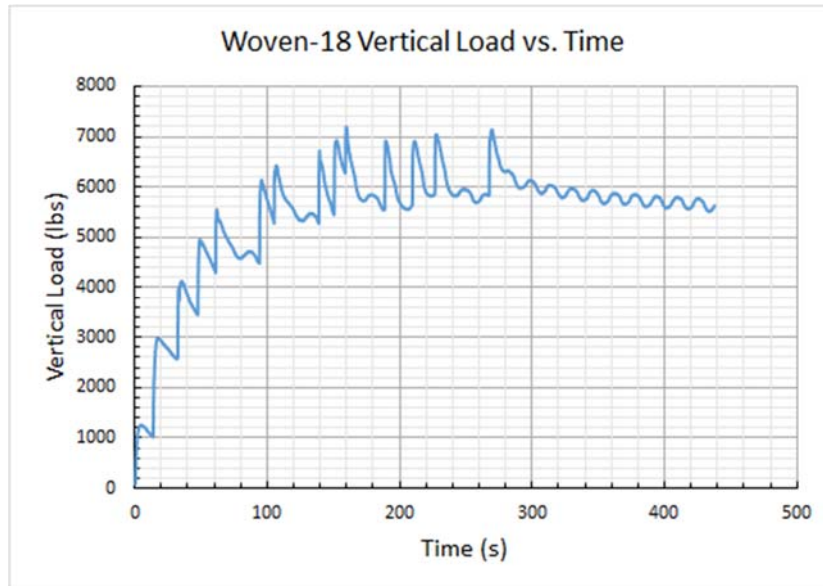
Figure 28: Vertical test of Woven-18 in load vs. time.

As shown in the vertical load versus time graphs, the slope after each peak decreased more quickly as the load got higher. If given enough time, the vertical load may have returned to zero.

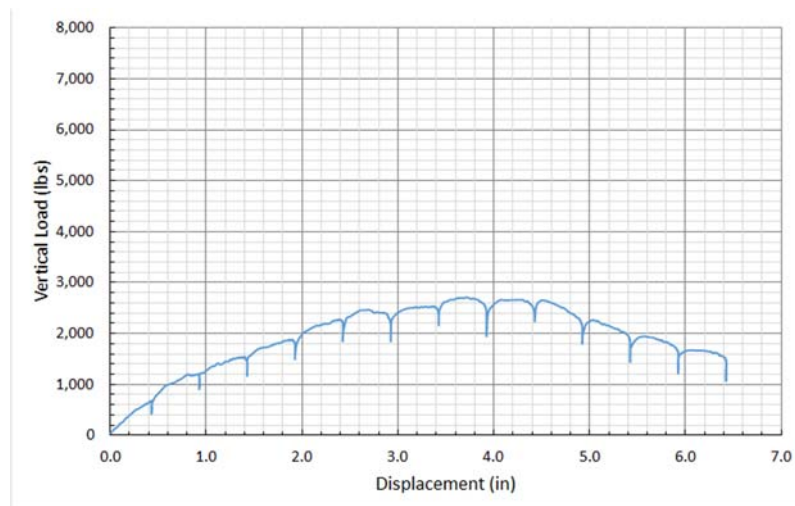
Figure 29: Vertical test of Welded-14 wall in load vs. displacement.

The Welded-14 wall’s maximum compressive load was 2710 lbs, but the maximum sustained load was only 1,600 lbs (Figure 29). “Sustained” was defined as the load the wall was bearing even after it was vertically displaced by 4 - 6 inches. The wall failed by global out of plane buckling. The unusual degree to which this wall deviated from true vertical suggests that even poorly constructed walls will have adequate capacity to hold roof loads (expected to be approximately 1,200 lbs) except in cases of unusually high vertical loads; attention to vertical trueness will allow much higher capacities to be counted on.

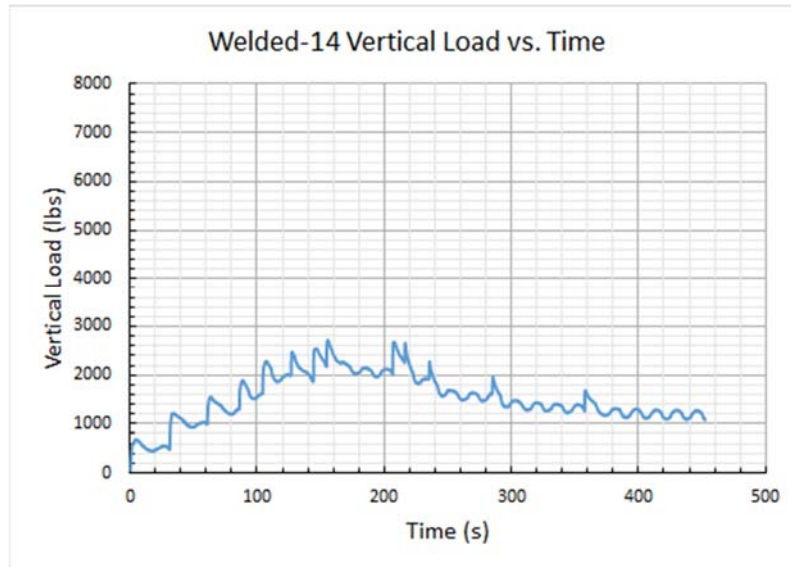
Figure 30: Vertical test of Welded-14 wall in load vs. time.

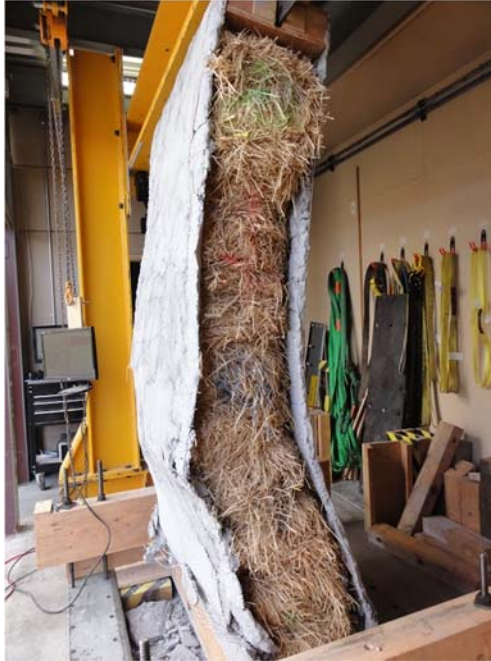
Figure 31: Side view of the Welded-9 wall buckling during the vertical test.

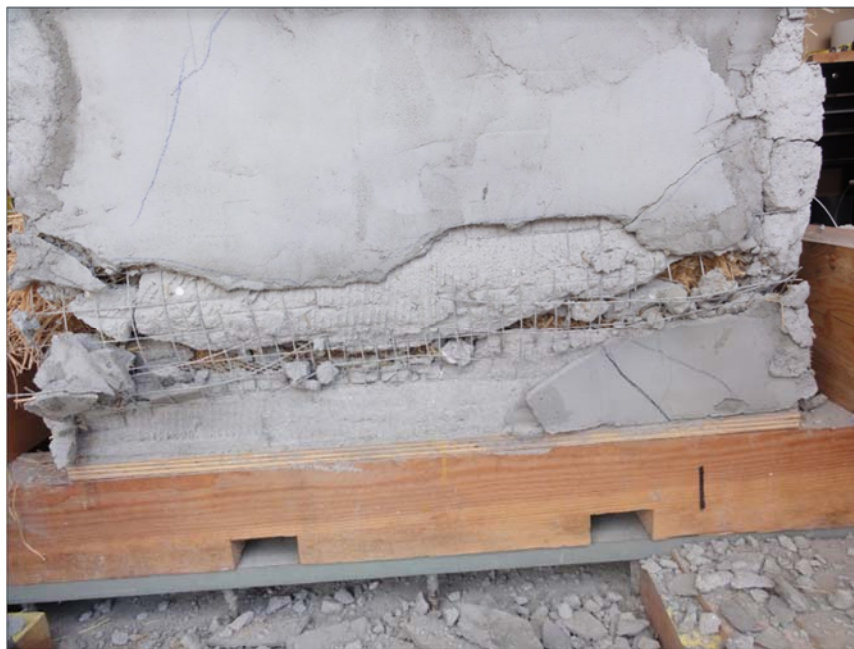
Figure 32: Damage sustained approximately 10" above the base of the Woven-14 wall after the vertical (and lateral) tests, after returning the top of the wall to its pre-test position.

In both cases, damage was concentrated at the bottom of the wall, as well as the middle sections where flexure took place. The modified workhorse details from Heckert et al. moved the damage up from the base, which was observed in the lateral test, and concentrated the damage in a line approximately 10” above the very bottom of the wall (Figure 32).
