The Research, Process, and Design of the Trout Creek Revegetation Plan

THE RESEARCH, PROCESS, AND DESIGN OF THE TROUT CREEK
REVEGETATION PLAN

MASTER OF LANDSCAPE ARCHITECTURE

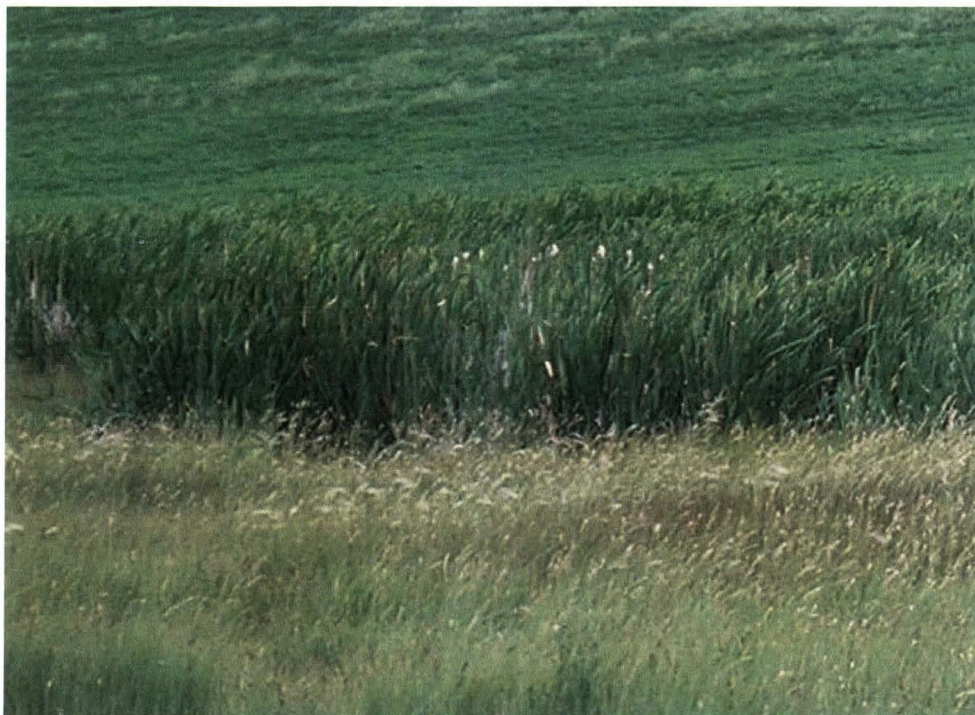
Figure 1- Emergent wetland community dominated by a monoculture of Common cattail on Trout Creek

Impacted wetlands on the Trout Creek site, although dominated by Common cattail (*Typha latifolia*), contain Hardstem bulrush (*Scirpus acutus*) and a variety of sedges (*Carex sp.*) (See Figure 1). The PRRP and LRR case studies used surveys of nearby areas to help determine historic vegetation composition (see Table 1 and Appendix Items 1 & 2). Healthier wetlands on the adjacent Whiskey Creek to the northwest contained a more balanced ratio of cattail, bulrush, and sedges (Figure 2). Although Whiskey Creek is not a pristine reference site, it is an adjacent site with a healthier composition of vegetation than Trout Creek and gives hints as to what historic vegetation may have existed. Conversations with experts, Chris Hoag and Eve Davies, confirmed these species were the historic dominant *emergent wetland community* species.

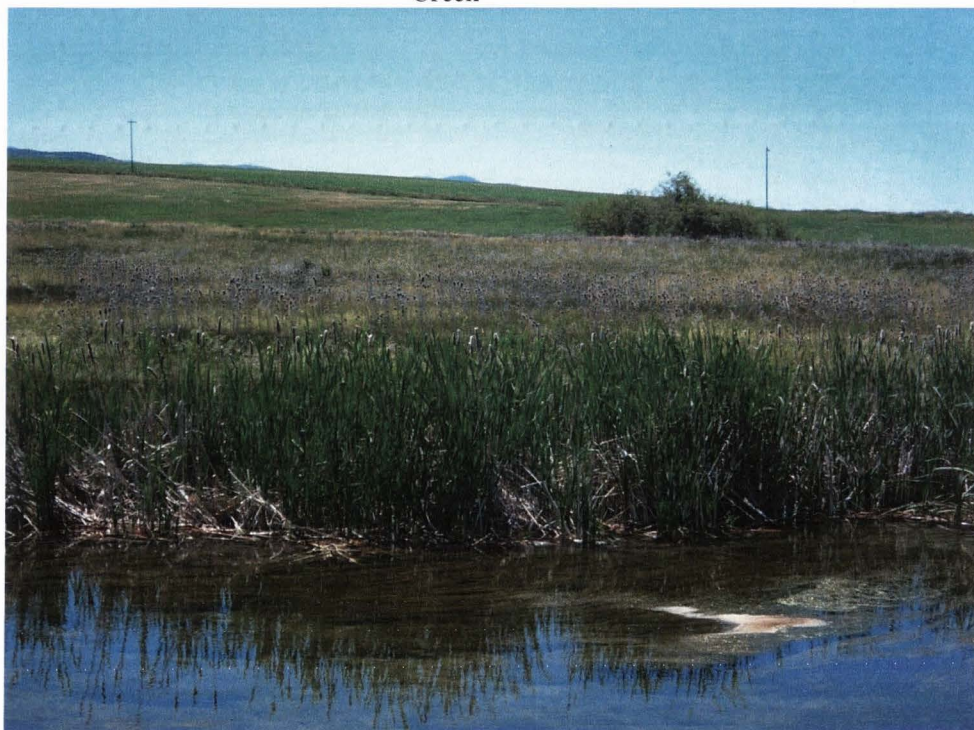
Figure 2- Mixture of Common cattail and Hardstem bulrush found in an emergent wetland community on Whiskey Creek.

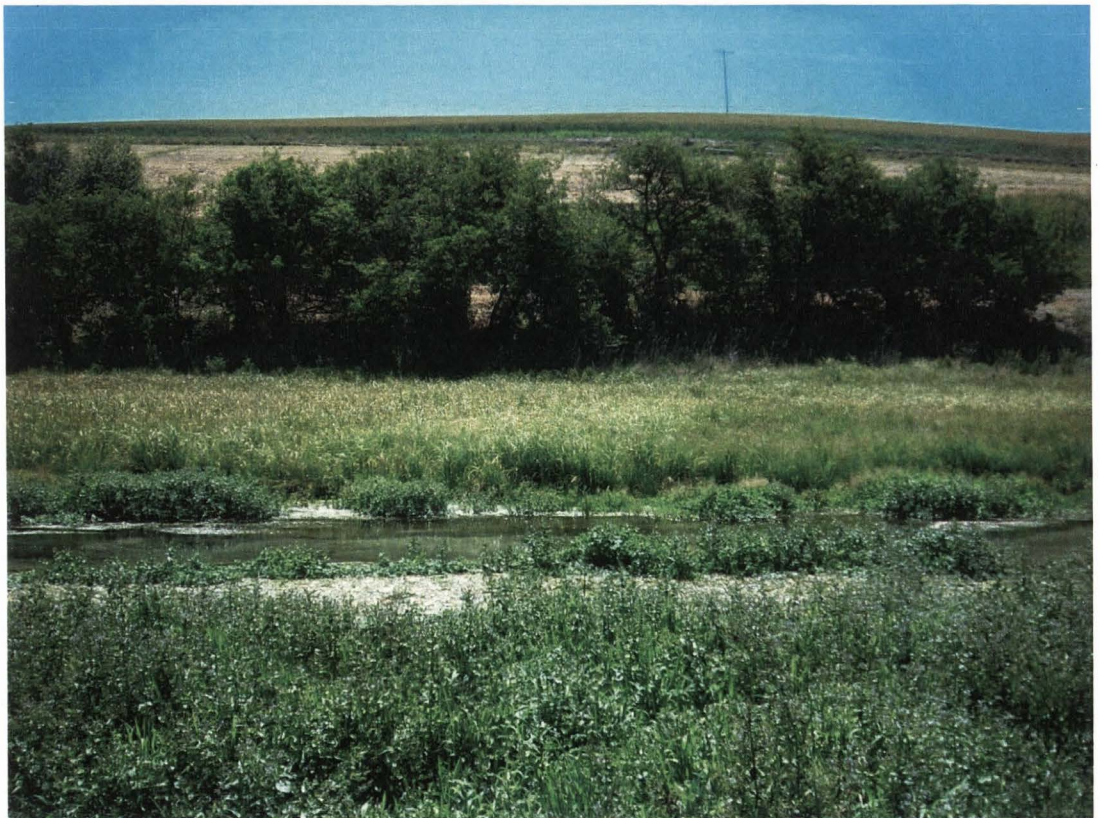
Figure 3- Western black hawthorn found on Whiskey Creek

The Whiskey Creek site also provided indications of the types of historic woody upland vegetation existed in the *mesic meadow community*. On Whiskey Creek, Wood's wild rose (*Rosa woodsii*), Western black hawthorne (*Crataegus rivularis*) (Figure 3), and Golden currant (*Ribes aureum*) were found in small amounts. All three of these species are native to the region. Chris Hoag and Eve Davies confirmed that it is probable these species also occurred on the Trout Creek restoration site.

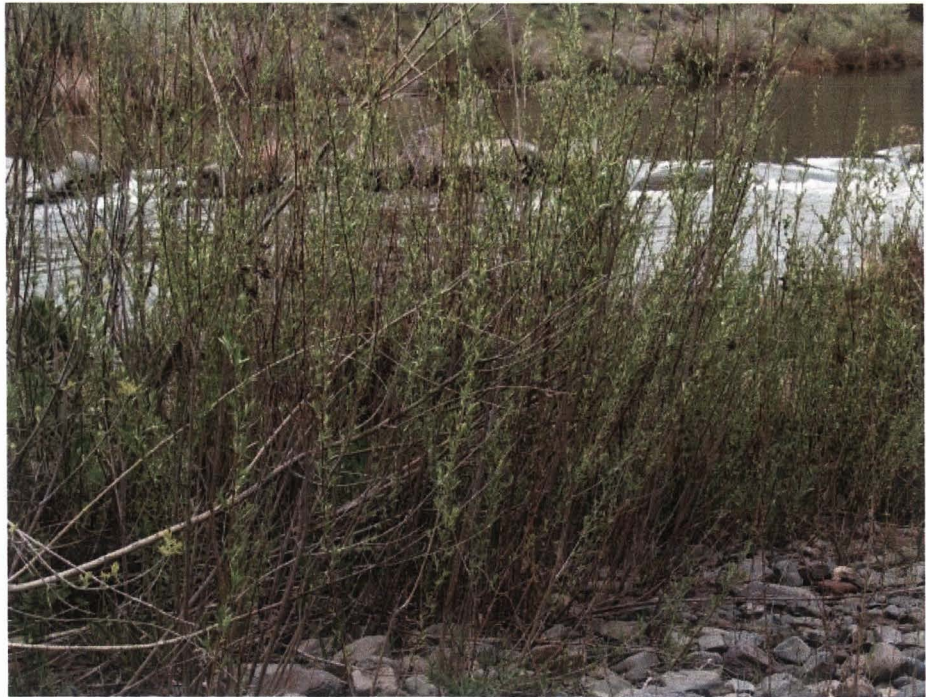
Figure 4- Example of Coyote willow (*Salix exigua*) on a streambank of the Owyhee River.

Step 3: The next step was to determine which species would be the most appropriate for revegetating the site in accordance with the management goals and site conditions. For streamside vegetation in the *mesic meadow community*, Coyote willow (*Salix exigua*) and Yellow willow (*Salix lutea*) were the obvious choices of willow species for several reasons (Figure 4). First, they are the historic willow community that existed on-site. Secondly, they are extremely successful species for streambank stabilization. Thirdly, these species are readily available to harvest from several local PacifiCorp owned sites near Soda Springs, ID.

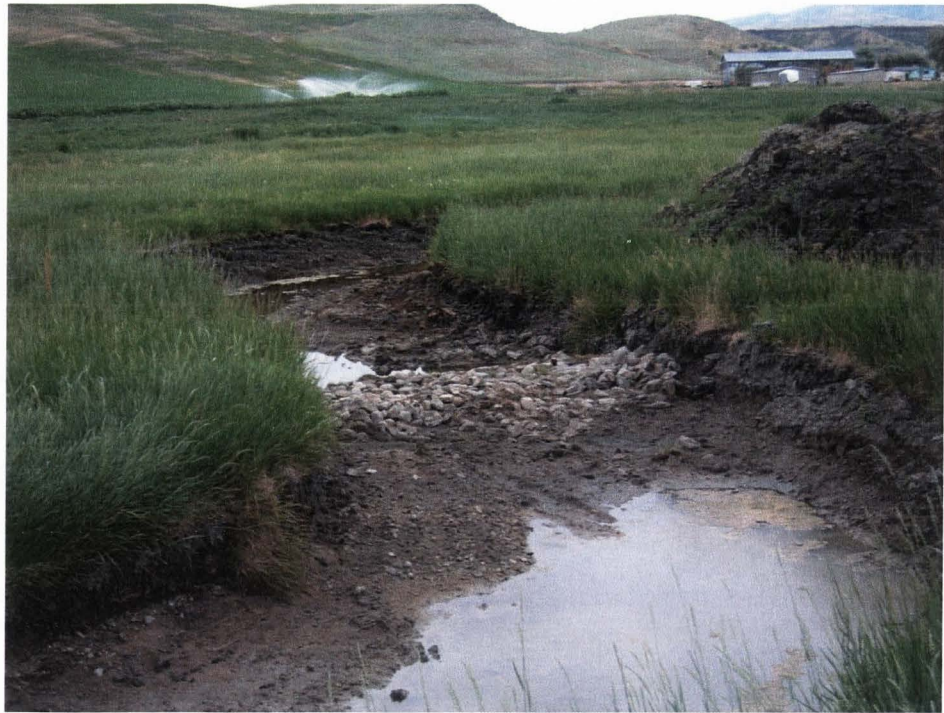
Figure 5- Section of newly constructed channel within a *mesic meadow vegetation community* at the Trout Creek site.

Step 5: Construction of the new stream channel was completed soon after the channel design was finalized. The new channel was mapped using a handheld GPS unit. Next the data was inputted into ArcMap GIS to produce a visual map of the new channel (see Reconstructed Channel map pp. 49). By overlaying the new channel data over the data for the existing vegetation communities it was possible to determine which vegetation communities existed at specific points along the new channel. Existing vegetation communities indicate a site's soil moisture conditions and its ability to support specific types of plant species. In combination with the topographic survey map of the area (see Appendix Item 4), the existing vegetation map was valuable in determining which re-introduced vegetation types would be likely to survive at any given point on the new channel.

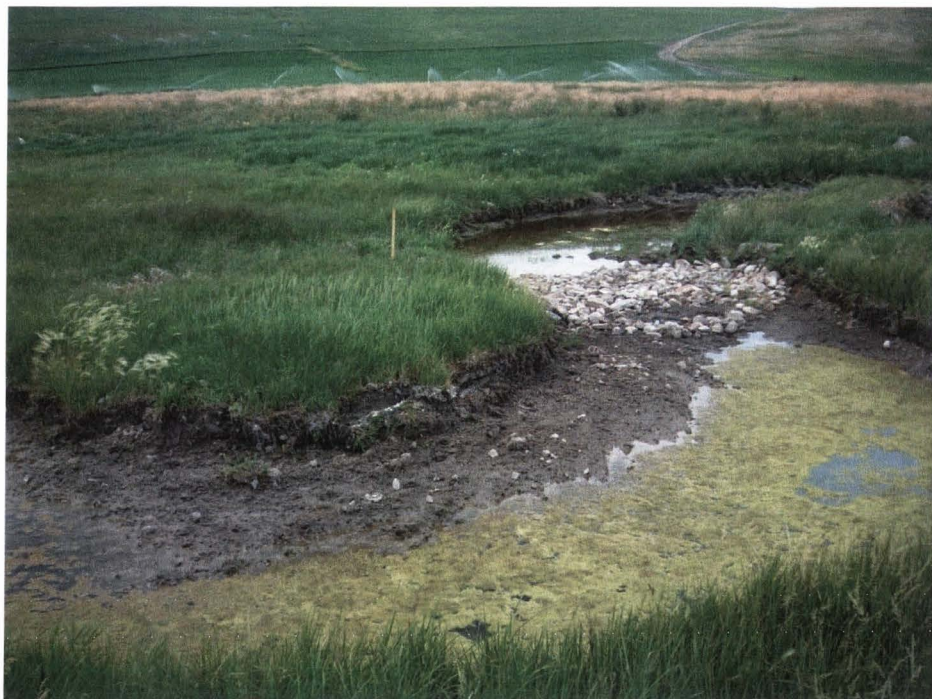
Figure 6- Inside bend of newly constructed channel within a *sedge/rush community* at the Trout Creek site.

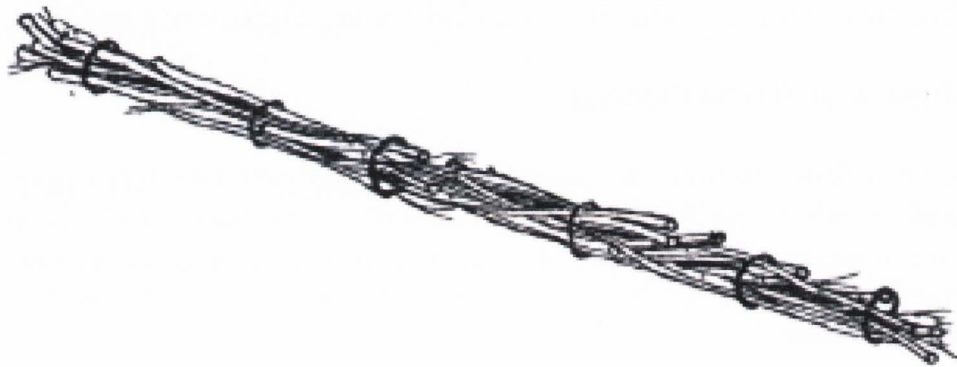
Figure 1- An example of a typical willow fascine - (illustration taken from The Practical Streambank Bioengineering Guide, USDA NRCS Plant Materials Center, Aberdeen, ID.)

- » Tie cuttings into bundles for transportation to the site. Remove terminal buds to send energy to lateral buds.
- » Soak the bundles for 5 to 7 days. Remove bundles before new roots emerge.
- » The cuttings should be constructed into one linear compressed fascine with the cut ends placed in alternating directions.
- » The fascines should be approximately 8 inches in diameter. The bundles should be tied every 18 inches with wire or heavy-duty twine.

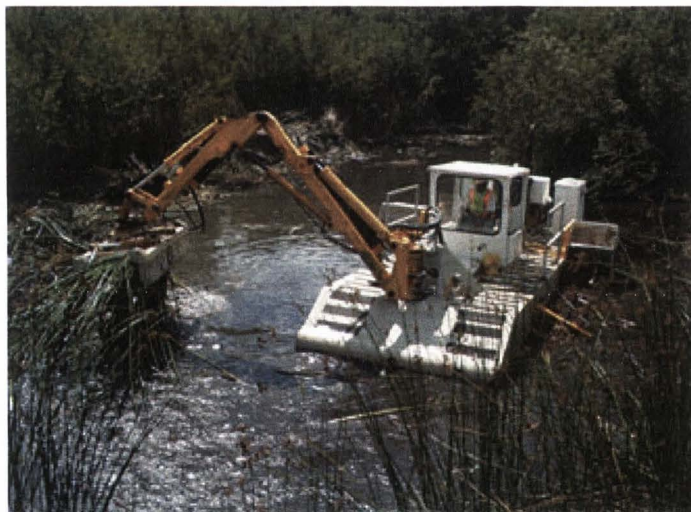
Figure 4 – An example of mechanical cattail removal

The native species composition on Trout Creek would likely be a mixture of hardstem bulrush (*Scirpus acutus*) and common cattail (*Typha latifolia*) for the deep-water emergent vegetation areas. The most optimal ratio of these vegetation types is a 9:1 bulrush to cattail ratio along with 50% open water (as per phone conversation with Chris Hoag). Due to the current monoculture of cattails, a mechanical treatment removing cattails from the wetlands and hauling them off-site will be necessary to successfully reach this ratio.

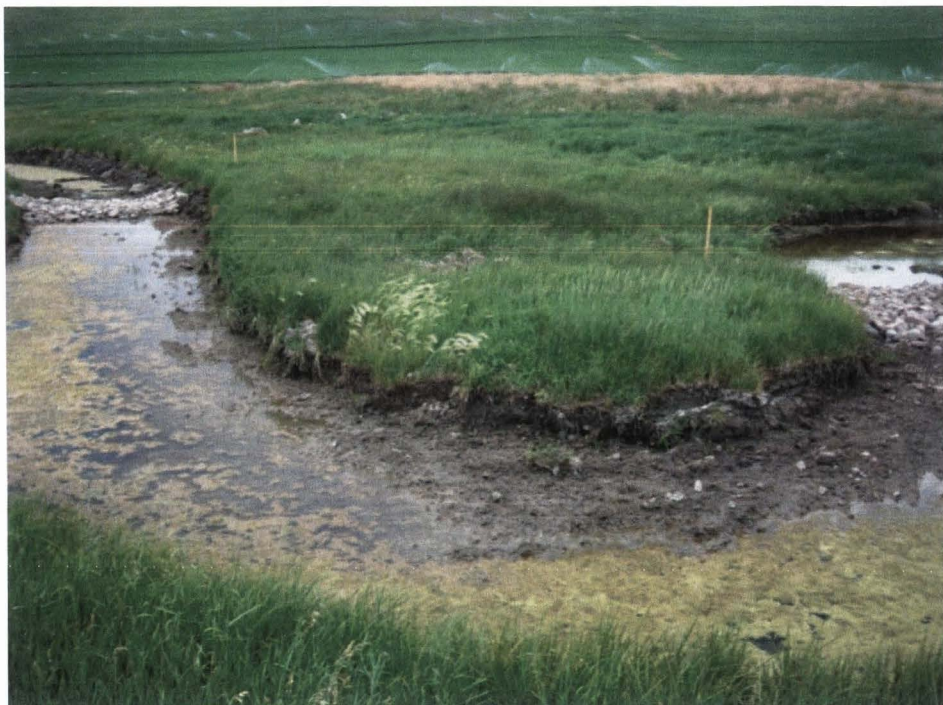
Figure 5 - Inside bend with sedge/rush community type.

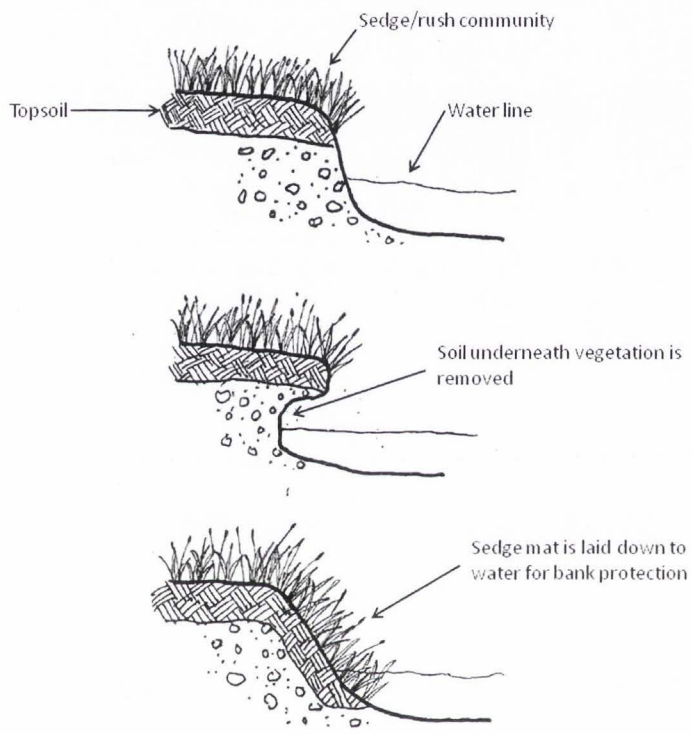
Figure 6 - Sedge/Rush Community Treatment

» Bank stabilization is to be accomplished by removing soil under vegetation to create an "undercut" that lays the mat of sedge/rush vegetation down to the low water line for bank protection (see figure 6). The amount of soil removed will vary depending on the condition of the vegetation and the bank. This should be done on all streambanks with at least 50% sedge/rush cover.

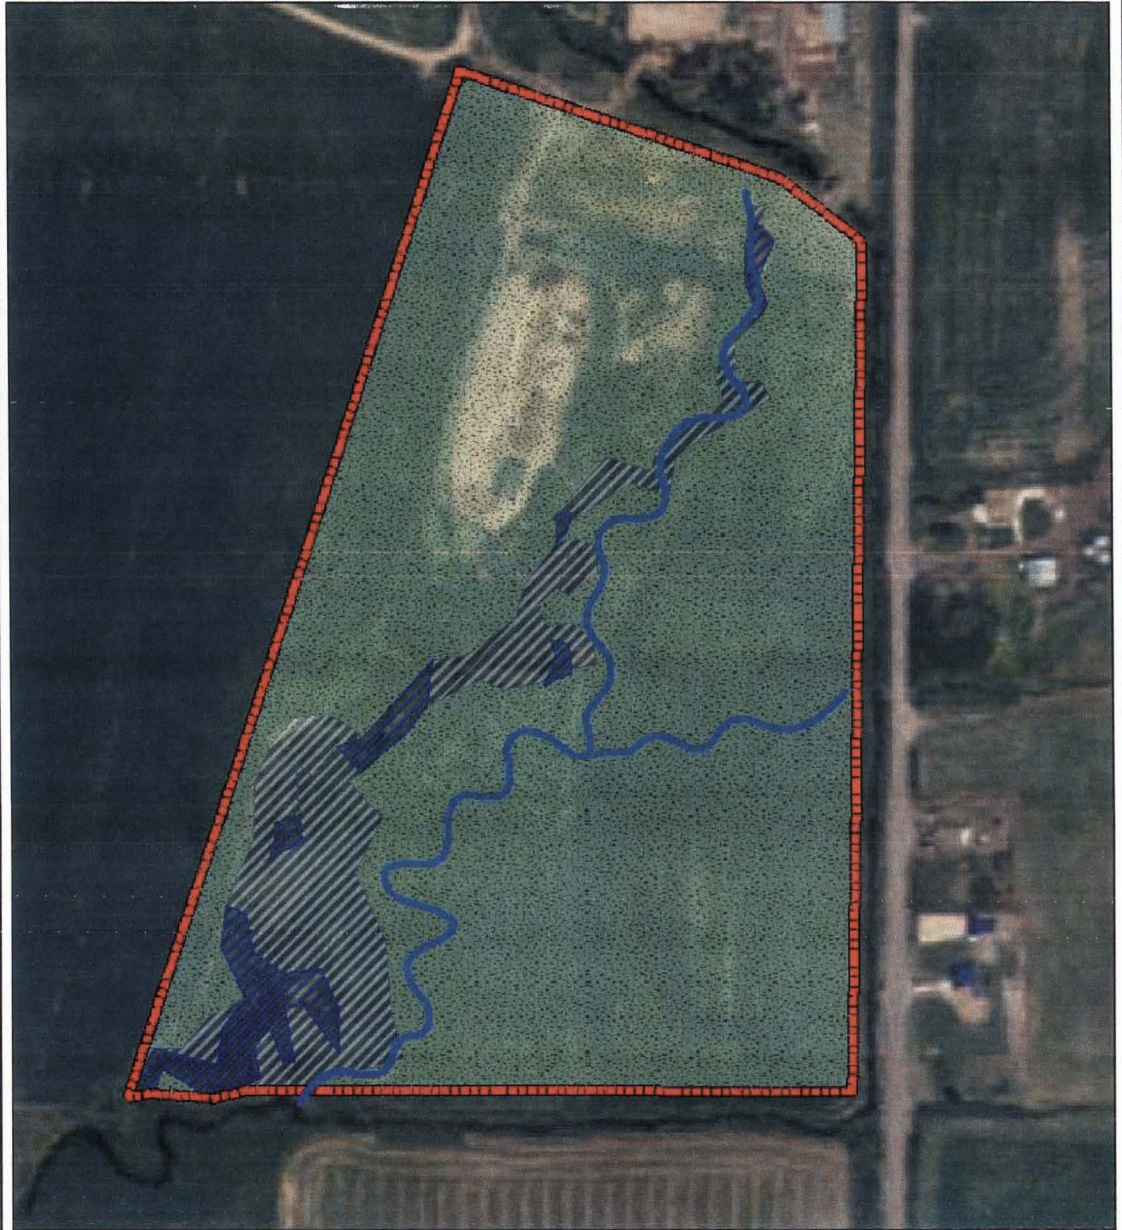
Trout Creek Revegetation Plan: Reclaimed/Reconstructed Trout Creek Channel

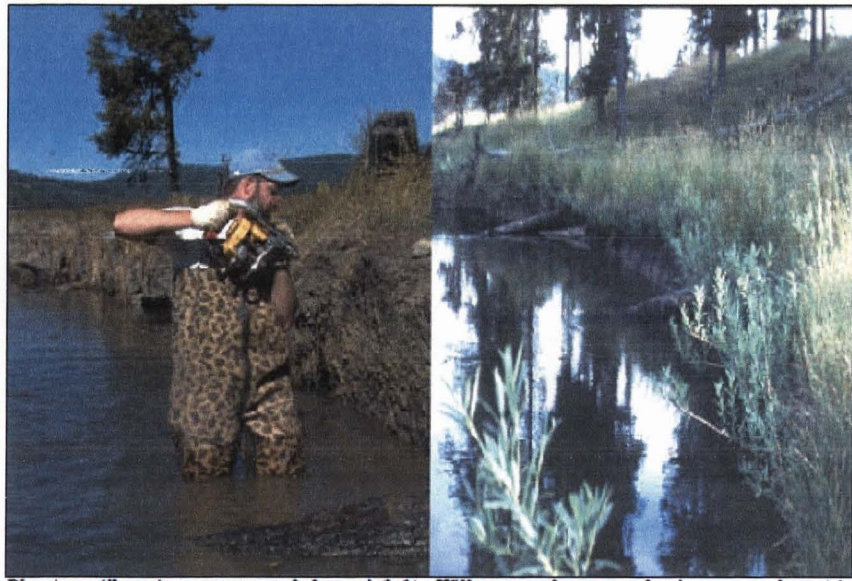
Planting willows in reconstructed channel (left). Willow growth on same bank, one year later (right).

Willow pole cuttings are collected, prepared, and cooler-stored during February and March prior to each field season. Pole cuttings are removed from the cooler and soaked in water for three days at ambient outside temperatures to initiate bud and root growth just prior to spring/summer planting. Project personnel experimented with a few red-osier dogwood pole cuttings (as opposed to seedlings grown in the greenhouse) in 1997. The red-osier dogwood pole cuttings received similar treatment as the willow plus horizontal scoring of the bark and soaking in a root-promoting acid solution (idolebutyric acid).

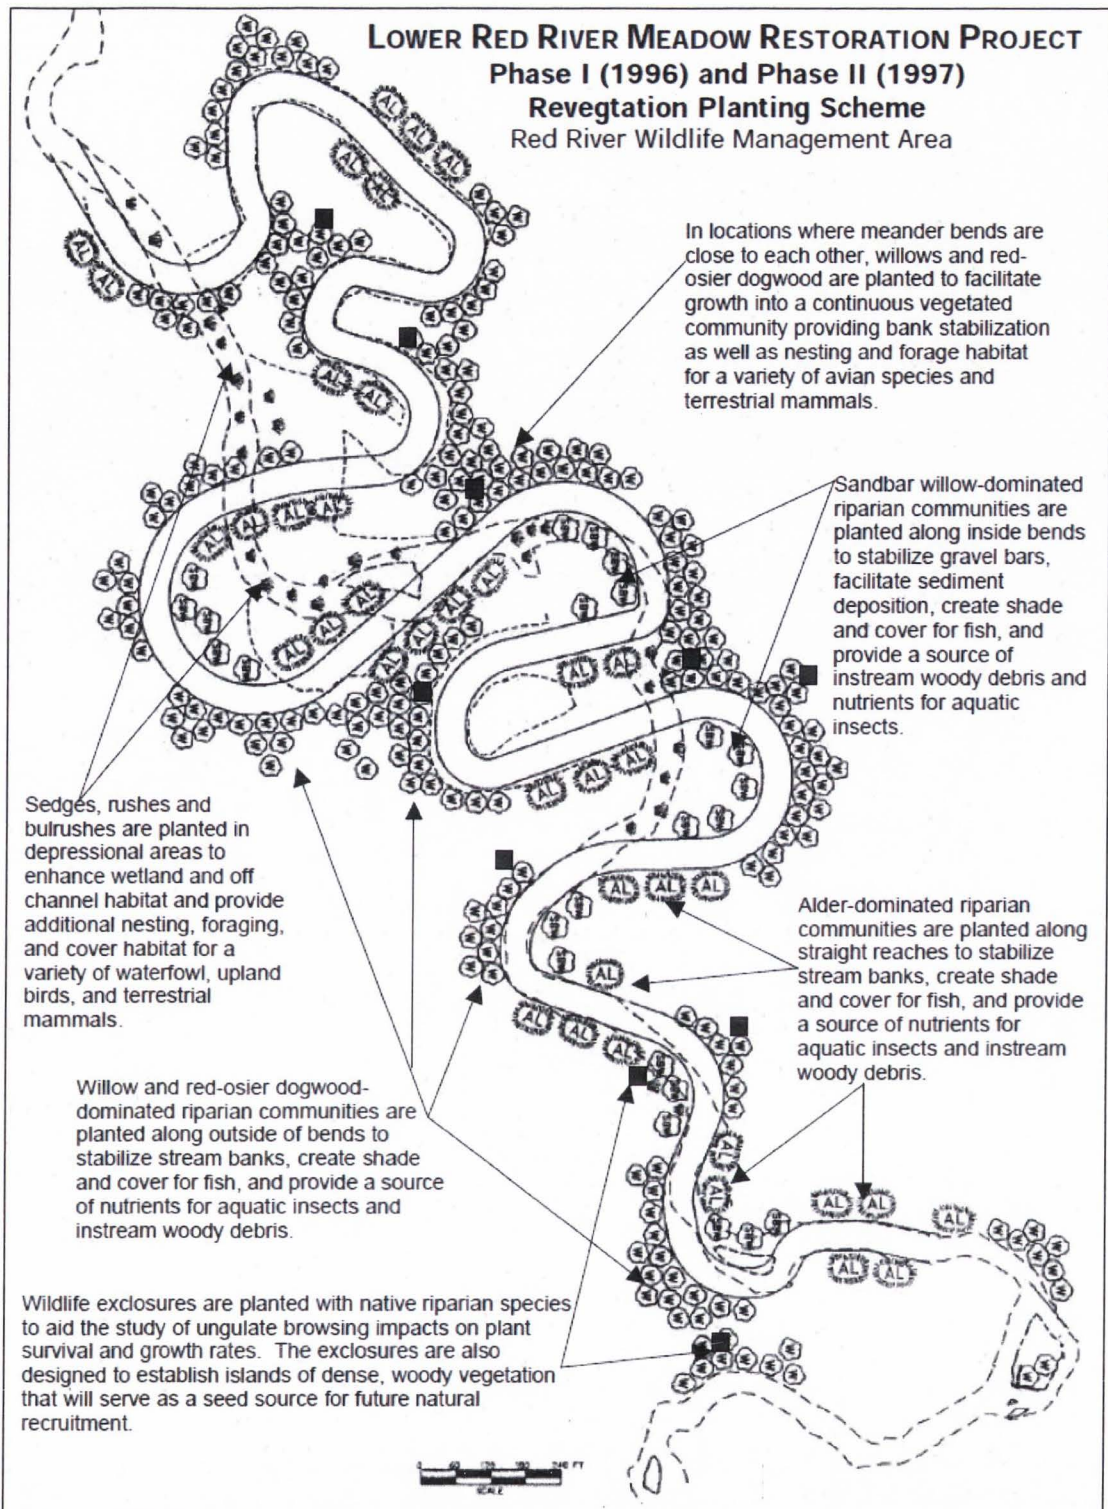
Figure 5.1. Locations and expected functions of native riparian plant communities in Phases I and II of the Lower Red River Meadow Restoration Project (adapted from RME, 1997).

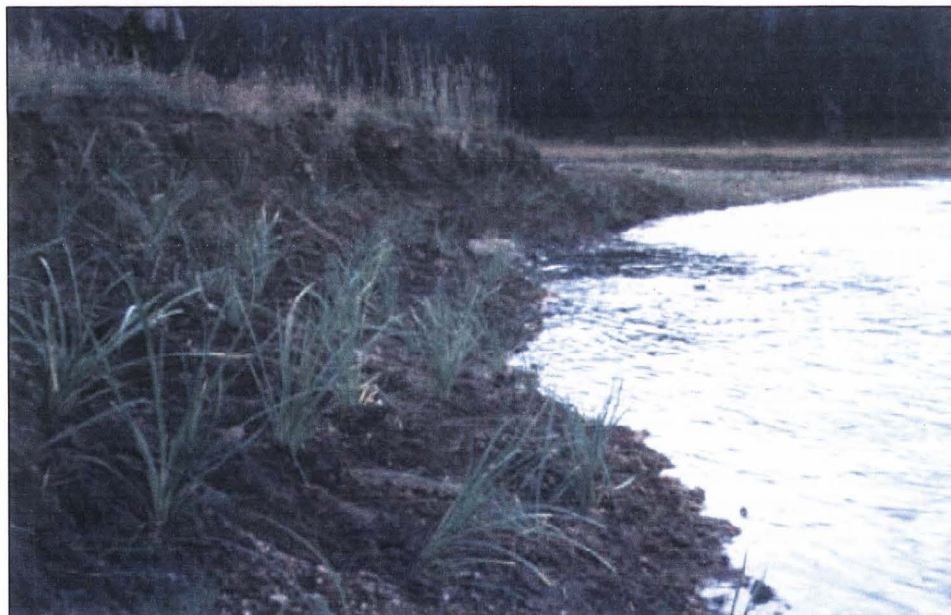
Figure 5.4. Native, water-loving small-fruited bulrush are planted into exposed soil of an outside bend in Phase I, RRRMA, Lower Red River Meadow Restoration Project.
