Energy Procedia 133 (2017) 243–256

Climamed 2017 – Mediterranean Conference of HVAC; Historical buildings retrofit in the Mediterranean area, 12-13 May 2017, Matera, Italy

## Keeping it modern, making it sustainable. Monitoring and energy retrofitting the Urbino University Colleges

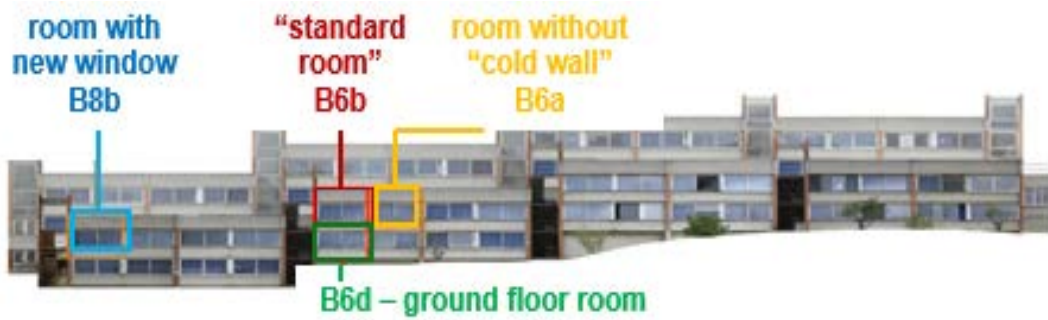
Fig. 2. Position of the monitored rooms on the South-West façade of the "Aquilone" building

Sensors were installed in a couple of overlapping rooms on different floors (Room B6B and B6D) with original windows. This is the most typical room disposition within the colleges. Sensors were also installed in other parts of the complex, with a different room configuration. Room B8B is similar in position while the original window was already substituted by a new one with aluminum frame without thermal break. Room B6A represents the case of a room not in touch with an external brickwall.

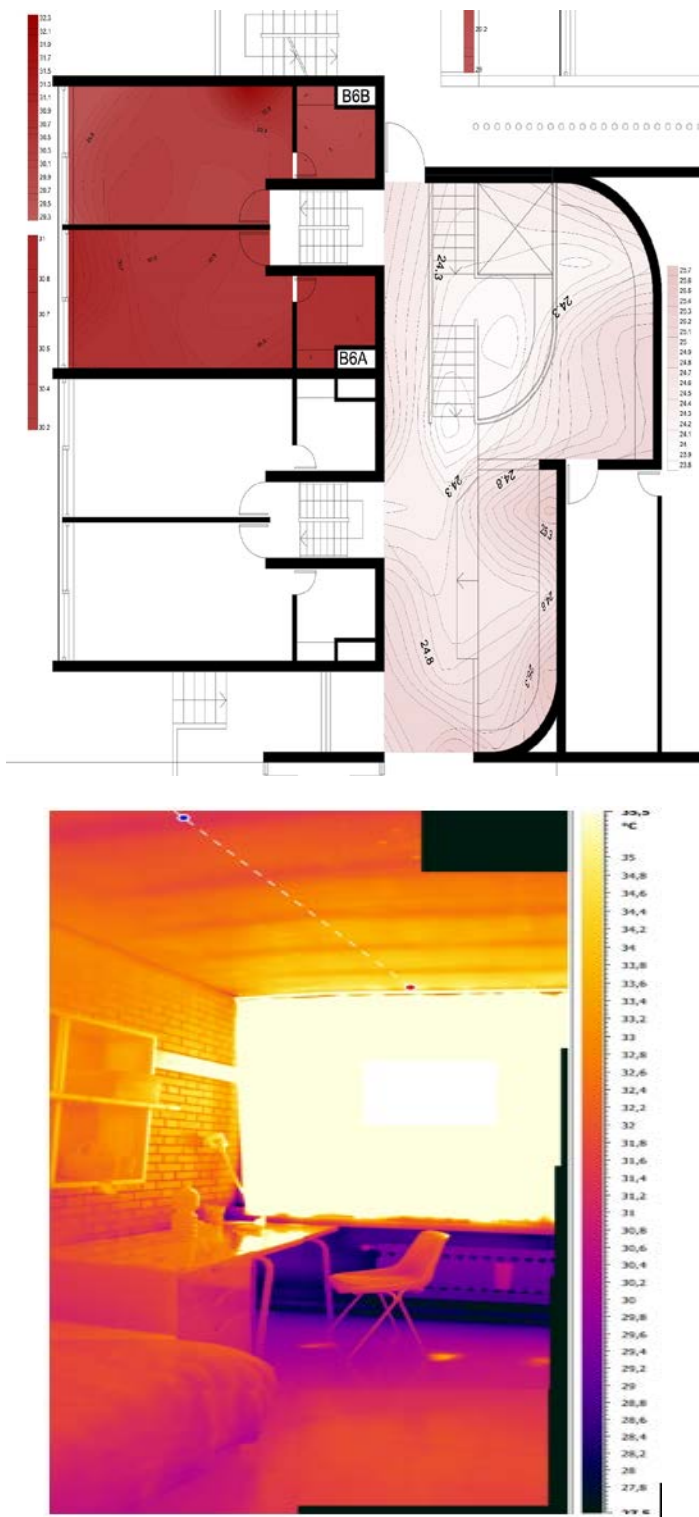
Fig. 9. Distribution of temperature (left) in B6b room (top) and B6a (bottom) compared with the common space (in the middle) of the “Aquilone” building– 14/07/2016. Thermal image of B6b room - 14/07/2016 (right).

The same rooms were analysed during summer (Fig. 9). On the left, the temperature in rooms B6b and B6a (around  $30^{\circ}\text{C}$ ) is compared to the common space ( $24^{\circ}\text{C}$ ). In the corresponding thermal image, the ceiling's concrete joists are perfectly visible, just like all the non-insulated structures. The surface temperature of the inner side of the roof is  $35^{\circ}\text{C}$ , thus confirming the data mentioned in the previous paragraphs.
