Safety of Lithium Nickel Cobalt Aluminum Oxide Battery Packs in Transit Bus Applications

MNTRC Report 12-61

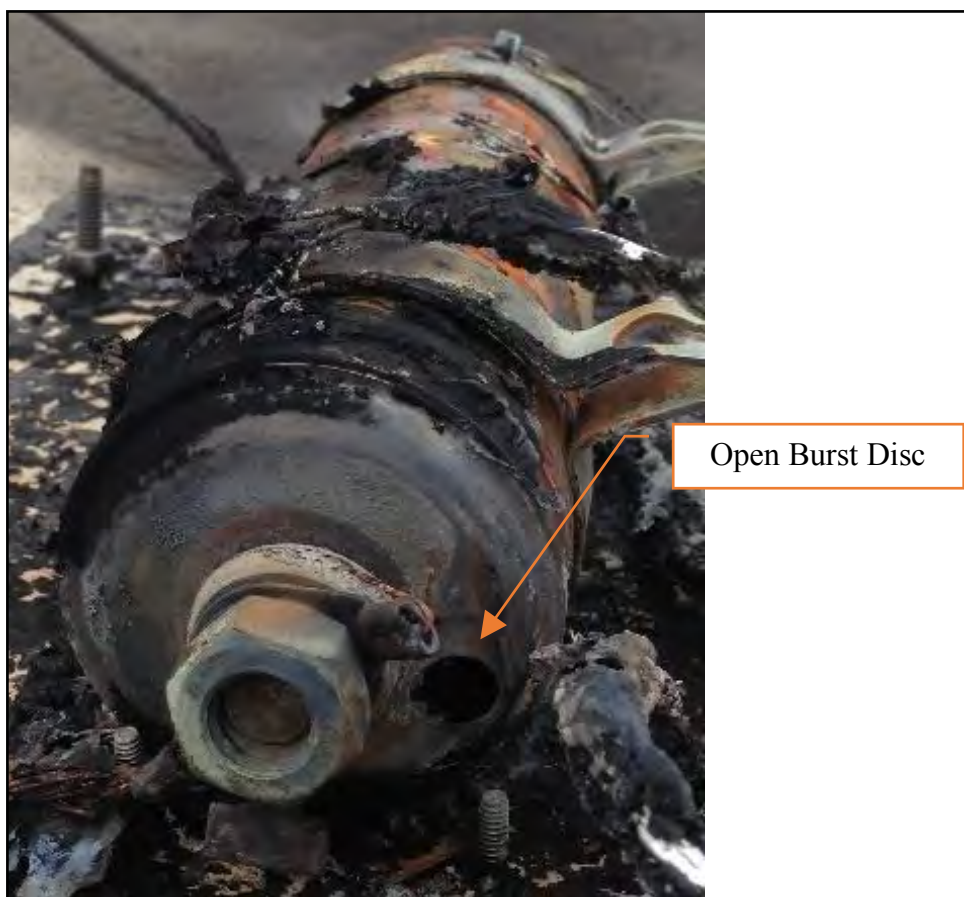
Figure 1. Cell after Venting Event

In general, whenever a charged Li-ion cell is exposed to temperatures above 60°C, there is a risk of initiating a strong exothermic reaction within the cell. The heat generated by these reactions will result in a rise in the cell temperature, which in turn activates heat generation amplitude or additional exothermic reactions that build up pressure in the cell. The cells used in this research are equipped with a safety/pressure burst disc at each terminal side rated at 144-200 psi at room temperature. Figure 1 shows a cell that was overcharged until its burst discs were opened and the cell vented.

The venting process implies release of flammable electrolyte, generation of gases, or even rupture of the cell casing. In most cases, all three happen almost simultaneously. Figure 2 demonstrates the intensity of the venting process, as exhibited by flames and gases energetically flowing out over approximately five seconds.

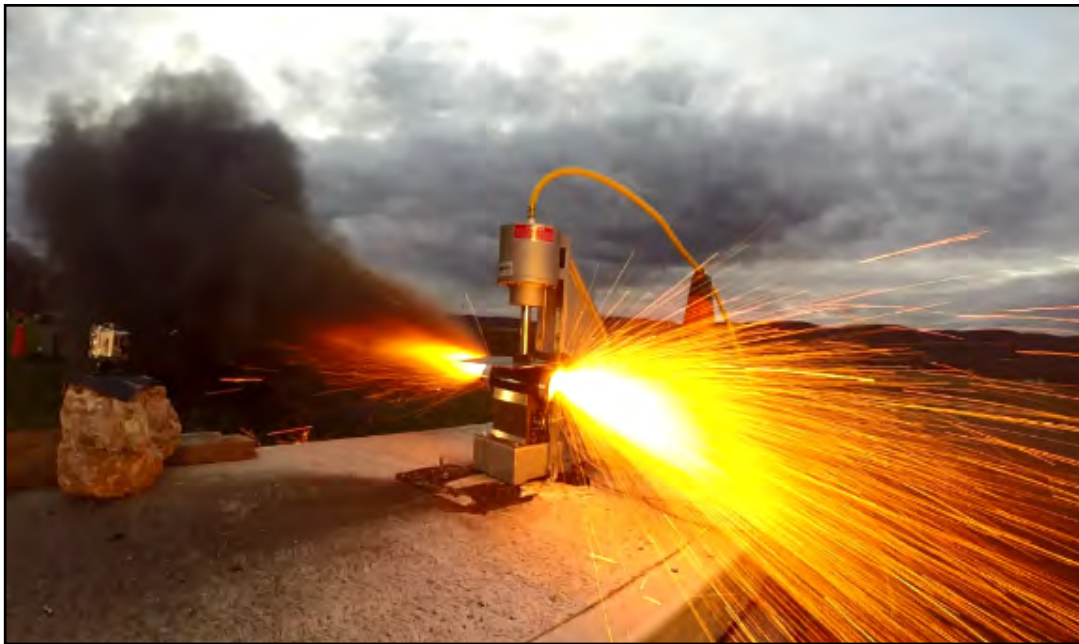
Figure 2. Single Cell Nail Puncture Test

Figure 2 only shows what can happen to one cell, but in heavy buses, battery packs consist of hundreds of cells wired in a series/parallel configuration. In a high-quantity, multi-cell pack, such as an electric bus, the venting of just one cell can propagate its thermal energy to neighboring cells causing a chain reaction until all cells rupture due to extreme thermal conditions.

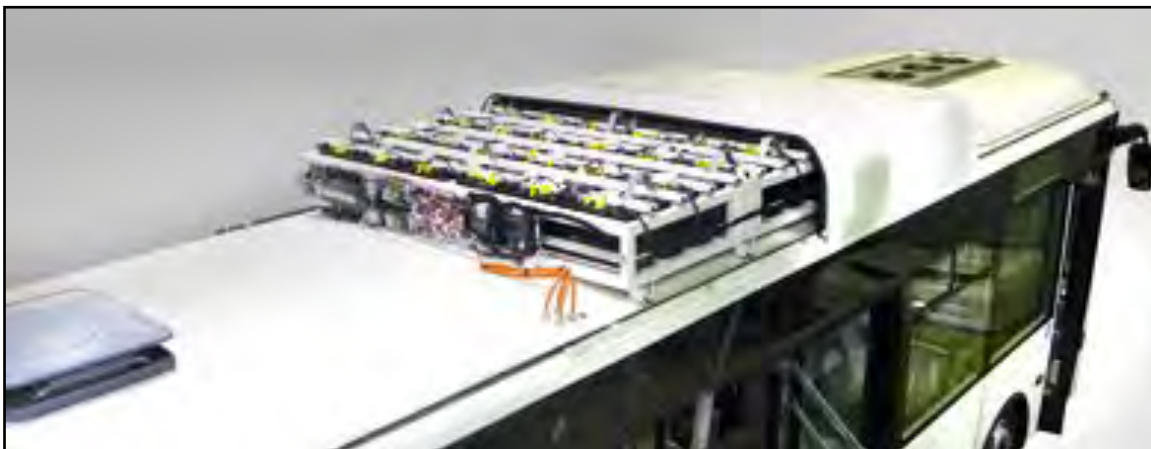
Figure 10. Battery Pack on the Roof of the Bus

The most common locations are the roof and sides. Figure 10, taken from the web site of Power Vehicle Innovation, shows a battery pack on the roof of a bus.¹² Roof mounting is also used in buses running on gaseous fuels like compressed natural gas or hydrogen to protect tanks from side impact.

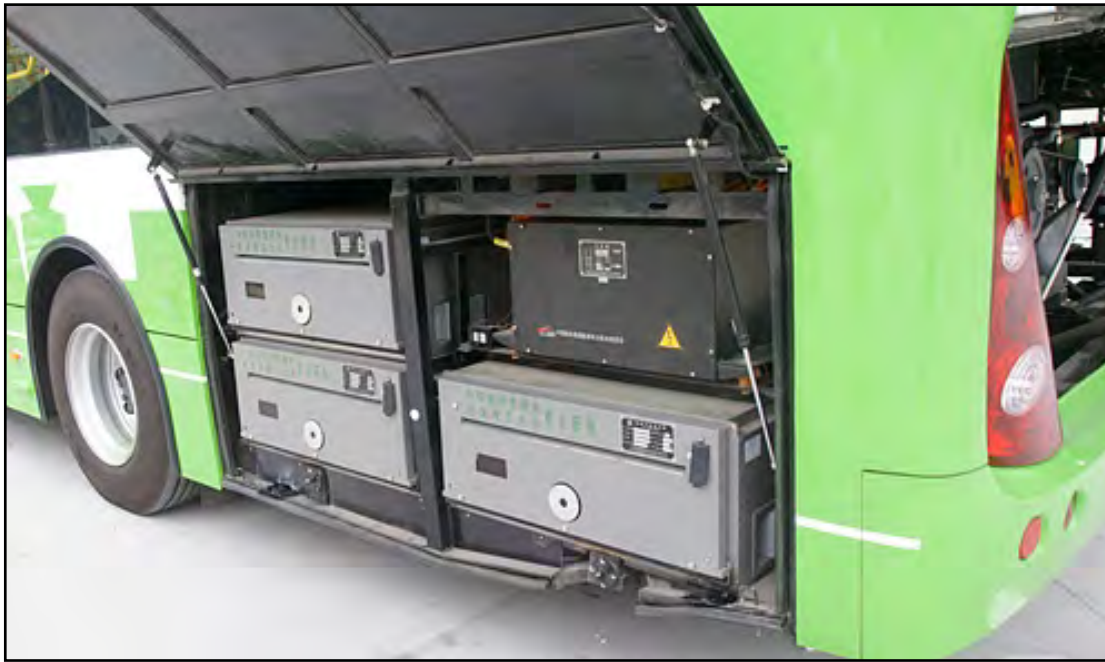
Figure 11. Battery Packs on the Side of the Bus

Alternatively, Figure 11 taken from the web site of the Life of Guangzhou¹³ shows the battery packs mounted on the side. In some cases, cooling systems are also rooftop mounted. The packs also have to be properly enclosed and sealed to avoid any contact with water and prevent damage to any electronic components.

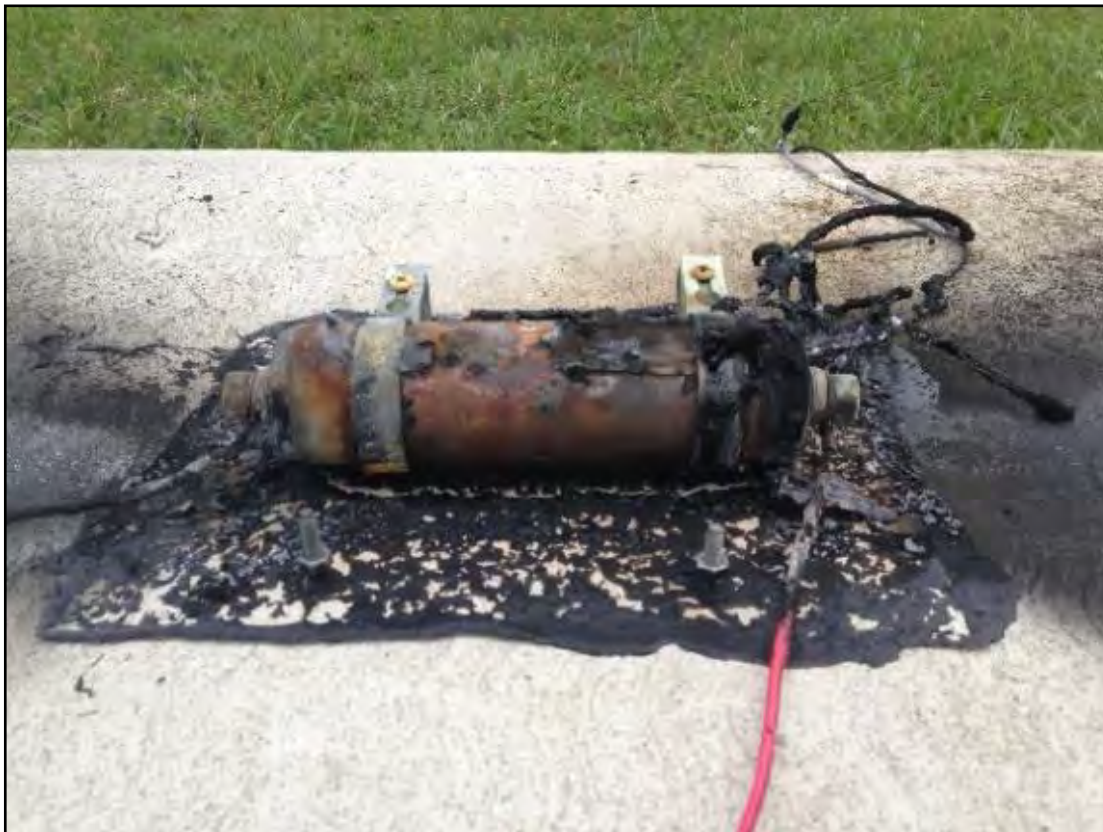
Figure 16. Results of a Single-Cell Acetal Test

The fact that Teflon (PTFE) is inherently flame-resistant makes this material very interesting for the worst-case scenario conditions that this research will test. It is expected that this material should not act as a combustible, potentially reducing the length of heat generation and smoke production during an event. Preliminary testing was performed to investigate the real-world performance of some commonly used materials. More detailed tests and test setups are discussed later in this report. Figure 16 shows the results of a single-cell test when acetal was used to hold the cell. The material continued to burn well after the cell vented, producing smoke for approximately 30 minutes after the event and concluding in a complete lack of structural support, mechanical separation, or electrical isolation.

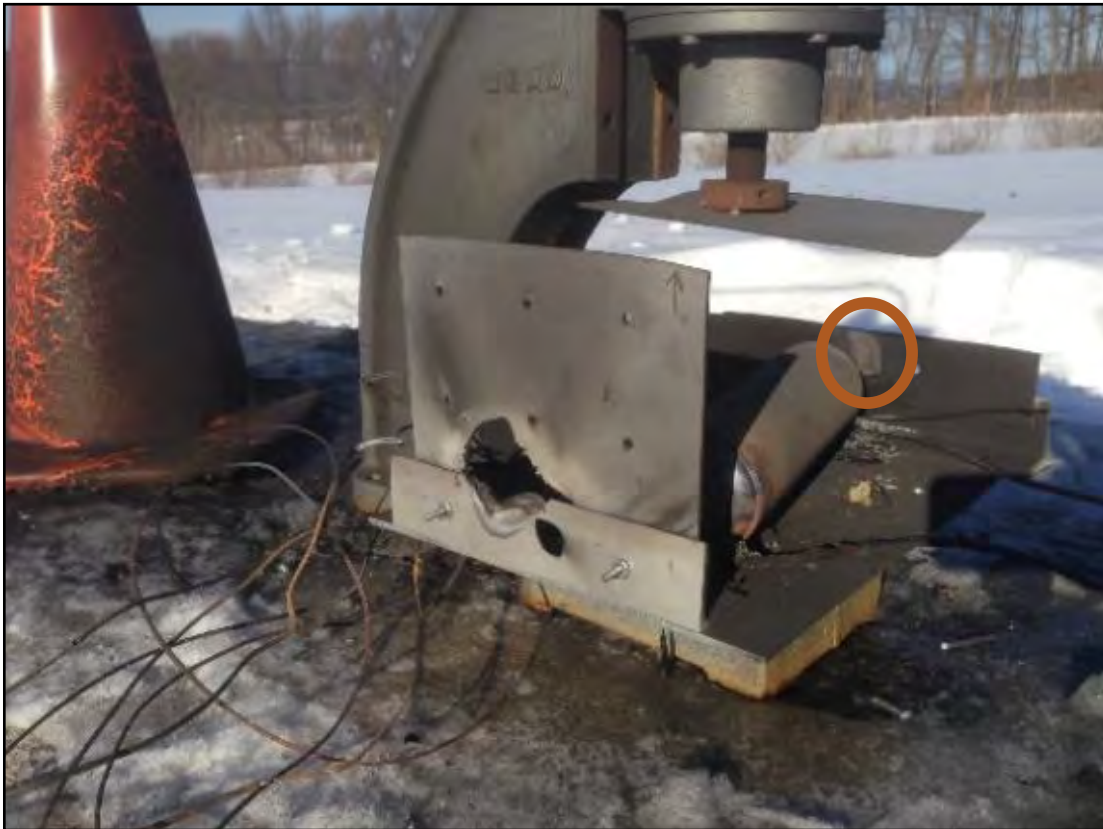
Figure 20. Results from a Metal Test

other hand, the steel plate was able to withstand the hot gases and remain intact. A mark, indicated by a red circle, where the gases met the steel can also be seen on the far side of the cell in Figure 20.

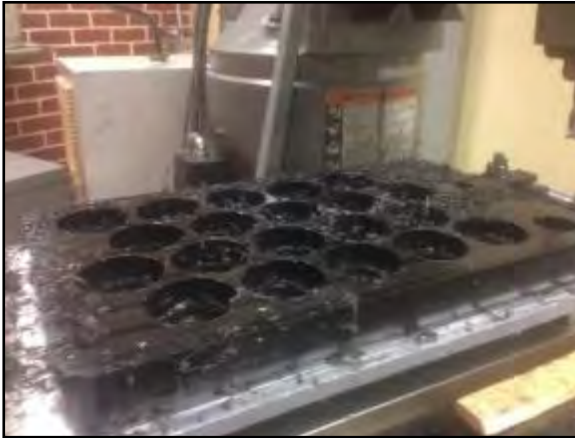
Figure 24. Cell Pockets

Figure 24 and Figure 25 show some of the intermediate phases in the machine process while Figure 26 represents the final completed part.

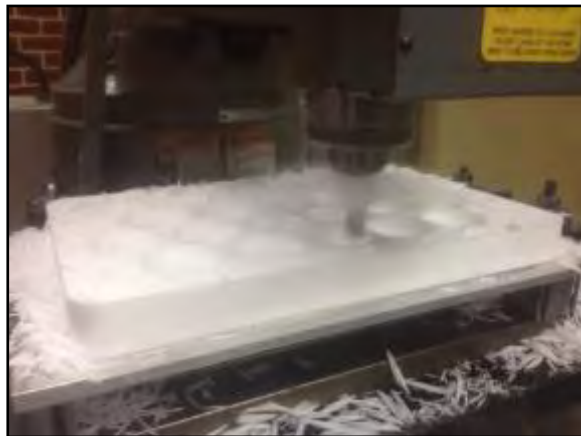
Figure 27. PET Machining

The same steps were followed for all three materials selected for testing. Figure 27 shows the PET material during separator machining. Figure 28 shows a researcher preparing a battery enclosure for module testing while Figure 29 shows the completely machined internal module assembly: top and bottom cell separators and isolation walls.

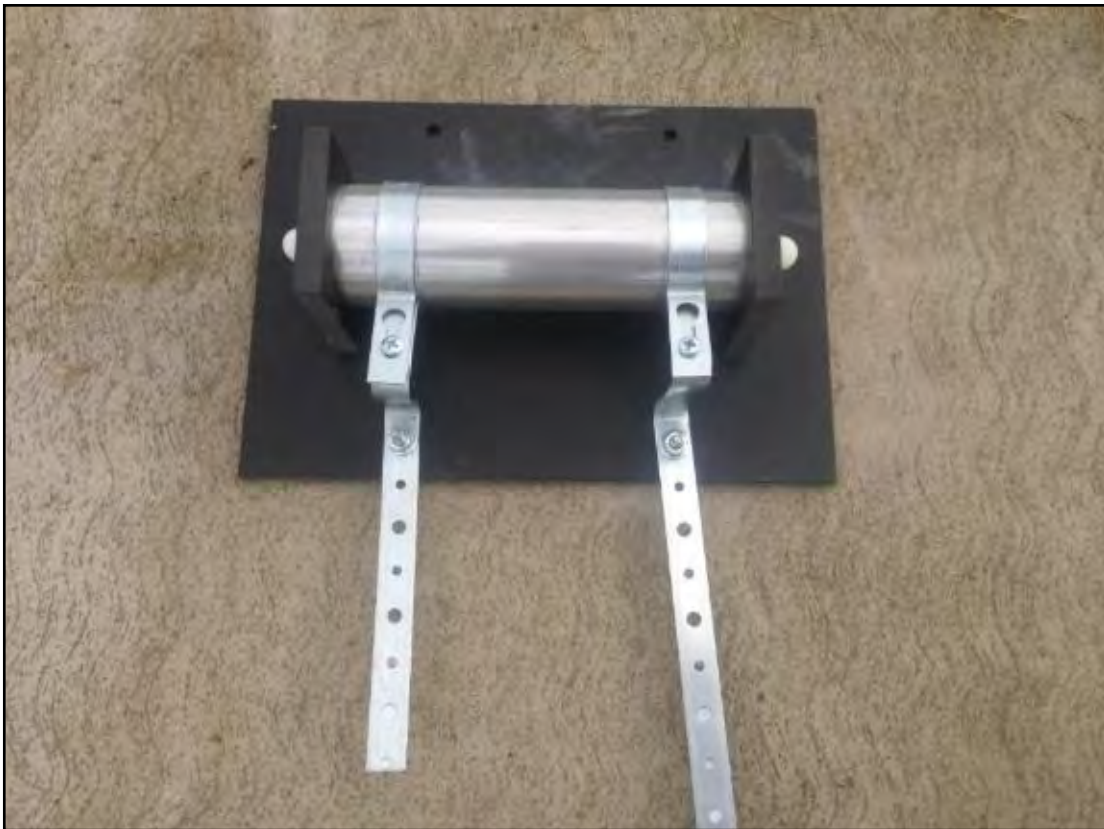
Figure 35. Metal Straps

To be sure that a cell would not escape during a venting or nail puncture test, metal bands (seen in Figure 35) were used to secure the cell.

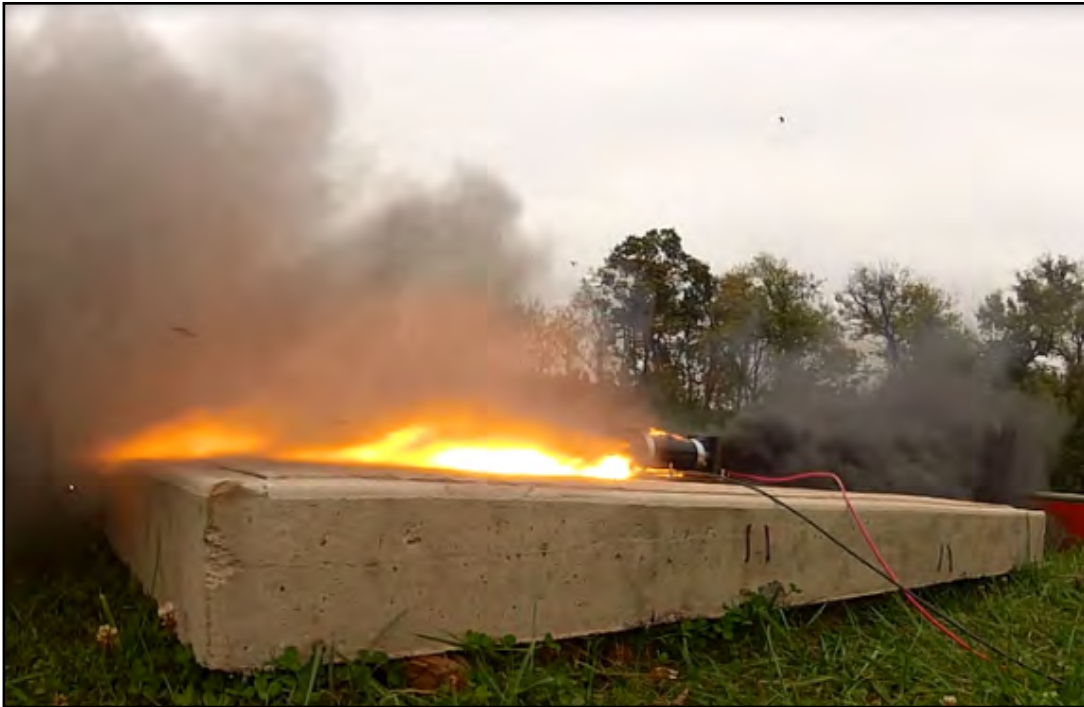
Figure 39. Venting Cell – First Test

The battery venting lasted roughly five seconds as indicated by flames and huge clouds of smoke. The magnitude of the event is displayed in Figure 39.

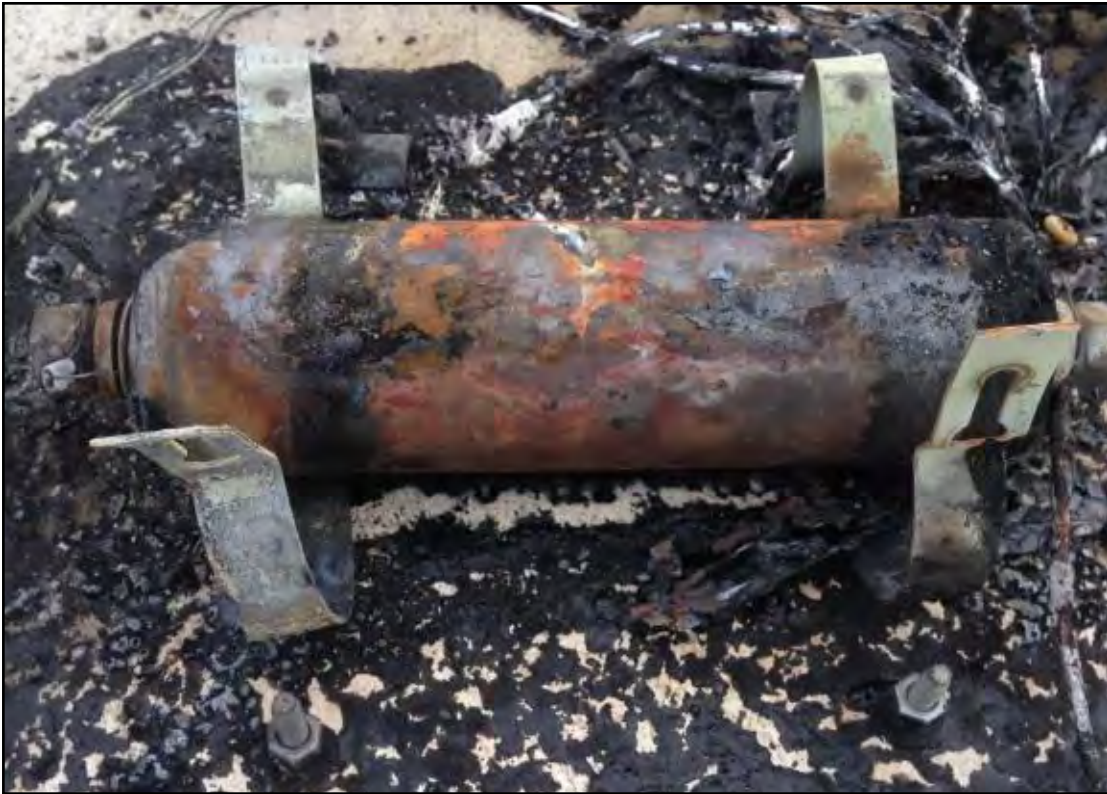
Figure 40. Cell, Hours After Venting Event

The single cell was held down to the concrete test pad through an acetal cell holder and plate. The flames and high temperature associated with the venting ignited the acetal plastic, which acted as a combustible and burned out until it was completely gone, as seen in Figure 40.

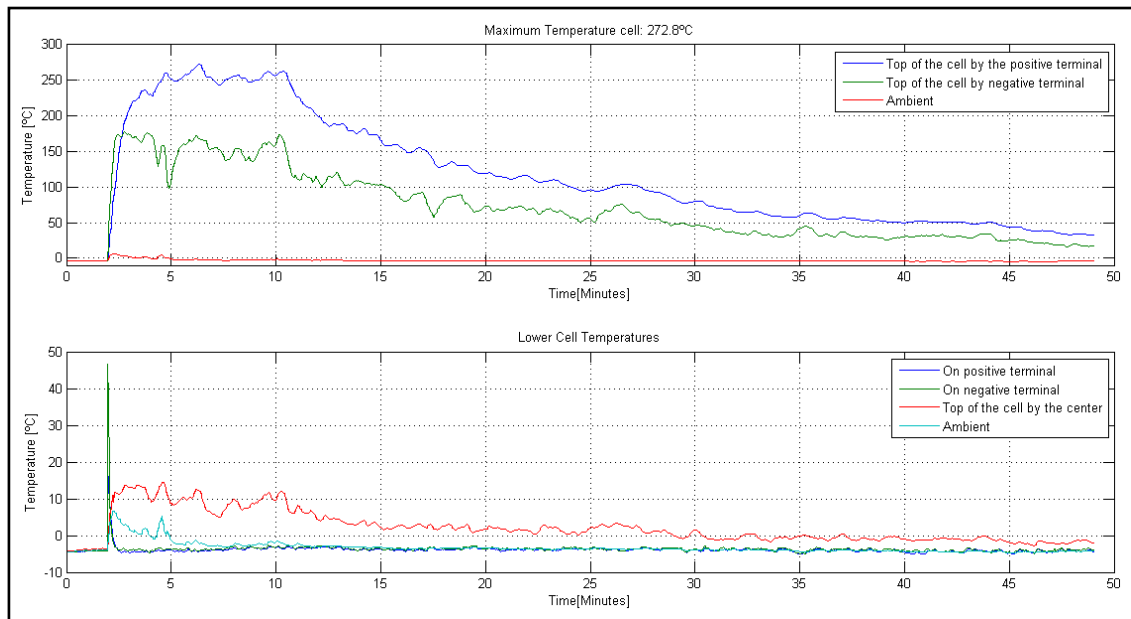
Figure 41. Acetal Nail Puncture – Cell Temperatures

Figure 41 shows cell temperature measurements in two charts. The top is scaled to the highest temperatures while the bottom is scaled to the lower values. The highest values were measured on the top of the cell by the positive and negative terminals, peaking at about 273 °C and 175 °C respectively. The bottom chart shows little rise in temperature. Note that this test was performed in -3 °C ambient conditions.

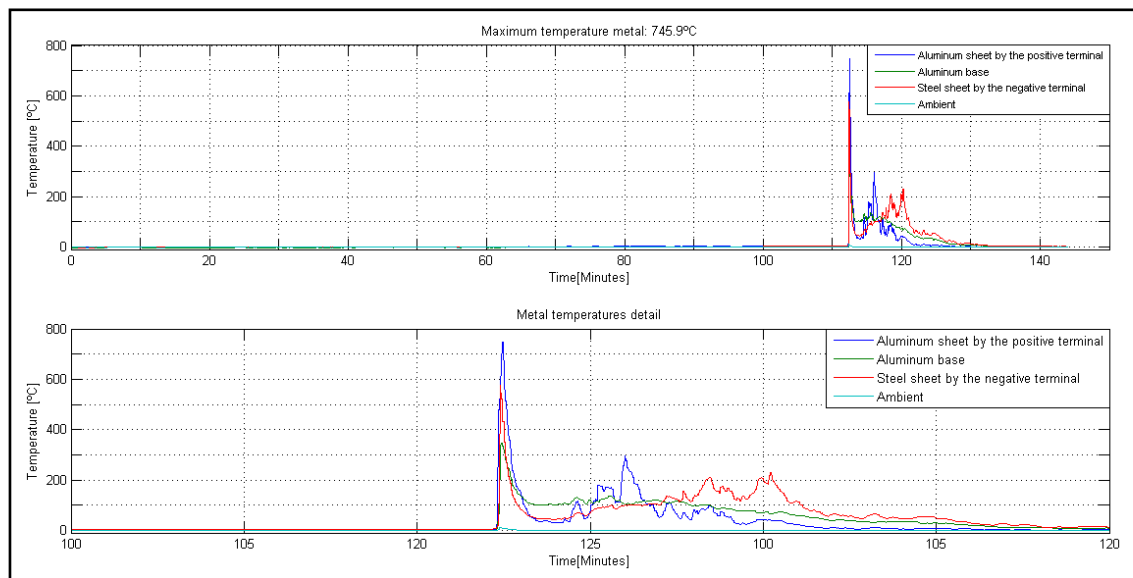
Figure 44. Acetal Overcharge w/ Material – Material Temperatures

The response of the metal is summarized in Figure 44. The first noteworthy point is that the metal's temperature exceeds temperature measurements from the cell itself. This is likely a result of the metal blast shields being in direct contact with the venting gases while the cell surface temperature sensors are likely limited by the insulation properties of the cell casing. These material temperatures are assumed to be much closer to internal cell temperatures than the surface measurements captured from the cell's exterior. The aluminum sheet experiences a temperature 100°C warmer than the steel sheet. One of the causes of this response could be that the cell did not vent uniformly. Also, the thermal distribution properties of each material are substantially different. If the sensors were directly on the opposite side of the impact area, more accurate readings would be possible. In reality, the sensors were at different distances from the impact point of the gases, which also contributed to this difference.

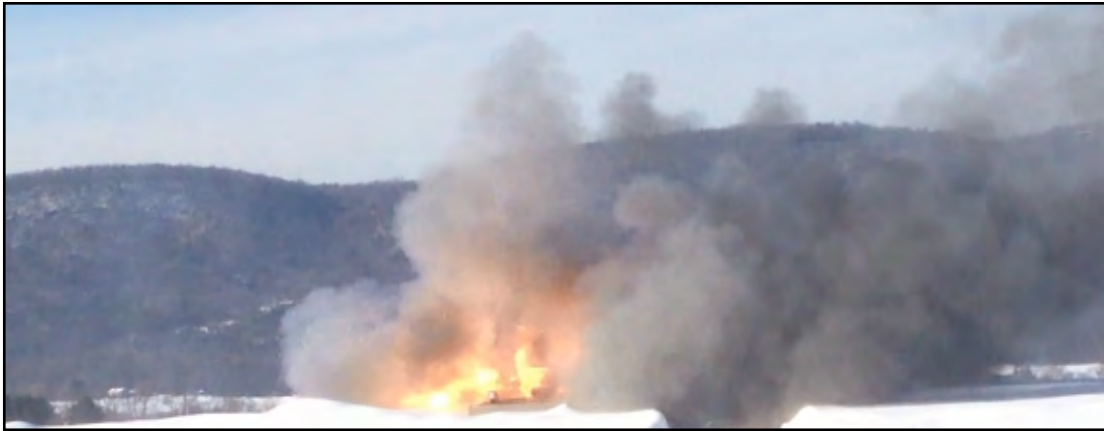
Figure 45. Acetal – Overcharge with Material Test

The venting process for this test was very intense, as Figure 45 demonstrates. Although the testing was completed in non-ideal environmental conditions (very cold, windy weather), it did unexpectedly provide a valuable measurement. The black smoke escaping the cell stained the snow, providing a radius for measuring the effective distance debris can be expected to travel. Upon visual inspection, the smoke and flames traveled approximately 125 inches from each side of the cell, or in a radius of the same dimension.

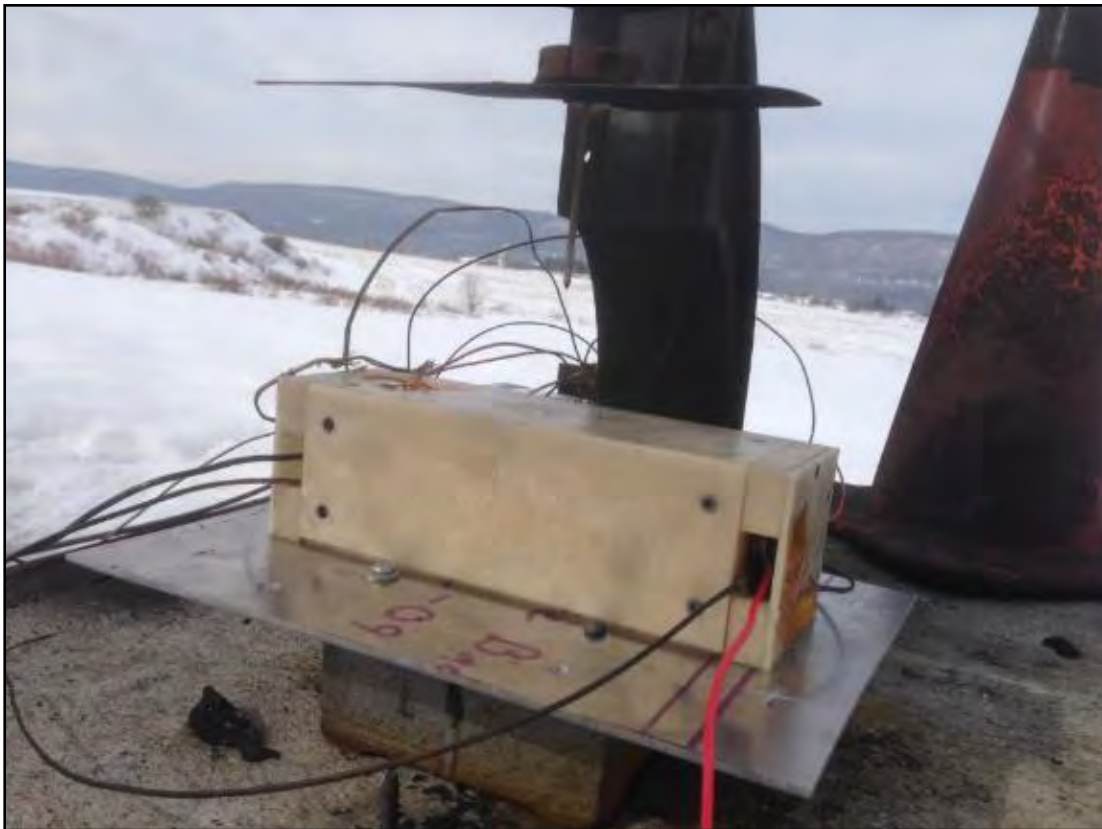
Figure 46. Pyrophobic – Overcharge Setup

Part of this research was to investigate fire suppression systems and fire prevention techniques using new materials and design. Pyrophobic Systems produces proprietary compounds that claim to both absorb fires and suppress them from spreading to adjacent areas. This research team formed a partnership with Pyrophobic by receiving donations of their materials in the form of machined components ready for testing in our single-cell scenarios. To thoroughly test this material an overcharge test was commissioned. It is well known from previous tests that the most stressful scenario will occur from an overcharge-venting event. For this test the cell was surrounded by a wall of Pyrophobic material with cell separators holding the cell at each terminal. Again the assembly was bolted down to an aluminum base that was also secured down to the air press just in case the cell failed to vent and a nail had to be put through to induce the discharge.

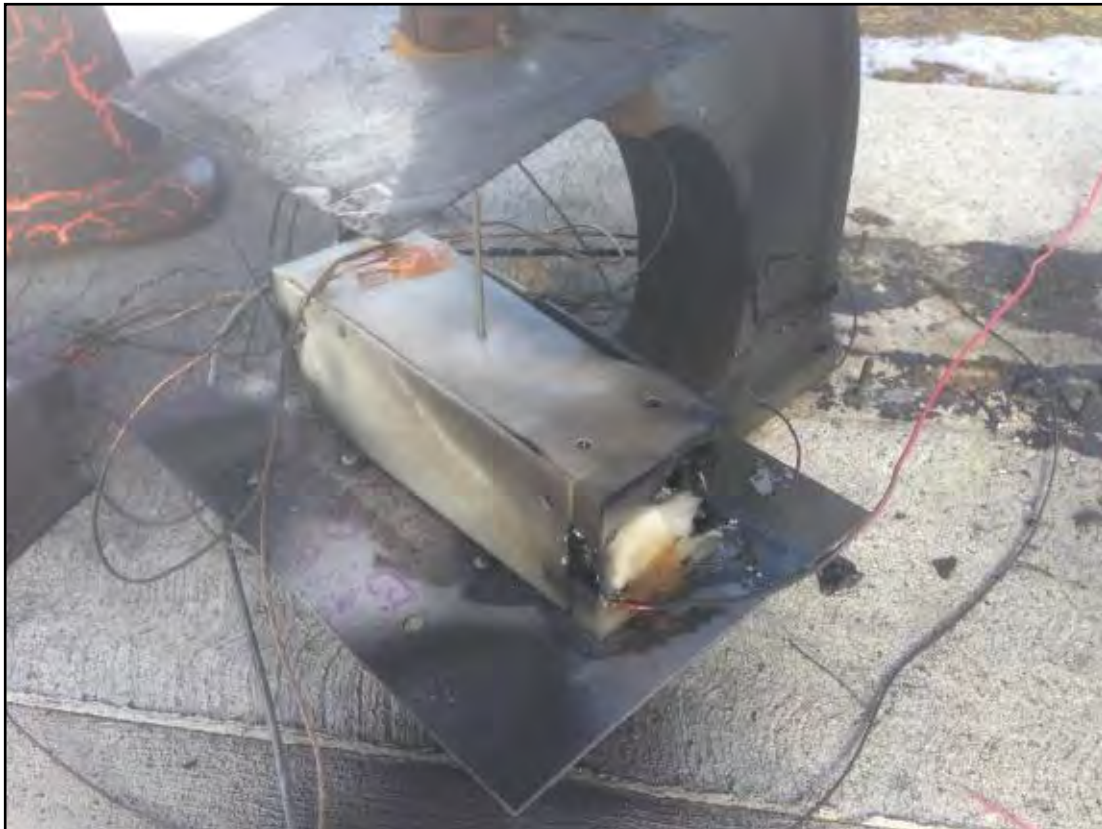
Figure 48. Pyrophobic – Overcharge Results

It is notable that the venting event resulted in a peak cell surface temperature of approximately 400°C, which is considerably lower than in the earlier tests.

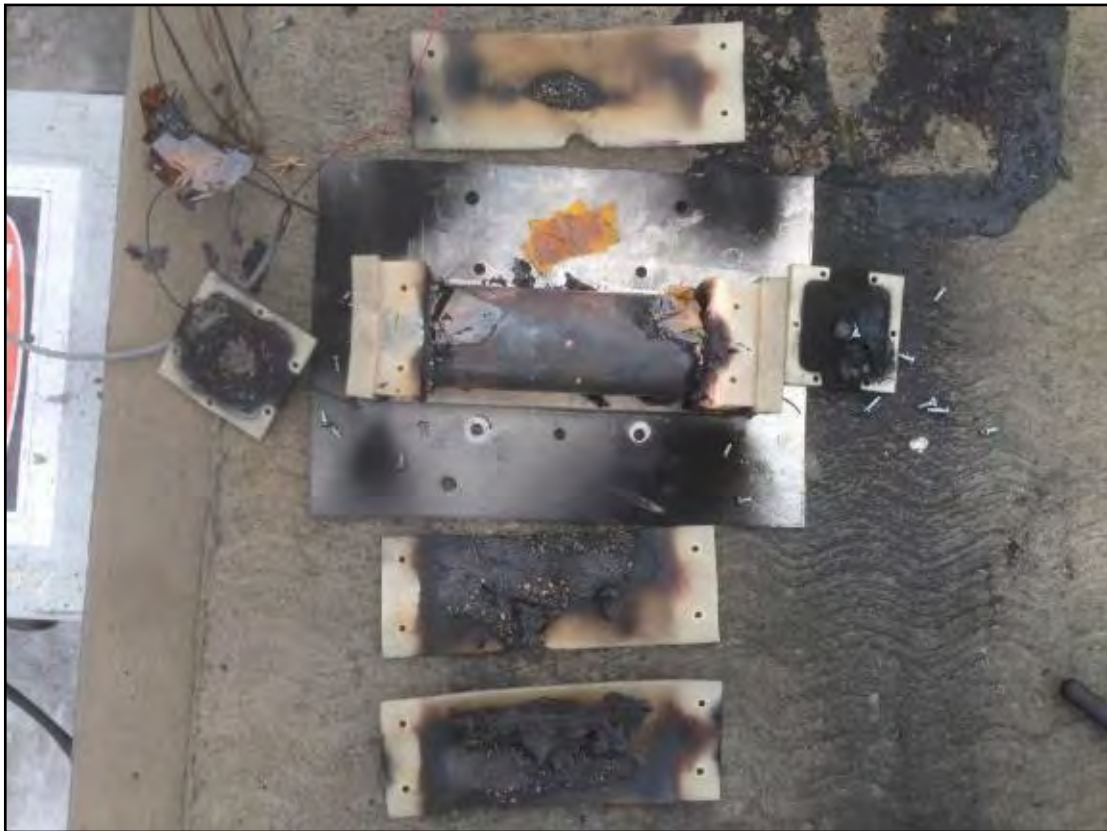
Figure 51. Pyrophobic Material After Nail Puncture

Figure 51 shows all the parts used to contain this cell nail puncture event. The material has obviously grown in thickness, yet it clearly hasn't lost integrity. It would likely keep this event from impinging into another area, limiting thermal propagation and maintaining structural integrity.

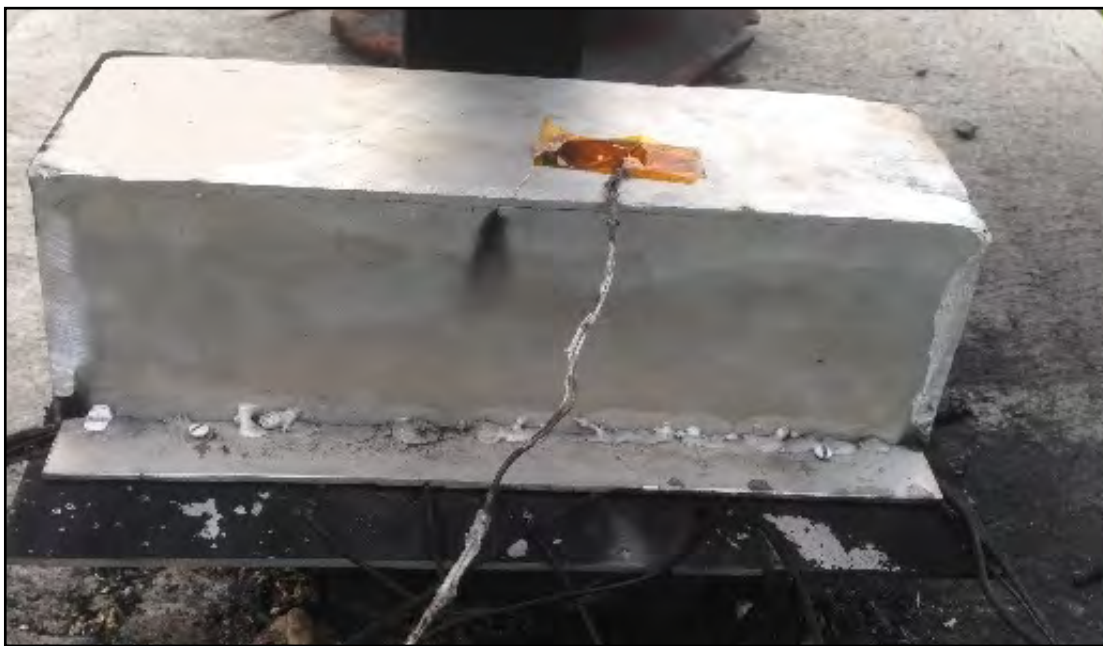
Figure 52. Pyrophobic – Overcharge with Enclosure Setup

The housing was bolted down on the same aluminum base that held all previous assemblies on the air press as seen in Figure 52.

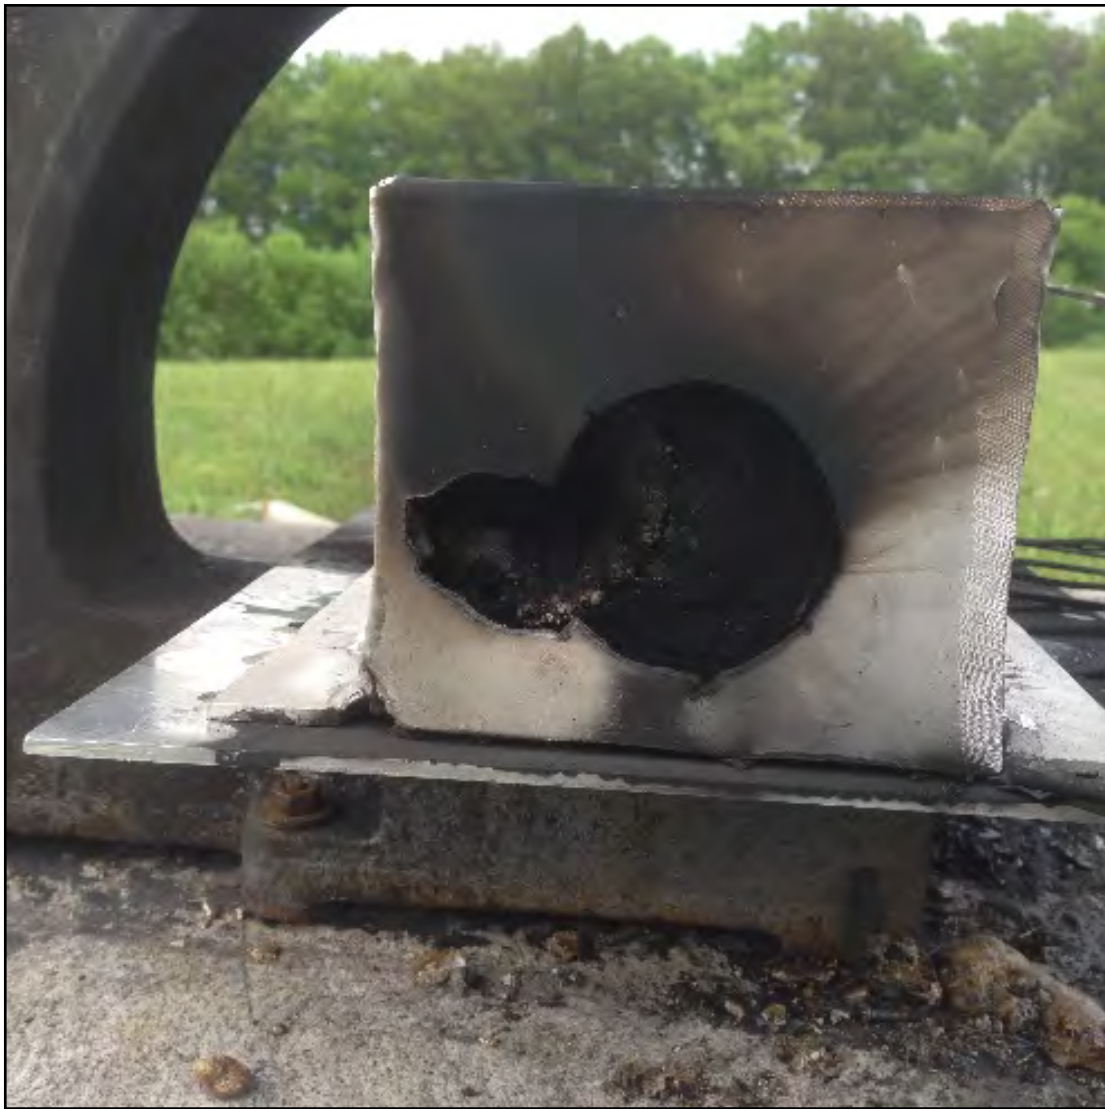
Figure 54. Pyrophobic Enclosure Vent Opening

Figure 54 shows the machined opening, the larger diameter hole, and the smaller opening cut by the venting gases.

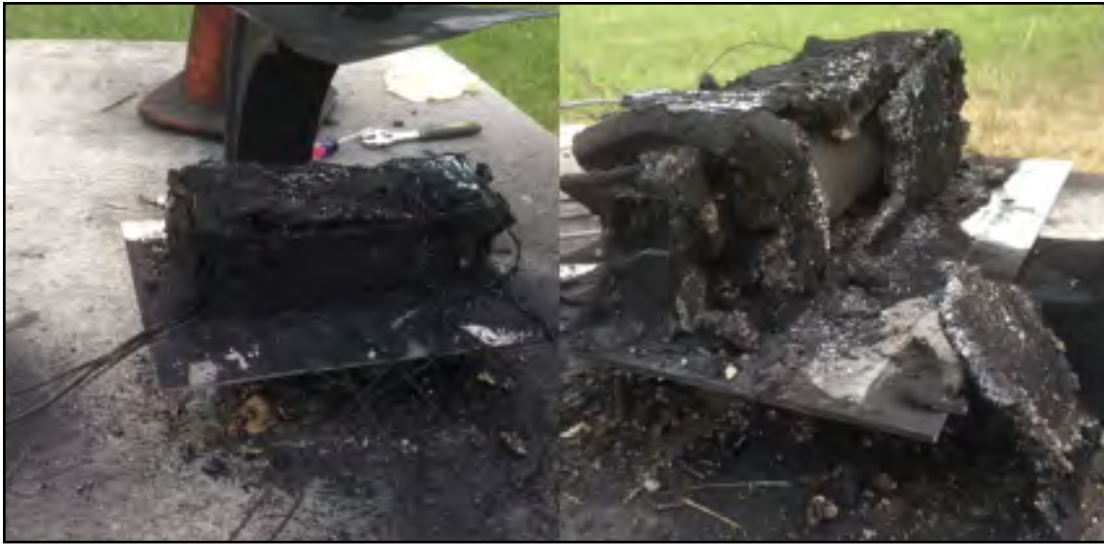
Figure 55. Pyrophobic Overcharge with Enclosure Material Results

Figure 55 shows the results of using the Pyrophobic material inside the enclosure. Clearly this material is more charred and not as strong or capable of holding a cell as that in the test performed without an enclosure.

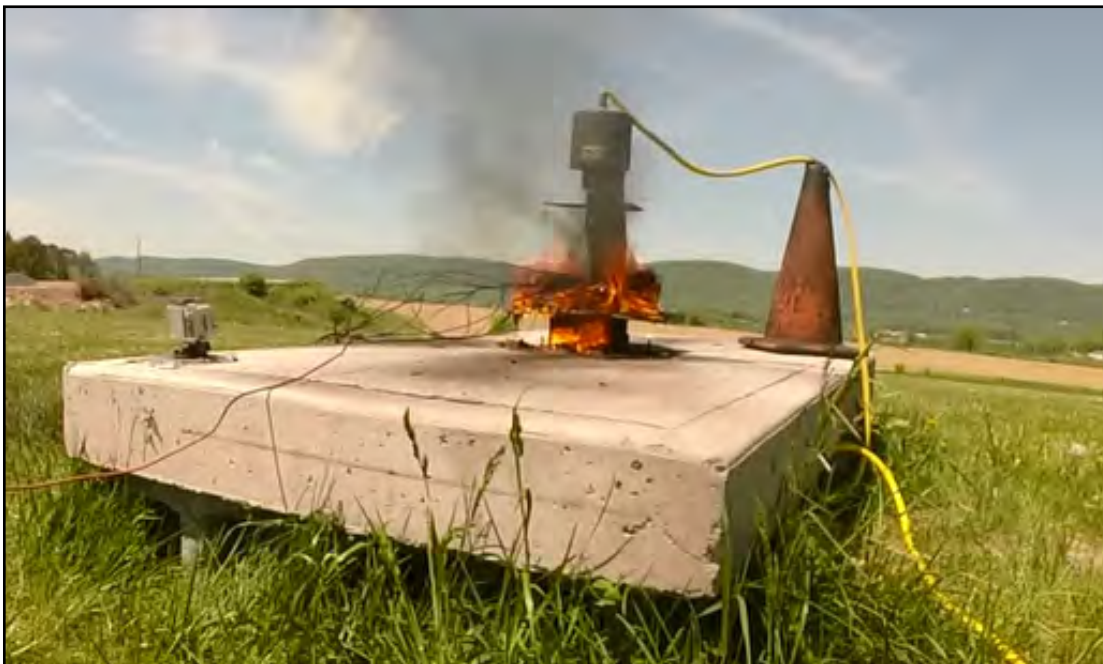
Figure 59. PET – Material Result

Not all tests result in exactly the same temperature measurement distribution. Some show that the positive terminal is hotter than the negative. In this test, however, because the PET material caught fire (as seen in Figure 59) most sensors detected extremely high and sustained values.

In this test, after the violent venting that included flames, the material kept burning until completely gone. In fact, playing back the video recorded during the test, it took around ten minutes to burn the entire cell enclosure down to nothing. After that the enclosure cooled down very quickly, because it basically disappeared after ten minutes and sensors then read ambient temperature. This fire surrounded the cell, heating it. As a consequence, the cell did not cool down as rapidly as the PET enclosure.

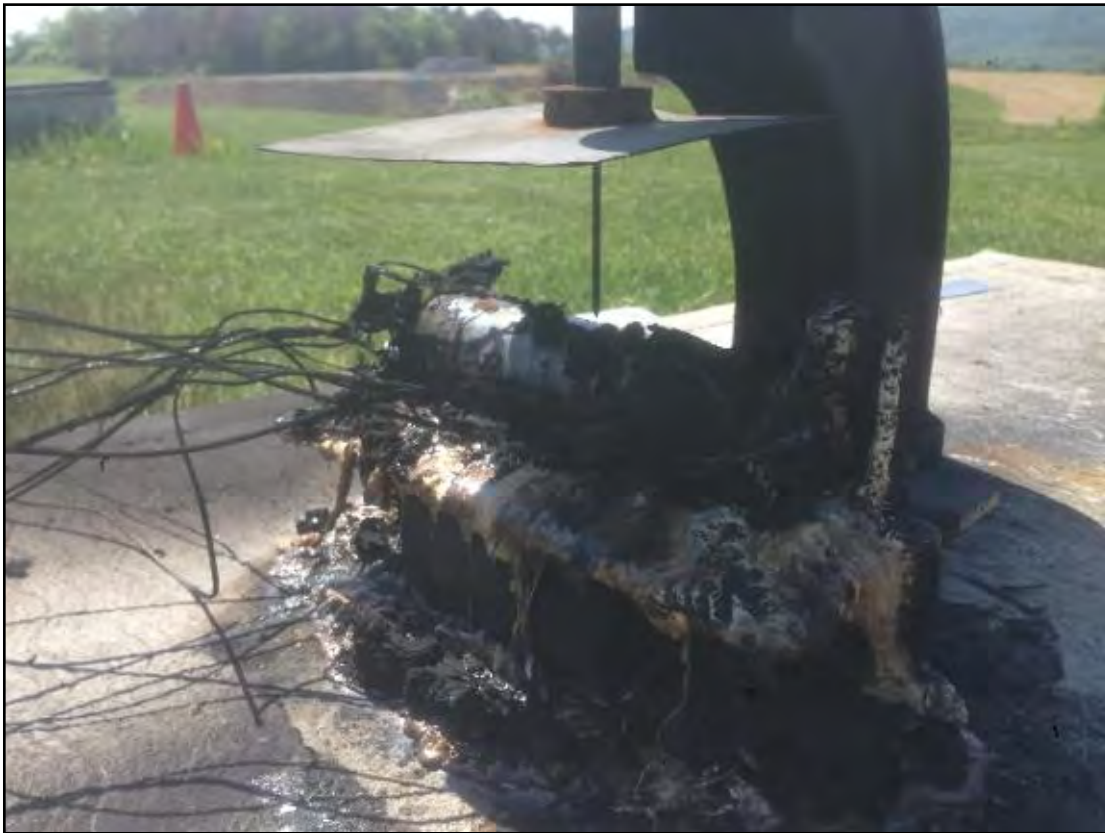
Figure 60. PET – Material Result 2

Figure 60 shows the remains after the PET enclosure melted down. The only part not damaged was the base, which was made of a substantially thicker, 0.5-inch plate.

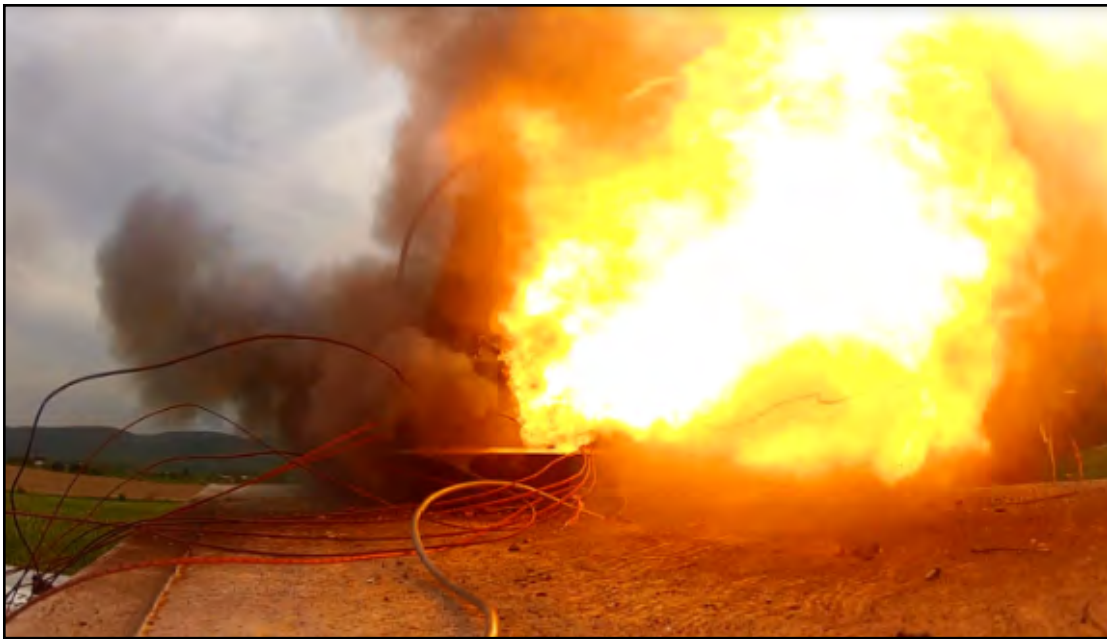
Figure 62. PET – Positive Venting First

In a review of the recorded video, some notable points stand out. The positive terminal was the first to reach the high temperatures recorded and was also the first side to experience a disc rupture, resulting in hot gases venting and flame. This can be seen in Figure 62. Note that the right side represents the positive terminal.

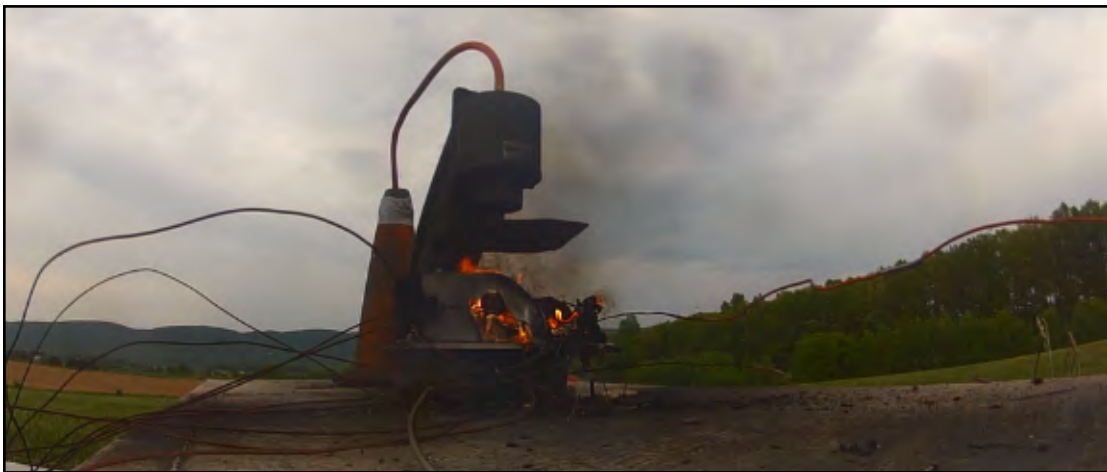
Figure 63. PET – Nail Puncture Material Result

As with the previous PET tests, the material caught fire and burned until completely gone. The fire lasted about ten minutes, which according to the graph corresponded to the period of time between the 15th and 25th minute, when the cooling down profile started. The fire a few minutes after the nail puncture can be seen in Figure 63.

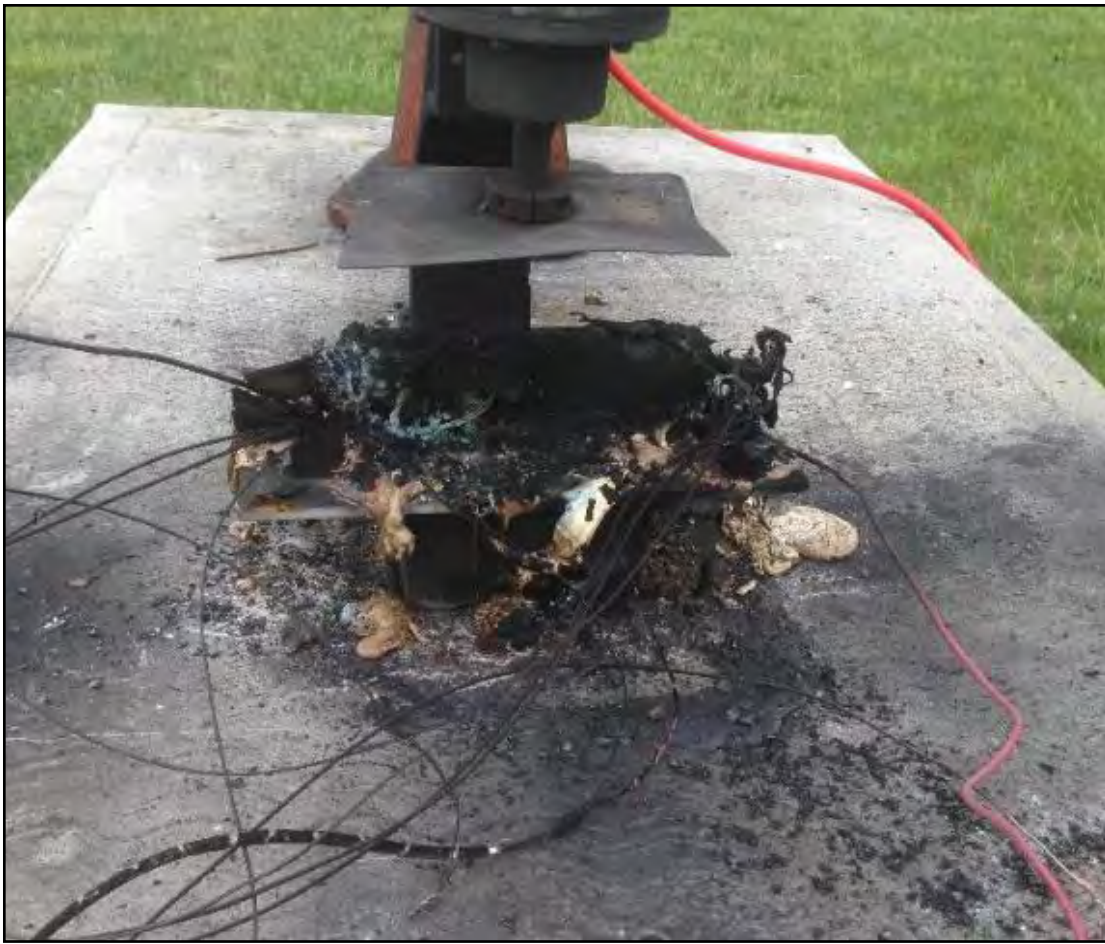
Figure 64. PET – Nail Puncture Results 2

The flames of the venting ignited the material by the terminals, and the fire then propagated throughout the entire enclosure. Figure 64 shows that the enclosure was nonexistent after a few minutes and only the cell case and plastic base remained.

The results of this test were similar to that of the other PET/acetal tests. The material is not capable of handling a thermal event from a large-format 45 Ah NCA cell.
