Safety of Lithium Nickel Cobalt Aluminum Oxide Battery Packs in Transit Bus Applications

MNTRC Report 12-61

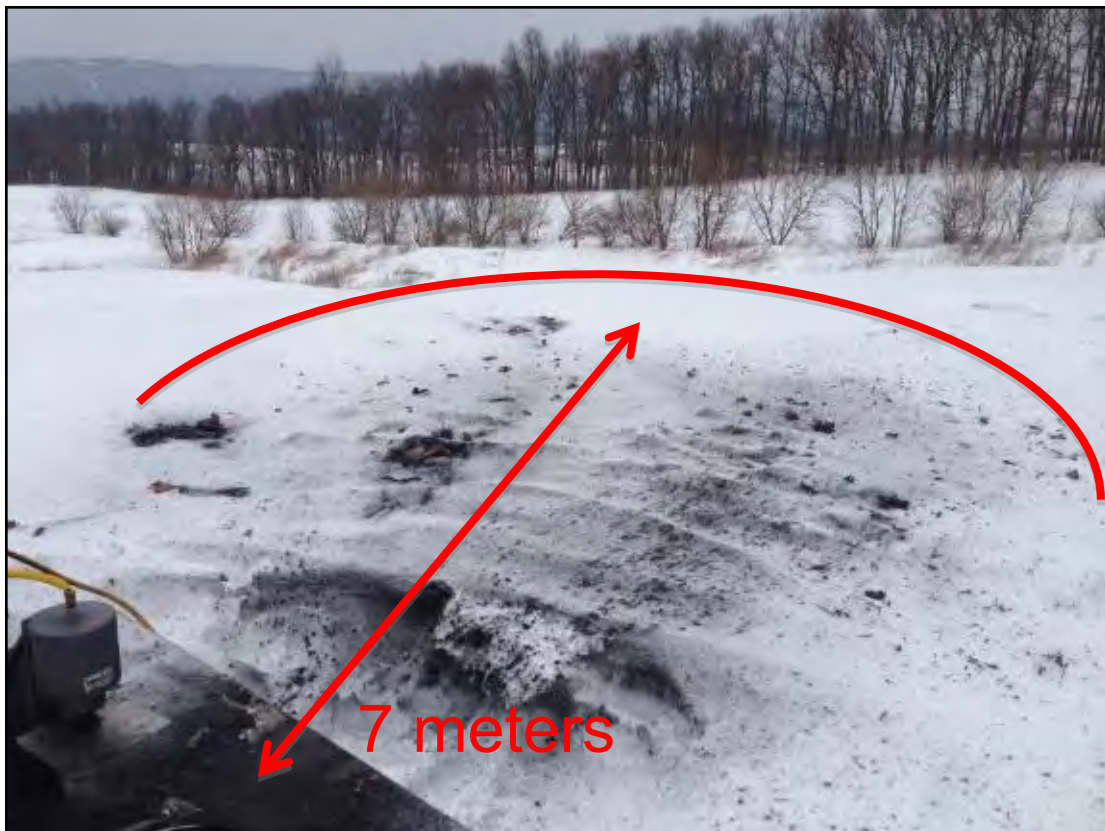
Figure 65. Blast Radius

As with all other tests, a fully charged 45 Ah cell was installed into a test stand made of the candidate material in an overcharge event. The first attempt at a Teflon test resulted in a structural failure because the entire cell end-cap burst instead of the burst disc. Shortly after the venting event started, the end-cap came off and the force of the venting gases projected the cap about seven meters from the test site. Cell casings are made by welding end-caps to each end of a stainless steel tube. This weld failed and as a result ejected a substantial amount of electrode material. Figure 65 shows how far this material spread from the test site.

The cell also ejected from the base and would have likely gone a great distance but hit a pile of snow, limiting its travel. This event gave the researchers an even greater respect for the power released during an event. It should be noted that each cell overcharge/nail puncture usually results in a violent venting event, but the result of each event affects the cell casing slightly differently. In some cases, the burst disc fails and entire sections of the cell burst. A review of the test plan and setup was performed, resulting in an increased distance between the test site and researchers/visitors.

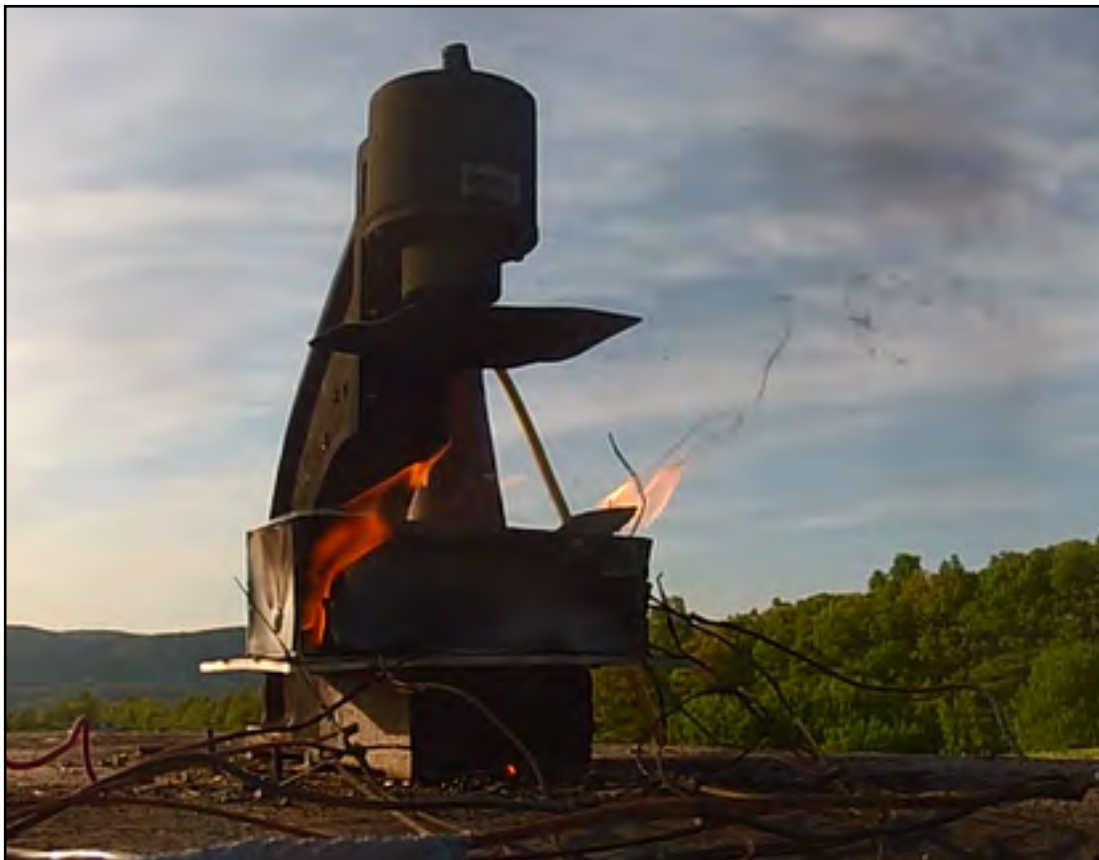
Figure 67. Teflon Overcharge Material Results

Figure 67 shows the fire resulting from the overcharge event. Note that this fire only lasted about **43 seconds**. Figure 68 shows the temperatures measured by sensors mounted to the walls of the cell enclosure made of Teflon. Note that these temperatures were only above ambient for approximately 2 minutes. This was in contrast to all other tests where high temperatures are typically sustained for at least 10 minutes. Only one signal reported a temperature above 100°C and is likely due to hot gases venting from the cell.

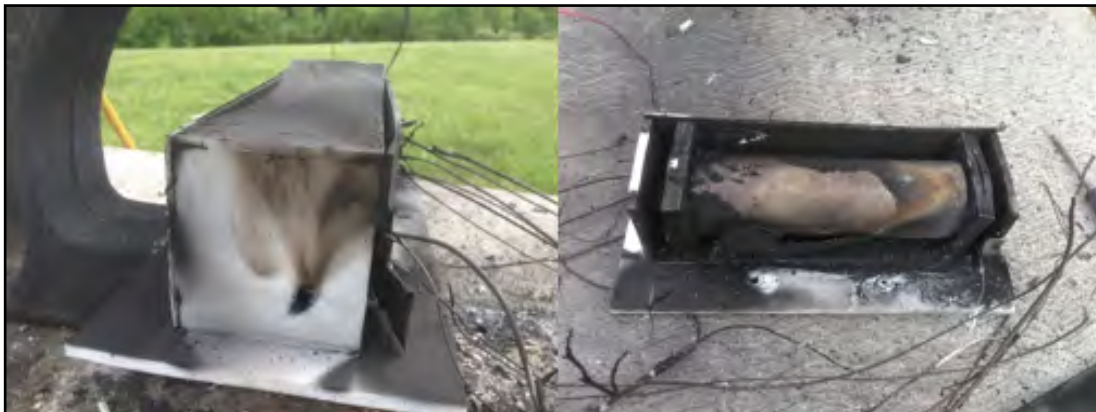
Figure 69. Teflon Overcharge Material Results 2

Figure 69 shows the results of the Teflon material after the cell and material cooled down to ambient temperature.

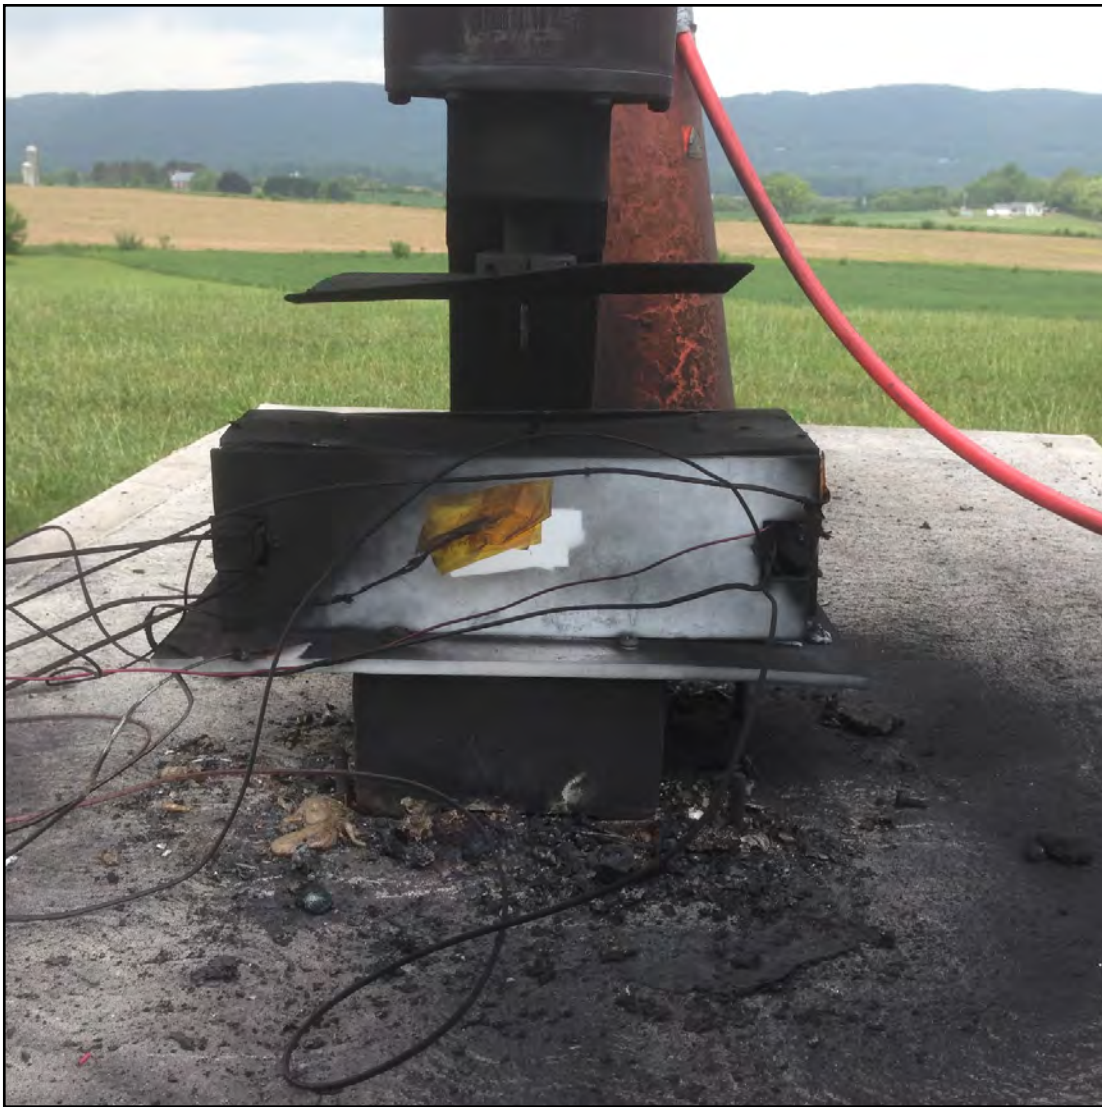
Figure 71. Teflon – Nail Puncture Material Results

Figure 71 shows the result of this nail puncture test. Note that the material is intact and shows little signs of damage, only a black coating of burned electrolyte.

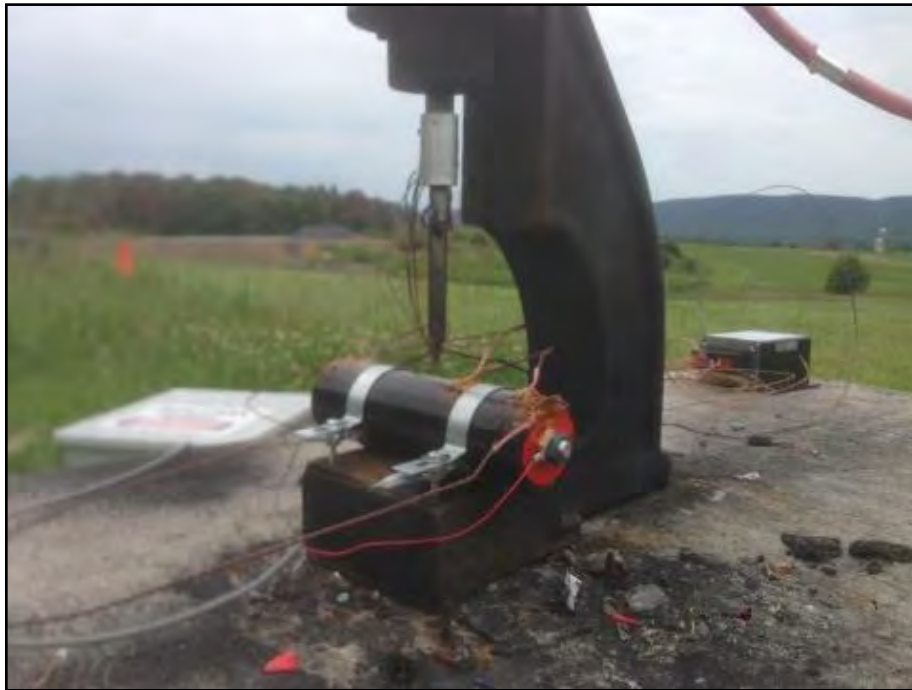
Figure 72. Nail Tip Temperature Measurement Test Setup

Voltage and case temperature of the cell were also recorded in addition to values recorded by six temperature sensors in the nail with one of them located at the very tip.

Figure 72 shows the test setup. Notice that the nail and the cell were lined up symmetrically to get the best approximation of electrolyte temperature.

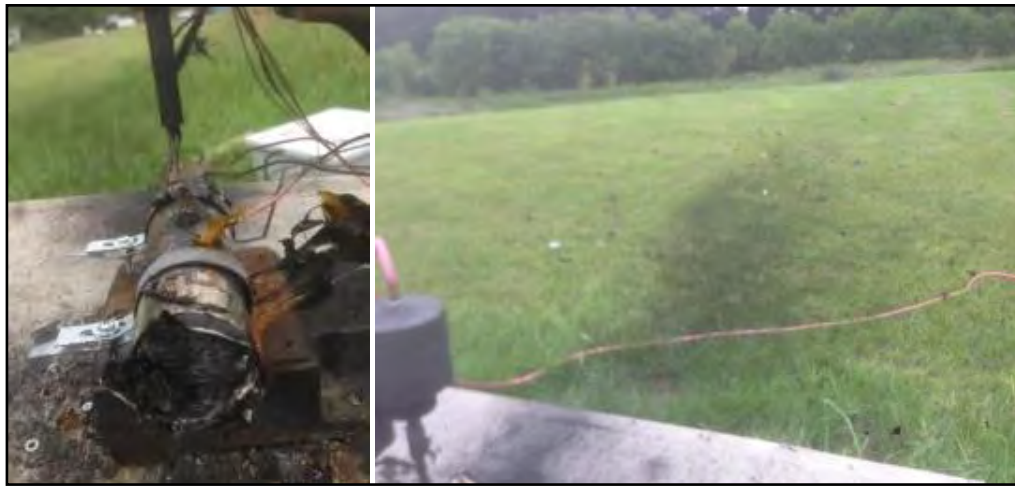
Figure 74. Cell and Surroundings After Test

This larger diameter instrumented nail caused a more dramatic event relative to the smaller nails used in previous testing. This result indicated that the severity of the puncture and short would change the severity of the venting event. Note that in this test the steel end-cap of the positive terminal broke off and was projected several feet as seen in the Figure 74. The left image shows the internal construction of the cell. Visible are the long strips of foil rolled into a cylindrical jellyroll shape that comprise the different layers of the cell. The same picture also shows how the nail tip broke off in the cell as the air press lifted up. The image on the right demonstrates how savage the event was because the smoke and flames marked the ground.

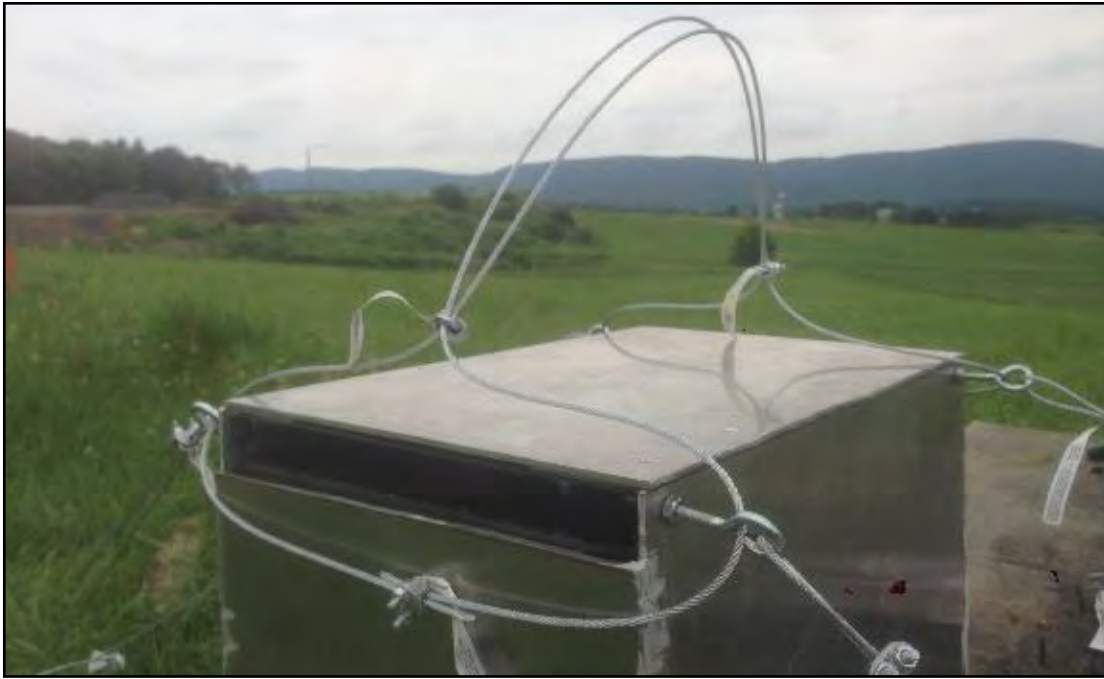
Figure 86. Handle to Lift the Battery Pack up with the Forklift

Due to the sheer amount of energy released by the whole module, it is unsafe to leave it unsecured during a destructive test. Prior single-cell testing proved to the research team that tie-downs to the ground were necessary to ensure the pack did not take off once cell venting occurred. Figure 86 shows the tie-down configuration.

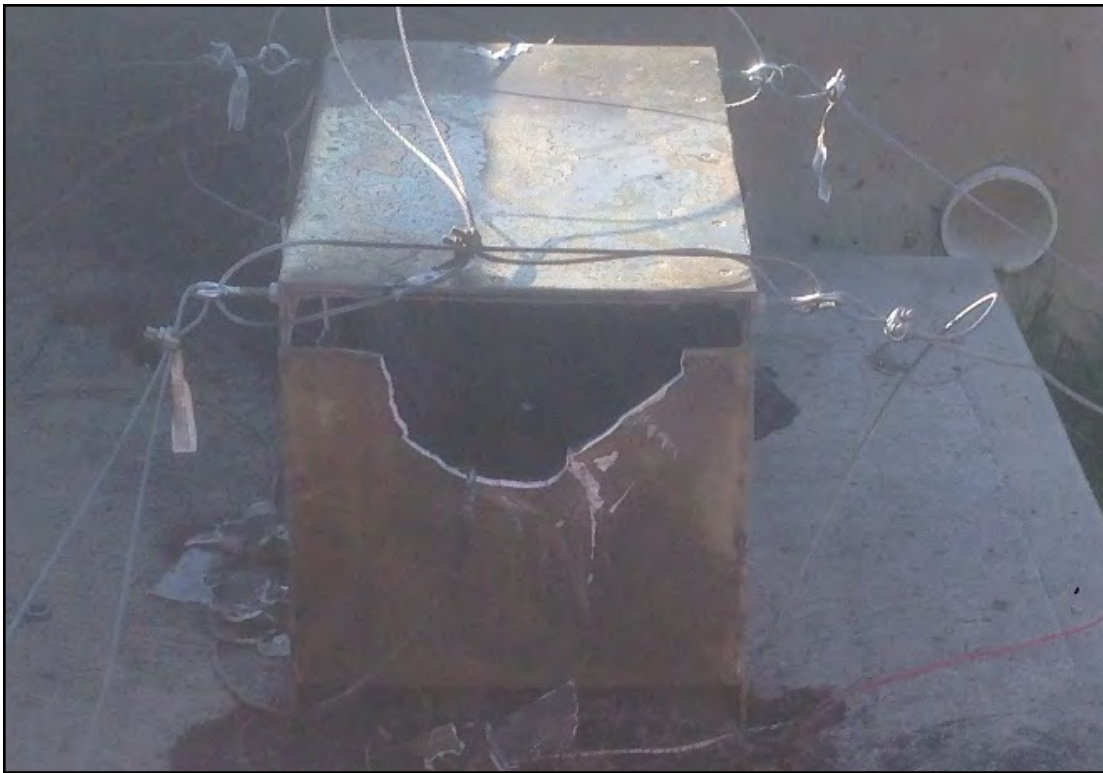
Figure 93. Enclosure After the Test

Note that, based on the test data and notes from this test, it is clear that the “top cover right” sensor fell off during the test as it was much closer to ambient measurements than the temperature of the venting gases. Once everything cooled down to ambient temperature, the cleanup procedures started. The first surprise was that the front and back sides of the enclosure’s Aluminum were melted as well as the sides as shown in Figure 93. The heat of the plastic headers burning likely caused it. On the other hand, the top and bottom steel plates successfully handled the direct impact and heat exposure of the cells venting gases.

All cells were investigated and confirmed to have vented given that all burst discs were opened. Inside the enclosure only metal parts remained. No plastic part remained. No clear sign was left that the box had ever contained any plastic.

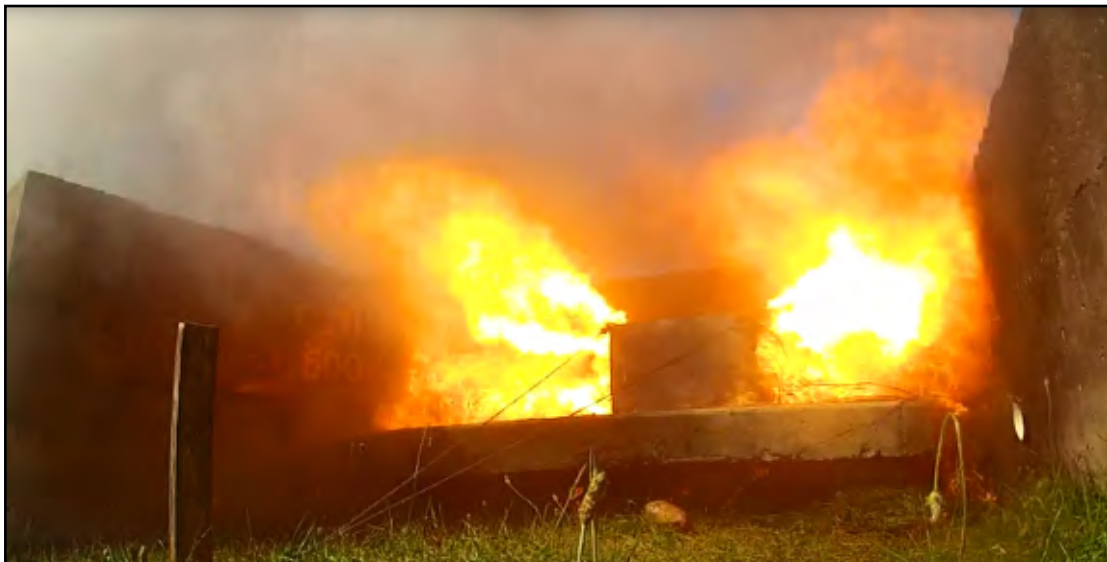
Figure 99. Battery Pack Venting

Figure 99 is a screen shot of video recorded during the event. The picture demonstrates the brutality of the flames coming out of the openings of the pack. It would not be unreasonable to think that some batteries vented at the same time due to the effect of the thermal runaway propagation.

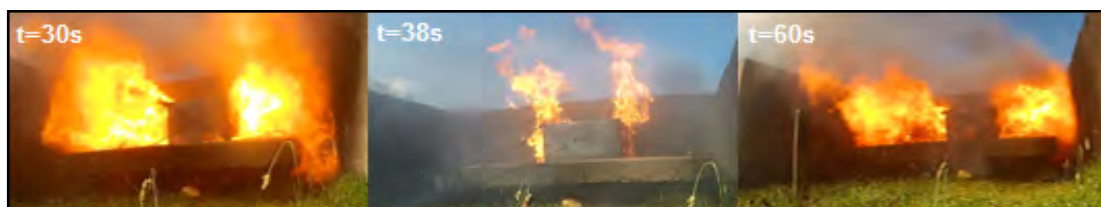
Figure 100. Sequence of the Venting Process

The thermal propagation was also palpable, however, because multiple times, right after one cell had finish venting, another one started venting right away. The event is shown and explained through the next sequence of images in Figure 100.

On the top left of each picture is the exact second the image was taken counting from the first cell that vented. As has been mentioned before, the thermal propagation appeared several times and actually happened before the 30th second, but the shots were not as clear as these ones.

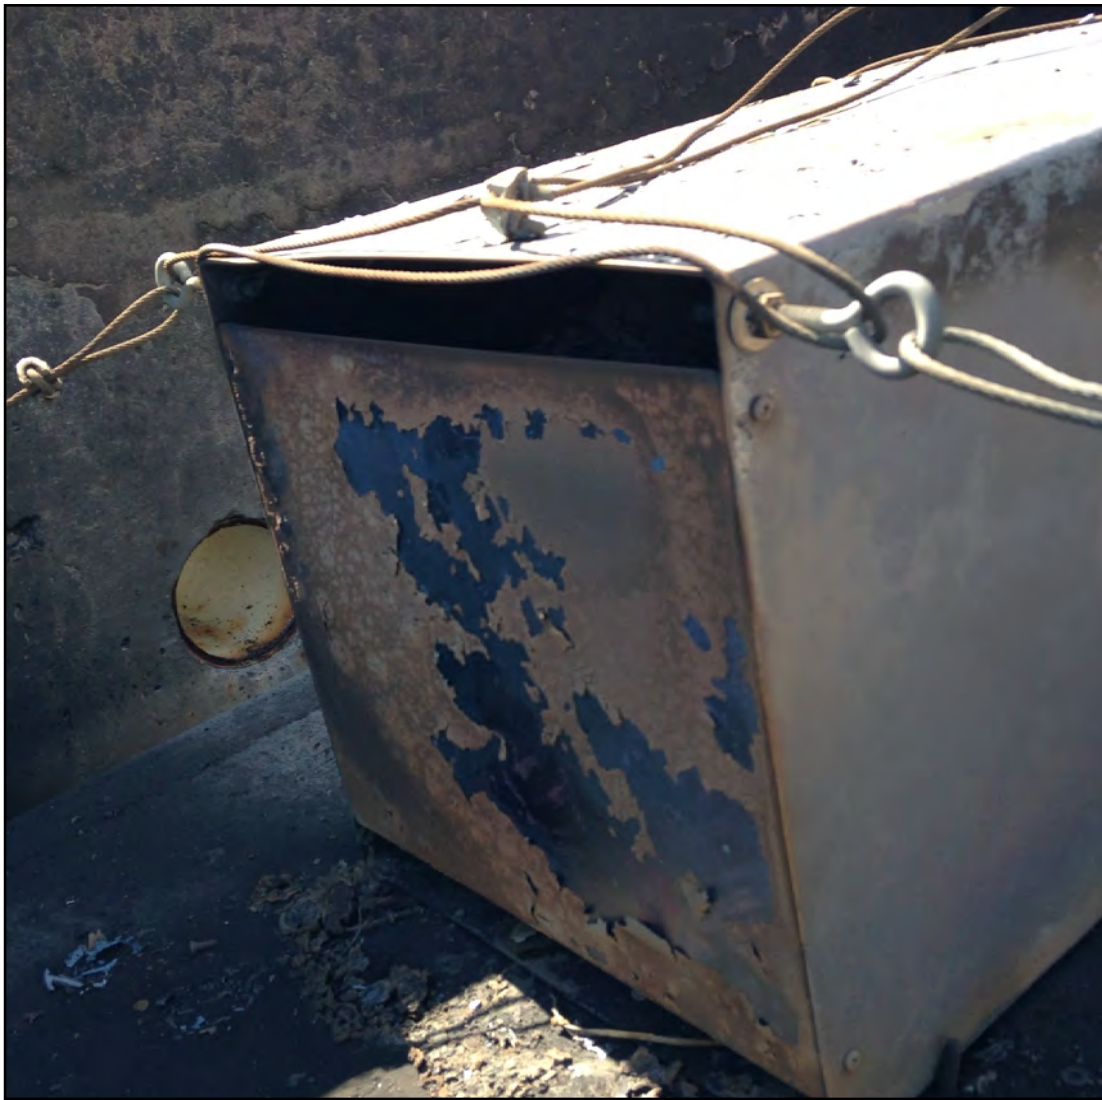
Figure 101. Resulting Steel Module Enclosure

The steel enclosure did a great job; it could handle those extreme temperatures without any problems. It did not melt and could be even reused for another test. Figure 101 shows the resulting steel module enclosure.

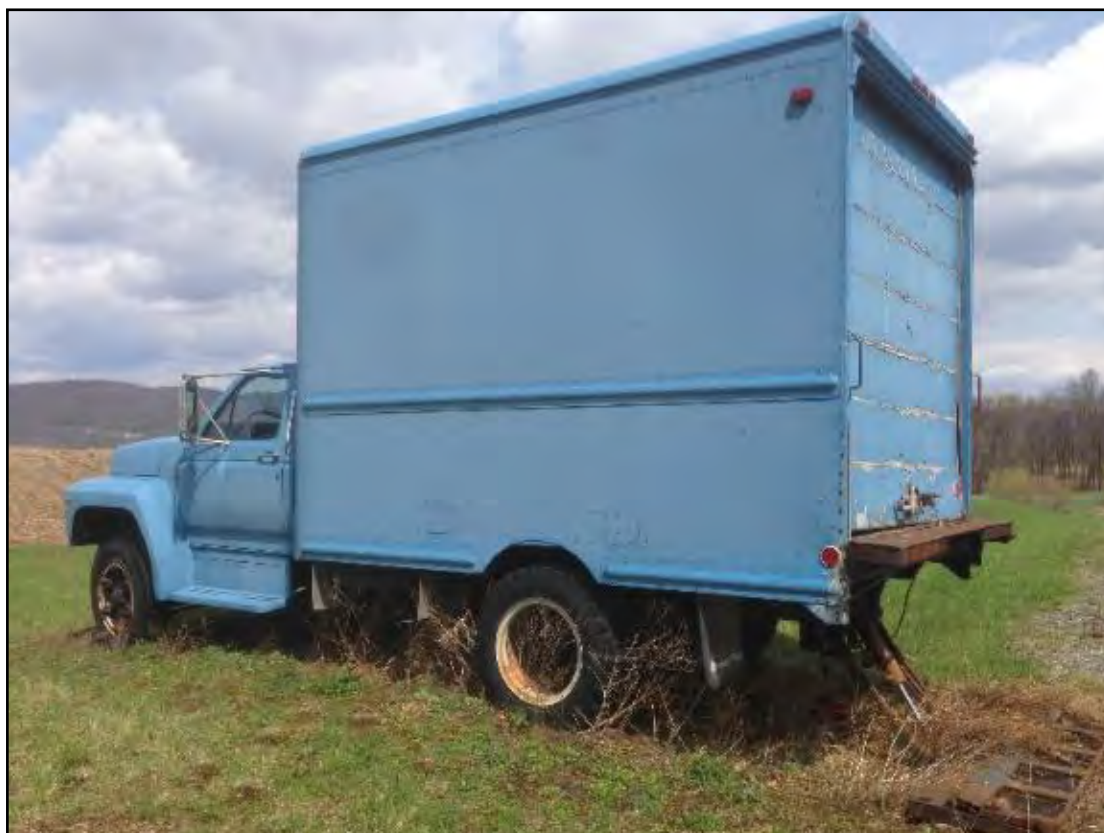
Figure 102. 18,400-lbs. GVWR Refrigerated Truck to Simulate Bus

To simulate a small to medium transit bus, an 18,400-lb. Gross Vehicle Weight Rating (GVWR) refrigerated box truck was selected from an inventory of available crash trucks at our test track. The particular truck shown in Figure 103 was used for on-campus delivery by the Penn State Creamery and was not in running condition, a fact that would not affect the goal of replicating the dynamics of the vehicle during an impact.

The box was removed from the truck for safety reasons, because if the batteries burned the bed could also catch on fire. In addition, current buses do not use similar insulated materials for their side panels, so it was incompatible to test it. Using a torch, the box was cut off and lifted by two forklifts. The truck was then pulled from underneath the box. All liquids were removed, the tires were filled up with air, and the exhaust was cut off.

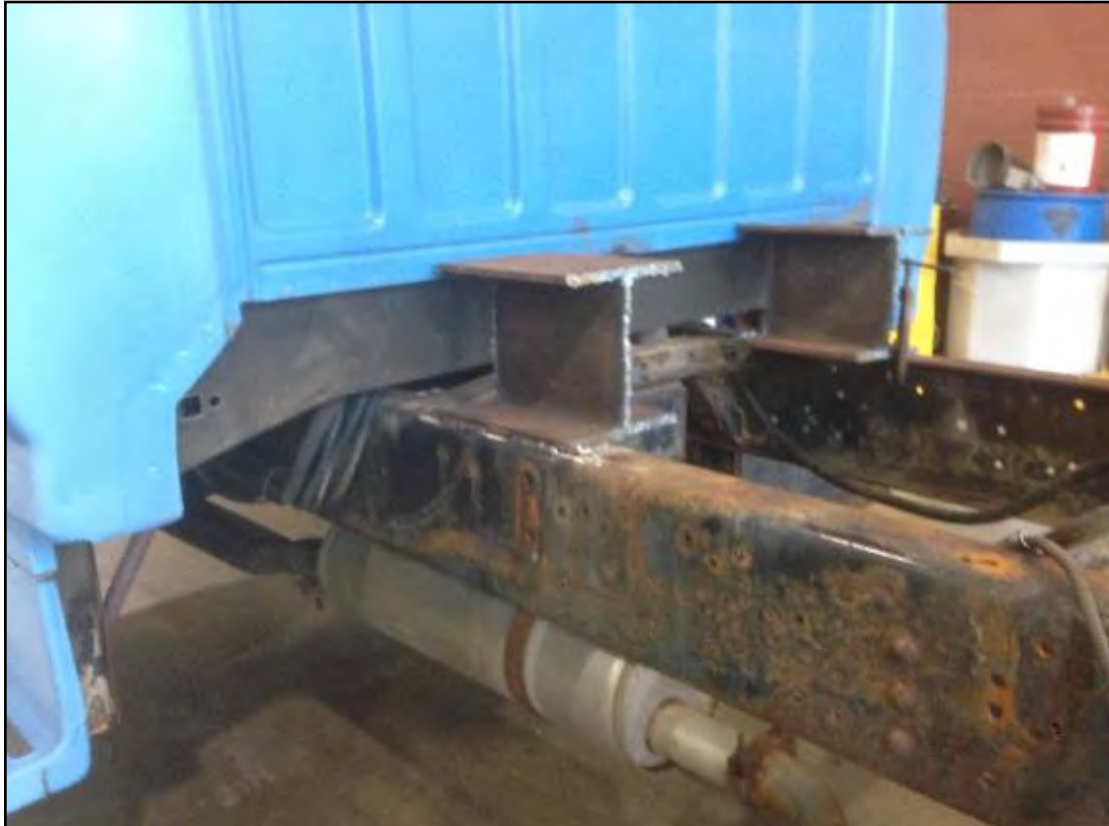
Figure 103. I Beam Sections Welded to Chassis Frame

The bare truck chassis weighed in at 12,250 lbs. Several options were considered to add weight; the final choice was to mount two Jersey barriers at 4,750 lbs. each mounted on I beam sections welded to the frame as shown in Figure 104 and Figure 105. Heavy ratchet straps secured the Jersey barriers.

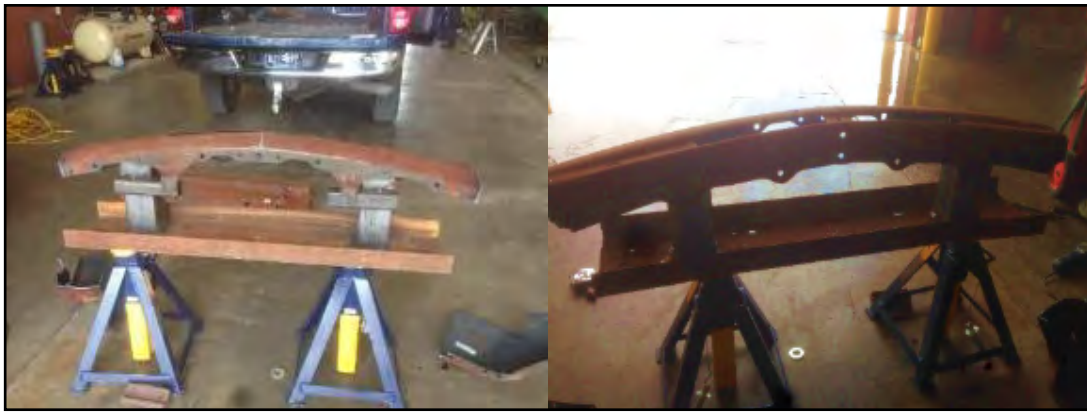
Figure 105. Left, Top View of Bumper, Right Bottom View

A front bumper for a 2006 Suburban was shortened to avoid a collision with the truck cab and back wheels. It was attached to the impact mass with steel tubes of similar proportions to the original Suburban frame. Figure 106 shows that both square tubes were welded to a c-channel base, and extra tabs were added to support the bumper from the main square frame tube in a manner similar to the vehicle design.

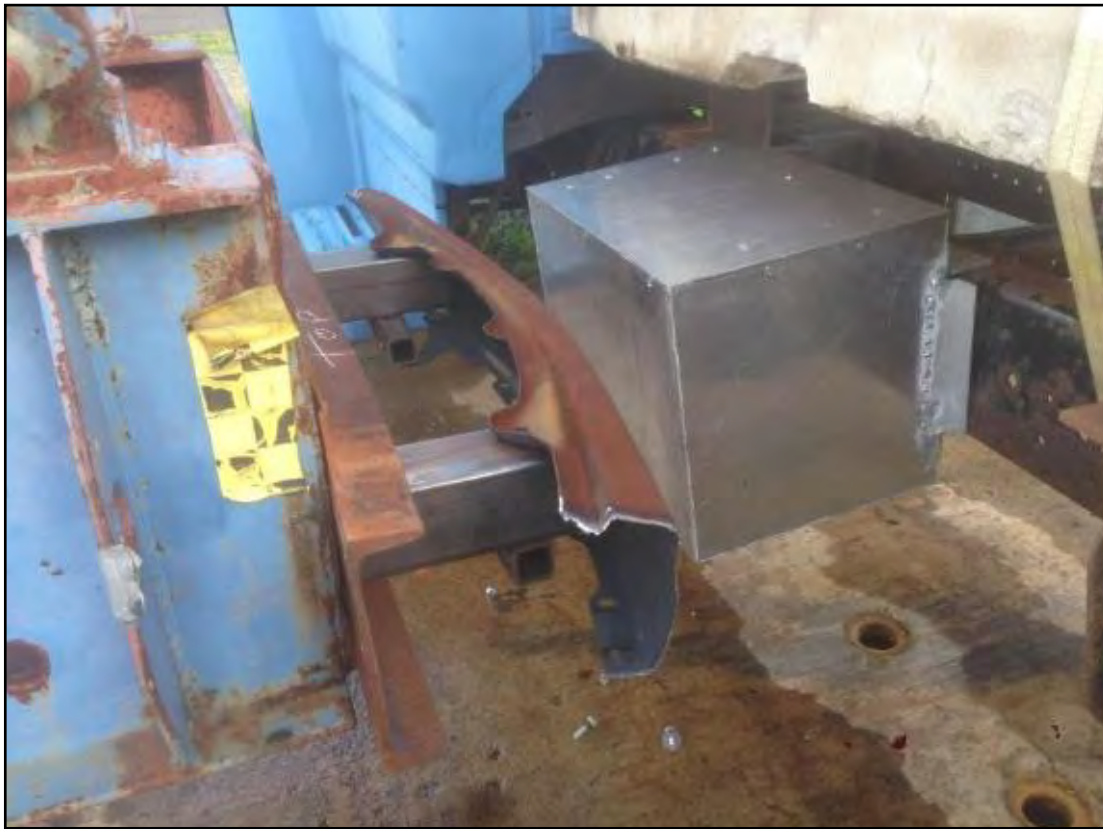
Figure 106. Impact Mass Mounted Bumper and Battery Position

The bumper was mounted on the impact mass and the truck aligned for direct impact on the battery module as shown in Figure 107.

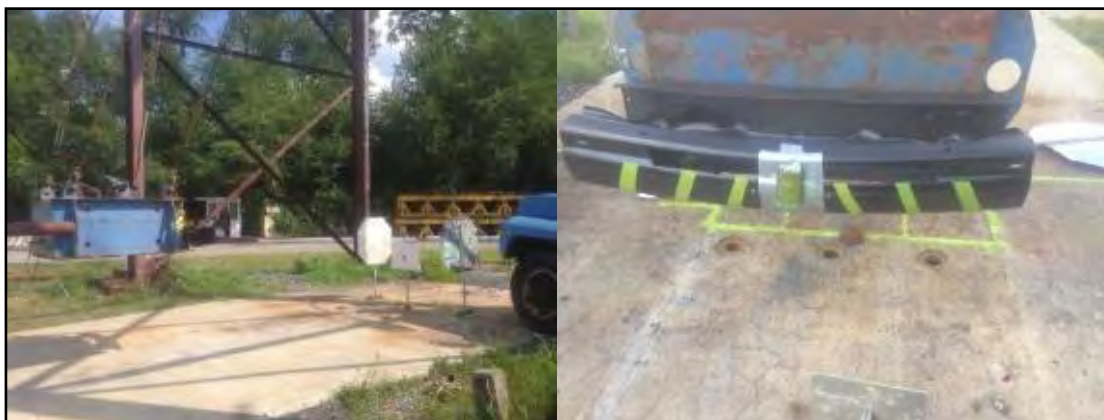
Figure 107. Pendulum Test Swing Setup

To determine exactly where the pendulum would impact the battery module, a sponge filled with yellow paint was attached to the bumper. A white cardboard target of the same dimensions as the battery pack was placed on the spot and height where the battery pack would be mounted on the truck, as shown in Figure 108. Additional targets were placed in the positions of the truck cab and wheels to insure pendulum clearances.

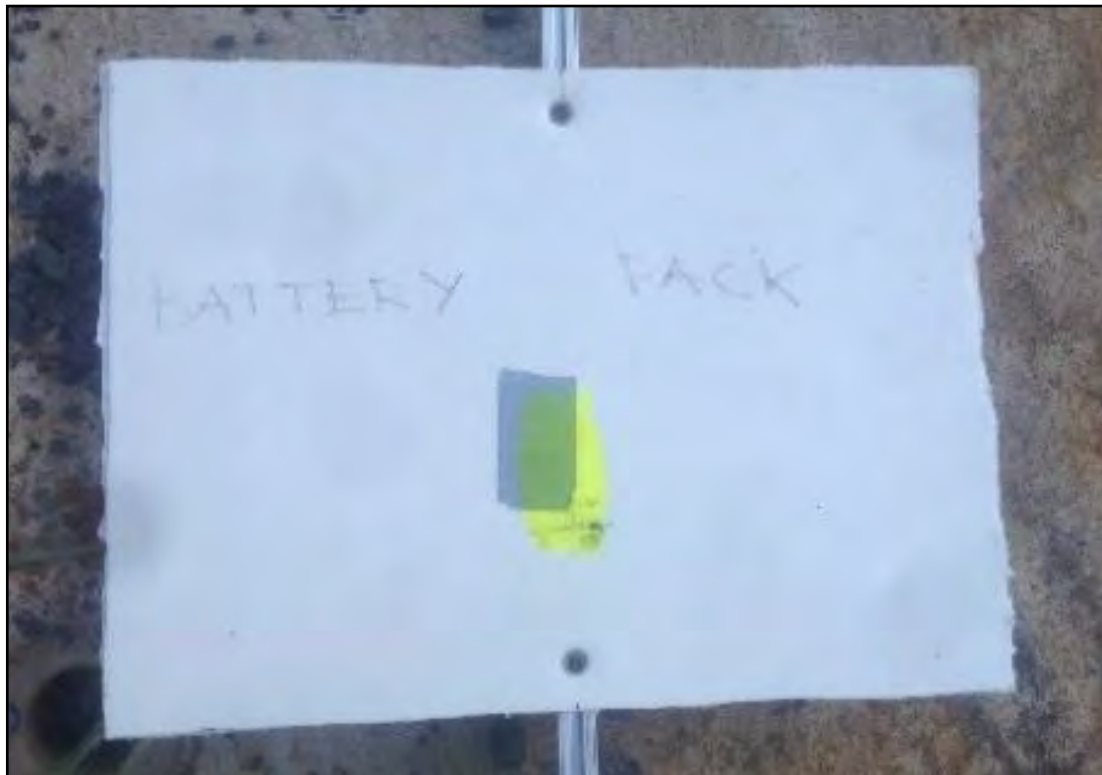
Figure 108. Impact Accuracy of Pendulum to Battery Position

The last free swing was also used to validate the accuracy of bumper impact location relative to the battery box position. In Figure 109, the yellow paint mark indicates that the bumper impacted the battery position (simulated by the gray tape) within two inches of the original alignment. The fact that the pendulum impacted lower than the static alignment is likely due to cable stretching under additional dynamic loading from swing velocity.

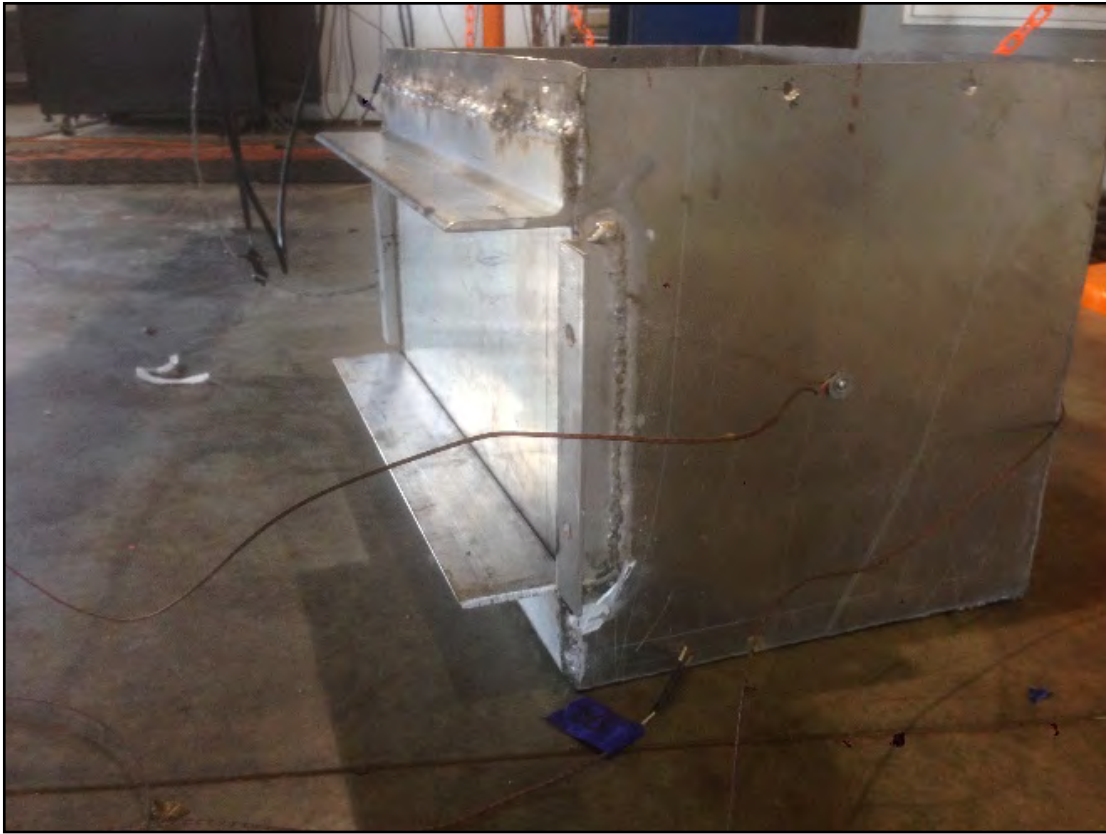
Figure 109. Aluminum Enclosure with Frame Mounting Flanges

The intention of this test was to simulate a full-sized bus battery pack, but space limitations on the frame of the truck restricted the test to a single module with 20 cells. After making sure that all BMS and temperature data was logging properly, the investigators inserted the pack into a steel box that was subsequently housed within an external aluminum enclosure as shown in Figure 110. The aluminum enclosure was designed with flanges for mounting to the truck frame between the cab and rear wheels. A power connector was also attached to the pack to simulate a real pack as closely as possible.

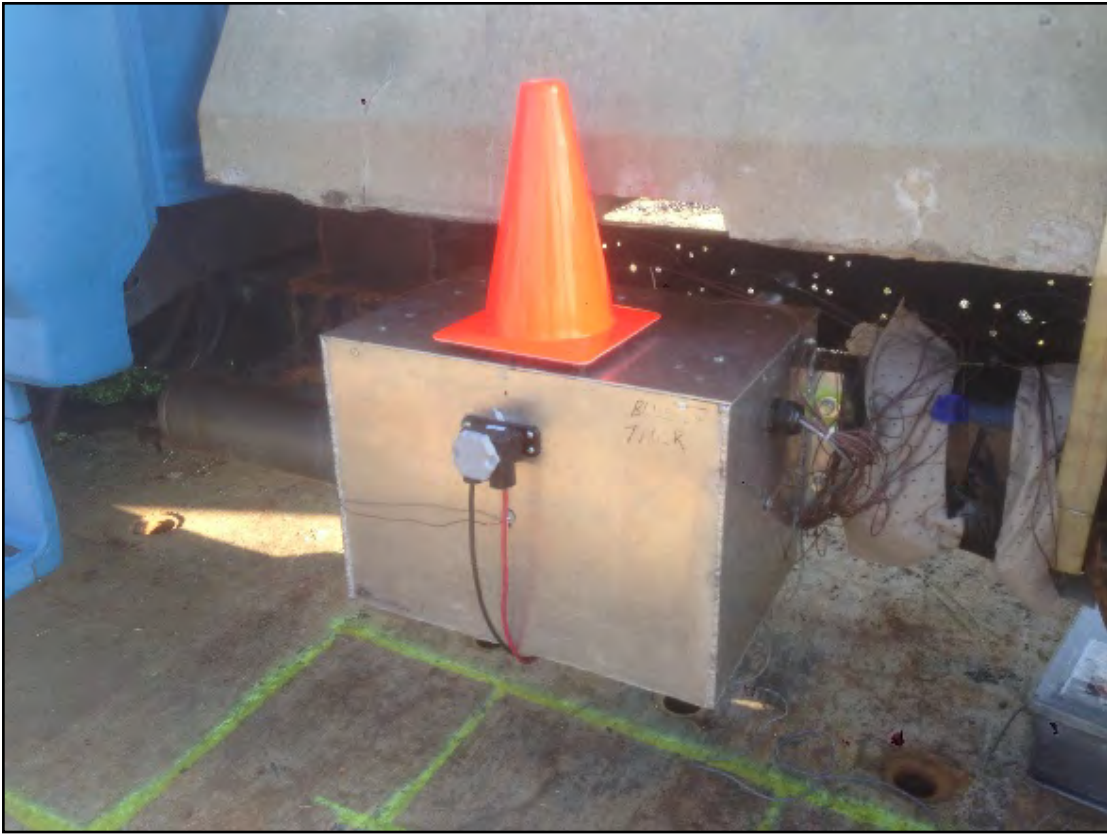
Figure 110. Battery Module Mounted on Frame with Data Acquisition

Figure 111 shows the battery module mounted to the truck frame between the cab and rear wheels. A thermocouple scanner was mounted to the truck frame, and a data acquisition box was placed on the ground as far away as cabling allowed.

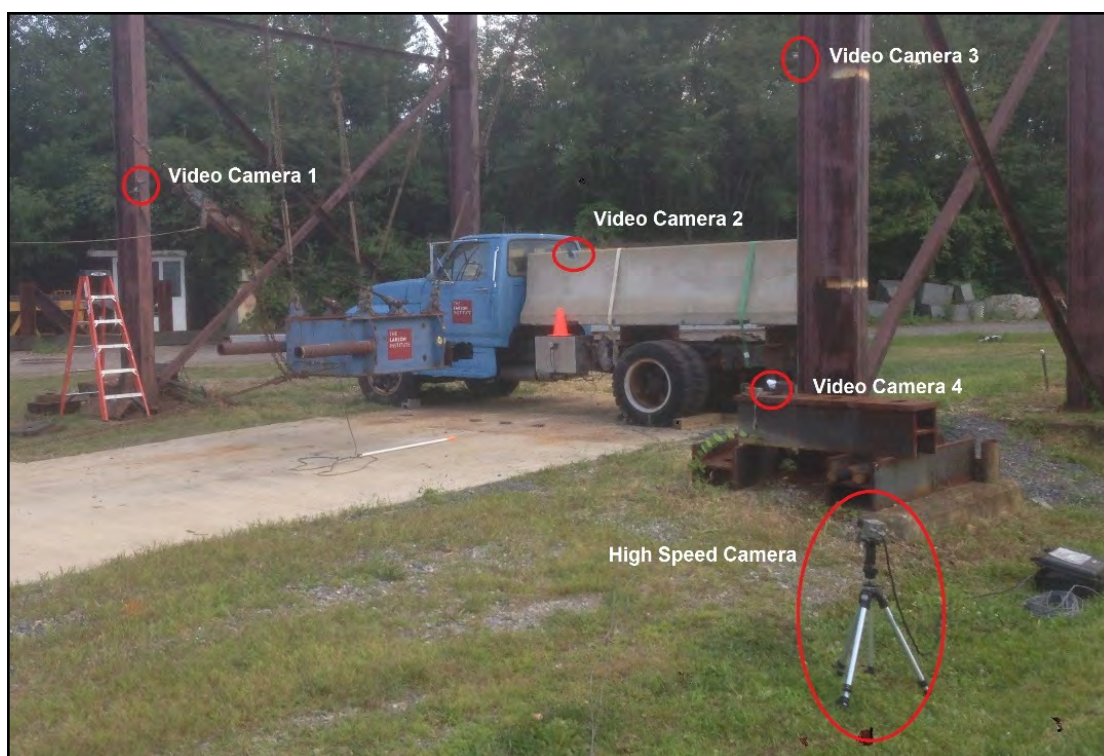
Figure 111. Camera Layout

Figure 112 shows the positions of video and high-speed cameras placed to capture the crash event. The orange cone atop the pack is intended to serve as an inertial reference in the high-speed video. The pendulum can be seen suspended a few feet away from the battery module prior to lifting.

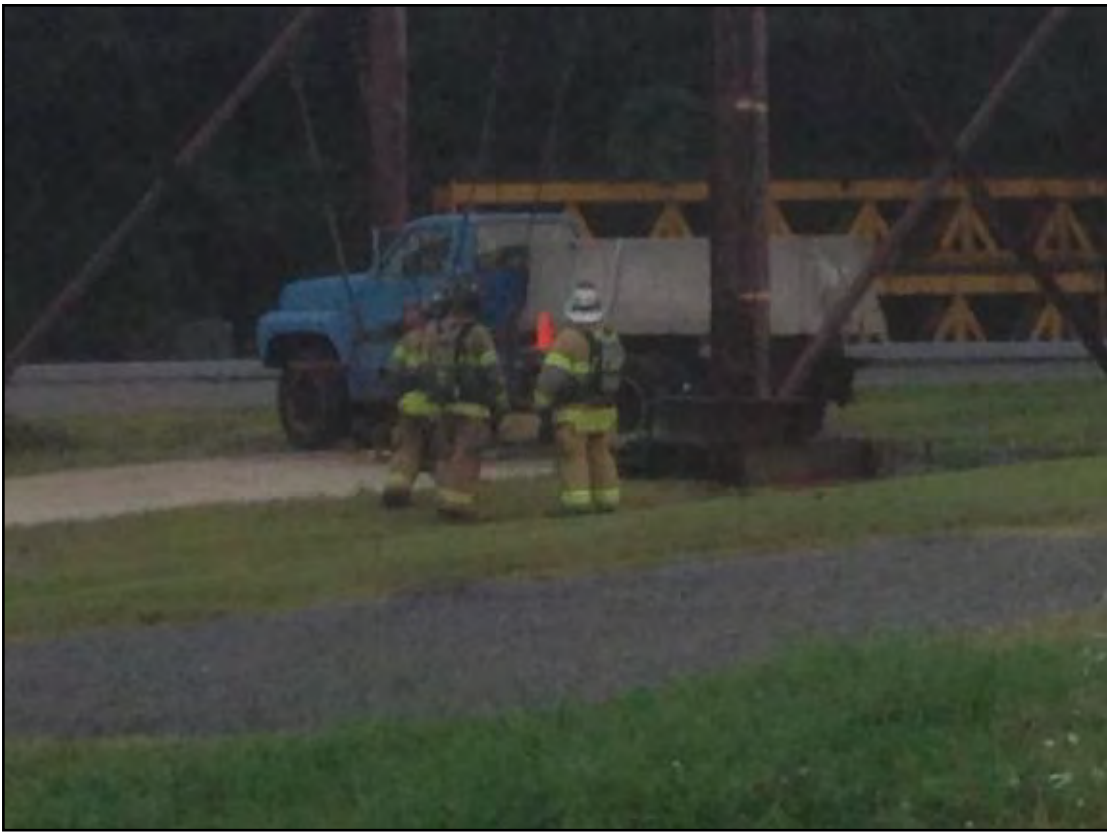
Figure 112. Fire Fighters Approach Battery Pack after Impact

Test setup included camera placement and extension of the pendulum release tether to 200 feet. Local fire departments were invited to observe the test. The area was cleared of all personnel except one observer and the tow truck driver. The pendulum was pulled up to the 25 mph lifted height of 18.92 ft. Finally, the cameras were triggered, and the area was cleared of all personnel to a radius of 200 feet. A horn blast was given and the release mechanism was triggered to drop the pendulum. The pendulum impacted the box and truck, which was pushed back about one foot. No venting of cells was detected upon impact. As shown in Figure 113, local firefighters drilled on approaching the pack in full personal protective equipment (PPE) ready to apply water coolant, as would be their practice in response to an actual traffic accident involving an electrified transit bus. They also deployed an infrared camera to remotely detect hot spots on the pack, an indication of thermal runaway. No excessive heat was detected. Afterwards, the pack was left undisturbed for at least 24 hours.

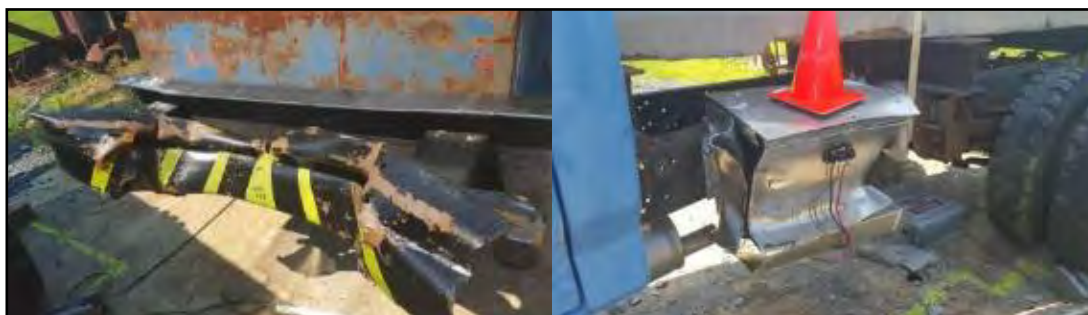
Figure 114. Deformation of Bumper and Module Enclosure

Upon inspection, it was noted that the center section of bumper deformed until the simulated SUV frame impacted the truck frame on either side of the battery module. The battery enclosure was significantly dented but not totally crushed, as shown in Figure 115. Some truck frame deformation was detected. The impact momentum transferred to the truck moved the front axle back 13 inches and the rear axle back 11 inches. Almost all the energy was transformed into deformation of the bumper and into movement of the truck.

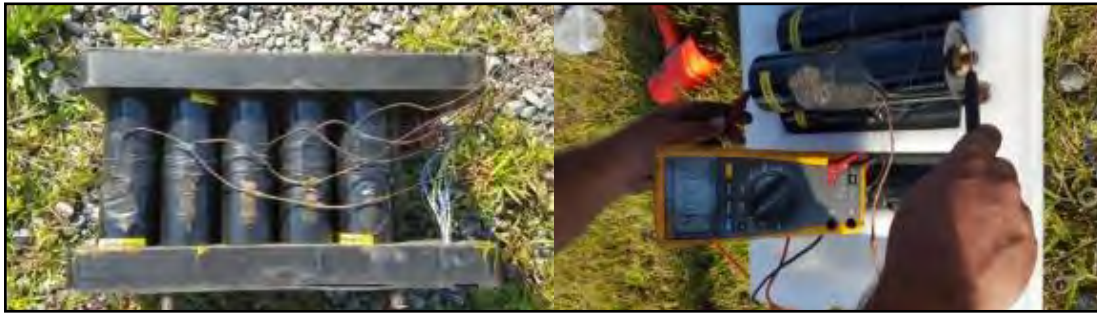
Figure 115. Dented Battery Cell

Upon disassembly of the battery pack, it was observed that none of the battery cells were severely crushed or penetrated by any part of the pendulum. In this case, all four cells on the impact side of the pack showed some abrasion and slight denting on the outside casings, as shown in Figure 116. This impact represents a best-case scenario, however, with the bumper and vehicle dynamics absorbing much of the energy. This would not have been the case if a more rigid component of the impacting vehicle, such as the frame, had penetrated the pack. Here no thermal runaway occurred within 48 hours before disposal. These dents are severe enough, however, to have potentially resulted in either immediate or eventual internal shorting leading to thermal runaway. Delayed thermal runaway has

occurred in some high-profile cases. Individual cells retained their full voltage output. All cells from this pack were placed in a saltwater bath to safely discharge prior to disposal.

This test demonstrated that the simulated shock of a 25 mph SUV collision directly into a battery module mounted outside a bus frame might not necessarily result in a venting event. In this case, the bumper absorbed much of the energy by deformation, a significant energy portion was transferred into vehicle momentum, and the battery pack was not penetrated by any rigid vehicle components. The dual-wall steel-aluminum enclosure and header also provided substantial strength and protection against crushing. A different outcome would have been expected, however, if the collision had included battery pack penetration.
