PRELIMINARY INVESTIGATIONS INTO SELECTIVE LASER MELTING

A Thesis

Master of Science in Industrial Engineering

June 2017

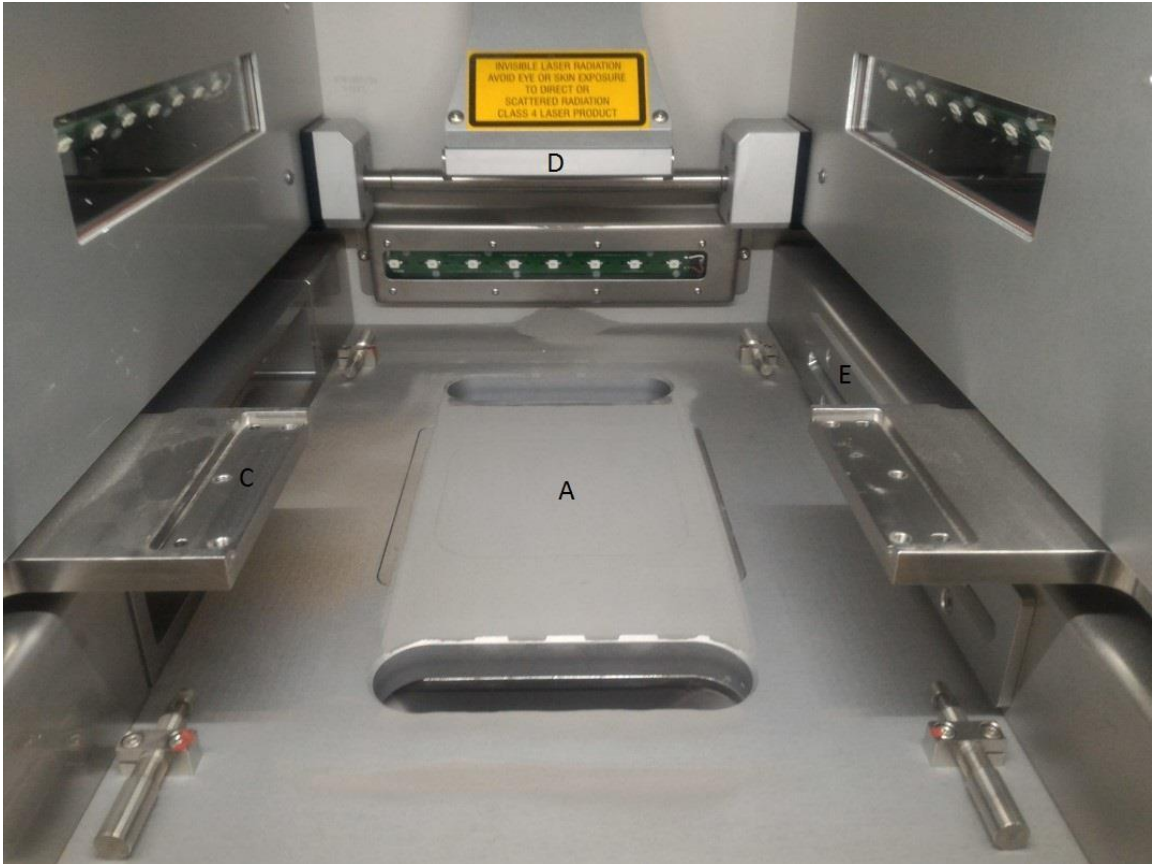
Figure 1. The SLM 125 HL build chamber. A) The build plate and elevator. C) Recoater Carriage. D) Power chute. E) Air flow vents.

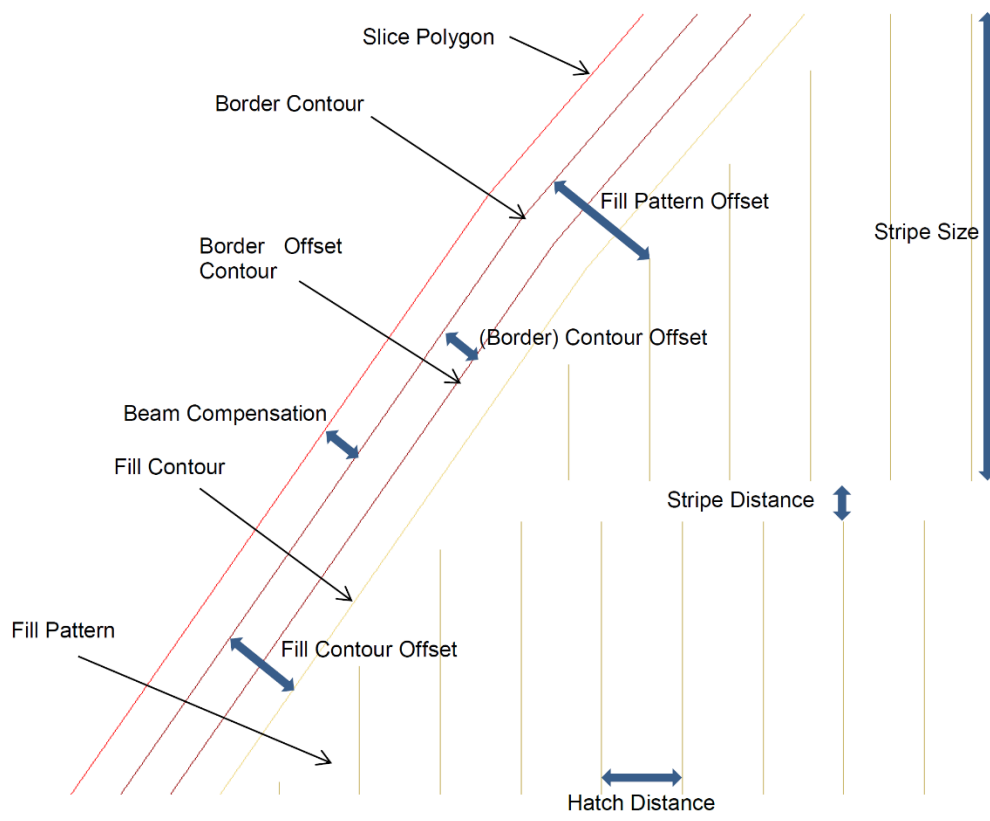
Figure 2. Various scan categories as defined by the SLM Build Processor module.

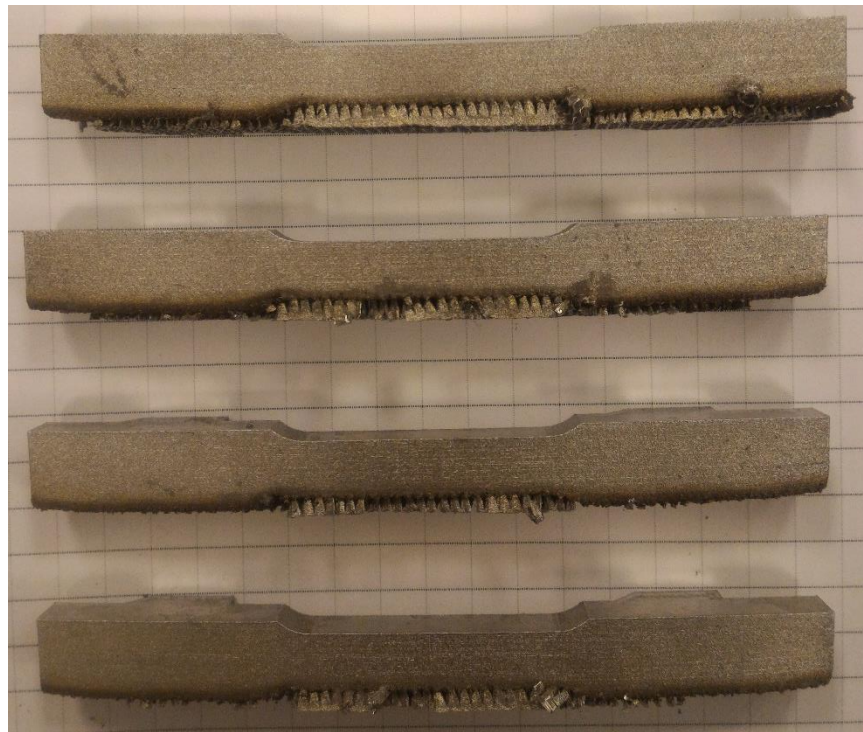
Figure 8. Warped modified tensile bars with burn-in and degradation along the downward facing surface.

The length-wise continuous laser raster inherent to the stripe parameter set resulted in high contractual residual stress on cooling. Subsequently, the high-aspect ratio tensile bars peeled off from the support structures, resulting in significant bowing (Figure 8). In this condition, the bars were too warped to machine to specification, necessitating a different approach.

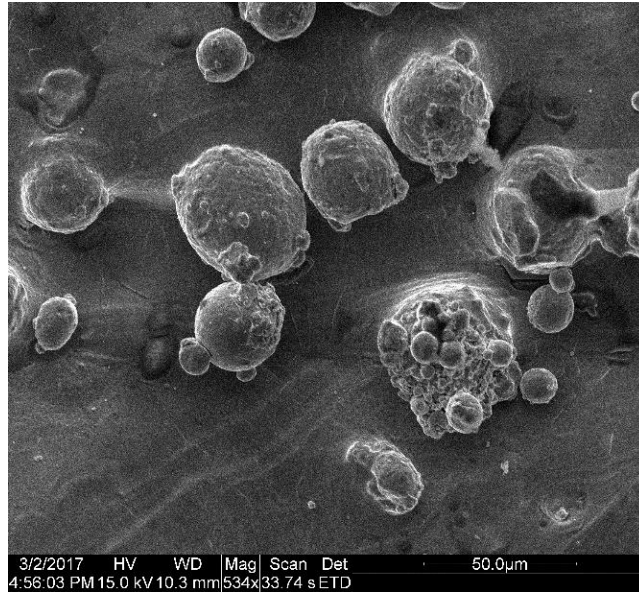
Figure 12. SEM image of particles adhered to the surface of the vertical wall of PAC-A-1.

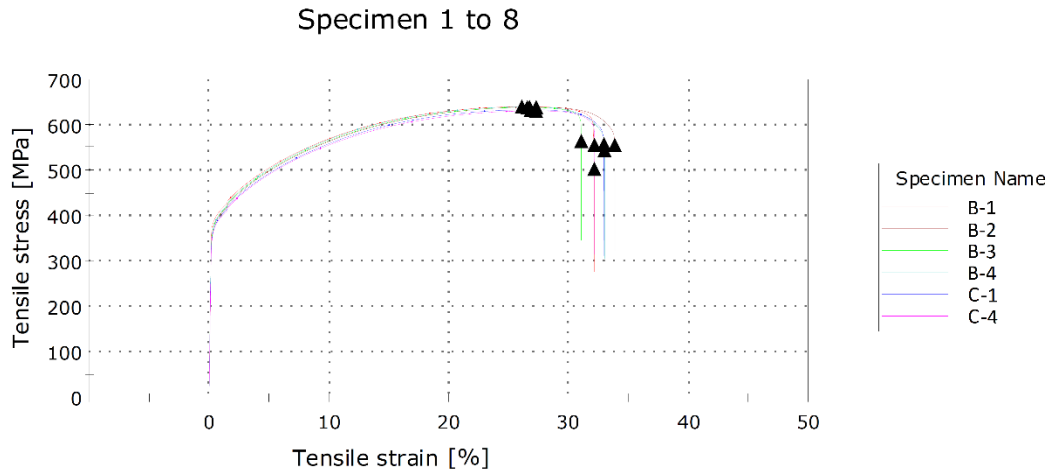
Figure 14. Stress-strain curve of valid tensile specimens.

All Build B specimens and specimens C-1 and C-4 from Build C were mechanically tested without any complications (Figure 14). The strain gauge on specimens C-2 and C-3 slipped during testing, invalidating their mechanical property results. The valid data exhibited low variation, with an average Young's modulus of 207.2 GPa, 0.2% offset yield strength of 375.87 MPa, Ultimate tensile strength of 636.8 MPa, and % elongation of 32.45% (Table 4).

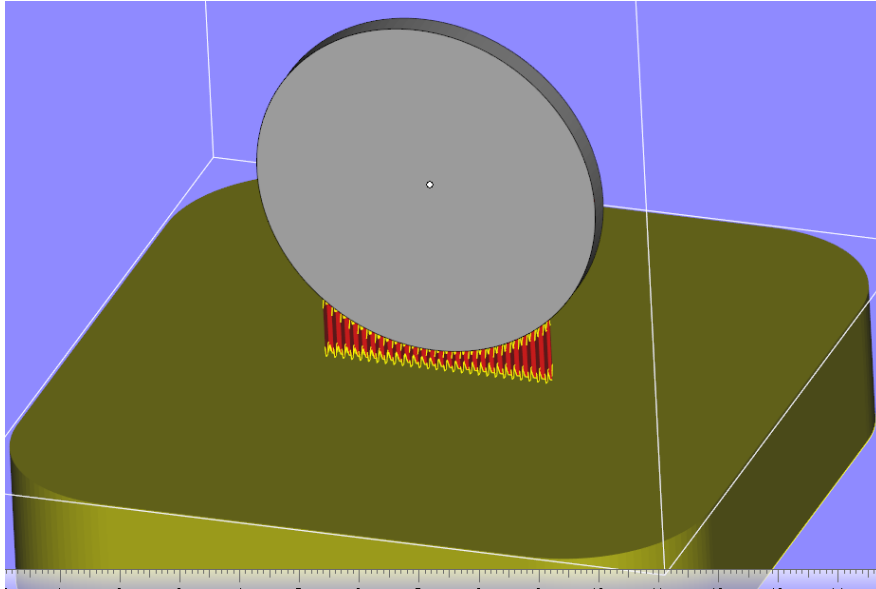
Figure 20. CAD model of the LLNL thin-disk component with support structures depicted in red and yellow. The orientation results in overhanging surfaces along the top and bottom sides of the cylindrical wall.

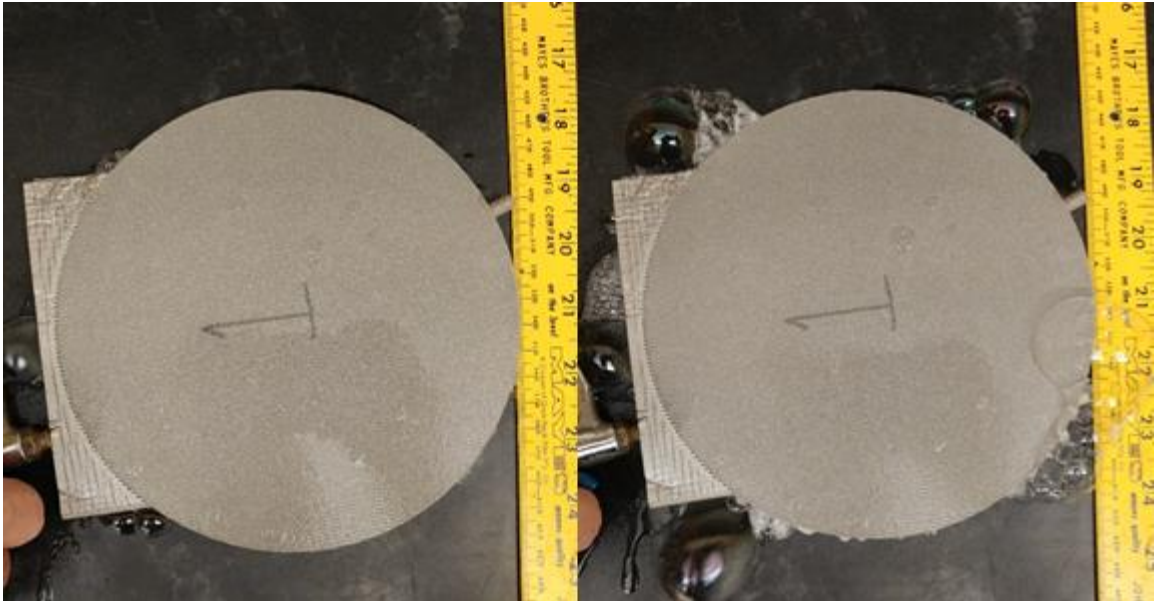
Figure 25. Soap-covered Disk #1 before and after air-pump induced internal pressurization.

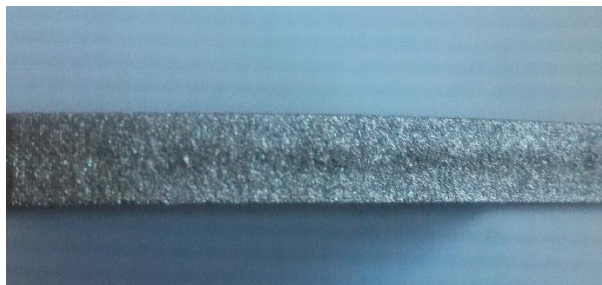
Figure 26. Mid-width dark coarsening on the upper cylindrical wall of Part #1.

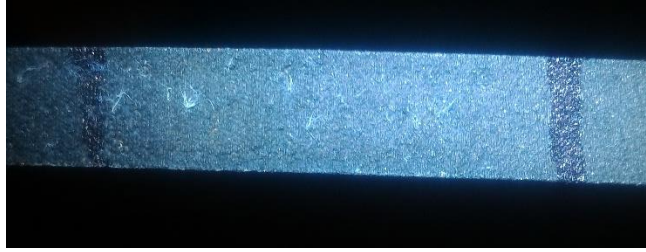
Figure 27. Location of bubble formation on Part #4. The surface lacks any visual indication of defects in the form of through-thickness channels.

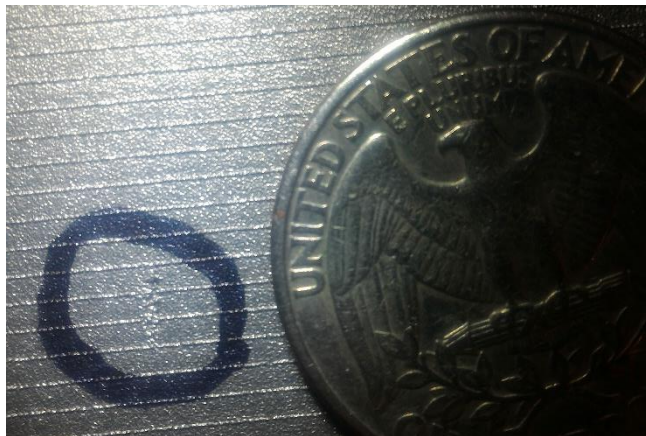
Figure 28. Bubble-forming scratch on the circular wall of Part #4.

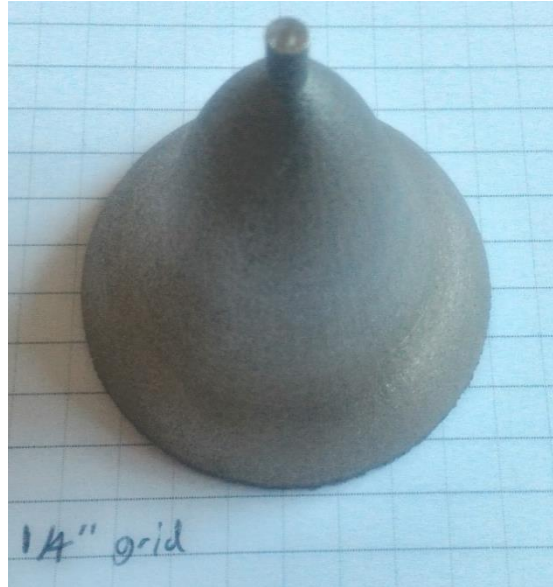
Figure 42. As-printed bell. Minor polygonization from the .stl to .slm conversion process is visible on the surface of the outer bell.

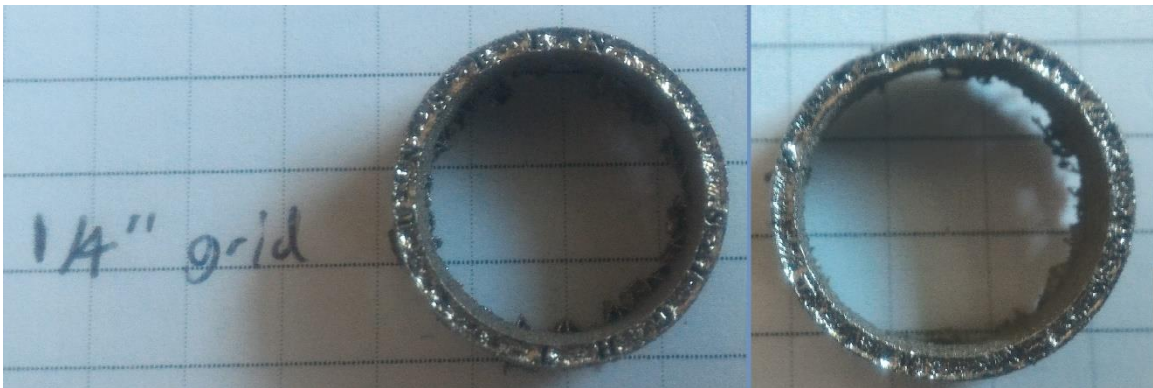
Figure 45. Top-down view of SIGHT UNSEEN (left) and Astrology (right) ring. Poor channel resolution obscures the through-thickness view.

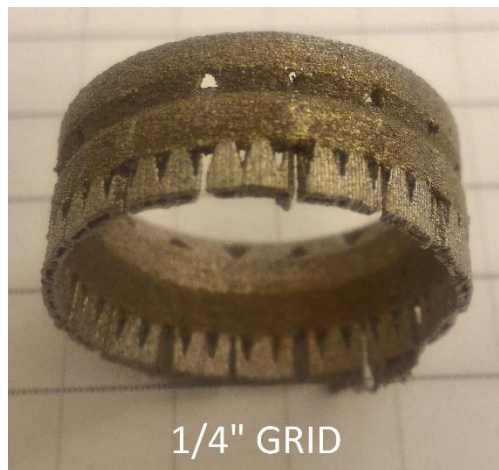
Figure 48. 4-chamfer ring with its central axis aligned with the stay-out region associated with the build plate screw holes. Contour-type support structures depicted in red and yellow.

When the outer face with alternating triangles is oriented to face the build plate in parallel, none of the internal features are less than 45° from the build plate (Figure 48).

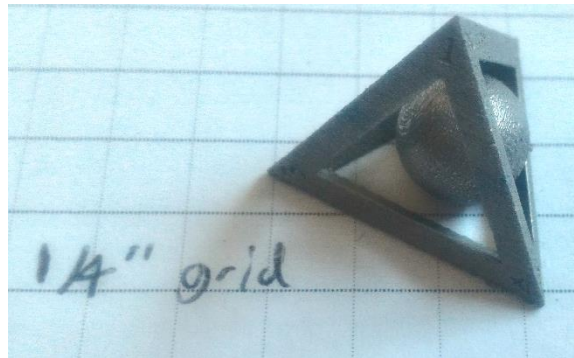
Figure 55. Tetrahedron and Caged Sphere attached to the “Block” type support structure.

The triangular face opposite to the corner labelled with the number “1” was aligned parallel to the build plate (Figure 55). In this orientation, a fraction of the debossed numbers was flagged as overhanging edges. The decision was made to override the default rules and to only generate supports on the downward facing triangular face and the caged sphere with the default “Block” support type. The debossed surfaces of the downward facing numbers were intentionally left unsupported. The part was printed successfully without any design-related complications arising during the SLM process.

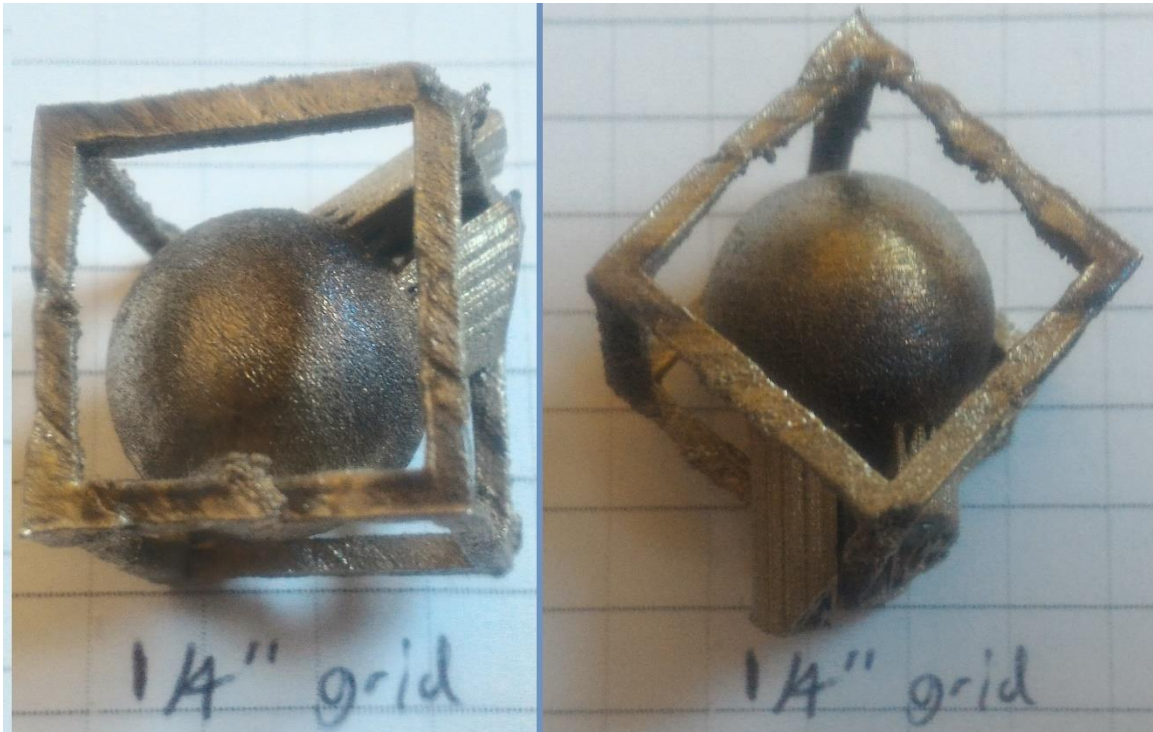
Figure 60. As-printed Cube with Caged Sphere. The effect of poor dimensional resolution caused by early damage to the recoater is exhibited by the cube members.

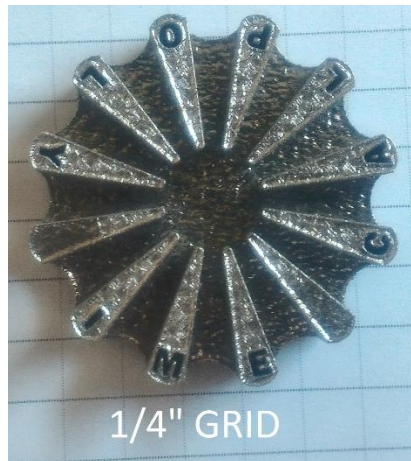
Figure 68. Top-down view of the Magics build plate with 2 IME Radial Card Holder Mementos and 3 IME Strut Card Holder Mementos.

The baseplate bottom surface was aligned parallel to the build plate and supported with the default ‘Block’ support type. Two copies of the component were printed with three other parts in two consecutive prints for a total of four radial card holder mementos (Figure 68). In both prints, the left-side of the print bed in the vicinity of the “IME” lettering had poor powder coverage, resulting in the incomplete formation of the component. Conversely, the right-side component exhibited adequate powder coverage and fabricated successfully in both prints (Figure 69). The cause of this discrepancy will be investigated by SLM technicians in a follow-up visit.

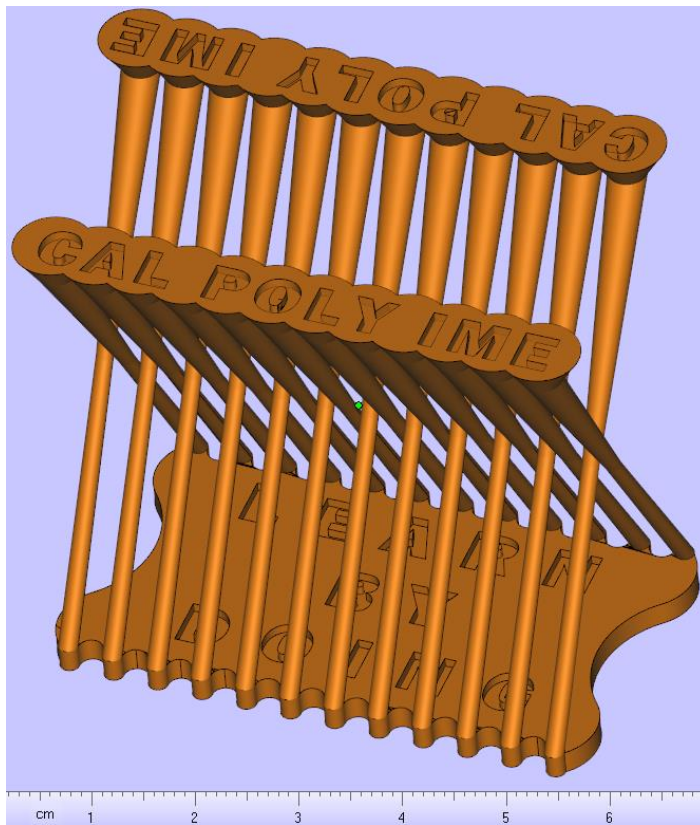
Figure 69. Top-down view of an IME Radial Card Holder Memento printed on the right-side of the build plate.

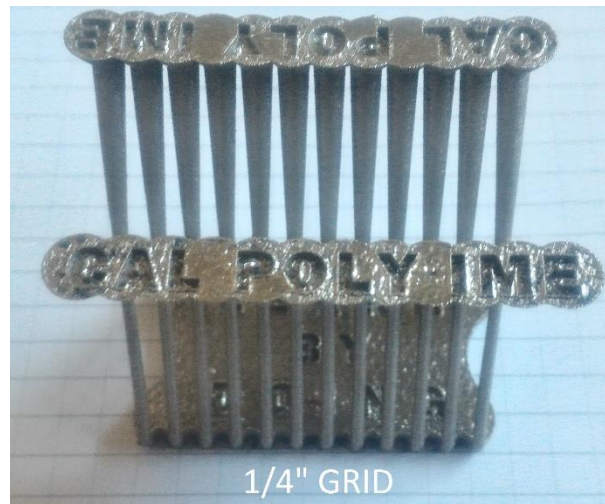
Figure 70. CAD image of IME Strut Card Holder Memento.

A 60 mm x 38 mm x 57 mm card holder consisting of 24 interlocking struts lofted from a 2.5 mm baseplate was modelled in SolidWorks as a secondary hand-out to guests at the LLNL-Cal Poly partnership ceremony on June 2nd, 2017 (Figure 70). The letters “CAL POLY IME” and “LEARN BY DOING” were debossed into the upper strut platforms and baseplate, respectively. The struts are variable in diameter, starting at 2.0 mm at the baseplate to the interlocking mid-length, increasing to 4.0 mm at the base of the platform, and increasing again to 8.0 mm at the maxima of the platform.

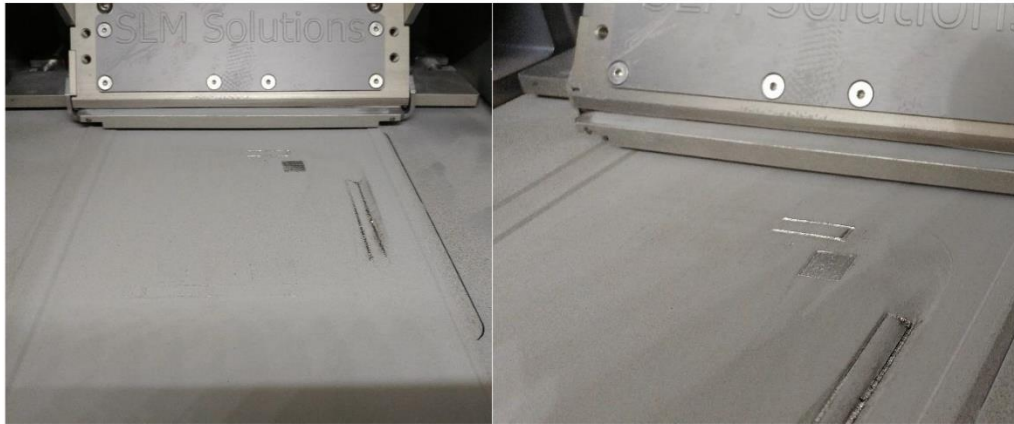
Figure 2. Poor powder coverage on the right side of the plate, affecting the right-side FullScale_QuarterCircle_NoLattice, the far-right rear Tensile Oversized V3, and the right-side of the rear FullScale_QuarterCircle_NoLattice.

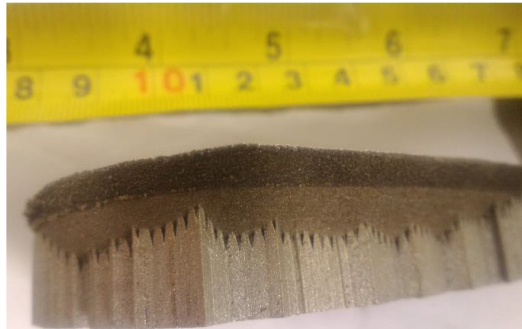
The unfinished NWYControlWedgeFinal shows a distinct change in surface quality at the layer of interruption. The post-interruption surface is darker and rougher than the pre-interruption surface.

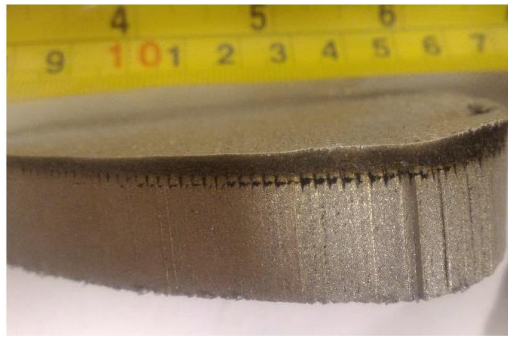
Additionally, the unfinished NWYControlWedgeFinal component shows significant melt layer percolation along the wide edge of the club. The outer surface near the percolation is degraded significantly.

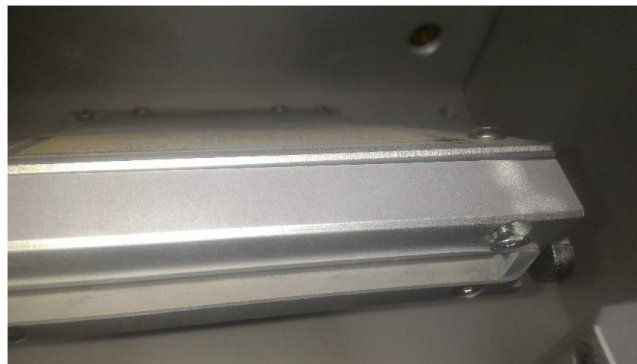
Figure 2. Stick-out of the front-right side powder gate screw that resulted in the obstruction of recoater motion.

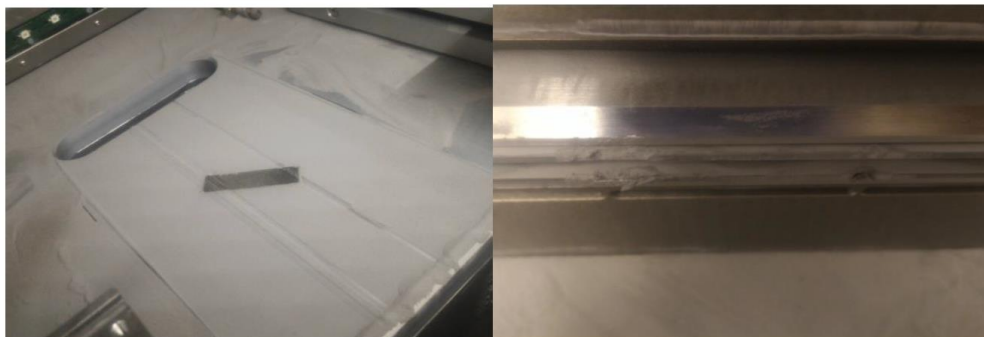
Figure 2. Powder bed tracks and the corresponding damaged recoater blade.

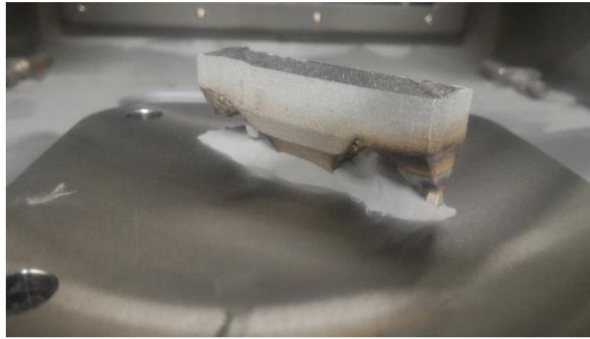
Figure 3. As-printed h_15 component with failed outer legs and burn-in characteristic of poor dimensional stability.

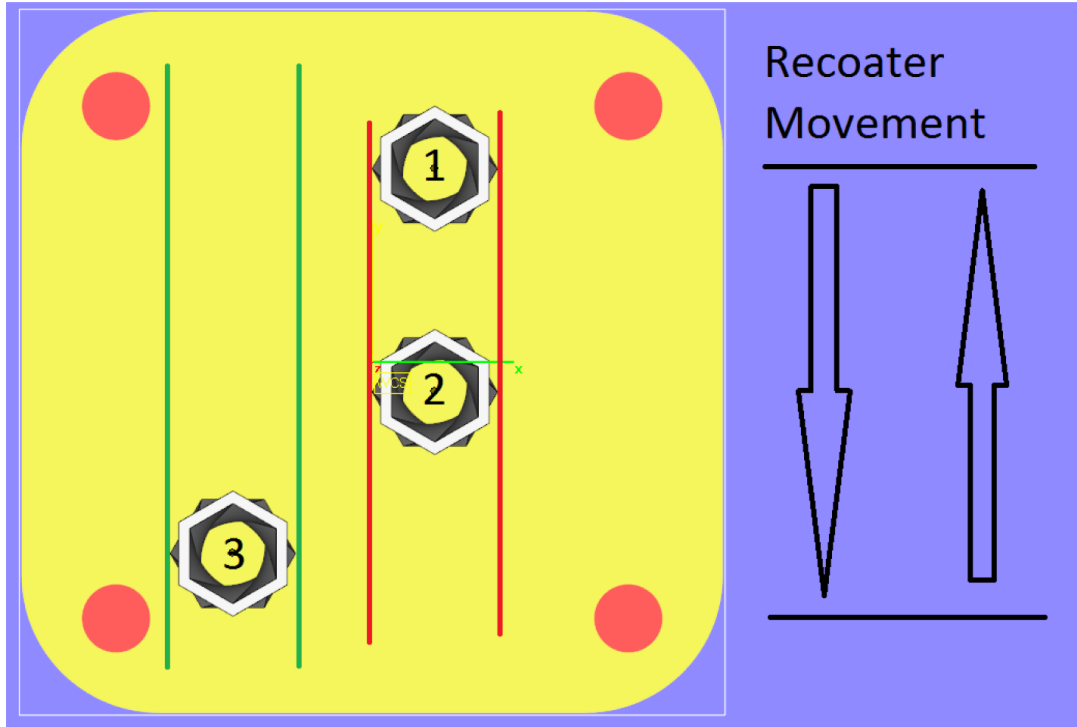
Figure 4. Example of proposed recoater stay-out zone. Component 1 and 2 share the same recoater path (red) and are therefore improperly placed. Conversely, Part 3 does not share a recoater path (green) with any other component and is therefore properly placed.
