The 8th International Conference on
Structural Health Monitoring of Intelligent Infrastructure
Brisbane, Australia | 5-8 December 2017

Project VIMTO: a new system for the vibration and impact monitoring of tram operations

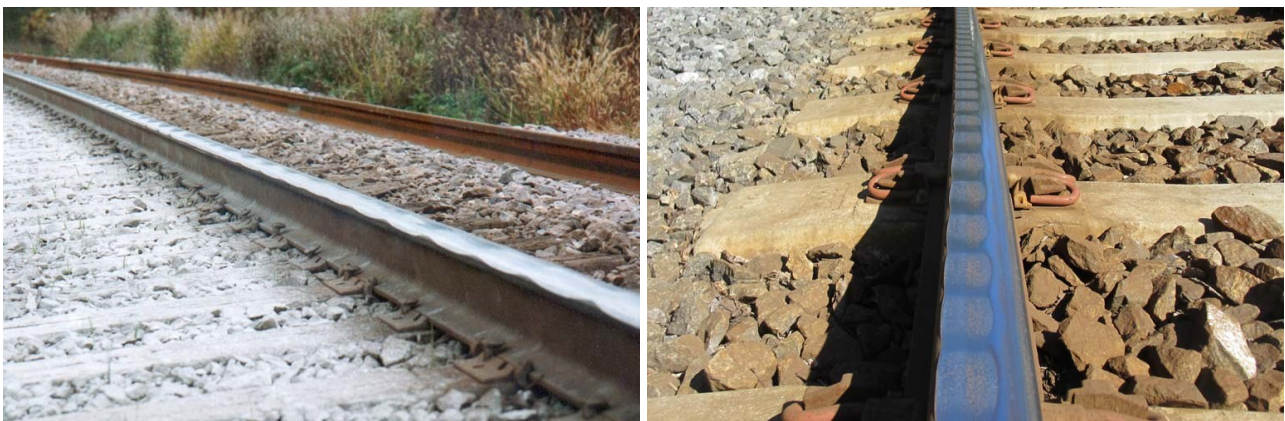
Figure 1: Examples of rail corrugation on mainline track
(Images: RailMeasurement Ltd. Used with permission)

The surface roughness of railway track increases during service. Along with other forms of deterioration, such as settlement at rail joints, this leads to an increase in the level of vibration and wheel-rail impacts generated as a vehicle runs along the track. From its origin at the wheel-rail interface, vibration propagates through the track structure, through the ground and into buildings, where it may then cause disturbance as perceptible vibration and/or re-radiated noise (Lang 1988, Howarth & Griffin 1991, Talbot 2013). A particular concern can be the development of corrugation (Figure 1), a short-wavelength irregularity (typically 20 mm to 200 mm) that forms along the rail head and leads to particularly severe, tonal noise due to the periodic wheel-rail interaction (Grassie 2009).

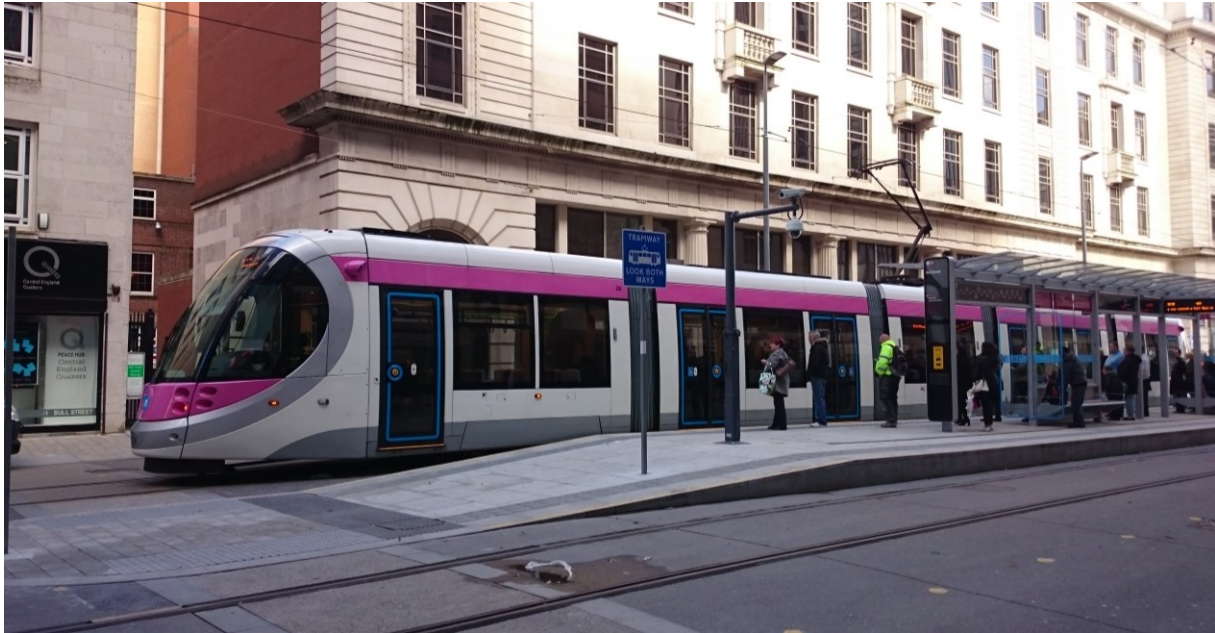
Figure 3: A CAF Urbos 3 Tram at the Bull Street tram stop
(Image: Jennifer Schooling. Used with Permission)

Since September 2014, the system has operated a fleet of CAF Urbos 3 trams (Figure 3), providing a service of 10 trams per hour in each direction. The trams are 33 metres long and consist of five modules with four articulations, three of the modules being mounted on bogies and the other two modules being suspended. The maximum operating speed of the trams is 70 km/h.

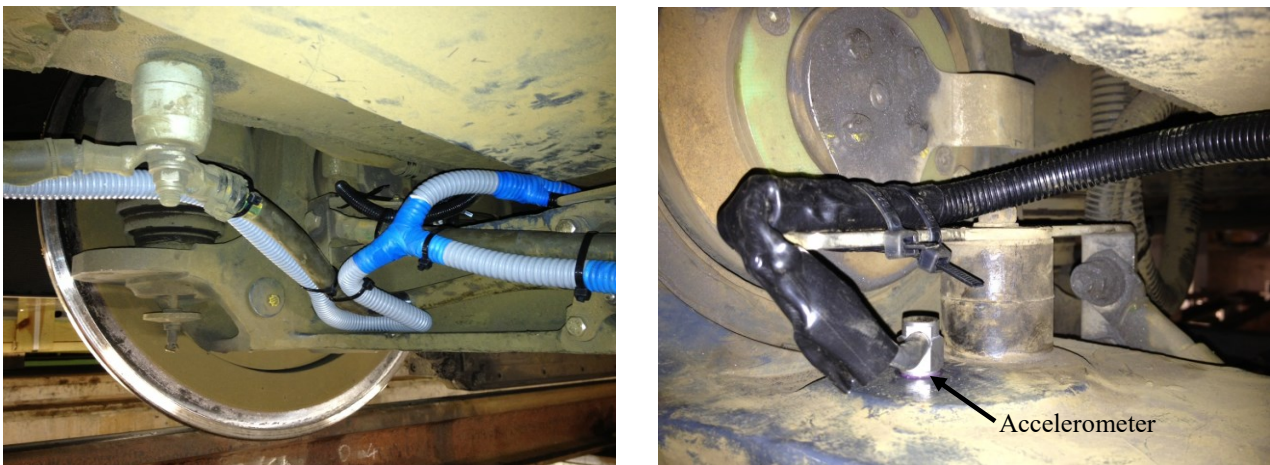
Figure 6: Accelerometer cabling (left) and location (right) on the axle bridge of the trailer bogie

During an initial visit to the tram depot, a cabinet in one of the two driver's cabins had been identified as a suitable location for the data acquisition unit. Installation of the monitoring system on the tram took place over a number of visits to the depot between November 2015 and July 2016. The cable installation took place on 5th November 2015, when four coaxial cables for accelerometers P1-P4 were routed to the power bogie behind the driver's cabin. A further three coaxial cables and the 4-core cable for the CAF speed sensor were routed over the roof of the tram, past the two intervening articulations and then down to the trailer bogie. All cabling was routed within fire-resistant flexible trunking (Figure 6) and is hidden from view, whether under the tram, within cable runs inside the tram cowlings or along the roof.
