# A Novel Non-Destructive Sensing Technology for On-Site Corrosion Failure Evaluation of Coatings

**ABSTRACT** The quality of coating and the resulting rate of corrosion of the underlying metal substrate can be measured by a variety of corrosion measurements (Tafel, Electrochemical Impedance Spectroscopy) by using standard laboratory electrochemical cells. However there is always a need of low cost, portable and non-destructive electrochemical cells which can be used on-site field for condition monitoring of large structures for example bridges and large infrastructures, complex operating systems as aircrafts, precision machines, petrochemical processes, automotive and locomotives. This research has developed state of the art cells fabricated by using a special magnetic aluminium compound ( $Al_nX_n$ ) which is highly electrically conductive and corrosion resistive. The research has commissioned for deploying this novel sensing technology for micro-defects detection, corrosion rate measurement and condition assessment of the defected coatings. Tafel measurement facilitated by these non-destructive cells is used to detect micro-defects and corrosion rate measurement while Electroch

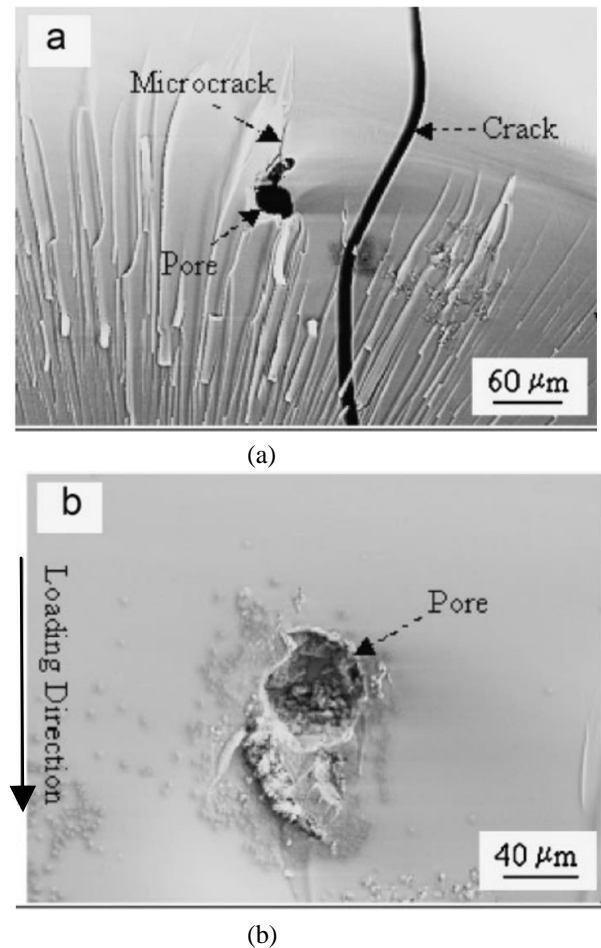
**FIGURE 1.** SEM fractographs demonstrating (a) a pore-like flaw, micro-crack, and crack on the fracture surface, and (b) a pore-like flaw, which resulted in macroscopic splitting failure under compression [3]

or exposure to an unanticipated environmental excursion [1]. During its service life, the coating undergoes changes in mechanical properties leading to formation of micro-defects including both pores and/or micro-cracks which upon mechanical and/or thermal loading subsequently propagate and expose substrate to atmospheric moisture and oxygen as shown in Fig. 1. This action results in accelerated dis-bonding of the paint and flake formation from the coating-substrate interface [2]. Fig. 1 shows the

pore-like defect in a polymeric coating. In Fig. 1 (a), a micro-crack can be seen that initiated from a pore and propagated a short distance [3]. These cracks typically propagate roughly parallel to the loading direction. Thus, macroscopic splitting failure under compression likely result from pores (Fig. 1 (b)). For practical applications, it is desirable to deposit continuous, defect-free coatings to achieve optimal performance.

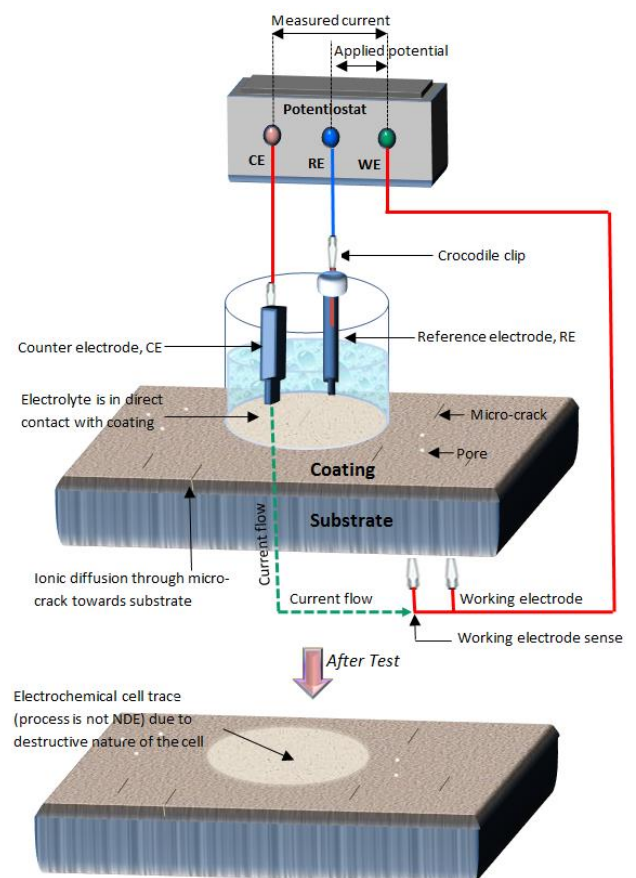
FIGURE 2. Schematic diagram for standard electrochemical cell setup for performing the electrochemical analysis of coating.

A typical electrochemical setup for coatings consists of an electrochemical cell and a potentiostat. In testing practice, a standard electrolytic cell (the system under investigation) is setup consisting of an electrolyte, a reference electrode (RE), a counter electrode (CE), working electrode sense (WES) and the coated sample of interest as shown in Fig. 2. The coated sample is called the working electrode (WE) and can be seen to possess micro defects providing the pathways for corrosive ionic species towards the substrate. The WES is required when measuring currents in excess of 200mA. All the electrodes are connected to an electronic instrument called as potentiostat. The potentiostat applies the potential and analyses the response of the system to determine the electrochemical response of the system. The reference and counter electrodes are placed in the electrolyte, generally a solution that most closely resembles the actual application environment of the material being tested.

The complete cell is placed above the coated sample (working electrode) such that the electrolyte comes in contact with the coated side of sample.

The most basic form of the cell has two electrodes (2-electrode configuration) as shown in Fig. 3 (a). The potentiostat cell cables WE+WES leads are connected together to working electrode and cell cable CE+RE leads are connected to counter electrode as there is no reference electrode. It is also used in measurements of electrochemical measurements at high frequencies (> 100 kHz), especially when the thickness of coating is very large or coating is in very good condition (defect free - ideal) [20]. A three-electrode configuration for an electrochemical cell is most common for typical electrochemical applications. The cell cables WE+WES leads are connected together to working electrode however due to the addition of reference electrode cell cable CE connects to counter electrode and cable RE connects to reference electrode. A third additional electrode (the reference electrode) is used to determine the potential across the electrochemical interface accurately as shown in Fig. 3 (b). Such setup gives reliable results for damaged coatings which poses large defects [20]. Cell schematic in Fig. 2 is a three electrode configuration [20].

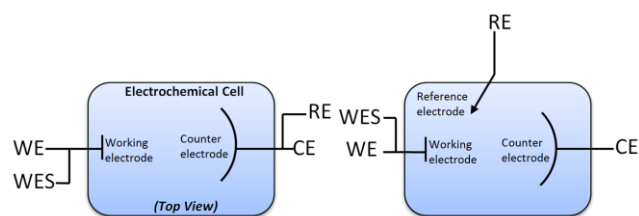
FIGURE 3. Schematic overview of the (a) 2-electrode setup (b) 3-electrode setup

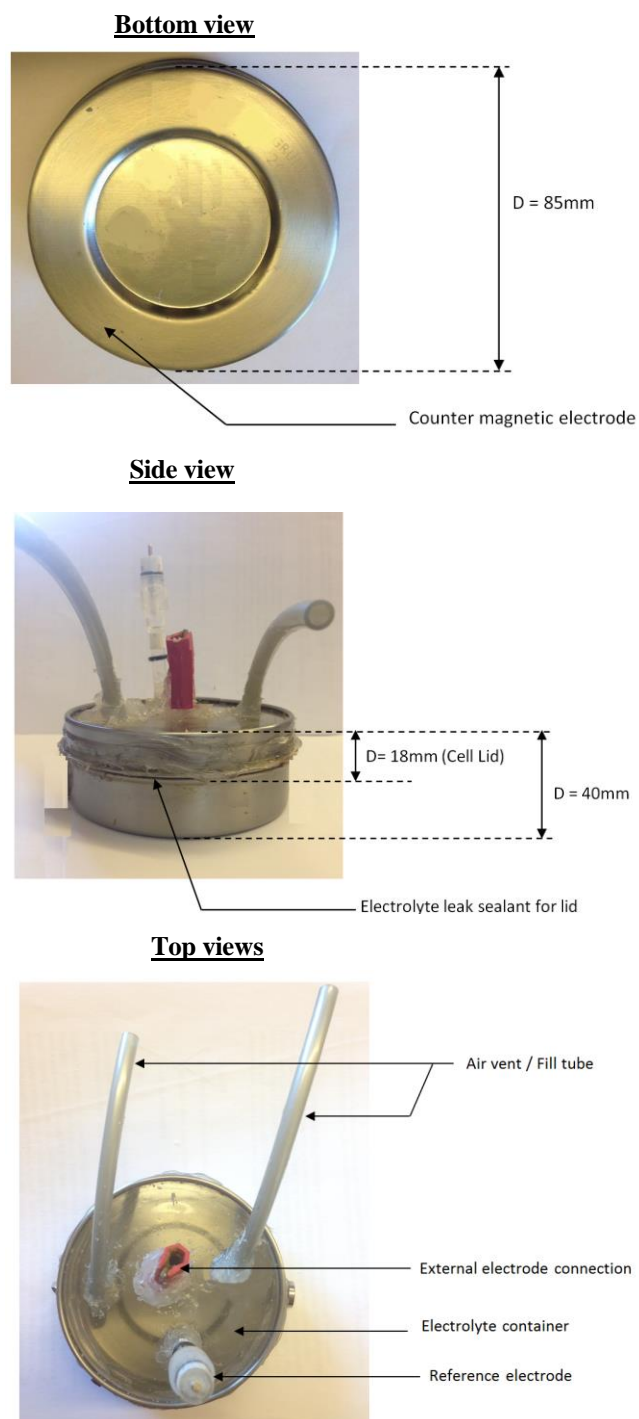
FIGURE 4. Bottom view, side view and top views of portable electrochemical cell (PEC)

The PEC system unlike standard electrochemical cell is a portable cell with a magnetic body which can be attached to any horizontal, vertical and upside down metal object. In this way the object constitutes the bottom of the PEC and the object itself can be used as an electrode. The cell can be filled with the electrolyte (3.5% NaCl solution) by using a tube that leads directly into the cell. A similar tube allows air to escape to ensure a completely filled cell in order to prevent air pockets inside the cell compartment. The inlet filling tube is positioned in a way such that it is always lower in level compared to outlet/ air vent tube. Another purpose of inlet and outlet tubes is for cleaning the cell by flushing the used electrolyte out and filling it with fresh electrolyte. PEC design does not allow the electrolyte to come in direct contact with the coating due to magnetic aluminium compound  $Al_nX_n$  base of cell which ensures non-destructive monitoring of coating condition.  $Al_nX_n$  has been specifically chosen for fabricating PEC to obtain optimum corrosion monitoring data due to its exceptional electrical-conductive and corrosion resistance properties.  $Al_nX_n$  is prepared by doping aluminum with ferrite nanoparticles [36].

There are two main parts of PEC: (i) the bottom and (ii) the cell lid. The circular bottom of PEC consists of  $Al_nX_n$  area which constitutes the counter electrode as shown in Fig. 4 (bottom view).  $Al_nX_n$  electrode is magnetic which allows the cell to be easily placed on the metal surface. From bottom to top this consists 2 layers: the  $Al_nX_n$  container and the cell lid (side view). The  $Al_nX_n$  container holds the electrolyte such that the container is tightly sealed to the lid using silicone gel to avoid any electrolyte leakage. The reason for selecting  $Al_nX_n$  as a counter electrode is its light weight, corrosion resistance and high electrical conductance especially for sensing  $\mu$ Amp and PicoAmp corrosion currents for high impedance coatings (defect free). The top lid holds the electrode connector, 2 filling holes and a reference electrode. The reference electrode is placed near the counter electrode for accurate measurement. Saturated calomel was used as the reference electrodes.

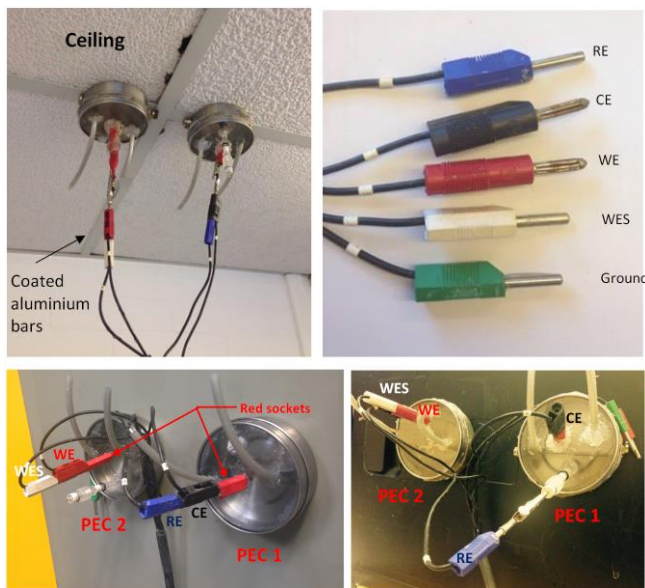
**FIGURE 5.** The top left image shows the corrosion monitoring of steel coated ceiling bar. The top right image shows the type of leads. Two PEC are being used together for analysing the condition of coating in a two electrode configuration in top right and three electrode configuration in bottom left. This non-destructive system is able to detect the micro-defects over the large surface area of coating.

as counter (or working) electrode. This object can be both coated and an uncoated structure. For non-destructive testing of coated object (without damaging the coating), an additional PEC is used as a second electrode which works in combination with the first PEC. This combination allows the condition monitoring of large coated structures with no possibility to reach the metal substrate. The two PECs in combination can work both in 2-electrode and 3-electrode configuration by using the leads shown in Fig. 5 (top right).

Fig. 5 (bottom left) shows the two electrode configuration in which the base metal cannot be accessed, the potentiostat cell cable CE+RE leads are connected together to the stainless steel electrode of PEC1 (red socket). The potentiostat cell cable WE+WES leads are connected together to the stainless steel electrode of PEC2 (red socket). In the shown 2-electrode connection no reference electrode is used. However, if reference electrode is used to form a 3-electrode configuration, a reference electrode in PEC 1 is connected by using cell cable RE lead as shown in Fig. 5 (bottom right). The cell cable CE lead is connected to counter electrode in PEC 1 while cell cable WE+WES leads are connected together to the working electrode of PEC 2.

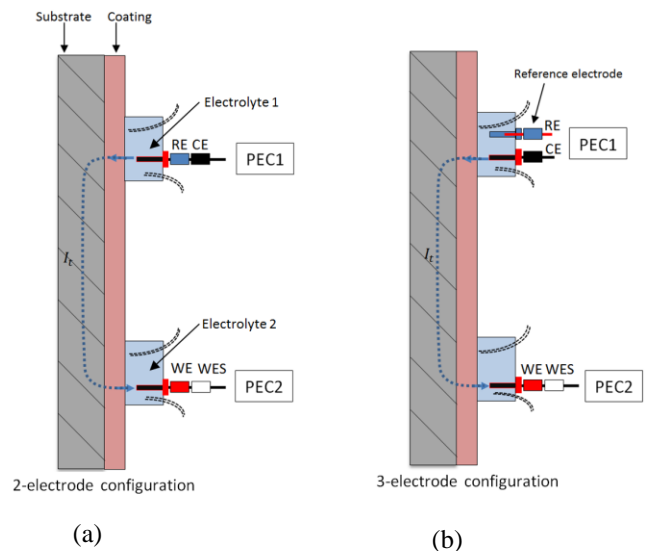
**FIGURE 6.** Schematic representations of (a) 2- electrode configuration PECs and (b) 3- electrode configuration PECs

The above setup shown in Fig. 6 and 7 can only monitor the condition and detect pores in the coating area which is directly under the PEC. This is because that only the coating area which is directly under the PEC acts as a conductive region for the current  $I_t$  between the counter electrode and metal substrate. The pores which are not located under the PEC will not be detected. In order to detect such pores an alternative conductive path (path 2) is needed between the electrode of PEC and the substrate such that the current can flow from electrode to pore and then from pore to substrate via path 2 as shown in Fig. 8 (a). Path 2 is created by

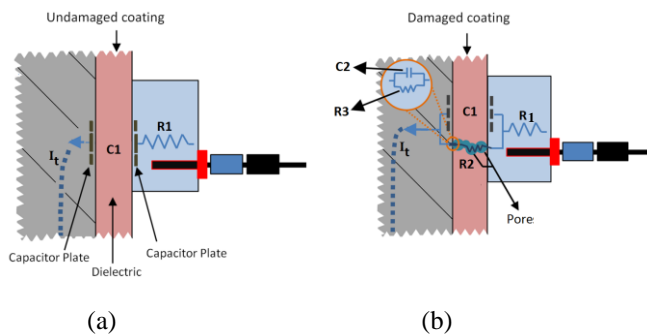
FIGURE 7. Equivalent circuit in 2-electrode configuration (a) undamaged coating (b) damaged coating

A metal covered with an undamaged coating generally has very high impedance resulting in negligible current  $I_T$  flow mostly in PicoAmp as shown in the equivalent circuit in Fig. 7 (a). The model includes a very high resistor R1 (due to electrolyte resistance) and a very low coating capacitance C1 in series. In the case of a coated metal in contact with the electrolyte through PEC's counter electrode (at bottom), the substrate metal is one plate, the coating is the dielectric, and the electrolyte in PEC is the second plate as shown in Fig. 7 (a). The coating capacitance relationship is [37]

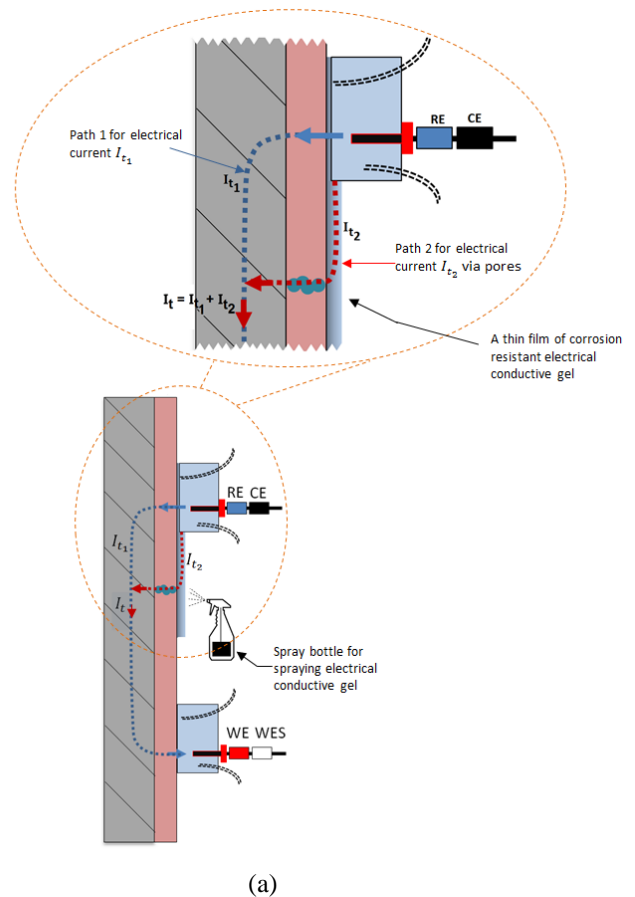
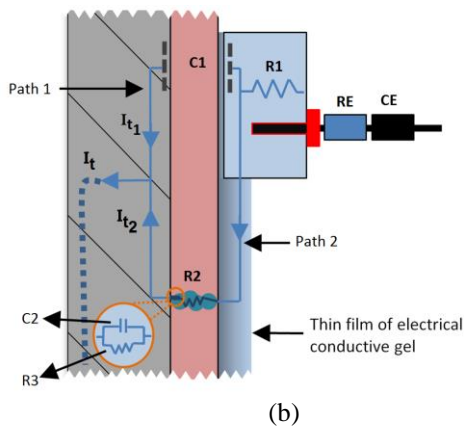
**FIGURE 8.** Schematic showing that the (a) large sized pores have smaller R2 which accounts for large current  $I_{t2}$  (b) the magnitude of current  $I_{t2}$  through path 2 increases with the number of pores 'n' in this path.

uniformly spraying a thin film of easily removable, non-reactive corrosion resistant electrical conductive gel on coating, which comes in contact with the pores forming a closed path between counter electrode and substrate. After the gel has been sprayed, there will be two parallel paths: path 1 and path 2. Path 1 is via undamaged coating region therefore it has very high impedance resulting in negligible current flow  $I_{t_1}$  while path 2 contains pores causing low impedance which results in large current flow  $I_{t_2}$  as shown in Fig. 8 (b). The net current  $I_t$  which flows between PEC 1 and PEC 2 is given as:  $I_t = I_{t_1} + I_{t_2}$ .

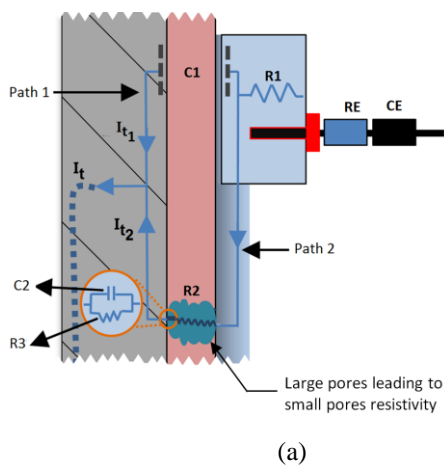
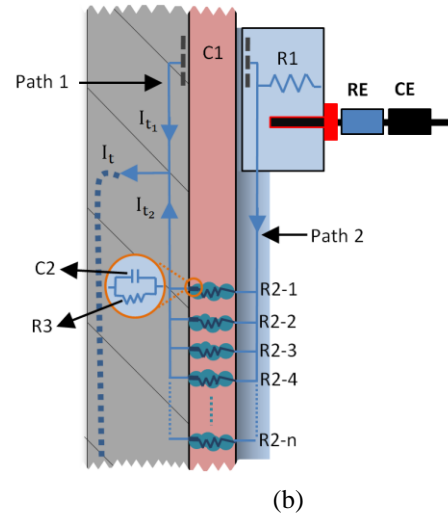
**FIGURE 9.** Schematic showing that the (a) large sized pores have smaller R2 which accounts for large current  $I_{t2}$  (b) the magnitude of current  $I_{t2}$  through path 2 increases with the number of pores 'n' in this path

The magnitude of current  $I_{t2}$  which flows through path 2 depends on the pore resistivity R2. Smaller R2 (meaning large sized pores) accounts for large current  $I_{t2}$  which increases the net current  $I_t$  and vice versa as shown in Fig. 9 (a). Similarly the magnitude of current  $I_{t2}$  through path 2 depends on the number of pores 'n' in this path, each pore having resistance R2-1, R2-2, R2-3 up to R2-n respectively as shown in Fig. 9 (b). The larger the number of pores, the larger is the current  $I_{t2}$  which consequently results in larger net current  $I_t$  as show in Fig. 9 (b).

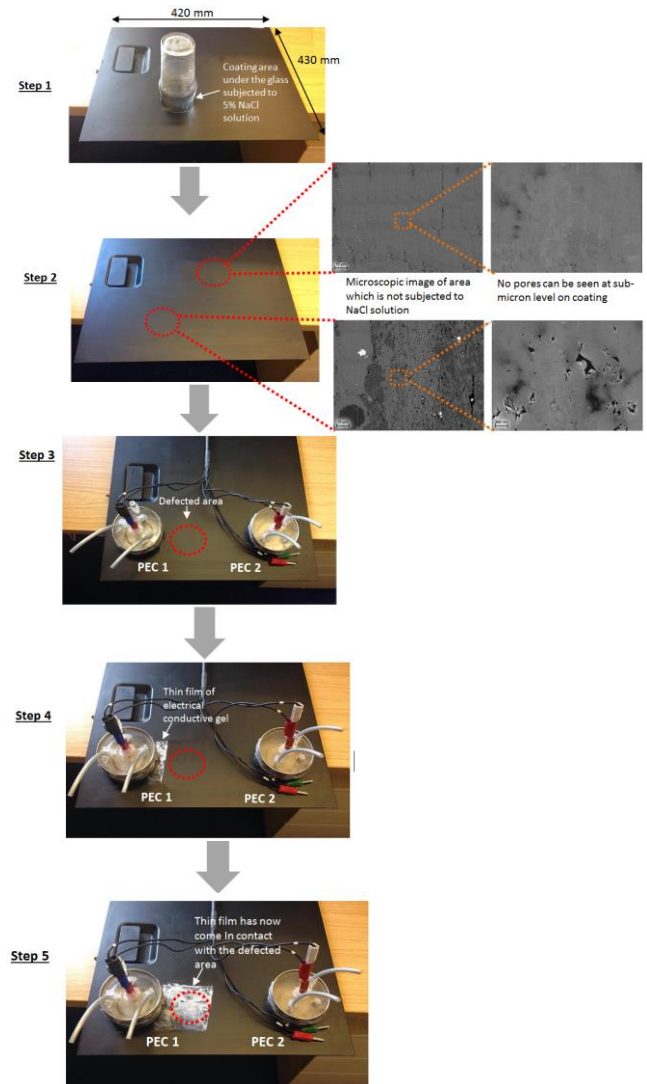
FIGURE 10. The five step experimental study performed to analyse the working of PECs

A five step experimental study was performed by using a 420mm x 430mm aluminium sample coated with polymeric epoxy resin in black as shown in Fig. 10. The equivalent weight and density of aluminium are 26.9g and 2.7 g/cm<sup>3</sup> respectively. For the most part, epoxy coatings are used as functional coatings for substrate protection where corrosion resistance, impact resistance, and adhesion are essential. This coating is normally used in industrial equipment, automotive components, metal furniture and appliances [39]. The objective of this experiment was to detect invisible micron and sub-micron level defects (pores) and to determine the condition of defected coating by using a custom developed PEC.

In the first step, a selected area on the coated sample was subjected to 5% NaCl solution for 72 hours as shown in Fig. 10 (step 1). This process was performed to degrade the specific area of coating under the glass which resulted in the opening of pores in the coating. In step 2, the microscopic analysis of the subjected area was performed which was compared with the microscopic images taken from the non-subjected area of coated sample. In step 3, the two PECs were installed on the sample in 2-electrode configuration. In next step 4, a thin film of corrosion resistant electrical conductive gel was sprayed on coating by using a precise gel coat spray gun. The gel is non-corrosive, non-reactive and can easily be removed by using a dry wipe. The gel was sprayed in a stepwise manner such that the coverage area of gel was slowly increased until it incorporated the degraded area beneath it. At the same time the Tafel scan was also performed, in which the potential on counter electrode was increased from -3 V (E start) to +3 V (E end) which resulted in the corresponding change in net current  $I_T$ . The scan rate (from -3 to +3V) was set to a low value of 20 mV/sec which resulted in large scan duration giving enough time to increase the coverage area of gel gradually. In step 5, as the conductive gel came in contact with the degraded area it resulted in the formation of a closed path (path 2) between the counter electrode of PEC 1 and the substrate. It is at this specific instance that the sudden rise in  $I_T$  is observed in the form of large trough in I - E graph indicating the location of defected area on coating.

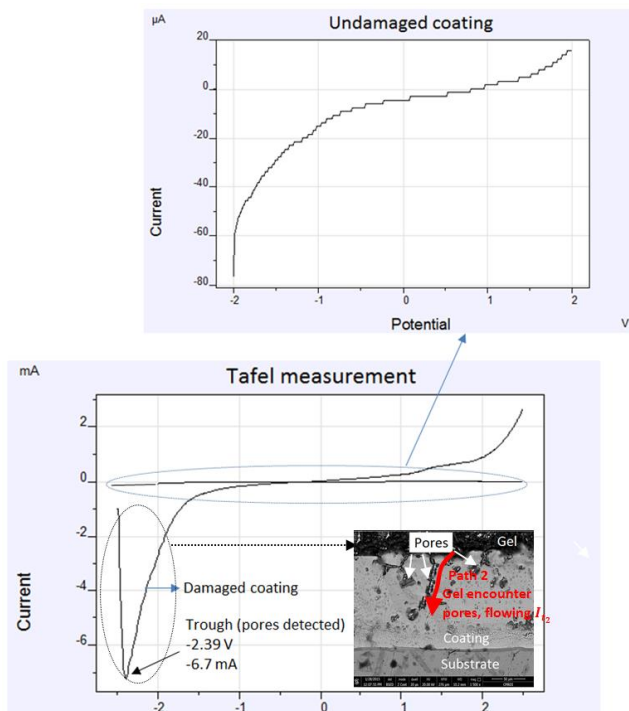
FIGURE 11. Tafel measurements for both the damaged (bottom graph) and undamaged (top graph) coatings. The graph for the damaged coating shows the trough which indicates the detection point of pores on damaged coating during Tafel scanning.

From the above experimental setup, the results are shown in Fig. 11 below. It can also be seen from the trend of damaged coating that the Tafel scanning was performed from -3 V to +3V at the same time when the coverage area of gel was increased by spraying (as depicted in steps 4 and 5 of Fig. 10). As the coverage area was increased during

scan, the gel encountered the pores at  $E = -2.39V$  which resulted in the sudden drop in net current  $I_t$  to a level  $-6.7$  mA and then the subsequent exponential rise in  $I_t$ . This sudden drop and rise in  $I_t$  was observed in the form of a trough, indicating the detection point of pores. The exponential rise in  $I_t$  is associated with the formation of low impedance conductive path 2 through pores resulting in large current flow  $I_{t2}$ . The cross-sectional microscopic image of coating-substrate interface on the right of graph shows the instance when the gel encountered the pores and resulted in the formation of a trough due to development of path 2 causing large current flow  $I_{t2}$ .

Comparison between the Tafel measurements from damaged (after NaCl exposure) and the undamaged (prior to NaCl exposure) coating can also be seen in the graph. Undamaged coating possesses only one high impedance path (path 1) for current flow  $I_{t1}$ , therefore the magnitude of net current  $I_t$  is extremely small, mainly in  $\mu A$ 's as can be seen in Fig. 11. However, damaged coating possesses two paths (path 1 + path 2), therefore, the magnitude of net current  $I_t$  is high because of the formation additional low impedance path 2 (due to presence of pores) eventually adding more current:  $I_t = I_{t1} + I_{t2}$ , mainly in mA's. It can also be seen that for damaged coating the current reached to maximum peak current of 2.4 mA which is certainly very high current indicating the presence of low resistive large sized pores within the damaged area.

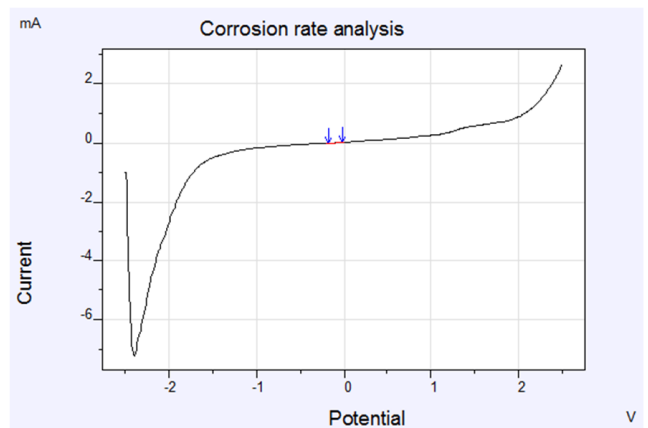
FIGURE 12. Measurement of corrosion rate by using ‘slope analysis’ approach.

At first, the ‘slope analysis’ was performed as shown in Fig. 12. Slope analysis identifies the corrosion potential and the polarisation resistance  $R_p$  at the zero current intersection point. The calculated quantitative results ( $E_{corr}$ ,  $I_{corr}$ ,  $R_p$  and C Rate) from slope analysis can be seen under the ‘Pol Res’ column of table in Fig. 13.

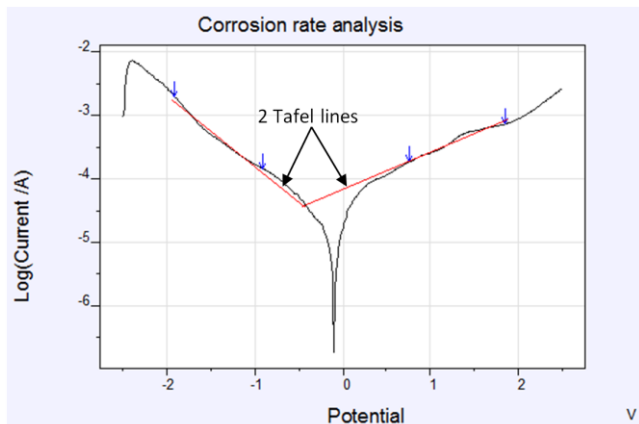
FIGURE 14. Measurement of corrosion rate by using ‘tafel analysis’ approach.

The ‘Tafel analysis’ was performed on the damaged coating to calculate the corrosion parameters from the 2 Tafel lines as shown in Fig. 14. The calculated quantitative results from Tafel analysis are shown in the second column of table ‘Tafel data’. Further the corrosion parameters were calculated with a numerical analysis of the available data by using ‘Model analysis’ as shown in Fig. 15. Model analysis utilises the material constants i.e. surface area, equivalent weight and density (already identified in previous section) to calculate the corrosion data. The Model analysis is expected to yield the best results in most cases, because it applies the complete Butler-Volmer to the full data range therefore model data results are most reliable compared to slope analysis and Tafel analysis.

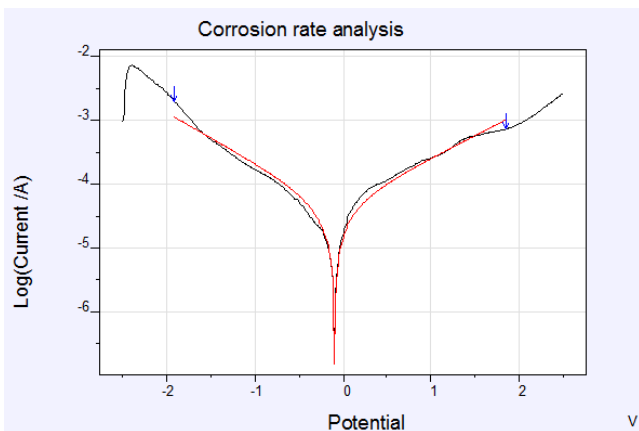
FIGURE 15. Calculation of corrosion rate by using ‘Model analysis’ approach.

Comparing the corrosion parametric values obtained from all three approaches (Table in Fig. 13) shows a minute difference in the values of certain parameters. The analysis of  $R_p$  shows values close to one another in between 0.0652 and 0.0674 Ohm for all three approaches. Likewise corrosion rate shows values in between 0.2188 and 0.3867 mm/y. The table also identifies and compares the values of Tafel constants ( $b_a$ ,  $b_c$ ),  $I_{corr}$  and  $V_{corr}$ .

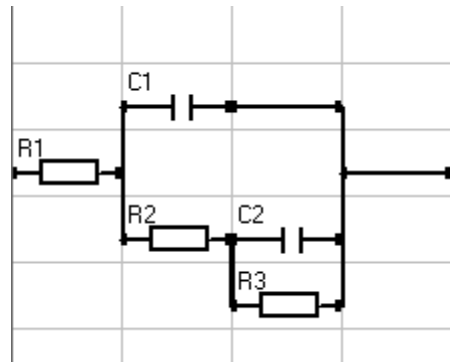
FIGURE 16. Equivalent circuit for the damaged coating

Once the defected area and the corrosion rate of the damaged coating sample has been determined by using Tafel measurement (after performing all five steps), an EIS measurement was done on the same damaged sample in a 2-electrode configuration. The EIS scan was performed between 0.06 Hz start and 1MHz end frequency with 20mV amplitude and  $E = 0V$  vs. OCP (Open Circuit Potential). EIS measurement was performed to determine the parametric values ( $R_1$ ,  $C_1$ ,  $R_2$ ,  $C_2$  and  $R_3$ ) in the equivalent circuit shown below (Fig. 16) by using various plots for example Bode, Nyquist plots. Fig. 16 shows the circuit for the damaged coating accepted by most coating researchers.

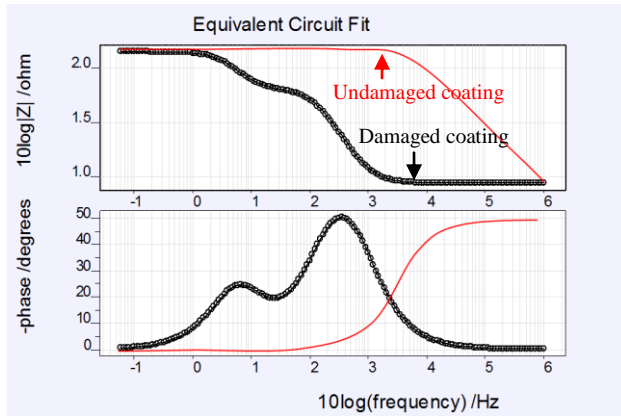
FIGURE 17. Bode plot for the damaged and undamaged coating

The bode plot for both damaged and undamaged coating samples are plotted in the same graph in Fig. 17. It can be seen that initially at low frequency i.e. 0.06Hz ( $10\log f/Hz = -1$ ), the corresponding impedance ( $10\log |Z|/Hz$ ) for both damaged and undamaged coating stayed high till  $10\log f/Hz = 0.2$ . After this point the impedance for damaged coating drastically decreased while for the undamaged coating it still sustained to the same level as before till  $10\log f/Hz = 3.8$  was achieved which is very high frequency. Similarly, for damaged coating the corresponding phase angle reached to a high level just after start while the corresponding phase angle for undamaged coating remained low till it reached a high frequency of  $10\log f/Hz \approx 2$ . Therefore it can be concluded that the undamaged coating has greater ability to sustain higher frequencies compared to the damaged coating. Bode plots in Fig. 17 works in accordance with the relation shown in eq. 3.

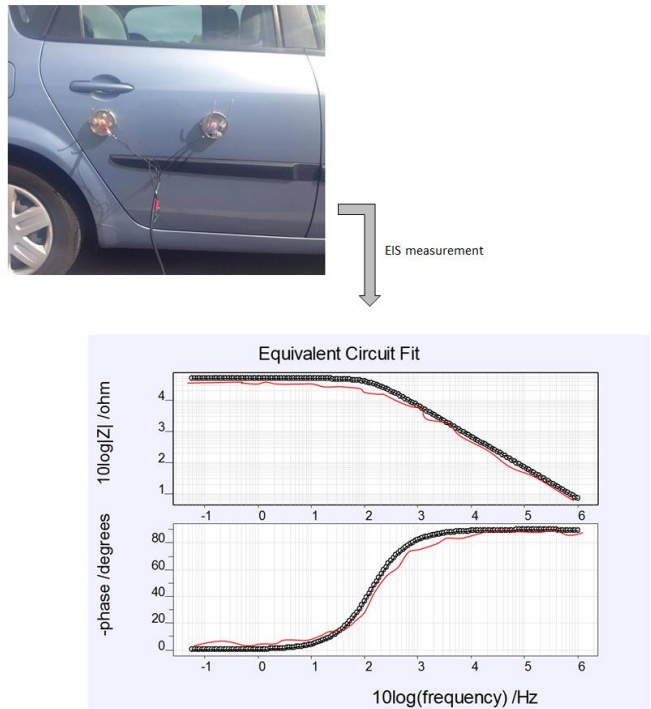
FIGURE 20. EIS measurement of automotive coating taken by using PEC and standard electrochemical cell (red trend)

Measurements in the field have been carried out to test and validate the PEC performance. In first example, the PECs were installed on back door of car coated with (D47 storm blue paint) to assess the condition of coating by using EIS measurement. The same measurements were also done with the standard electrochemical cells and the results were compared as shown in Fig. 20 (Red trend lines). EIS measurement from PECs was then used to calculate the

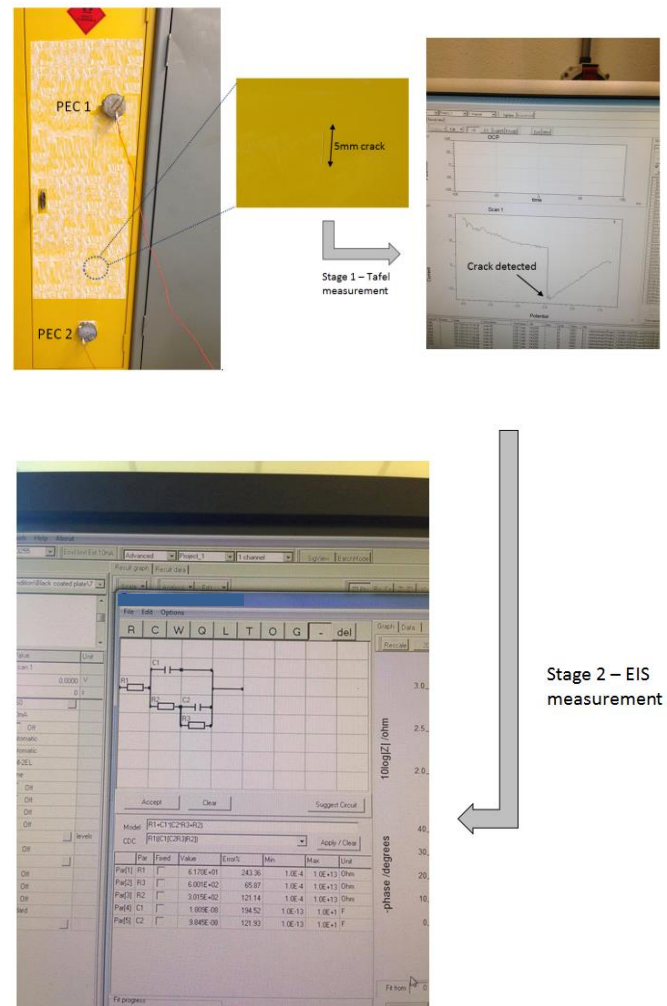
FIGURE 22. Tafel scanning performed by using PEC to detect the invisible crack on hazardous compartment coating (Stage 1). EIS measurement is used for calculating the parametric values of the equivalent circuit (Stage 2)

In the second example, PECs were installed on hazardous compartment. Two stage analyses was performed in which the defect in coating was detected by using Tafel measurement in stage 1 and then the coating condition was identified in stage 2 by using EIS measurement as shown in Fig. 22.

The stage 2 measurement shows a low pore resistance R2 (3.015 E+02) which indicates that the coating is defected but at the same time it also shows a high coating capacitance C1 (9.845 E-08) which points out that the defect is not big and the overall condition of coating is good. If both C1 and R2 would have been low

simultaneously, then this would have been an indication of degraded coating.

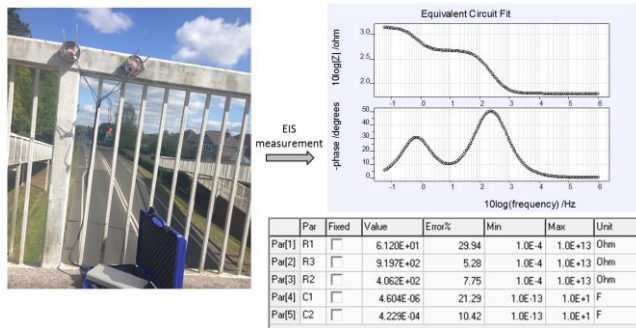
FIGURE 23. EIS measurement and result of overhead pedestrian bridge coating taken by using PEC

PECs were installed on overhead bridge to measure the condition of coating as shown in Fig. 23. Visual inspection showed that the coating of bridge was significantly damaged. Non-destructive EIS measurement was performed to calculate the parametric values of equivalent circuit which showed considerable low pore resistance R2 (4.062 E+02) and high coating capacitance C1 (4.604 E-06).

The results clearly show that the coating of overhead bridge is significantly degraded as both pore resistance R2 (4.062 E+02) and coating capacitance C1 (4.229 E-04) are low.
