Manuscript number	IJRMHM_2017_451
Title	Elevated temperature repetitive micro-scratch testing of AlCrN, TiAlN and AlTiN PVD coatings
Article type	Research Paper

**Elevated temperature repetitive micro-scratch testing
of AlCrN, TiAlN and AlTiN PVD coatings**

B.D. Beake^{1*}, J.L. Endrino², C. Kimpton², G.S. Fox-Rabinovich³ and S.C. Veldhuis³

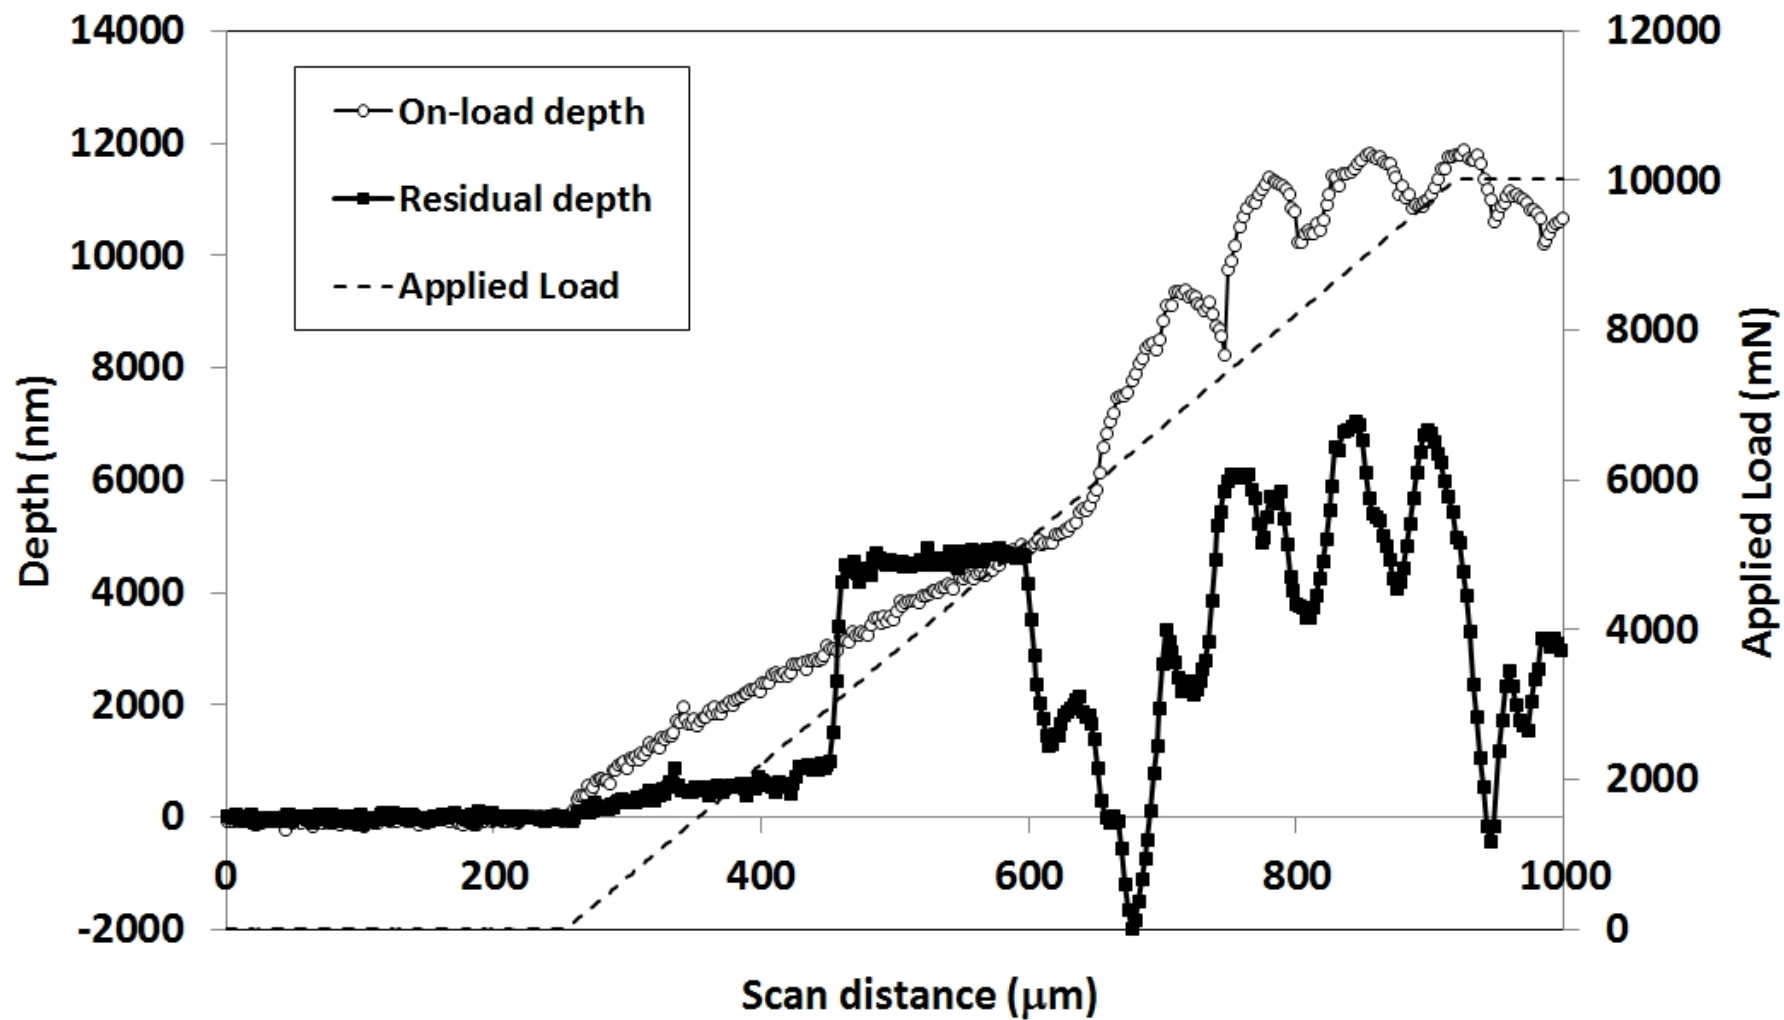
1. Illustrative example of an unloading failure in a ramped load micro-scratch test on AlCrN at 25 °C.
2. (a) On-load scratch depth data at 500 °C (including elastic deformation). (b) Residual depth data at 500 °C (excluding elastic deformation).

As the load increased L_{c1} (= onset of cracking or unloading failure) and L_{c2} (= total failure in front of the probe) failures were observed. The critical load data from progressive load micro-scratch tests at 25 and 500 °C have previously been reported in [24,32] and are shown in Table 1(b). Hertzian analysis suggests that the maximum von Mises stress at the L_{c1} failure is located below the free surface, and moves further away from the coating-substrate interface by L_{c2} (Table 1(b)). An example of an unloading failure (i.e. a failure originating just behind the contact zone, resulting in extensive coating removal) on AlCrN is shown in figure 1. In the tests at 25 °C the unloading failure was seen predominantly on AlCrN, occasionally on AlTiN and was absent on TiAlN. There was significant chipping outside the scratch track which was more extensive for AlCrN.

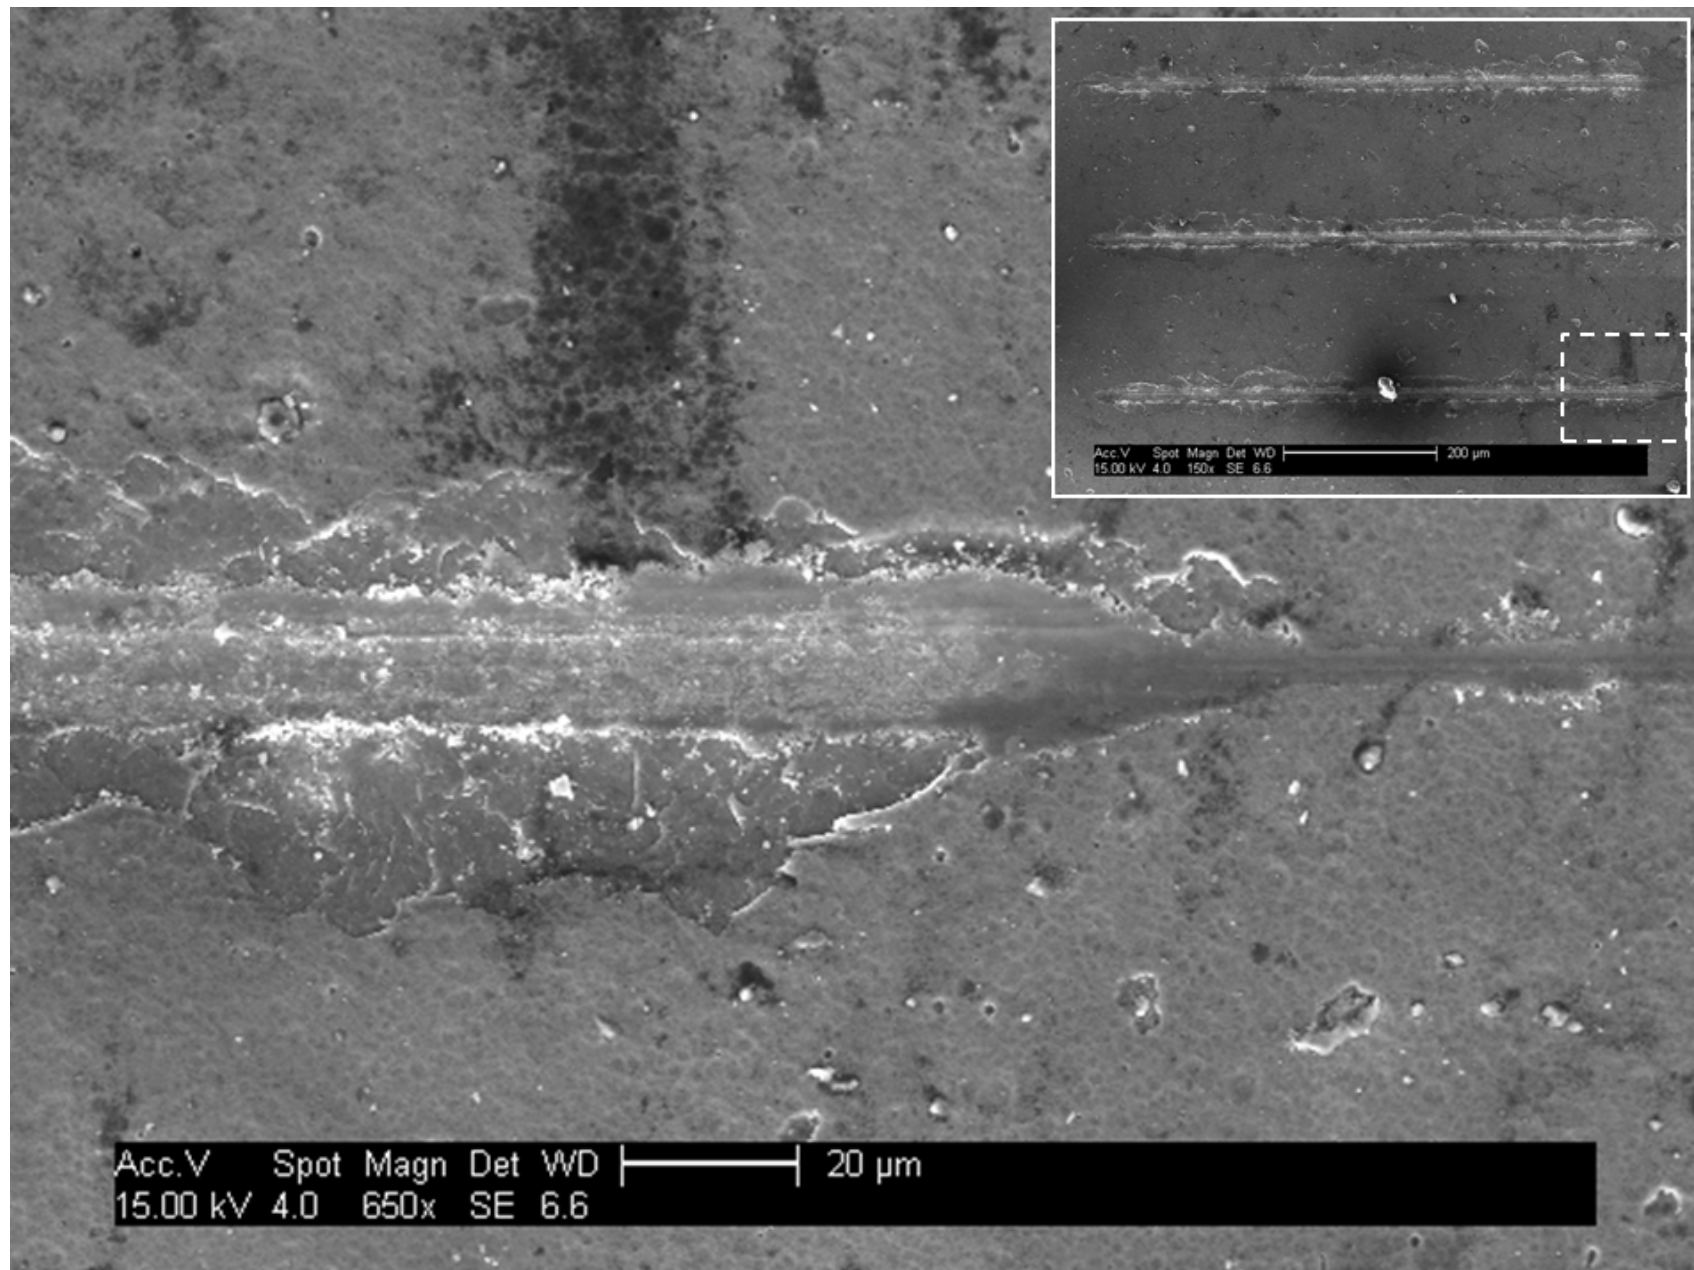
3. SEM images of ramped and repetitive scratch tests at 500 °C. The scratch direction is from right to left in all cases. (a) Ramped scratch at 500 °C on AlCrN (b) ramped scratch at 500 °C on TiAlN. Repetitive wear test at 1 N at 500 °C on (c) AlCrN. The back-scattered image in the inset reveals carbide exposure outside the scratch track. (d) TiAlN. A lower magnification image of repeat tests is shown in the inset.

depth is larger than the film thickness for AlCrN and AlTiN. Some plastic deformation of the cemented carbide substrate therefore occurred prior to coating failure. As at room temperature SEM imaging showed significant chipping outside the scratch track. This was more extensive for AlCrN (figure 3(a)) than TiAlN (fig. 3(b)).

With each scratch TiAlN showed a gradual increase in on-load scratch depth with SEM imaging revealing some chipping outside the scratch track (figure 3(d)). AlCrN was initially wear resistant but after several cycles it failed over the majority of the wear track. It exhibited significant chipping outside the wear track (figure 3(c)). There were isolated regions outside the track where the coating was completely removed to reveal bare WC-Co as confirmed by EDX analysis. AlTiN did not fail during the 10 repeat scratches at 500 °C at 1 N. Increasing the wear load to 2 N produced similar behaviour to observed at room temperature, although a larger number of cycles were required to cause coating failure. EDX revealed the presence of oxygen (~18-20 wt.%) and Co enrichment (to ~13-14 wt.%) in the scratch tracks for the ramped load and 1 N repetitive scratch tests on AlCrN and TiAlN when the coating was removed. Oxygen was absent from the unworn regions of the coating surface and from chipped regions of the coating outside the scratch track. Compacted regions were observed over part of the wear tracks.

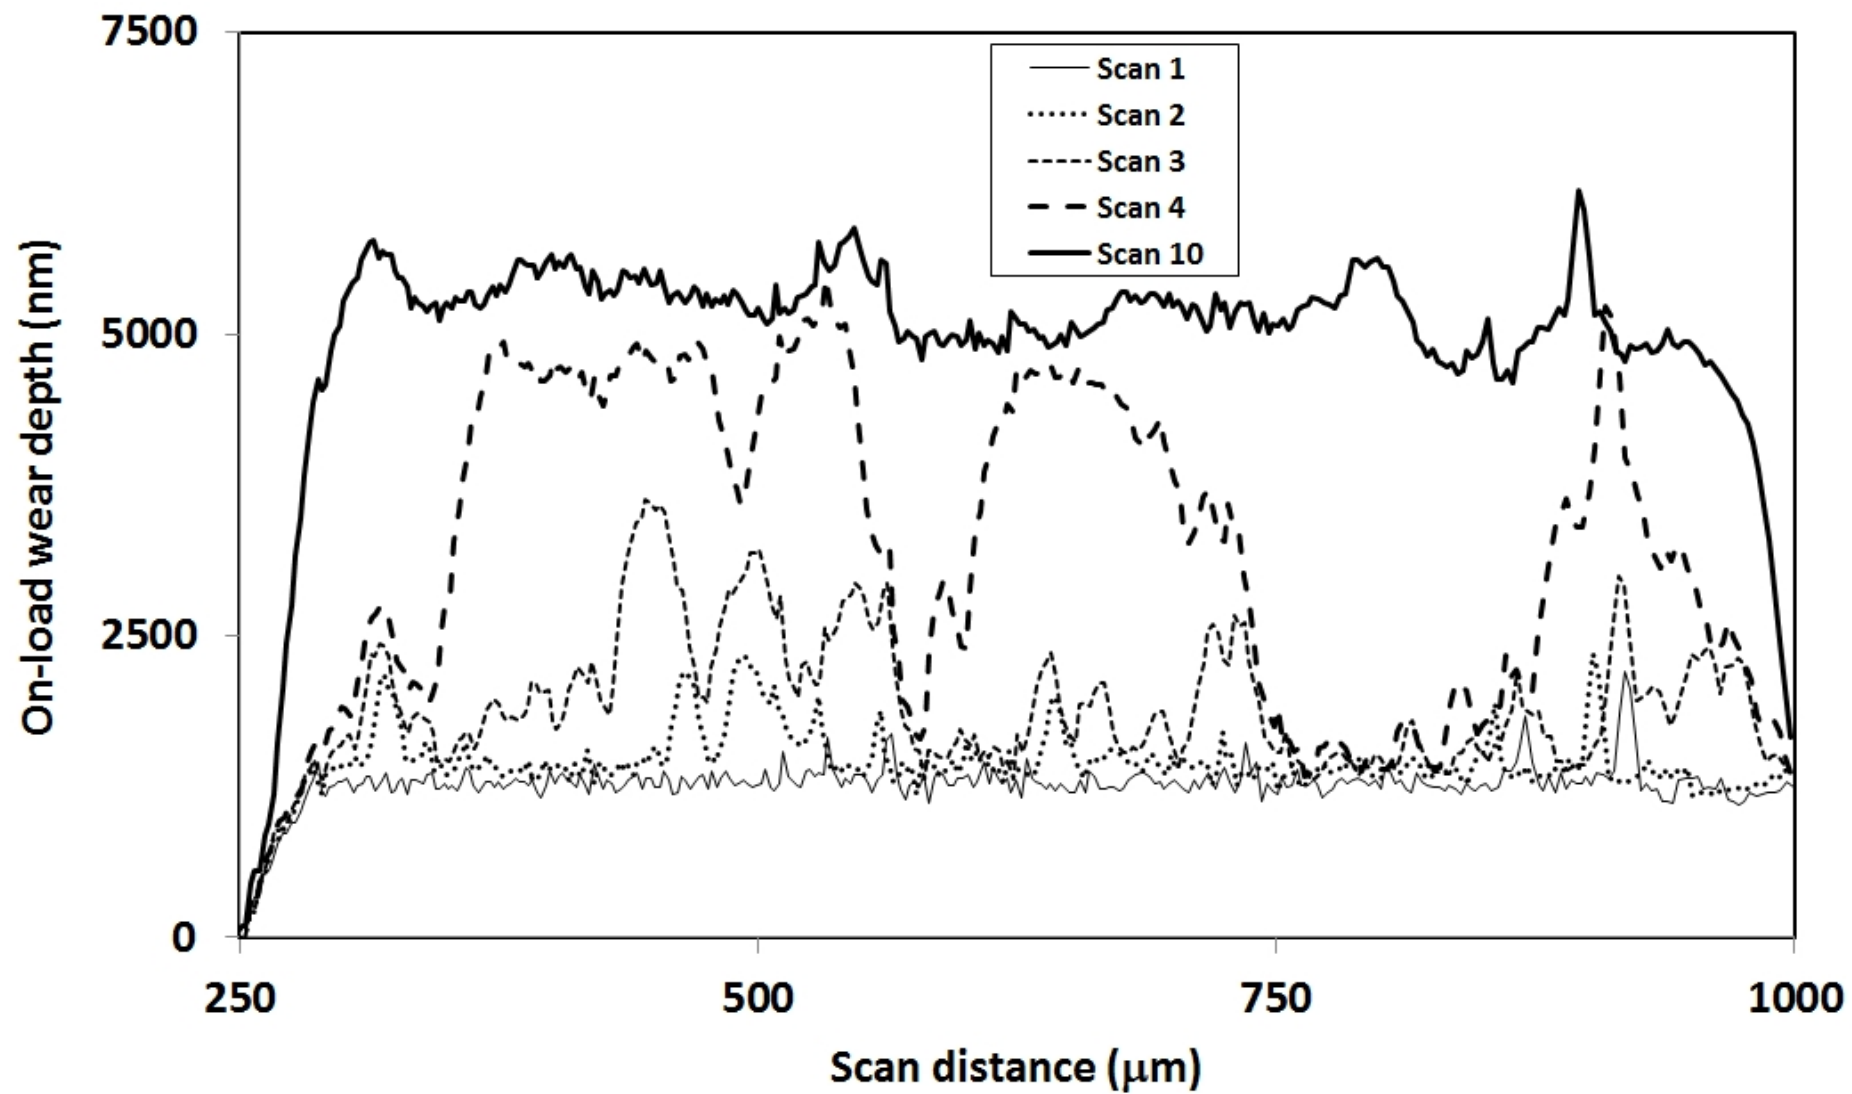
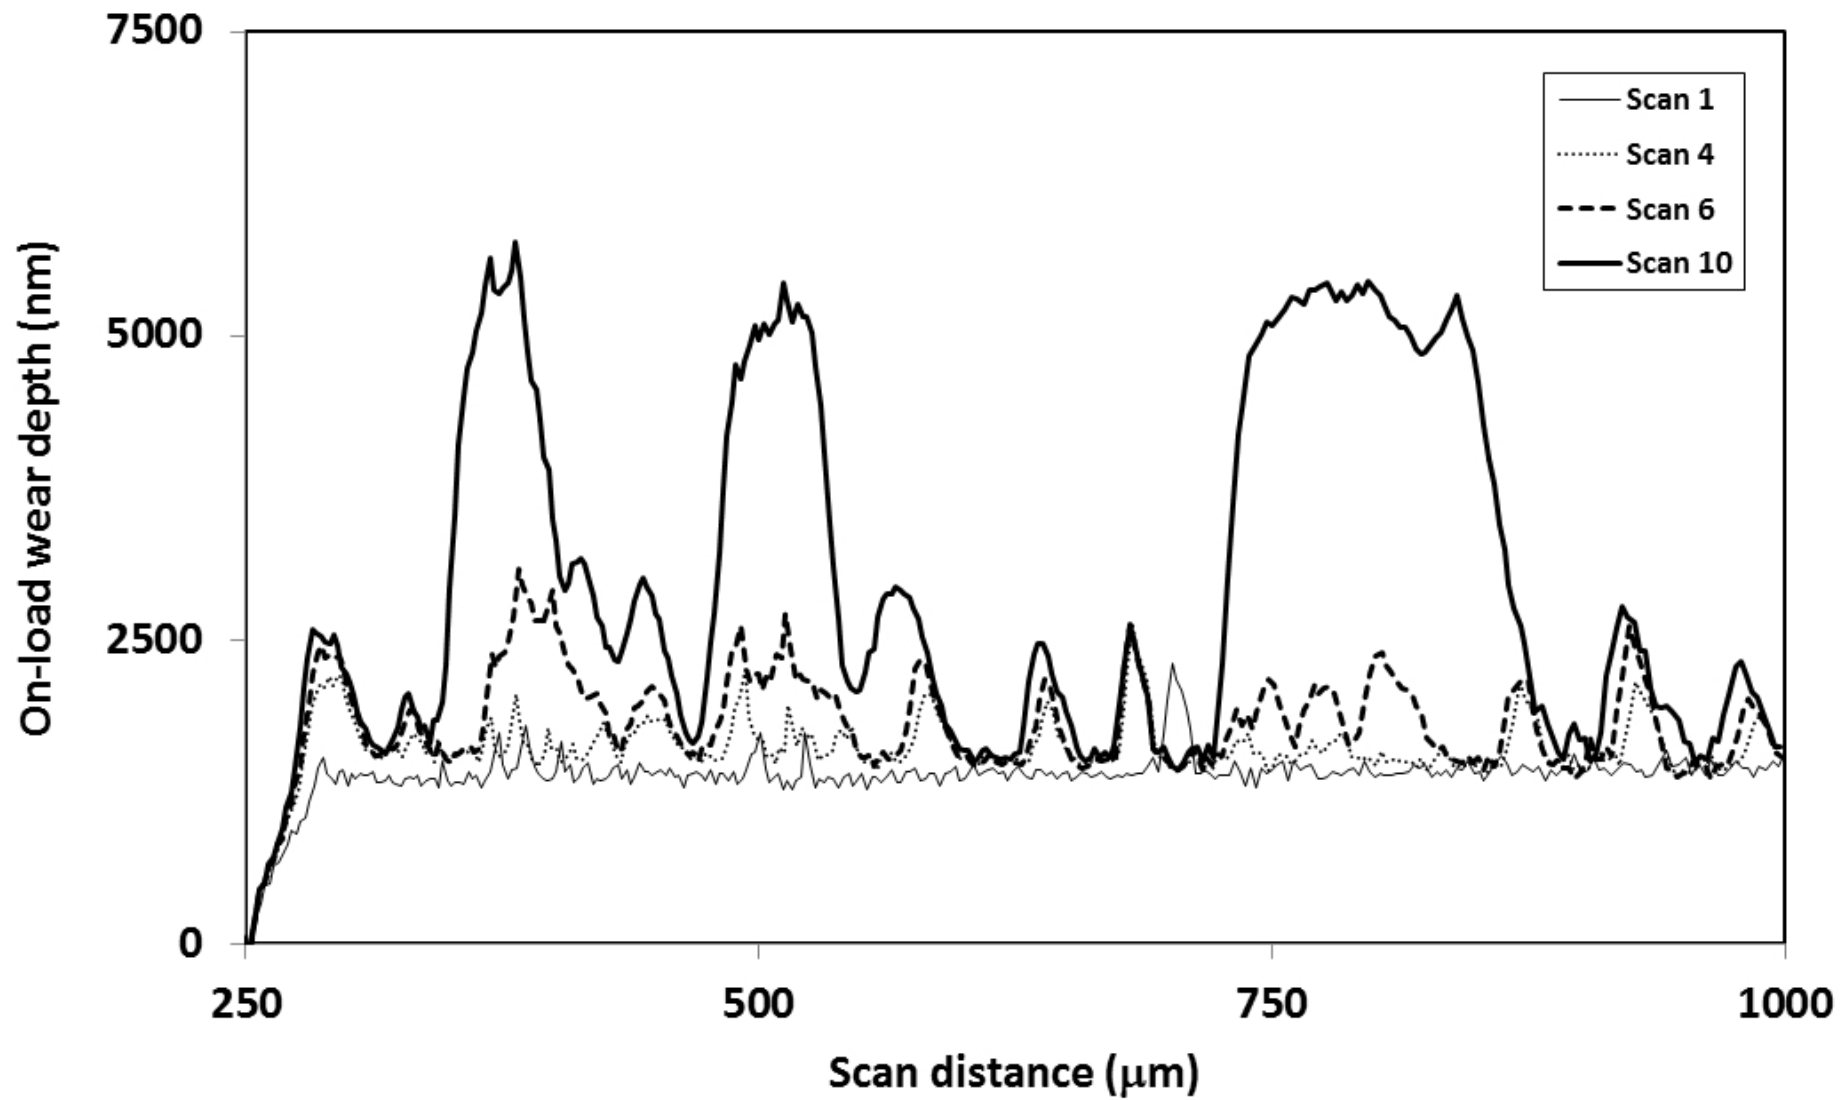
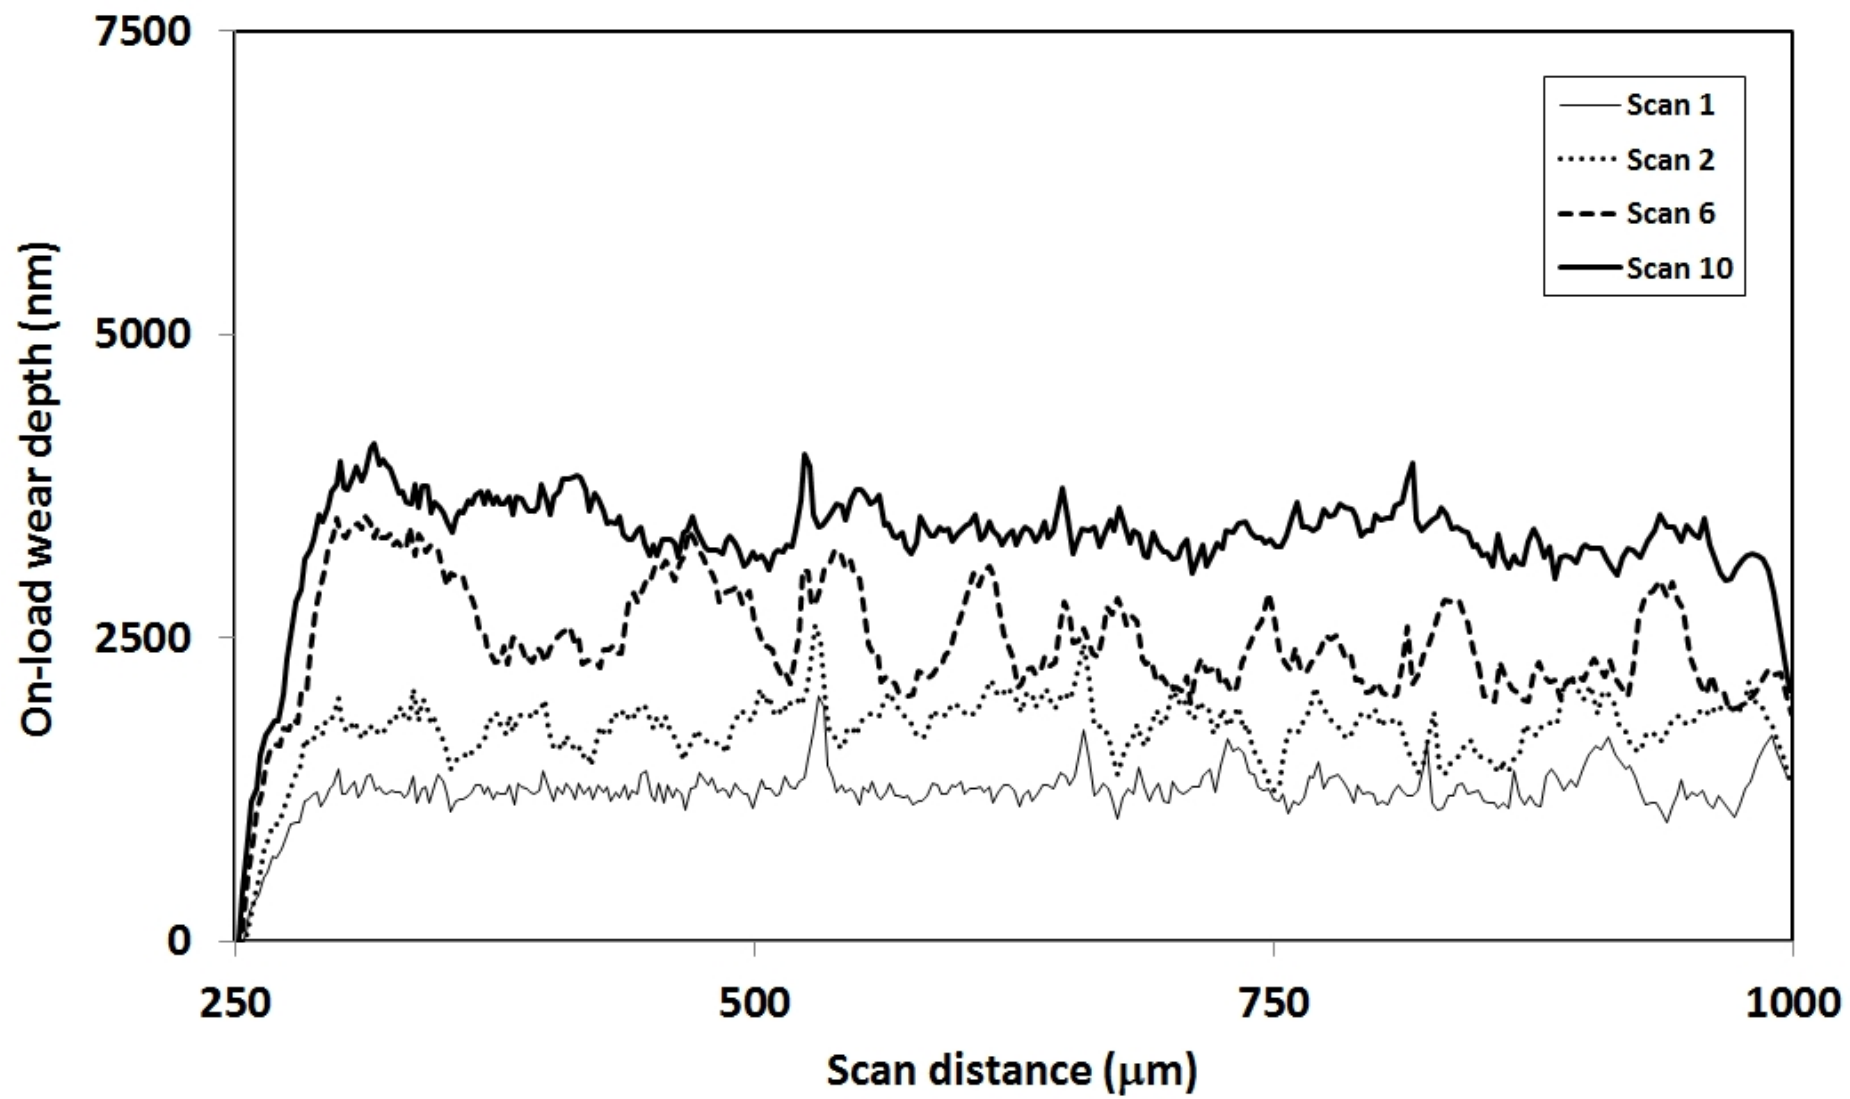
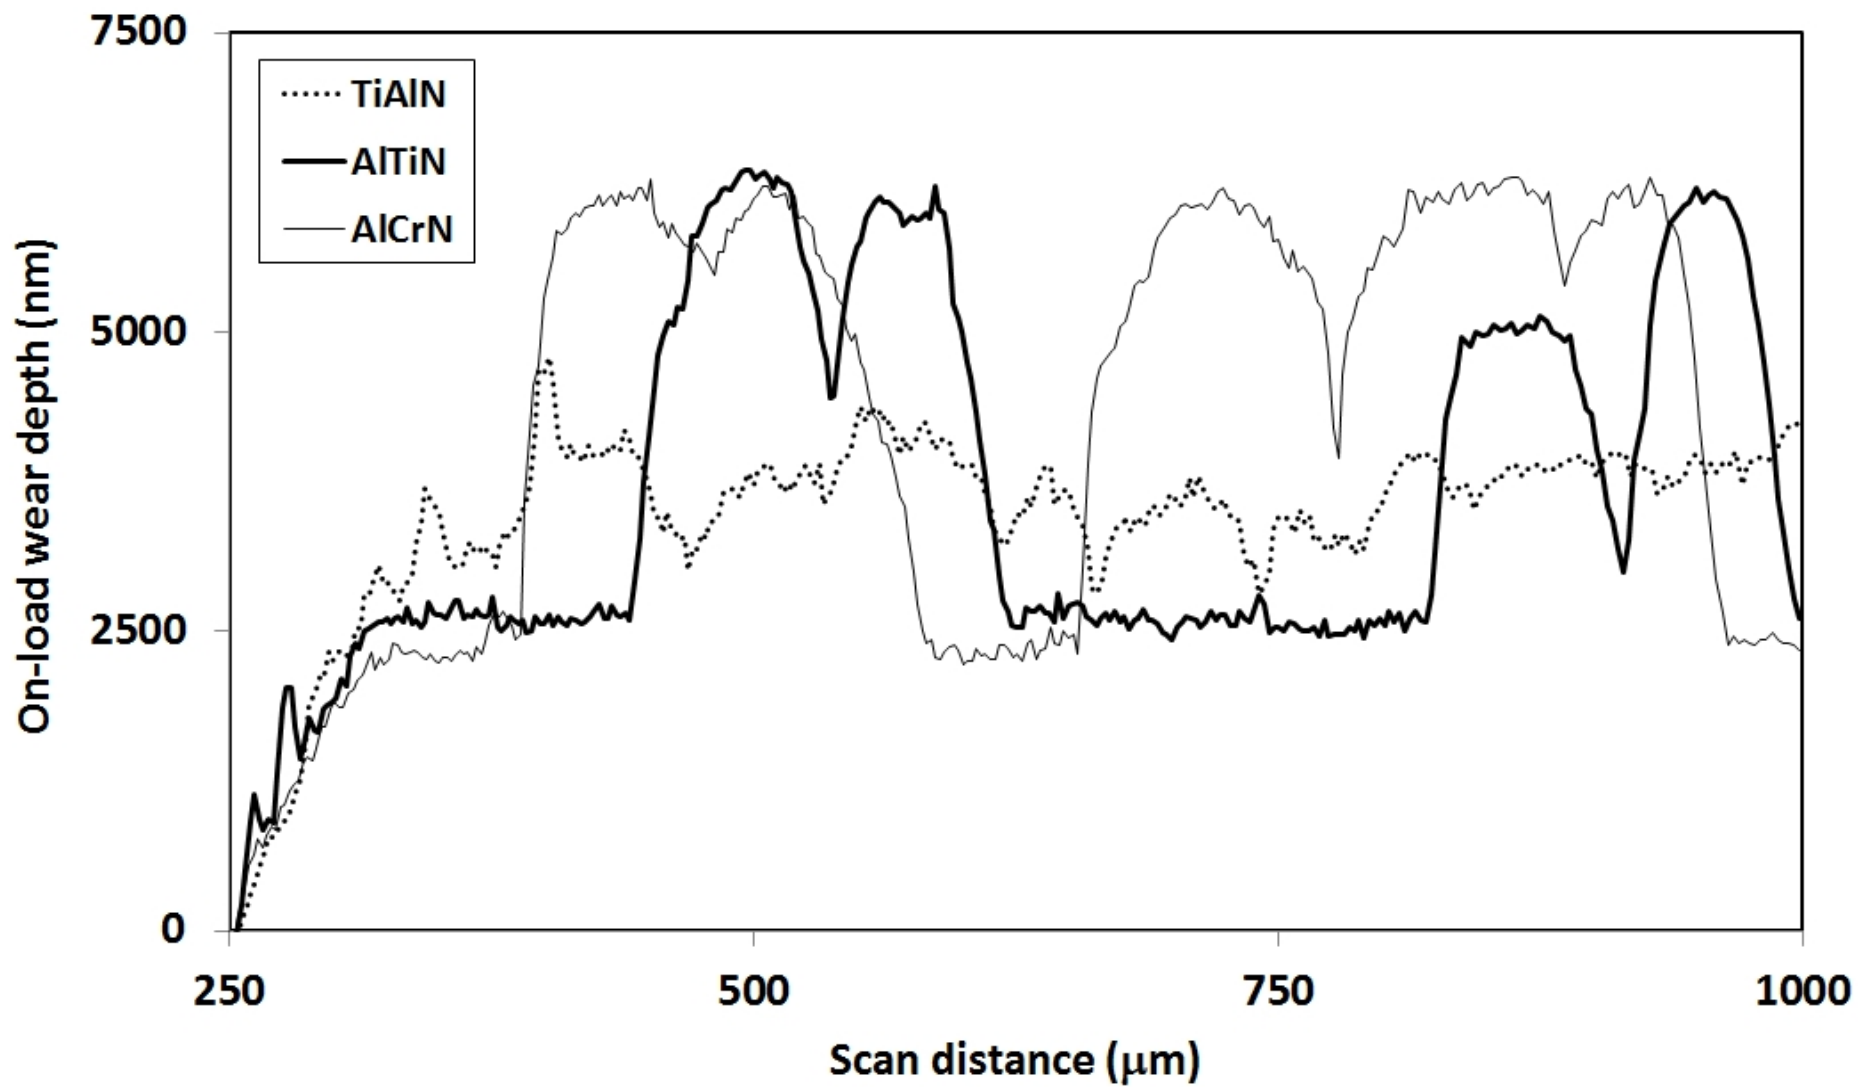
4. Repetitive micro-scratch tests at 1 N at 25 °C; (a) TiAlN (b) AlTiN (c) AlCrN. (d) Comparison of wear depths during second scratch pass at 2 N 25 °C.

The repetitive scratch depth data are summarised in Table 2. The depth during the initial pass under load at 1 N was almost the same for all three coatings. Illustrative constant load repetitive micro-scratch tests at 25 °C are shown in figure 4(a-d). The on-load depth includes the elastic deformation, so is greater than the residual wear depth which excludes it. Since the elastic contribution is expected to be approximately constant during the tests the on-load depth can provide a convenient assessment of the evolution of the wear with each subsequent scratch. For clarity only some of the wear cycles are shown. The deformation behaviour and the relative performance of the coatings were both highly load-dependent. After a few cycles at 1 N AlCrN worn regions along the scratch track were observed. Total coating failure occurred over 2/3 of the wear track by the 4th wear scan and was complete by the sixth scan (figure 4(a)). In the tests at 1 N AlTiN showed a mixture of low-wear areas and almost total coating removal in one test and minimal failure in the other (figure 4(b)), with lower scratch (elastic) recovery in the final post-scratch scan depth for the failed regions than the minimally worn regions. At 1 N (see figure 4(c)) and 2 N TiAlN exhibited a gradual fracture wear process without as abrupt an increase in depth. At 2 N the stress field calculations show the maximum von Mises stress moved to ~4 µm below the surface. The maximum contact pressure was estimated at 7.3-8.3 GPa at 1 N. At 2 N there was total coating failure over much of the wear track during the second or third scans on AlCrN and AlTiN. Figure 4(d) contrasts the behaviour on these coatings to TiAlN. After the coating was removed from the

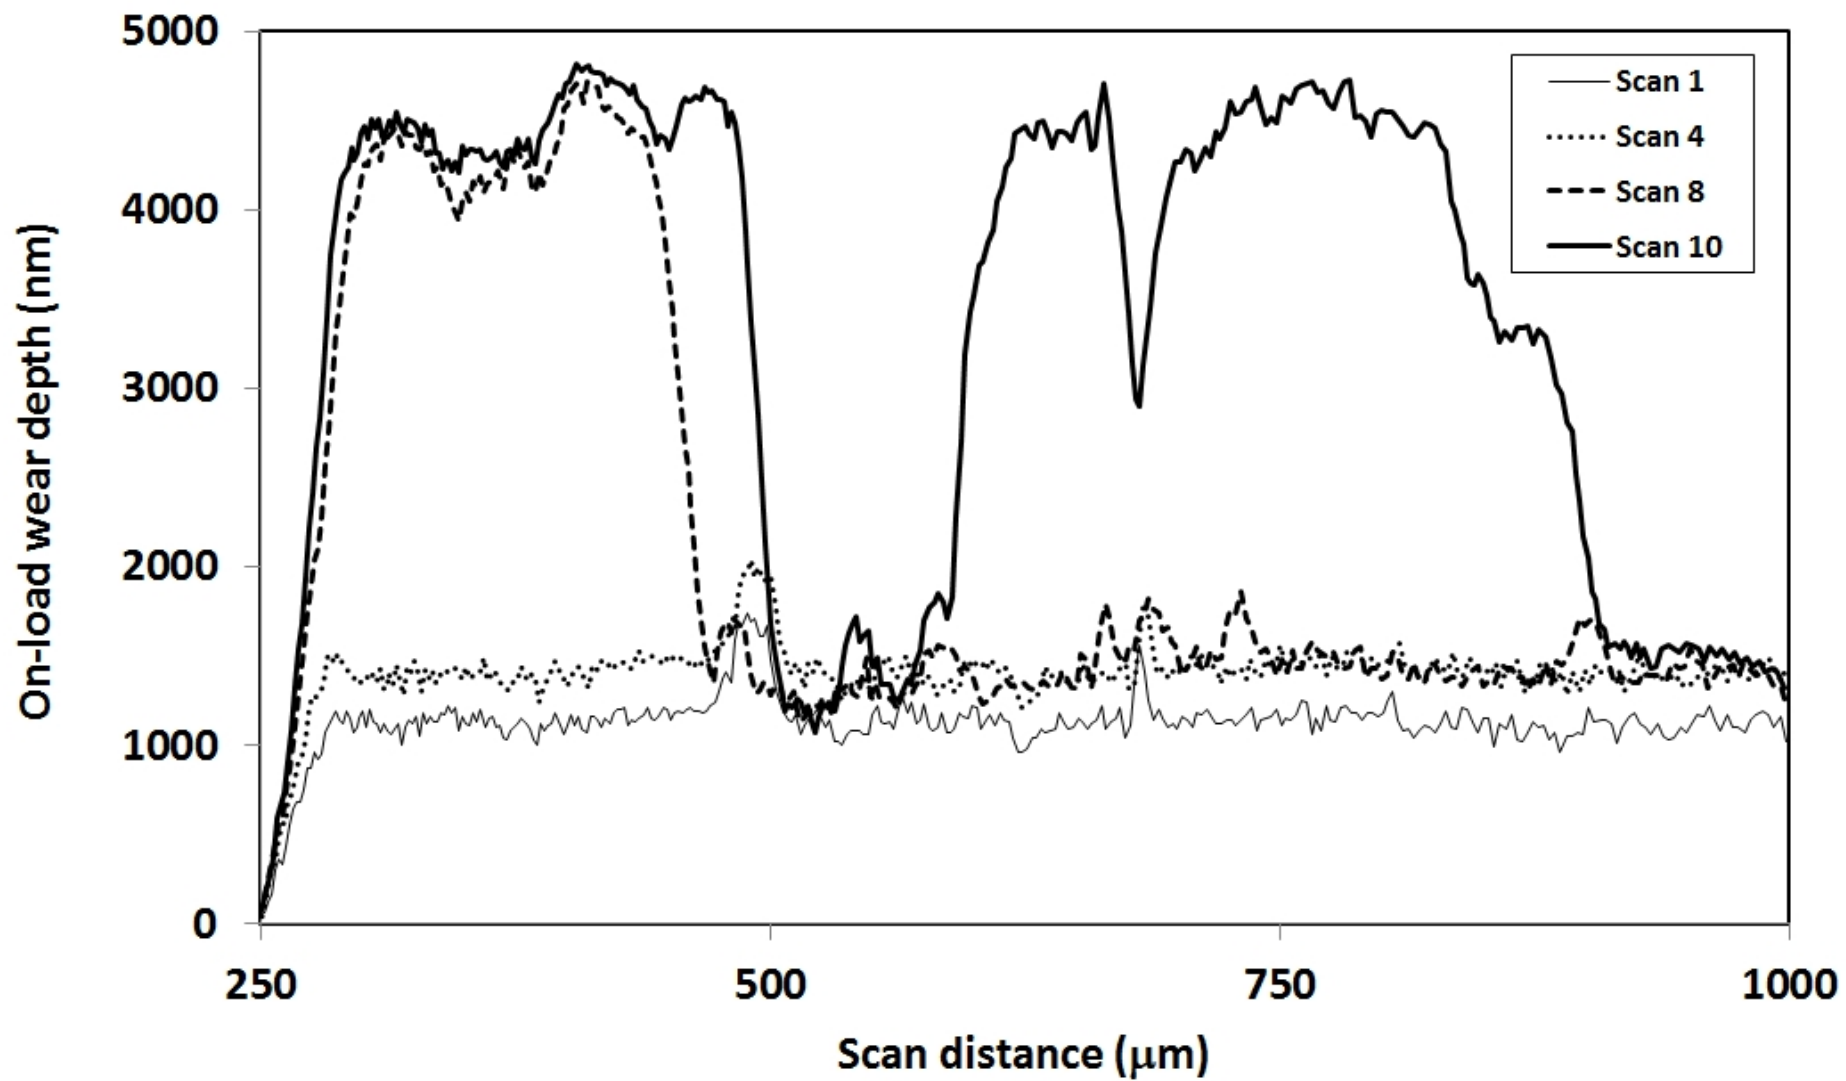
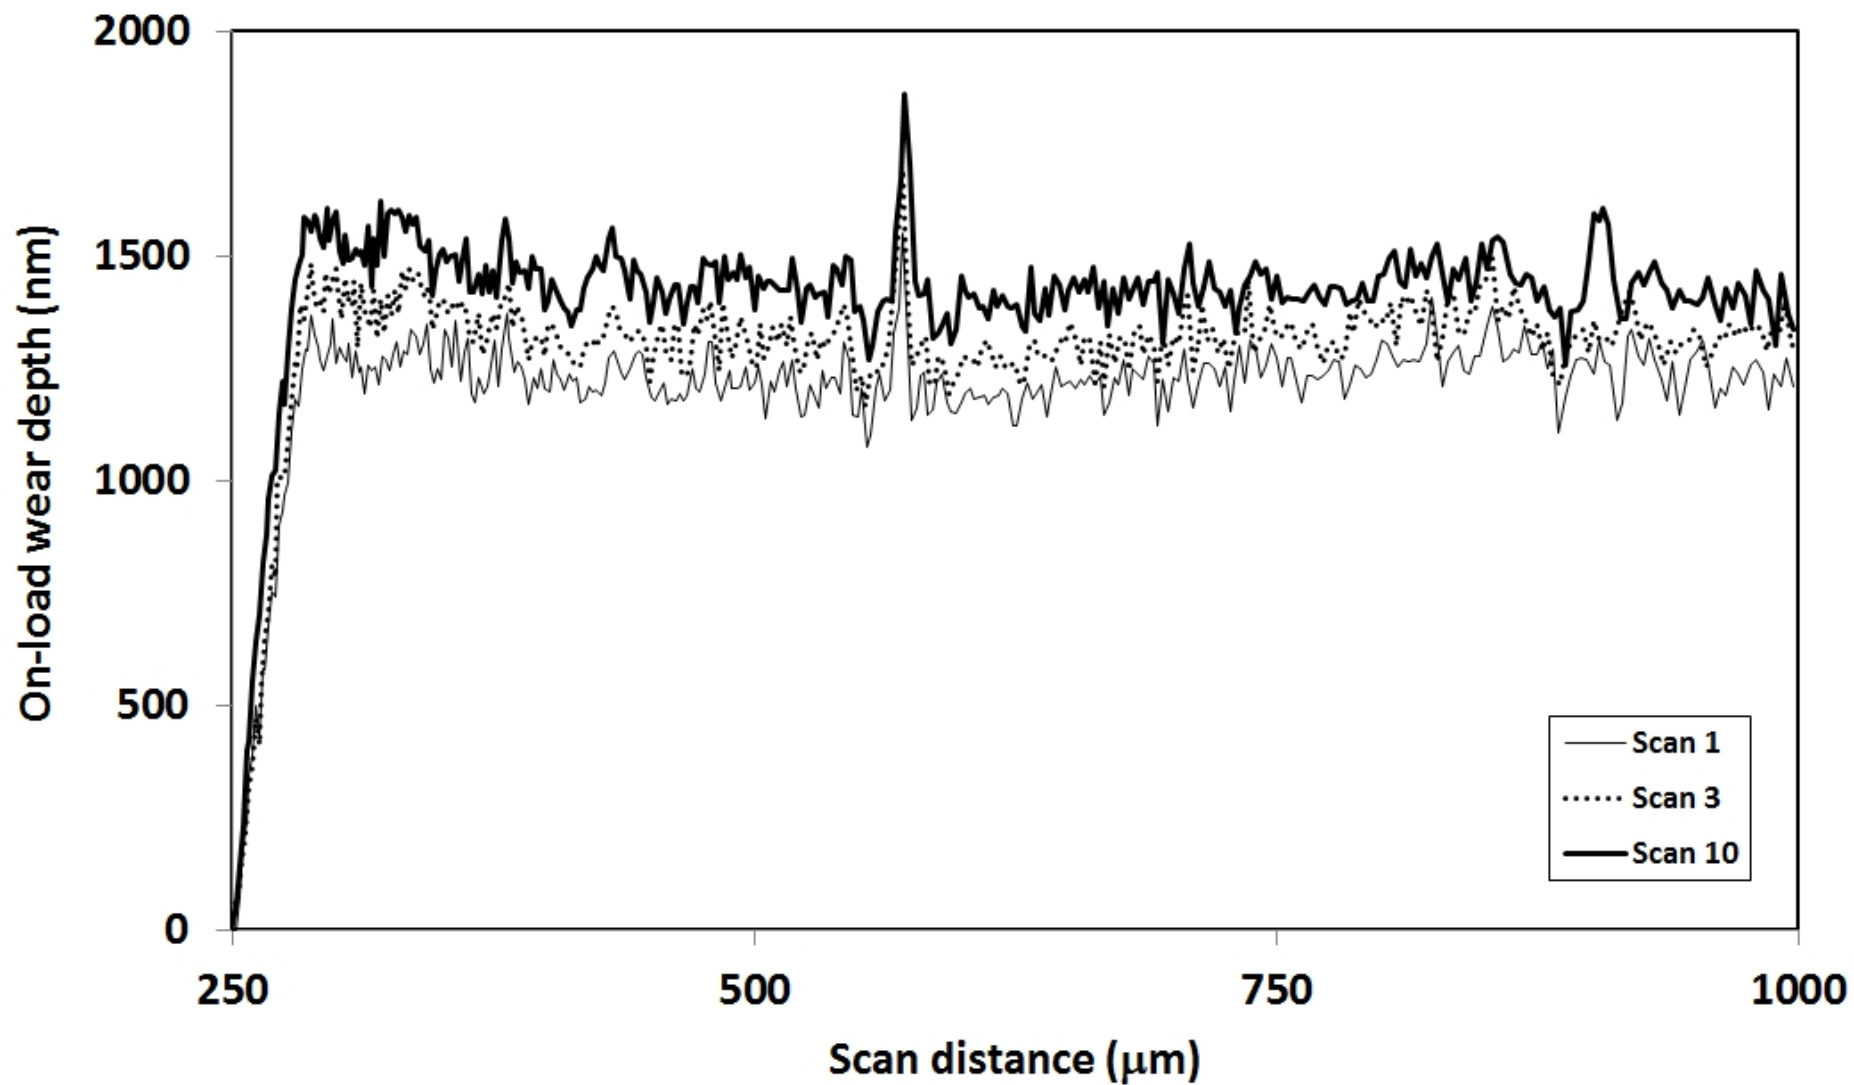
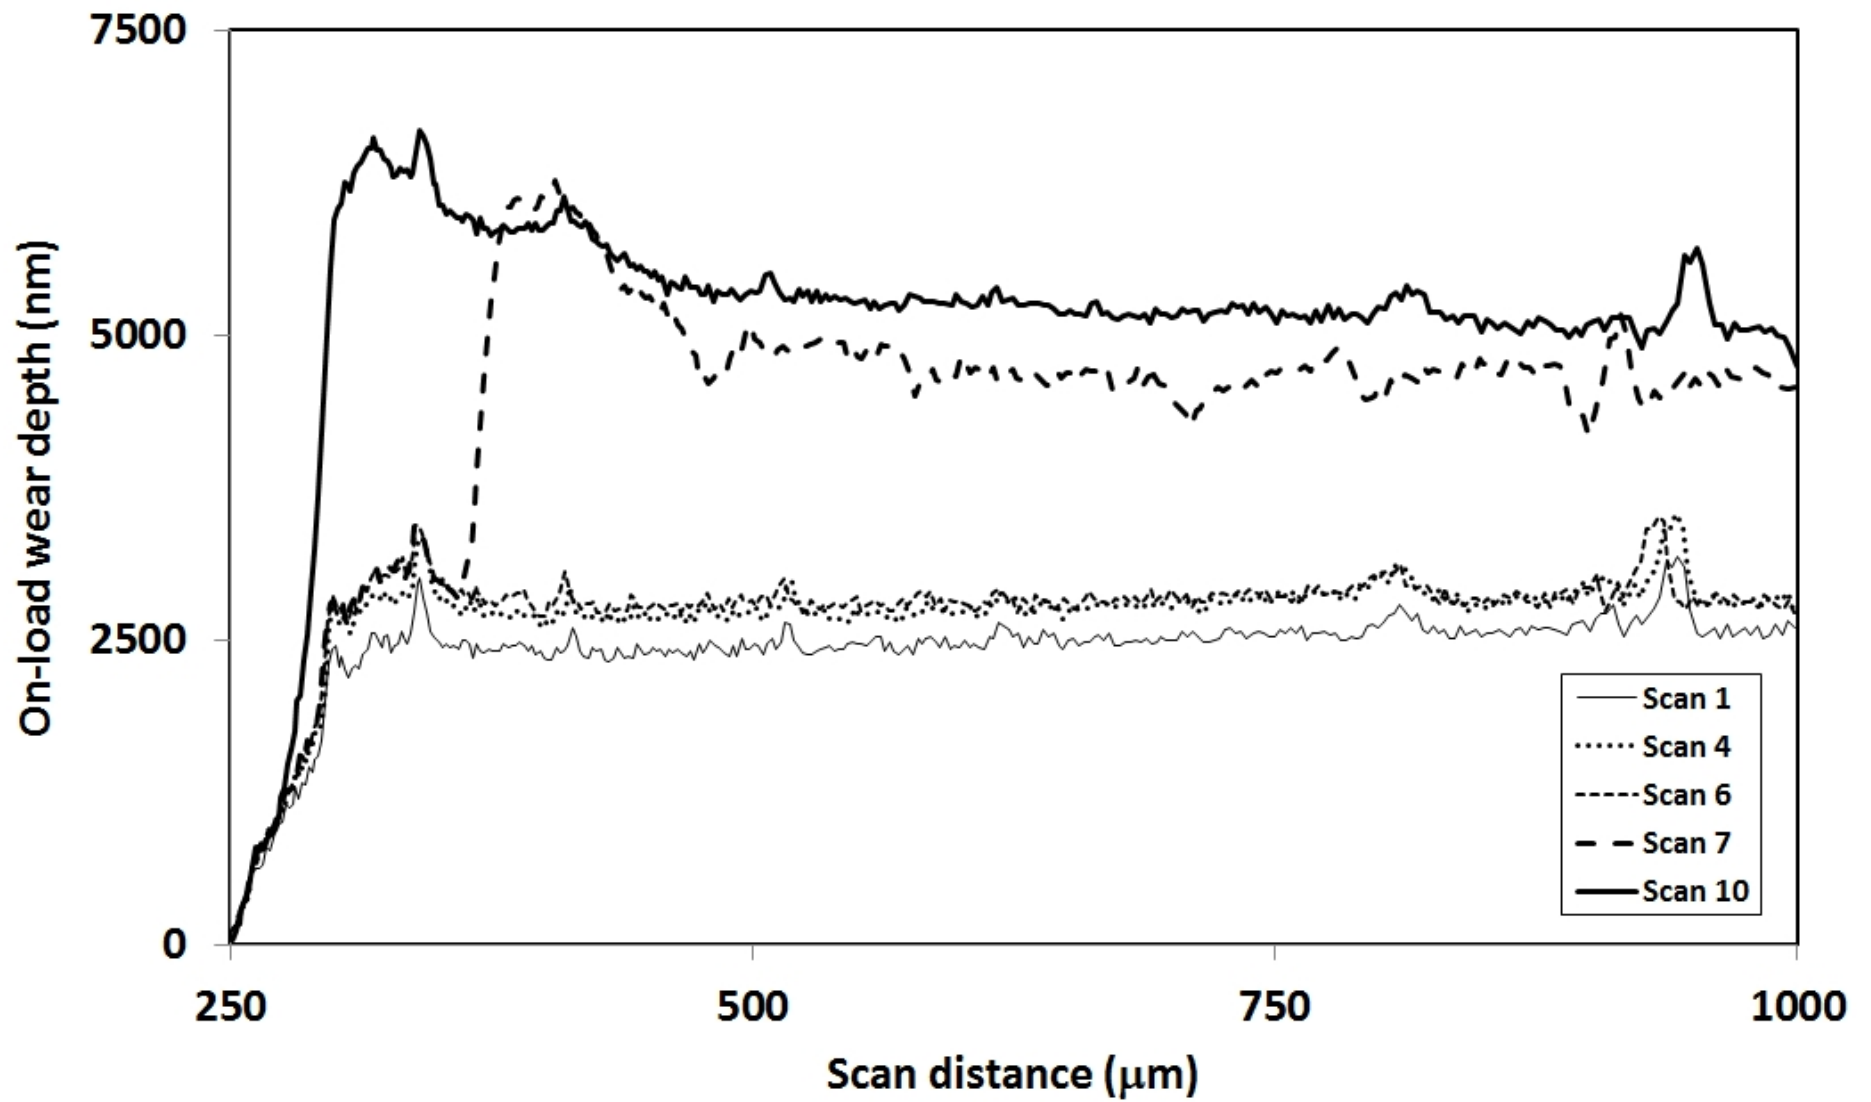
5. Repetitive micro-scratch tests at 500 °C (a) AlCrN at 1 N (b) AlTiN at 1 N (c) AlTiN at 2 N.
6. (a-c) Simulated von Mises stress distributions in the 1 N wear tests at 500 °C. a = TiAlN; b = AlCrN; c = AlTiN. The scratch direction is from left to right.
