Manuscript number	IJRMHM_2017_451
Title	Elevated temperature repetitive micro-scratch testing of AlCrN, TiAlN and AlTiN PVD coatings
Article type	Research Paper

**Elevated temperature repetitive micro-scratch testing
of AlCrN, TiAlN and AlTiN PVD coatings**

B.D. Beake^{1*}, J.L. Endrino², C. Kimpton², G.S. Fox-Rabinovich³ and S.C. Veldhuis³

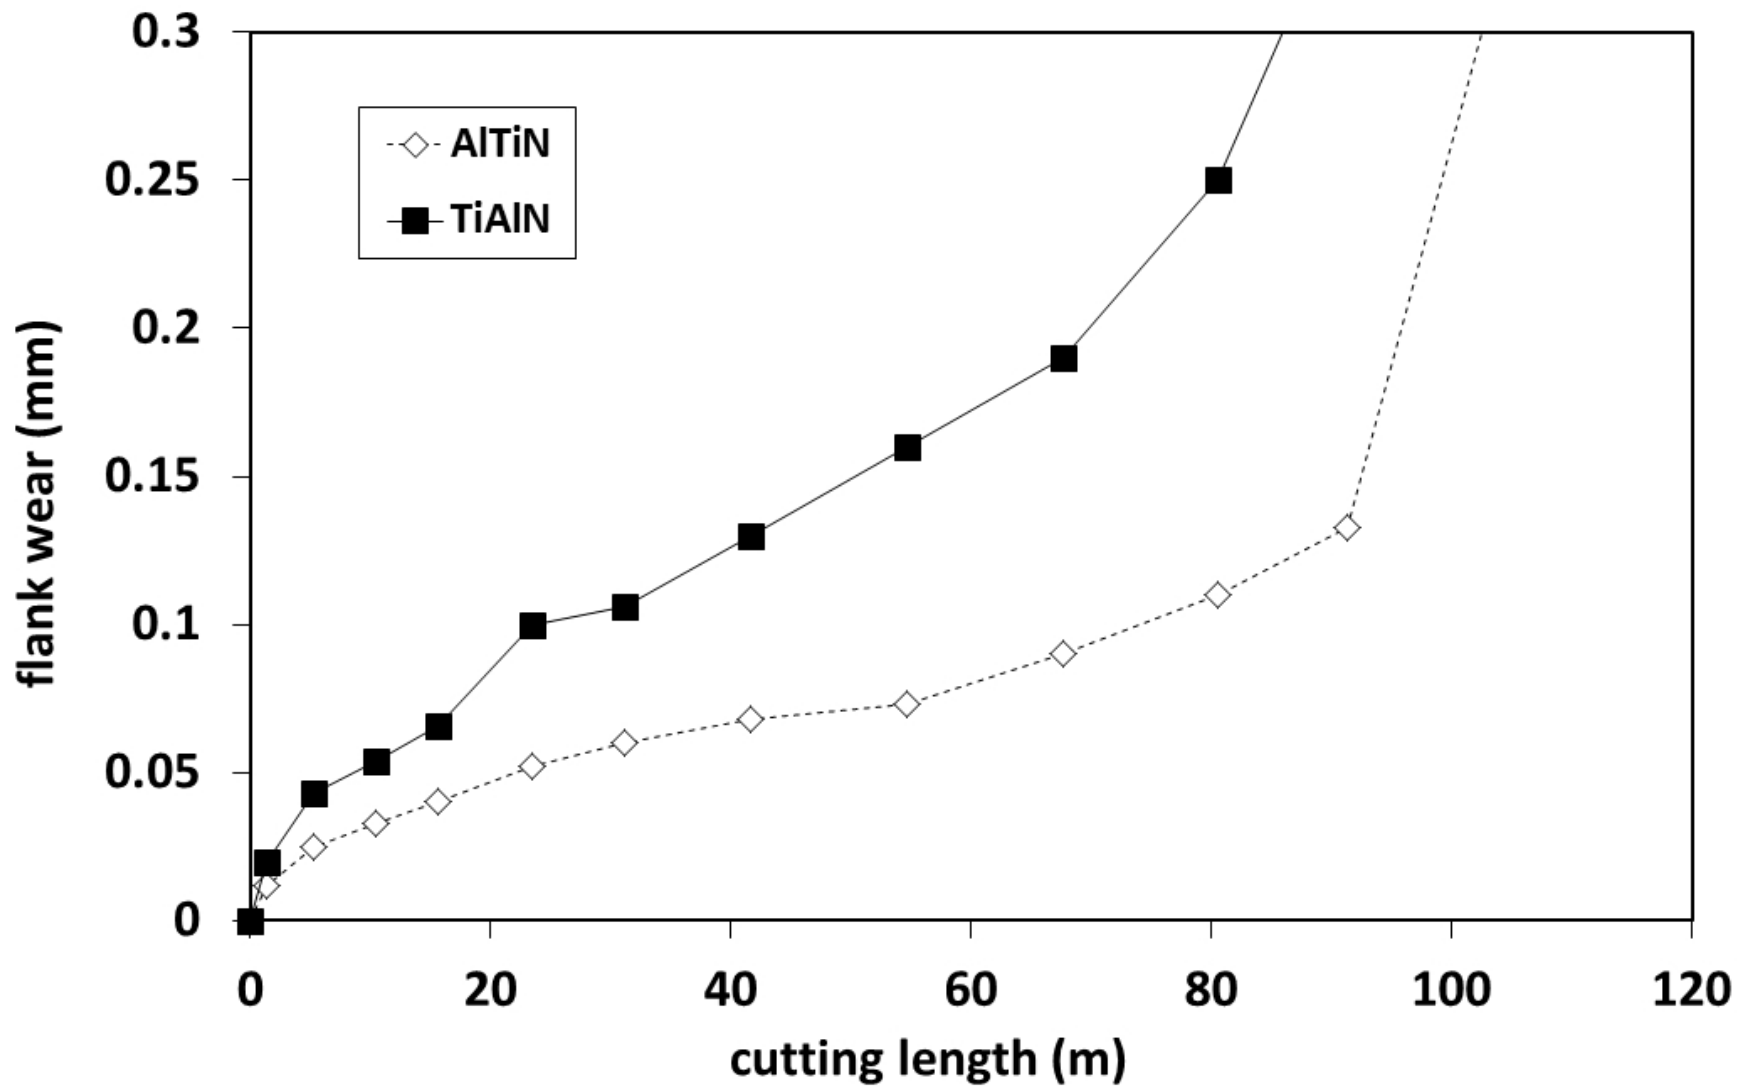
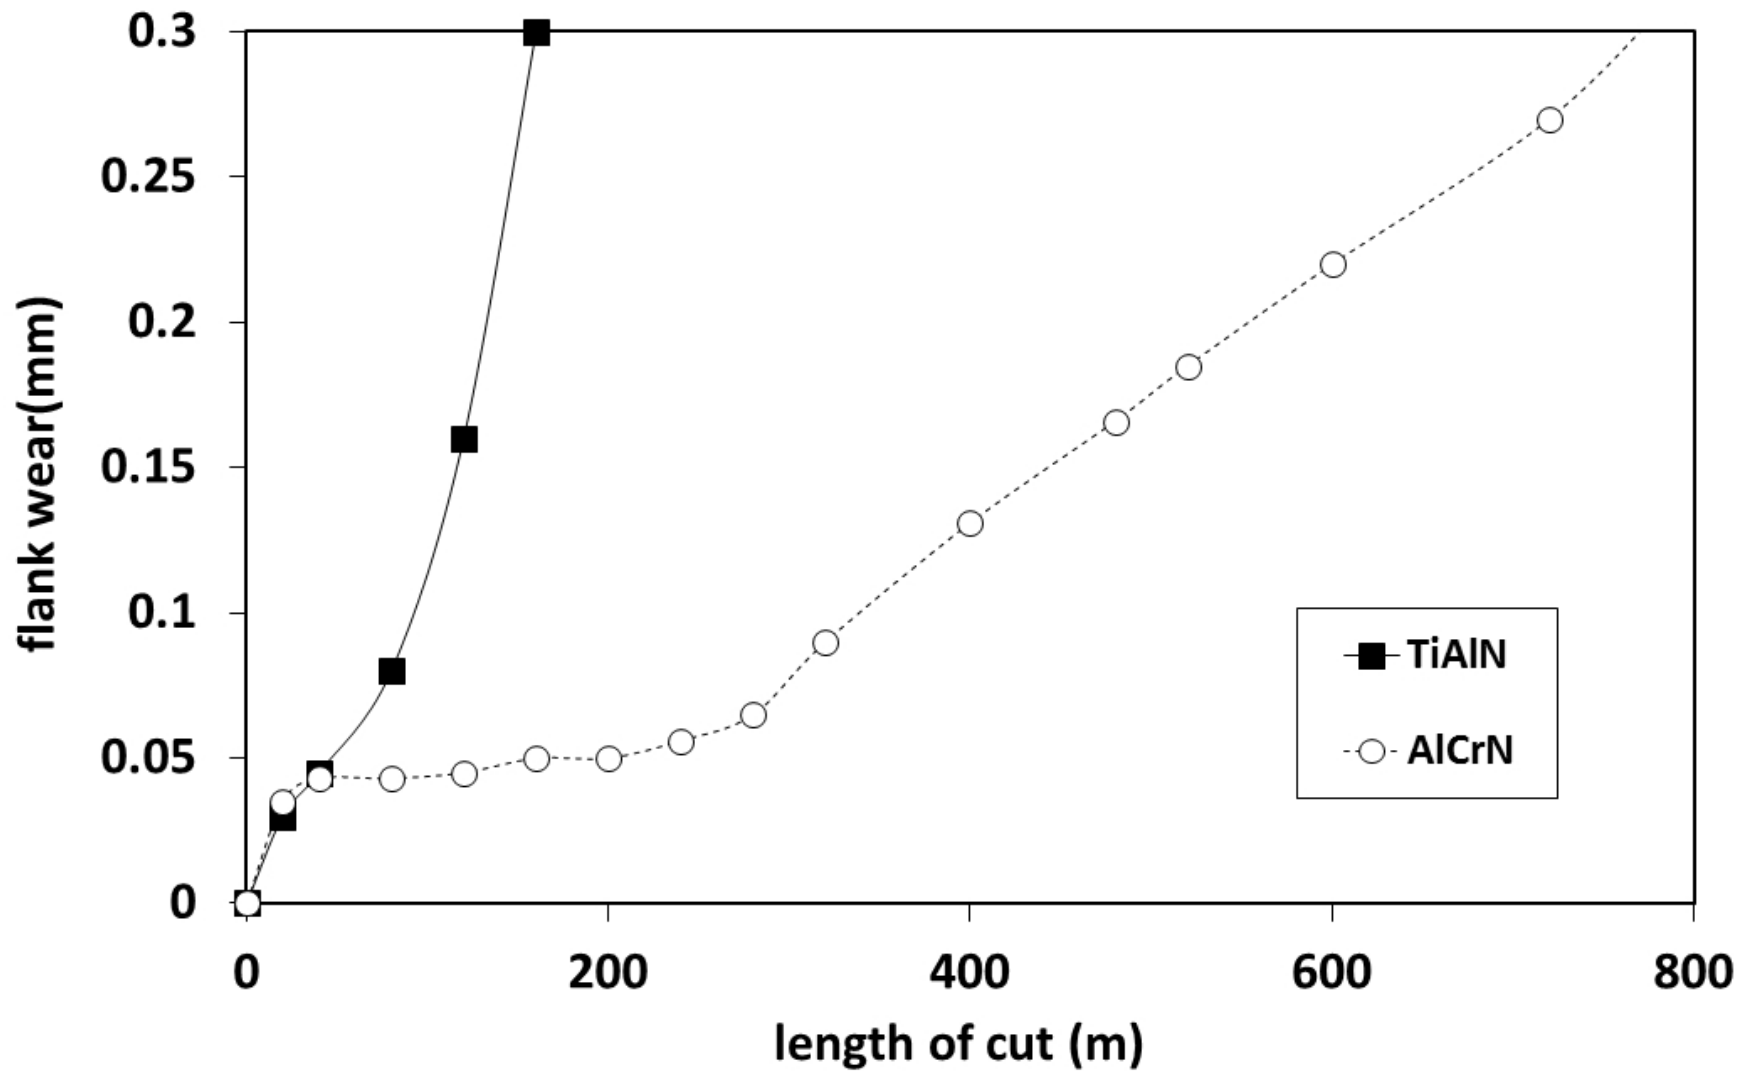
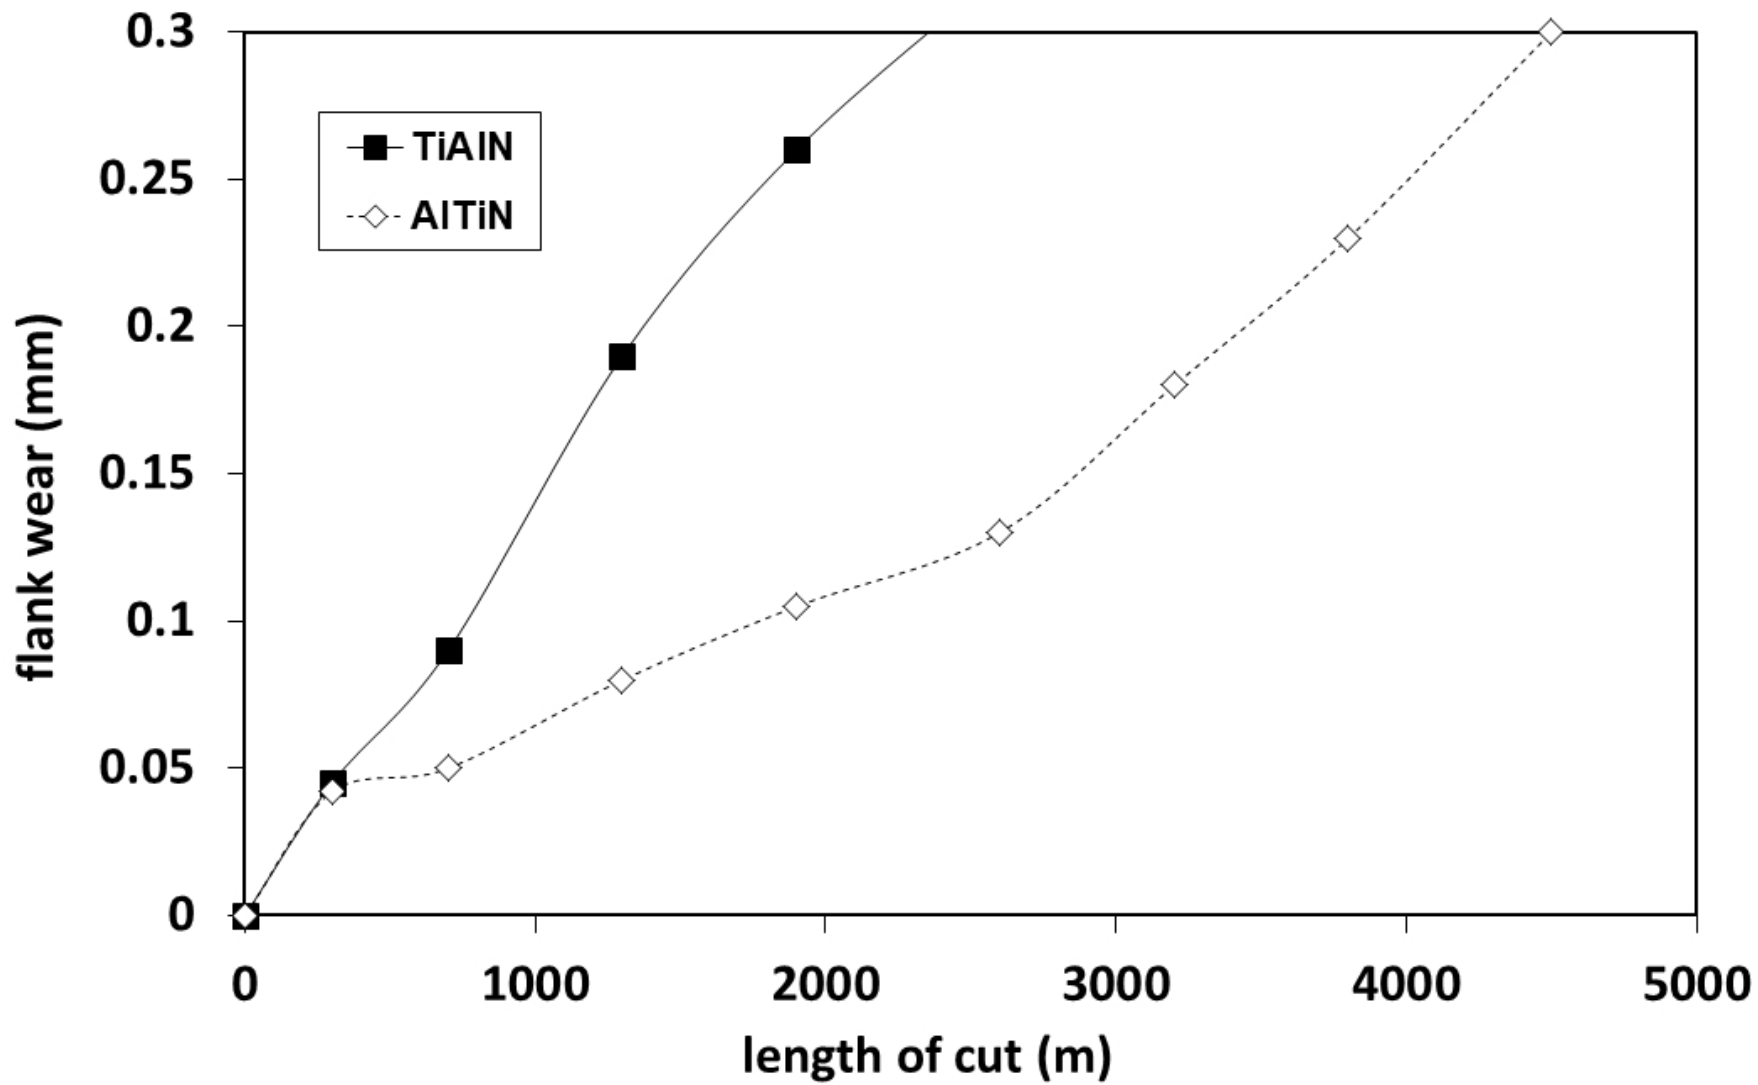
7. Tool life flank wear data in cutting with coated cemented carbide inserts (i) end milling of 4340 steel with TiAlN and AlTiN (ii) end milling of 1040 steel with TiAlN and AlCrN (iii) face milling of 1040 steel with TiAlN and AlTiN. Full cutting conditions are given in references [24-25].

The results of the high temperature ramped and repetitive micro-scratch tests are consistent with reported cutting test data. The high Al-fraction coatings AlCrN and AlTiN both can outperform TiAlN in a range of aggressive cutting conditions. Although it has relatively low elastic modulus, the high L_{c1} on AlTiN is not due to having high H^3/E^2 since the other two coatings studied have higher H^3/E^2 . Instead it is a consequence of lower interfacial stresses, plastic flow in the coating and reduced substrate deformation, especially at 500 °C. This may explain its excellent performance in cutting materials, such as Ti6Al4V, where high temperature coating plasticity is more important than high temperature hardness.
