Cerebrospinal fluid leak after bone marrow biopsy.**Dr Thomas Fox**

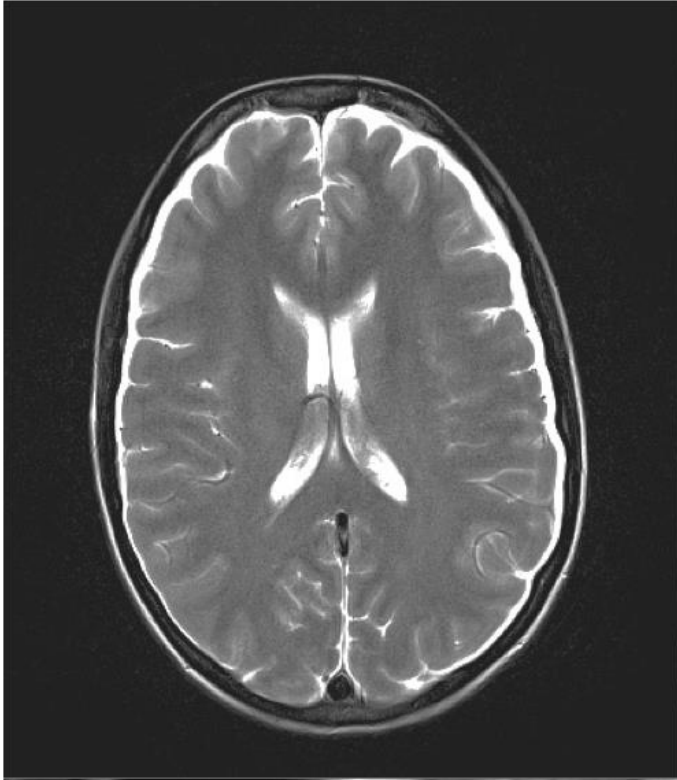
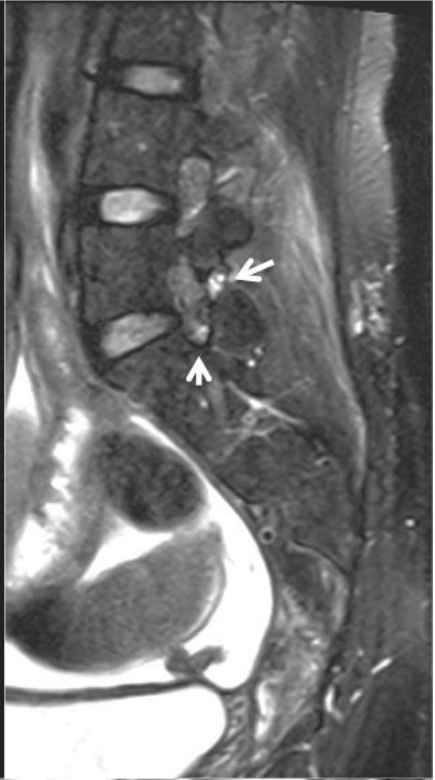
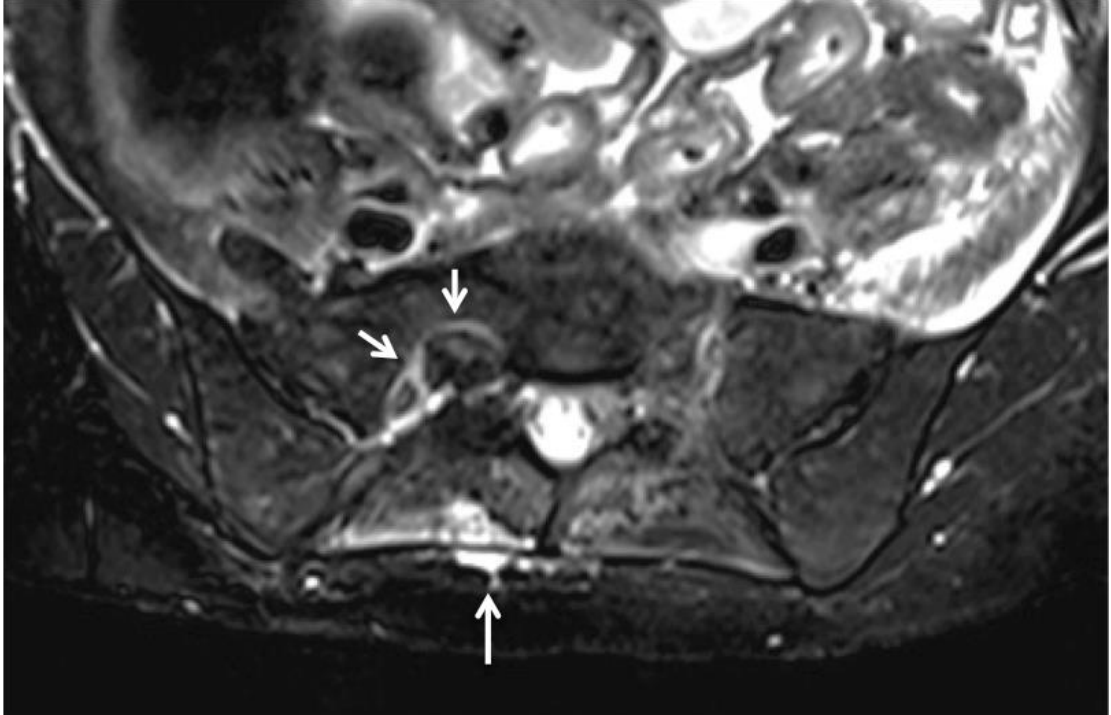
A magnetic resonance imaging (MRI) scan of brain and whole spine was performed, which demonstrated bilateral subdural effusions suggestive of extremely low CSF pressure (axial T2 weighted image, top left). Sagittal oblique images demonstrate a traumatic L5/S1 pars intra-articularis defect (long arrow) and fluid at the floor of the right L5/S1 intervertebral foramen (short arrow) (top right). High signal intensity in the soft tissues and paraspinal muscles on additional fat saturated images indicates the needle trajectory (long arrow). A bone fragment within the right side of the sacrum is surrounded by fluid (short arrows), related to a CSF leak, which is likely to be the result of a dural tear in the adjacent right S1 nerve root sleeve (bottom). Neurosurgical colleagues suggested that a blood patch should be performed in the first instance although it was acknowledged that the neurosurgical team had not previously encountered this complication. Anaesthetic colleagues then performed a blood patch at the L5/S1 level, following which the patient reported improvement in symptoms and cessation of the discharge from the biopsy site. The patient made a full recovery and proceeded to complete her chemotherapy regimen, including intrathecal prophylaxis.
