Investigation on the Monitoring of Brick Structure in Yokosuka City

ABSTRACT

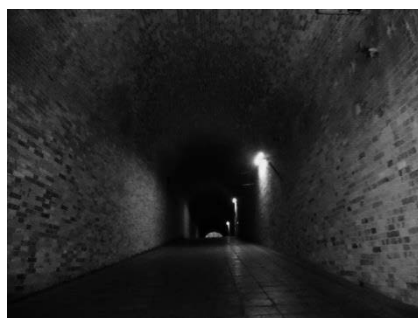
Figure 1: Brick structure in Sarushima

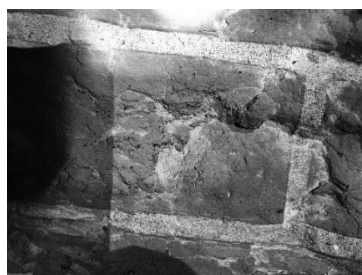
show the changes of brick masonry in Japan. However, many brick structures in Sarushima suffer from surface deterioration; for example, salt weathering (Figure 2). Salt weathering brings about collapse of bricks. One of the drivers that cause salt weathering is environment in brick structures.

Figure 2: Salt weathering

Results of XRD, Calcite (CaCO_3) was detected from brick debris at d3 spot, and Gypsum ($\text{CaCO}_4 \cdot 2\text{H}_2\text{O}$) was detected from brick debris at f1-2, and f1-3 spot. Both Calcite and Gypsum are poor solubility, and it is reported that these salts tend to form and separate in a high relative humidity environment. Moreover, it is reported that collapse of bricks is caused when humidity rises again, then salts in bricks deliquesce, because salts on the surface of bricks become heavy by absorbing moisture in the air, and it cause collapse of bricks. Therefore, amount of collapsed brick has increased even if Sarushima in July. Salt weathering is one of the drivers that induce the collapse of bricks, but amount in the f1-2 spot was larger than f1-3 spot despite Gypsum has been detected in f1-2 spot as well as f1-3 spot, thus it will be considered that the influence of vibration by tourists and the wind is other driver cause the collapse of bricks.

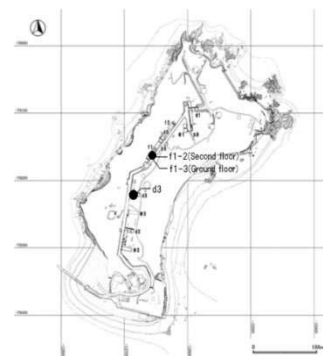
Investigation on monitoring was carried out in 3 places such as d3 spot, f1-2 spot, and f1-3 spot from June 5 through June 29, and June 29 through August 2, 2017 in Sarushima (Figure 3). Behavior of temperature and humidity were measured by HOBO U23 Pro v2 Temperature/Relative Humidity data logger which was set to be measured every 30 minutes. Amount of collapsed brick was measured by tray containers set on brick walls and weighed it every one month. The number of trays which were set is 2 at d3 spot, 3 at f1-2 spot, and 1 at f1-3 spot. Brick debris which obtained monthly were analyzed by using X-ray diffractometer (Bruker AXS, NEW D8 ADVANCE) to identify salts in brick debris. The X-ray target was Cu, the tube voltage was 40 kV and the tube current was 40 mA.

Figure 3: Measurement spots in Sarushima

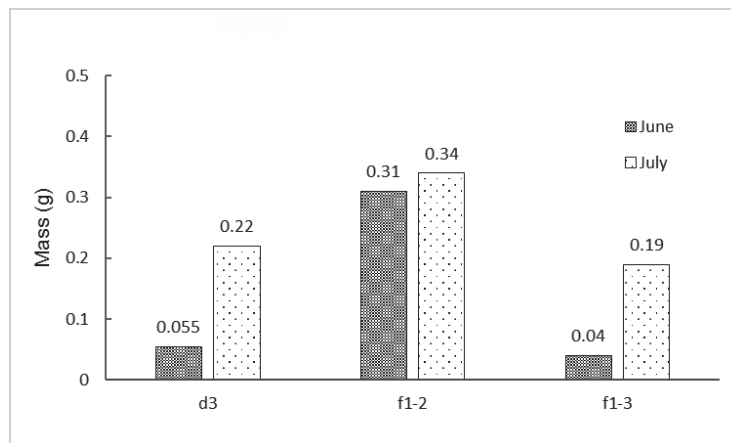
The environment in brick structures is high humidity, although amount of collapsed brick increase in July. Amount of collapsed brick of July 4 times larger than that of June at d3 spot, and 4.8 times larger than that of June at f1-3 spot (Figure 4).

Figure 4: Monthly amount of collapsed brick
