Institute for Sustainable Energy, University of Malta

**SUSTAINABLE ENERGY 2016:
THE ISE ANNUAL CONFERENCE**

**INVESTIGATING CRYSTALLINE SILICON CELL-BASED SOLAR PHOTOVOLTAIC MODULE
DEGRADATION IN THE MALTESE CLIMATE**

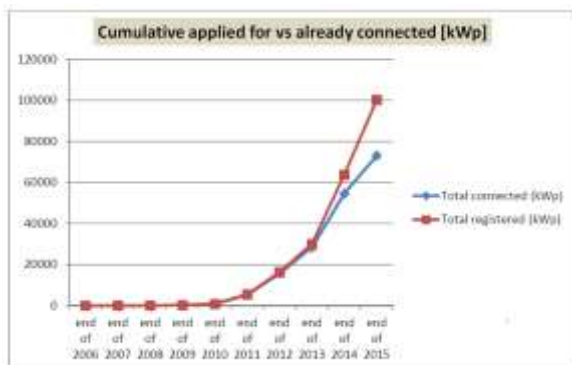
Figure 1: Cumulative PV installations in Malta [4]

short time span, and this is expected to remain so for the years to come, provided that the right incentives are made available. As shown in Figure 1 the cumulative installed capacity in Malta at the end of year 2015 reached 73.4 MWp, up from 54.8 MWp in year 2014. By the end of year 2011, a total of only 5.3 MWp were installed. This means that the total PV installations in 2015 represent a fourteen-fold increase [4].

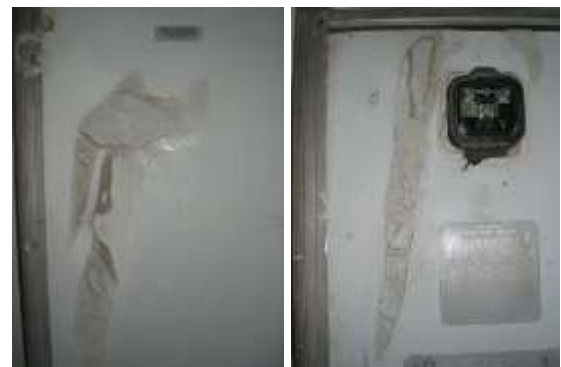
Figure 5: Backsheet tearing

The backsheet of a number of PV modules experienced tearing as shown in Figure 5.

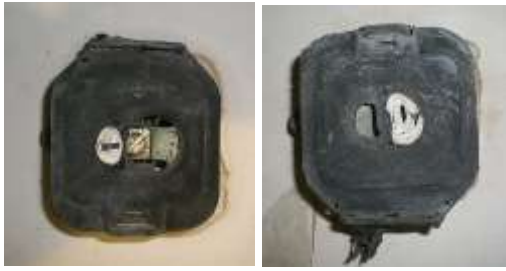
Figure 6: Junction boxes

As shown in Figure 6 the junction box's cover experienced substantial damage due to weathering. Humidity ingress and corrosion of the metal contacts are also evident. The bypass diodes inside the junction boxes were all functional.

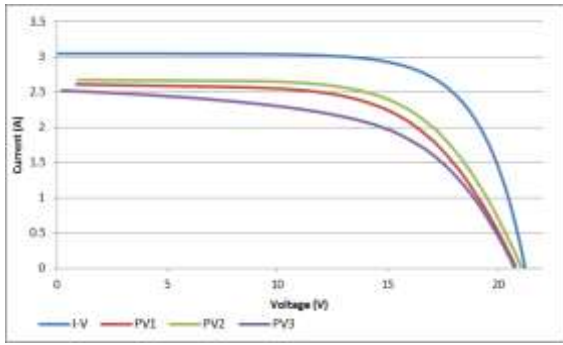
Figure 9: Photowatt Eighteen Year Modules I-V Curves

The average short circuit current (I_{SC}) of the modules with an intact substrate was measured at 2.65 A, which represents a drop of around 13% from the datasheet value of 3.05 A. The average open circuit voltage (V_{OC}) was at 21.13 V, which is 0.33% less than the specified value of 21.2 V. The average maximum power (P_{MAX}) was at (34.88 ± 1.79) W, compared to the datasheet value of 46W this results in a percentage drop per year of (1.34 ± 0.07) %/yr. Figure 9 shows the corrected I-V curves to standard STC for four modules.

The short circuit current of the module with a shattered glass substrate (PV3) was calculated at 2.53 A, which is 17% less than the specified value of 3.05 A. The open circuit voltage was at 20.92 V, which is 1.32% less than the datasheet value of 21.2 V. The maximum power stood at (29.63 ± 1.52) W, which is 35.58% less than the datasheet value of 46 W. This resulted in a further decrease in P_{MAX} of 11.5%.

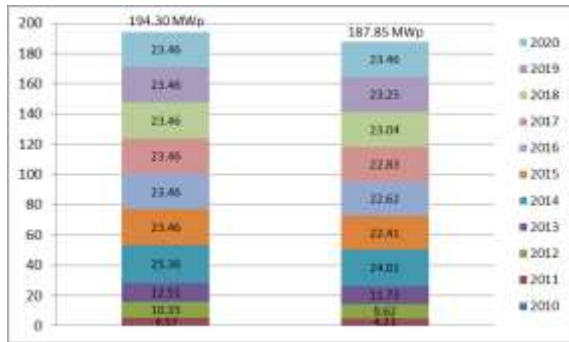
Figure 12: Average Degradation per Year Analysis

The average degradation rate was calculated considering the modules exposed to the Maltese climate between five and twenty-eight years. This results in a degradation rate of 0.91 %/yr. A loss of 6.45 MWp was calculated as shown in Figure 12. This is equivalent to around 14 football fields.

of 194.3 MWp is needed with an additional 6.45 MWp to cater for the expected degradation over the years leading to 2020.
