PRELIMINARY ANALYSIS OF THE NOVEMBER 10, 2014 RAINSTORM AND RELATED LANDSLIDES IN THE LOWER LAVAGNA VALLEY (EASTERN LIGURIA)

ANDREA CEVASCO^(*), GIACOMO PEPE^(*),
GIACOMO D'AMATO AVANZI^(**) & ROBERTO GIANNECCHINI^(**)

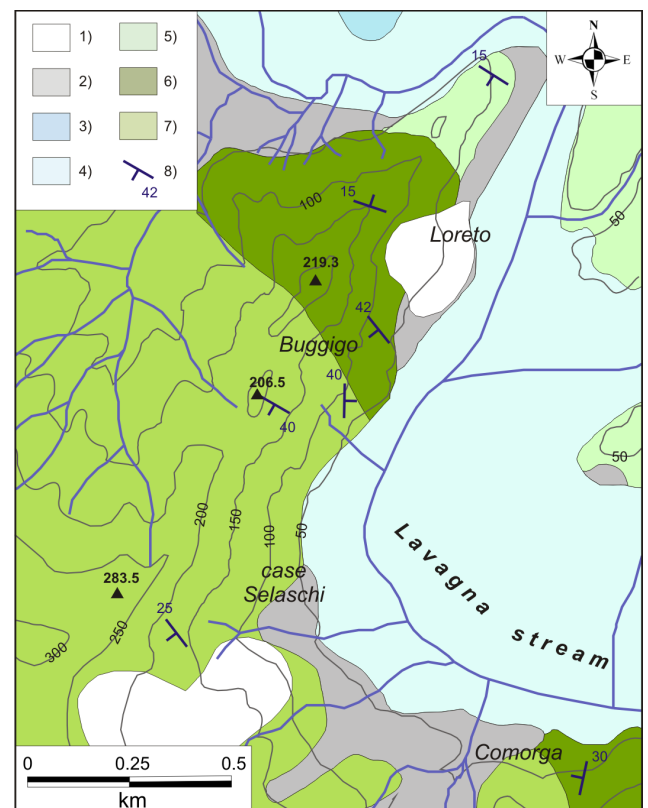
Fig. 2 - Geologic map of the study area (after ABBATE *et alii*, 2011, re-drawn and modified.). LEGEND: 1) landslide deposit; 2) slope deposit; 3) terraced alluvial deposit; 4) alluvial deposit; 5) M. Verzi Slate; Manganiferous Shales; 6) Palombini Clays; 7) bedding attitude

From a geological point of view, the bedrock is represented by formations belonging to the Gottero Unit (Internal Ligurid Units of the Northern Apennines). From SW to NE they outcrop in the following order (Fig. 2; ABBATE *et alii*, 2011): Palombini Clays, Manganiferous Shales and M. Verzi Slates. The Palombini Clays (Berriasian-Santonian p.p.) are formed of grey claystones and silstones with dark grey limestone interbedding; the Manganiferous Shales (upper Santonian-lower Campanian) are constituted by arenaceous-pelitic turbidites with exclusively siliciclastic composition whereas the M. Verzi Slates (Campanian) are represented by arenaceous-pelitic-turbidites interbedded by siliciclastic and marly-limestone levels (ELTER *et alii*, 2005). Such formations are tightly folded with axes NW-SE striking and show a dominant bedding attitude oriented south-westwards.

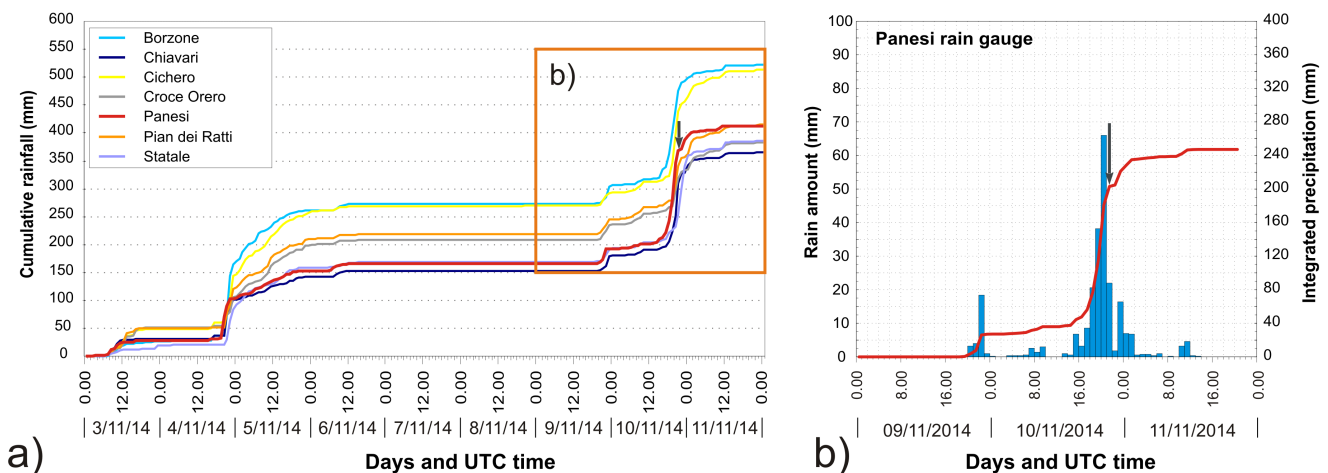
Fig. 3 - a) cumulative rainfall recorded by different raingauges located in the Lavagna, Sturla and Graveglia valleys from November 3, 2014 to November 11, 2014 (data from REGIONE LIGURIA-ARPAL 2014); b) hyetograms (blue bars) and cumulative rainfall (red line) of November 9-11, 2014 recorded at the Panesi raingauge (after CEVASCO *et alii*, 2015b, modified). The dark green arrows reported in a) and b) mark landslides a and a1 occurrence

meteorological network (Fig. 1). These were located at Borzone (386 m a.s.l.), Chiavari (6 m), Cichero (615 m), Croce d'Orero (640 m), Panesi (25 m), Pian dei Ratti (70 m) and Statale (593 m). The cumulated rainfall recorded on November 10, 2014 were almost 200 mm at Panesi and Borzone (194 mm and 193 mm respectively), whereas slightly lower values were recorded by the other rain gauges (Fig. 3a; Tab. 1). Rainfall intensity peaks were recorded in all the raingauges in the evening of November 10, 2014 (Fig. 3b; Tab. 1). The highest rainfall intensity was recorded

at Panesi, which is located about 2 km east from the study area. The 1h maximum intensity reached 66 mm between 20.00 and 21.00 UTC (Fig. 3b). The same raingauge recorded 147 mm/4h from 18.00 to 22.00 UTC. As an example of the very low lag time characterizing most of the Liguria basins, the hydrometric level of the Lavagna Torrent at Carasco raised 5.5 m in only three hours (from 19.00 to 22.00 UTC).

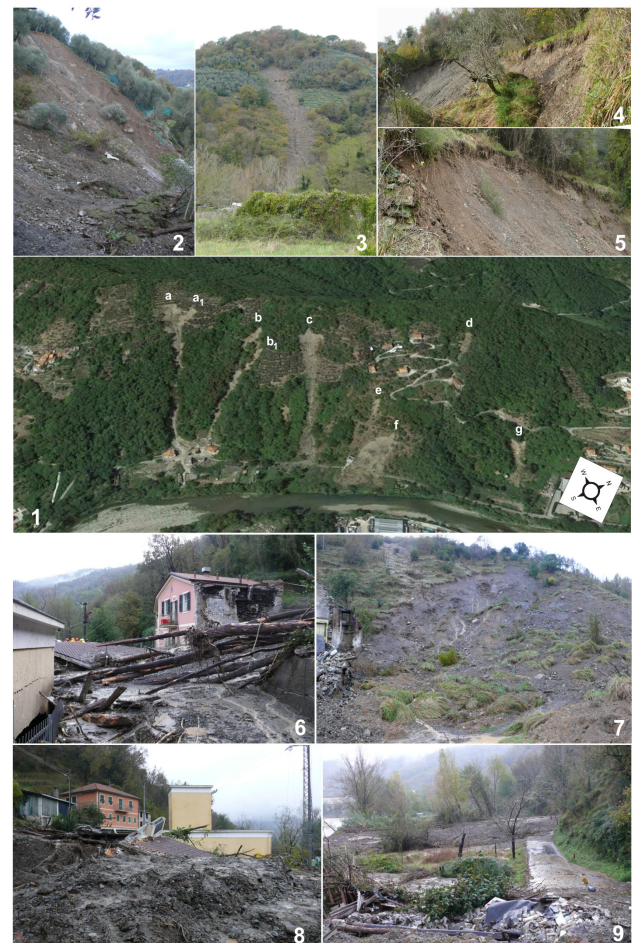
Fig. 4 - Views of the shallow landslides triggered on November 10, 2014 in the study area and related damage. 1) aerial image (from Google Earth); letters indicate the landslides; 2) detail of the source area of a large shallow landslide that gave rise to a debris flow (landslides a, a1); 3) landslide c; 4) detail of the scar of the landslide c; 5): detail of the scar of the landslide d; 6) and 8) view of the toe of the slope, where a debris flow (landslides a and a1) destroyed one building, causing two casualties; 7) landslide f; 9) damage to roads and private properties by landslide activity

In the evening of November 10, 2014 eight shallow landslides (Fig. 4) occurred on an area of just 160.000 m² (0.16 km²). According to the landslides classifications proposed by CRUDEN & VARNES (1996) and HUNGR *et alii* (2014), such landslides can be classified as debris slides, debris flows and debris avalanches. Shallow landslides affected terraced slopes which were characterized by different state of conservation. Abandoned terraced areas (partially invaded by mixed woods) were mainly affected by landslide activity, even though large portions of well maintained and cultivated terraces with olive grove were also scoured and damaged. However, solely one of the considered landslides affected a sparsely vegetated area. Landslide activity involved man reworked debris covers (from 0.5 m to about 3-4 m thick) and portions of the weathered and fractured bedrock. In all cases, landslide deposits reached the

toe of the slope, involving one road and some sparse houses. In the south-western sector, one of such houses was destroyed by a debris flow (Fig. 4), causing two casualties, whereas a nearby service station for water supply was impacted and damaged by debris deposits, leading to a long time interruption of water distribution. Damage also affected other two houses located in the central and the north-eastern sector of the slope, respectively. The first one was impacted and partially destroyed; the second one was only damaged by landslide deposits. Long tracts of the road running parallel to the Lavagna stream at the slope's toe were buried by landslides debris, producing interruption which currently continues. As a consequence of the severe damage, all the people living on slope settlements were evacuated.

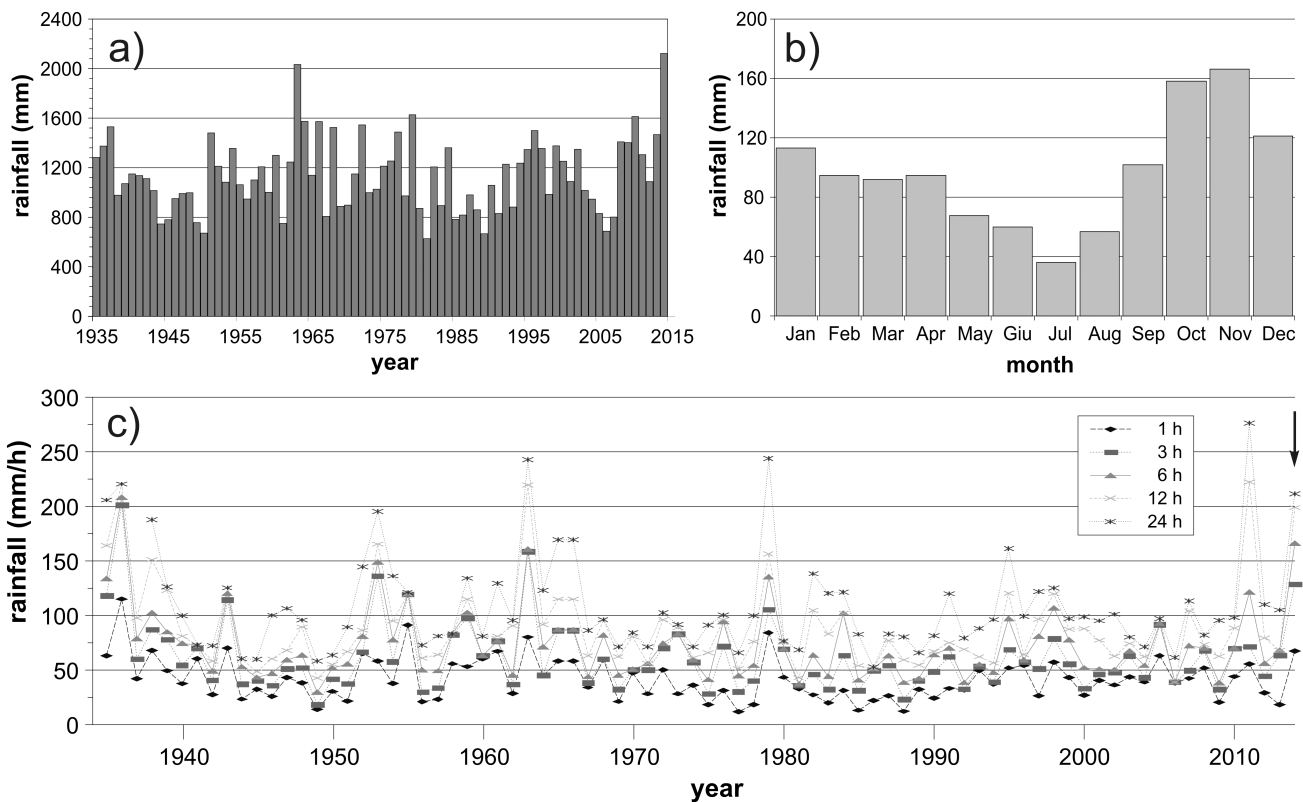
Fig. 5 - Historical rainfall data at Panesi (1935–2014 period). a) Mean annual precipitation; b) mean monthly precipitation; c) maximum intensity rainfall in 1, 3, 6, 12 and 24 h. The black arrow indicates the maximum intensity rainfall in 1, 3, 6, 12 and 24 h recorded at Panesi during the November 9-11, 2014 rainfall event

and analysed. For the 80-years time period analysed, the assessed Mean Annual Precipitation (MAP) is 1164 mm, the minimum and the maximum annual rainfall are 627 mm (detected in 1981) and 2122 mm (referred to 2014), respectively (Fig. 5a). The rainiest month is November, with a mean precipitation of 166 mm, whereas July appears the driest month, with a mean precipitation of 36 mm (Fig. 5b). The maximum rainfall intensity analysis showed that the 1h peak intensity of November 10, 2014 was largely exceeded already in 1936, 1955, 1963 and 1979, as well as the 3h peak intensity, exceeded in 1936, 1953 and 1963 (Fig. 5c). Decreasing trends for 1h, 3h, 6h and 12h maximum rainfall intensity were observed in the reference period whereas there was a substantially stable trend regarding 24 h maximum rainfall intensity.

With reference to the 1963 event (which occurred on September 4th), return times higher than 50, 500 and 200 years were assessed for the maximum intensity rainfalls in 1, 3, 6 and 12 h, respectively (ARPAL-CFMI-PC, 2013). No data about the return times of the maximum rainfall intensity were available regarding the September 25, 1936 intense rainfall. However, the maximum rainfall intensity data referred to the Chiavari rain gauge highlighted that the intensity values recorded on November 10, 2014 were about doubled on September 25, 1936, with maximum rainfall intensity in 1, 3, 6 and 12 h equal to 115, 201, 208 and 220.4 mm, respectively. Taking into account the distribution of the maximum rainfall intensity events in the analyzed time period, the last fifty years (1964-2014) seem quieter with respect to the 1935-1964 period. The maximum rainfall intensity values in 3 and 6 h recorded on November 10, 2014 were the highest of the last fifty years (Fig. 5c). Moreover, it is interesting to note that the value of the mean rainfall of the rainiest month (166 mm) was equalled on November 10, 2014 by the maximum intensity rainfall only in 6 h. This would suggest a strongly localized in time and space heavy precipitation event, which would explain the resulting effects at the surface.

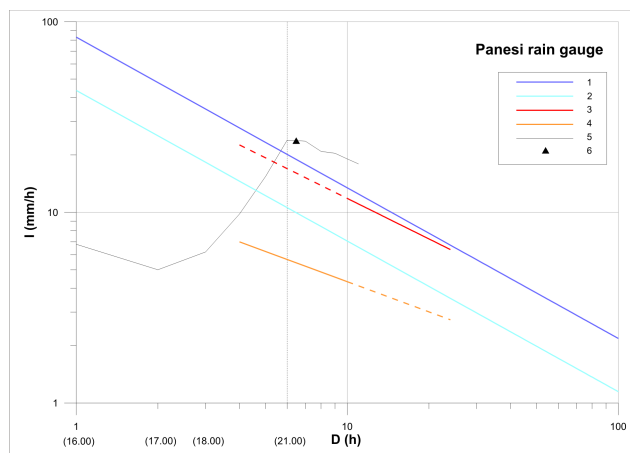
Fig. 6 - Rainfall I-D thresholds established locally for triggering shallow landslides. The UTC time is shown, in brackets, on horizontal axis. LEGEND: 1) Eastern Ligurian Riviera (upper) (GIANNACCCHINI et alii, 2015); 2) Eastern Ligurian Riviera (lower) (GIANNACCCHINI et alii, 2015); 3) Bisagno valley, Genoa (upper) (CEVASCO et alii 2008; 2010); 4) Bisagno valley, Genoa (lower) (CEVASCO et alii 2008; 2010) 5) November 10, 2014 rain path at Panesi raingauge; 6) landslides a and a1 occurrence

exceeded the worldwide (CAINE, 1980), national (BRUNETTI *et alii*, 2010) and local rainfall intensity-duration thresholds (CEVASCO *et alii*, 2008, 2010; GIANNACCHINI *et alii*, 2015) for shallow landslides activation (Fig. 6). As regards the time of landslides triggering, information coming from local people and newspapers revealed that the most destructive phenomenon was triggered on November 10, 2014 between 21.00 and 22.00 (UTC), which means just before the maximum 1h intensity peak recorded at the Panesi rain gauge.

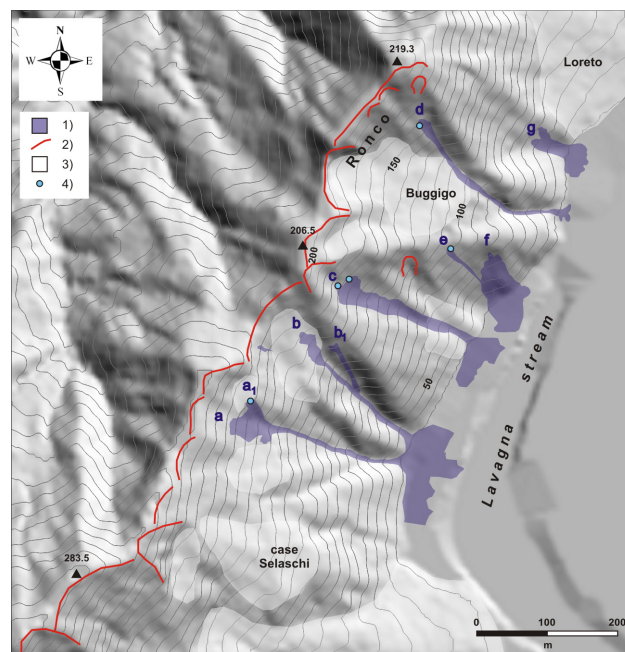
Fig. 7 - Map of shallow landslides occurred on November 10, 2014 in the Leivi slope and morphological features of ancient landslides. LEGEND: 1) shallow landslides occurred on November 10, 2014 in the Leivi slope; 2), 3) scars and deposits of ancient landslides detected by the analysis of topographic maps and aerial photographs; 4) location of sampling points

The morphological features of the landslides are shown in Fig. 7. The scars of the four main landslides that evolved into flows (a, b, c, d in Fig. 7) are located at similar height, ranging between 160 m and 185 m a.s.l. On the contrary, three shallow landslides (e, f, g in Fig. 7) initiated and affected the middle-lower slope, with scars reaching altitudes ranging between 60 and 100 m a.s.l. On-site observations showed that most of the landslides (a, b, c, d, g) initiated in hollows or in concave slopes; in all cases the landslide material reached the toe of the slope by means of a movement which can be classified from rapid to very rapid (Fig. 7).

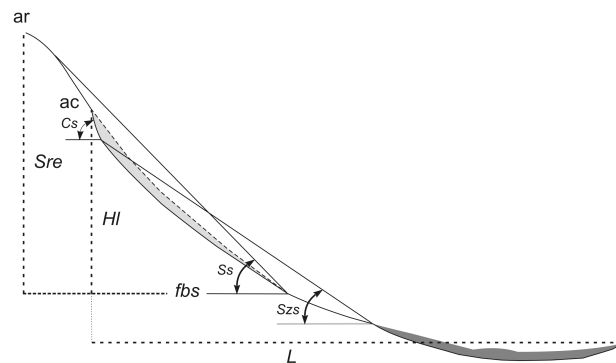
Fig. 8 - Morphometric parameters considered for the main earth-debris avalanches/earth-debris flows (after DI CRESCENZO & SANTO, 2005, modified). LEGEND: ar) altitude of the ridge (a.s.l.); ac) altitude of the landslide crown (a.s.l.); fbs) altitude of the first break of slope at the foot of the slope (a.s.l.); Sre) slope relief energy; HI) height of the landslide crown zone; L) length of the landslide; Ss) slope steepness; Cs) crown steepness; Szs) sliding zone steepness; Ass) extent of the landslide source area; Ad) extent of the landslide deposit

proposed by DI CRESCENZO & SANTO (2005) was applied (Fig. 8). The main morphometric parameters obtained for the four main landslides that evolved into flows (a, b, c and d) are showed in Tab. 2. They included slope angle of the crown (Cs) and of the sliding zone (Szs), crown altitude (ac), areal extent of the landslide source areas and sliding zone (Ass), areal extent of landslide deposits (Ad), length of the landslide (L), height of the landslide crown zone (HI), slope steepness (Ss) and slope relief energy (Sre). According to DI CRESCENZO & SANTO (2005), the slope relief energy was calculated as the difference in height between the divide of the landslide slope (ar) and the first break of slope at the foot of the slope (fbs).

The length of landslides a, b, c, d ranges between 258 m (landslide c) and 342 m (landslide a) while the extent of source areas and sliding zones varies between about 1,800 m² (landslide b) and 4,000 m² (landslide c). The length of landslides occurred in the middle lower slope (e, f, g) is lower than the previous ones and ranging between 88 m (landslide g) and 120 m (landslide f), as well as the extent of landslide source areas and sliding zones (Ass), which ranges between 360 m² (landslide e) and 1800 m² (landslide f). In the cases of landslides a, b, c and d, the slope steepness ranges between 32° (landslide d) and 39° (landslide b) while the crown steepness varies between 30° (landslide b) and 39° (landslide d). Values of sliding zone steepness are slightly lower than the previous ones, ranging between 26° (landslide d) and 33° (landslides a and c). As for the relief energy of slopes (Sre), the landslides a, b, c and d occurred on slopes between 114 m (landslide d) and 180 m (landslide a) in height. There is a small difference between the total extent of landslide source areas and

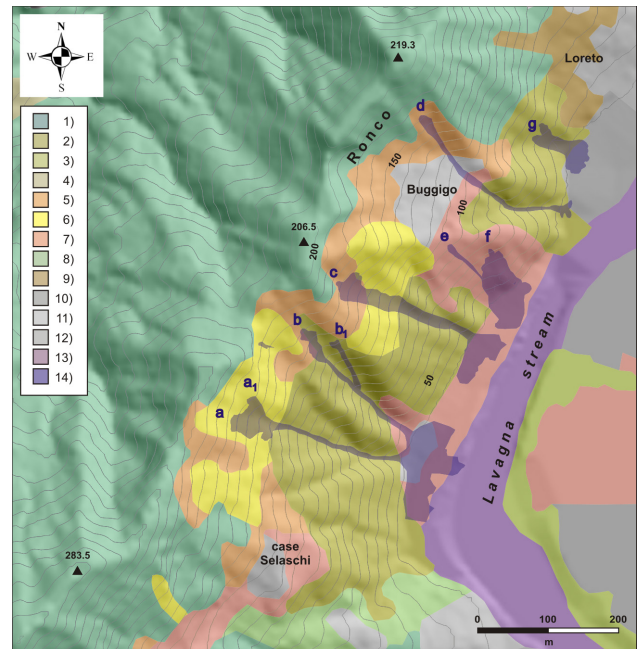
Fig. 9 - Map of shallow landslides that occurred on November 10, 2014 in the Leivi slope and land use. LEGEND: 1) chestnut; 2) mixed wood; 3) wood of hygrophilous species; 4) area with shrub vegetation in evolution; 5) abandoned olive grove 6) olive grove; 7) complex cropping system; 8) grassland; 9) vineyard and olive grove; 10) industrial areas; 11) sparse residential fabric; 12) dense residential fabric; 13) riverbeds with scarce vegetation; 14) November 10, 2014 shallow landslides

As stated previously, in the source areas the land use setting prevalently consists of terracing characterized by different state of maintenance. Where terracing has been abandoned since short and long time, scrubs and woods had grown, respectively. As can be seen in Fig. 9, most of the shallow landslide source areas affected abandoned terracing (landslides b, b1, c, d, e, f, g), which currently appear occupied by vegetation cover of different age. In particular, the source areas of landslides b, c and d were triggered on short time abandoned olive groves, where a sparse vegetation has grown. On the contrary, the source areas of landslides b1 and g were triggered on long time abandoned olive groves, where a mixed wood had grown. The source areas of landslides e and f affected very scarcely vegetated areas. Lastly, well maintained terraces with olive grove cultivations were involved by landslides source areas belonging to landslides a and a1 (Fig. 9).

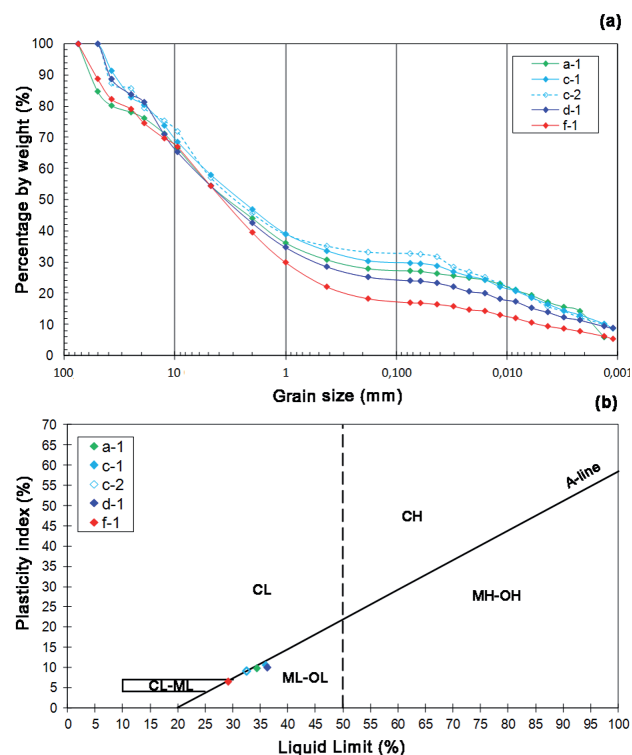
Fig. 10 - Grain size distribution (a) and Casagrande Plasticity Chart (b) of the soil samples collected at different landslide source areas

in different landslide source areas. Laboratory tests allowed both the soil classification and the determination of the physical properties (Fig. 10). According to the U.S.C.S. soil classification system, the soils can be classified as silty sands with gravel (SM). The results of the grain size analysis showed that the slope materials are somewhat homogeneous (Tab. 3). All the soils are very poorly sorted, with coefficient of uniformity (CU) values

greater than 100. Gravel content often reaches 45%, while sand fractions are 30% on average. The fines contents are usually less than 30%, and the clay contents rarely exceed 12%. The gravel fraction consists of angular and platy pebbles with a strong fissility. Liquid limits were not very high, ranging between 29.1% and 36.2% (Tab. 4). The Plasticity Index (PI) values, ranging between 8.3% and 10.7%, show a low plasticity of the soils. Lastly, the specific gravity of the soil particles ranges from 2.5 to 2.7 g/cm³.
