Session B6- Dam Removal on Main Street in Historic Pawtuxet Village

Restoring an Urban River in a Historic Setting

Lower Pawtuxet River, R.I.

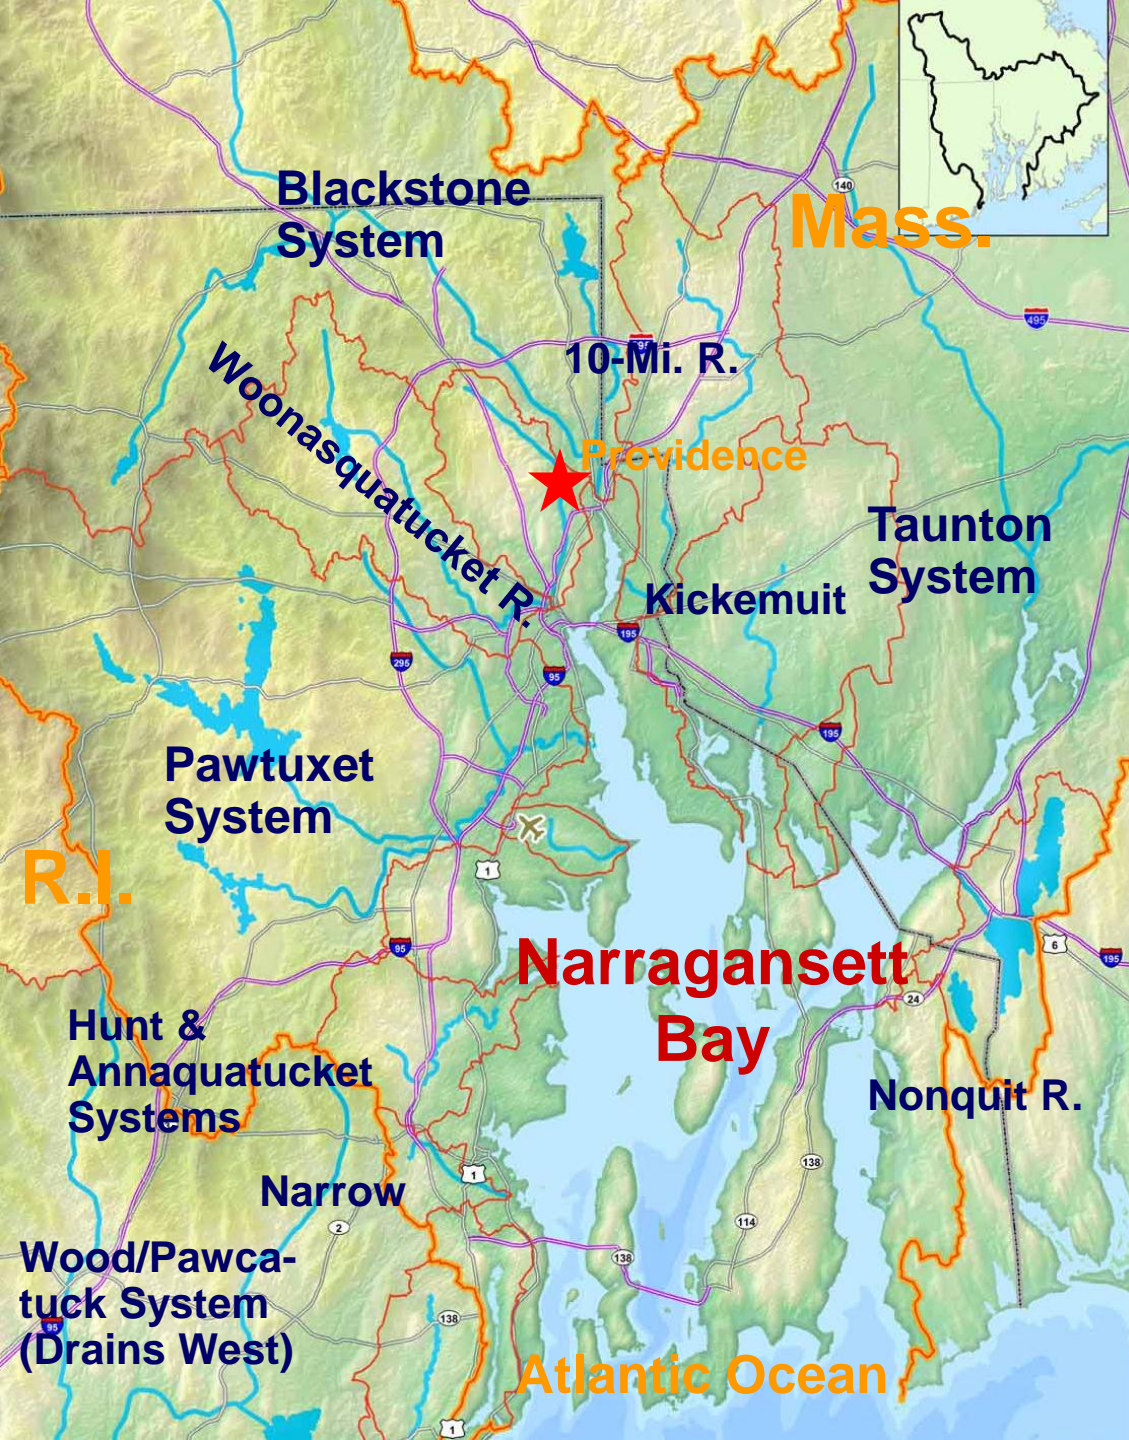
Narragansett Bay Sub-Basins

Avg. Flows, m³/s

- All Rivers = 93
- Taunton = 30
- Blackstone = 21
- Pawtuxet = 10
- (collectively 2/3 of flow)
- Others < 10
- Larger systems flow into northern (upper) reaches of estuary
- Pawtuxet Basin is rural with large reservoirs upstream; highly urbanized downstream

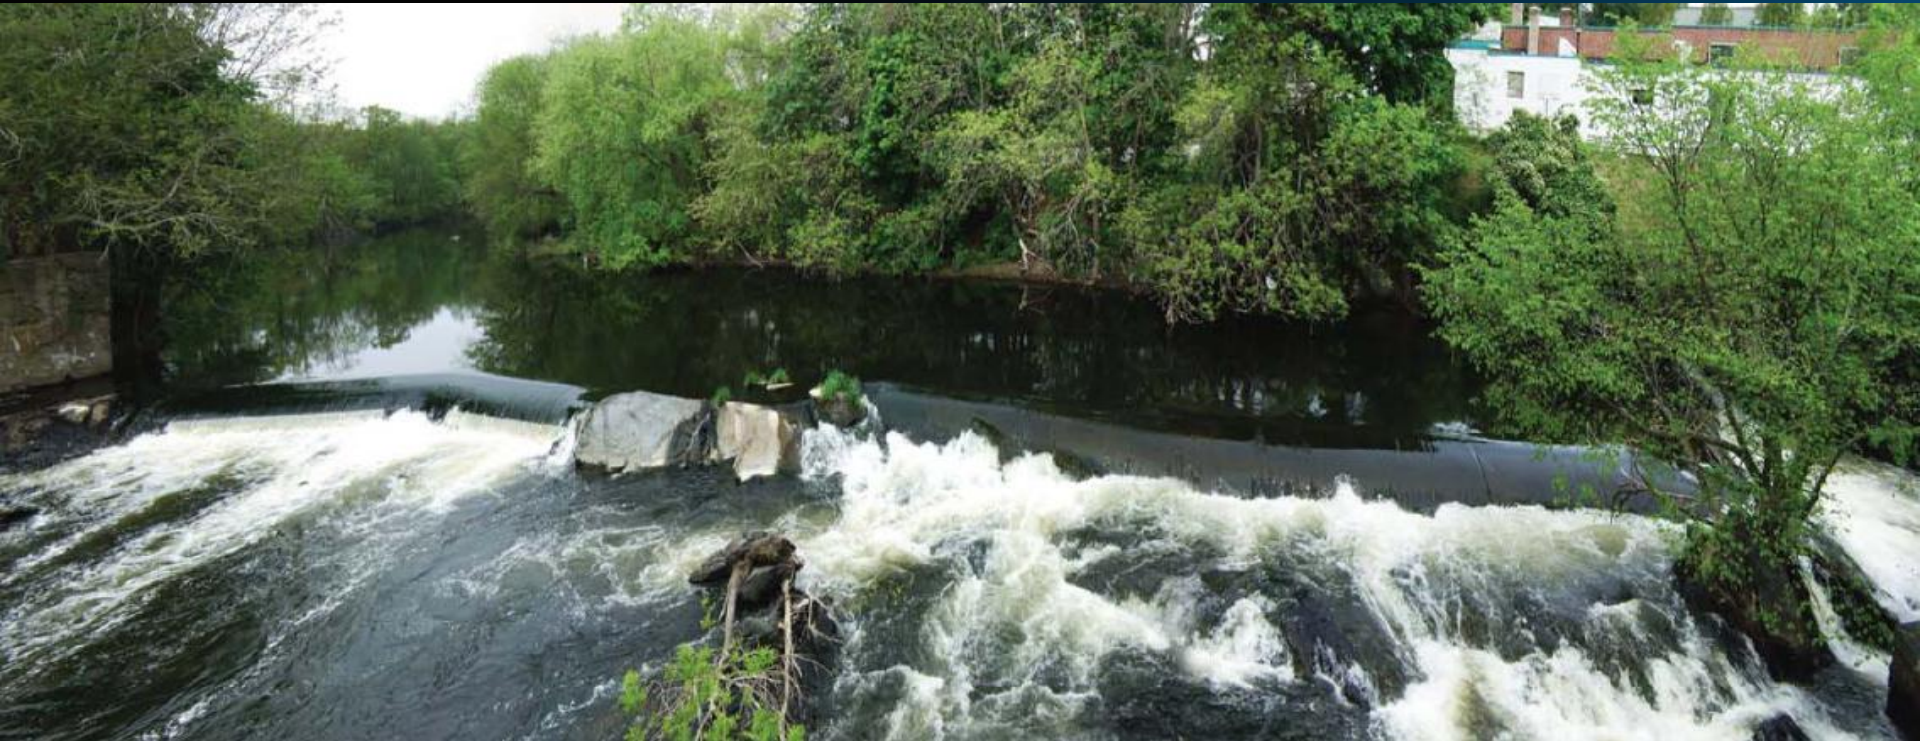
Pawtuxet Falls Dam

- Located at head of tide: 7 river miles to next dam
- 3.5' hydraulic height; 150' spillway
- Contributing feature of NHR district—centerpiece of historic village
- Dammed location 200+ years
- Mill power, water supply, recreation
- Concrete structure built 1920's

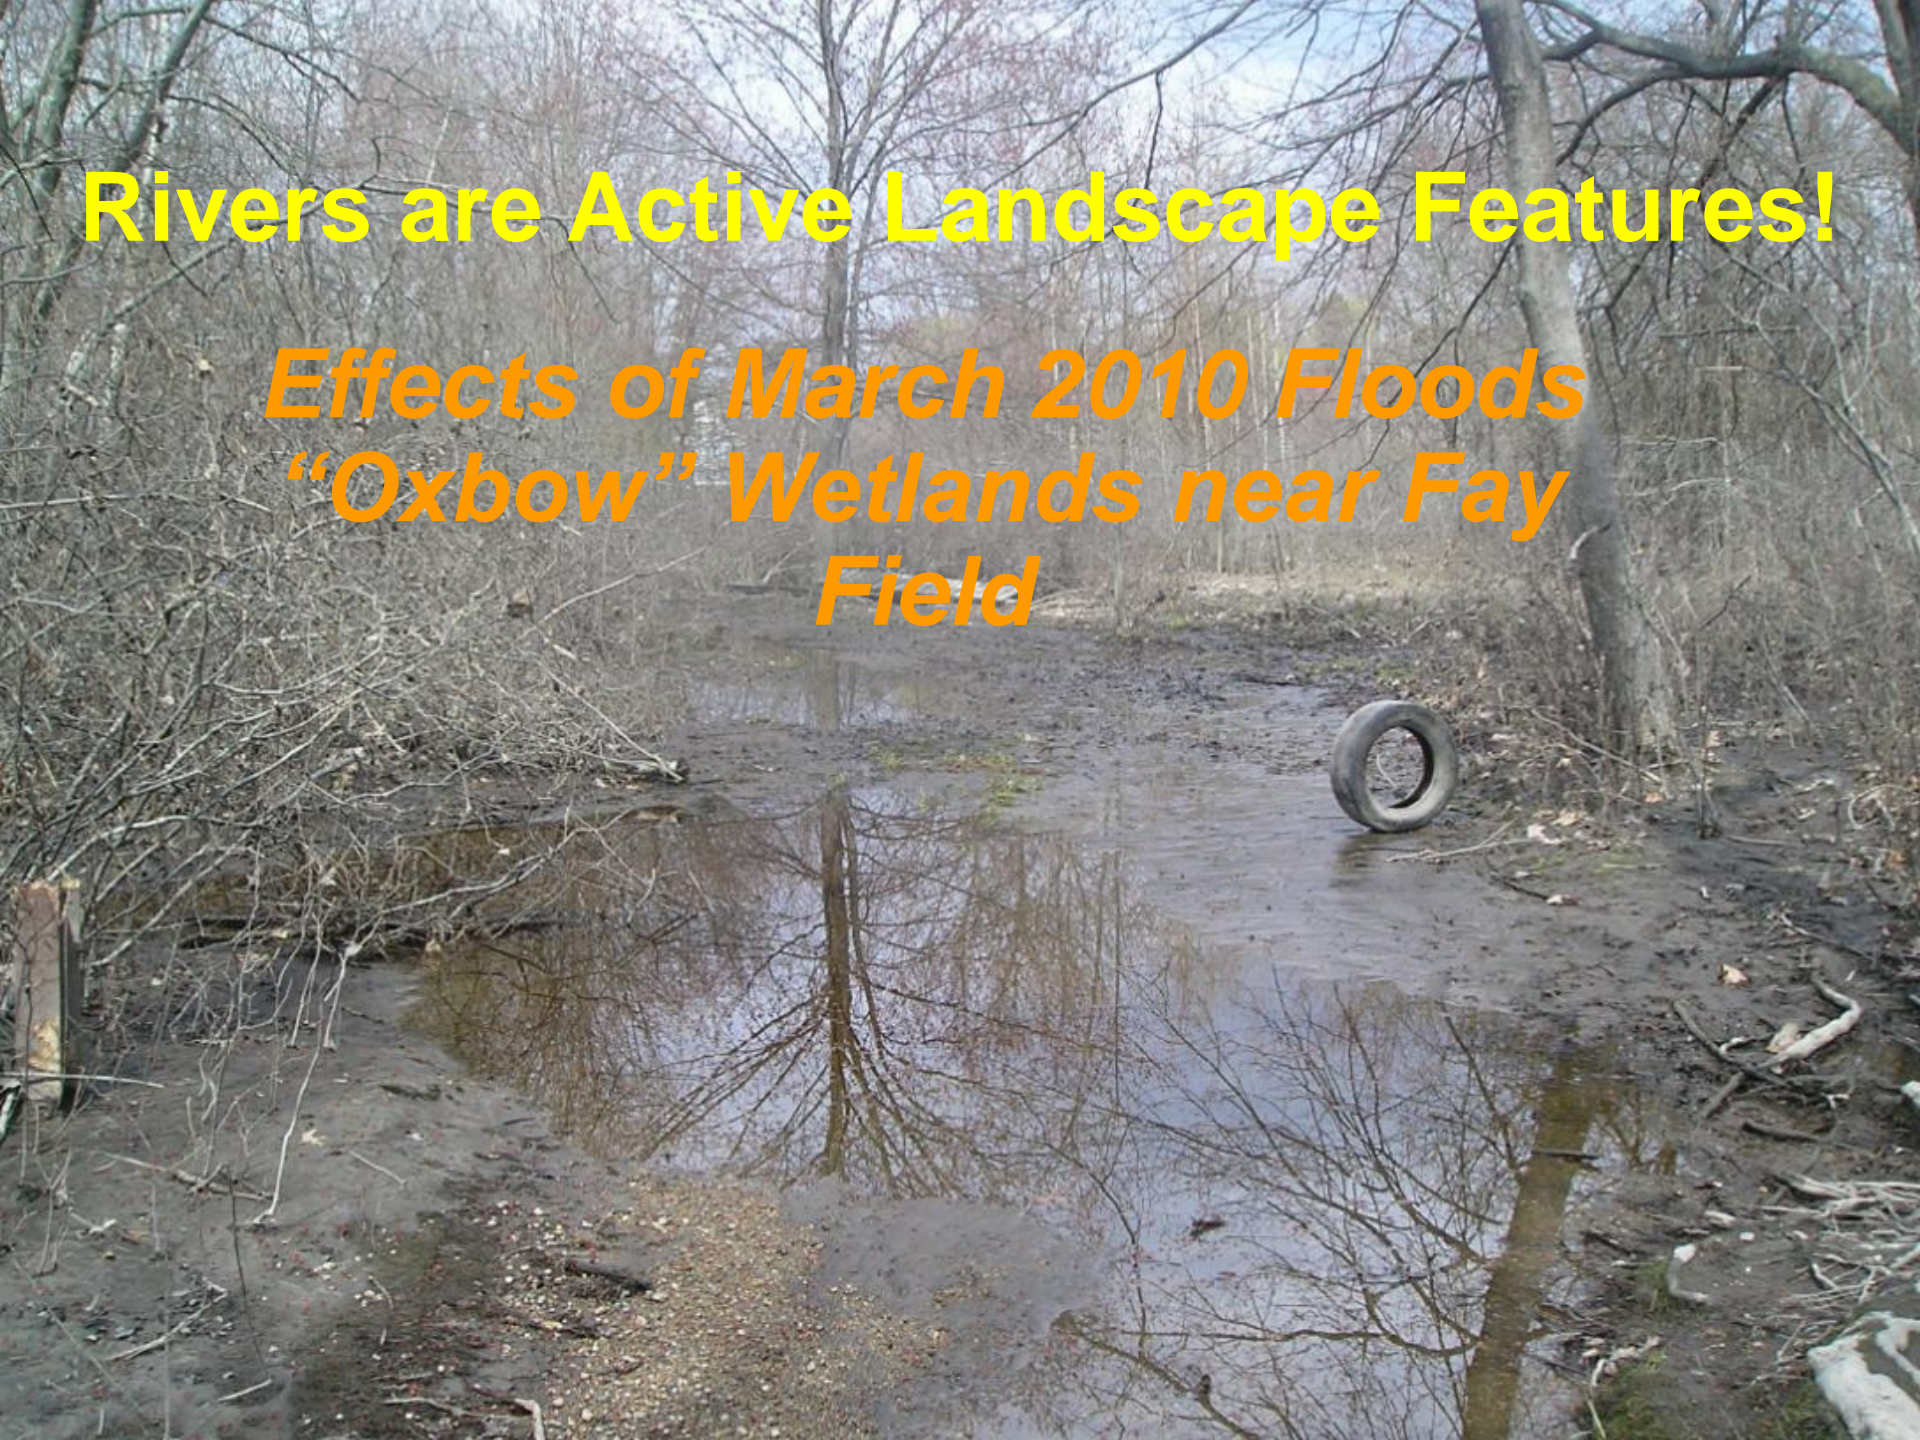
Rivers are Active Landscape Features!

*Effects of March 2010 Floods
“Oxbow” Wetlands near Fay
Field*

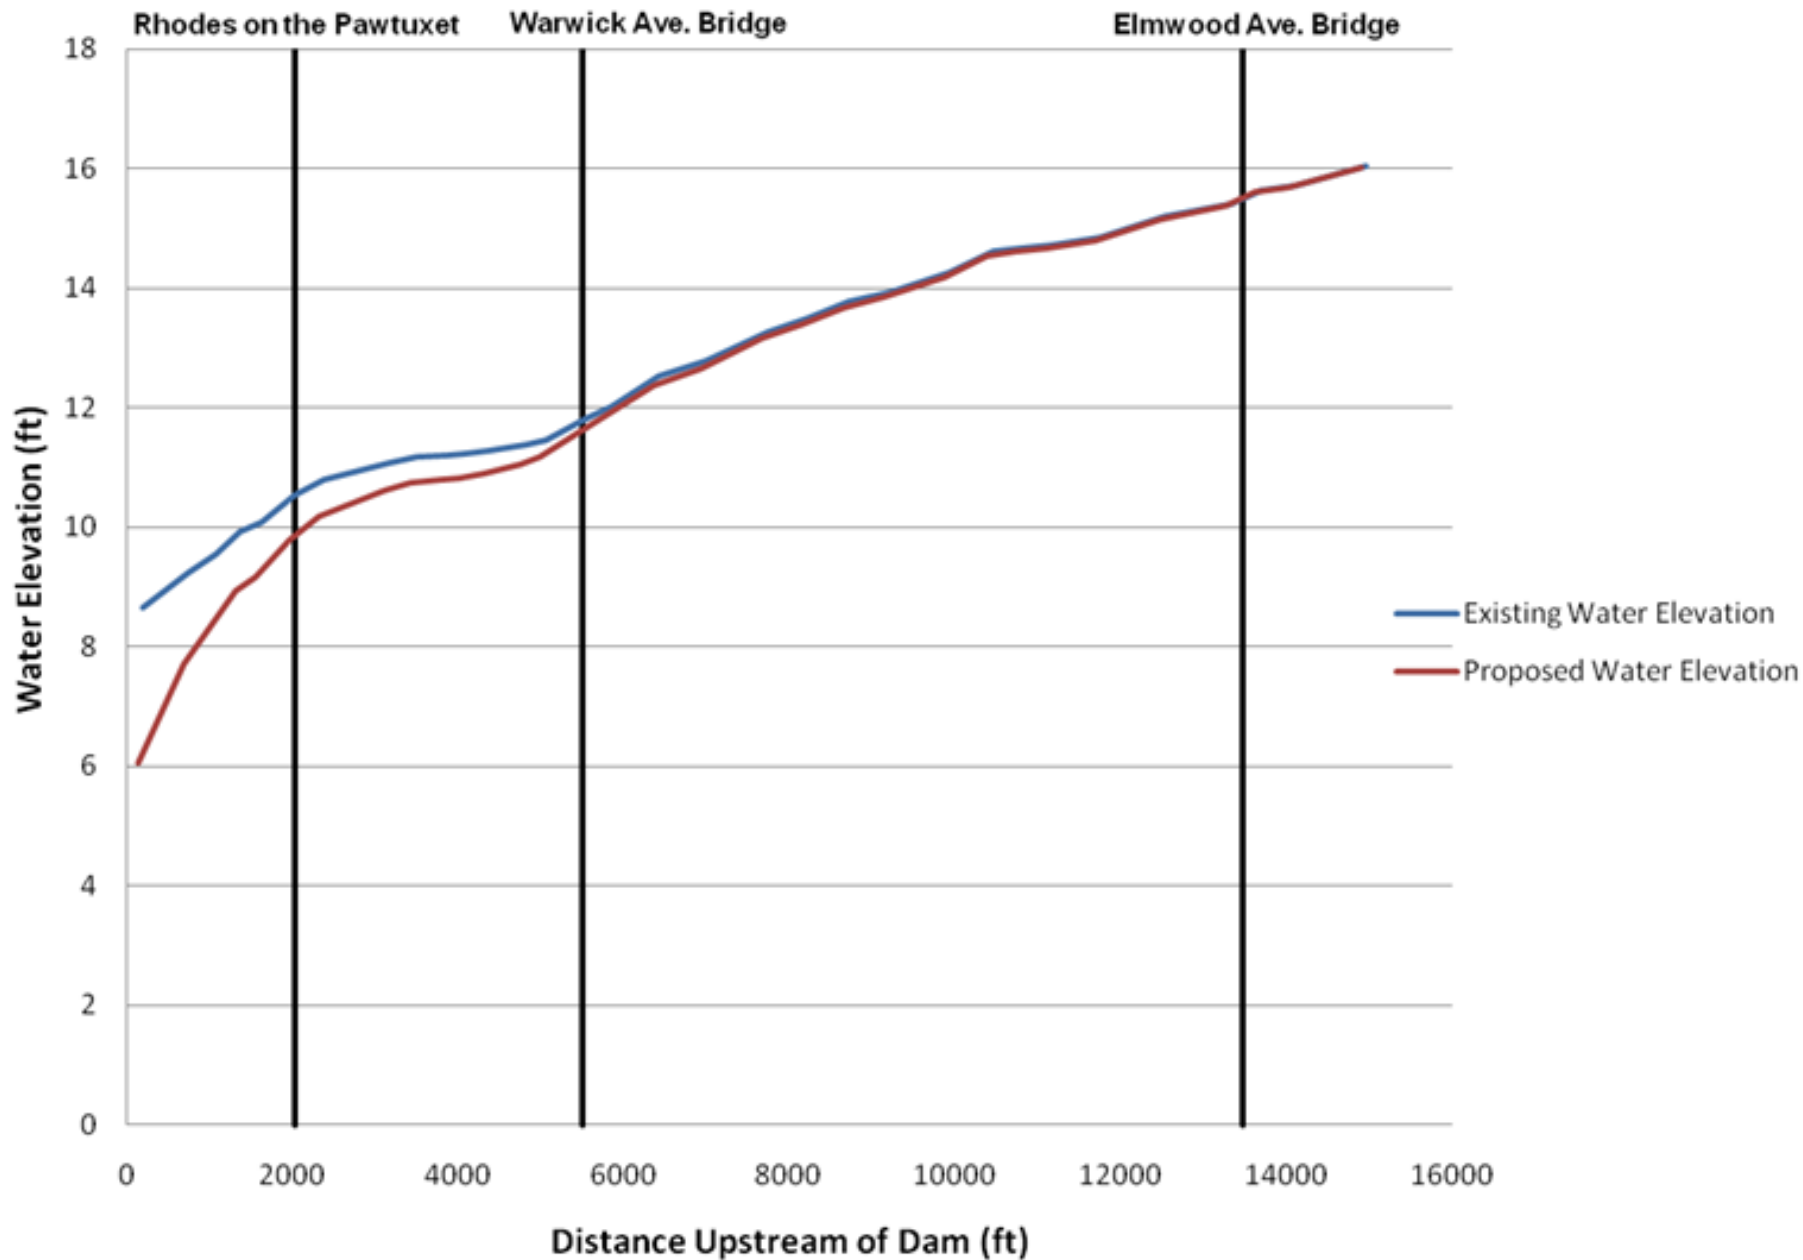
10-yr Storm (10% Chance of Occurring Each Year)

Effect of Pawtuxet Partial Dam Removal

- Maximum reduction in water height:
 - 3.5 feet (low flow at dam)
 - 2 feet (Warwick Ave)
 - Zero change at I-95
- Reduced flooding impacts up to 10 year storms
- No change under very high flows/large floods
- No increase in erosion
- Faster drainage following larger floods
- Maintain sufficient depth for recreational boating

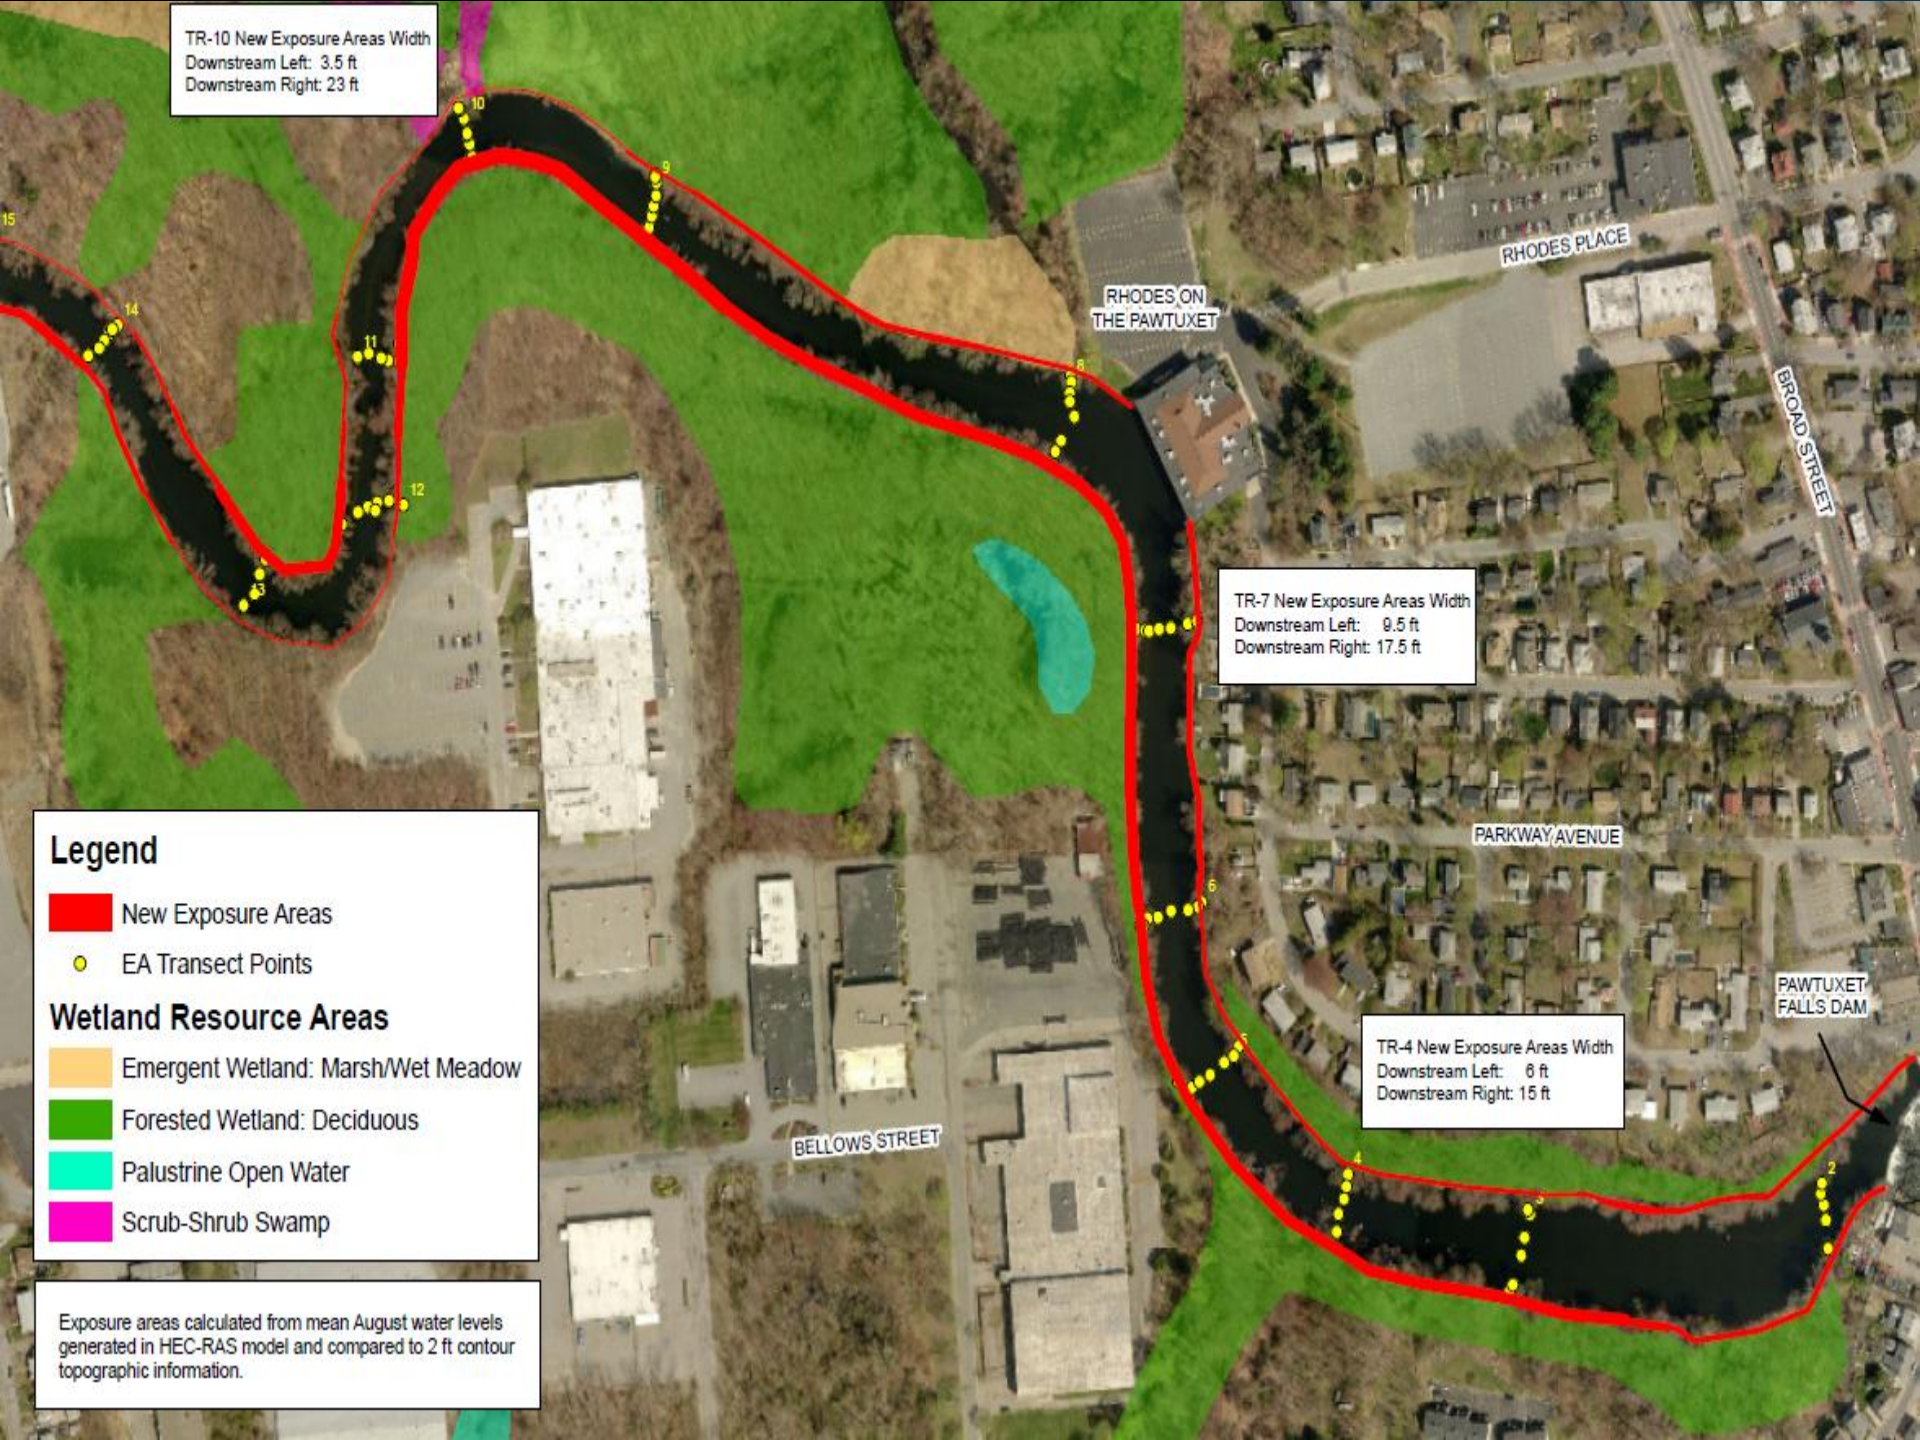
TR-10 New Exposure Areas Width
Downstream Left: 3.5 ft
Downstream Right: 23 ft

TR-7 New Exposure Areas Width
Downstream Left: 9.5 ft
Downstream Right: 17.5 ft

TR-4 New Exposure Areas Width
Downstream Left: 6 ft
Downstream Right: 15 ft

Exposure areas calculated from mean August water levels generated in HEC-RAS model and compared to 2 ft contour topographic information.

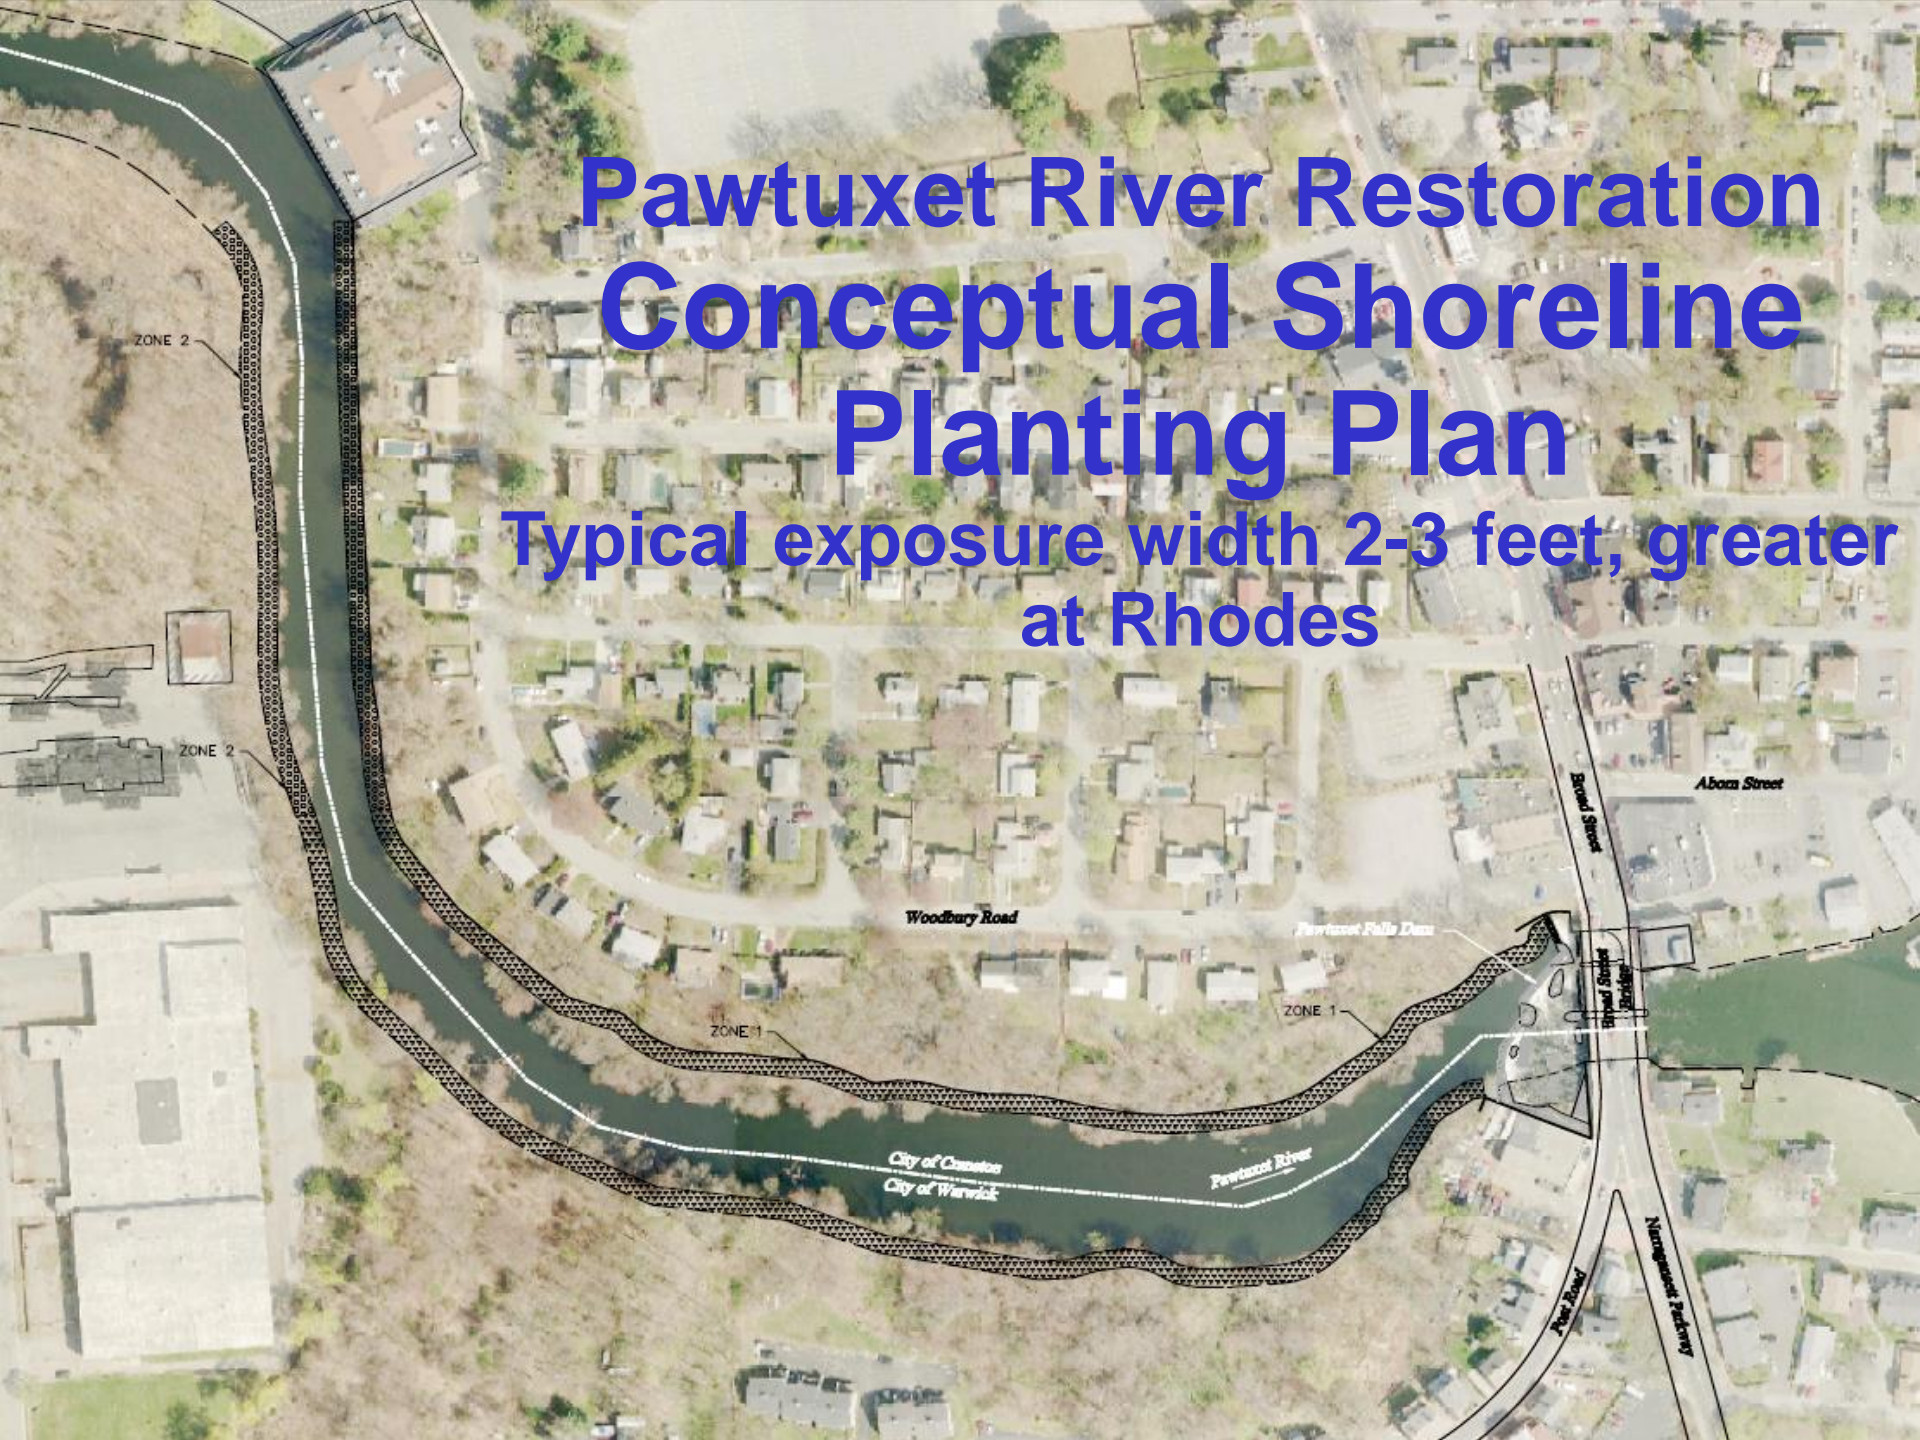
Pawtuxet River Restoration Conceptual Shoreline Planting Plan

Typical exposure width 2-3 feet, greater
at Rhodes
