Material Loss at the Taper Junction of Retrieved Large Head Metal-on-Metal Total Hip Replacements

Published online 5 August 2013 in Wiley Online Library (wileyonlinelibrary.com). DOI 10.1002/jor.22431

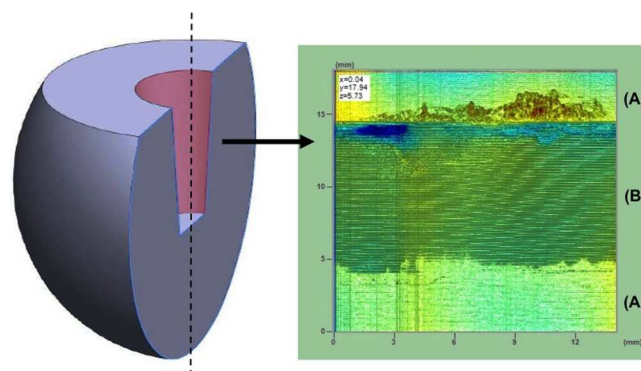
Figure 1. Schematic demonstrating the method and analysis of taper surface measurement. The regions labeled (A) represent unworn areas of the male taper. The worn area of the female taper, labeled (B), represents the area engaged with the male taper.

The female taper measurement was a series of vertical traces coincident to the taper axis. These were combined into a rectangular surface contour map, and analyzed using a Matlab (Mathworks, Inc., Natick, MA) program to calculate the volume of material loss, accounting for the taper's conical shape. The data were leveled through manual selection of the taper that can be considered to constitute the unworn reference surface (Fig. 1). The surfaces were then digitally regenerated and the volume of material loss calculated using a generated Abbott–Firestone curve.

Material loss from the male taper was more difficult to assess. In most cases the entire surface had been engaged with the female taper, and so a true reference surface was unavailable. In such cases, individual areas of material loss were isolated and assessed to give localized volumes of material loss, which were then summed to give the total volume of material loss. A separate Matlab based program was used to calculate the volume of material loss, for which it was required to filter the measured machine-threaded surface texture from the measurement.

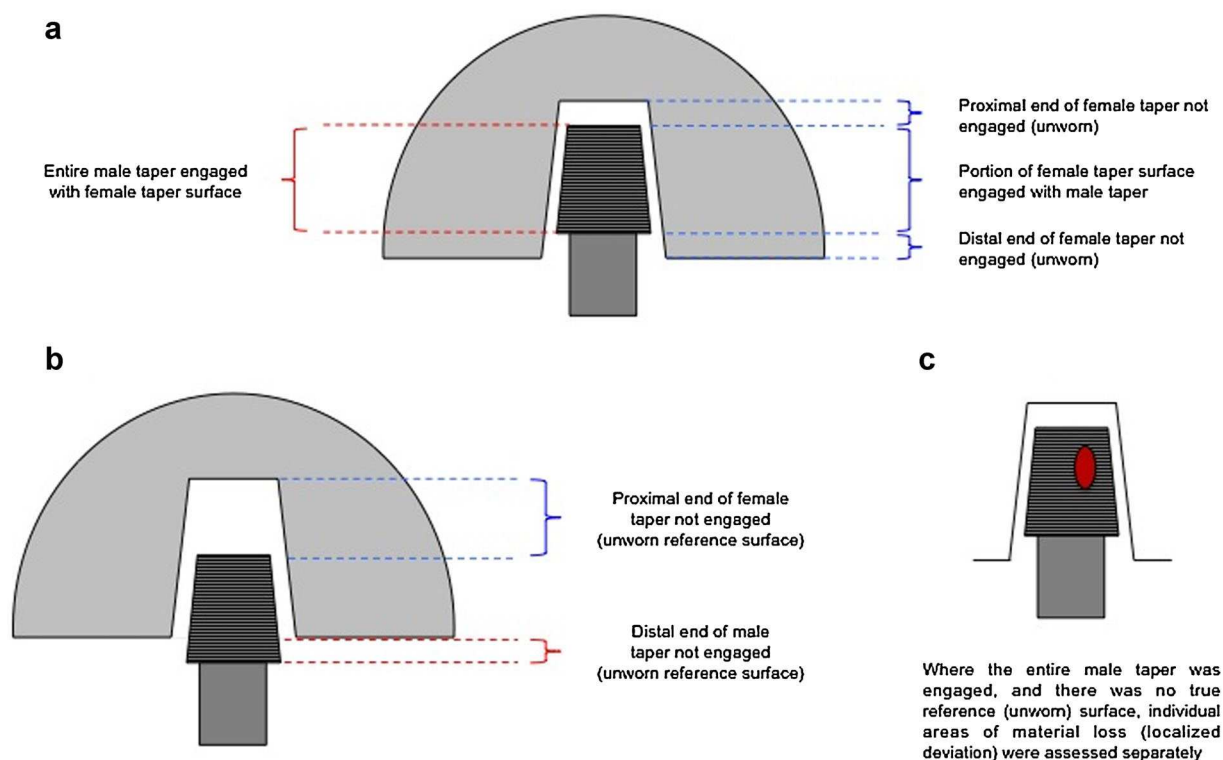
Figure 2. Schematic diagram of the taper junction. (a): The most common situation in which the entire male taper is engaged with the female taper. While unworn regions of the female taper could be used as a reference surface, the entire male taper is engaged with no unworn regions. In this case, areas of material loss (deviations) were assessed individually (c). In some cases, the most proximal portion of the male taper was not engaged and could be used as an unworn reference surface (b).

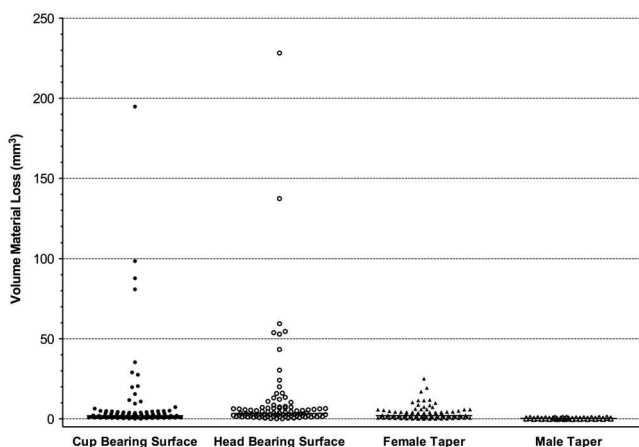
Figure 3. Graph comparing volumetric material loss of the bearing and taper surfaces.

A summary of the surface measurement data is given in Table 3. The median volume (2.02 mm³) of material lost from the female taper surface was significantly less than the median volume of material lost from the femoral head bearing surface (3.44 mm³, $p < 0.001$), but not different to that from the acetabular bearing surface (1.94 mm³, $p = 0.55$). For the 36 male tapers, the volume of material loss was negligible (<1 mm³) in all cases. The median volume (0.29 mm³)

was significantly less than that lost from the female taper and the head and acetabular bearing surfaces (all $p < 0.001$). Comparison of the taper and bearing surface data is shown in Figure 3. Material loss from the female taper was greater than that from the combined bearing surfaces in only 23% of the cases.

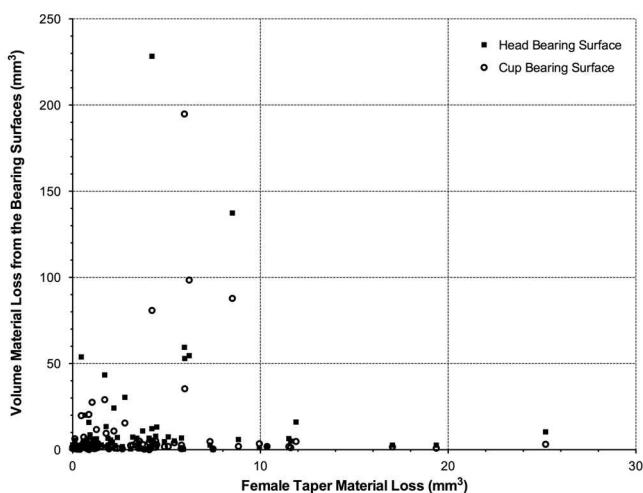
Figure 4. Scatter plot showing the correlations between the volume of material loss from the female taper and the bearing surfaces.

A weak but significant positive correlation existed between the volume of material loss from the female taper and that from the head-bearing surface ($\rho = 0.25$, 95% CI = 0.05–0.44, $p = 0.017$). The correlation between volume loss from the female taper and that from the acetabular bearing surface ($\rho = 0.17$, 95% CI = -0.04–0.36, $p = 0.12$) was not significant (Fig. 4).

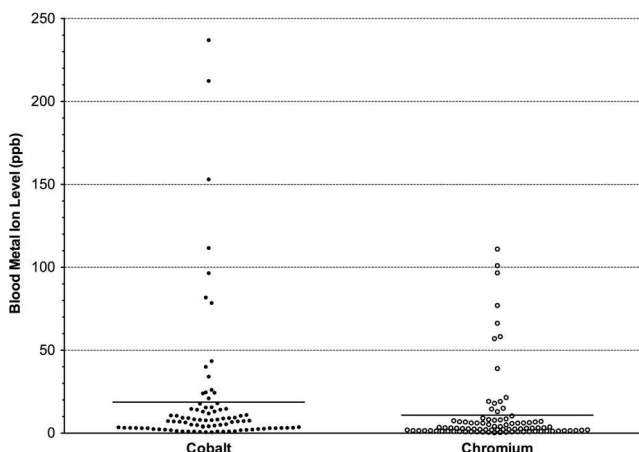
Figure 5. Comparison of whole blood Co and Cr ion levels.

The median Co level of 7.6 ppb was significantly higher than the median Cr level of 3.0 ppb ($p < 0.0001$; Fig. 5).

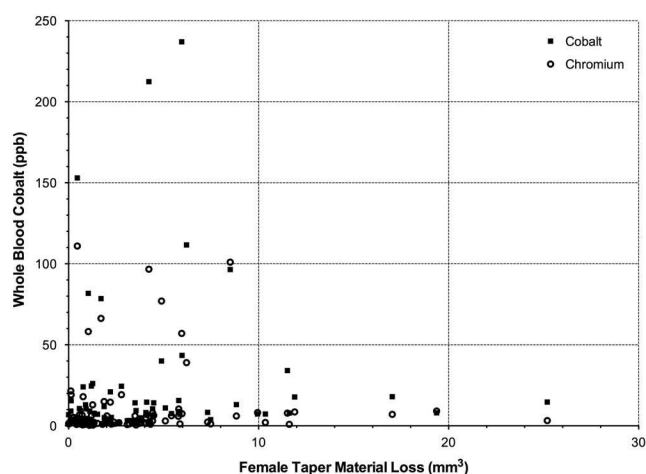
Figure 6. Scatter plot showing the correlation between whole blood metal ion levels and the volume of material loss from the female taper.

Univariable analysis showed that a weak but significant positive correlation existed between the volume of material loss from the female taper and Co levels ($\rho = 0.29$, 95% CI = 0.09–0.47, $p = 0.01$); however, no significant correlation was found with Cr levels ($\rho = 0.19$, 95% CI = -0.02 to 0.38, $p = 0.08$). No significant correlations existed between the male taper volume loss and either Co ($\rho = 0.41$, 95% CI = -0.10 to 0.75, $p = 0.10$), or Cr ($\rho = 0.47$, 95% CI = -0.03 to

0.78, $p = 0.06$) levels. Conversely, univariable analysis showed that the volume of material loss from the femoral bearing was significantly correlated with both Co ($\rho = 0.40$, 95% CI = 0.21–0.56, $p < 0.001$) and Cr levels ($\rho = 0.41$, 95% CI = 0.22–0.57, $p < 0.001$). Similarly, the acetabular bearing volume loss was significantly correlated with Co ($\rho = 0.39$, 95% CI = 0.20–0.55, $p < 0.001$), and Cr ($\rho = 0.37$, 95% CI = 0.18–0.54, $p < 0.001$) levels (Figs. 6 and 7).

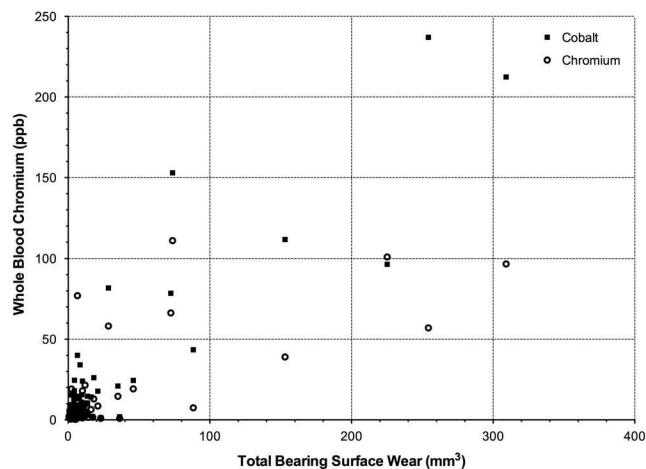
Figure 7. Scatter plot showing the correlation between whole blood metal ion levels and bearing surface wear volumes.

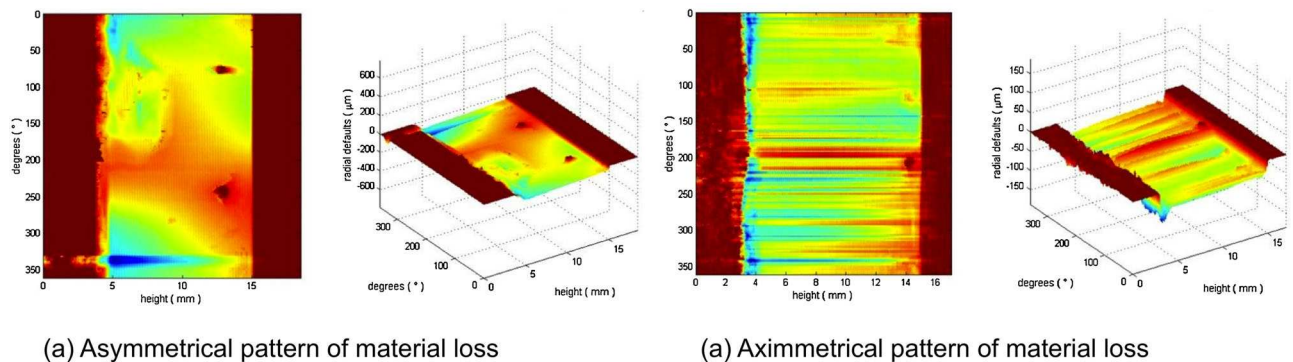
**Figure 8.** Typical taper surface measurements demonstrating (a) asymmetrical (19.4 mm³), and (b) axisymmetrical (17.0 mm³) patterns of material loss.

taper surface measurement profiles was rarely consistent with a mechanical process. In most cases we observed an axisymmetric pattern of material loss (Fig. 8), where material was lost uniformly over the male taper surface. This likely represents uniform loss or transfer of material, supporting a mechanism involving corrosion rather than wear. In contrast, increased local contact pressures would result in localized areas of increased material loss.
