Arctic field work in building technology

Thermo vision

Field work: 3 weeks in August 2007 (site visit)

Report: 9th January 2008

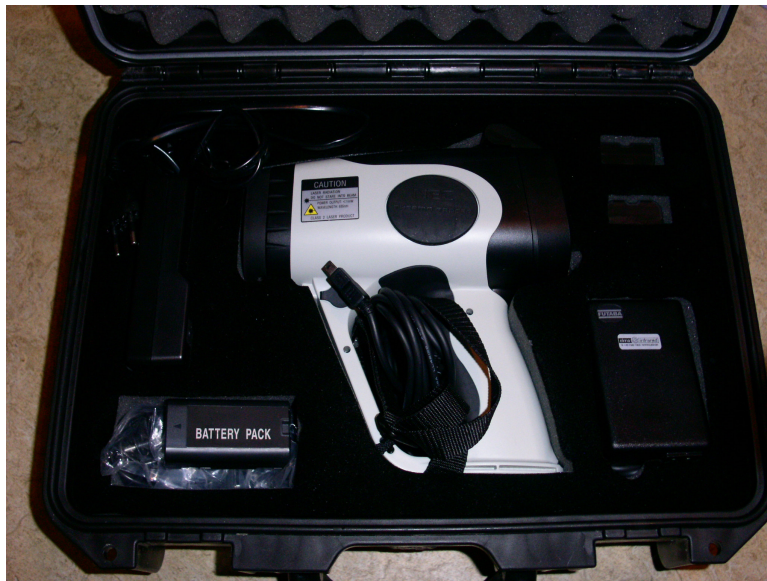
For measuring was used the thermo camera ARTRAY ARTCNV-NECS1 and for data evaluation was used software Viewer Program (TH78-719).

Figure 2: Thermo camera

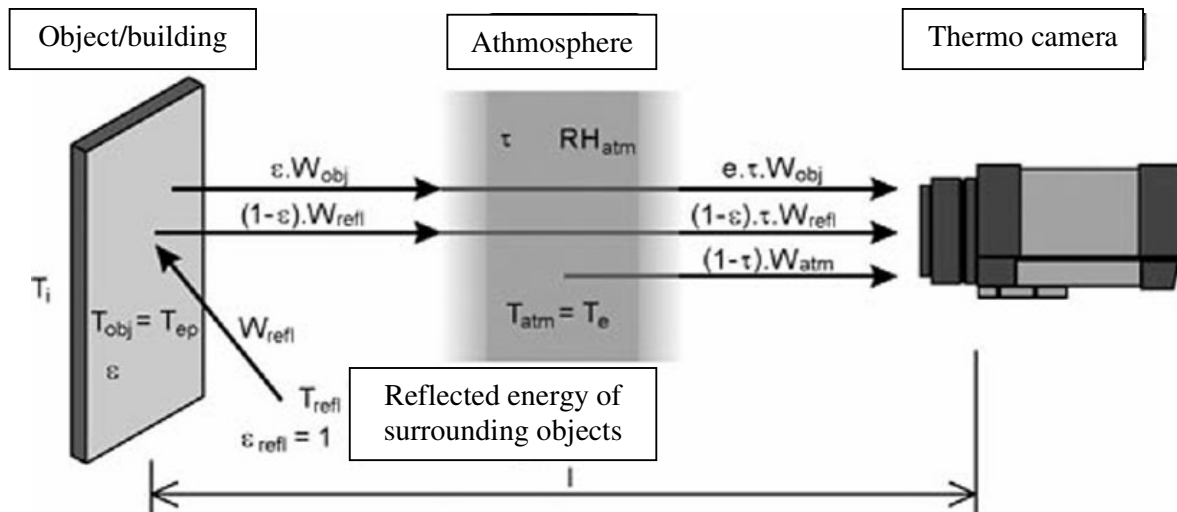
Figure 3: Scheme of thermo graphic measurements and boundary conditions [3]

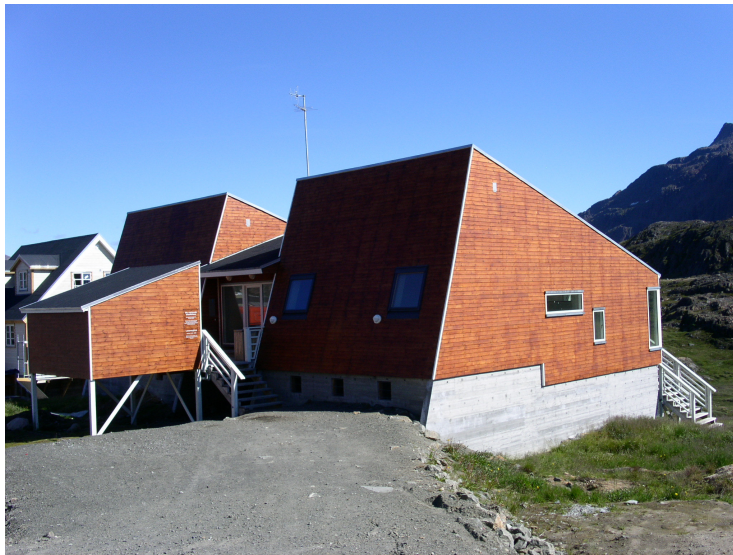
Figure 4: Low Energy House (LEH), Sisimiut

Low Energy House has been built in 2005 with new construction technology and with a larger focus on energy consumption and efficiency. Its area is 200 m² and it is a double house build by Technical University of Denmark and Sanaartornermik Ilinniarfik (The Building and Construction School of Sisimiut) with funding from the Villum Kann Rasmussen foundation. U-value of walls can be found in Table 3.

The Low Energy House is a very good example of a low-energy house and will be taken as comparison example for other buildings.

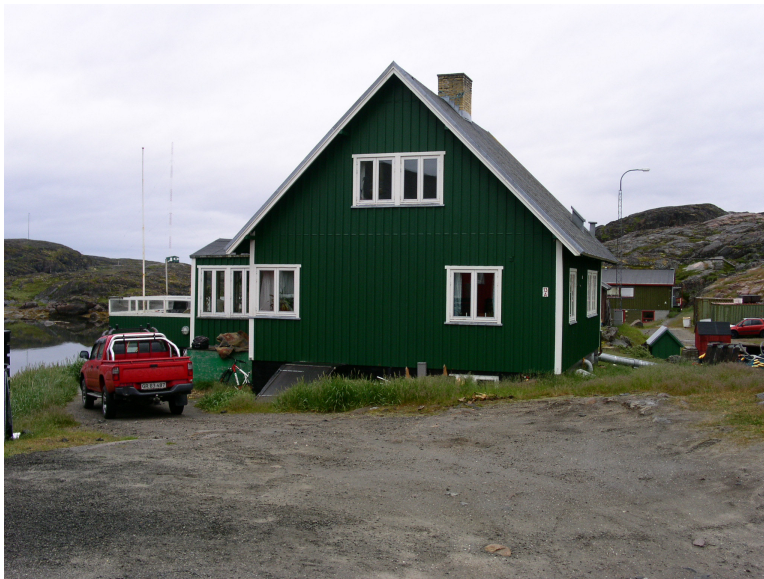
Figure 6: SFH, Sisimiut

Family house in Sisimiut is a standardized typical house from 1947 which has been renovated in 1989 with area 150 m². Its heating costs are 12 000 -14 000 DKK per year and they usually heat the house for 20 °C.

The owner of the house would like to decrease the heating consumption by insulating the house and there are complaints from too cold part of the house where the winter garden is (wind coming from the sea).

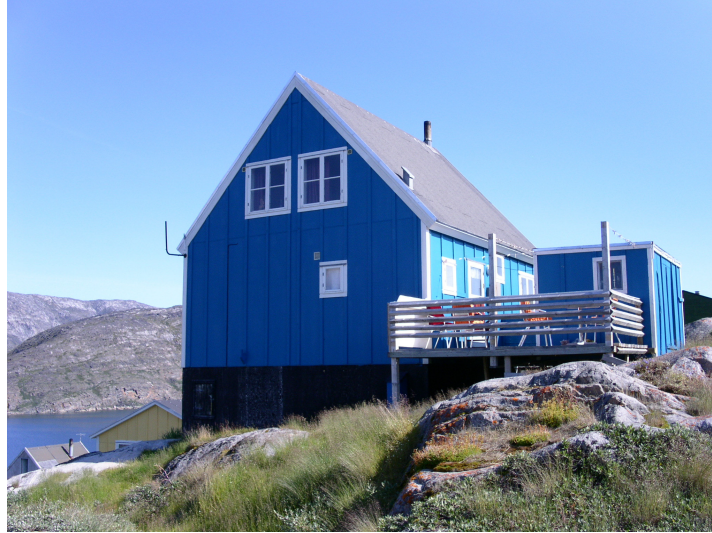
The next single family building is also a typical family house built in 1982, floor area 85 m² and its current insulation is 150 mm. The owner of the house has recently have changed the windows and door, and is thinking also about the extra insulation for walls. The windows are energy class A 1,1*.

Figure 10: SFH, Sarfannguaq, without new windows

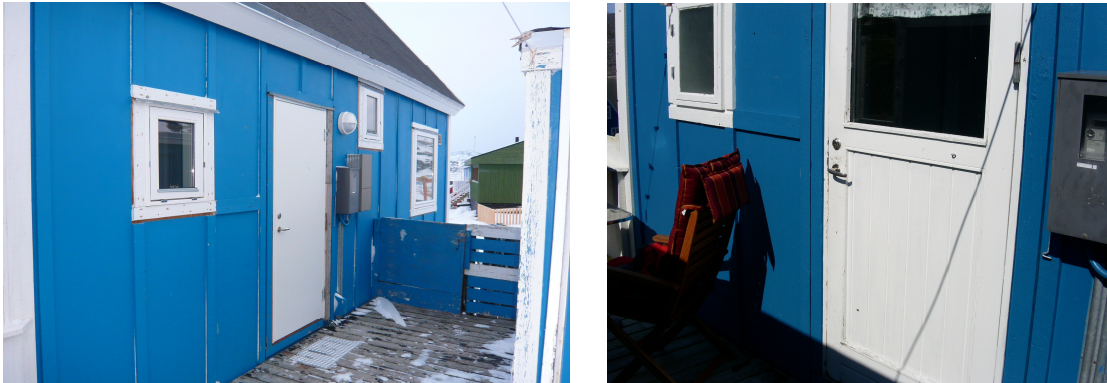
Figure 11: New and old doors

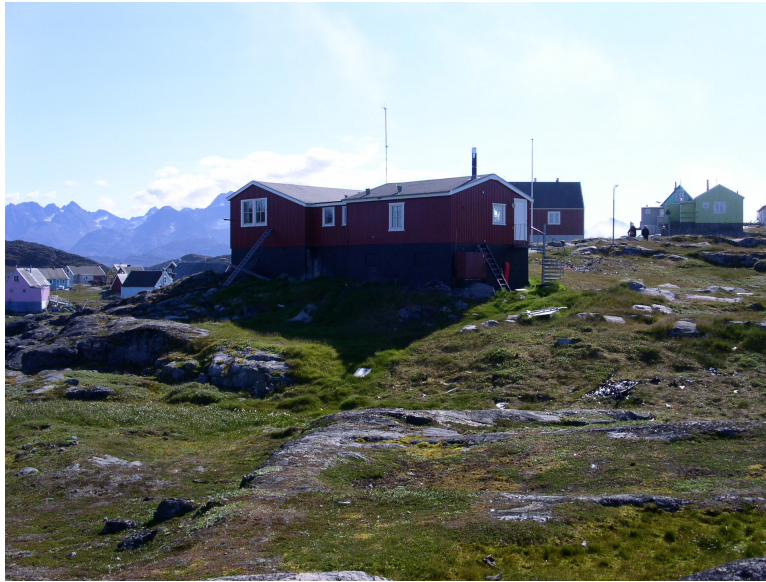
Figure 13: ES, Itilleq

The elementary school in Itilleq has been built in 1952 and renovated in 1984 with area 190 m². The school will be again renovated in 2008 (new extension, renovation of insulation, heating system, etc.).

The teachers are complaining about the wind coming through the basement (mostly through the exhaustion holes) from west side.
