Final Report on In-Reactor Creep-Fatigue Deformation Behaviour of a CuCrZr Alloy: COFAT 1

Risø-R-1571(EN)

At present, practically nothing is known about the deformation behaviour of materials subjected simultaneously to external cyclic force and neutron irradiation. The main objective of the present work is to determine experimentally the mechanical response and resulting microstructural changes in CuCrZr(HT1) alloy exposed concurrently to flux of neutrons and creep-fatigue cyclic loading directly in a fission reactor. Special experimental facilities were designed and fabricated for this purpose. A number of in-reactor creep-fatigue experiments were successfully carried out in the BR-2 reactor at Mol (Belgium). In the present report we first describe the experimental facilities and the details of the in-reactor creep-fatigue experiments carried out at 363 and 343K at a strain amplitude of 0.5% with holdtimes of 10 and 100s, respectively. For comparison purposes, similar creep-fatigue tests were performed outside of the reactor. (i.e. in the absence of neutron irradiation).

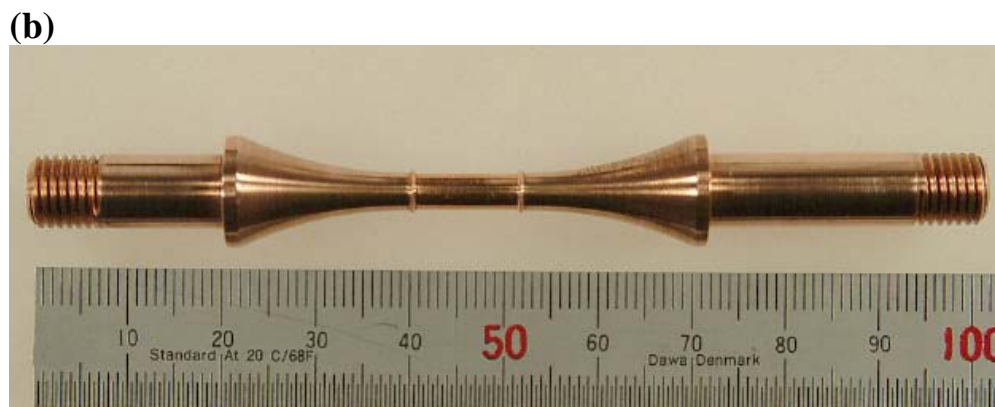
Figure 1. (a) Size and geometry of the creep-fatigue specimens used in the out-of-reactor and in-reactor creep-fatigue tests and (b) a photograph of one of the creep-fatigue specimens used in these tests.

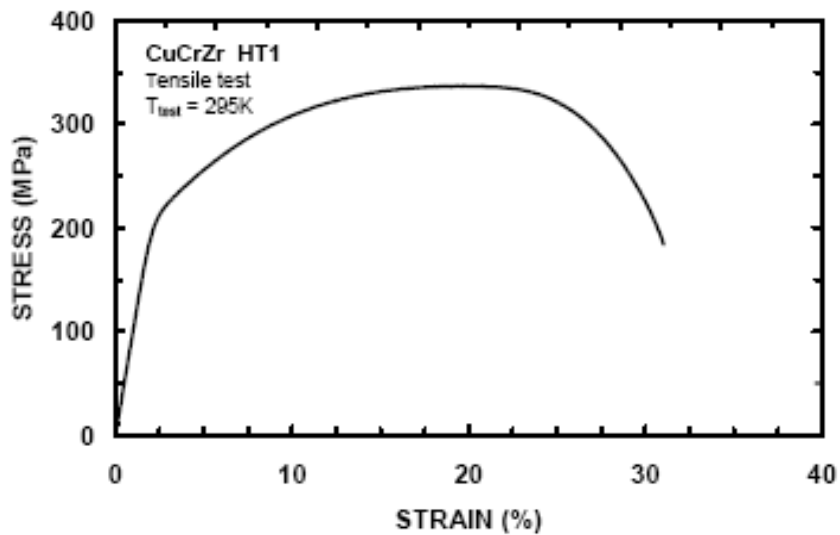
Figure 4. Stress-strain curve for the overaged CuCrZr (HT 1) alloy tested at 353K at a strain rate of 10^{-5} s^{-1} in the unirradiated condition. The test was performed on a specimen with the same size and geometry as used in the in-reactor tests and using a test module similar to that used in the in-reactor creep-fatigue tests.

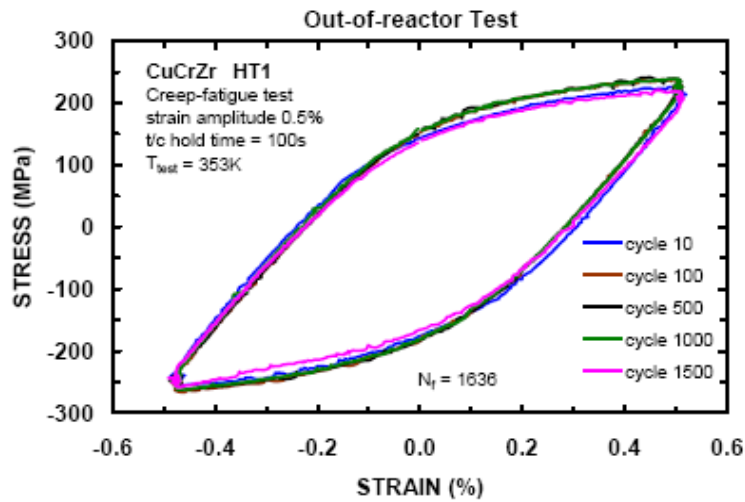
Figure 6. Same as in Figure 5(b) but for the higher number of creep-fatigue cycles representing increasingly higher level of deformation. The appropriate cycle numbers are indicated in the figure.

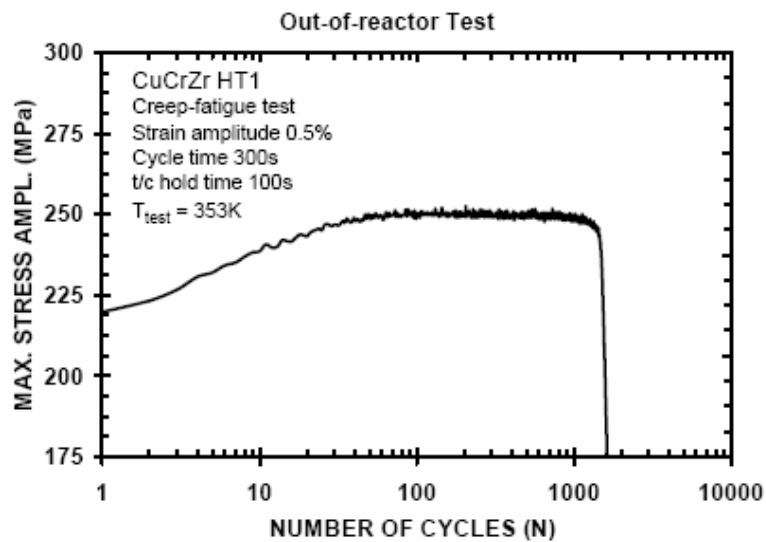
Figure 7. Variation of the maximum stress amplitude with the number of cycles during creep-fatigue test on the overaged CuCrZr(HT1) alloy at 353K with a strain amplitude of 0.5%. The maximum stress amplitude is the average of the maximum tensile and compressive stresses recorded during each cycle.

It is interesting to note that beyond the saturation in hardening, the deformation in the out-of-reactor test continues at the same maximum stress amplitude until about 1000 cycles and then the stress level decreases rapidly leading to final failure of the specimen. In the in-reactor tests Test No. 1 and 2, on the other hand, specimens begin to soften already after about 100 cycles first slowly and then rapidly beyond about 1000 cycles, leading to final failure of the specimens.

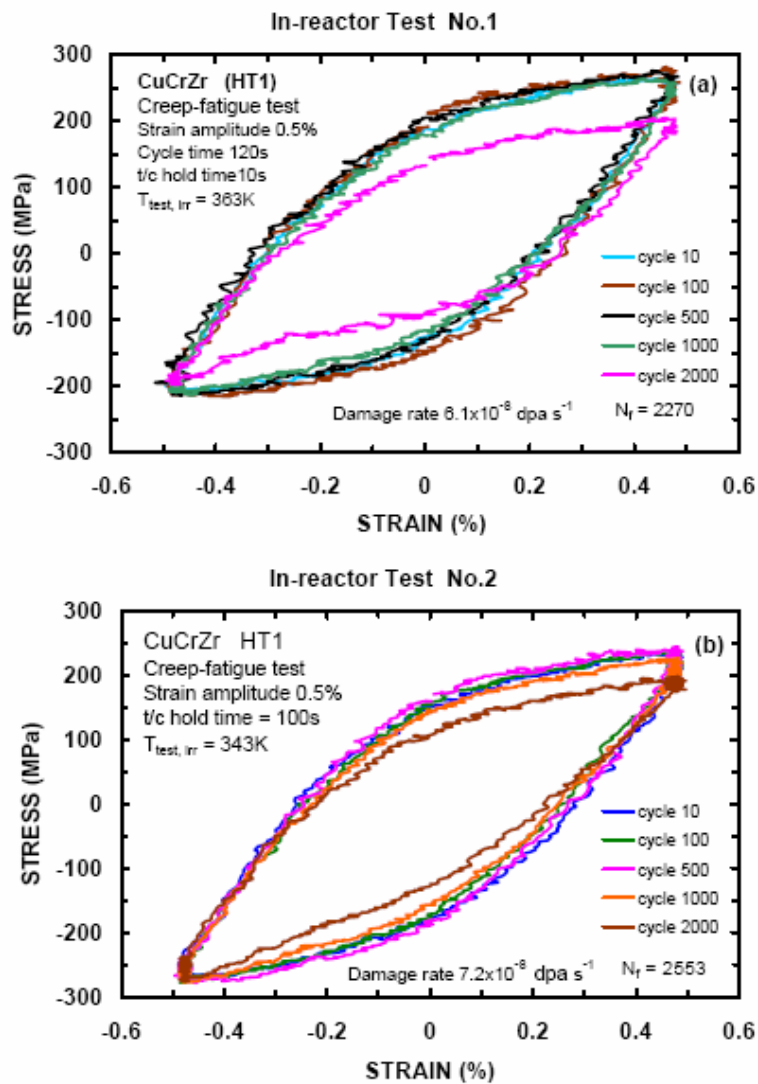
Figure 11. The cyclic deformation behavior in the form of hysteresis loops obtained for the higher number of creep-fatigue cycles representing higher level of deformation (and accumulated displacement dose) during the in-reactor creep -fatigue tests carried out at (a) 363K with a holdtime of 10s (Test No.1) and (b) at 343K with a holdtime of 100s (Test No.2). Both tests were carried out with a strain amplitude of 0.5 %.

Since both Test No.1 and 2 were carried out until the end of life of specimens (see section 2.3), a number of hysteresis loops for the higher number of creep-fatigue cycles during Test No.1 and 2 are shown in Figure 11. The position and the symmetry of hysteresis loops clearly show that a proper cyclic nature of deformation is maintained during the whole test period of the in-reactor Test No.1 and 2. It should be noted that the hysteresis loops for the cycle number 2000 both in Test No.1 and 2 clearly show a sharp drop in the stress amplitude indicating the presence of major cracks in the specimens.

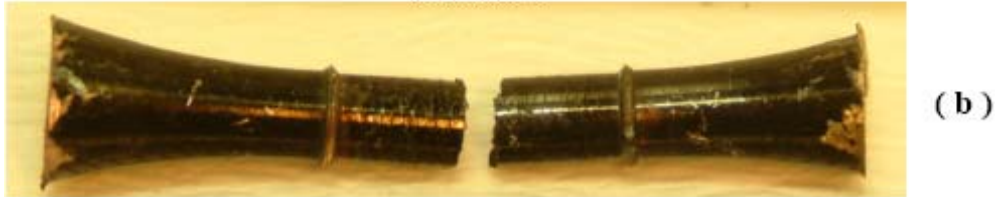
Figure 13. Photographs of the broken parts of the in-reactor creep-fatigue tested specimens used in (a) Test No. 1 and (b) Test No.2. None of the broken parts showed any evidence of necking of specimens prior to fracture

Photographs of the fractured parts of the specimens used in the in-reactor creep-fatigue (a) Test No1 and (b) Test No.2 are shown in Figure 13. It should be noted that these specimens did not break into pieces during the actual tests in the reactor. In fact they broke in the hot cells during the removal of the specimens from the test modules. It is also worth noting that these specimens did not show any sign of necking prior to fracture.
