Corrosion Reliability of Electronic Systems

Published in:
E C S Transactions

CORROSION RELIABILITY OF ELECTRONIC SYSTEMS

Rajan Ambat, Stine Garder Jensen, and Per Møller

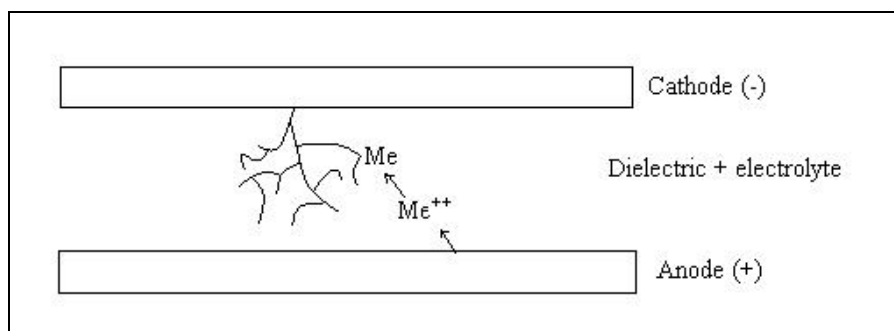
Figure 1. A schematic showing the electrolytic migration and dendrite growth between electrodes.

One of the common corrosion failure modes observed on PCBs is the electrolytic migration. The electrolytic migration is an electrochemical phenomenon involving metal dissolution at the anode and deposition at the cathode, which is controlled by the chemistry of the solution layer over the components and electric potential. The electrolyte contact needed for the process to occur, is often established by an adsorbed surface layer of water on the PCB surface. Charged dust particles, which are attracted to the surface, enhance the possibility of formation of water layer as they absorb moisture. Therefore, migration involves dissolution and deposition reactions and metal ion transfer induced by such factors as metal dissolution, diffusion and migration.

At the cathode, a part of the current will also be used for other cathodic reactions such as oxygen reduction or hydrogen evolution depending on the solution chemistry and potential. Formation of metal complexes, salts or oxides are other possible anode reactions. However, the important factor is the deposition of the metal at the cathode. Due to large resistance within the thin solution layer, significant current localization occurs at the electrode surface leading to preferential deposition and growth in the form of dendrites from cathode towards anode (as shown in Figure 1) eventually filling the electrode gap and short circuiting two parts of the components temporarily or permanently.

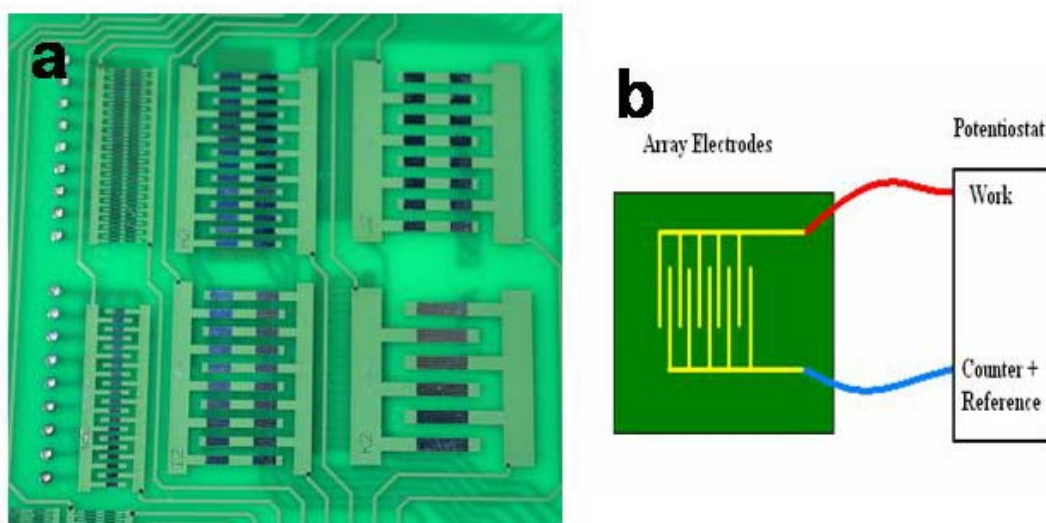
Figure 2. Electrodes and cell arrangement: (a) Model PCB with different electrode arrays and (b) cell arrangement used for the investigation with one set of arrays.

A model PCB with arrays of Sn-Pb alloy conduction lines as shown Figure 2a was made by re-flow soldering process. Each set of array electrodes on the PCB (Figure 2a) has different separation distance between alternative lines. For the experiment, a suitable array electrode set was cut from the PCB. Figure 2b shows a schematic of the cell set up arrangement for the electrolytic migration experiments. The array electrodes with cell connections as shown in Figure 2b is placed inside a humidity chamber under saturated conditions. The electrodes were cleaned thoroughly prior to each experiment with alcohol followed by water to remove any unwanted organic or inorganic contaminants on the surface. The variables related to array electrodes for investigation was only the separation distance between electrodes, which was varied between 0.3 mm – 3 mm. Exposure condition variables are temperature and applied voltage. The applied voltage shown in this paper is the potential difference between the adjacent electrodes in the array, which means that each electrode is polarized to a value that is half of the applied potential to negative and positive side. The current resulting from the migration is recorded as a function of time until a permanent surge in current was observed due to dendrites (due to electrolytic migration as explained before) filling the gap, which leads to a permanent electrical short.

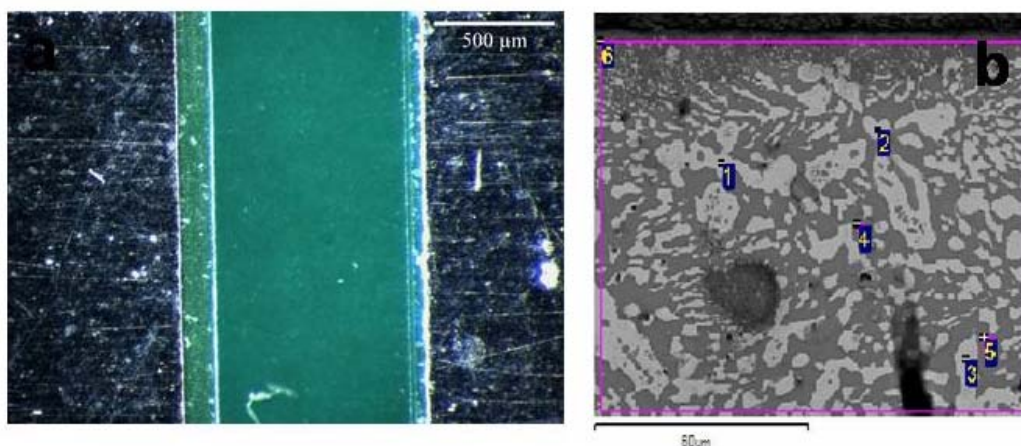
Figure 3. (a) Surface morphology of array electrodes, and (b) Microstructure of the array electrode at high magnification.

Figure 3a shows an optical micrograph of a pair of electrode from the model PCB (Figure 2a). The electrodes are compact without any visual defects. A number of such layers were analyzed with different separation distance using optical microscope. No significant variation in separation distance was observed between different arrays. The surface topography of the re-flow solder layer was also found to be uniform with a smooth surface appearance. Figure 3b shows the typical microstructure of the solder lines using SEM. At high magnification the solder arrays showed a dendrite structure with Pb dendrites in Sn matrix. This is attributed to the solidification process of the solder alloy with eutectic composition. The phase with bright contrast is lead rich and the other has more Sn. Table 1 shows composition of the overall alloy and various phases marked in Figure 3b. Overall composition of the solder material is shown in spectrum 6, which consists of 59 wt. % Zn, 32 wt. % Pb, and 9 wt. % Cu. The presence of copper is because of the higher interaction volume of the electron beam that will penetrate down to the base copper layer on the PCB over which the solder lines are formed by re-flow process.

Table I: EDS analysis of array electrodes (Analysis areas are numbered in Figure 3b)

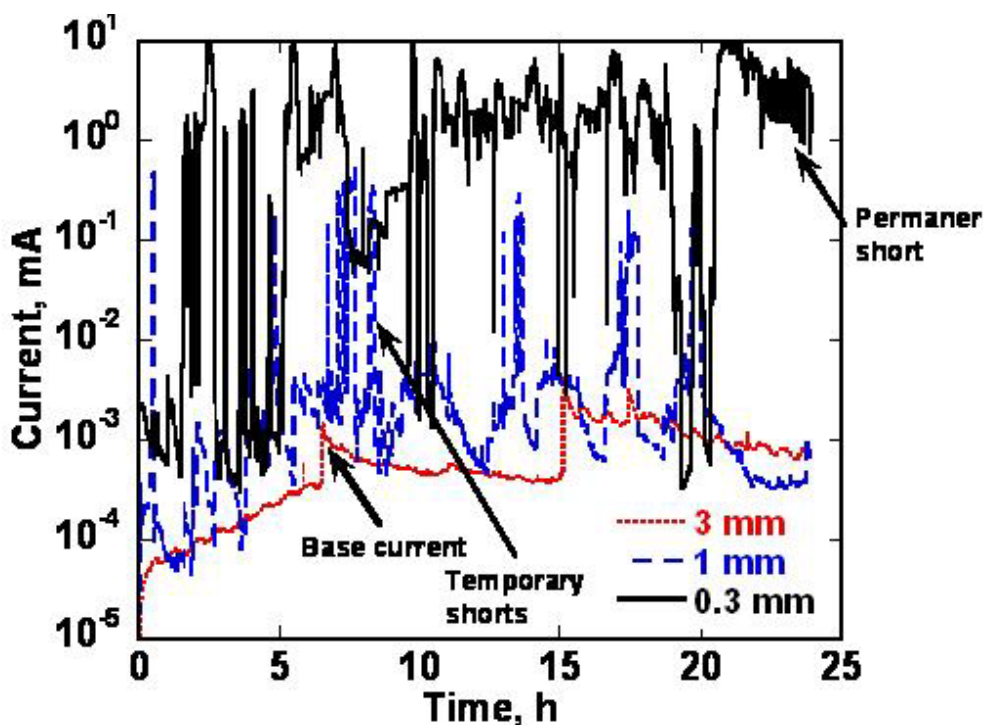
Figure 4. Migration current spectra as a function of separation distance.

Figure 4 shows the current spectra resulting from the exposure of electrode arrays with varying separation distance (the distance between two oppositely charged lines on the array in Figure 2) under exposure to saturated humidity with an applied potential of 1V at 50°C. The resulting base current (marked in the figure) level for each curve is a function of the electric field acting between lines. The magnitude of electric field is controlled by the distance of separation, IR drop within the solution layer, and the rate of faradic reactions occurring at the anode and cathode. The intermittent peaks (marked as temporary shorts) are due to dendrite formation and burning off, and a gradual increase in current to higher values (for example for the curve 0.3 mm distance after 20h) is due to a permanent short by dendrites filling the electrode gap.

The base current levels in Figure 4 (in electronic reliability terms, it is usually called as leakage current as it represents the level of current leaking through the solution layer between two points on a PCB surface) increases slightly with decrease in distance. This might be attributed to the increased electric field with decrease in separation distance. The difference in leakage current was high initially between various separation distances (by an order of magnitude), however, the difference decreases with exposure time. This is because with time as the ions build up in the solution due to dissolution of electrodes, naturally the current increases due to increased conductivity of the media reducing the difference between different separation distances. Table 2 gives the calculated electric field between the conduction lines at various potential differences.

The curves in Figure 4 also shows intermittent peaks (temporary shorts) corresponding to instantaneous surge in current. The temporary electric shorts produced by a growing dendrite, which eventually burn off due to current surge during the shorting, produce these peaks. This process will continue until a significant volume of the dendrite is formed, which cannot be burned by the surge in current. The curve shows that the distance between electrodes has a significant effect on the temporary shorts as it can be observed that the number of peaks increases with decrease in distance between electrodes. The time elapsed until the formation of the first temporary short is also decreased with

decrease in distance of separation. Also for 0.3 mm distance, a permanent short has been established after 20h of exposure that is absent for other distances. Takemoto (13) also reported a decrease in the time required for the formation of first short with reduction in distance between conductors, as the metal ions in this case have to migrate only shorter distances under higher electric field. From the perspective of the miniaturization of the electronic devices, the present results clearly show how a decrease in distance on PCB could influence electrolytic migration and therefore cumulative damage and malfunction of the components due to temporary shorts and current surge.

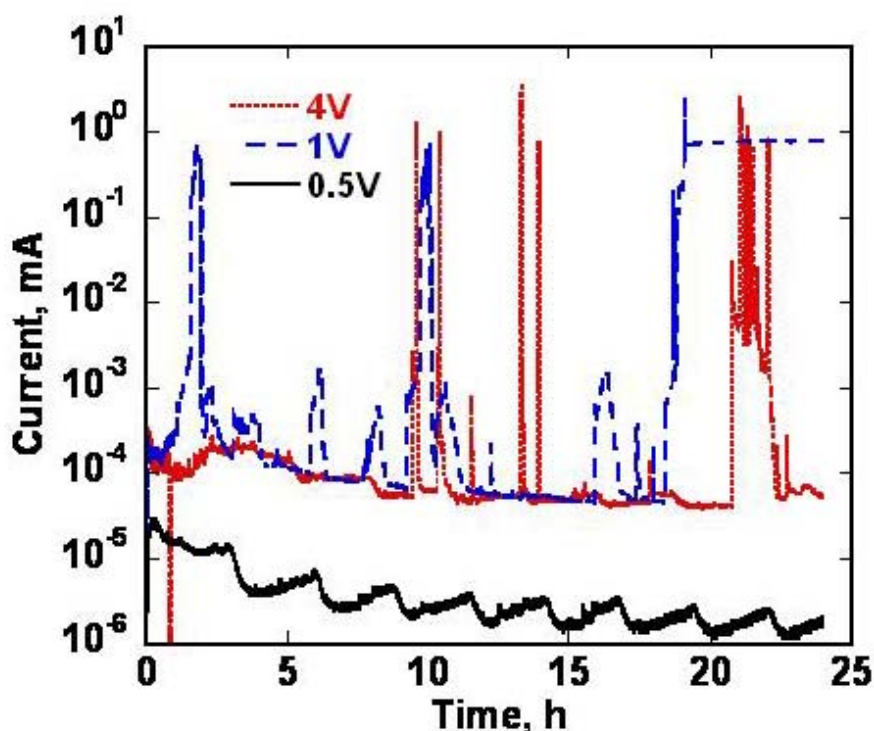
Figure 5. Migration current spectra as a function of applied potential.

Figure 5 shows the current spectrum from a similar experiment using 0.3 mm wide electrode array at 30°C with different potential values between them. The base leakage current increases by an order of magnitude with increase in potential from 0.5 V to 1 V, while further increase in potential did not show any increase. At 0.5 V, no temporary shorts were observed showing that the potential is not enough for electrolytic migration under these conditions. However, increasing the voltage to higher values showed temporary peaks (~1.5 h for 1 V and ~9 h for 4 V) and incidentally for 1 V, a permanent short was observed after 18 h of exposure. The number of temporary shorts were slightly more for the 4 V, however, the width of the peaks are higher for 1 V. At 1 volt, the peaks (dendrites) typically have duration of 1h, where as at 4V they burn off immediately. This is understandable as more migration is expected at higher potential and therefore growth of dendrites. Formation of more dendrites gives rise to more temporary shorts, while width of the peak decreases with increase in voltage due to fast burning of the formed dendrites due to higher current levels. Takemoto (13) has observed similar behaviour for Sn-Pb electrode with increasing potential gradient between them. The increased potential gradient enhances the driving force of migration of the metal ions, as well as it enhances the dissolution of metal ions, until the limiting corrosion current density is reached.

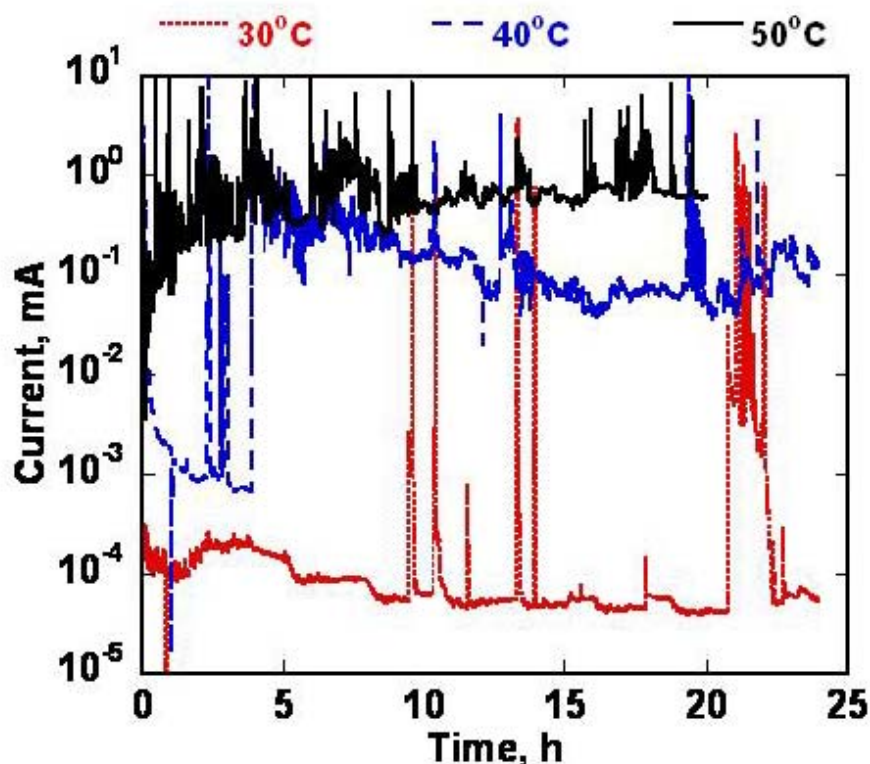
Figure 6. Migration current spectra as a function of exposure temperature.

Figure 6 shows the migration current spectrum as a function of temperature from an electrode array with 0.3 mm width with 4V potential difference. The effect of temperature is clear as the base current level at 30°C is low and only few temporary shorts are observed starting after 9 h. On the other hand at 40°C after 4h and 50°C within few minutes, current increases to a value of 1 mA corresponding to permanent short due to electrolytic migration. The observed effects are assumed to be due to increased rate of the overall processes including transport through the solution as the temperature increases. The results are very relevant as in practice PCBs undergo temperature cycling to the tune of 20-30°C or more depending on the application. A localized variation in temperature is also possible between different locations on a PCB surface.

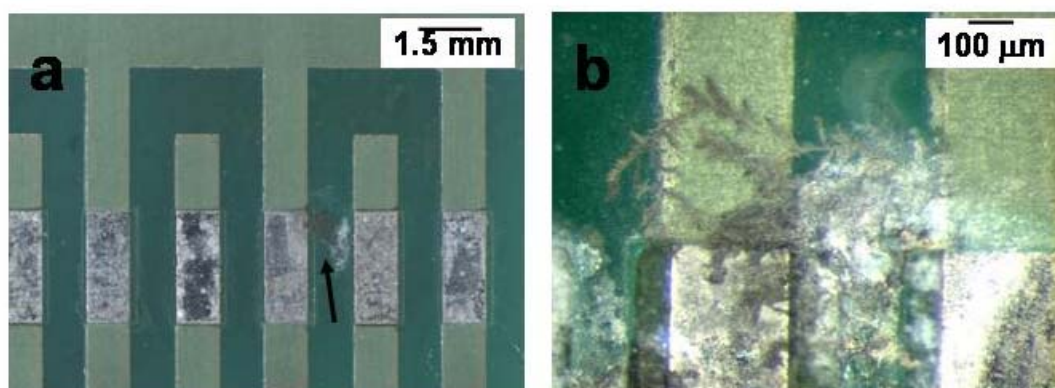
Figure 7. Optical micrographs showing morphology of electrode arrays (1 mm width, 40°C, 4V) after migration experiments.

Figure 7 shows the optical micrographs of the electrodes after migration experiments. Localized growth of dendrite could be seen (see arrows in Figure 7a) and white patches representative of the heat damage on the epoxy polymer. This is more visible in Figure 7b where the heat damage to the polymer is clearly seen as white patches together with dendrites covering one of the electrode surfaces. The heat damage indicates that when two conductors are short-circuited, some amount of heat is generated depending on the level of current. The amount of dendrites as well as the extent of damage to the polymer due to heat was found to be largest on the PCBs exposed to highest potential difference. Also, the electrode systems separated by the smallest distance were more affected by this heat damage than the electrode systems with larger distances.

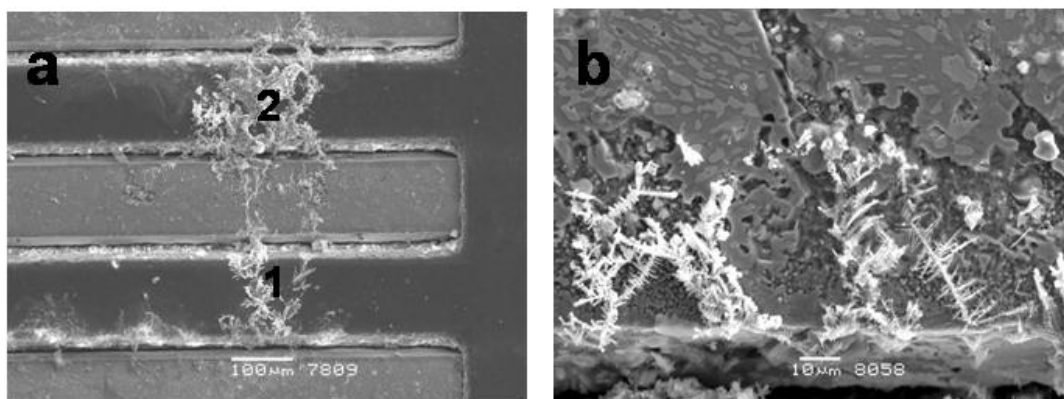
Figure 8. SEM pictures of migration tested electrode array at 50°C, 4V: (a) dendrite morphology, and (b) selective dissolution of microstructural features.

Figure 8 shows the SEM image of the array electrodes exposed at 50°C at 4V after migration experiments. The morphology of the migrated species between electrodes showed two types of morphology: (i) slim fine branched dendrites consisting mainly Sn (~80-90%, marked 1) and (ii) bulky dendrites consisting mainly Pb (~50-80%, marked 2) with some Sn. Formation of Sn rich dendrites with similar appearance for Sn-Pb alloy was reported by Yu et al (14, 15). Formation of Sn rich dendrites was more dependent on the applied potential difference. The amount of Sn rich dendrites increased with increase in applied potential.

At higher magnification, the effect of microstructure on dissolution is observed as shown in Figure 8b. The bright areas corresponding to Pb rich phase is preferentially dissolved compared to the Sn rich phase. This is understandable as Sn is more passive and less active than Pb.

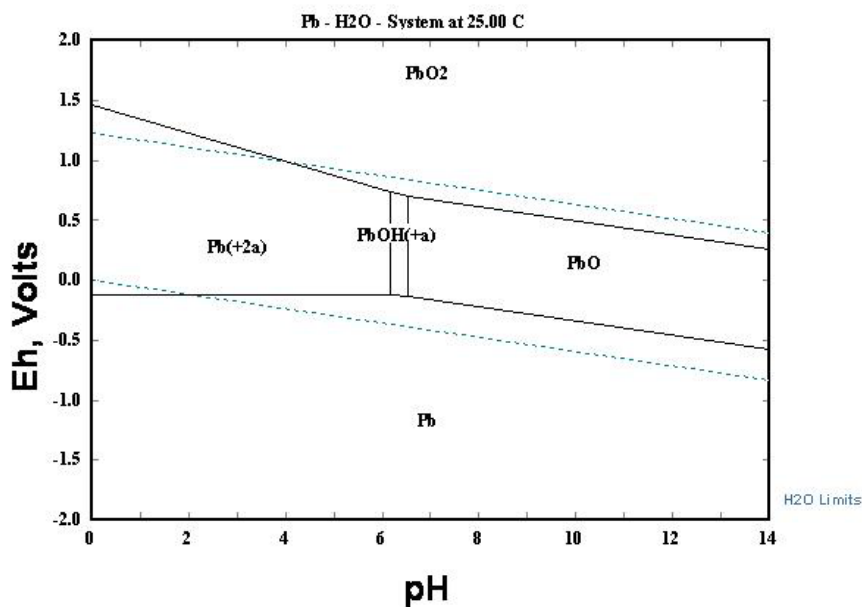
Figure 9. Pourbaix diagram for Pb in pure water with Molarity of Pb ions 1×10^{-6} Mols/l constructed using standard Outokumpu HSC Chemistry 4.0 software.

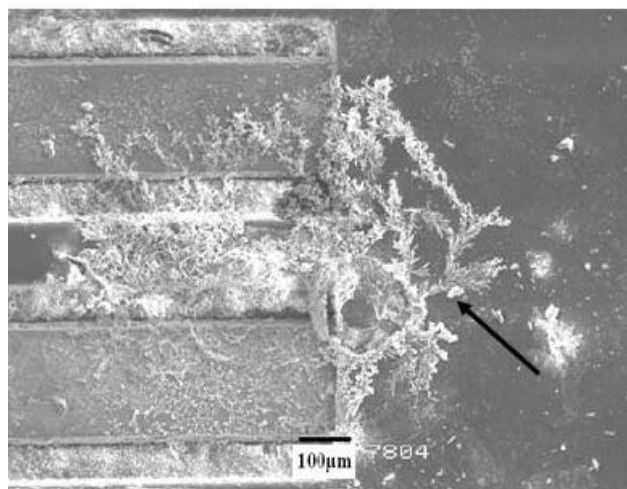
Figure 10. Edge effect on electrolytic migration.

Figure 10 clearly shows the edge effect on the electrolytic migration. As the current lines concentrate

preferentially at the sharp edges, preferential growth of dendrites in the form of an arc could be seen at the edge of the electrodes (see arrow in Figure 10).

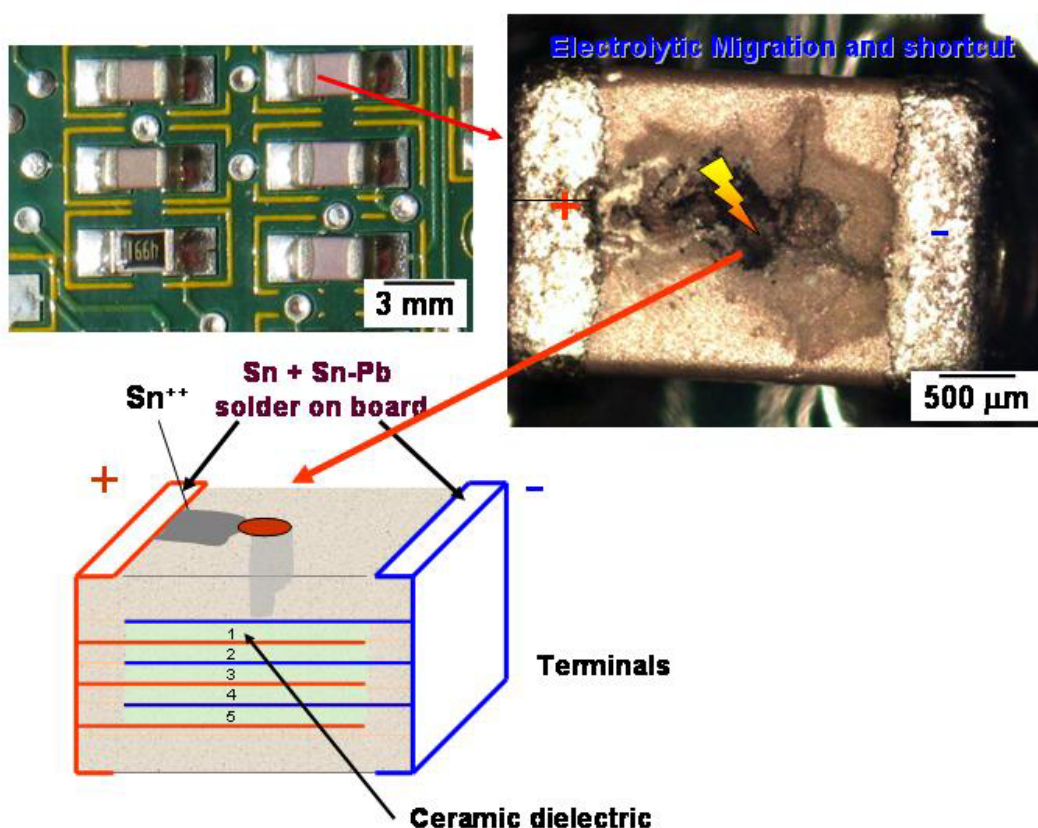
Figure 11. An in-service electrolytic migration failure of a ceramic capacitor.

Figure 11 shows a typical example of such in-service failure of a ceramic capacitor on a PCB under humid conditions. This ceramic capacitor had a Sn termination electrode that wave soldered on to the PCB using Sn-Pb alloy. The ceramic was dielectric Barium Titanate. A number of ceramic capacitors on this PCB have failed due to electrolytic migration in-service. The capacitor shown in Figure 11 shows migration tracks from cathode to anode produced by electrolytic migration. The capacitor has also been broken up at the centre possibly due to penetration of humidity inside and downward migration as shown in the schematic in Figure 11.

The ingress of water into the capacitor leads to evolution of gases at the negatively biased metal foils of the capacitor as well as downward migration causing shorting and current surge. Microscopic flaws in the ceramic layer lead to ingress of water for facilitating a conducting path between the inner electrode layers of the capacitor to the outer electrodes

(as shown in the schematic). This results in electrochemical reactions at the inner foils depending on the bias. A possible scenario is the coupling of the cathode foil layers with positive electrode of the capacitor giving rise to cathodic reactions on the inside foils evolving gases making the capacitor to break.
