Published in:
E C S Transactions

Interface Resistance Between FeCr Interconnects and $\text{La}_{0.85}\text{Sr}_{0.15}\text{Mn}_{1.1}\text{O}_3$

L. Mikkelsen, K. Neufeld, and P. V. Hendriksen

Fuel Cells and Solid State Chemistry Division, Risø National Laboratory for Sustainable Energy, Technical University of Denmark – DTU, DK-4000 Roskilde, Denmark

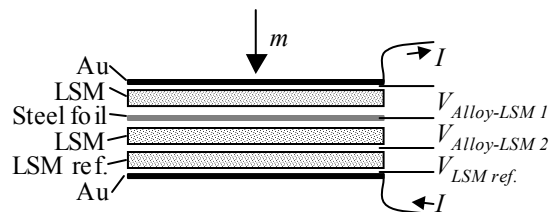
Figure 1. Schematic illustration of the experimental setup used for electrical characterization of alloy-LSM interface.

with a two-layer coating consisting of an inner layer of Co_3O_4 and an outer layer of $\text{La}_{0,85}\text{Sr}_{0,15}\text{Mn}_{1,1}\text{O}_3$ (LSM15) containing a small amount of Co_3O_4 . Each coating layer had a thickness of $\sim 15 \mu\text{m}$. A $2 \times 2 \text{ cm}^2$ mask was used for the spraying in accordance with the dimensions of the auxiliary LSM15 plate (see below). The samples were positioned between unsintered LSM plates ($2 \times 2 \text{ cm}^2$) giving a nominal contact area of 4 cm^2 between the foils and the LSM plates. Platinum wires were spot-welded to the alloy sheets for voltage probing. Platinum voltage probes were also applied on either side of the LSM plates completing the sandwich. A schematic illustration of the experimental setup is shown in Figure 1. The electrical interface resistance between the steel samples and LSM plates was measured by a DC four-point method. Each sample resulted in two measurements of the interface resistance. The values shown below are an average of the two measurements. Details of the experimental setup are given in (2).

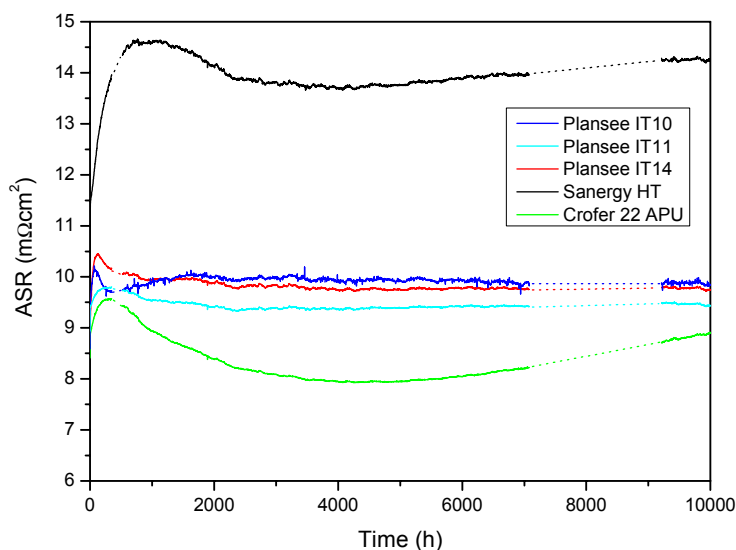
The measured ASR-values are shown in Figure 2. The ASR-values include a contribution from the auxiliary LSM plate corresponding to $7\text{-}8 \text{ m}\Omega\text{cm}^2$. The interface resistance increases for all the alloys during the initial $100\text{-}800 \text{ h}$ of annealing, until the ASR-values start to decrease slowly. The ASR-values are a result of a complex interplay between the scale growth, increased electrical contacting between the coated interconnects and the LSM plates as a result of sintering, and a gradual change of

Figure 2. ASR-values of the interfaces measured in air at 750°C. Data acquisition failed for two periods of time as indicated in the plot.

composition of the oxide scale as a result of diffusion of cations from the alloy and reaction between the oxide scale and the coating. The initial increasing ASR-values indicate that a fast growth of the oxide scale dominates the ASR-values initially. After the increasing interface resistances, the ASR-values start to decrease. This is probably a result of a slower oxide growth combined with a gradual change of the composition of the oxide scale and a better electrical contact. The ASR-values of Sanergy HT and Crofer 22 APU increase after approx. 5000 h, probably as a result of a higher growth rate for these alloys. The ASR-values of the Plansee alloys are almost constant with time after 2000 h, probably as a result of a very slow oxide growth rate of the oxide scale at the interface.

Low degradation rates were observed for all the interfaces. Thermal cycles were performed after 10000 h of testing without a degradation of the ASR-values. This shows that the differences in TEC-values do not lead to delamination between the different layers. The interface resistances were strongly temperature dependent, showing an Arrhenius type temperature dependency with an activation energy of 0,5-0,6 eV.

The contact resistance measurements showed that all the interfaces had ASR-values of less than $10 \text{ m}\Omega\text{cm}^2$ (after subtract of the auxiliary LSM plate) after 10000 h oxidation at 750°C in air. The measured ASR-values must be a result of the formed oxide scale at the interface. The electrical conductivity is approx. 5 S/cm for MnCoCrO_4 at 750°C in air (6). The conductivity is too high to account for the observed ASR-values, so the interface resistance must be governed by Cr_2O_3 instead. It was found that Sanergy HT formed the thickest layer of Cr_2O_3 . This explains that this alloy also exhibited the largest ASR-values. The evolution of the ASR over time indicates that the largest part of the Cr_2O_3 is formed during the initial oxidation. The ASR-values of the Plansee alloys are almost constant after an initial period.

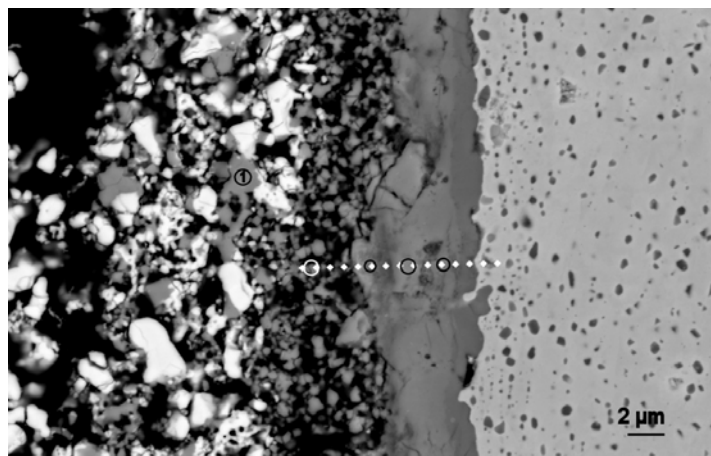
A cross section of Plansee IT10 is shown in Figure 3. An oxide scale with a thickness of 4-5 μm has grown on the alloy. Linescan analysis across the oxide scale as well as the cobalt oxide coating is shown in Figure 4. The oxide scale was identified as an inner approx. 1 μm thick layer of Cr_2O_3 and an outer spinel layer. The two phases can also be distinguished by the contrast difference. The dark particles in the alloy matrix were identified as titanium oxide resulting from internal oxidation. Titanium was also identified in the Cr_2O_3 layer. The linescan analysis shows that the composition of the spinel layer changes from a chromium rich spinel to a cobalt and manganese rich spinel. The composition of the inner coating layer is almost constant containing a small amount of chromium. The compositions of the spinel phase in the oxide scale and in the inner coating are summarized in Table II for all samples.

Figure 3. SEM micrograph of cross section of the Plansee IT10-coating interface. The EDX linescan and points where composition analysis was carried out are indicated.

Dark particles were observed in the LSM15-based coating. EDX point analysis (see Table III) shows that the particles are (Mn,Co,Cr)-spinel containing approx. 3 at.% Cr. Dark particles were observed on all samples and no difference of the Cr-content was observed between the different samples. Furthermore, the chromium content did not vary systematically as a function of distance from the coating-oxide scale interface. The dark particles were evenly distributed in the LSM15 layer.

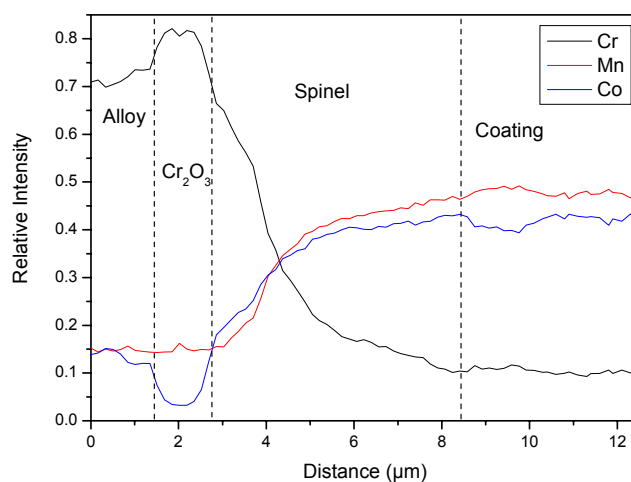
Figure 4. EDX linescan analysis across the Plansee IT10-coating interface. See Figure 3 for position of the scan.

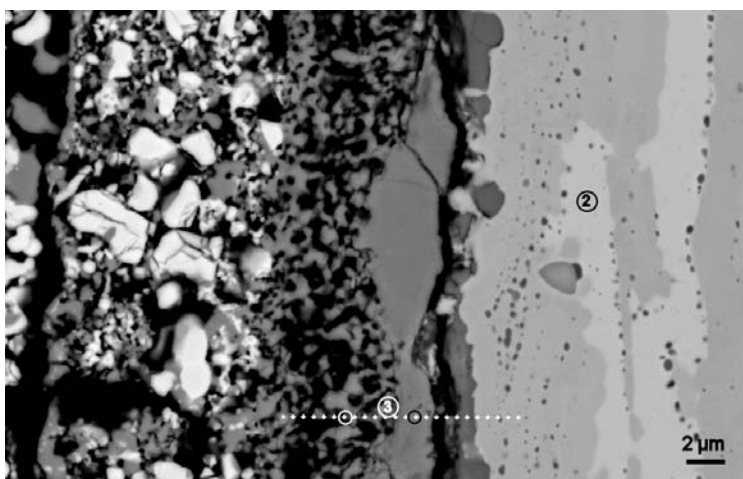
A cross section of Plansee IT11 is shown in **Figure 5**. An oxide scale with a thickness of 2-3 μm has grown on the alloy although areas exist where the oxide scale is thicker (4-5 μm) as shown in **Figure 5**. EDX analysis of the sample is shown in Table II and Table III. The coating contains a small amount of iron. The presence of iron does not increase the ASR-values measured over the interface (see Figure 2), since iron containing spinels in general have a high electrical conductivity (3). The presence of iron indicates, however, local failure of the oxide scale during oxidation. These failures of the oxide scale accelerate the growth of the oxide and may lead to catastrophic oxidation for longer oxidation times than 10000 h. It is also observed that the oxide scale is not adherent to the alloy over the whole alloy-oxide interface. A slightly smaller amount of manganese is present in the oxide scale and coating compared to Plansee IT10. Plansee IT11 does not contain manganese, so the manganese diffuses from the LSM15 coating layer instead. The comparison between the two alloys shows that a significant part of the manganese present in the inner coating layer and in the oxide scale originates from the coating. The thinner oxide scale grown on the Plansee IT11 is, however, a result of the lack of manganese in the alloy.

Figure 5. SEM micrograph of cross section of the Plansee IT11-coating interface.

White particles are observed within the alloy matrix. These particles are probably Sigma phases. The formation of Sigma phases has previously been observed in similar alloys (4). The Sigma phase is relatively chromium rich. The formation of Sigma phases probably alters the mechanical properties of the alloy, since the Sigma phases is known to be brittle.

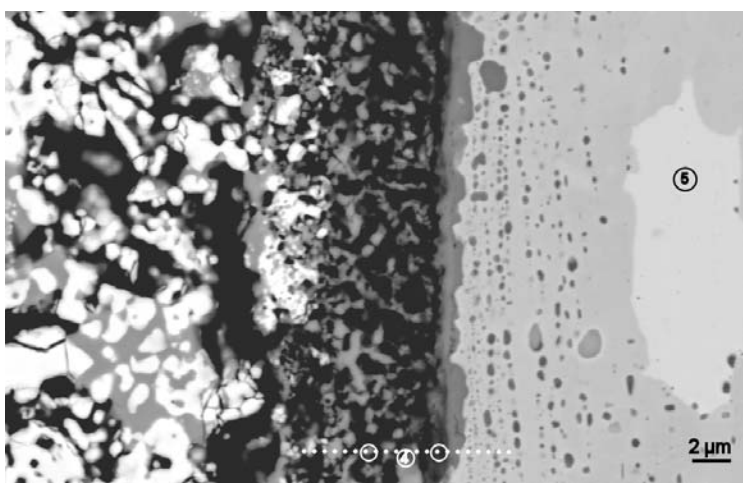
A cross section of Plansee IT14 is shown in **Figure 6**. Results from the EDX analysis of the cross section are shown in Table II and Table III. The microstructure of the cross section is similar to the microstructure of Plansee IT11. A higher content of manganese is present in the oxide scale, which is a result of the presence of manganese in Plansee IT14. The Sigma phase is also present in this sample. Iron is also present in the oxide scale in this case.

Figure 6. SEM micrograph of cross section of the Plansee IT14-coating interface.

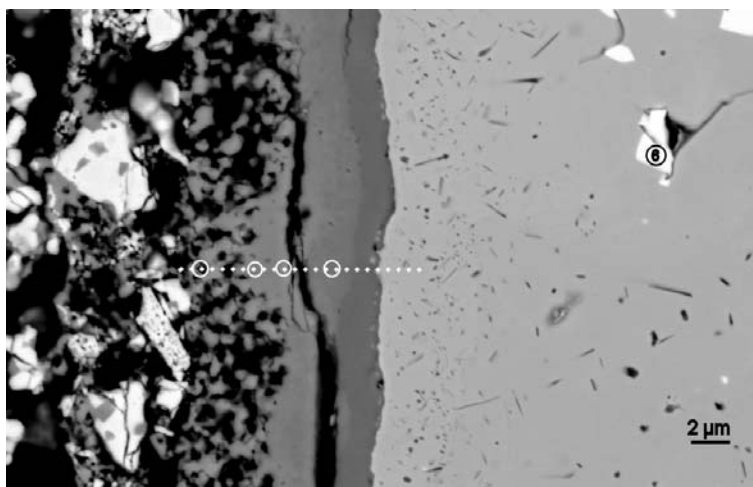
A cross section of Sanergy HT is shown in **Figure 7**. An oxide scale of approx. 5 μm has grown on the alloy. The linescan EDX analysis shows that the oxide scale consists of an inner Cr_2O_3 layer and an outer spinel layer. The thickness of the Cr_2O_3 layer is approx. 2 μm . The two layers can be distinguished by the contrast difference in the micrograph.

Figure 7. SEM micrograph of cross section of the Sanergy HT-coating interface.

The inner layer was identified as pure Cr_2O_3 . The content of chromium in the spinel is higher for Sanergy than observed for the Plansee alloys, albeit the Cr content in the outer spinel layer and in the Co_3O_4 coating is low. The chromium content of the spinel at the air-oxide scale interface is interesting, since Cr-species evaporates from the oxide scale during operation resulting in the so-called Cr-poisoning of the SOFC cathode. Thus, the results indicate that the oxide grown on Sanergy HT inhibits Cr-poisoning in a similar way as the Plansee alloys. The oxide scale appears to be well adherent on most of the interface and iron was not detected in the oxide scale. Titanium oxide is identified in the alloy matrix resulting from internal oxidation. White particles are observed in the alloy matrix. The particles are probably Laves phases. The formation of Laves phases have previously been shown to result in high creep strength and increased oxidation resistance of alloys (5).

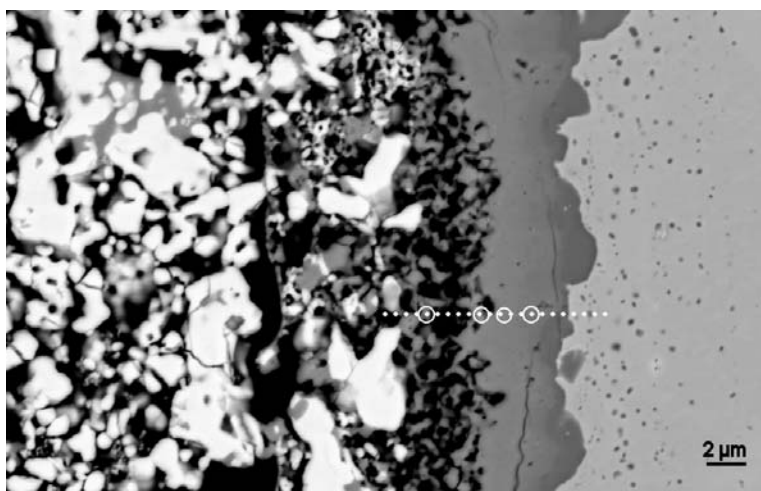
A cross section of Crofer 22 APU is shown in **Figure 8**. An oxide scale of approx. 5 μm has grown on the oxide scale. The oxide scale is similar to the oxide scale grown on Sanergy HT although the Cr_2O_3 layer grown on Crofer 22 APU is thinner. The content of chromium in the spinel grown on Crofer 22 APU is comparable to Sanergy HT (both have higher Cr-content than the spinel layer grown on the Plansee alloys).

Figure 8. SEM micrograph of cross section of the Crofer 22 APU-coating interface.
